Amchitka Annual Site Inspection Trip Report Amchitka, Alaska, Site

August 2017

U.S. DEPARTMENT OF
ENERGY

Legacy
Management

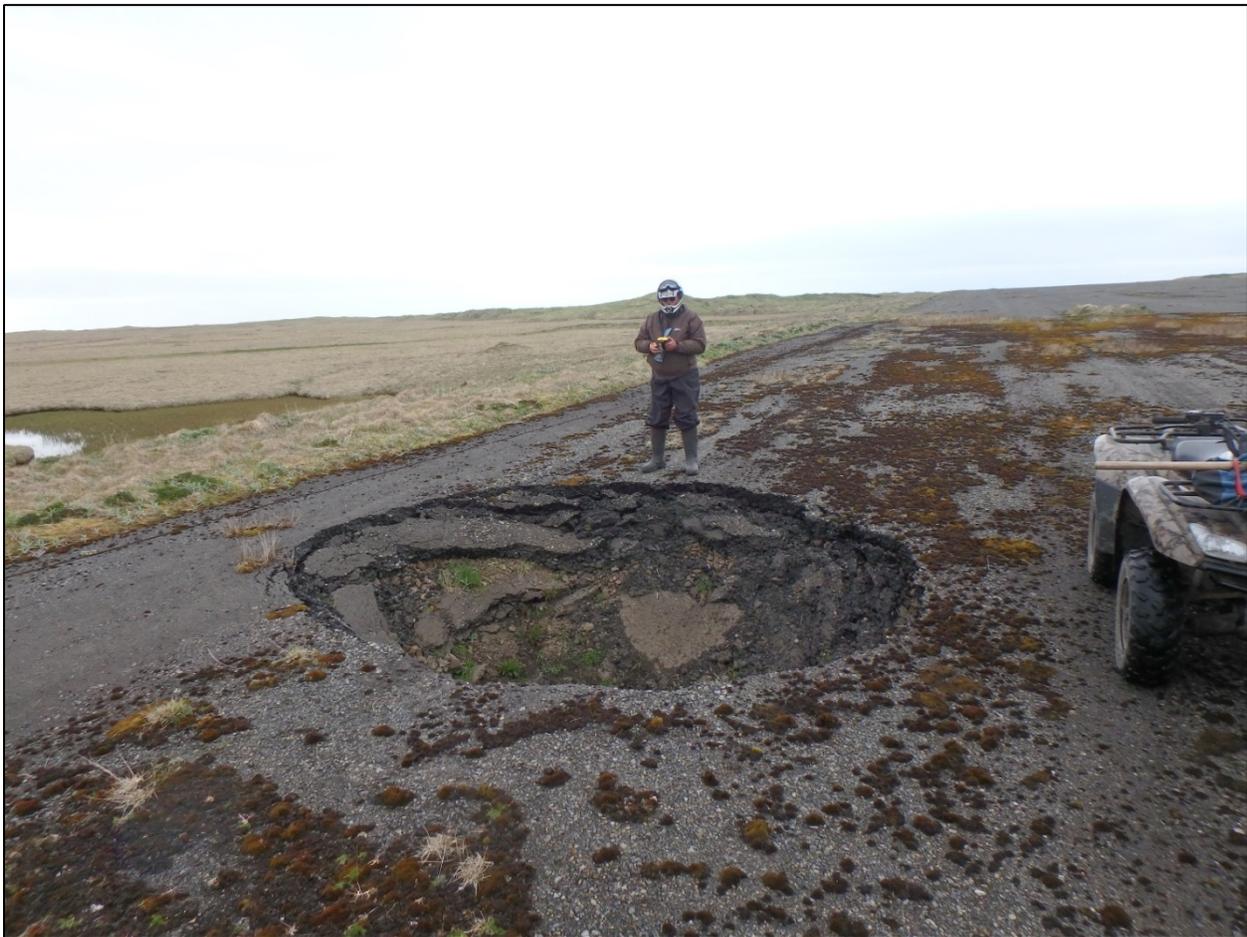
PL-CR07. Sink hole approximately 12 ft by 16 ft., 7 ft deep, approximately 200 yards from north end on east side

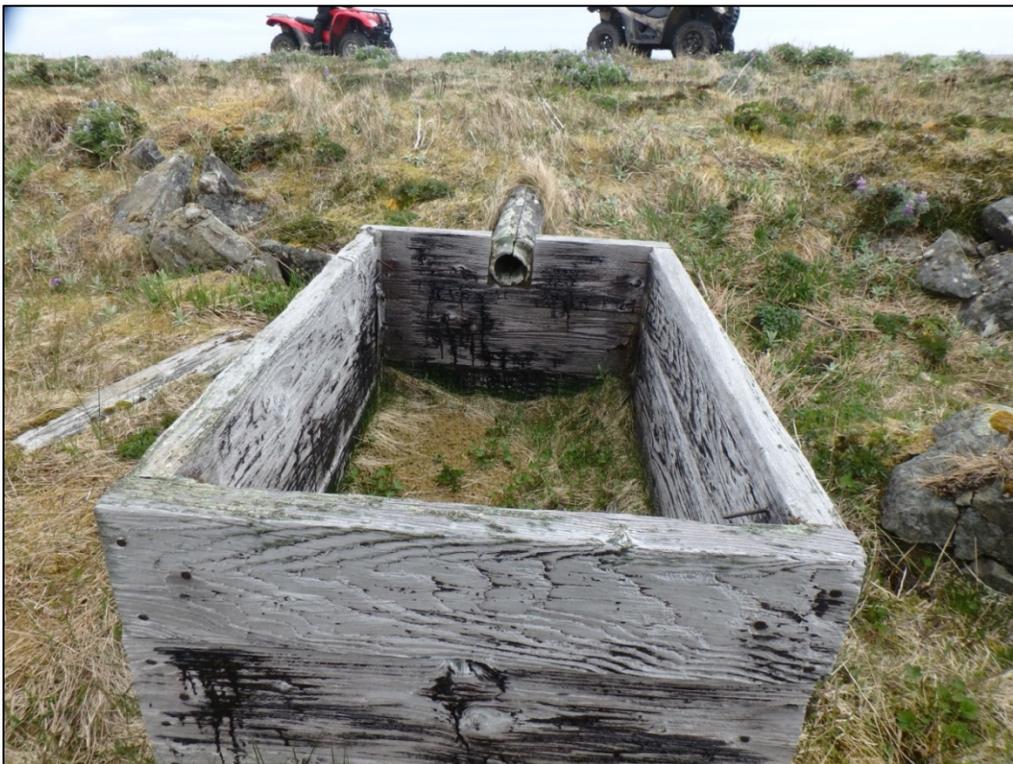
PL-CR013. Wood box and 4-Inch wood pipe approximately 800 yards from north end, west side

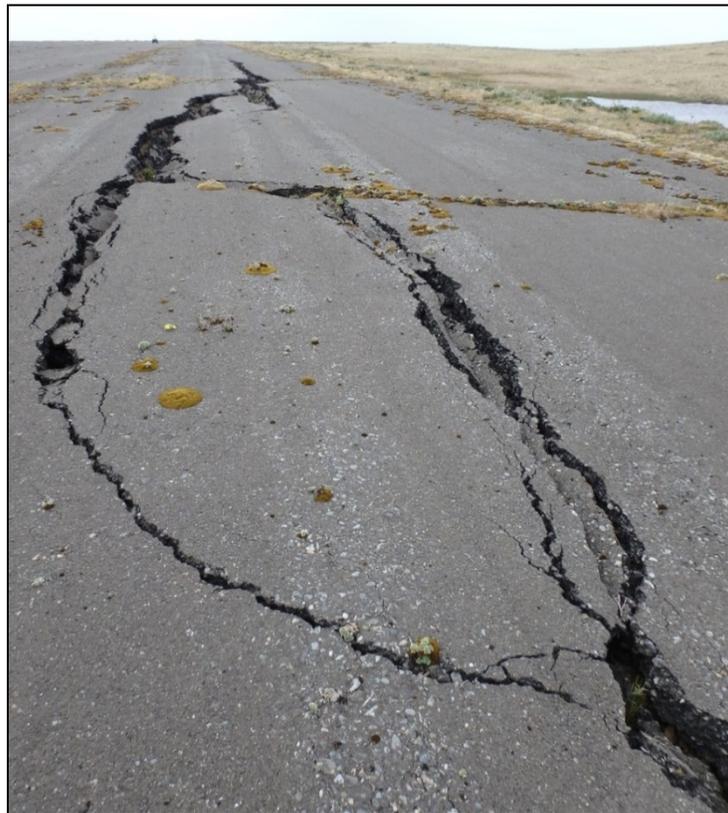
PL-CR022. Big longitudinal crack on W side, ~350 yards south of taxiway, ~450 yards from south end, ~200 ft long ranges from 4" to 32" width, asphalt is 6" THK, depth ranges from 2" to 10"

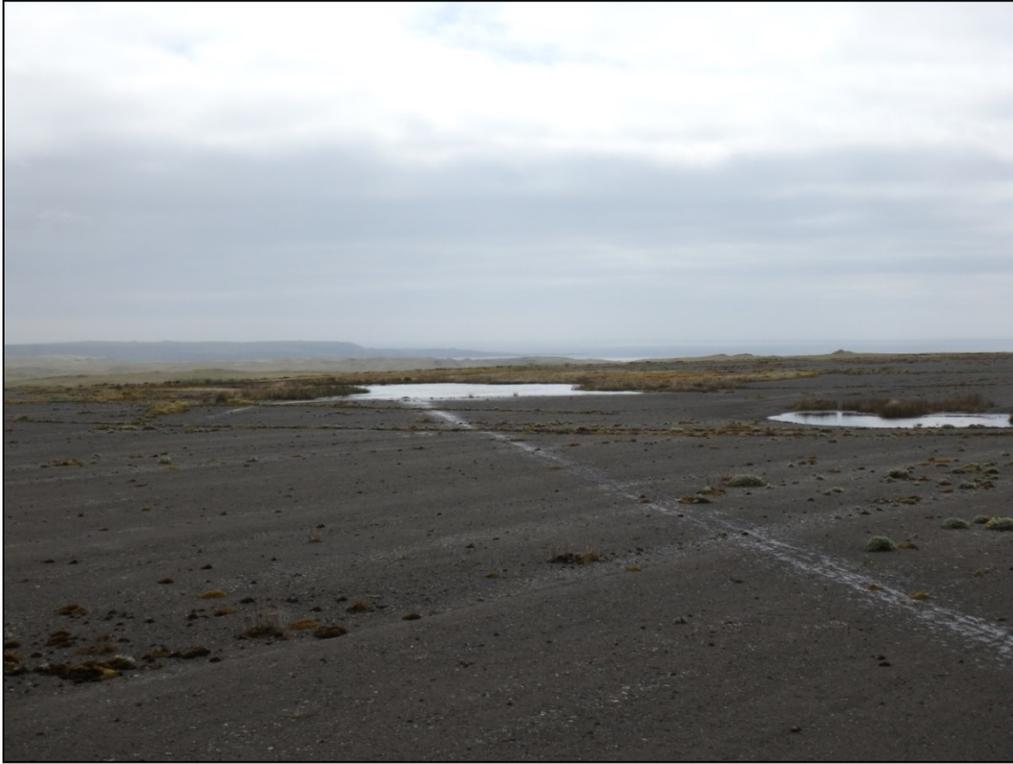
PL-CR025. Depression/ponding area, approximately 250 yards from south end

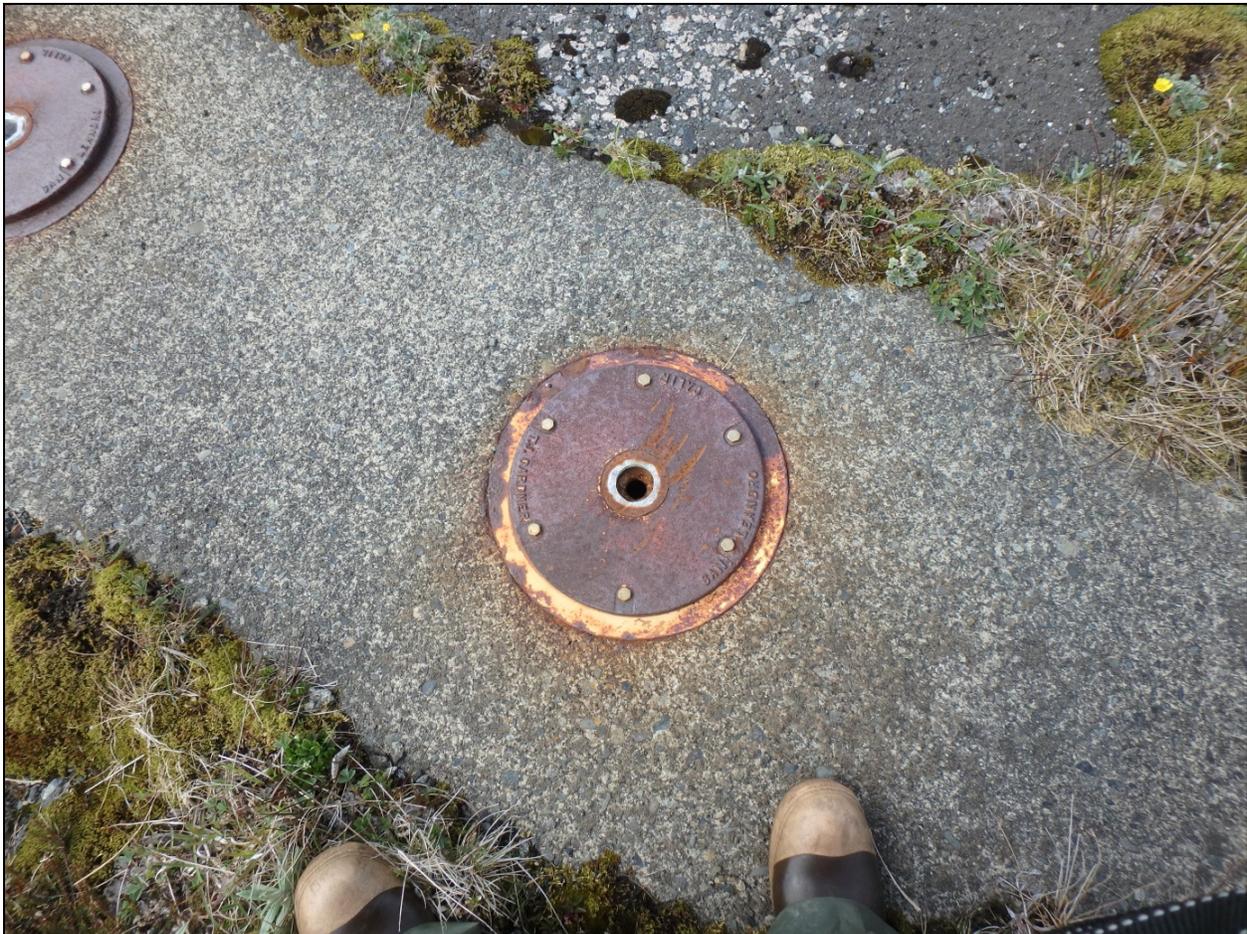
PL-BR03. Old runway light housing, east end

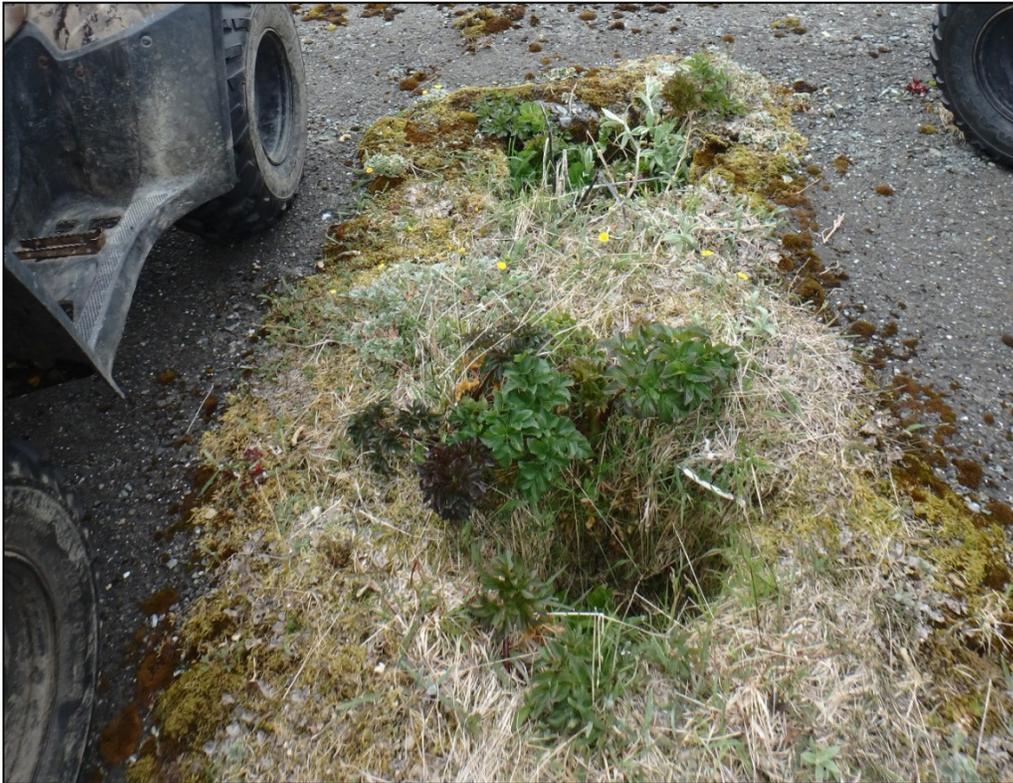
PL-BR08. Vegetation on old lights, east end

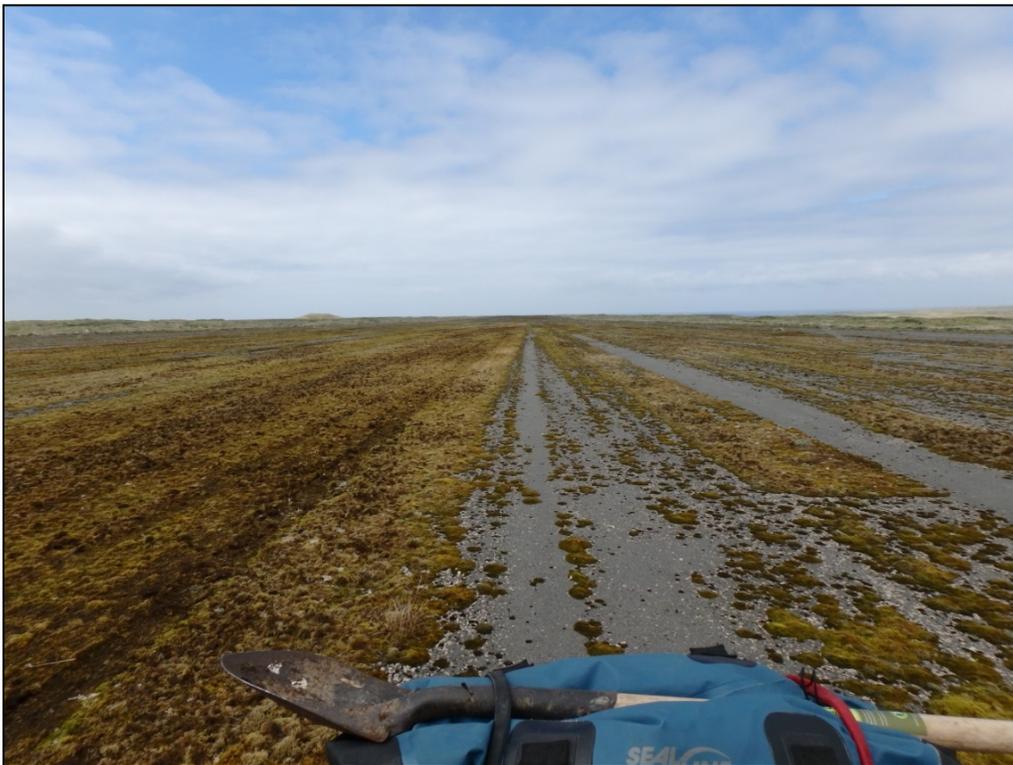
PL-BR09. Vegetation looking west standing at east end

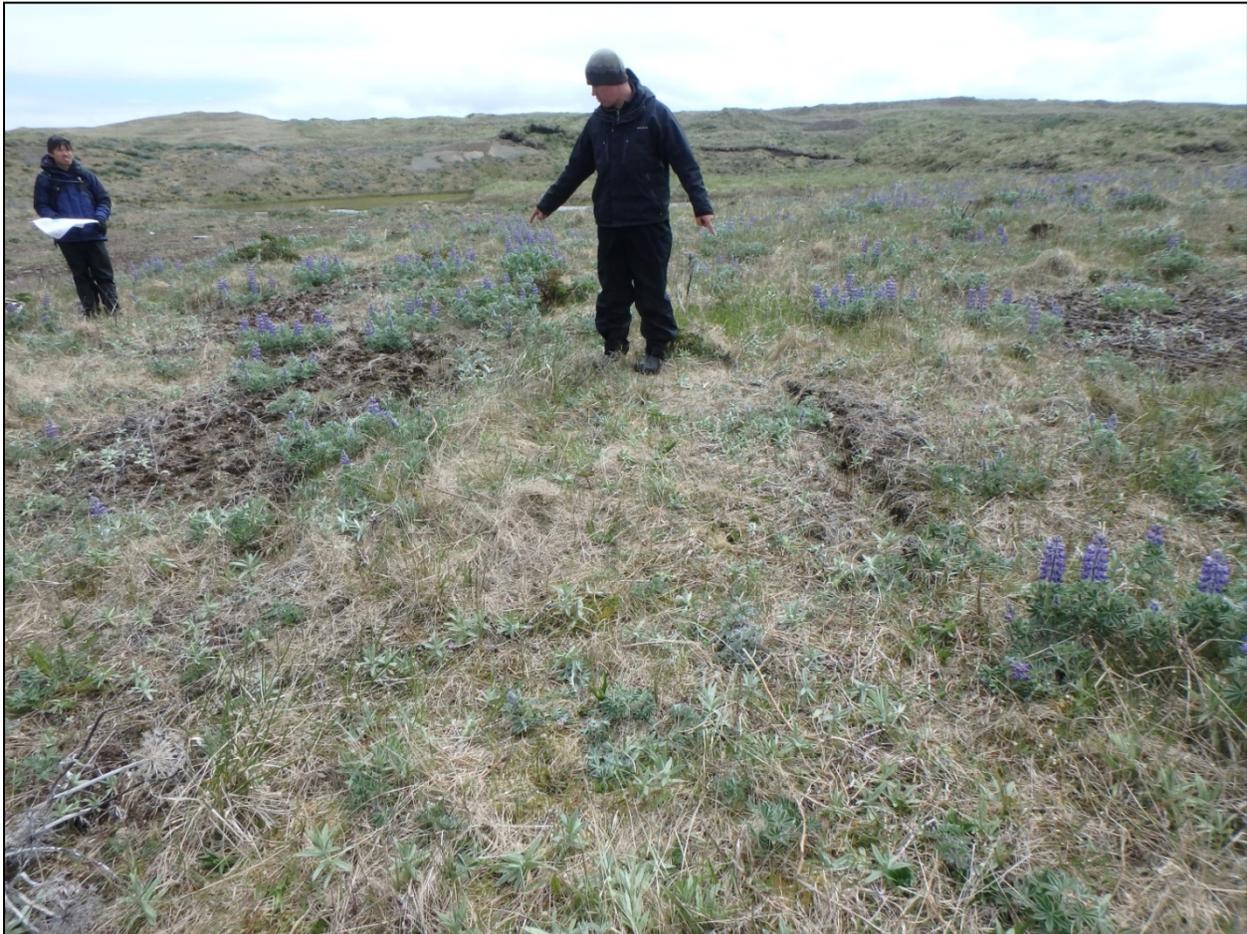
PL-RR01. West end of RR2 crack looking southeast, shows signs of self-healing from previous years

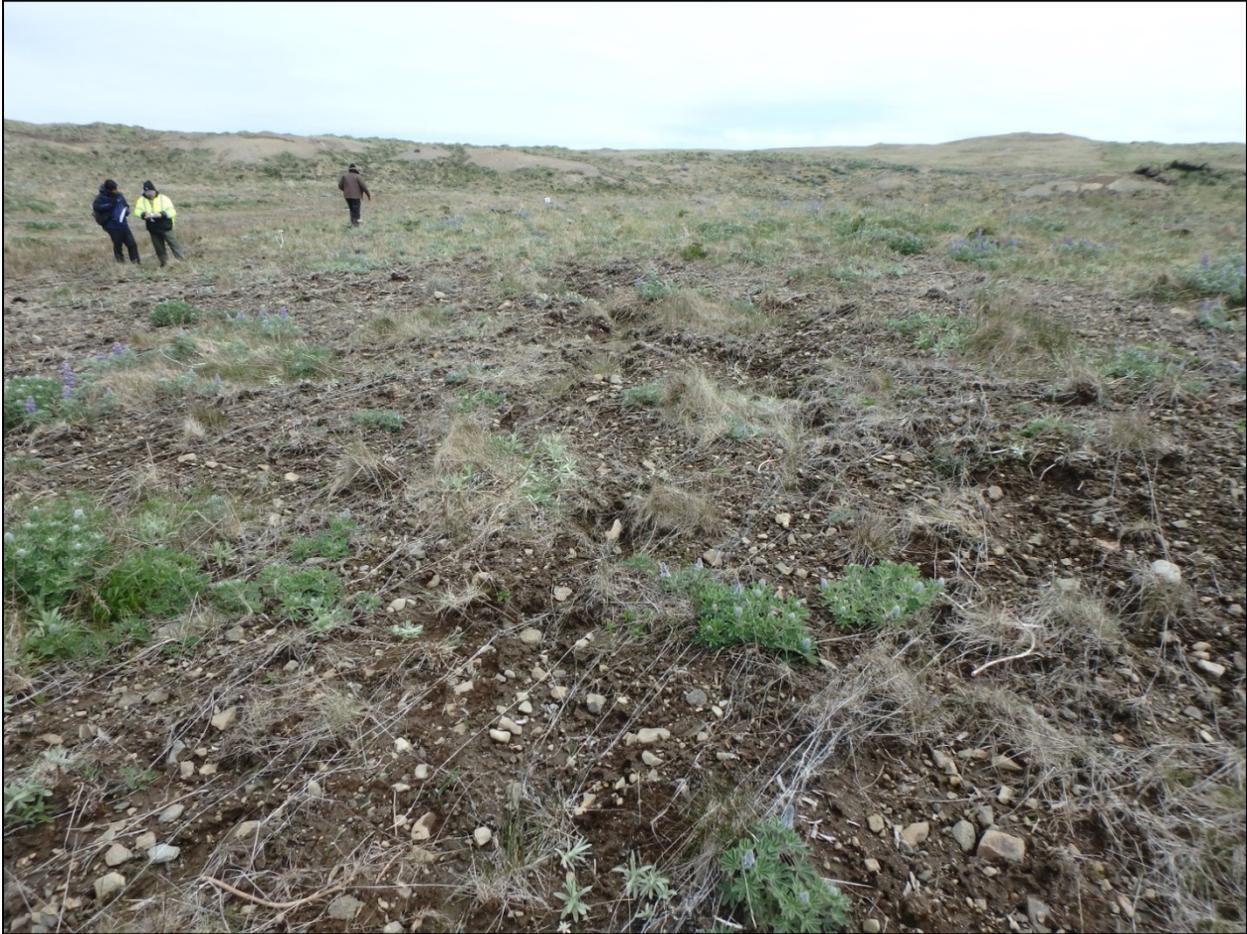
PL-RR02. West end of RR1 crack looking east, southeast shows signs of self-healing from previous years

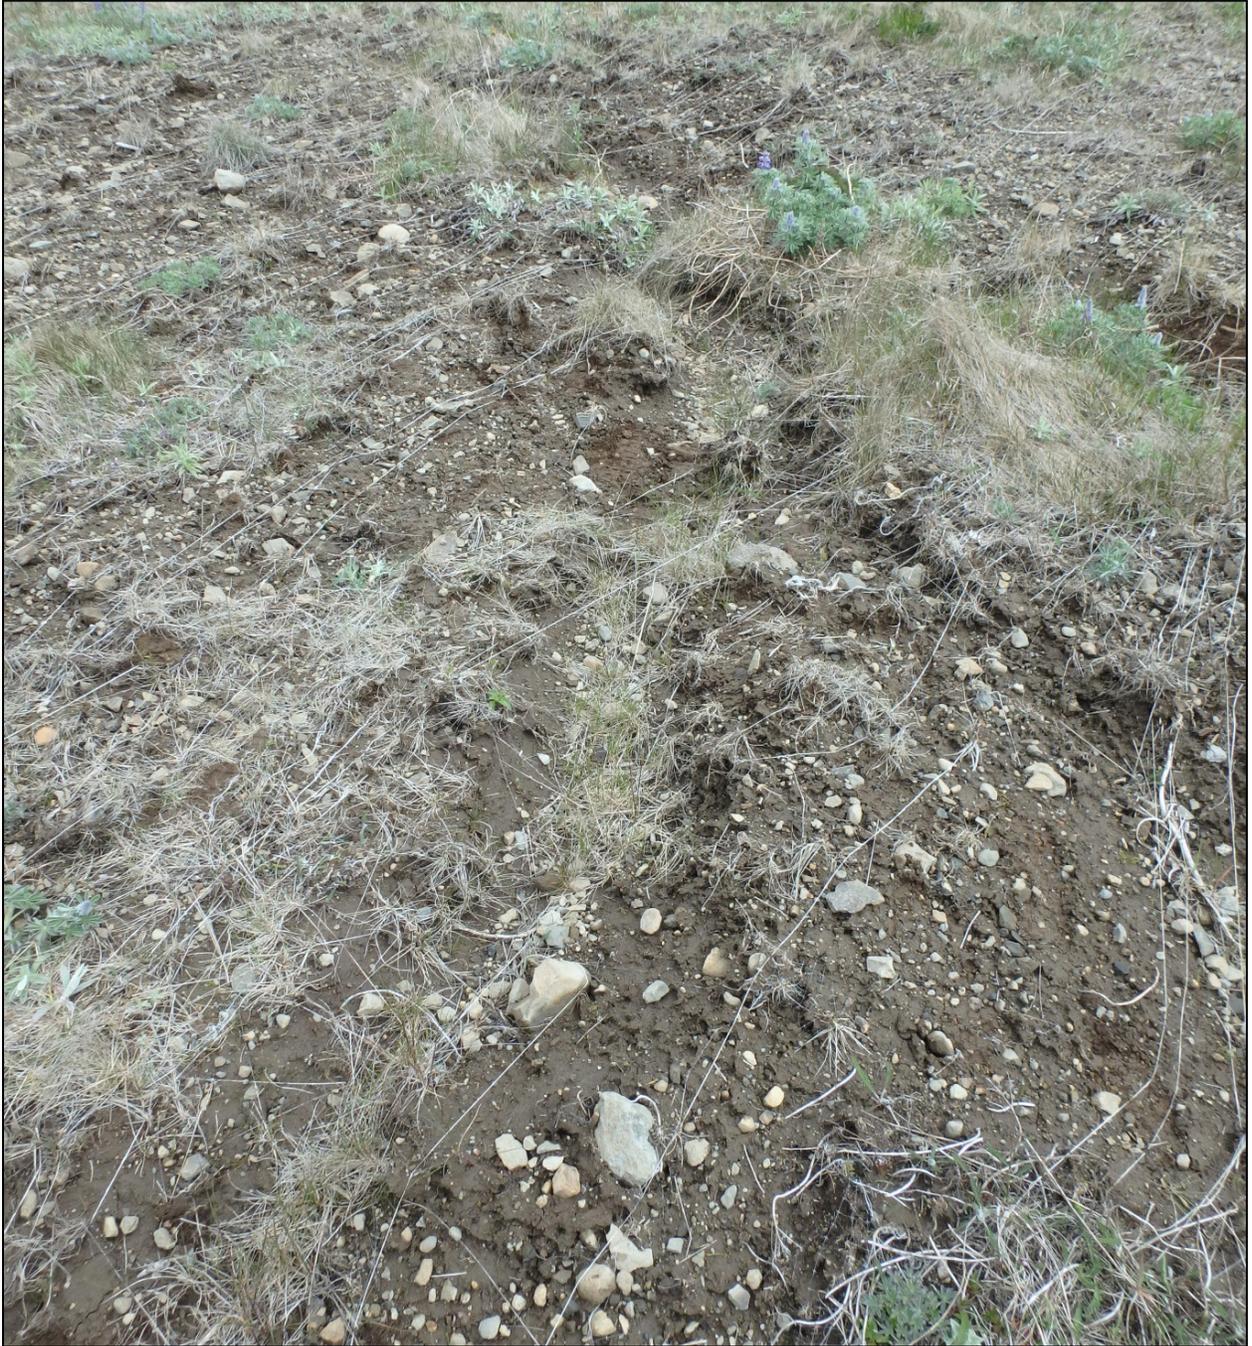
PL-RR03. RR2 crack looking southeast

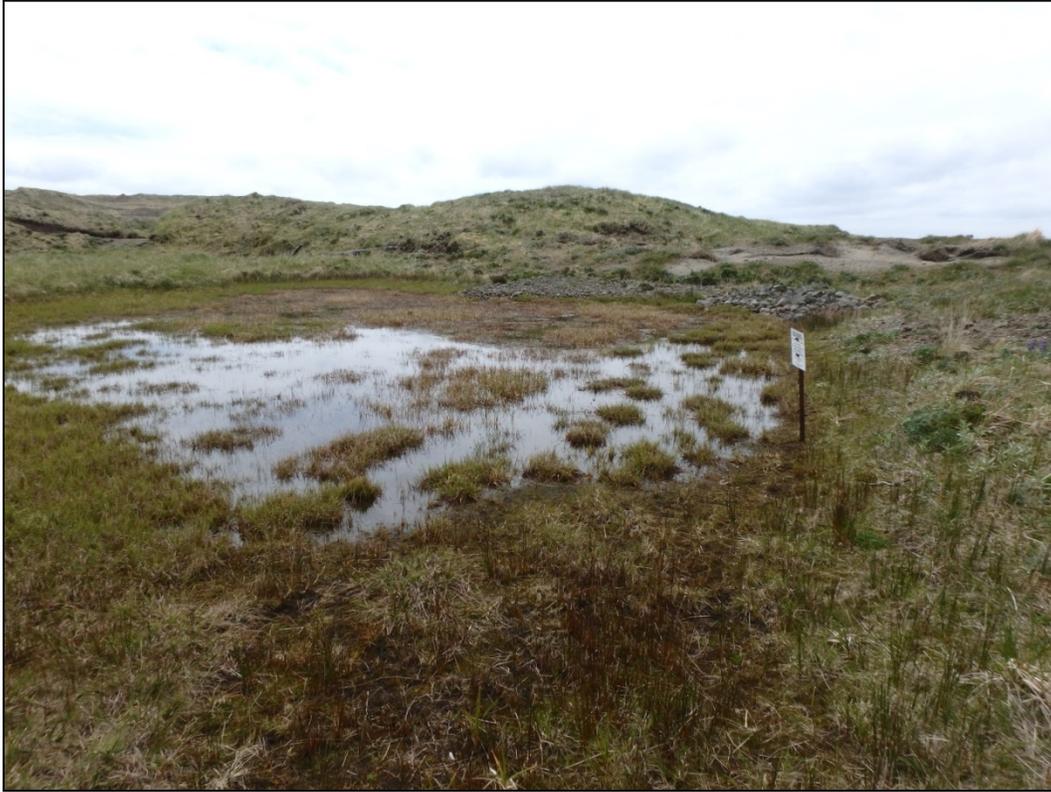
PL-RR08. Ponded water near toe at southeast end of cap

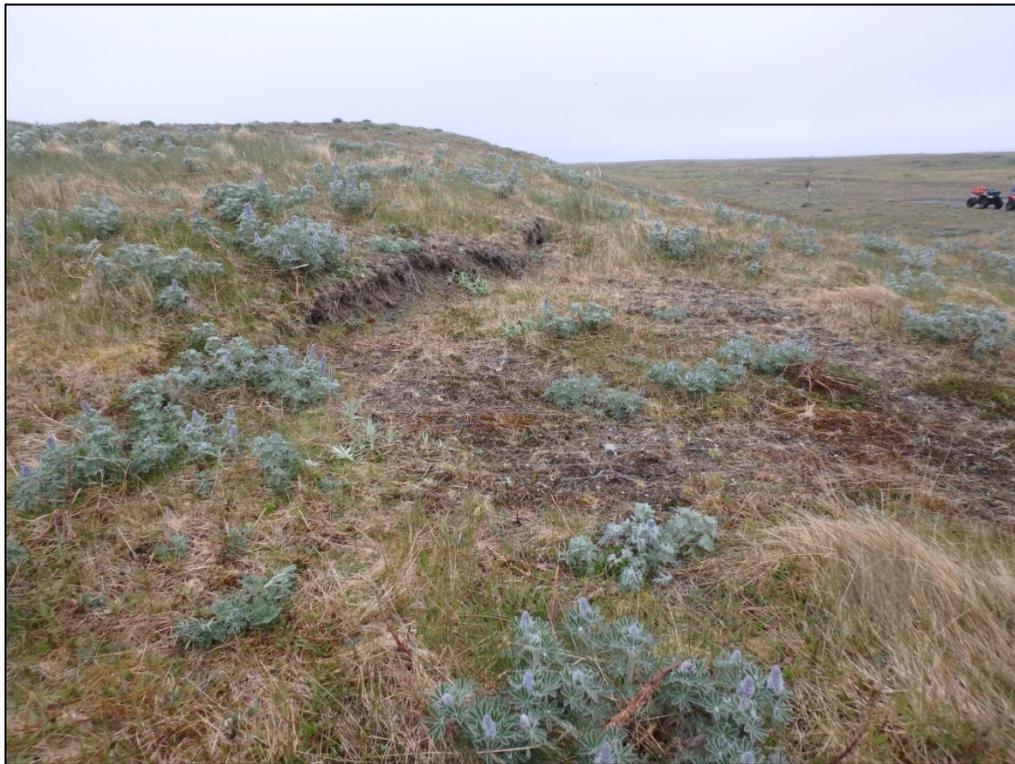
PL-LS01. Duplication of slump/scarp in southwest corner from previous inspections (IMG_801 from 2016 report)

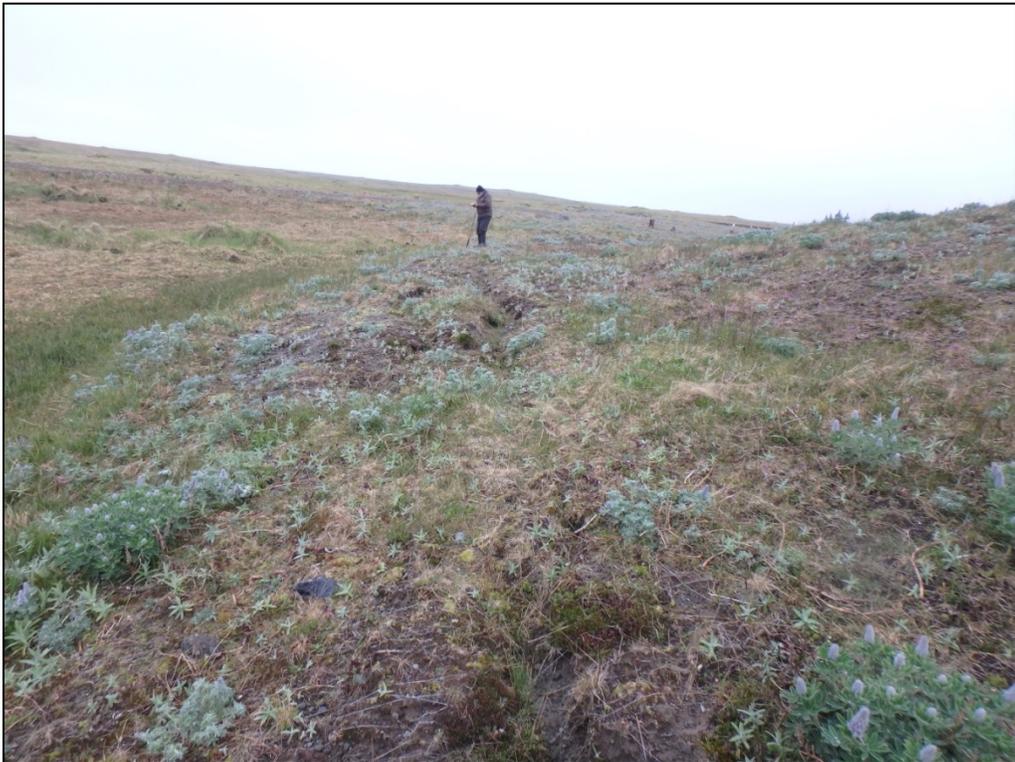
PL-LS05. Crack along east side near toe of slope

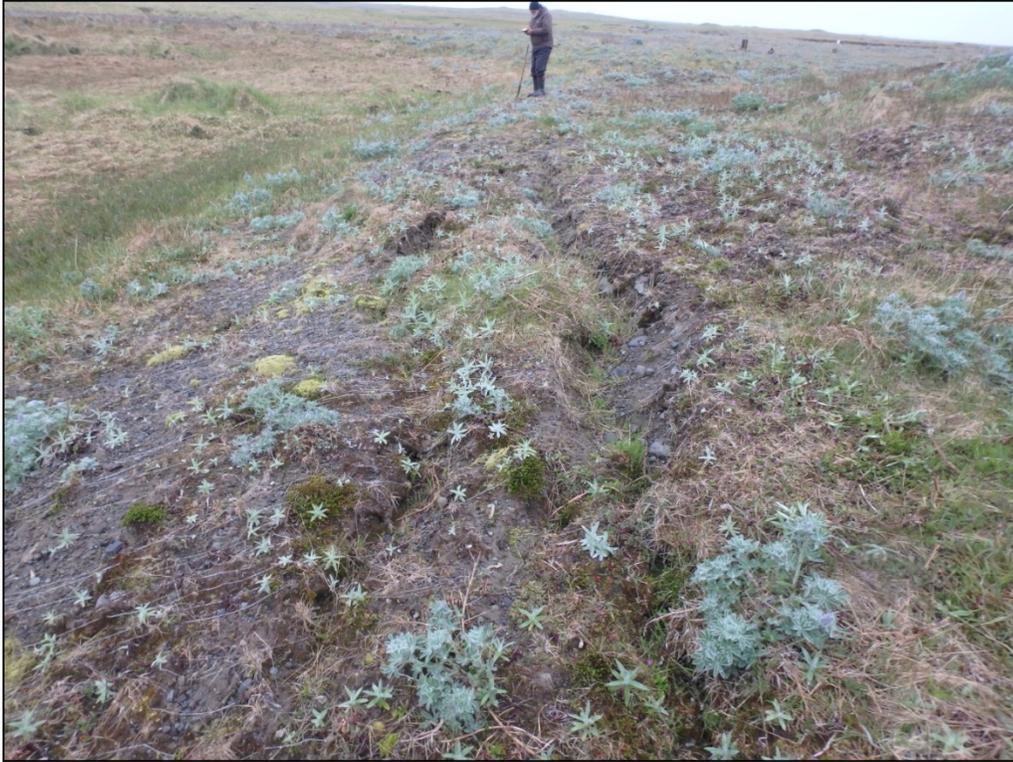
PL-LS06. Crack along east side near toe of slope

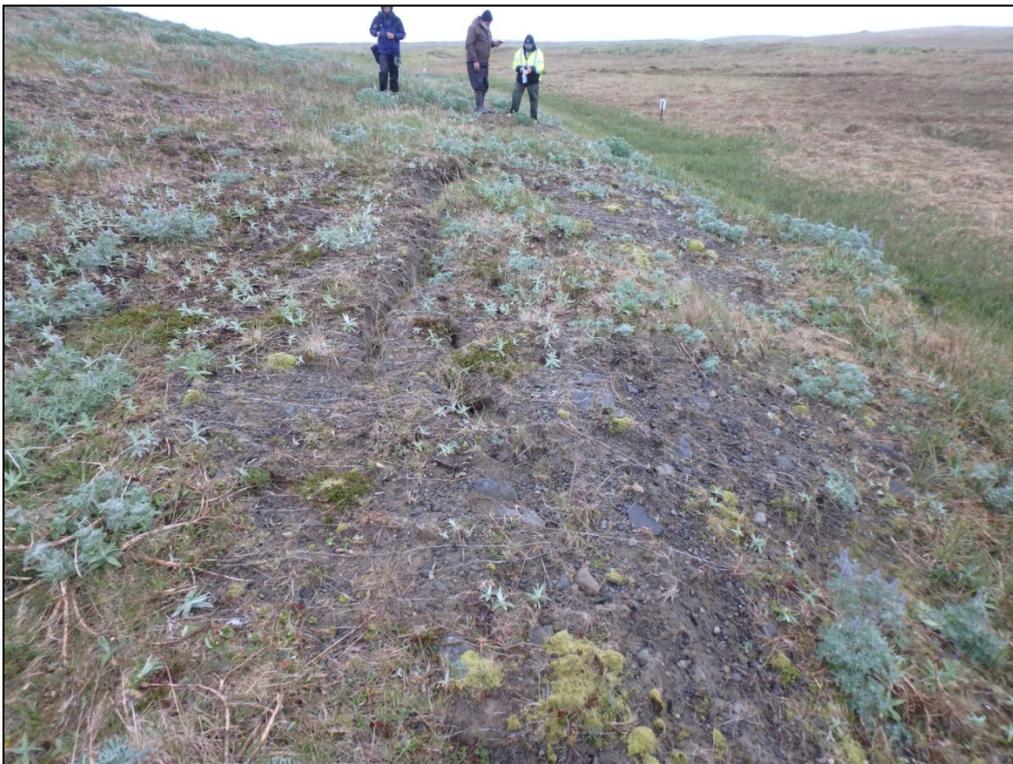
PL-LS07. Crack along east side near toe of slope (IMG_793 from 2016 report)

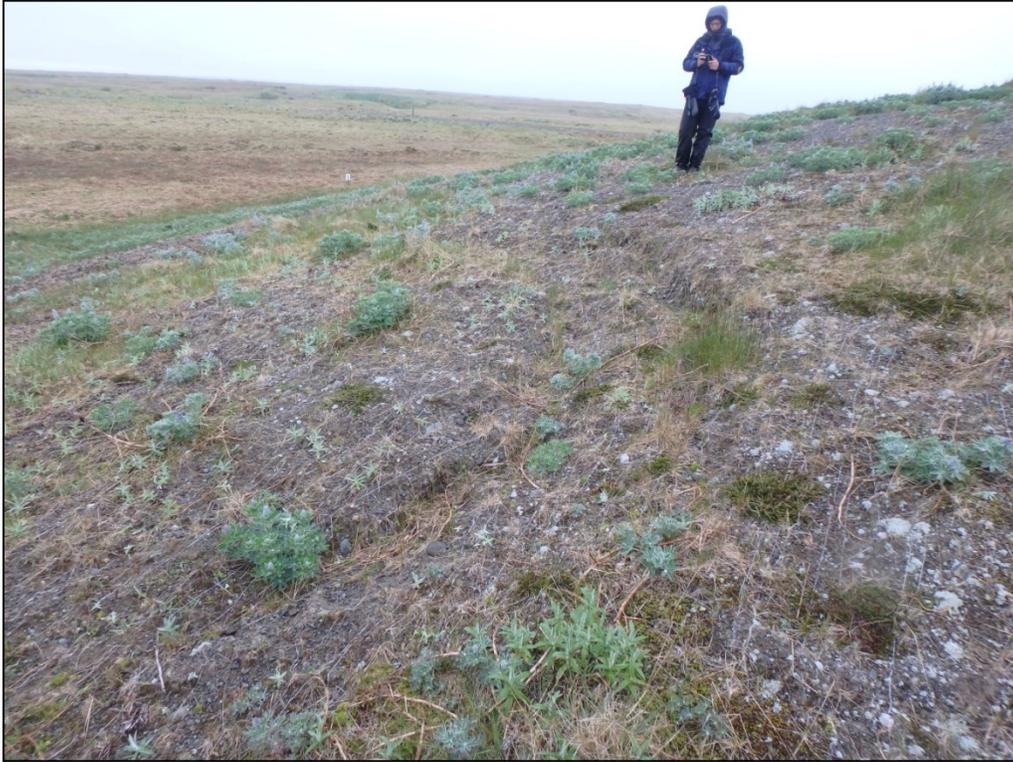
PL-LS08. Crack along northeast side, duplicate of IMG_797 from 2016 report

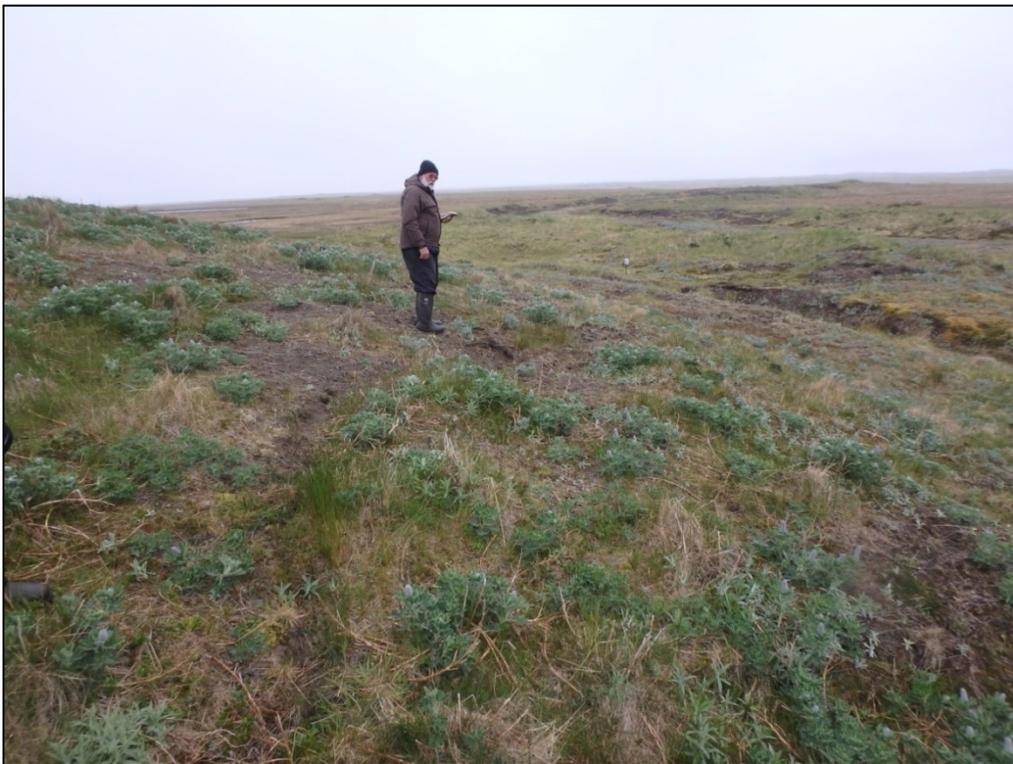
PL-LS09. Crack approximately mid slope (half way between top and toe), duplicate of IMG_798 from 2016 report

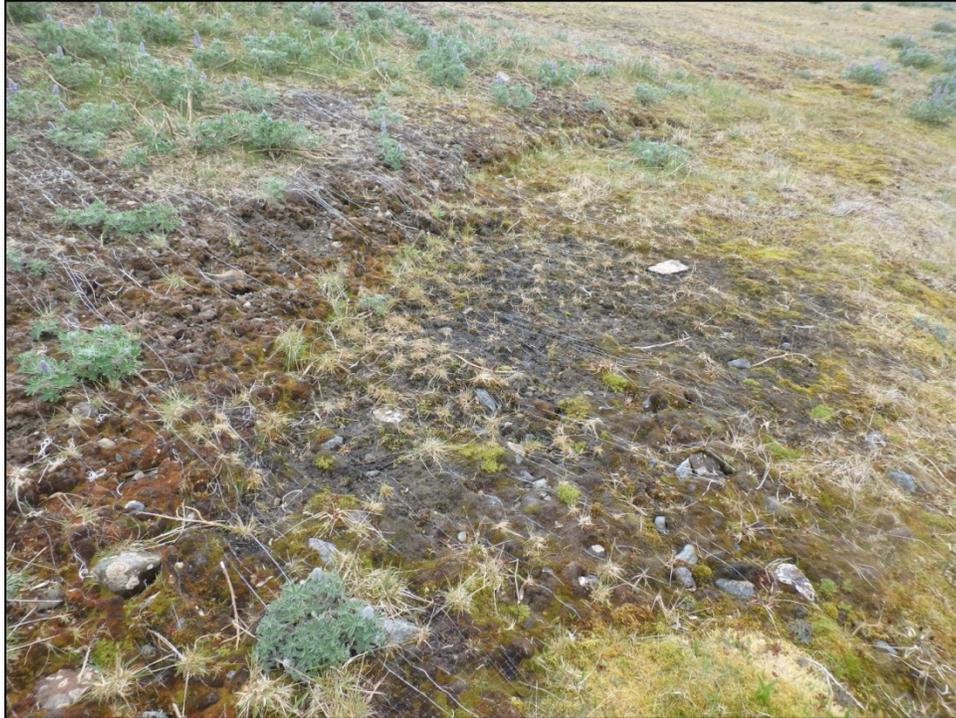
PL-D09. Standing south looking north of crack labeled "site d5" on 2014 inspection, crack appears to be self-healing

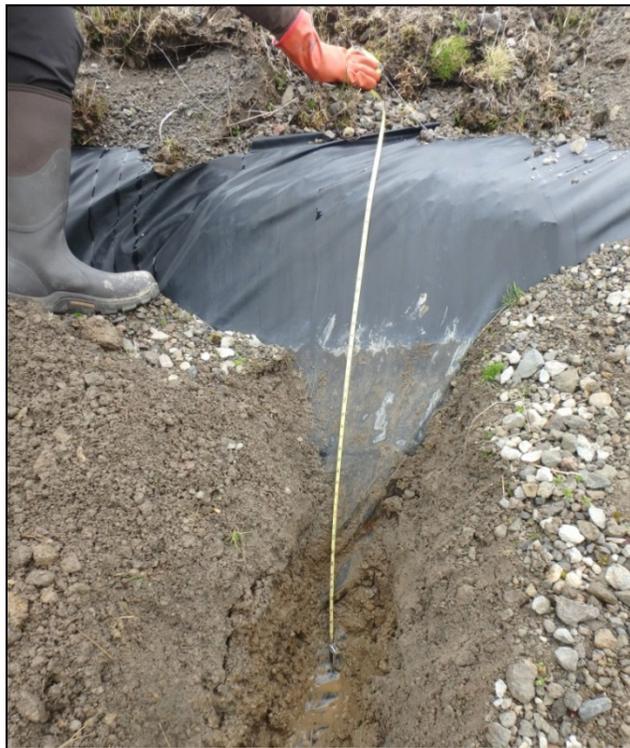
PL-D010. Exposed liner on south side of cap, approximately 3 feet 4 inches deep to where liner transitions from vertical to horizontal in anchor trench (east exposed section)

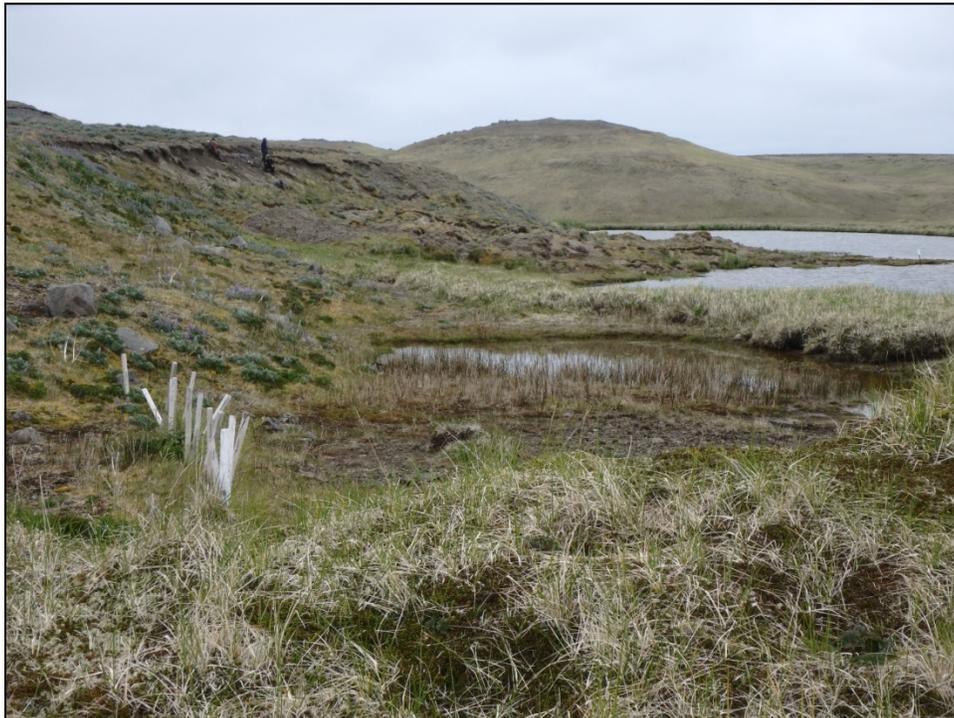
PL-D013. South side of cap damaged area standing southeast of south spillway looking east

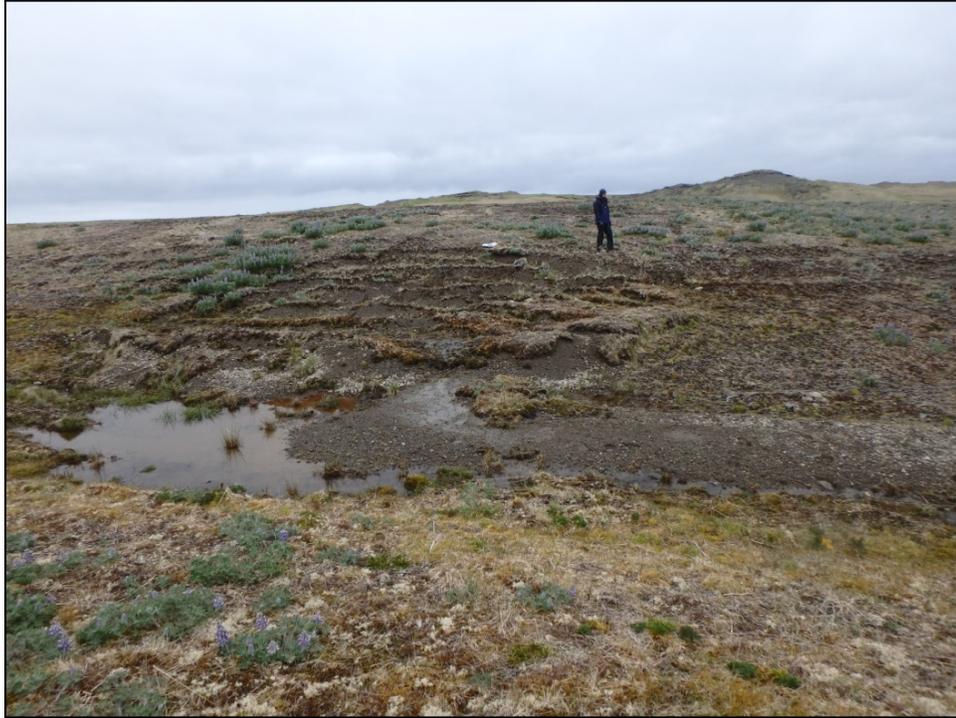
PL-D017. Looking north, northeast at terracing slump/failure on east cap, duplicate of IMG_01122 from 2016 report

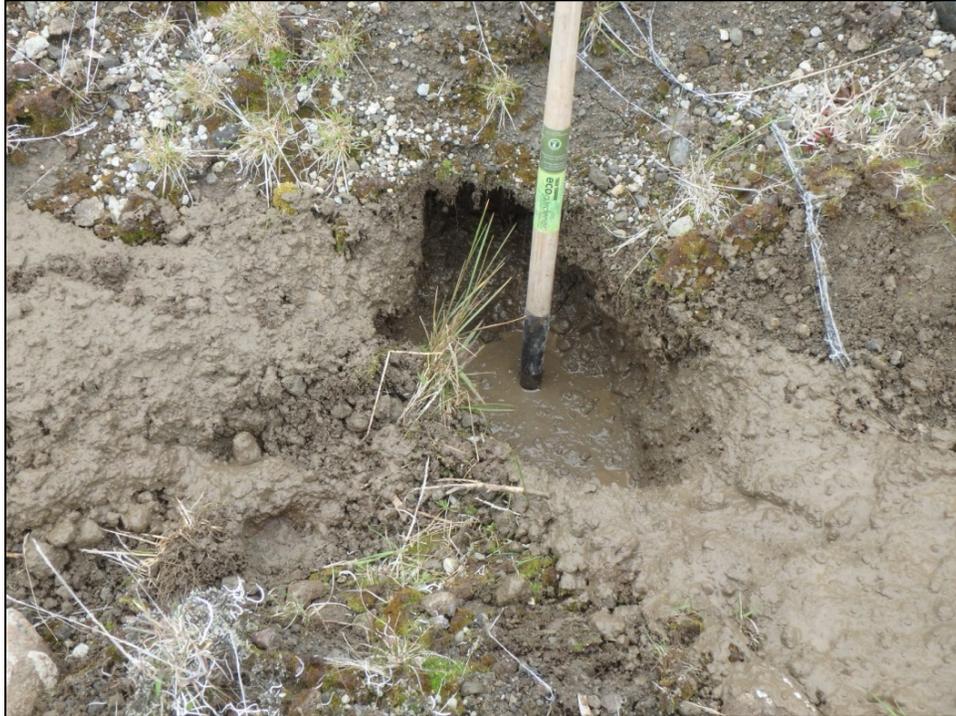
PL-D018. Trying to find liner; none found but perched water continued to seep into investigation hole, dug approximately 24 inches down, total depth below existing top of cover approximately 3 ft, seep flow rate approximately 0.5 to 1 gpm

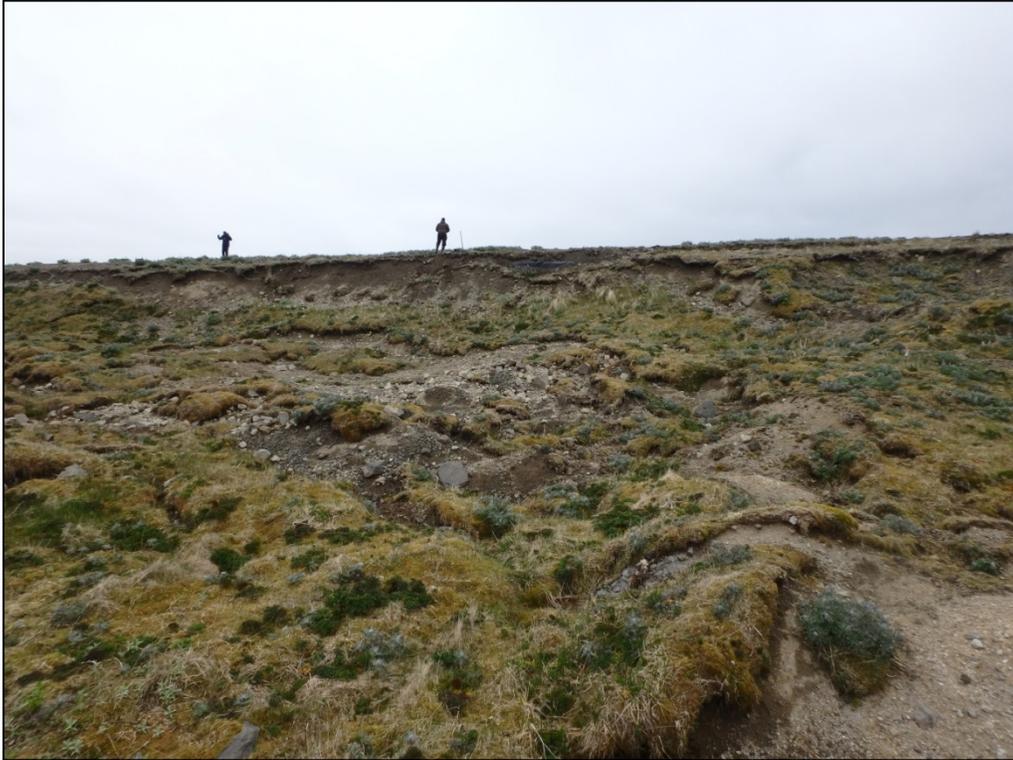
PL-D024. Standing south of south side failure looking north

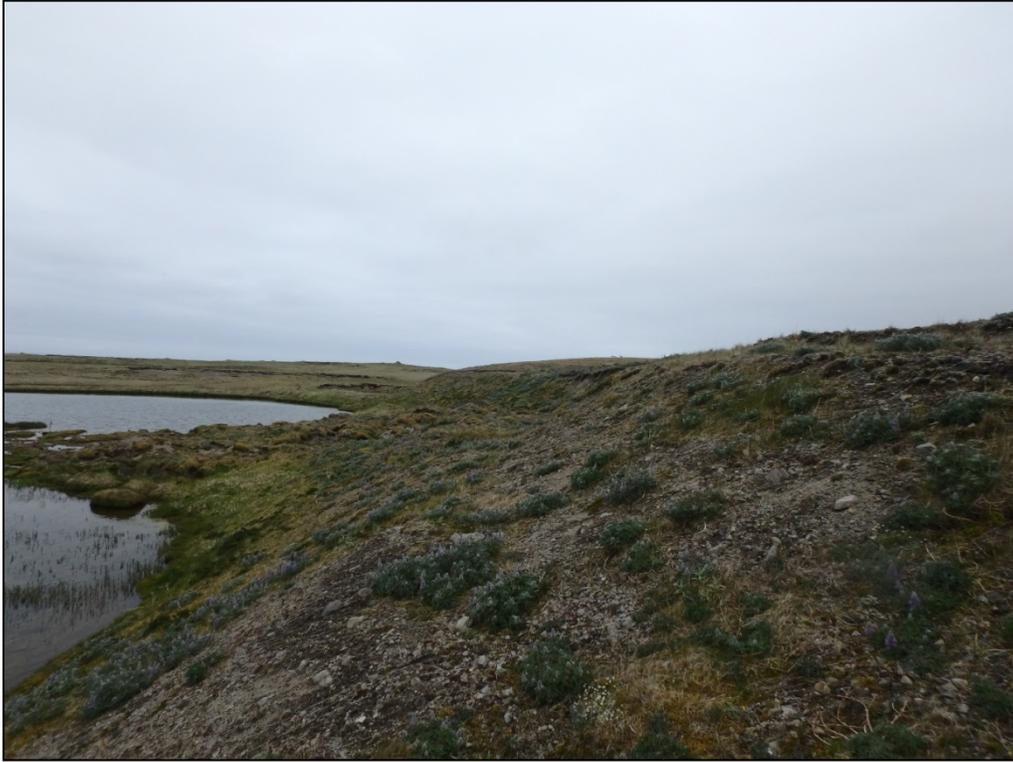
PL-D032. Standing mid slope on southeast side looking west along failure zone

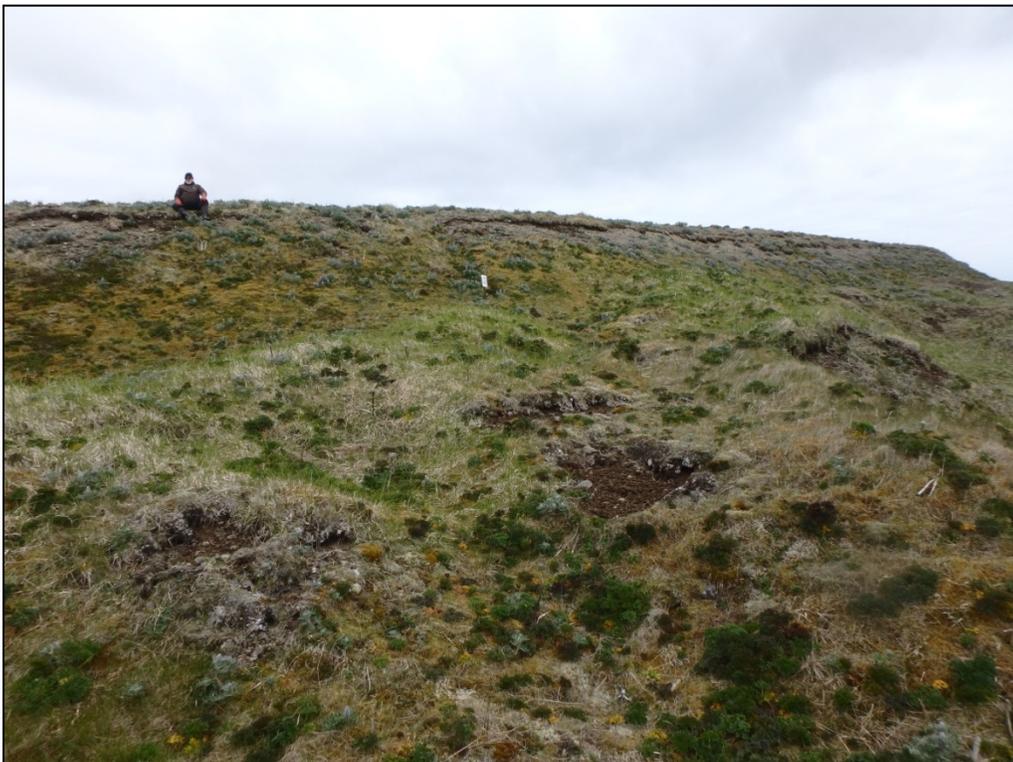
PL-F03. South side of cap looking north along scarp, duplicate photo of crack on south side (IMG_707 from 2016 report)

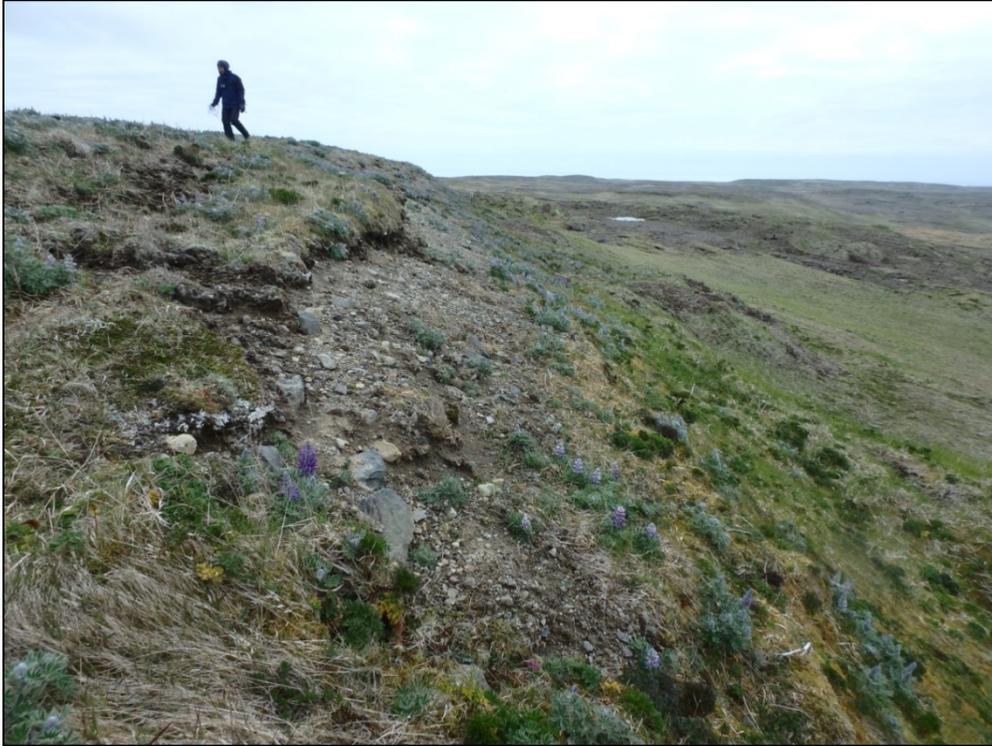
PL-F04. South side of cap looking east along scarp, duplicate photo of crack on south side (IMG_706 from 2016 report)

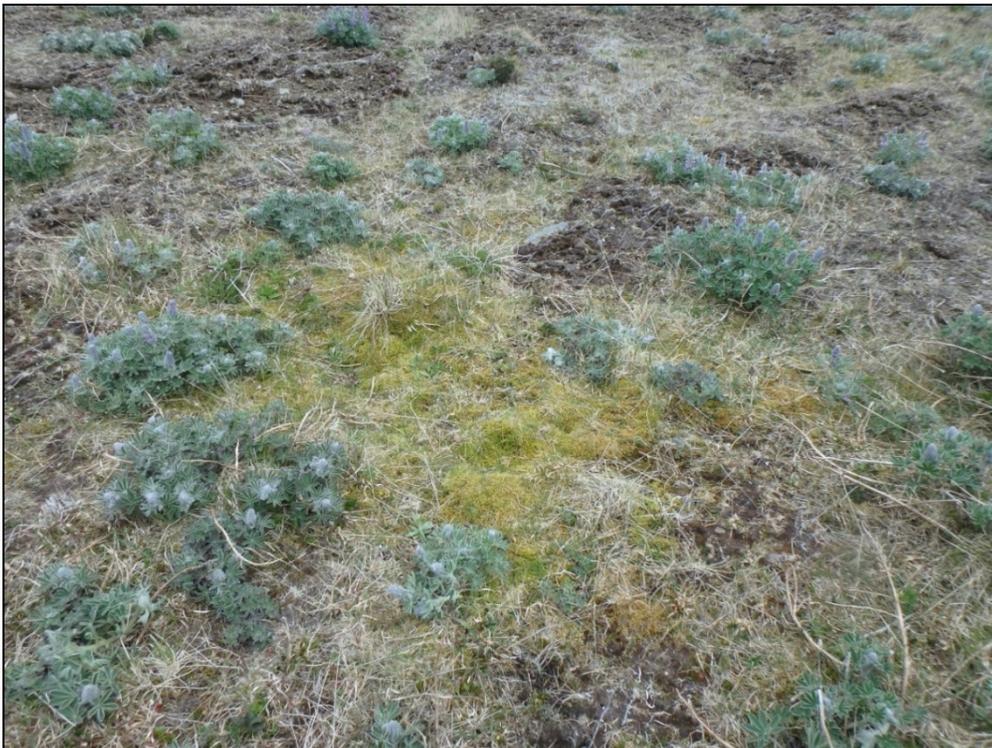
PL-F05. Depression in southwest part of cap, duplicate of IMG_708 from 2016 report
