Amchitka Annual Site Inspection Trip Report Amchitka, Alaska, Site

August 2017

U.S. DEPARTMENT OF
ENERGY

Legacy
Management

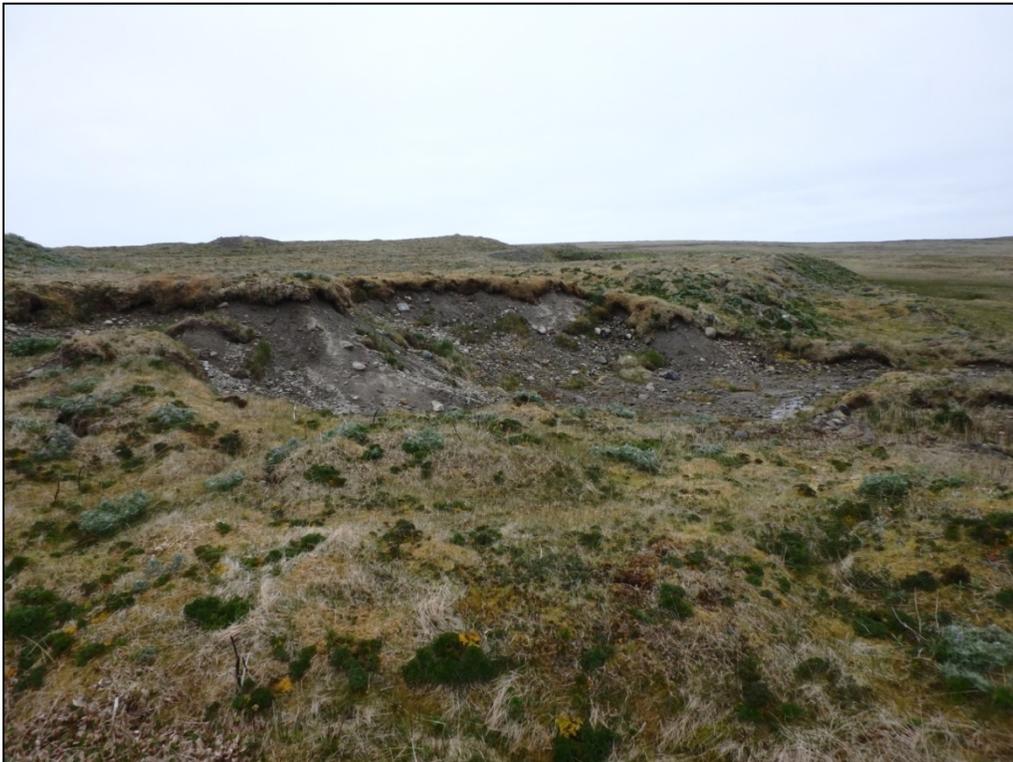
PL-E07. Slump/scarp area south of cap looking northeast, looks similar to previous years with no new conditions observed

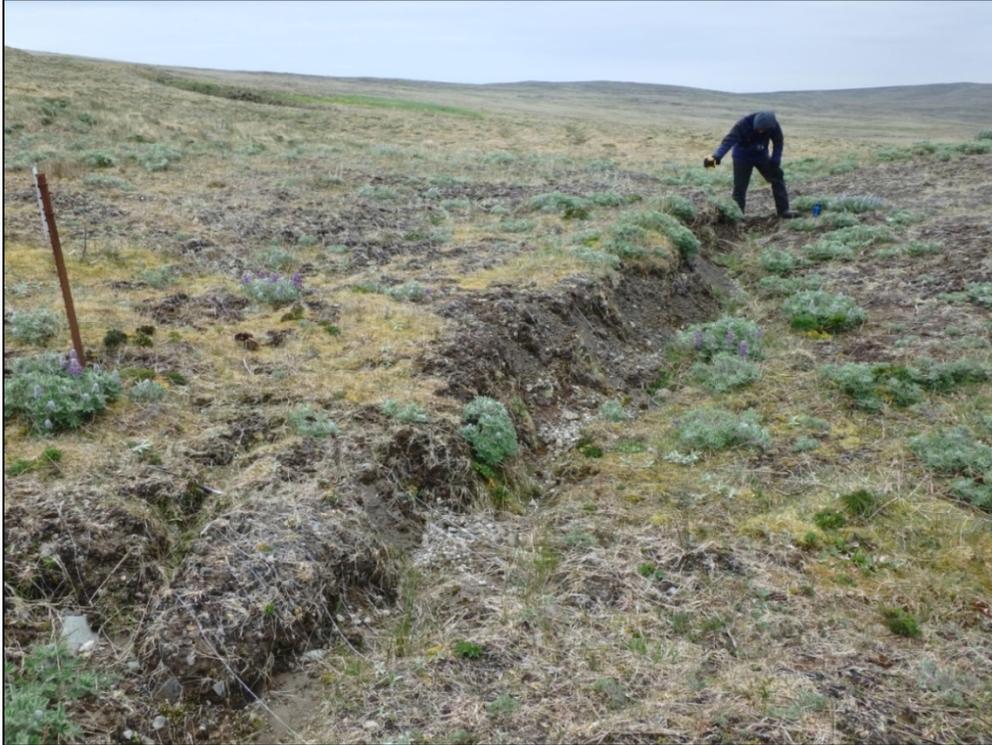
PL-E08. North scarp at west end looking east, depth varies from approximately 2 inches to 2.5 ft

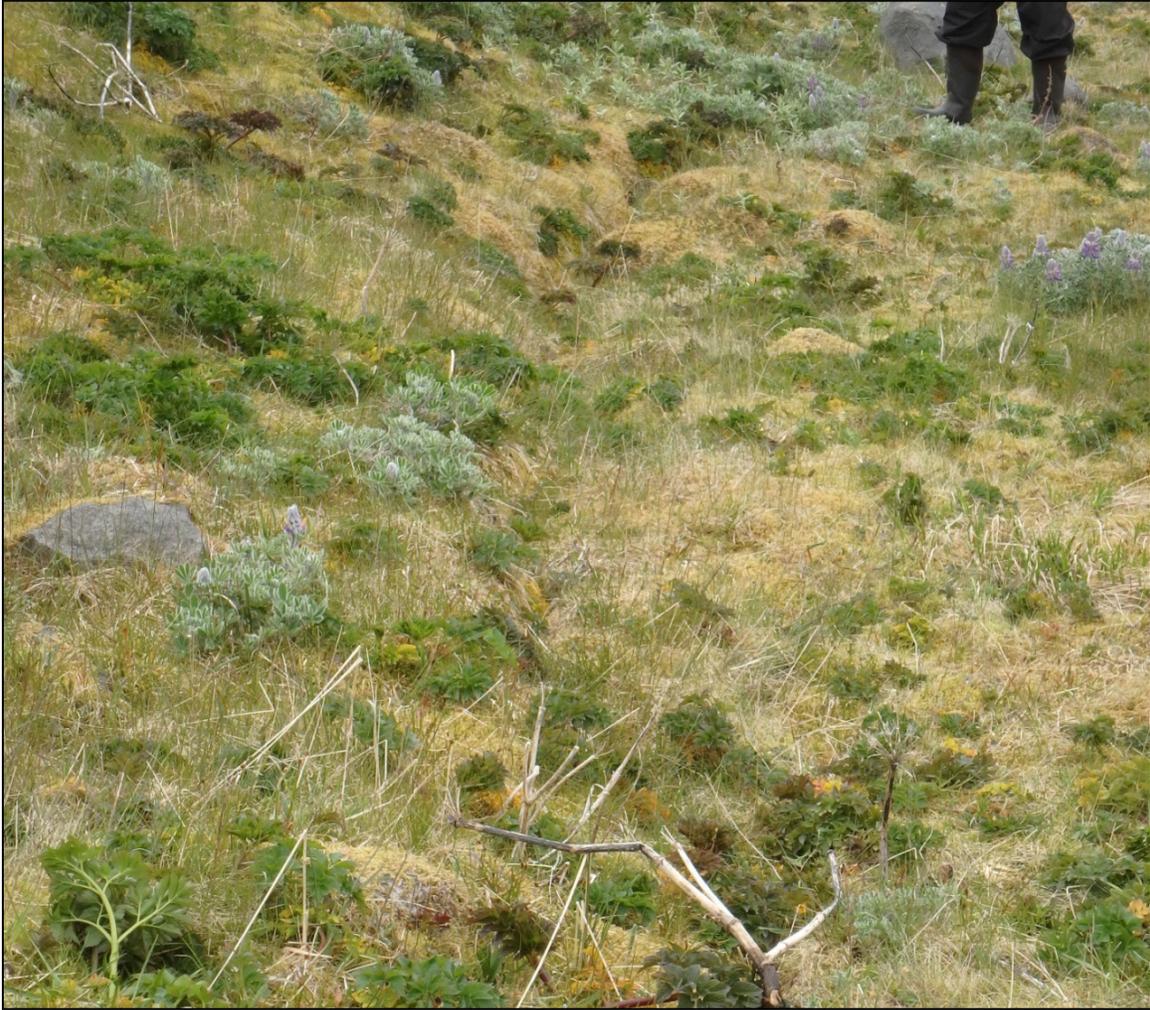
PL-E010. South scarp at west end looking east, covered in vegetation

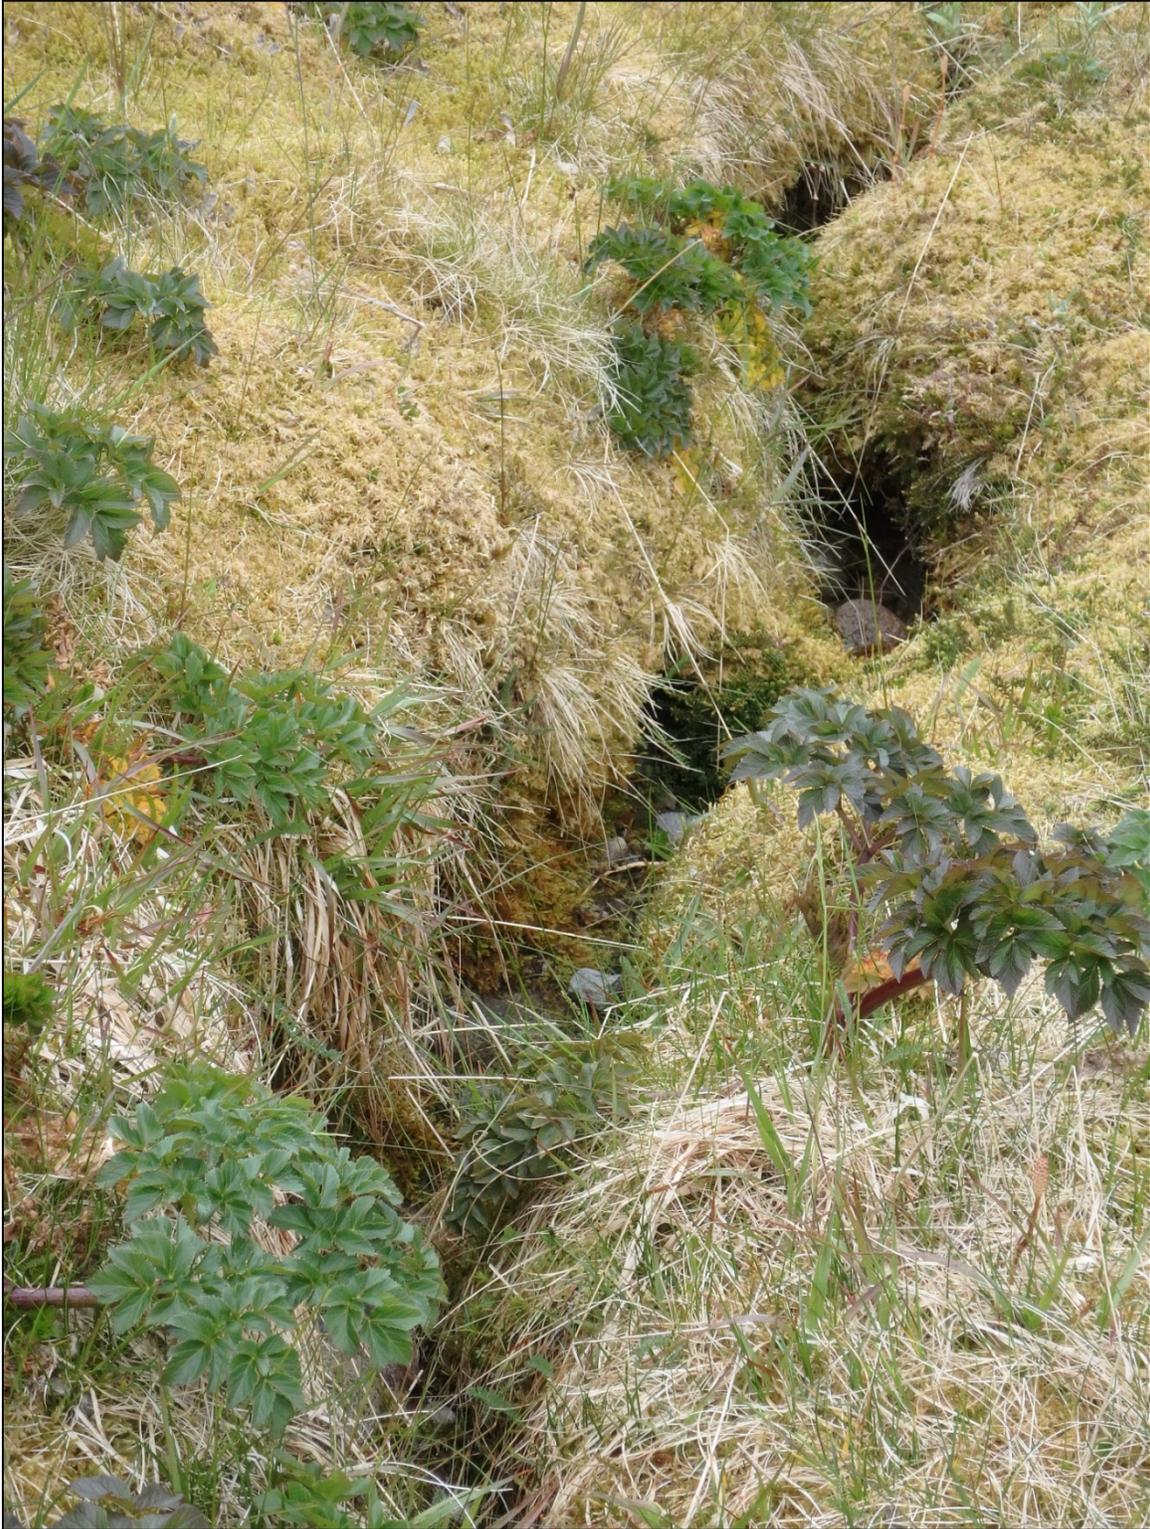
PL-E011. South scarp at west of centerline looking east, some areas covered in vegetation, exposed areas approximately 6 inches wide and 8 to 12 inches deep

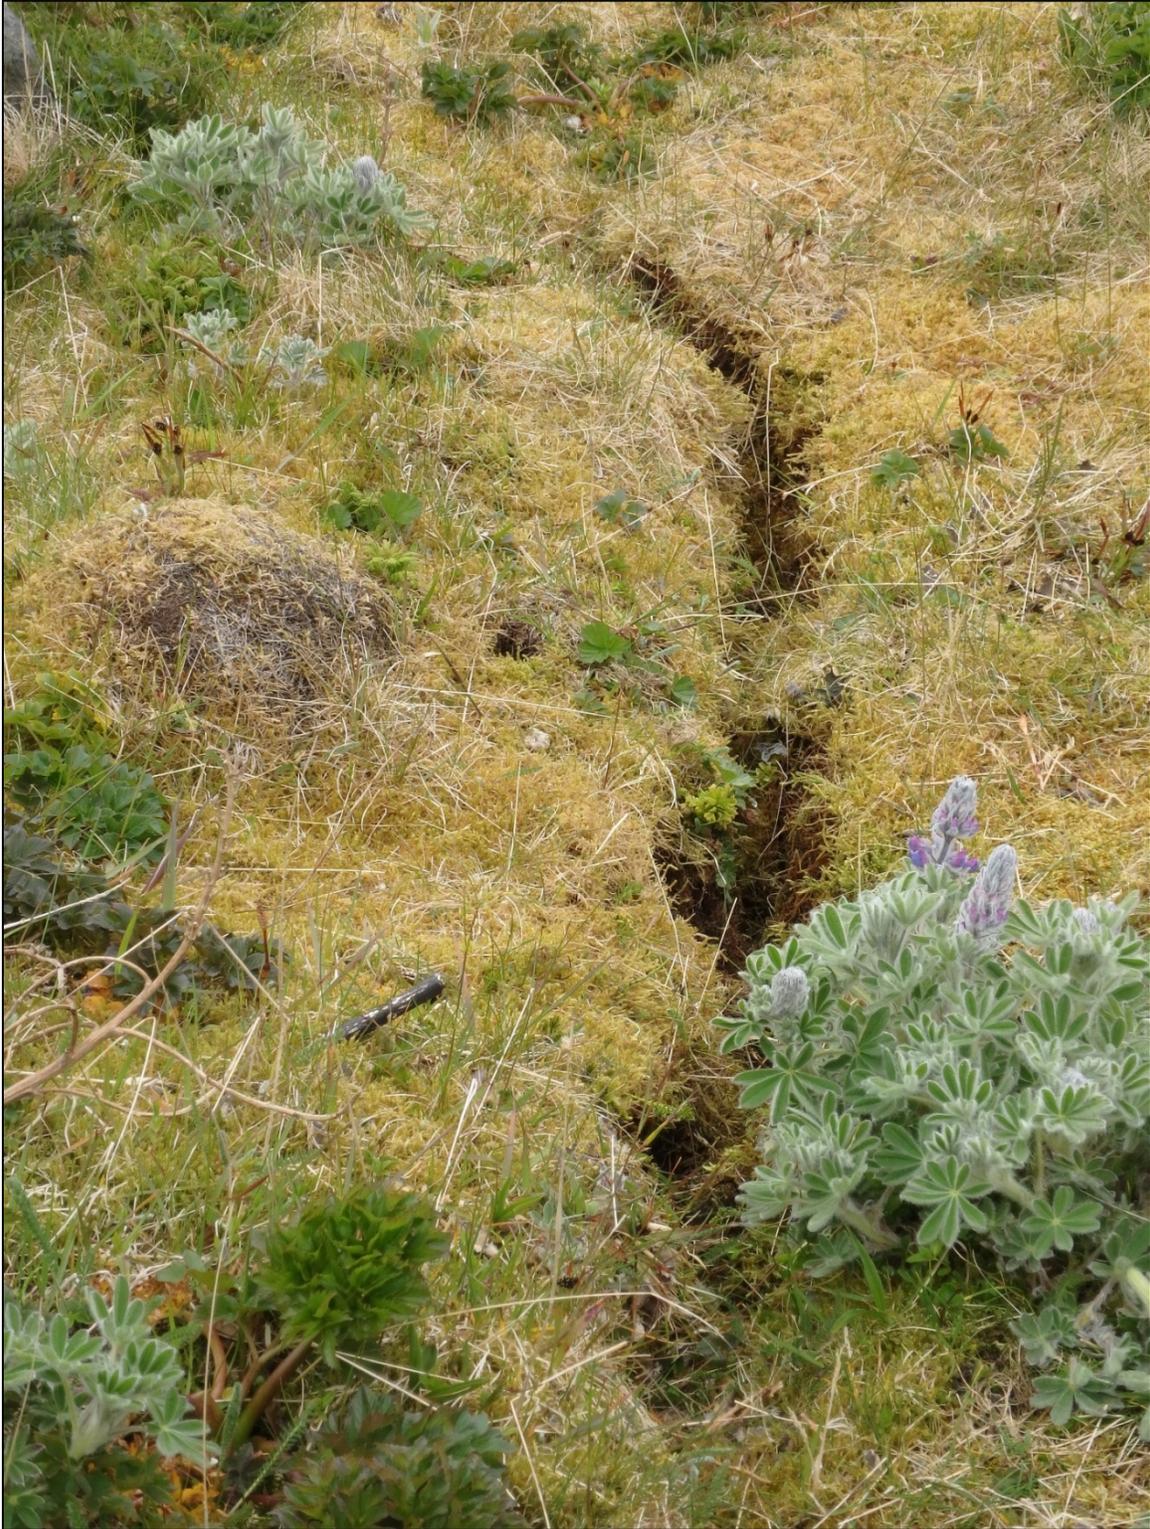
PL-E012. Scarp at west of centerline looking east, extension/additional crack that was previously covered in vegetation, added to previously mapped scarp

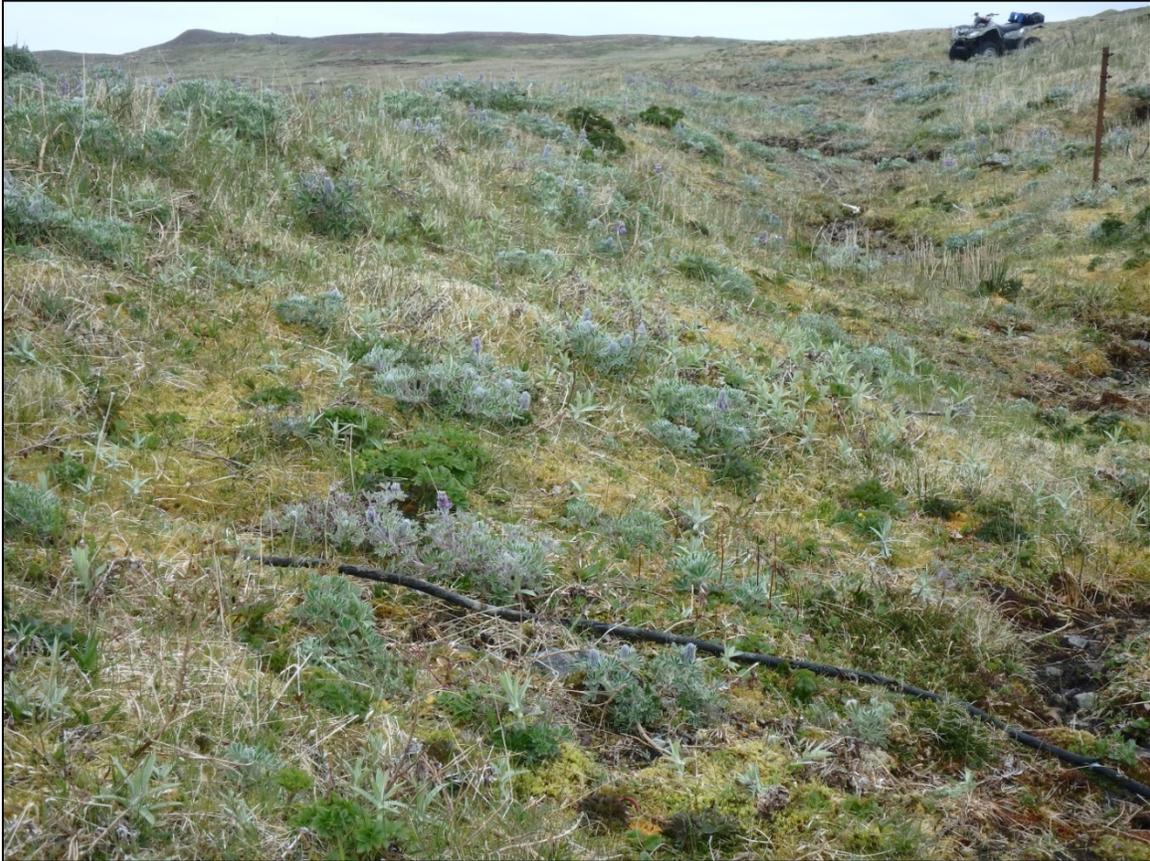
PL-E013. East drainage looking north, .5-inch-diameter black cable exposed crossing drainage and partially buried in cap

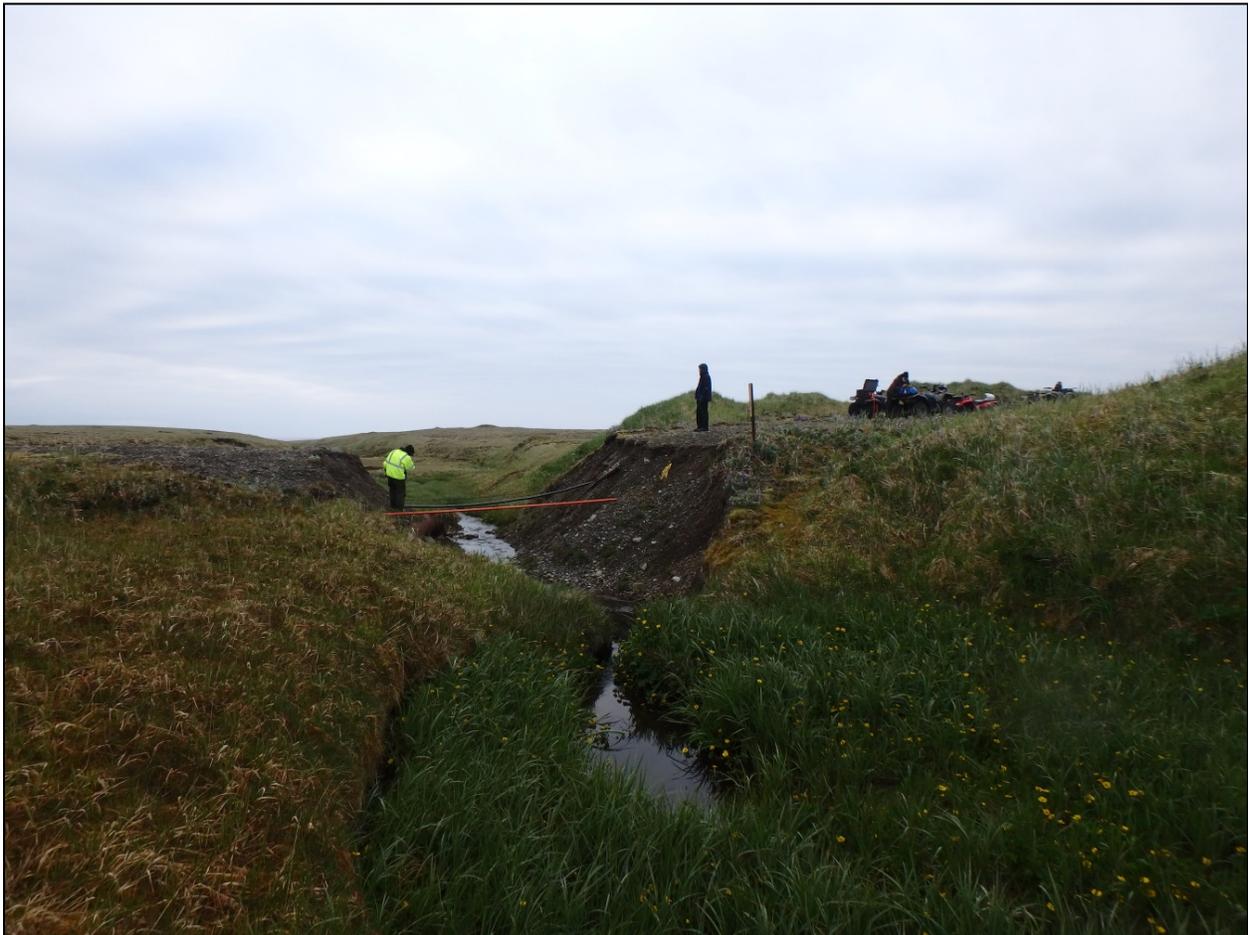
PL-MM4_01. Washout looking east from approximately 75 ft upstream

Stream crossings are in the same condition as observed in the 2016 inspection. Existing conduit is buried at crossings approximately 4 ft below grade and 5 ft from the edge of road. The contents and condition of the material inside the conduits was not investigated. The road width was approximately 24 ft at mile marker (MM) 4 and 30 ft at MM 8. The depth to creek flow line from road centerline was approximate 10 ft at both locations. The distance across the washout at MM 4 and MM 8 was approximately 24 ft and 28 ft respectively. Neither crossings are currently passable by equipment and will require repair. See Appendix B for photos.

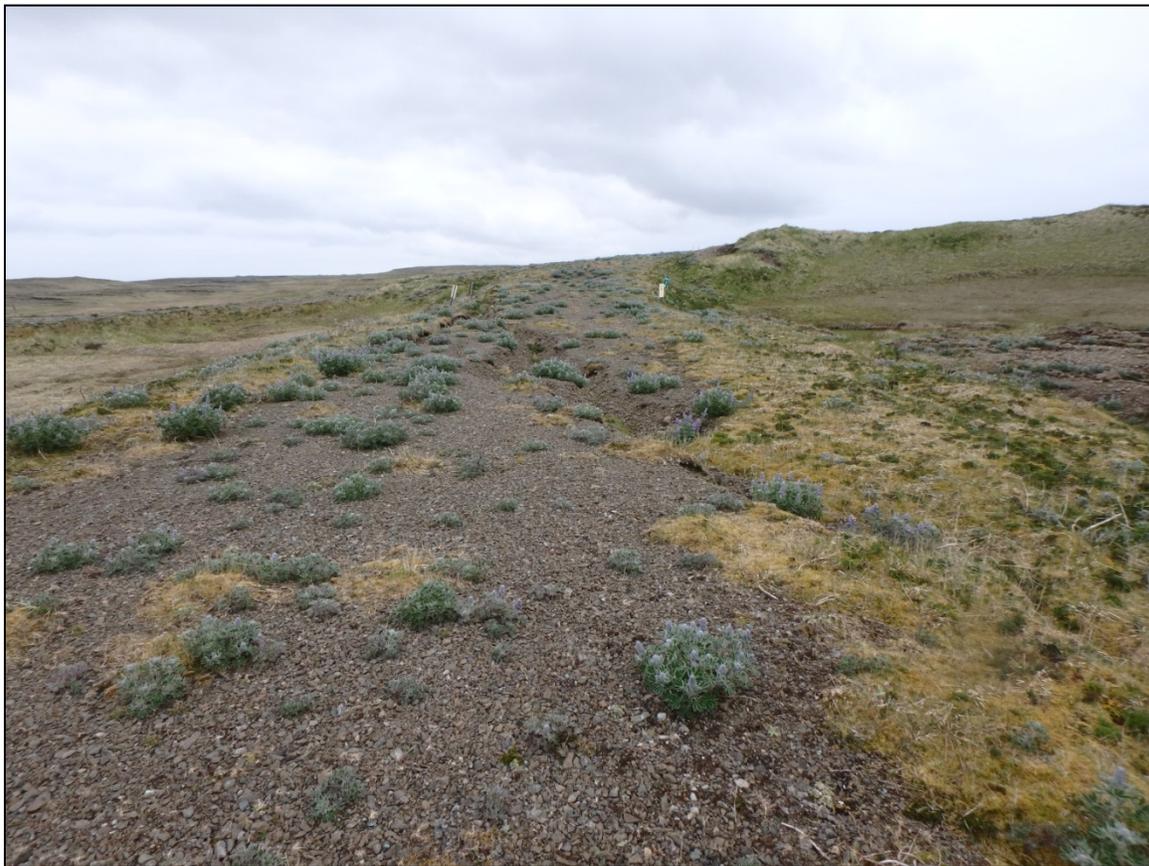
MM 18 road damage was in better condition than that observed in the 2016 inspection. Cracks and scarps appeared to be self-healing. The transverse cracks (north end of damage area) measured approximately 21 ft long and 1 ft to 2.5 ft deep and 2 ft to 4 ft wide. The longitudinal cracks ranged from approximately 40 ft long and 1 ft wide and up to 10 inches deep, to 60 ft long and up to 4 ft wide and 18 inches deep. This area is currently not passable by equipment and will require repair. See Appendix B for photos.

PL-MM18_01. Cracks in road

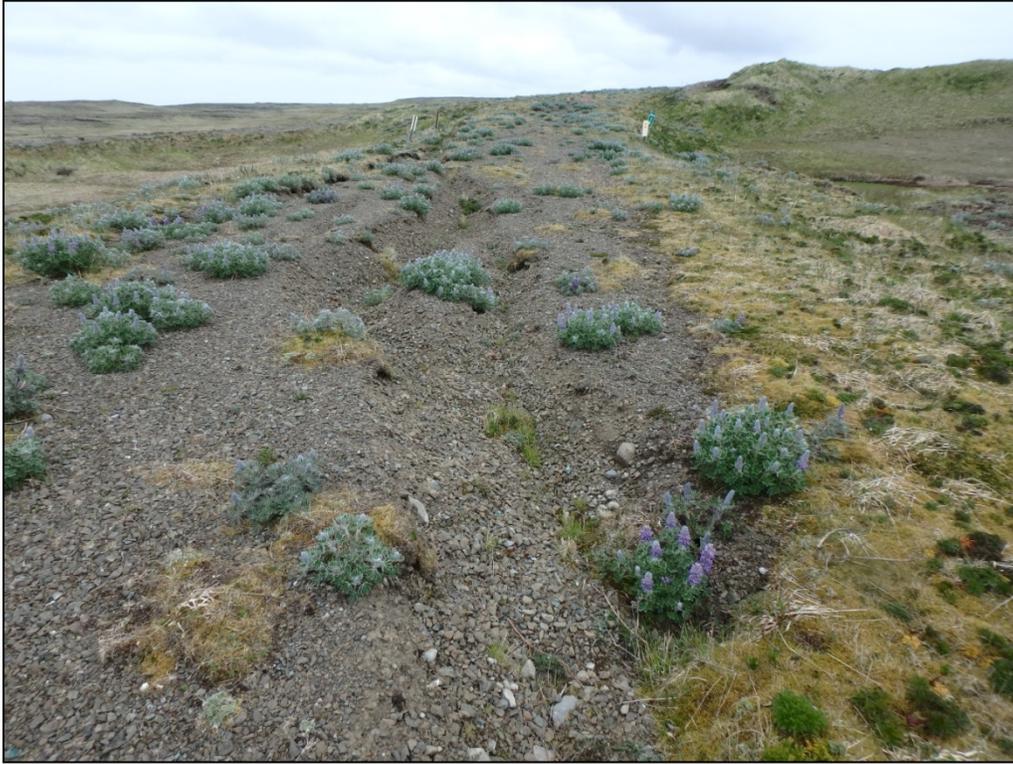
PL-MM18_02. Diagonal crack furthest south, approximately 60 ft long and up to 4 ft wide and 18 inches deep

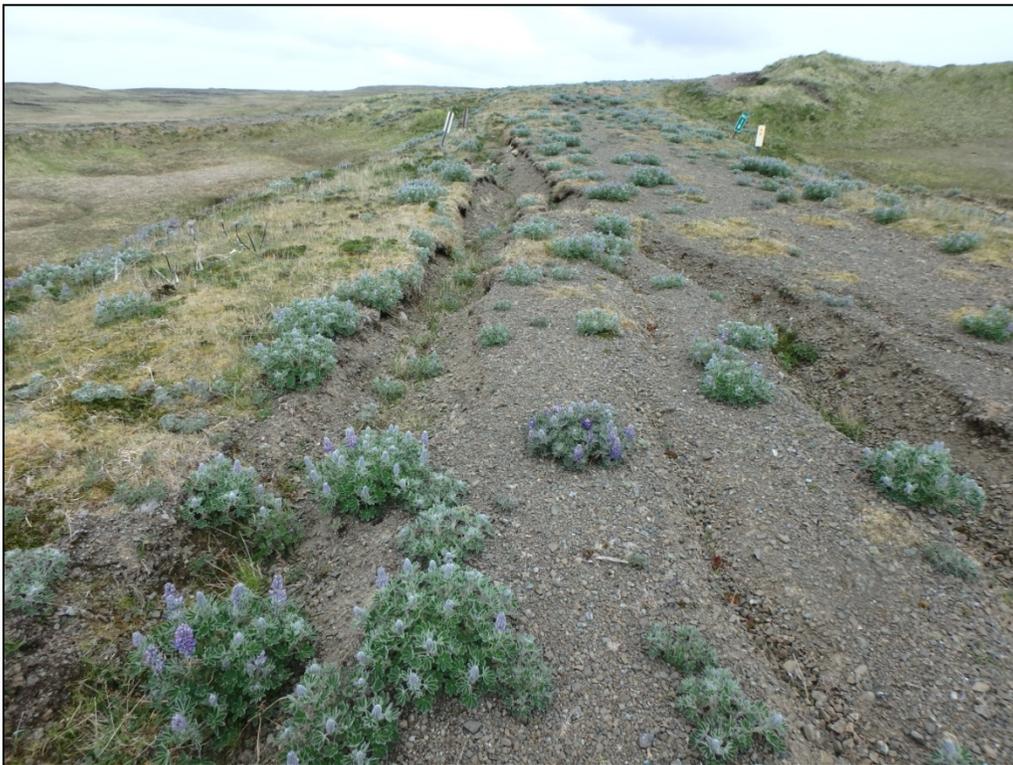
PL-MM18_03. Longitudinal crack along west shoulder of the road

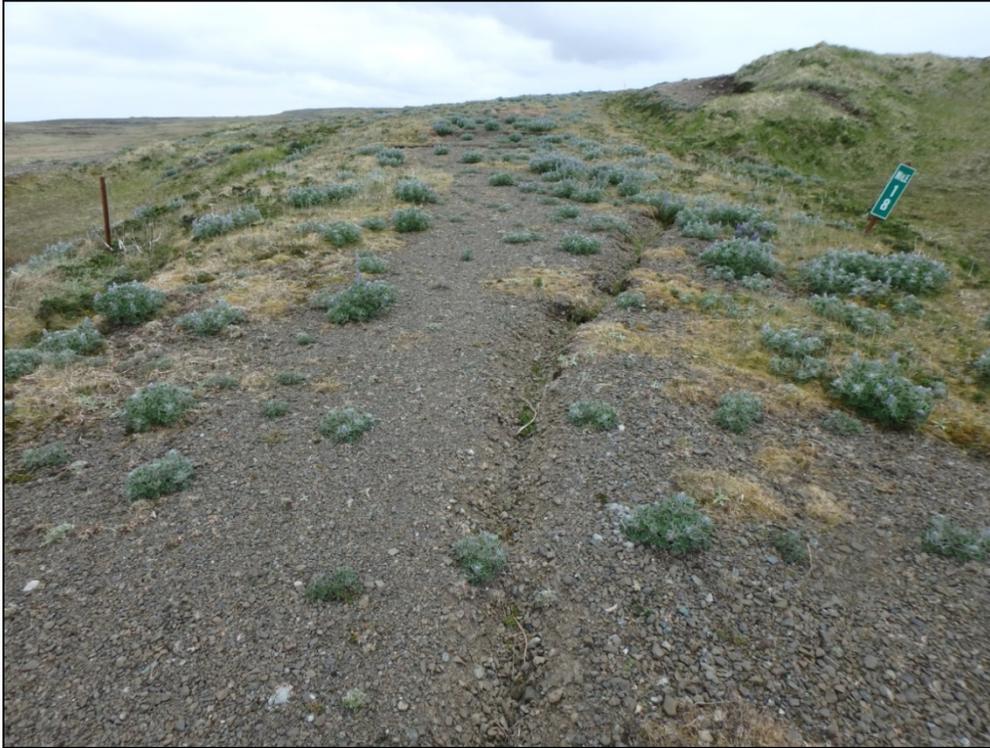
PL-MM18_04. Diagonal crack, approximately 40 ft long, up to 1 ft wide and 10" inches deep

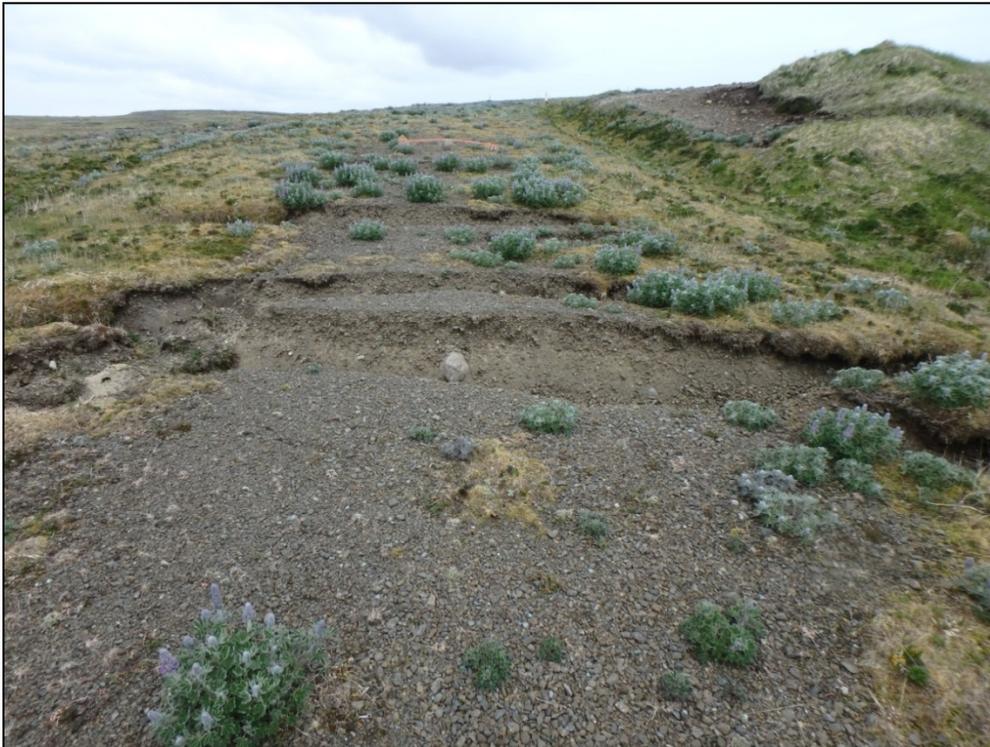
PL-MM18_05. Transverse cracks, three dominant and one minor, at north end of damage area

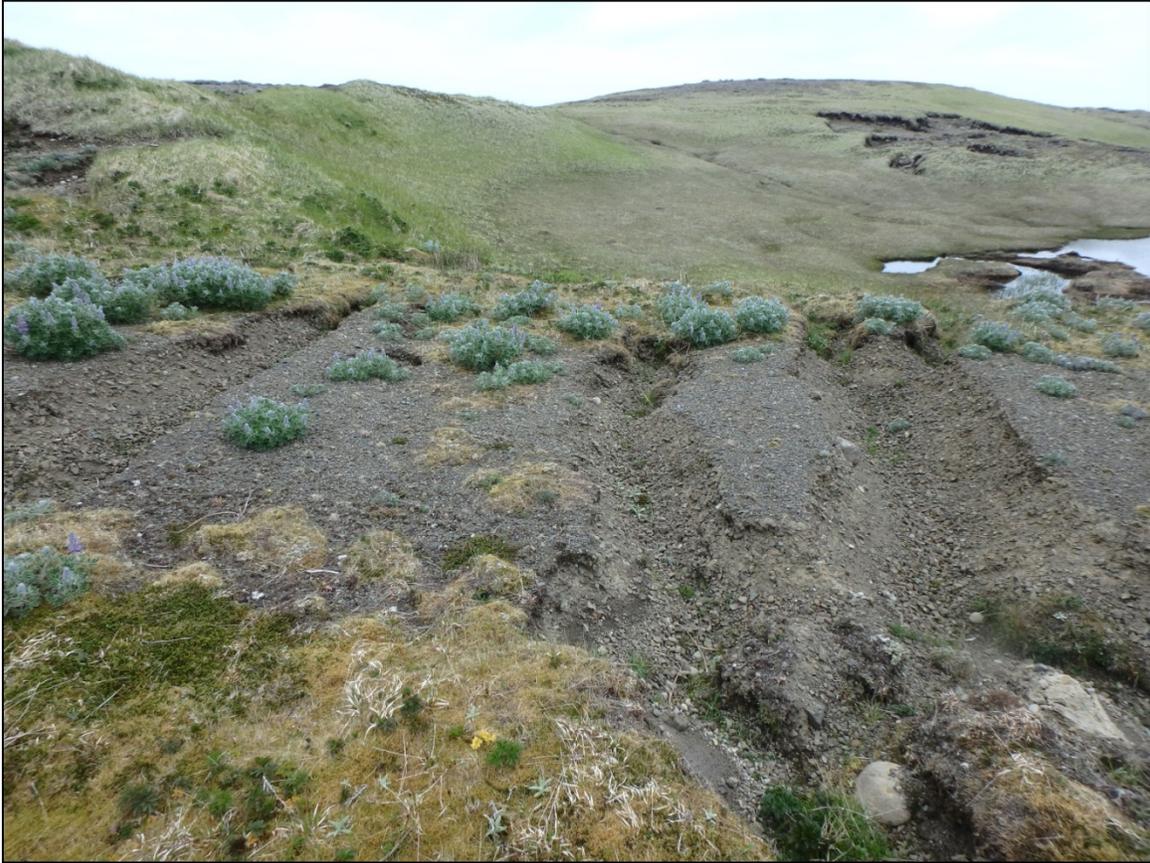
PL-MM18_06. Transverse cracks at north end of damage area, approximately 21 ft long, 1 ft to 2.5 ft deep, and 2 ft to 4 ft wide

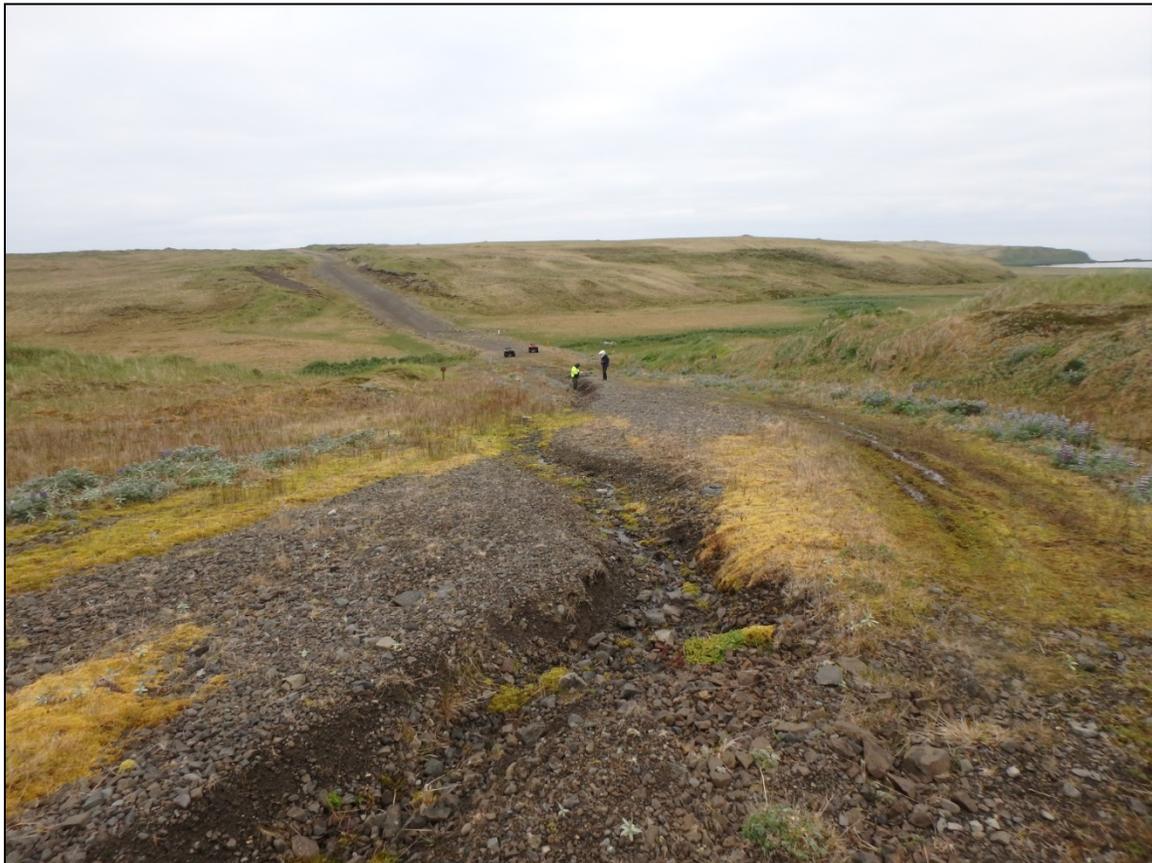
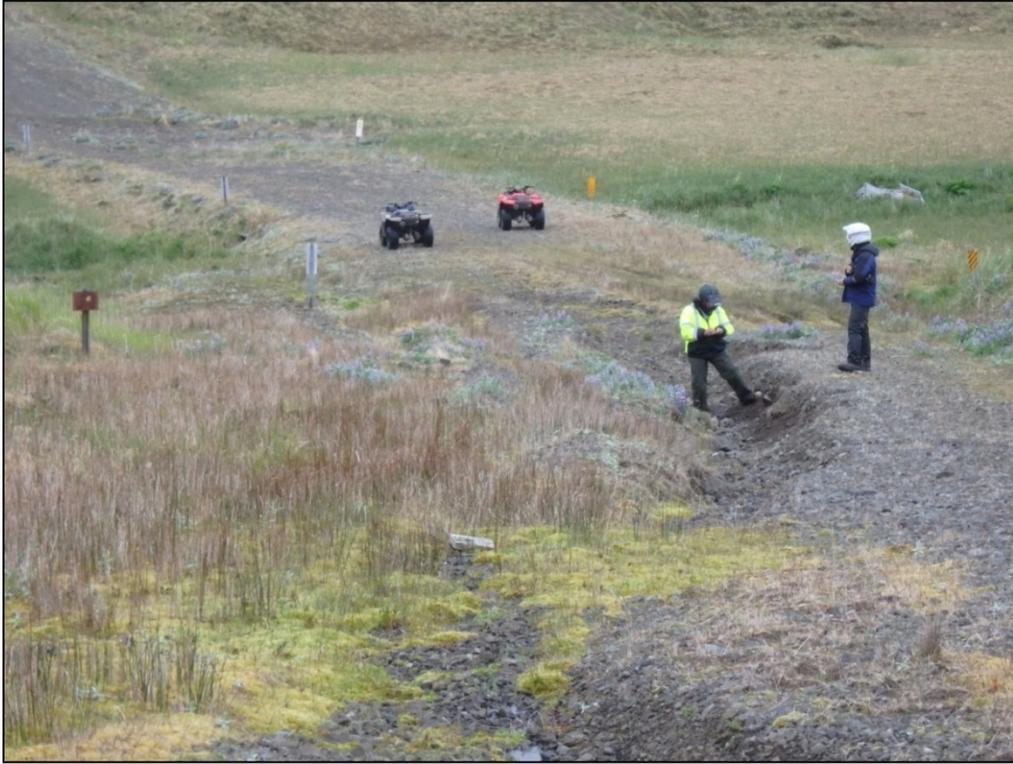
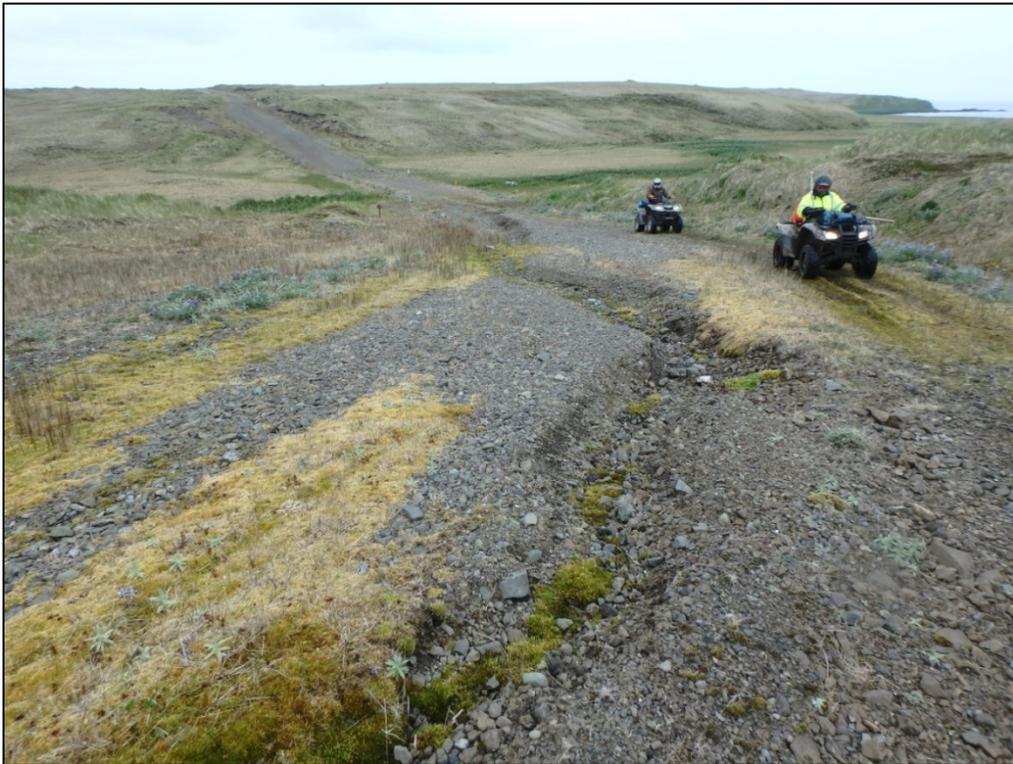
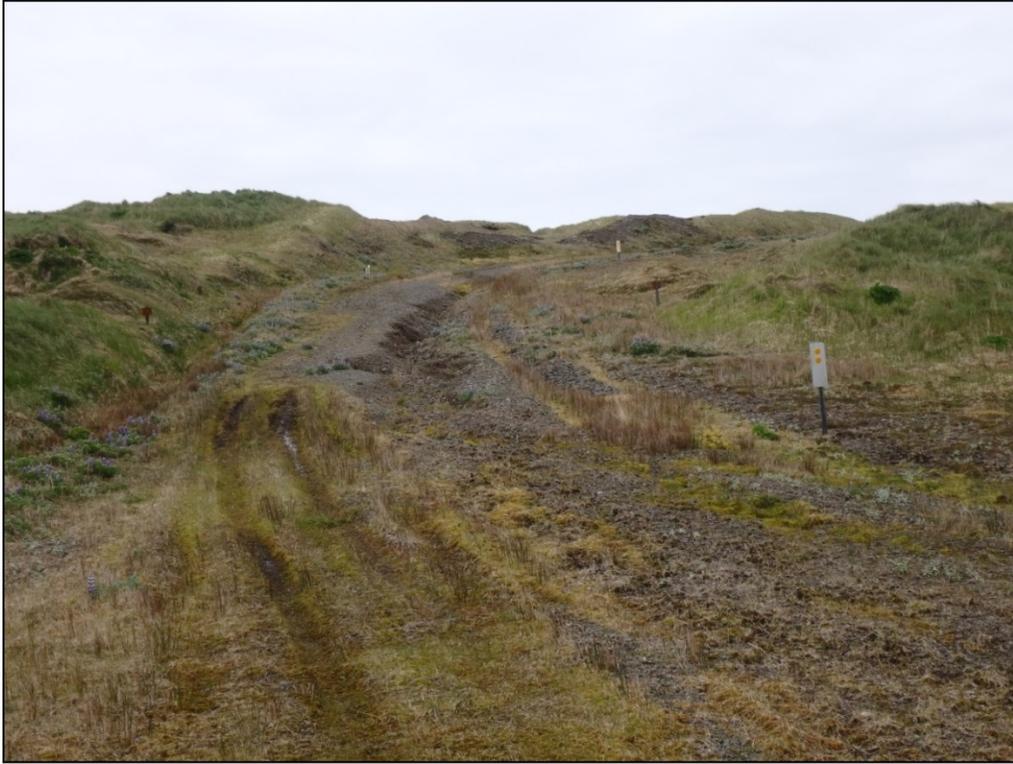
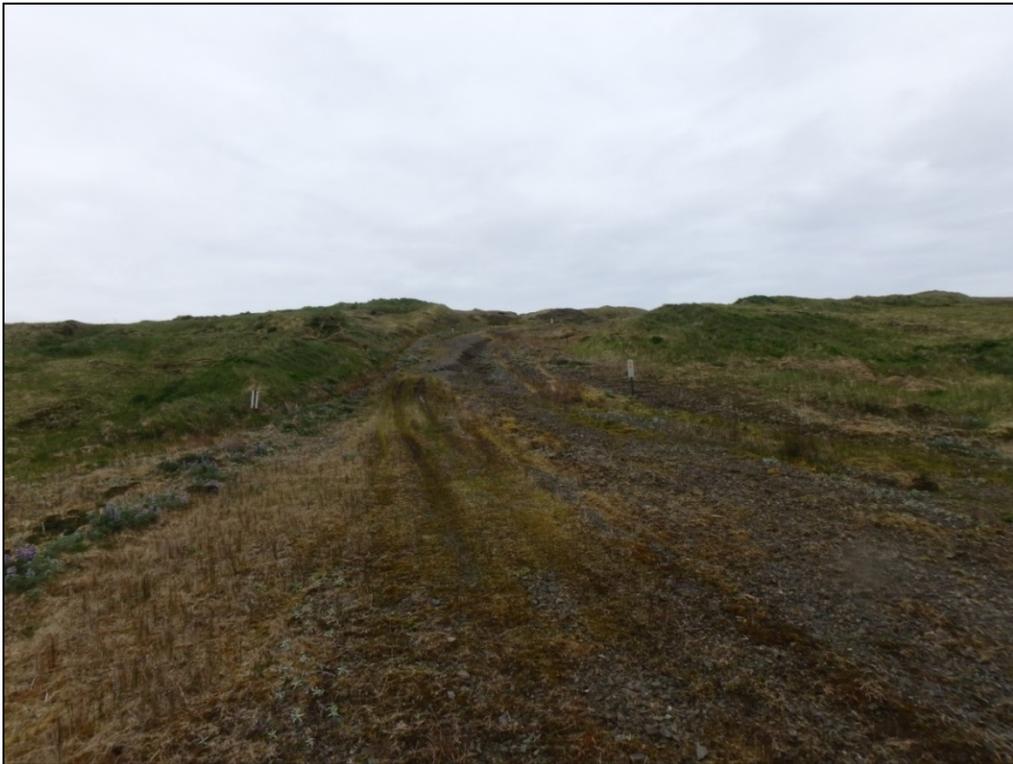
The road at approximately MM 5.5 has several large cracks along one side of the road that range from 6 ft to 10 ft wide and 1 ft to 2.5 ft deep. The road is currently accessible by ATV but will require repairs for access by standard-sized vehicles and equipment. Grading of the existing road material will likely fix the problem. See Appendix B for photos and the inspection checklist.

PL-MM5_01. Viewing crack in road standing on south end looking north

PL-MM5_02. Viewing crack in road standing on south end looking north

PL-MM5_03. Viewing crack in road standing on south end looking north

PL-MM5_04. Viewing crack in road standing on north end looking south

PL-MM5_05. Viewing crack in road standing on north end looking south

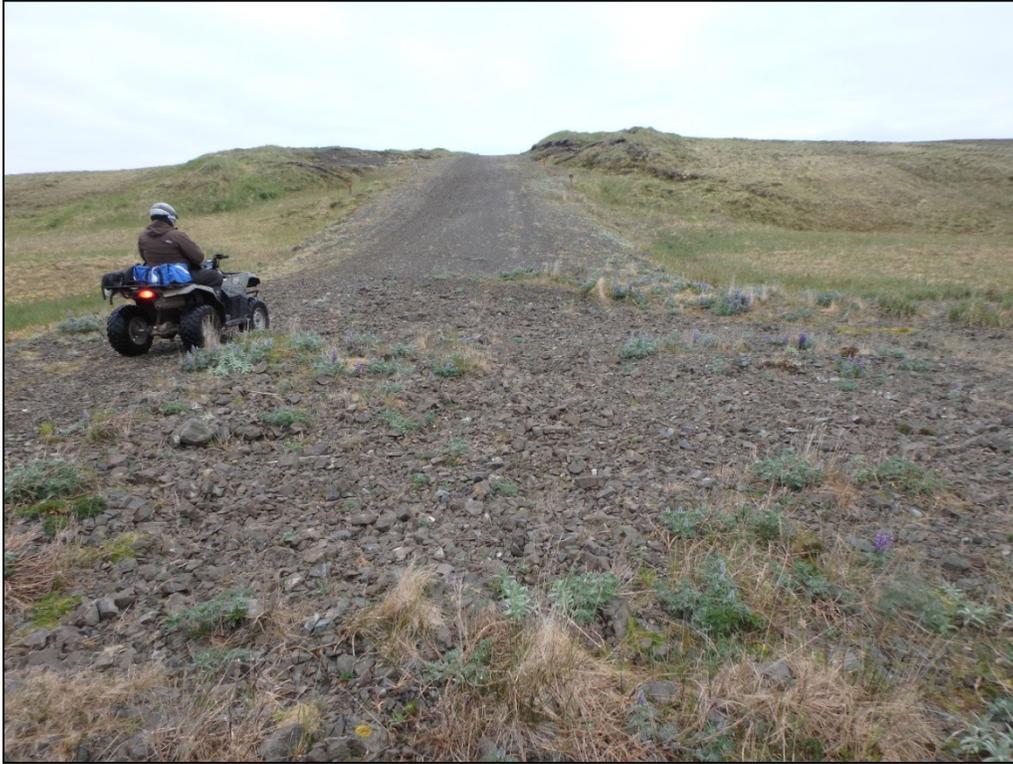
PL-MM5_06. Drainage channel flow line crossing road (low spot) looking north
