Amchitka Annual Site Inspection 2018 Trip Report Amchitka, Alaska, Site

January 2019

Amchitka Site 2018 Annual Mud Pit Caps Inspection

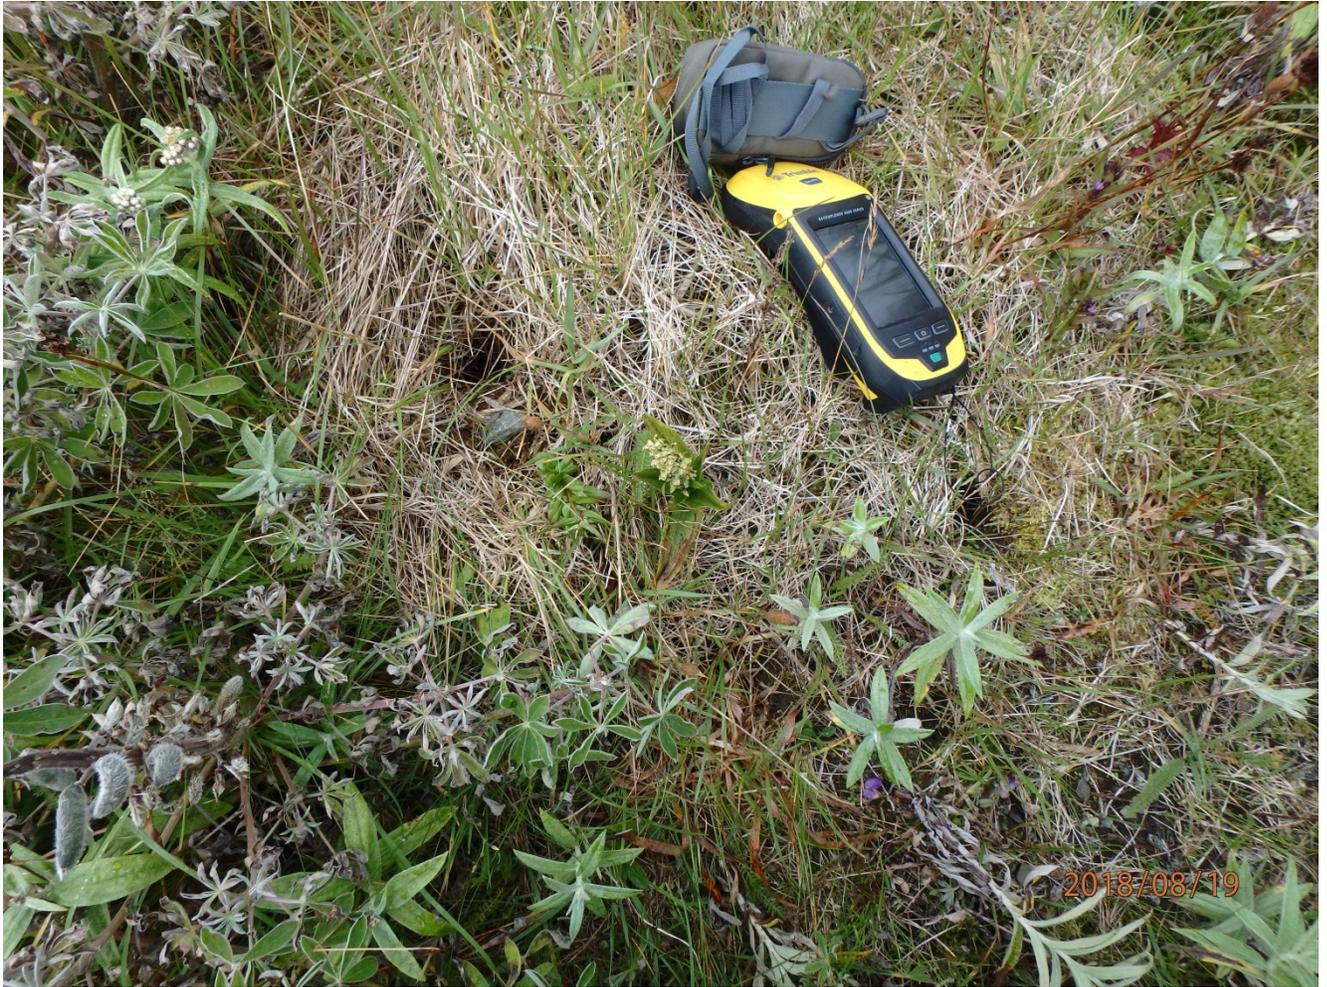
Photo RR01: Two animal burrows at the Rifle Range mud pit site

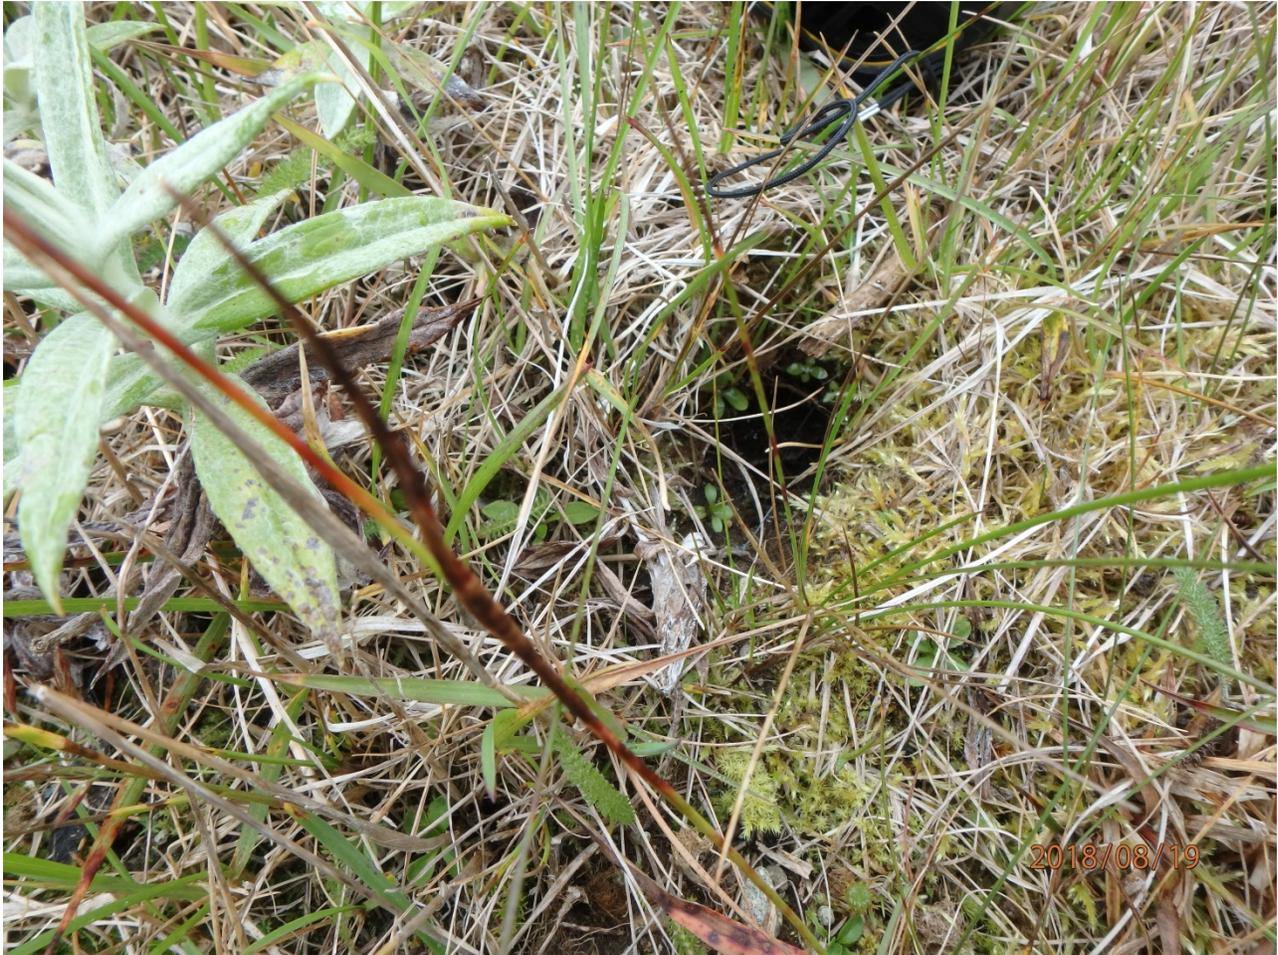
Photo RR02: New animal burrow (first of two) at the Rifle Range mud pit site

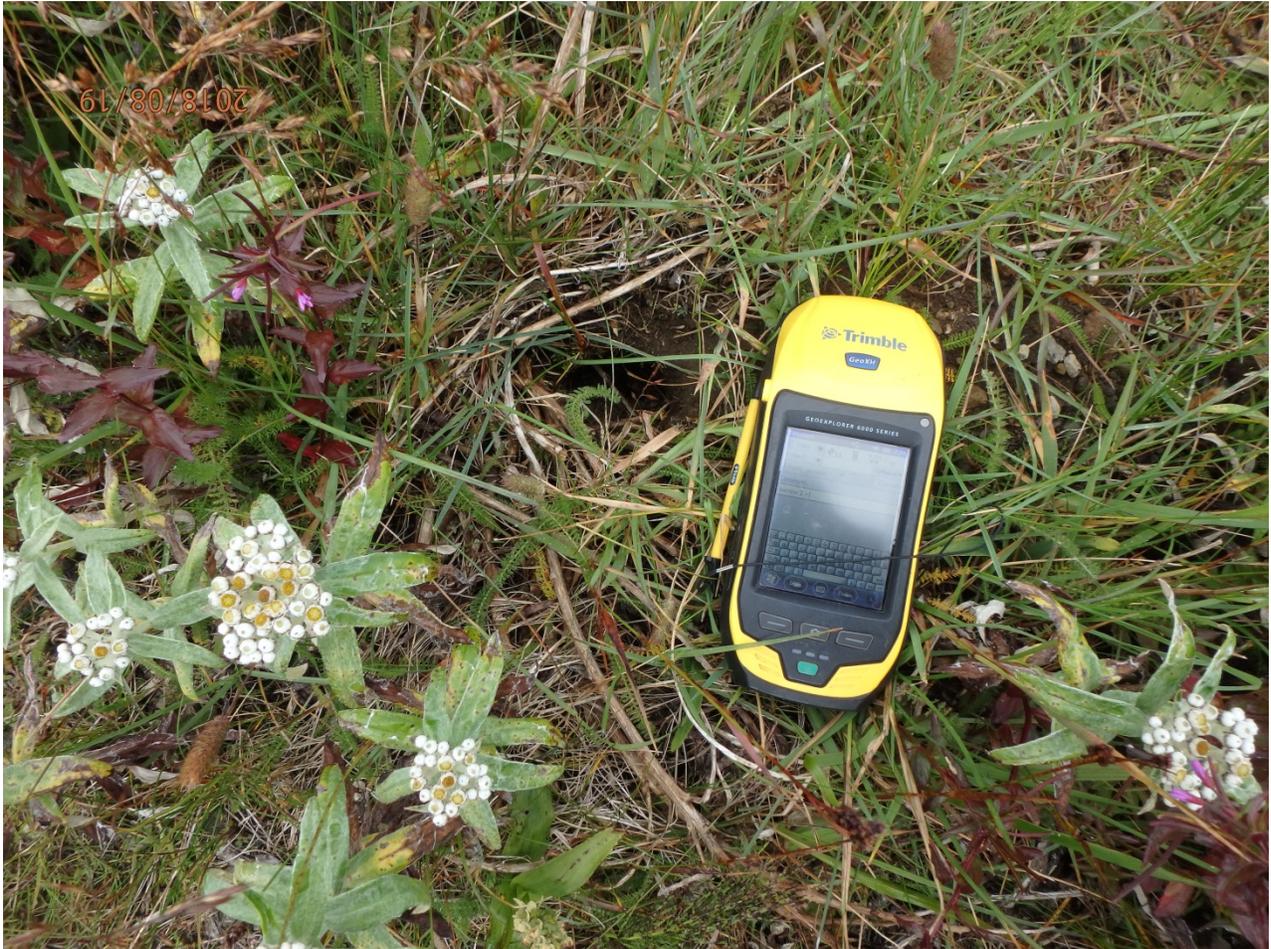
Photo RR03: New animal burrow (second of two) at the Rifle Range mud pit site

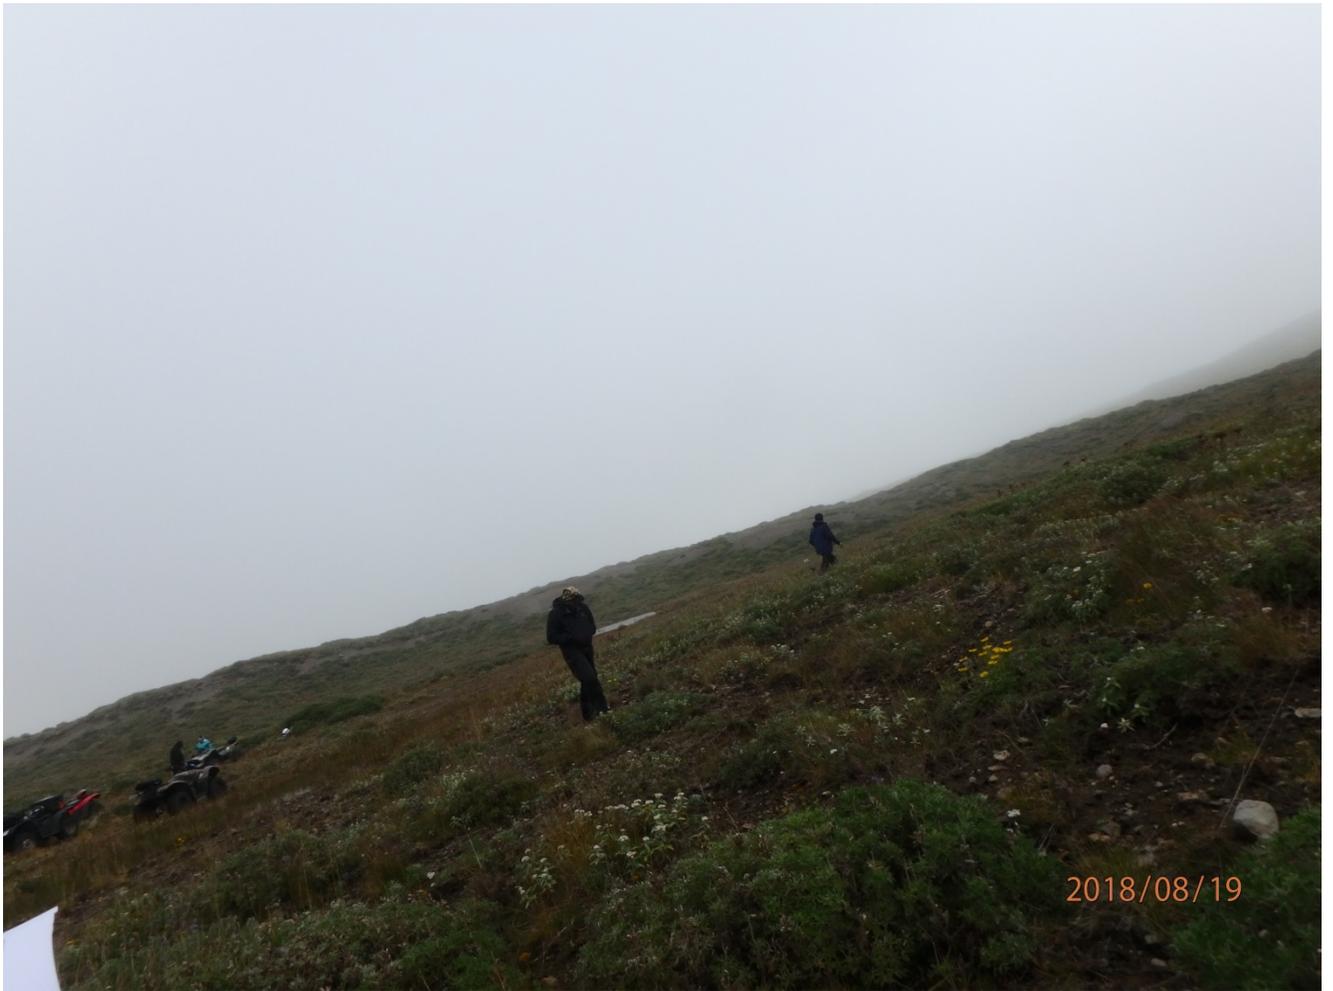
In general, no new earthquake damage was seen on the Rifle Range mud pit site and it appeared to show signs of self-healing compared to previous inspections. The previously observed primary crack on the north side of the pit (see photograph RR06) was still visible but new vegetation was growing in most of the cracks. The primary crack was measured to be approximately 20 feet (ft) long in 2017. The GPS coordinates for the primary crack matched the GPS coordinates recorded in 2017. No exposed liner was visible.

Photo RR06: Existing crack on the Rifle Range mud pit cap, similar to photo PL-RR01 in the 2017 Amchitka inspection report (DOE 2017)

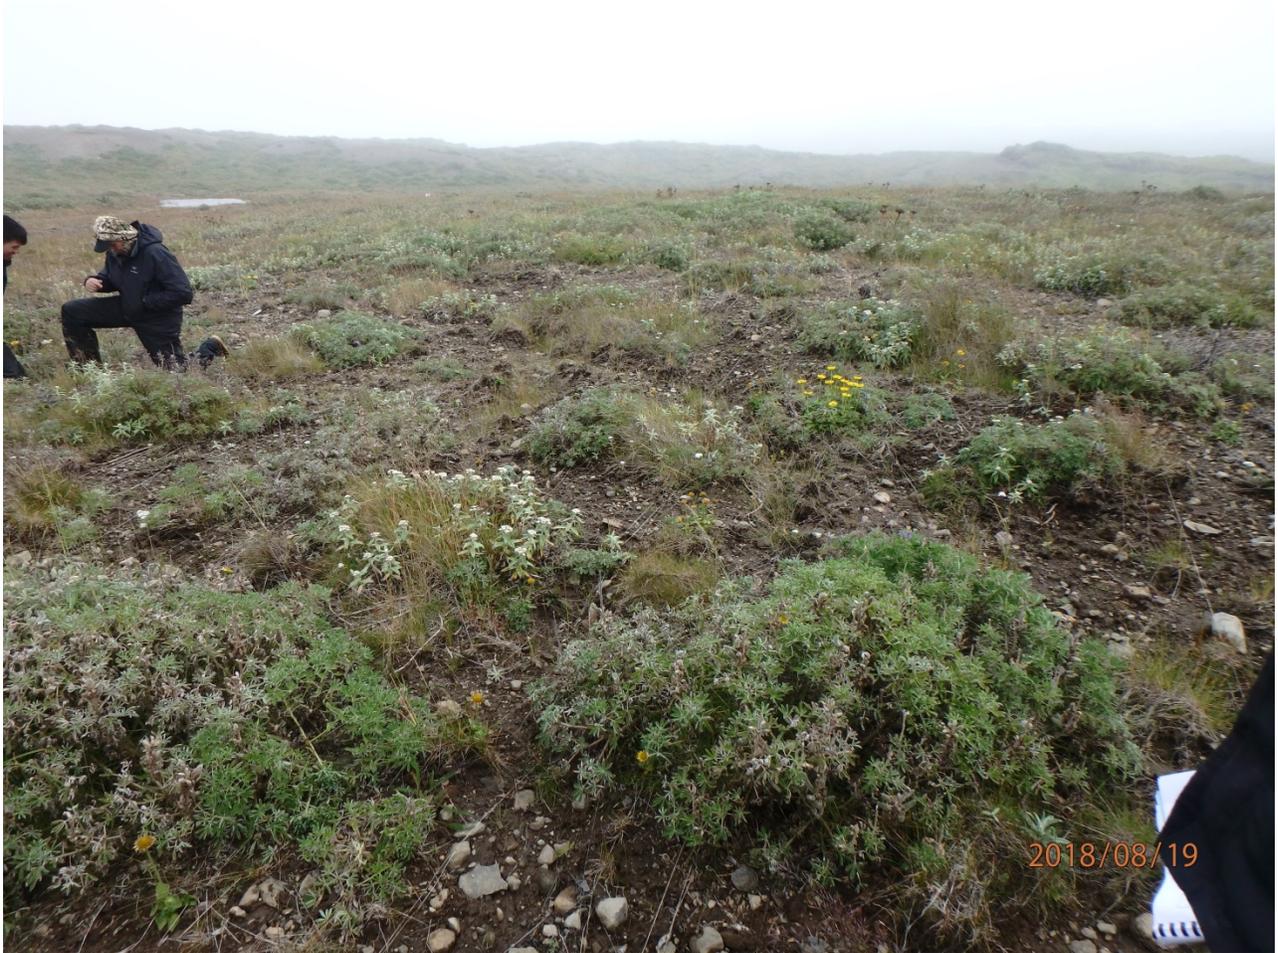
Photo RR07: Existing crack on the Rifle Range mud pit cap, similar to photo PL-RR03 in the 2017 Amchitka inspection report (DOE 2017)

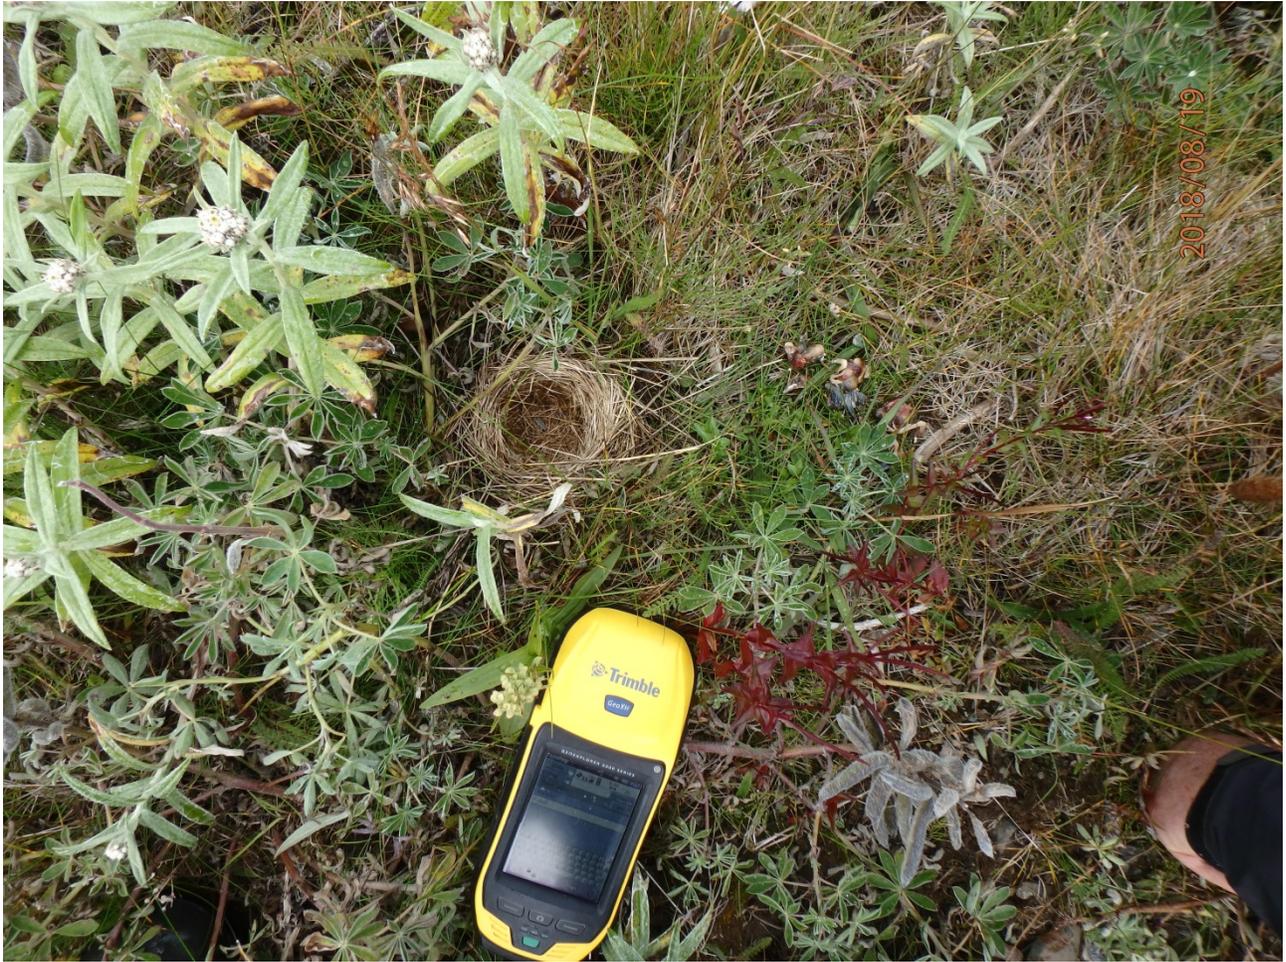
Photo RR08: Bird nest, baby bird remains, rat tracks, and hole at the Rifle Range mud pit site

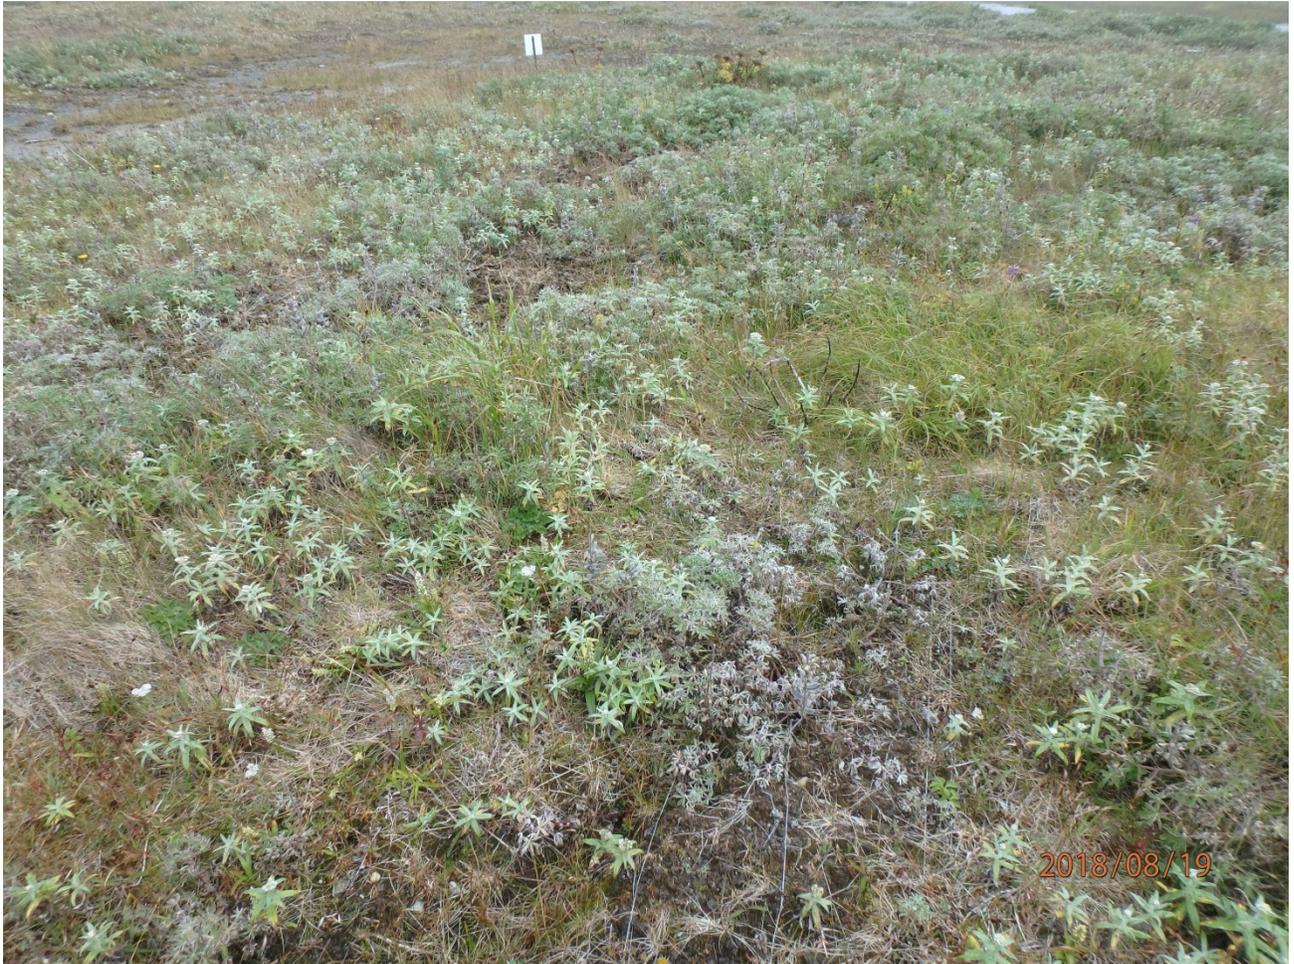
Photo RR09: Existing crack on the Rifle Range mud pit cap, similar to photo PL-RR02 in the 2017 Amchitka inspection report (DOE 2017)

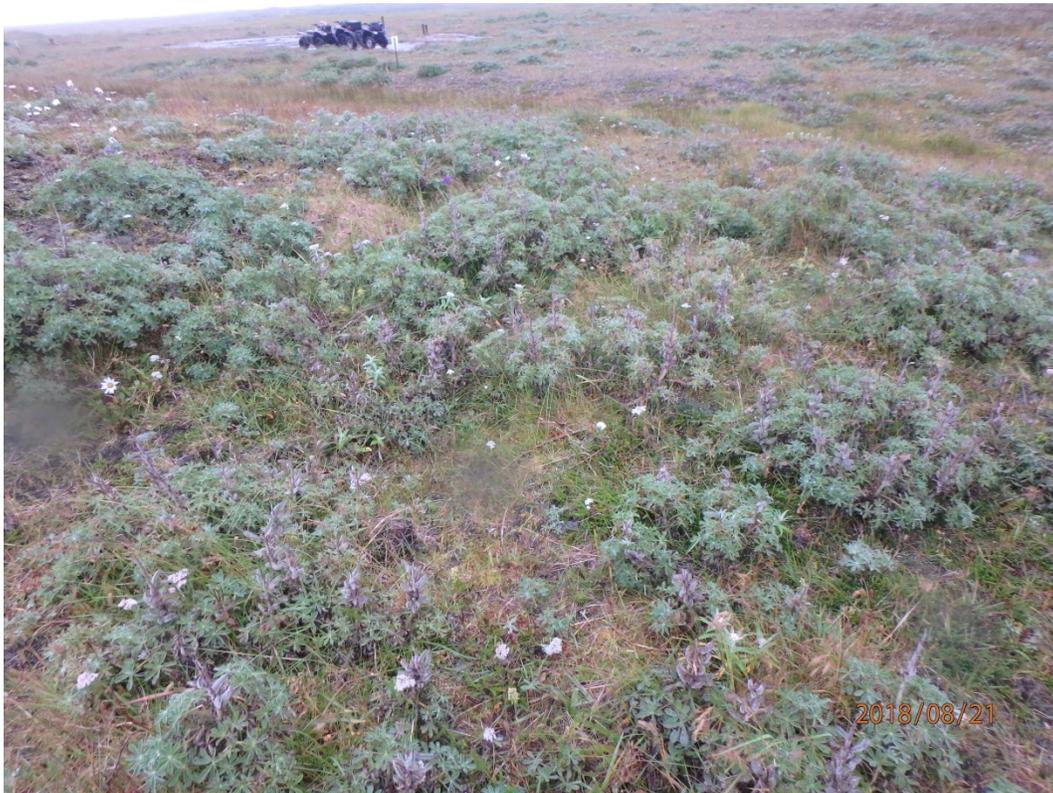
Photo LS03: General depression area at the Long Shot mud pit site that was described in the 2017 Amchitka inspection report

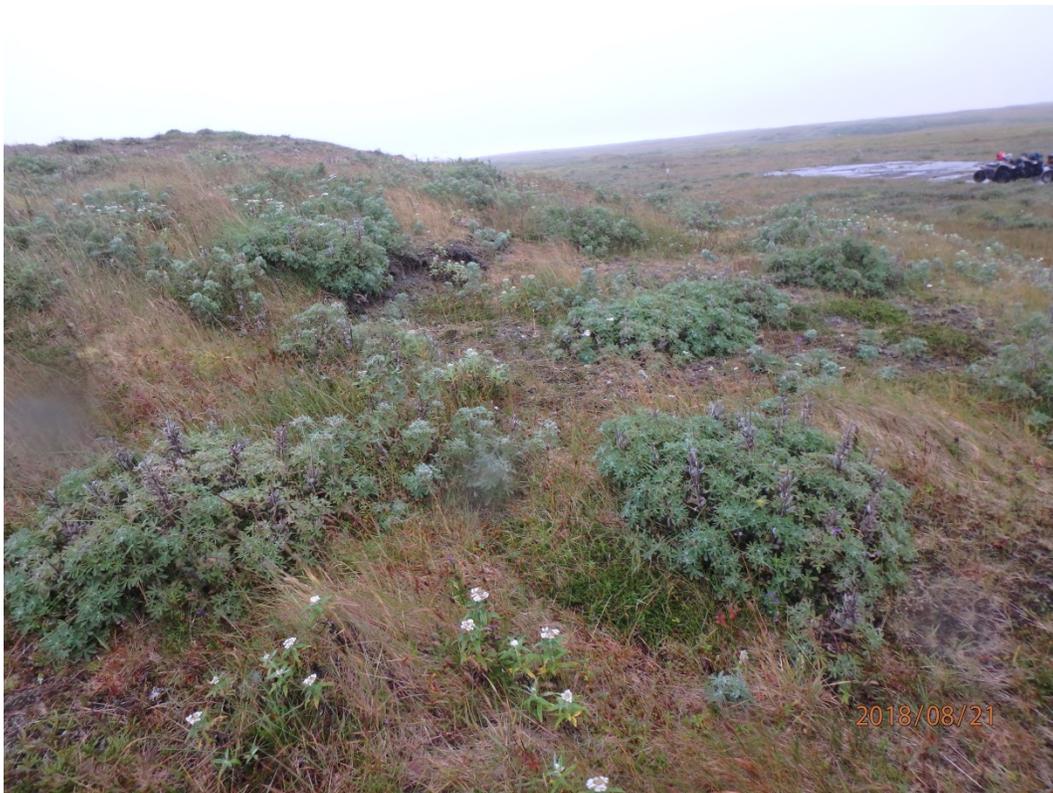
Photo LS04: Slump/scarp in southwest corner of the Long Shot mud pit cap, similar to photo PL-LS01 in the 2017 Amchitka inspection report (DOE 2017)

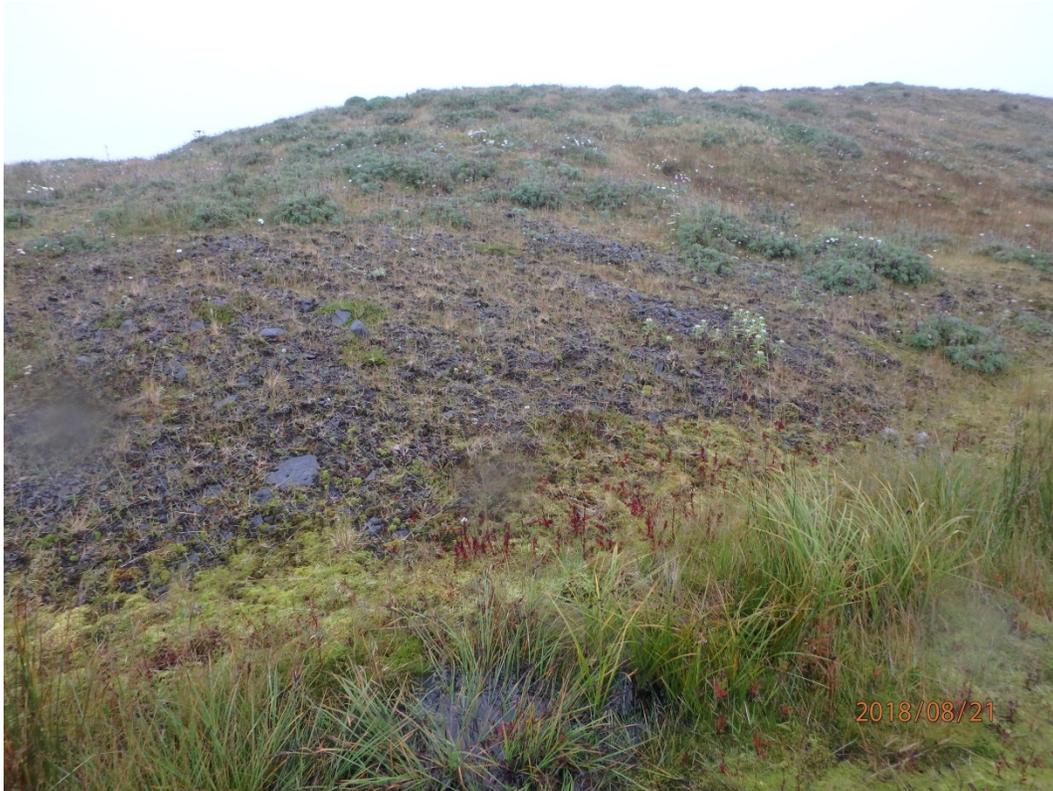
Photo LS05: Rills on the east side of the Long Shot mud pit cap, similar to photo PL-LS02 in the 2017 Amchitka inspection report (DOE 2017)

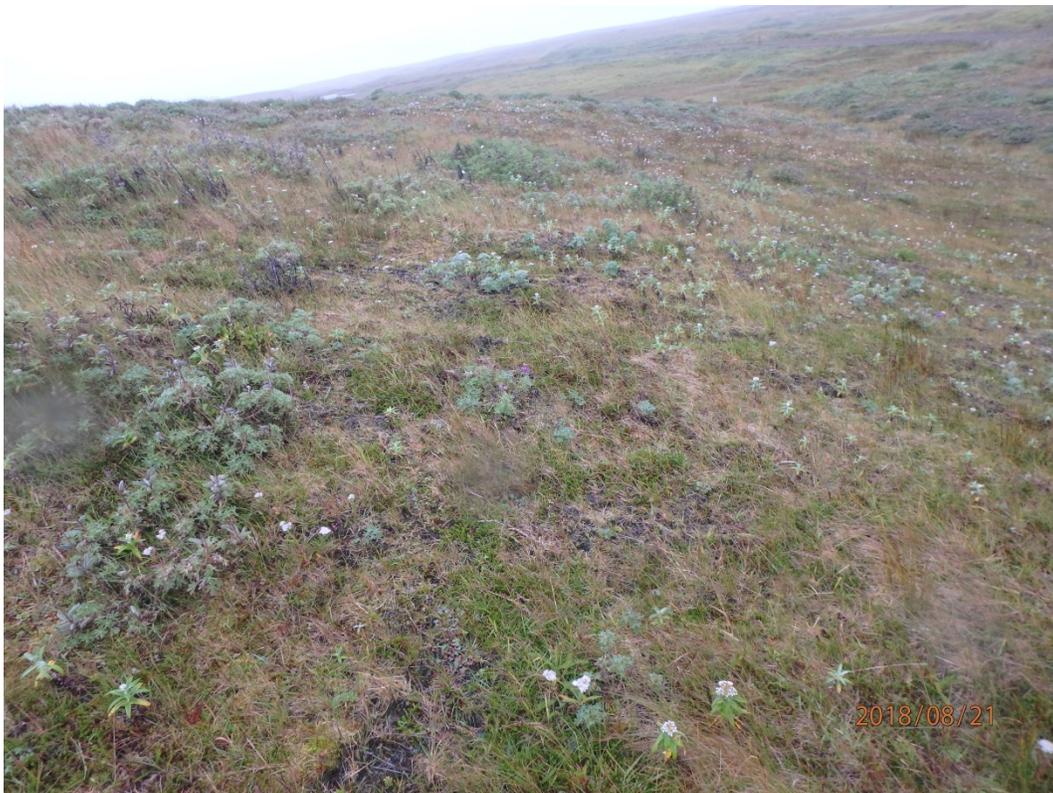
Photo LS06: Undulating surface along entire south side of the Long Shot mud pit cap, viewed from approximately the middle of the cap looking east, similar to photo PL-LS013 in the 2017 Amchitka inspection report (DOE 2017)

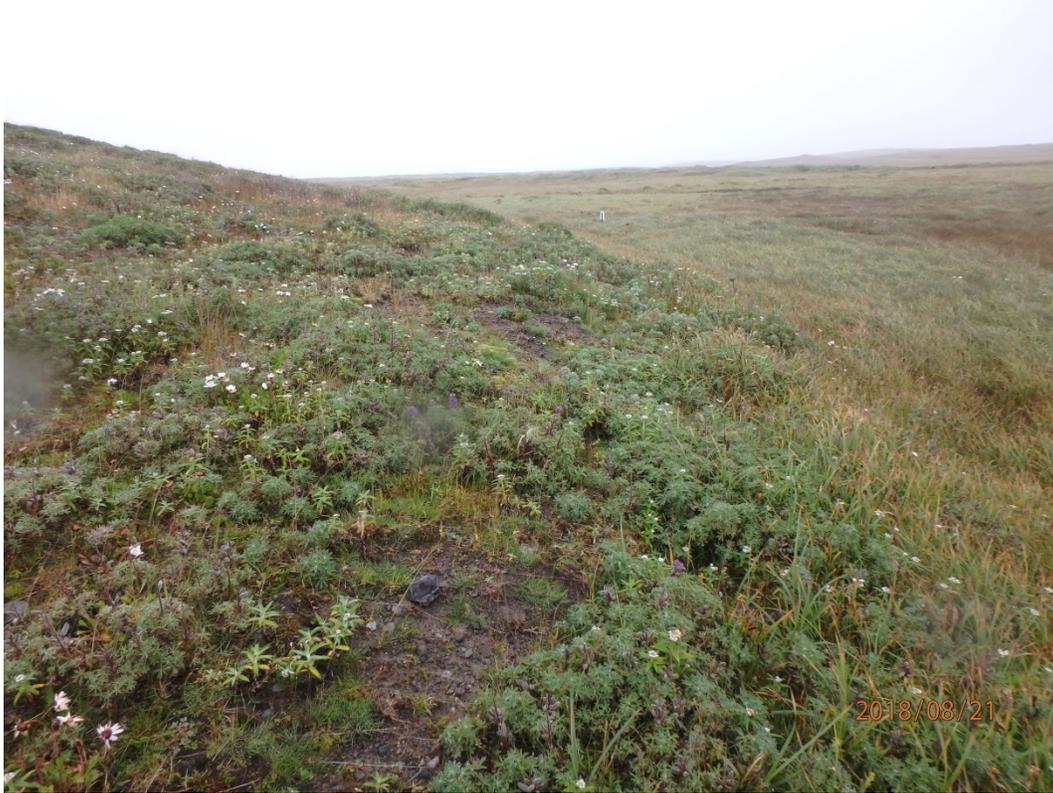
Photo LS07: Crack along the east side of the Long Shot mud pit cap near the toe of the slope, similar to photo PL-LS07 in the 2017 Amchitka inspection report

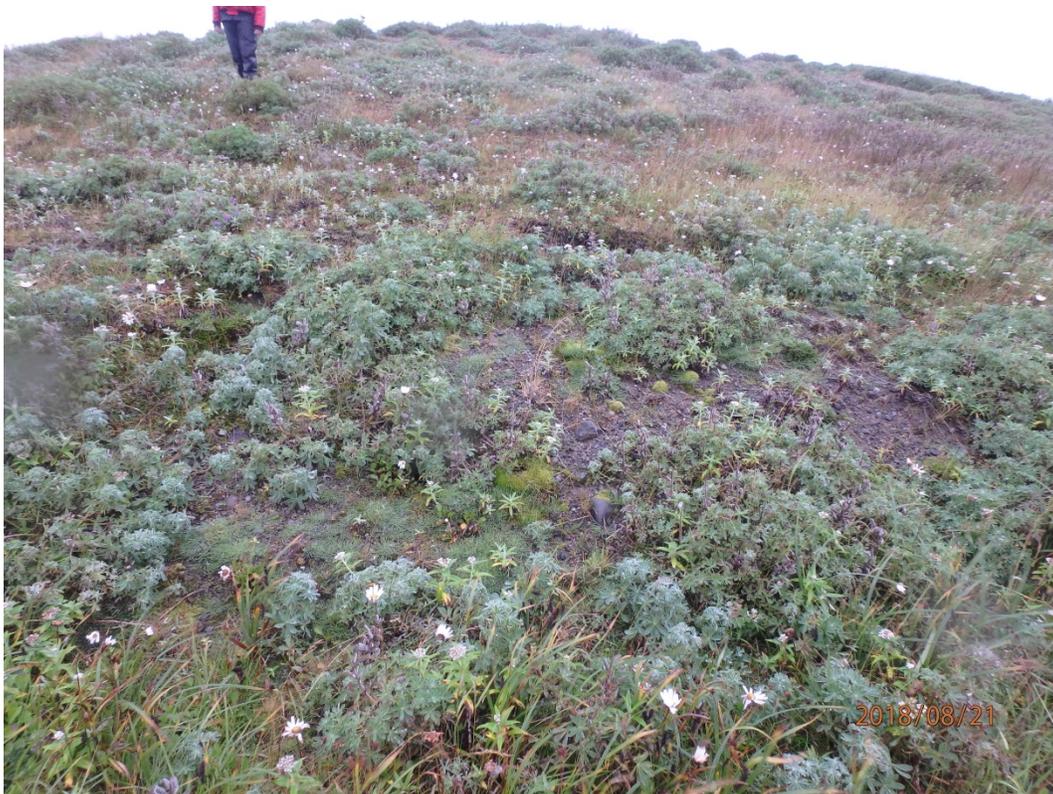
Photo LS08: Small holes near the east base and a crack on east side of the Long Shot mud pit cap, similar to photos PL-LS03 and PL-LS04 in the 2017 Amchitka inspection report (DOE 2017)

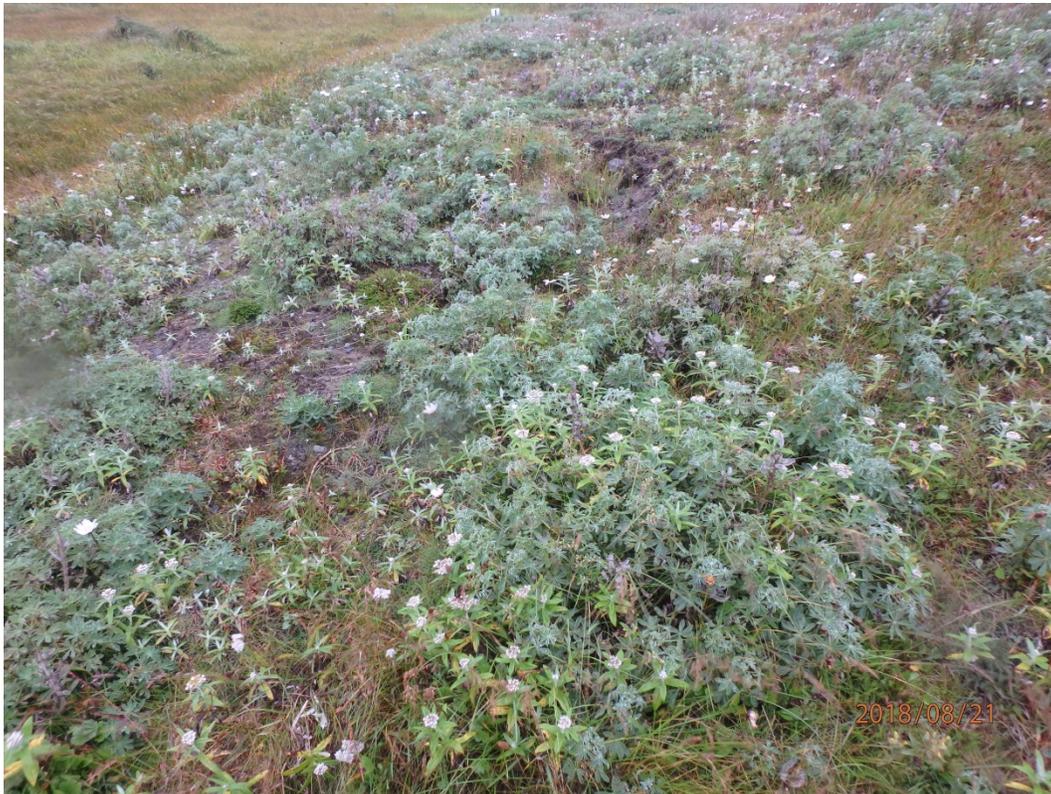
Photo LS09: Crack along the east side and near the toe of the slope of the Long Shot mud pit cap, similar to photos PL-LS05 and PL-LS06 in the 2017 Amchitka inspection report (DOE 2017)

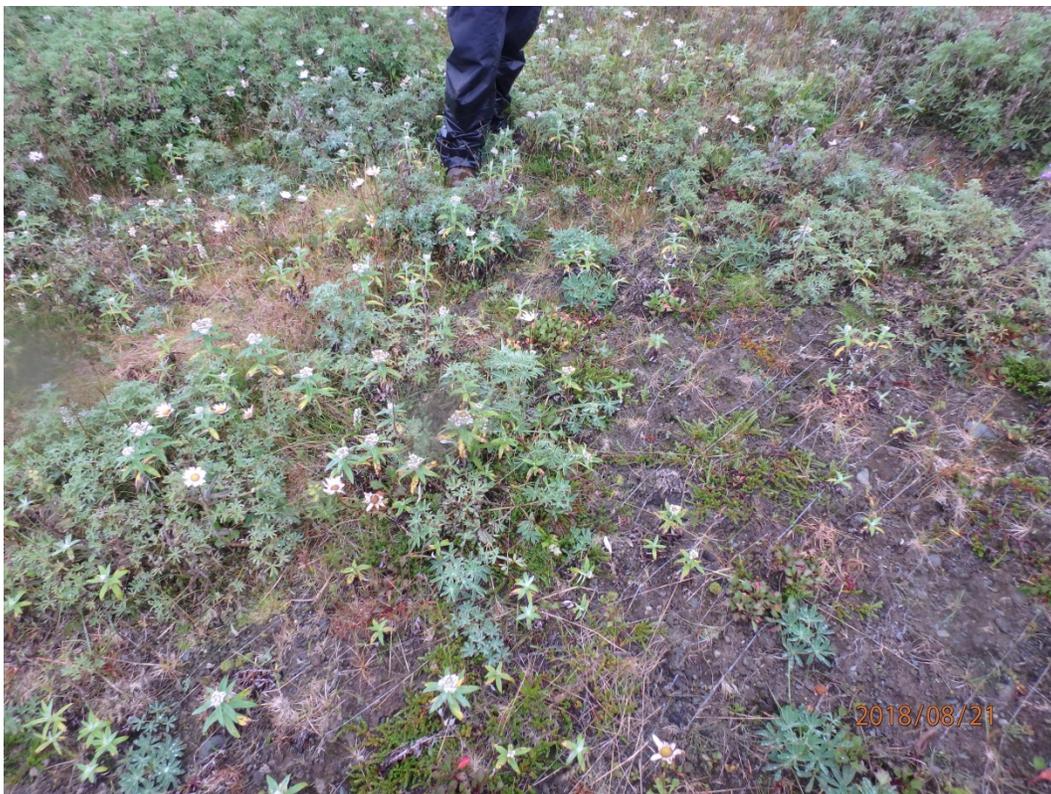
Photo LS10: Crack along the northeast side of the Long Shot mud pit cap, similar to photo PL-LS08 in the 2017 Amchitka inspection report (DOE 2017)

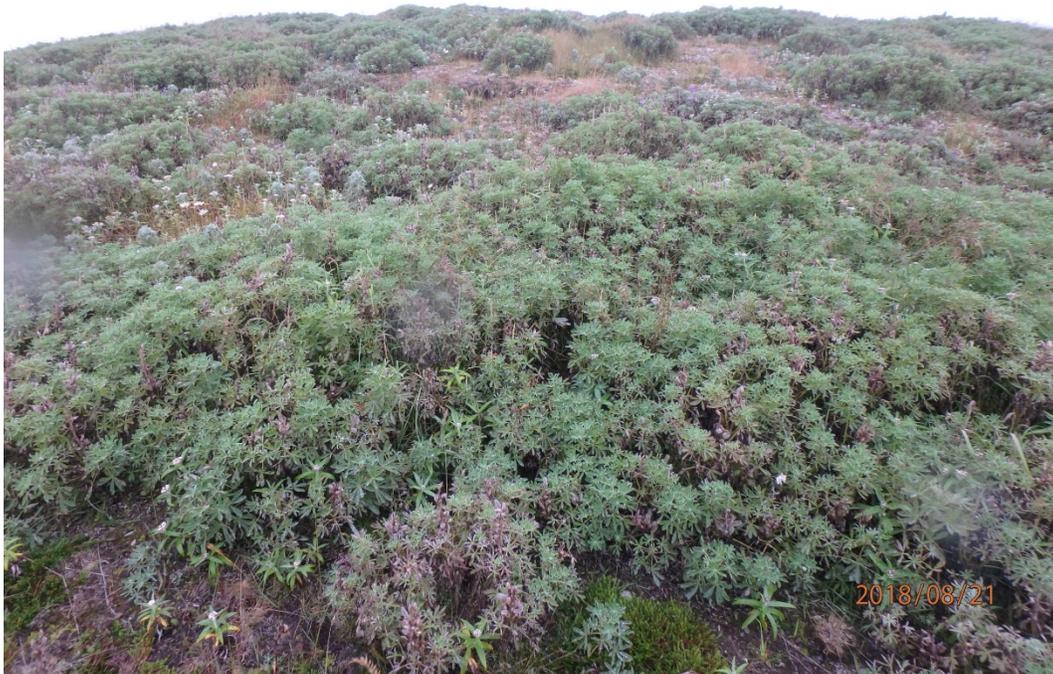
Photo LS11: Similar to photo PL-LS010 in the 2017 Amchitka inspection report (DOE 2017) looking at northeast corner of the Long Shot mud pit cap. Minor rills and cracks are hidden by vegetation.

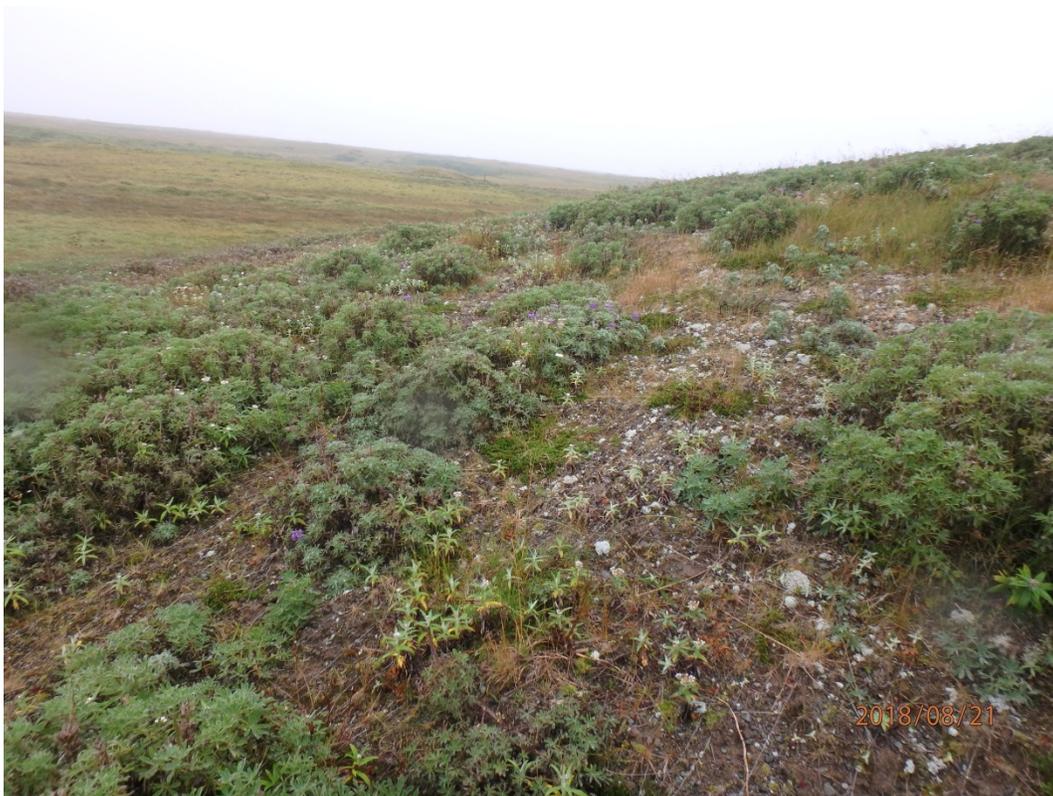
Photo LS12: Crack along the northeast side of the Long Shot mud pit cap, similar to photo PL-LS08 in the 2017 Amchitka inspection report (DOE 2017)

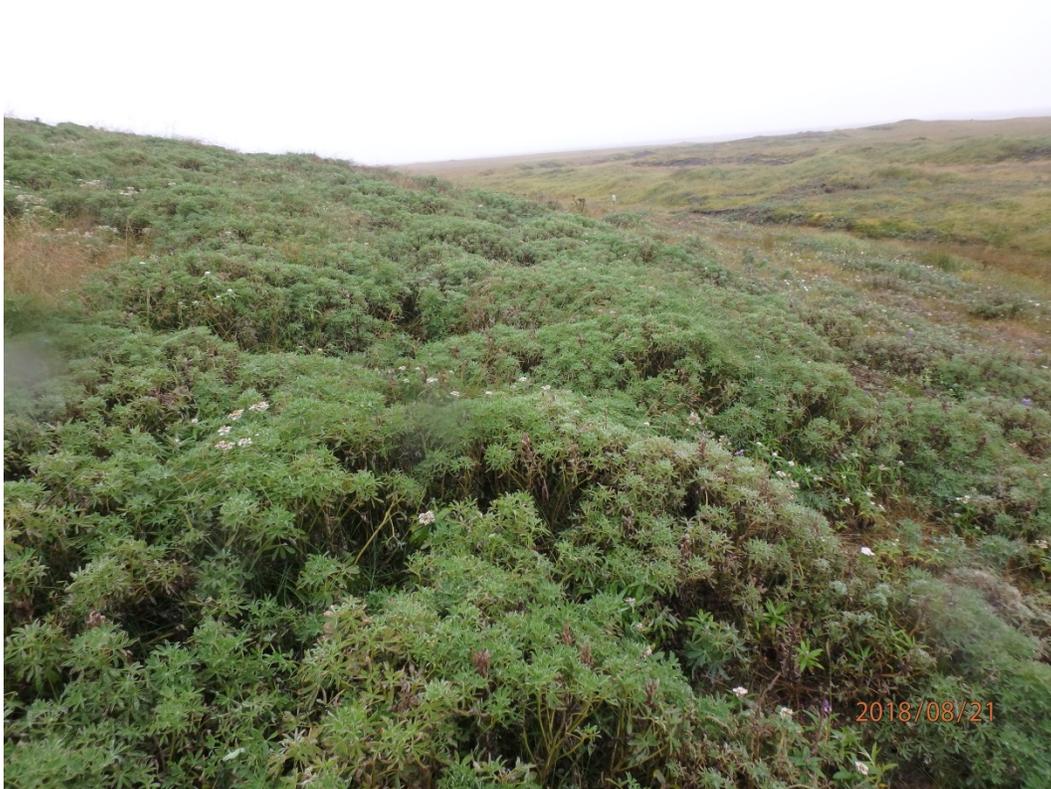
Photo LS13: Crack approximately midslope (i.e., halfway between top and toe) on the north side of the Long Shot mud pit cap, similar to photo PL-LS09 in the 2017 Amchitka inspection report (DOE 2017)

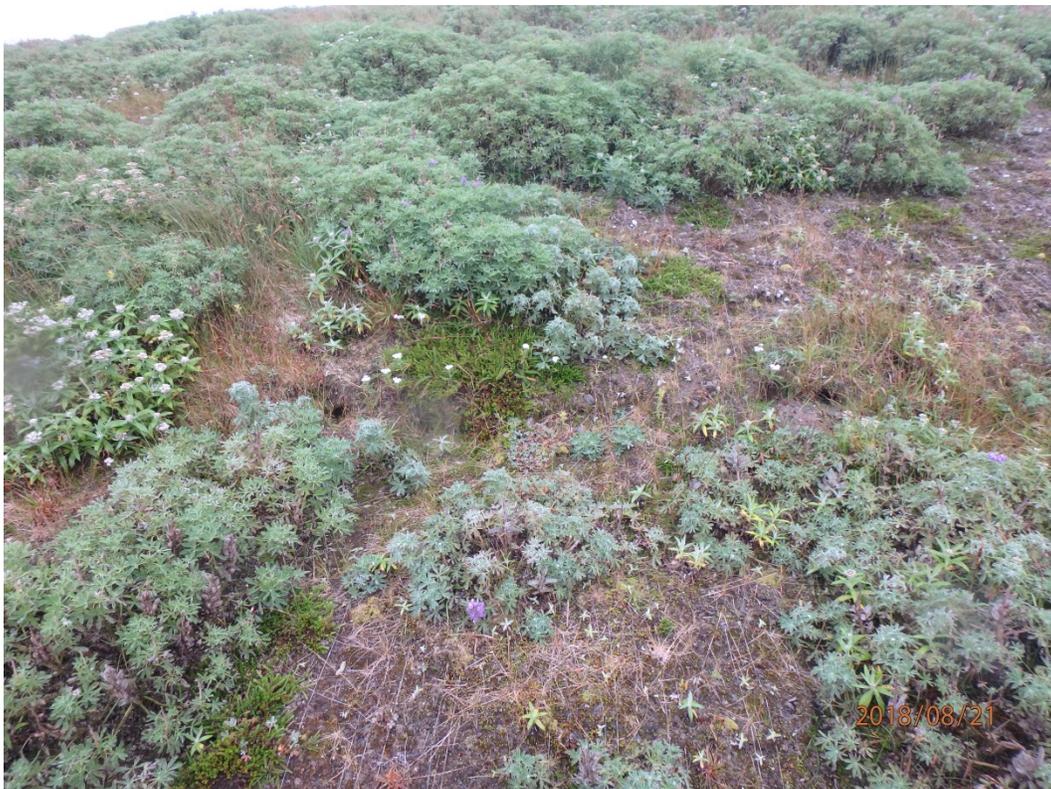
Photo LS14: Small burrow holes in the Long Shot mud pit cap, similar to photo PL-LS011 in the 2017 Amchitka inspection report (DOE 2017)

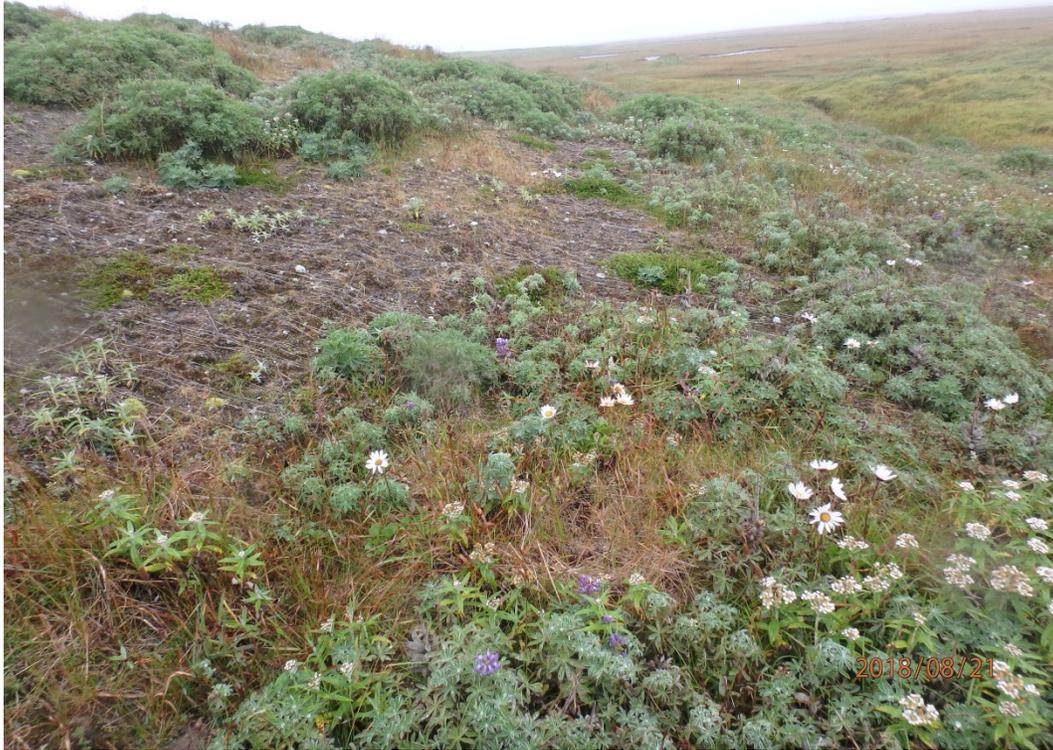
Photo LS15: Crack along the north side of the Long Shot mud pit cap, similar to photo PL-LS012 in the 2017 Amchitka inspection report (DOE 2017)

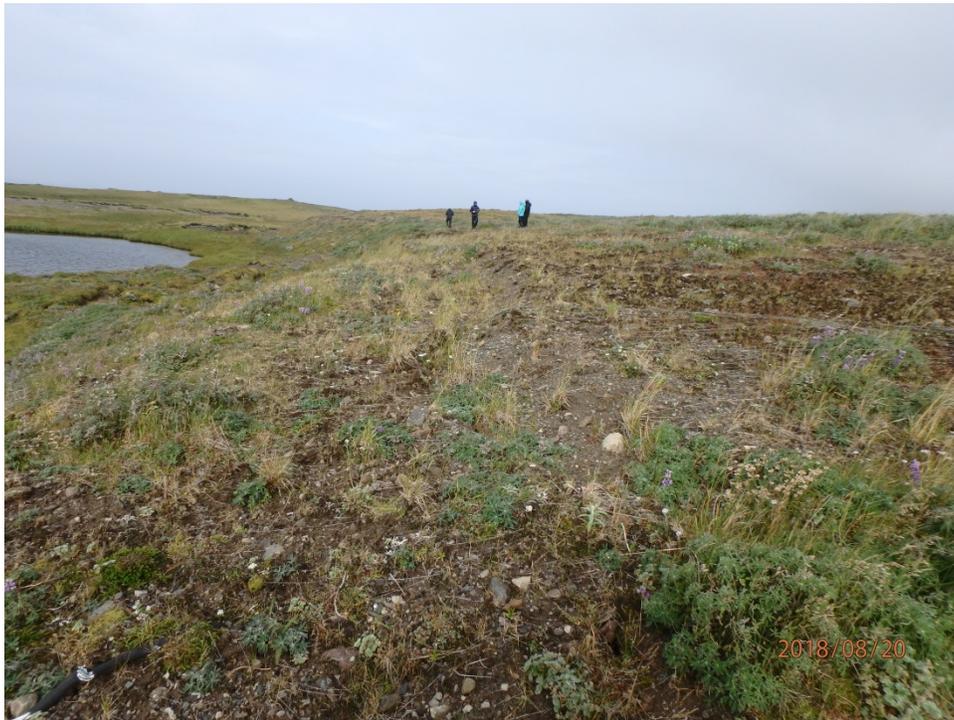
Photo D01: Southeast corner of the Drill Site D mud pit cap, similar to photo PL-D021 in the 2017 Amchitka inspection report (DOE 2017) and photo IMG_743 in the 2016 Amchitka inspection report (DOE 2016)

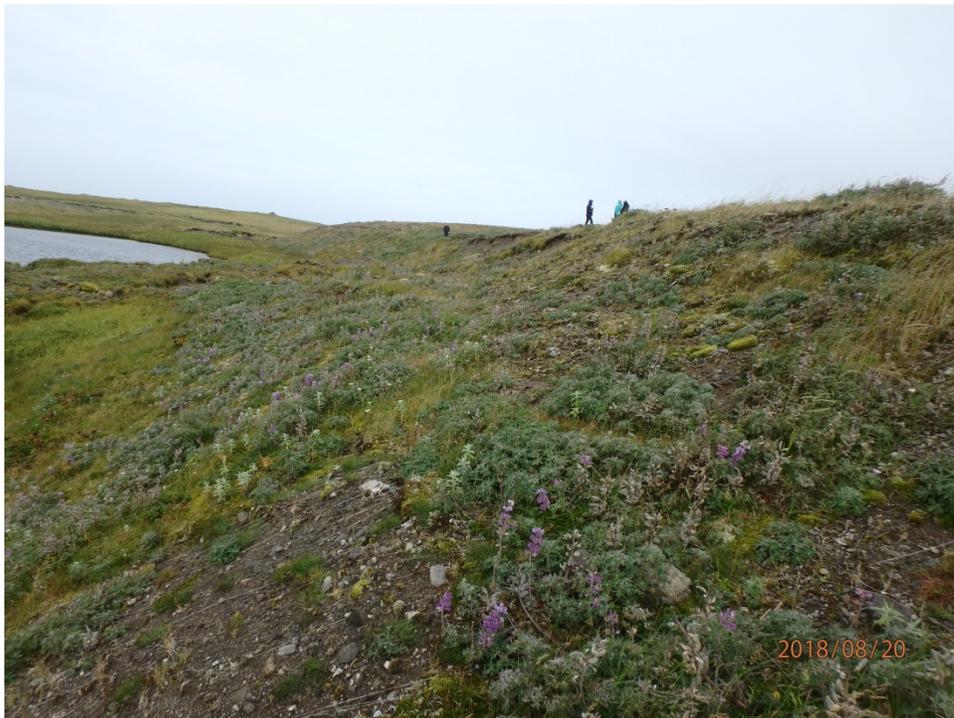
Photo D02: Midslope on the southeast side of the Drill Site D mud pit cap looking west along a failure zone

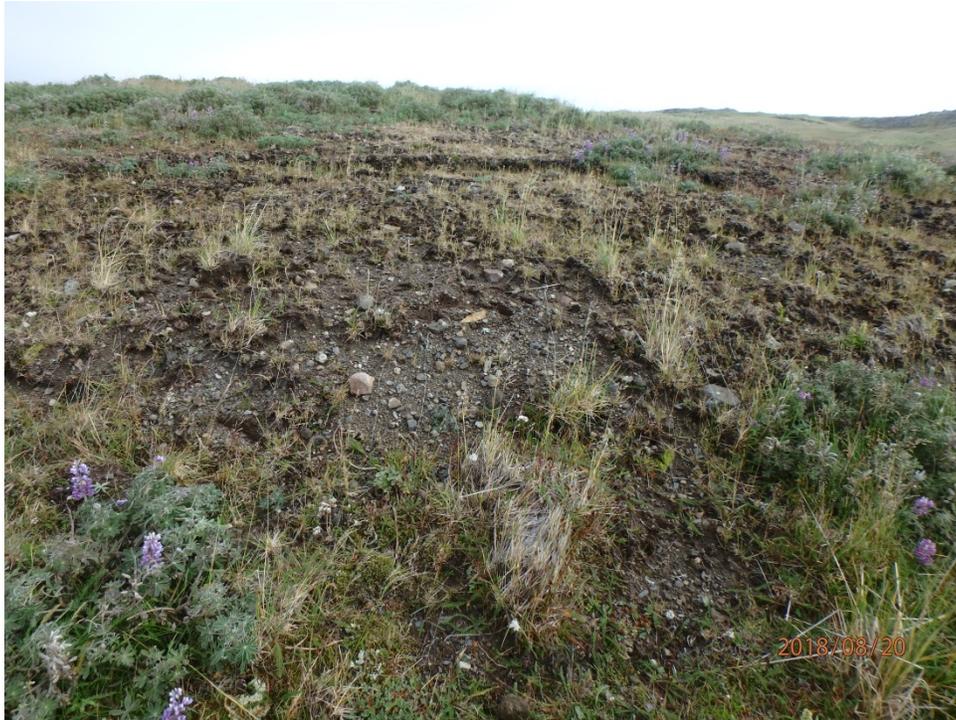
Photo D03: Cracks on the southeast side of the Drill Site D mud pit cap, where the cracks appear to be self-healing

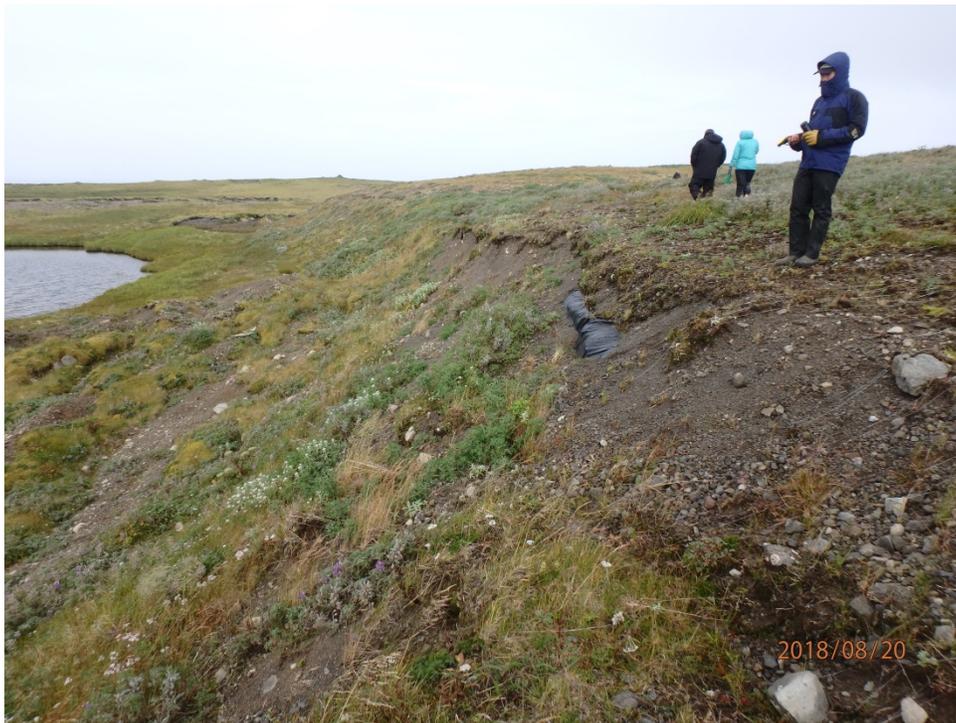
Photo D04: Exposed liner on the east side of the Drill Site D mud pit cap, similar to photo PL-D023 in the 2017 Amchitka inspection report (DOE 2017) and photo IMG_744 in the 2016 Amchitka inspection report (DOE 2016)
