Amchitka Annual Site Inspection 2018 Trip Report Amchitka, Alaska, Site

January 2019

Amchitka Site 2018 Annual Mud Pit Caps Inspection

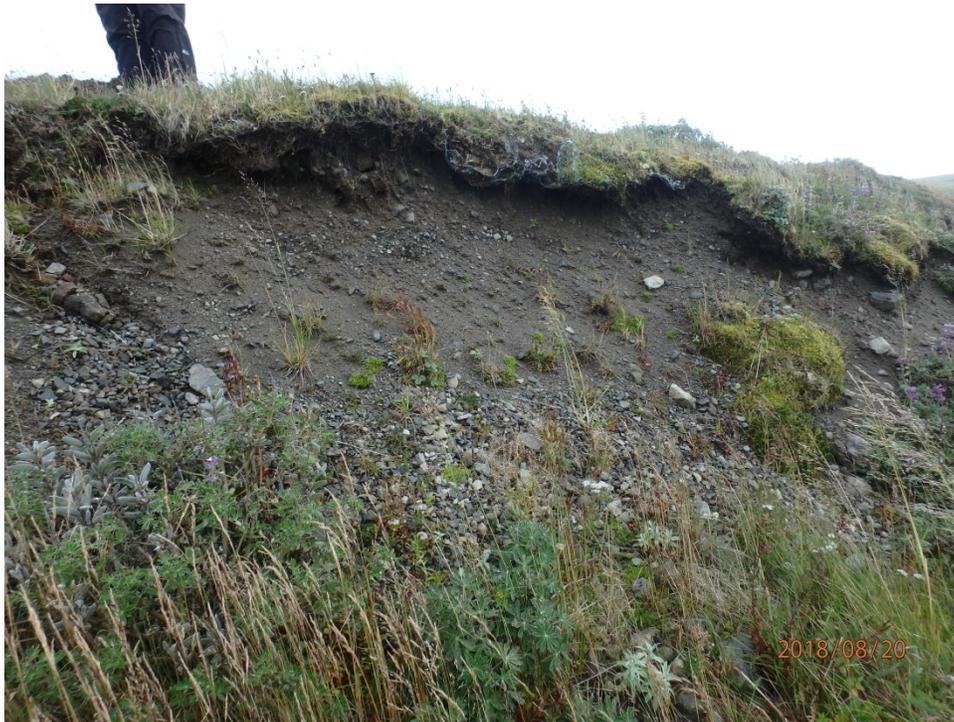
Photo D06: Damaged area (which is a possible new erosion area) southeast of the exposed liner area on the south side of the Drill Site D mud pit cap

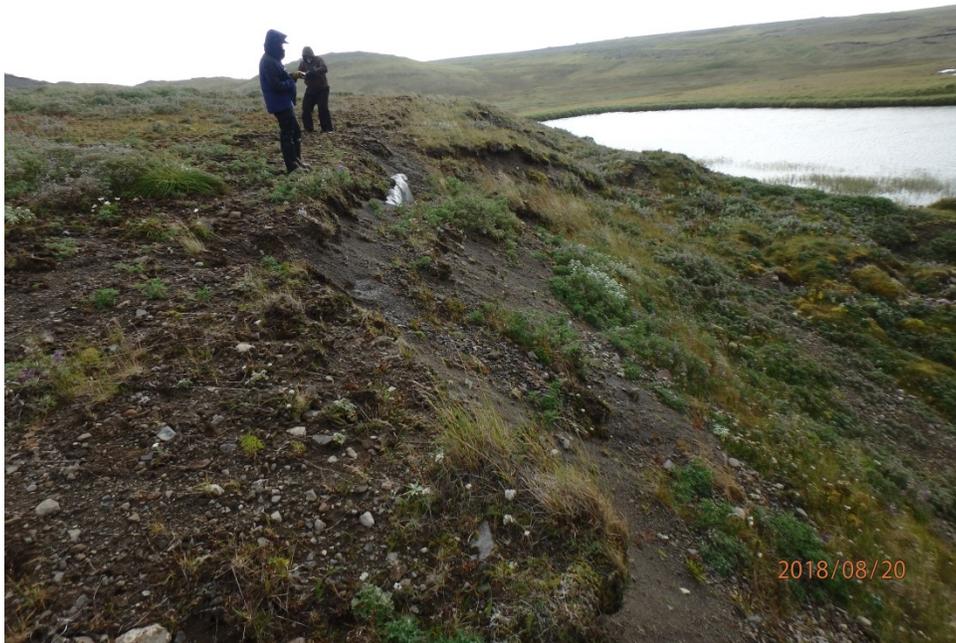
Photo D07: Closer view of exposed liner area on the south side of the Drill Site D mud pit cap

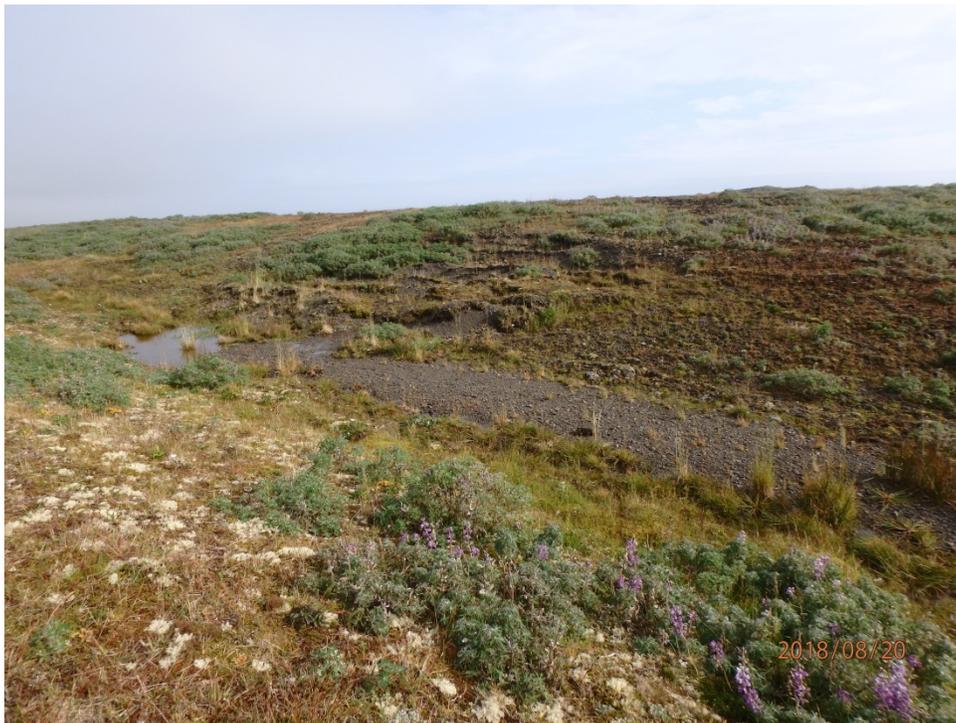
Photo D010: Terracing slump/failure on the east cap at the Drill Site D mud pit site, similar to photo PL-D017 in the 2017 Amchitka inspection report (DOE 2017)

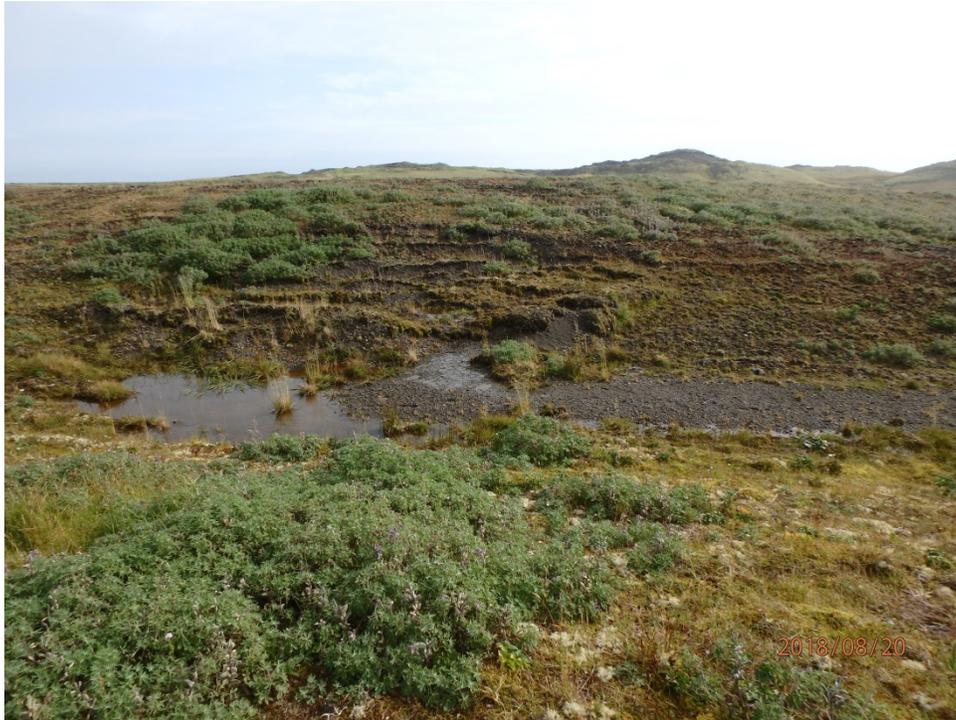
Photo D011: Terracing slump/failure on the east cap at the Drill Site D mud pit site, similar to photo PL-D019 in the 2017 Amchitka inspection report (DOE 2017)

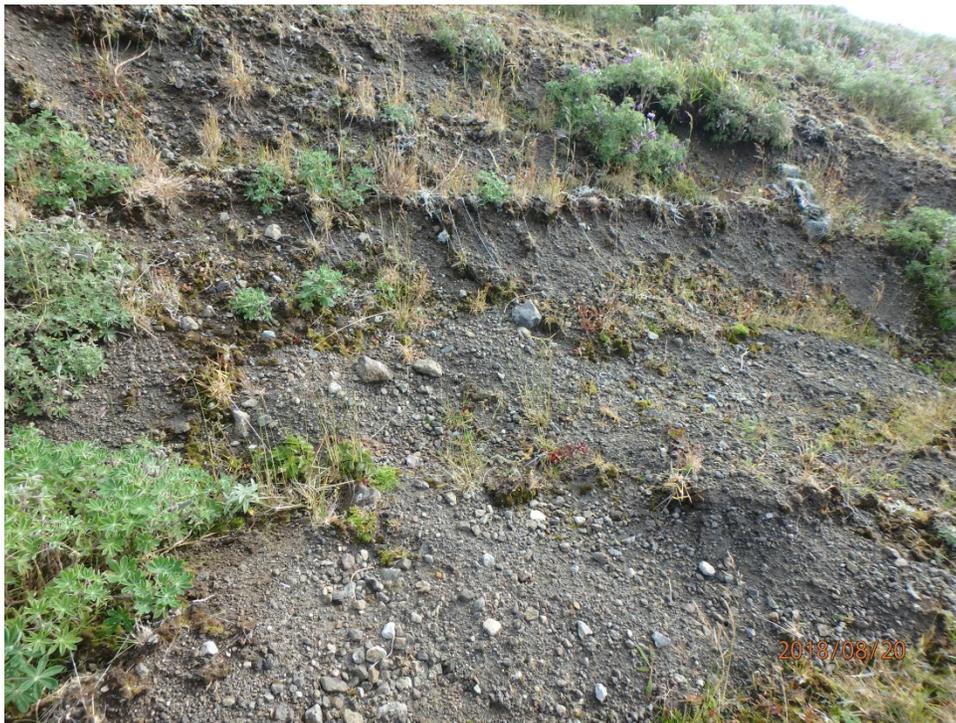
Photo D012: Terracing slump/failure on the east cap at the Drill Site D mud pit site, similar to photo PL-D018 in the 2017 Amchitka inspection report (DOE 2017)

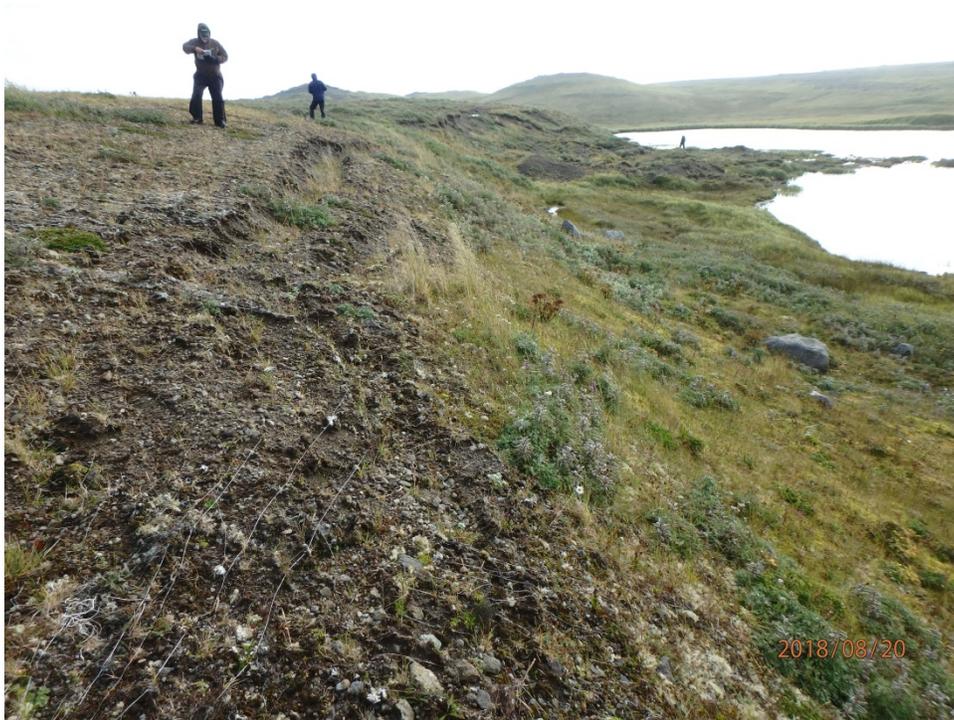
Photo D013: Failure area on the west cap at the Drill Site D mud pit site, similar to photo IMG_738 in the 2016 Amchitka inspection report (DOE 2016)

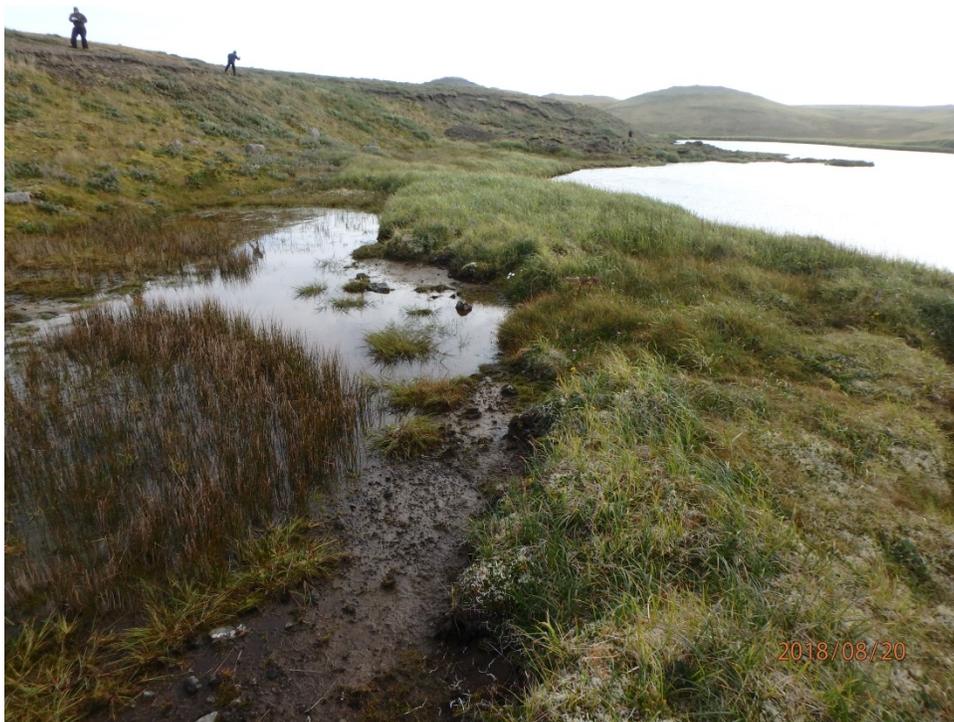
Photo D014: The toe of the failure area on the west cap at the Drill Site D mud pit site, similar to photo PL-D030 in the 2017 Amchitka inspection report (DOE 2017)

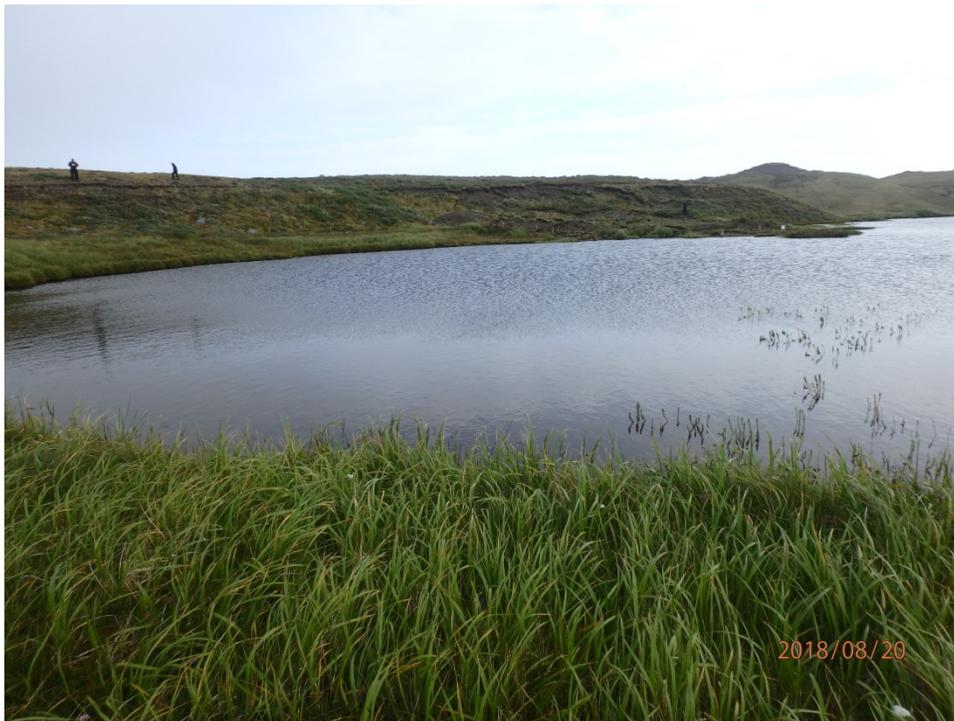
Photo D016: The failure area viewed from the southwest corner of the pond at the Drill Site D mud pit site

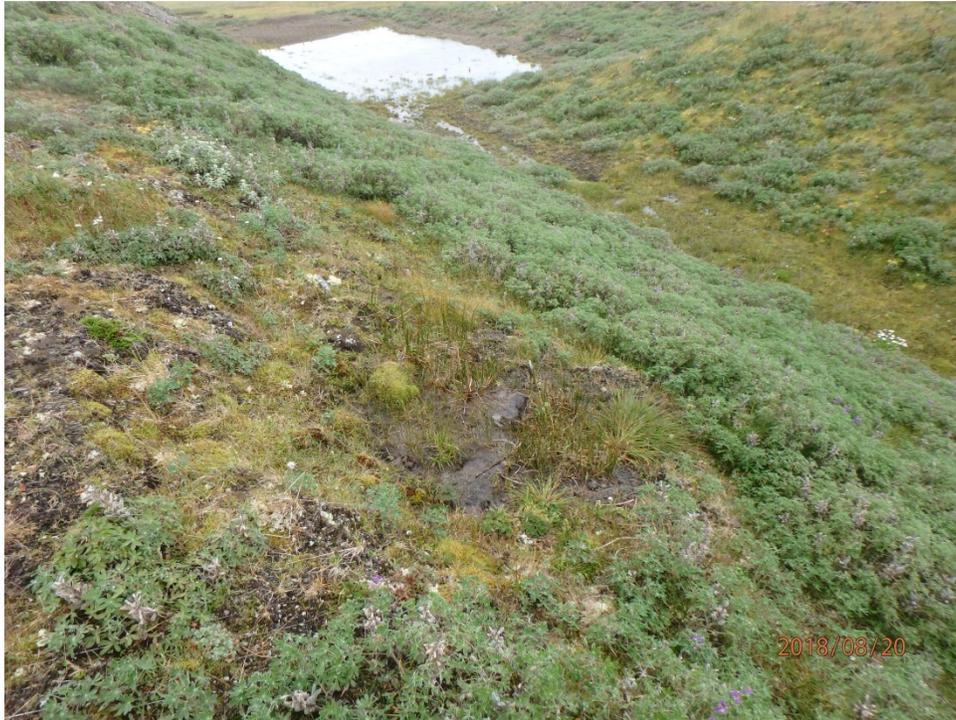
Photo D017: A depression/ponding area on the southwest side of the west cap at the Drill Site D mud pit cap, similar to photo PL-D08 in the 2017 Amchitka inspection report (DOE 2017)

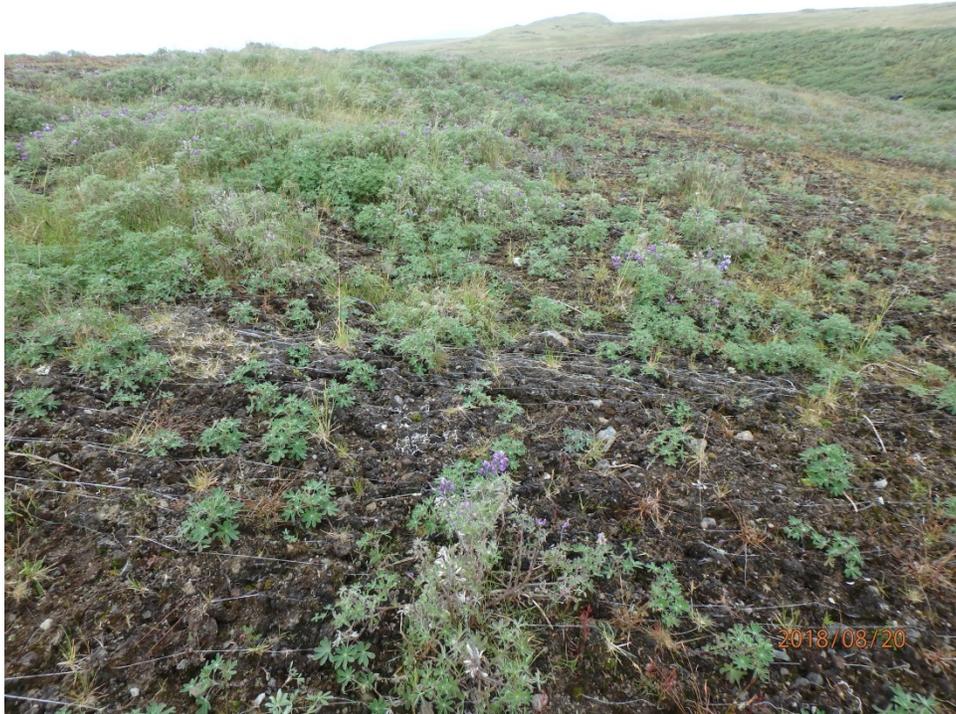
Photo D019: The crack in photo PL-D09 from the 2017 Amchitka inspection report (DOE 2017) is no longer visible and appears to have “self-healed”.

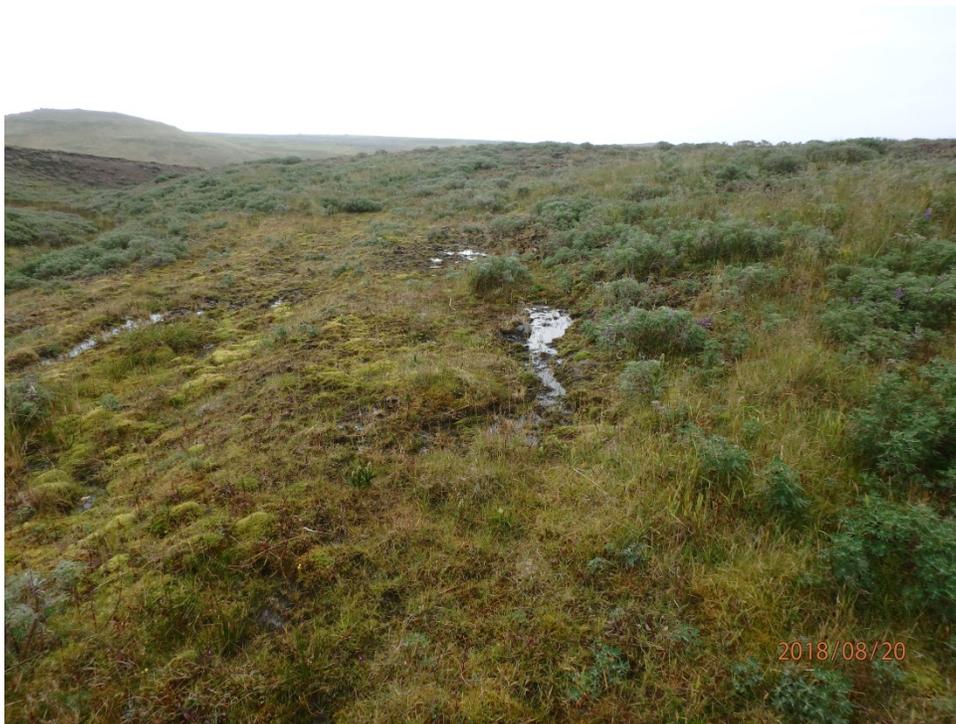
Photo D020: Standing water and a possible settlement area approximately at the north-to-south midpoint of the east slope of the east cap at the Drill Site D mud pit site

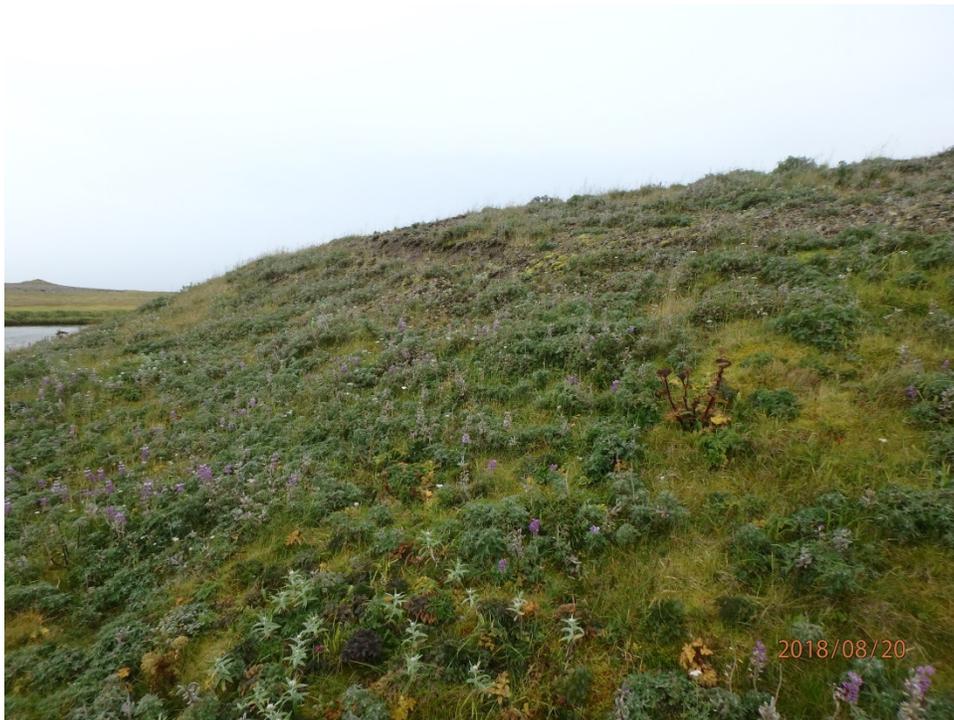
Photo D022: A view from the southwest corner of a concrete pad of a crack at the shoulder on the southeast corner of the east cap at the Drill Site D mud pit site

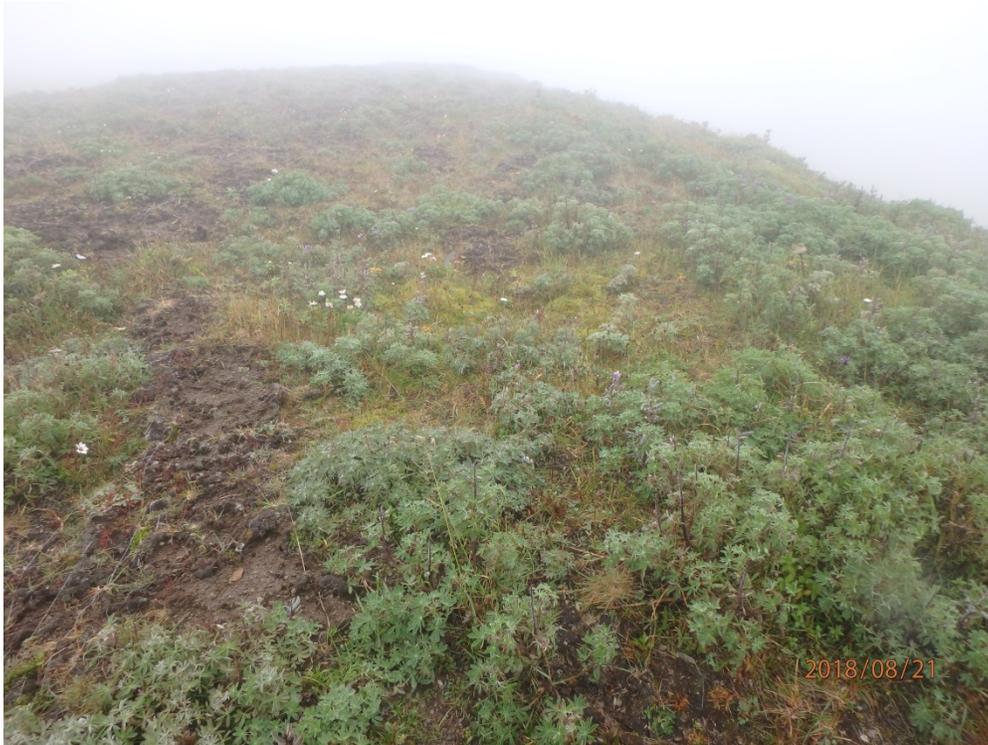
Photo F02: A depression in southwest part of the Drill Site F mud pit cap, similar to photo PL-F05 in the 2017 Amchitka inspection report (DOE 2017)

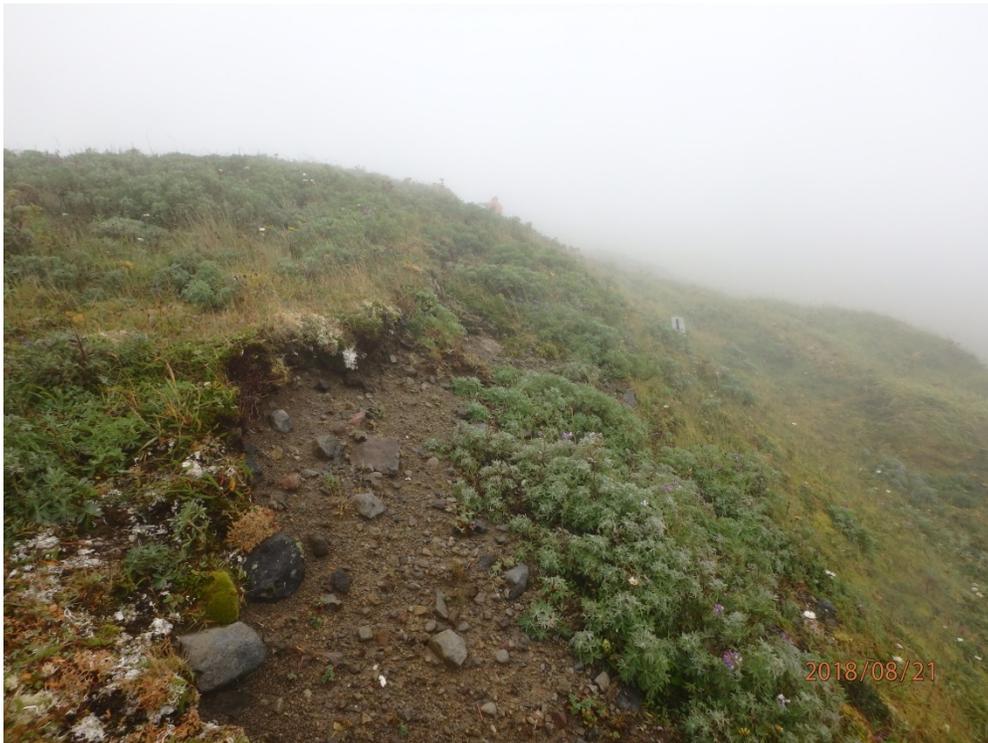
Photo F03: A scarp on the southern side of the Drill Site F mud pit cap, similar to photo PL-F04 in the 2017 Amchitka inspection report (DOE 2017)

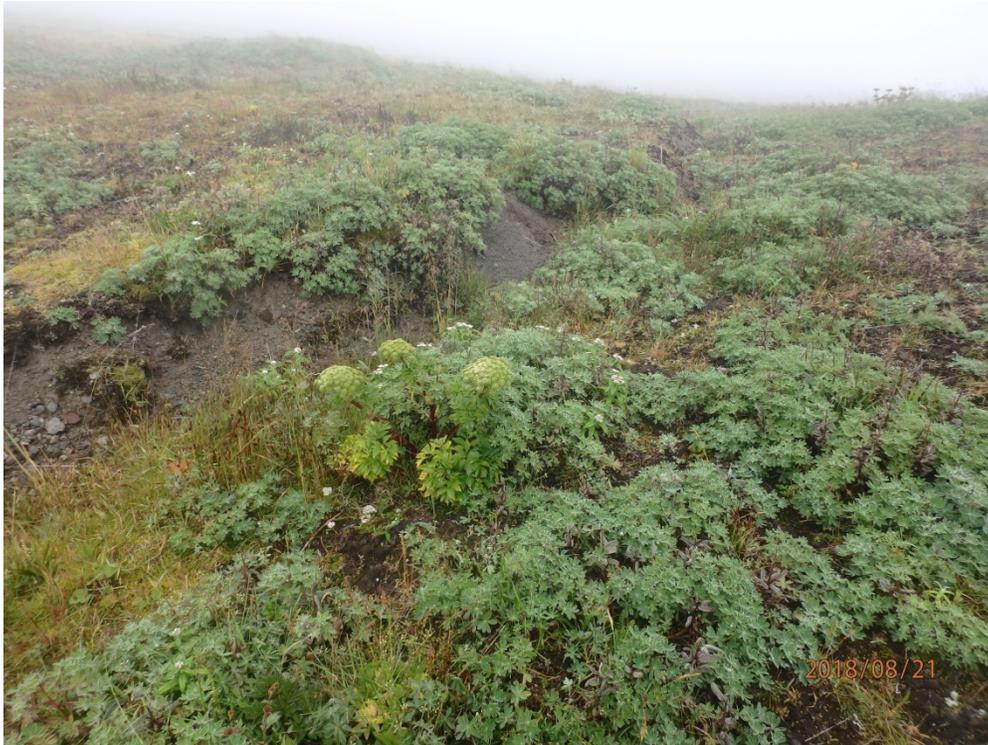
Photo E02: Crack north of the Drill Site E mud pit cap, outside of the cap toe, similar to photo PL-E08 in the 2017 Amchitka inspection report (DOE 2017)

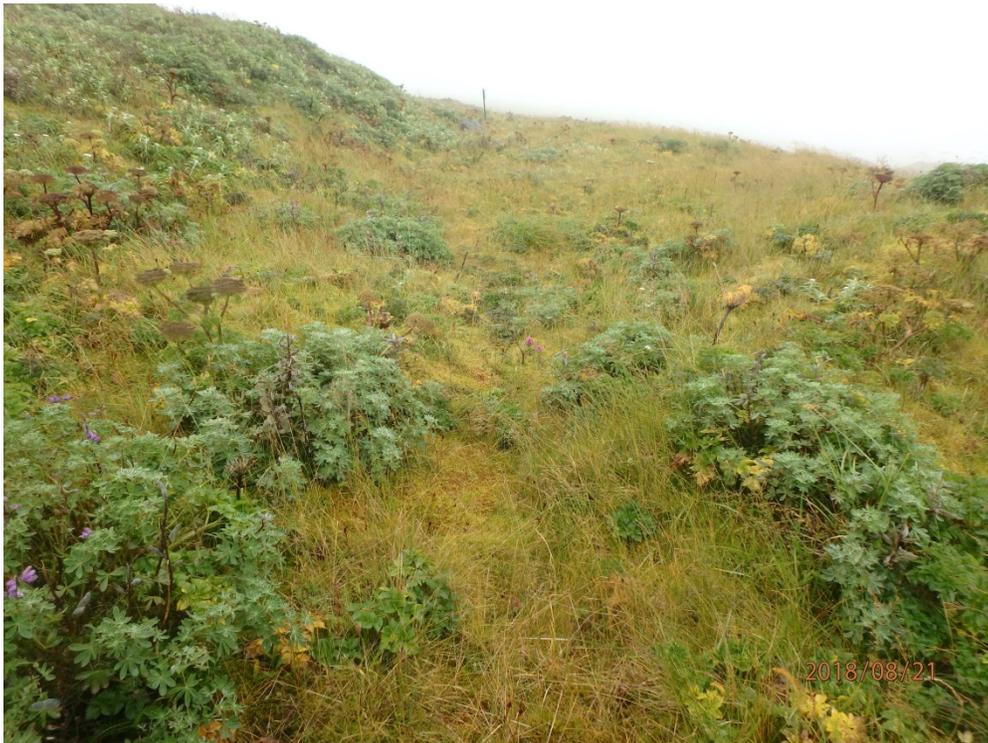
Photo E03: Crack south of the Drill Site E mud pit cap, outside of the cap toe, similar to photo PL-E010 in the 2017 Amchitka inspection report (DOE 2017)

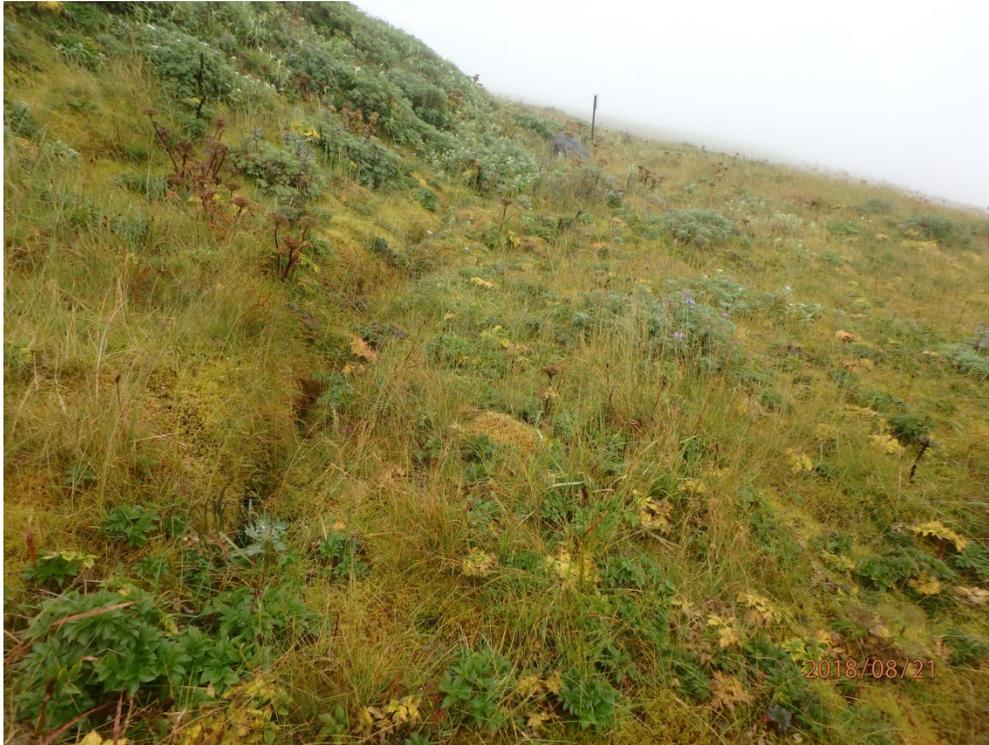
Photo E04: Crack south of the Drill Site E mud pit cap, outside of the cap toe, similar to photo PL-E011 in the 2017 Amchitka inspection report (DOE 2017)

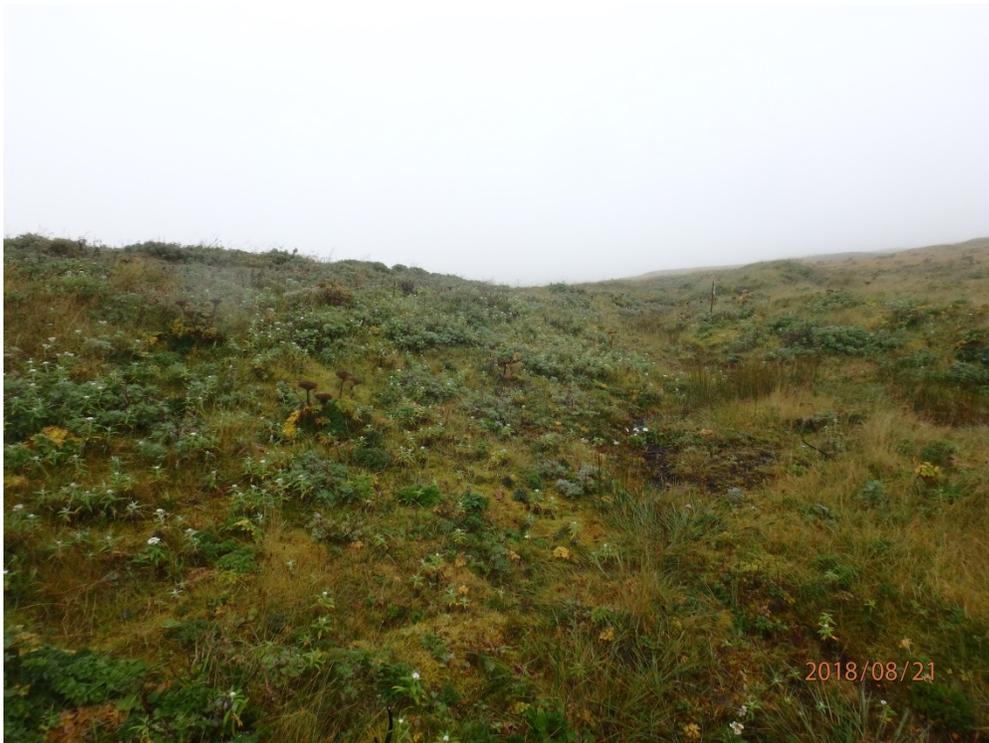
Photo E05: Crack south of the Drill Site E mud pit cap, outside of the cap toe, similar to photo PL-E012 in the 2017 Amchitka inspection report (DOE 2017)

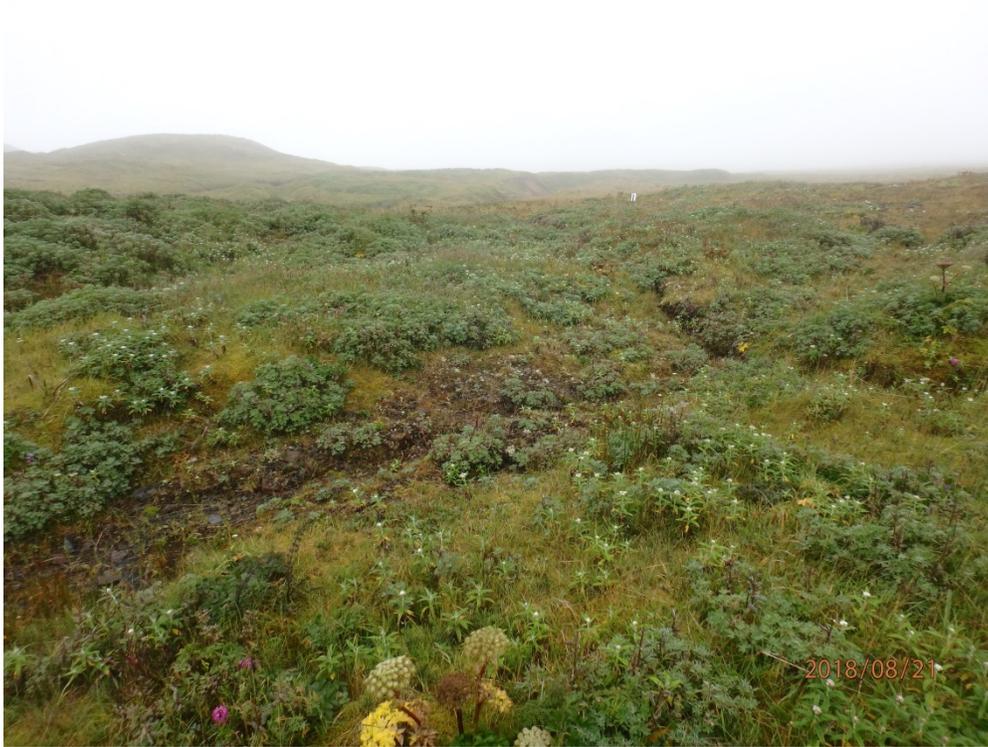
Photo E06: Crack north of the Drill Site E mud pit cap, outside of the cap, looking northwest toe

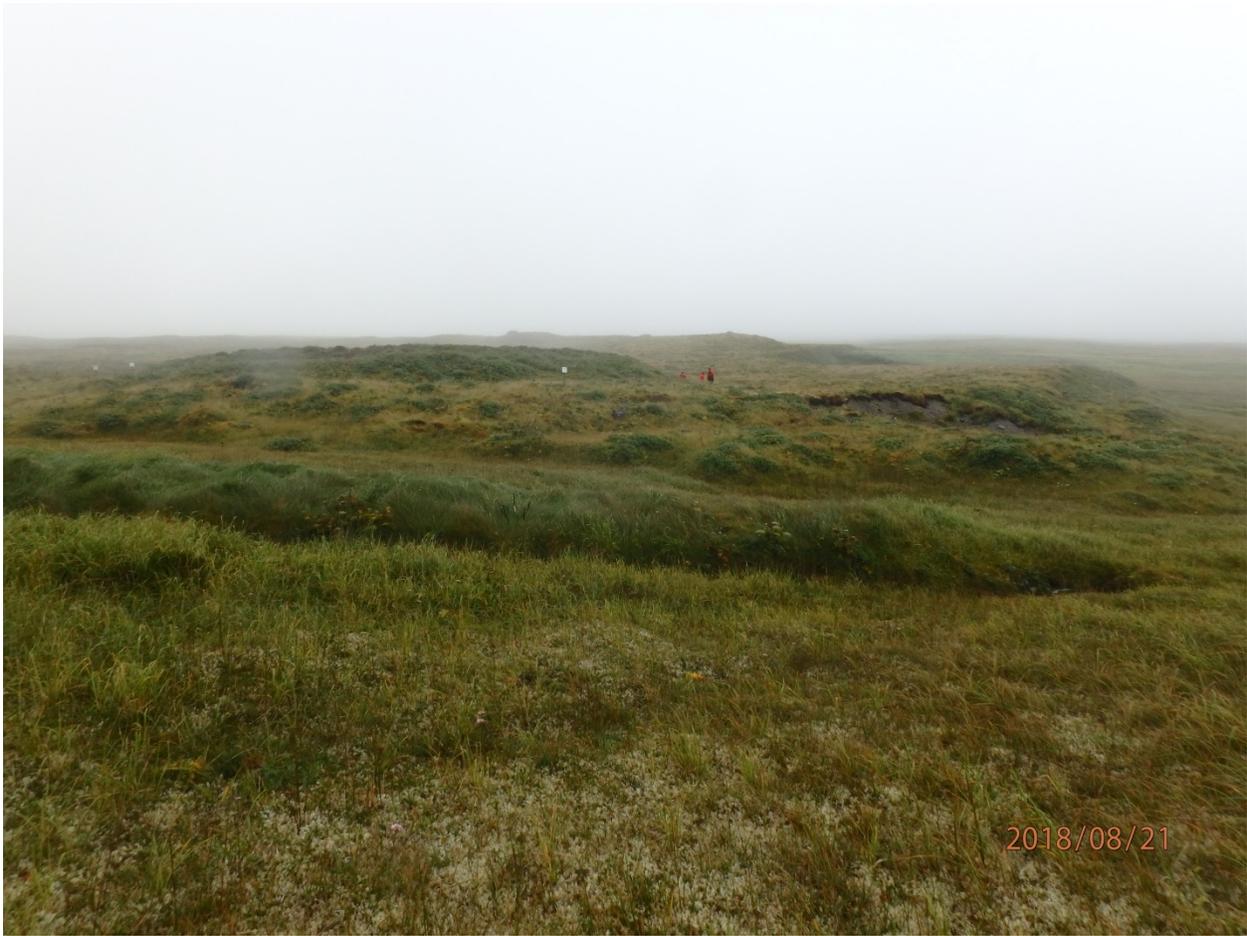
Photo E07: Slump/scarp area south of the Drill Site E mud pit cap, similar to photo PL-E04 in the 2017 Amchitka inspection report (DOE 2017)

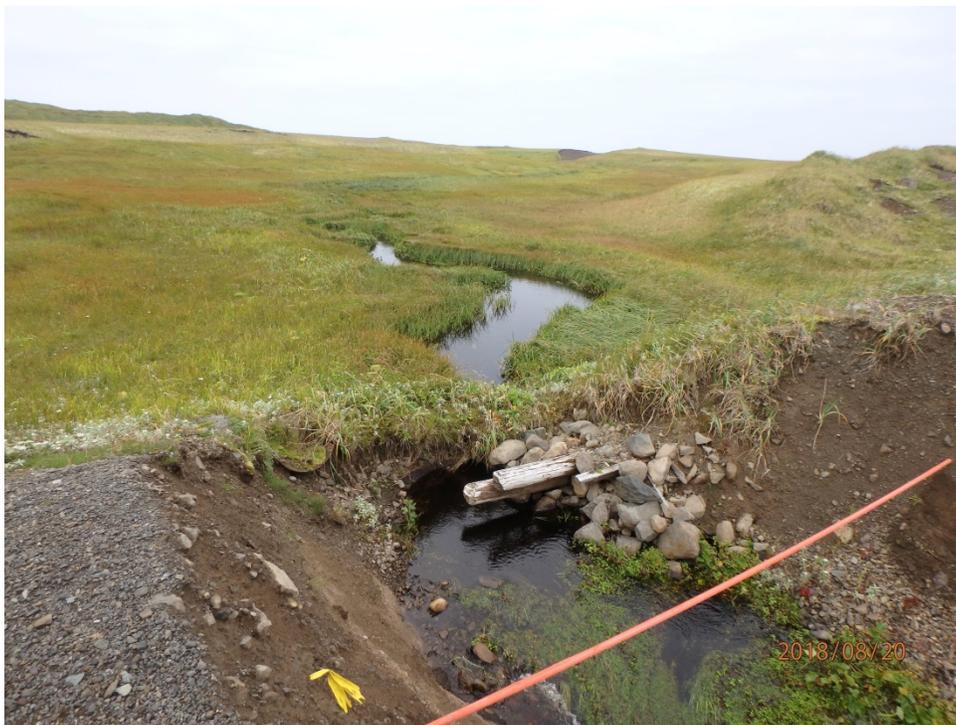
Photo MM8_04: Partial blockage on the west (upstream) side of the MM 8 stream crossing
