**DR. MODESTO IRIARTE TECHNOLOGICAL
MUSEUM (FORMER BONUS FACILITY)**

2016 ANNUAL RADIOLOGICAL SURVEY REPORT

**RINCON
PUERTO RICO**

October 2016

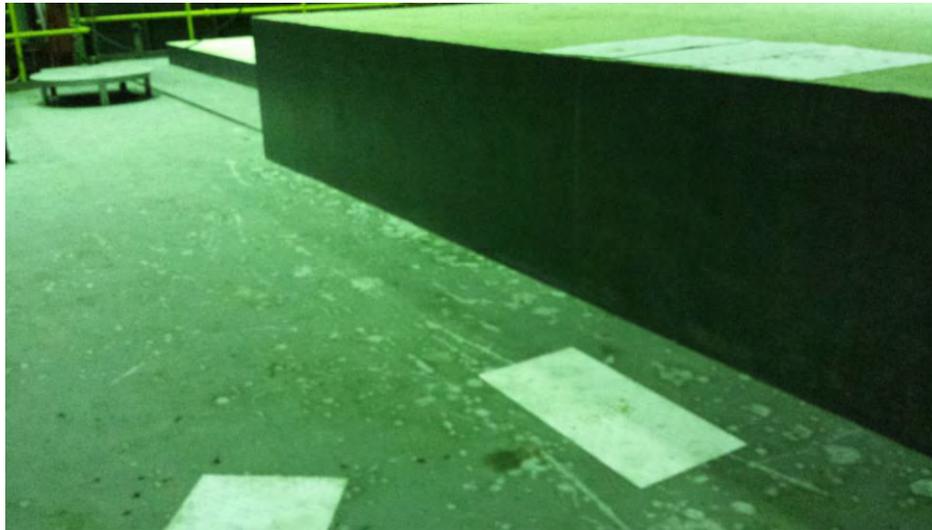
Figure 1. Entombment Top (Top Plug, Northwest Side) – Sampling Point 17 with Oil Pads Due to Overhead Crane (Left) and Oil Pad near Sampling Points 1 – 4.

- It is recommended that absorbent clothes continue to be placed at those locations where oil/grease is accumulating on the Concrete Monolith and, especially, after the crane is moved.

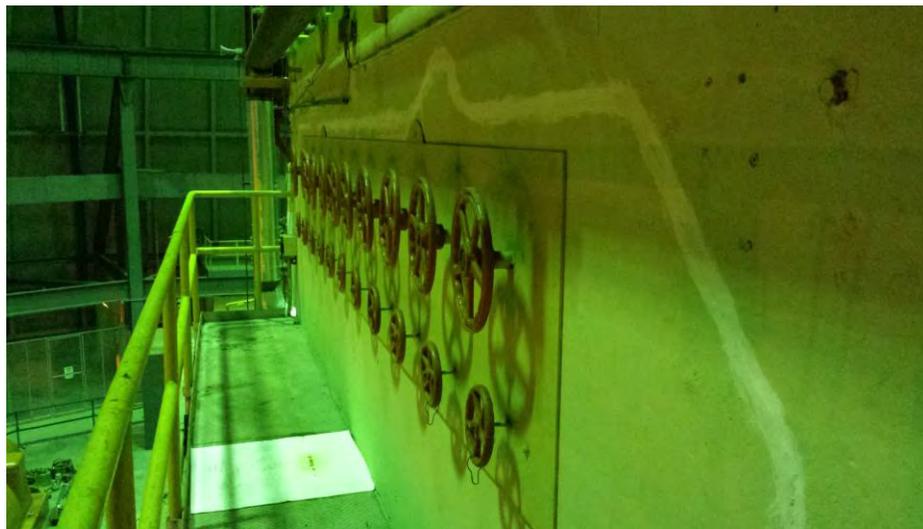
Figure 2. Entombment Top – Pad has been Placed to Address Oil Leaking from Overhead Crane (Near Sampling Points 1, 2, 3, and 4)

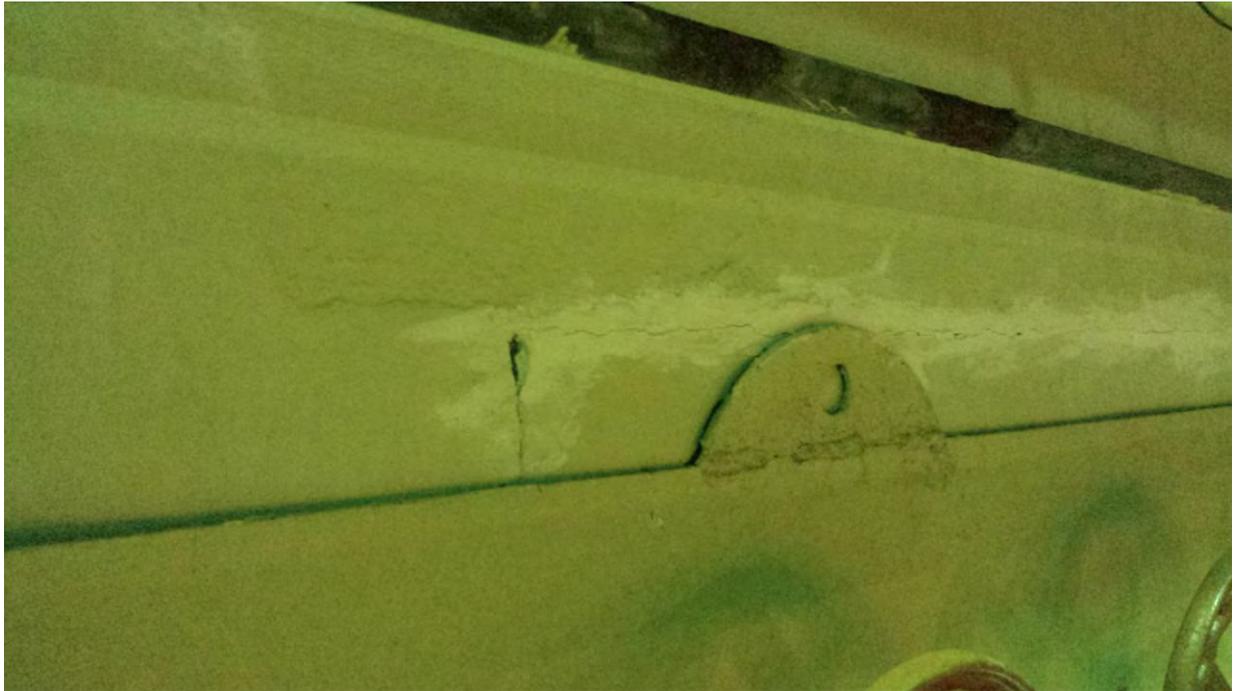
- **Dome-Entombed Concrete Monolith and Monolith Penetrations:** Inspection of the Concrete Monolith area revealed superficial cracks throughout the surface of the structure (Appendix A, Figure 3). Superficial cracks are also present along the base of the “top plug” of the concrete monolith top, but with no change from past inspections. All dose rate measurements taken around the structure were not significantly different from background measurements taken. No immediate action is necessary. Absorbent clothes have continued to be placed to collect oil/grease dripping from the crane system above (Appendix A, Figures 1 and 2). It is recommended that absorbent clothes continue to be placed at those locations where oil/grease is accumulating on the Concrete Monolith and, especially, after the crane is moved.

Figure 3. Entombment Top – Surficial Cracks (Typical)

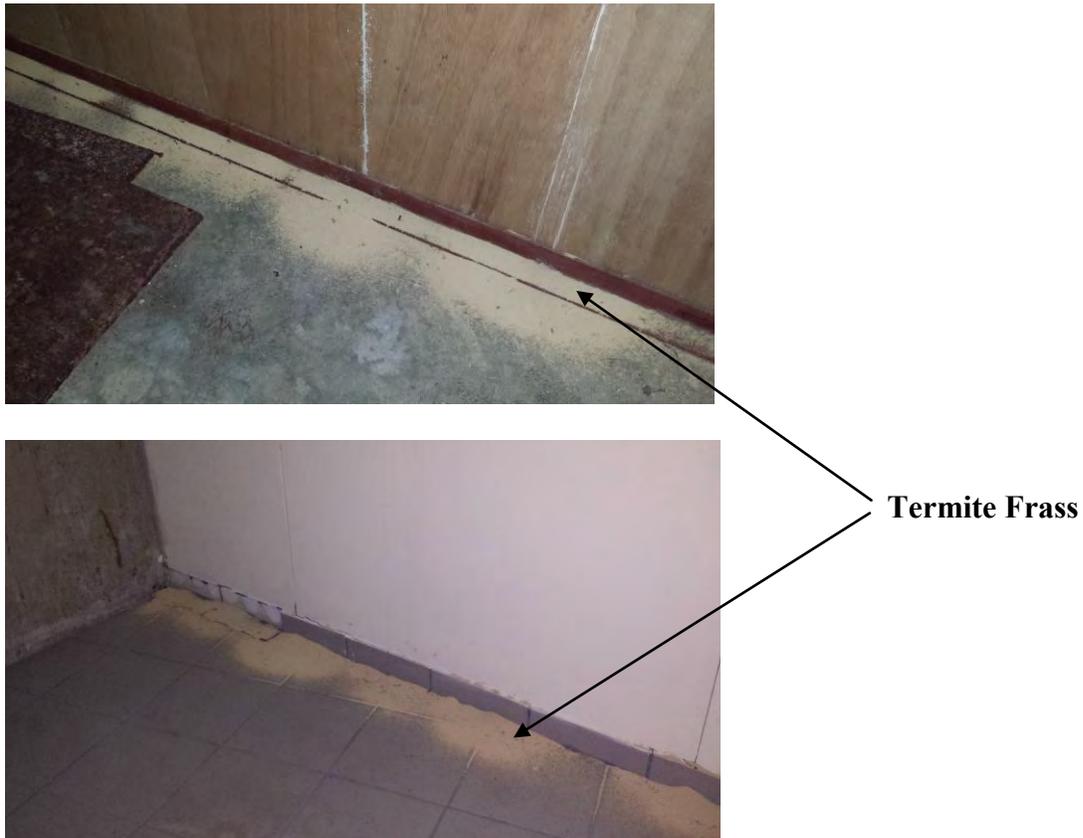
Evidence of termites (termite frass) was observed (repeat from 2015) on the east side of Main Level (Museum Area) where plywood walls were constructed in recent years (Appendix A, Figure 22). It is recommended that this area be inspected by a termite professional and treated, as necessary.

Figure 22. Main Level (Museum Area) – Wood Paneling with Evidence of Termites (East Side)

- Evidence of termites (termite frass) was observed on the east side of Main Level (Museum Area) where plywood walls were constructed in recent years (Appendix A, Figure 22). It is recommended that this area be inspected by a termite professional and treated, as necessary.

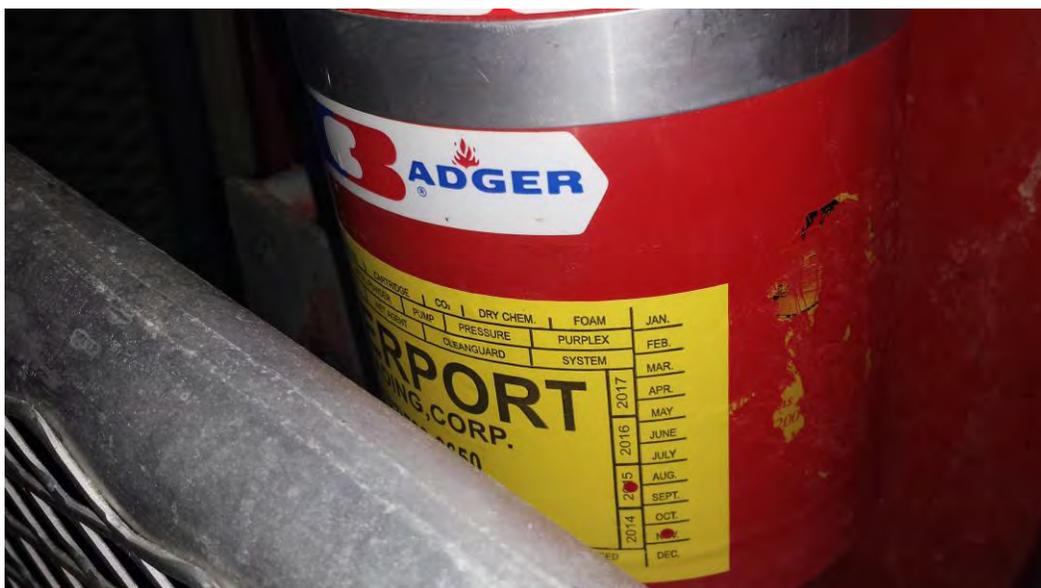
Fire extinguishers throughout the Main Level were inspected and appear to have out-of-date inspections and/or need to be replaced (Appendix A, Figure 23). It is recommended that all fire extinguishers throughout the facility be inspected and corrective actions taken, as necessary.

Figure 23. Main Level (Museum and Controlled Areas) – Fire Extinguisher Inspections Out of Date

- Fire extinguishers throughout the Main Level were inspected and appear to have out-of-date inspections and/or need to be replaced (Appendix A, Figure 23). It is recommended that all fire extinguishers throughout the facility be inspected and corrective actions taken, as necessary.

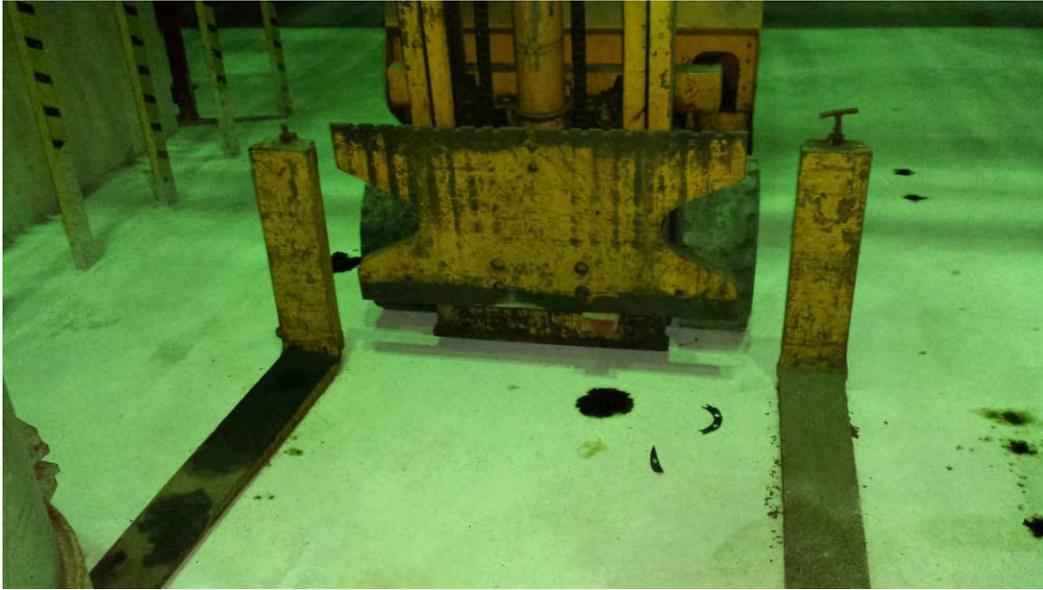
Figure 24. Basement Level – Oil/Lubricant Spots on Basement Floor from Overhead Equipment

- Near Sample Locations 50A and 50B, oil/lubricant stains were noted (Appendix A, Figure 24). It is recommended that absorbent clothes continue to be placed at these locations during quarterly surveys.

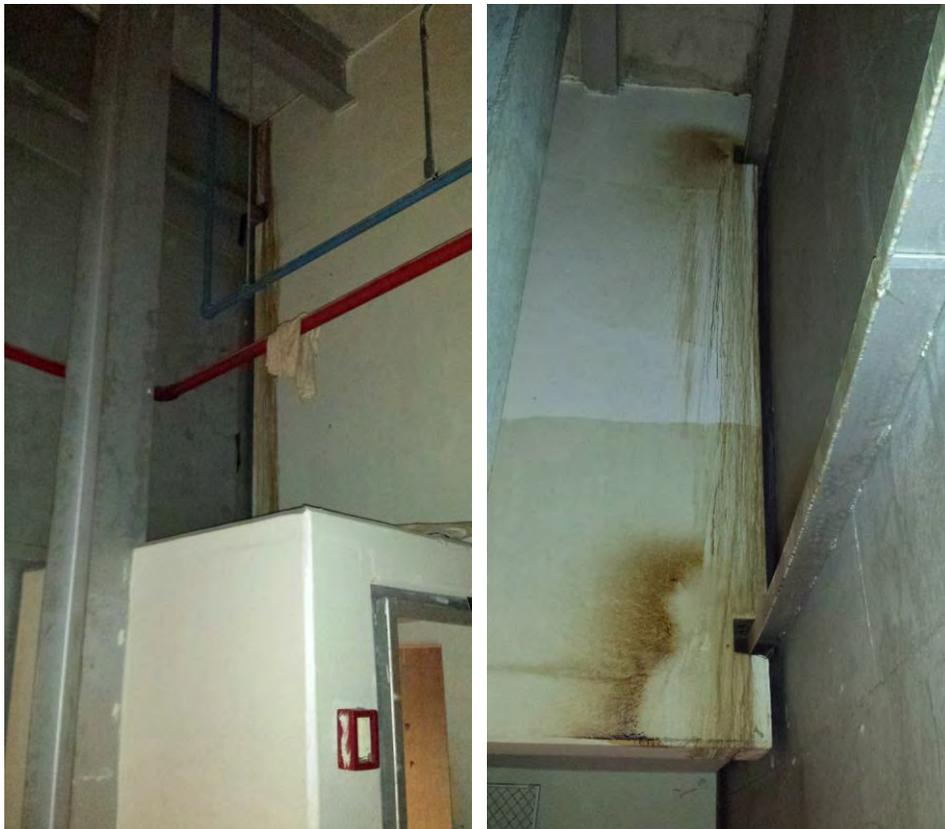
The gasket around the exterior base of the Dome, which is at ceiling level of the basement, remains intact and effective (Appendix A, Figure 25). The gasket is showing signs of weathering and surficial cracks in the low areas of the gasket where it holds rain water and dries in the sun (Appendix A, Figure 37). The drains in the trough below the gasket are clear and draining rain water properly (Appendix A, Figure 38). The large bay door at the Basement Level remains sealed with expanding foam to prevent rainwater infiltration into the Basement Level. It is recommended that, when the gasket around the base of the Dome is replaced, the gasket is installed in a manner that does not retain rain water.

Figure 25. Basement Level – Beneath North Entrance Air Lock (No Signs of Recent Water Infiltration – Older Stains Persist)

- the next two years (repeat from 2013, 2014, and 2015), which would increase the capacity of the sump to retain water until it evaporates.
- The gasket around the exterior base of the Dome, which is at ceiling level of the basement, remains intact and effective (Appendix A, Figure 25). However, the gasket is showing signs of weathering and surficial cracks in the low areas of the gasket where it holds rain water and dries in the sun (Appendix A, Figure 37). It is recommended that, when the gasket around the base of the Dome is replaced, the gasket is installed in a manner that does not retain rain water.

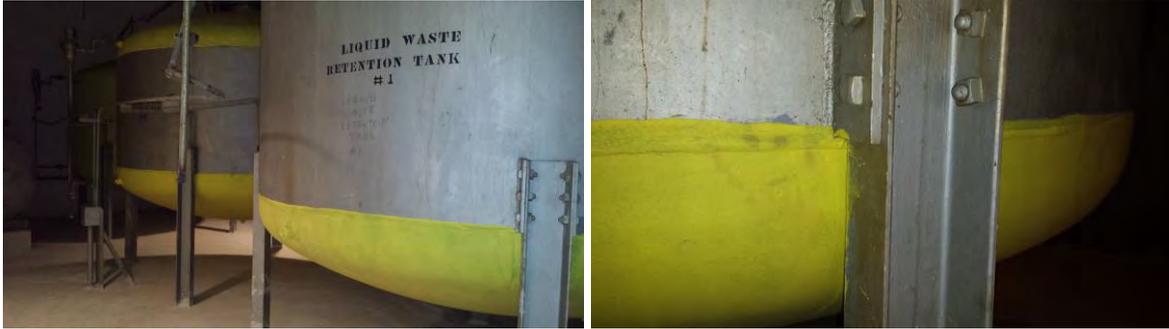
Control measures (fixed with paint and concrete layer in some places), which were previously implemented, were inspected (Appendix A, Figures 26, 28, 29, and 30). The yellow paint on the Liquid Water Retention Tanks is starting to show signs of thinning and wear, but smears indicated no removable contamination at this time. Ongoing and routine assessment of accessible surfaces in the basement is recommended to evaluate the continued effectiveness of the concrete cover flooring and control measures (e.g., paint) emplaced on previous contamination areas. Although immediate action is not critical, it is recommended that yellow paint be re-applied to the three liquid water retention tanks within the next year (Appendix A, Figure 30). Access to areas with historical removable contamination is being effectively controlled.

Figure 30. Basement Level – Sample Locations #30 and #31 on Liquid Water Retention Tanks with Engineering Control (Yellow Paint) – Showing Signs of Wear

- Control measures (fixed with paint and concrete layer in some places), which were previously implemented, were inspected. Although immediate action is not critical, it is recommended that yellow paint be re-applied to the three liquid water retention tanks within the next year (Appendix A, Figure 30).

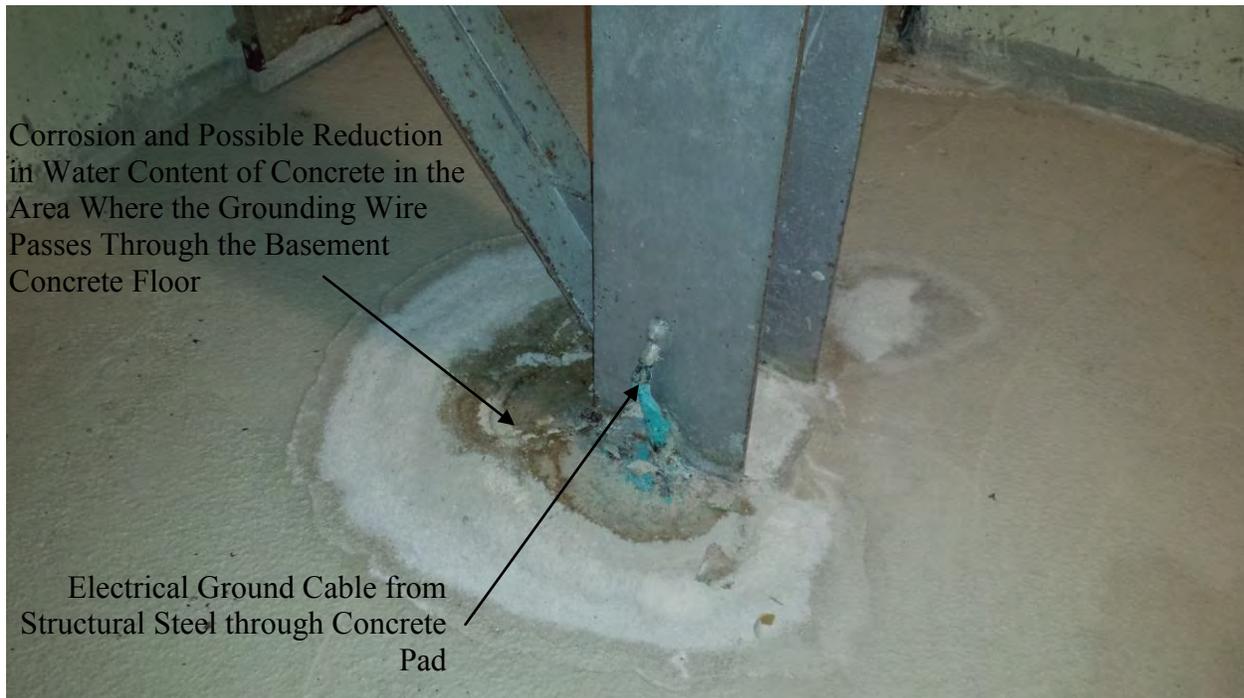
On the concrete flooring and structural steel near Sample Locations 50A and 50B, significant corrosion and concrete spalling is occurring (this is a repeat observation from 2013, 2014, and 2015). This appears to be centered on the grounding wire in this location which is attached to a structural steel column and passes through the concrete flooring (Appendix A, Figure 31). The spalling area does not appear any larger than

noted in 2015; however, loose/flaked concrete material is beginning to accumulate in the area. It is recommended that an electrician be contacted to inspect the grounding of structural steel in the basement. Also near Sample Locations 50A and 50B, oil/lubricant stains (similar to the previous 2015 inspection) were noted (Appendix A, Figure 24). It is recommended that absorbent clothes continue to be placed at these locations during quarterly surveys.

Figure 31. Basement Level – Corrosion Issues on Concrete Floor near Sample Locations 50A and 50B – No Change from Previous Year

- On the concrete flooring and structural steel near Sample Locations 50A and 50B, significant corrosion and concrete spalling is occurring (repeat from 2013, 2014, and 2015). The spalling area does not appear any larger than noted in 2015; however, debris is accumulating due to the spalling. This appears to have been caused by the grounding wire in this location which is attached to a structural steel column and passes through the concrete flooring (Appendix A, Figure 31). It is recommended that an electrician be contacted to inspect the grounding of structural steel in the basement.

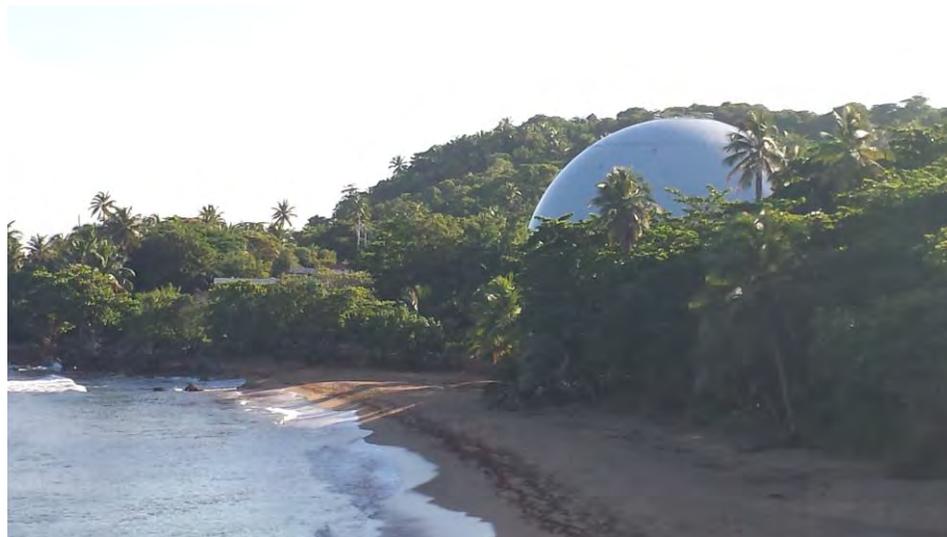
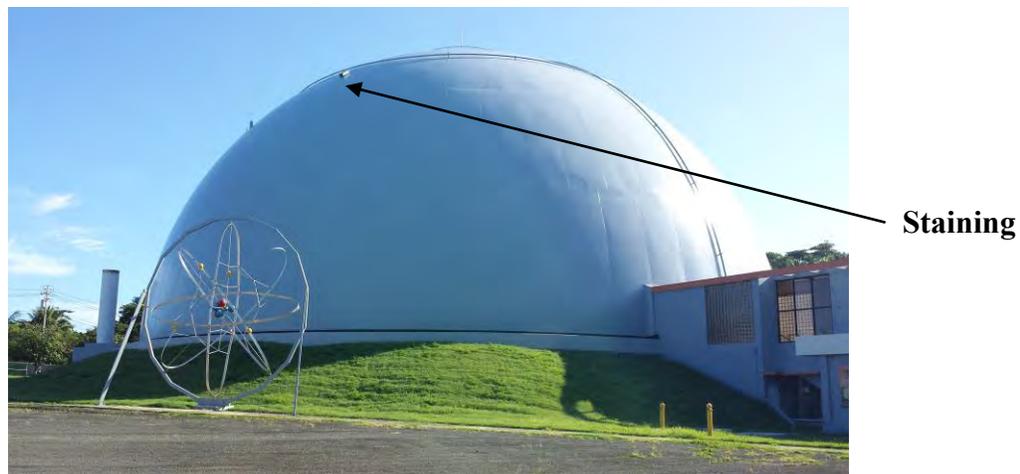
- **Dome-Exterior:** Inspection of the Dome structure did not reveal any significant structural discrepancies. The Dome structure exterior was re-sealed and painted before the 2015 annual survey. This coating is mostly in good condition. However, there is staining on the southwest side (Appendix A, Figure 32) below an iron channel, which is attached to the Dome exterior. The interior surface of the channel may not have been painted/coated and the corroded interior surface may be leaching/staining the Dome exterior. No immediate action is necessary. Both entrance portals are in good condition, except water is pooling on the roof above the southern portal and leaking onto the floor in front of the entrance to the portal (Appendix A, Figure 42) – refer to General Site Upkeep below.

Figure 32. Dome Structure – Exterior With Protective Coating and Paint (Staining Present Beneath Raised Channel)

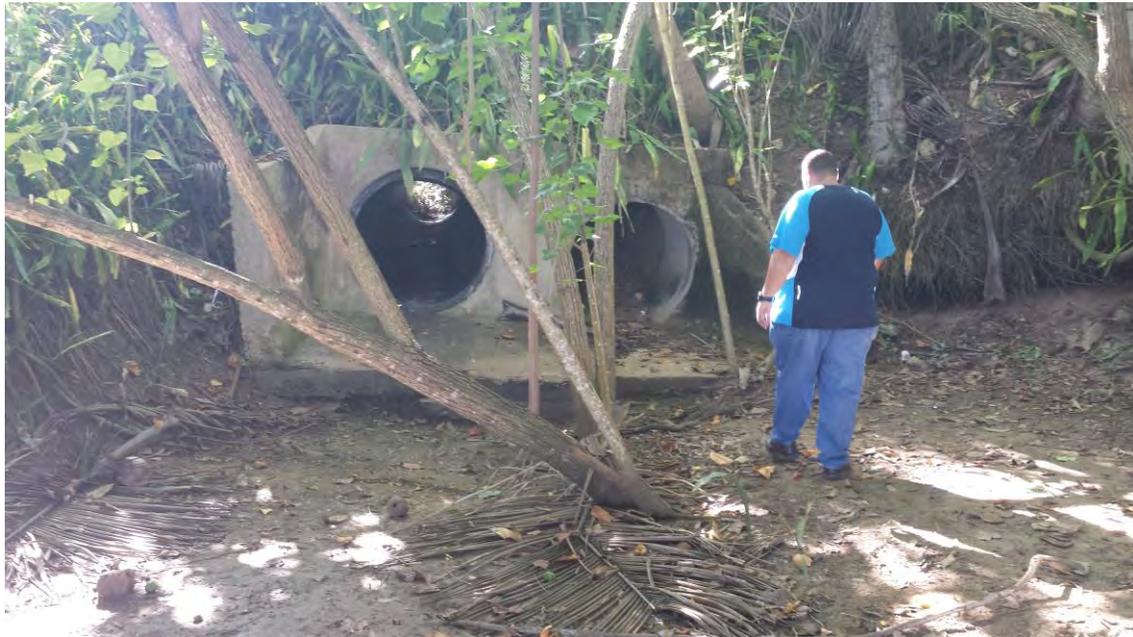
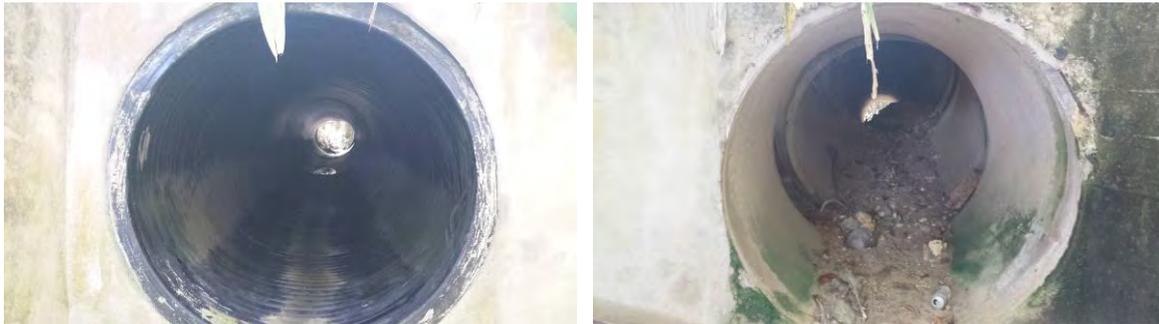
- **Dome-External Piping Systems:** Inspection of accessible external piping systems revealed no significant indications of deterioration. Outfall pipes on the west side of the property (on the beach outside of perimeter fence) and south side of the property (outside of perimeter fence) were inspected (Appendix A, Figure 34). One of the drainage pipes on the west side, where it passes under the main access road, is partially obstructed with silt and debris (Appendix A, Figure 35). It is recommended that the accumulated silt and debris be removed.

Figure 35. Dome Structure – Drainage Outfall Points and Ditches (Under Main Access Road – Once Pipe is Partially Filled with Debris)

- One of the drainage pipes on the west side (beach) of the property, where it passes under the main access road, is partially obstructed with silt and debris (Appendix A, Figure 35). It is recommended that the accumulated silt and debris be removed.

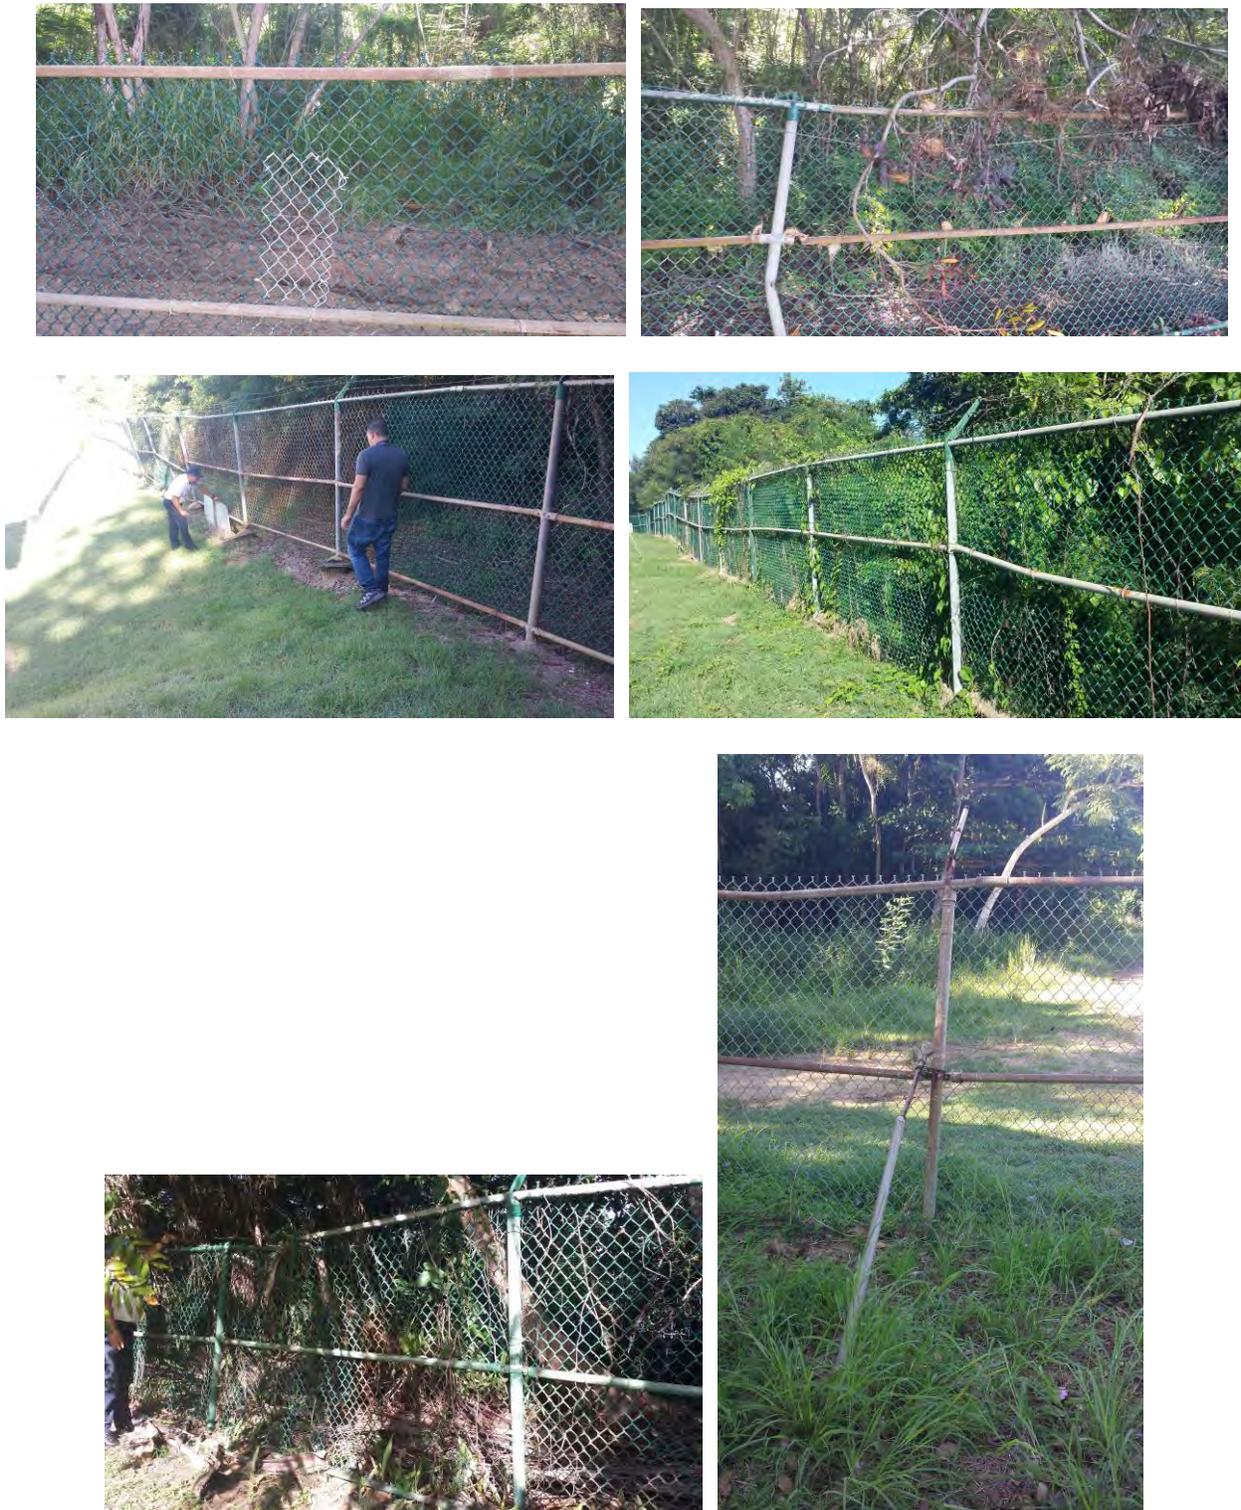
- **Site Surveillance Features:** Asphalt of the access road and parking area remains in fair and usable condition. There is some broken asphalt, but it is still functional. The entrance gate's motor is not operational; however it is manually operated by the attending guard (Appendix A, Figure 39). The security guard controlled access into the gated facility and kept a sign-in log of visitors. The fence surrounding the property is mostly functional at controlling access. However, it has been patched in many places as a temporary fix; there are also areas with gaps under the fence; and vegetation is crowding the fence in some areas (Appendix A, Figure 36). Recommend instructing the maintenance contractor to cut vegetation away from fencing to maintain a clear path around the perimeter of the property. One section of fence near the front gate is in need of repair (Appendix A, Figure 36). The Dome monolith plaques are in good condition – no change.

Figure 36. Fence –Fencing and Perimeter – Some Areas with Vegetation Crowding Exterior of the Fence, Patched Areas, and a Temporary Repair Where the Fence had Fallen

- Physical Condition:
 - The fence surrounding the property is functional at controlling access; however, vegetation is crowding the fence in some areas (Appendix A, Figure 36). Recommend instructing the maintenance contractor to cut vegetation away from fencing to maintain a clear path around the perimeter of the property. One section of fence near the front gate is also in need of repair (Appendix A, Figure 36). Recommend a more permanent repair to the fence in this location.

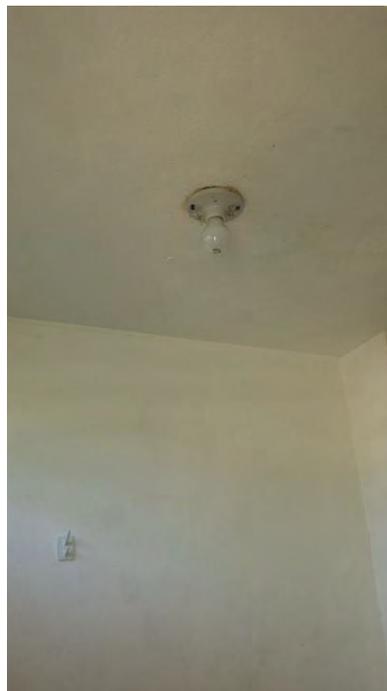
The roofing on the guard shack is also in need of repair. Water intrusion and staining is visible around the light fixtures (Appendix A, Figure 40). It is recommended that inspection and repair of the guard shack roofing be completed.

Figure 40. Ancillary Buildings and Structures – Guard Shack with Water Stains around Light Fixtures

- The roofing on the guard shack is also in need of repair. Water intrusion and staining is visible around the light fixtures (Appendix A, Figure 40). It is recommended that inspection and repair of the guard shack roofing be completed.

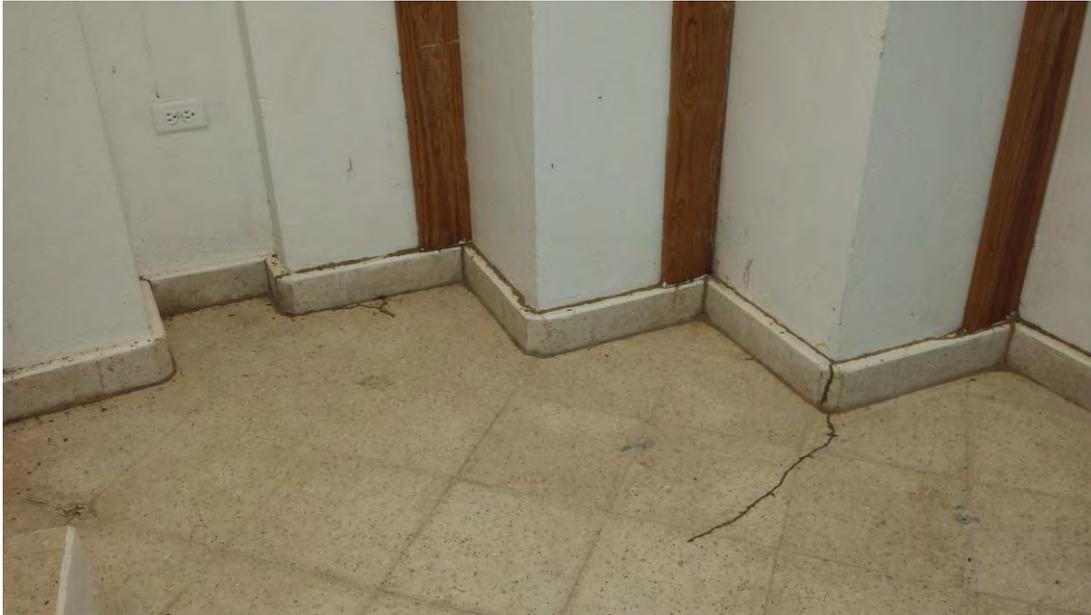
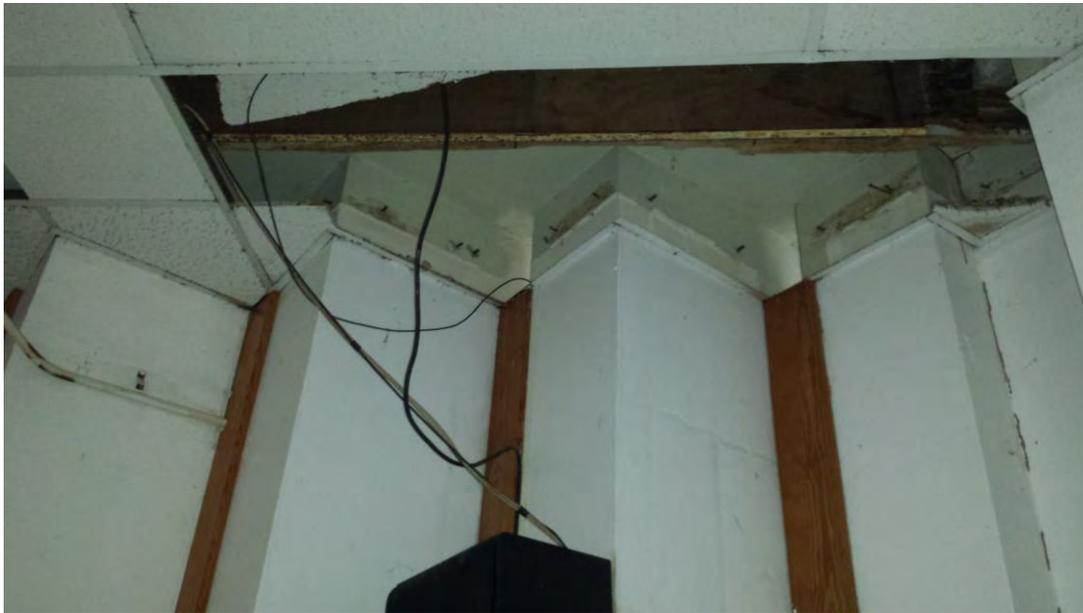
Figure 41. Ancillary Buildings and Structures – Theatre Building with Evidence of Rodents and Termites, and the Air Conditioning Units are Not Working Properly

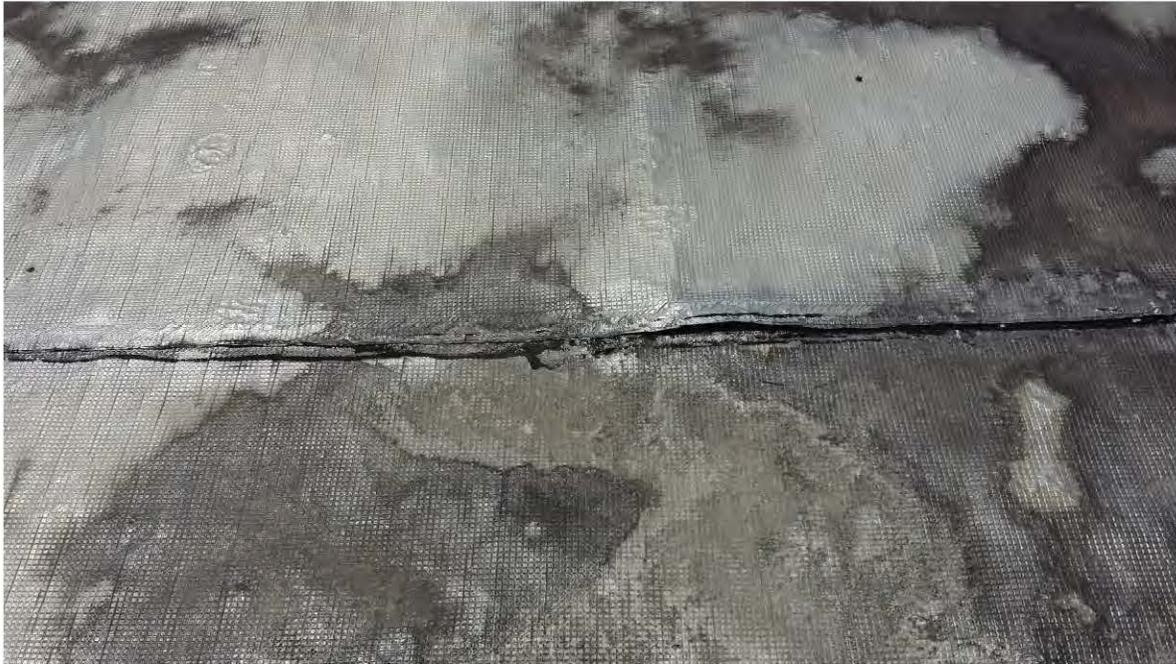
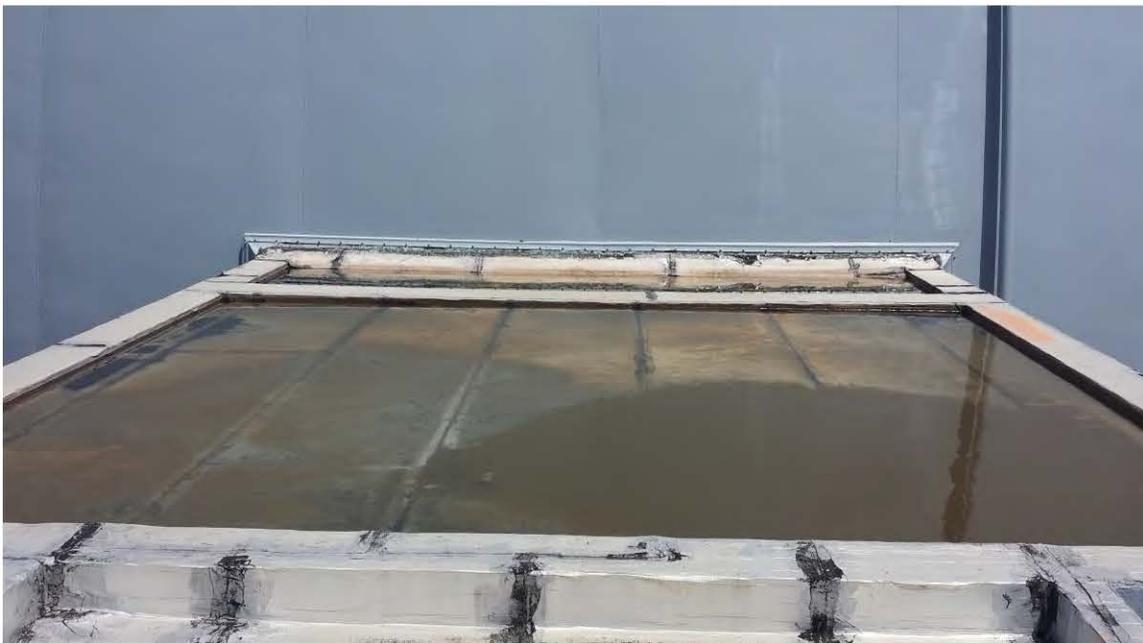
- **General Site Upkeep:** The Theatre Building and administrative building at the southern portal/entrance to the Dome were entered and inspected since they are utilized during museum tours. The roof of the administrative building at the south entrance of the Dome is holding water and leaks below onto the flooring in front of the southern portal (Appendix A, Figure 42). The roofing on other sections of the administrative building at the southern entrance is also in need of repair and leaking water into the rooms below (Appendix A, Figure 42). Evidence of termites (“mud tubes”) was also noted in the administrative building at the southern portal/entrance to the Dome. Evidence of termites and rodents (Appendix A, Figure 41) were noted on the interior of the Theatre Building (repeat from 2015). It is recommended that pest control inspection and treatment be administered at the Theatre Building and administrative building at the southern portal/entrance to the Dome. It is recommended that roofing repairs be made on the administrative building at the south entrance to the Dome to prevent rain water retention and/or intrusion.

Figure 42. Ancillary Buildings and Structures – Entrance/Administrative Building at Southern Entrance to Dome – with Roofing in Need of Repair (Top) and Retaining Water/Leaking into Building (Below)

- The roof of the administrative building at the south entrance of the Dome is holding water and leaks below onto the flooring in front of the southern portal (Appendix A, Figure 42). The roofing on other sections of the administrative building at the southern entrance is also in need of repair and leaking water into the rooms below (Appendix A, Figure 42). Evidence of termites (“mud tubes”) was also noted in the administrative building at the southern portal/entrance to the Dome. Evidence of termites and rodents (Appendix A, Figure 41) were noted on the interior of the Theatre Building (repeat from 2015). It is recommended that pest control inspection and treatment be administered at the Theatre Building and administrative building at the southern portal/entrance to the Dome. It is recommended that roofing repairs be made on the administrative building at the south entrance to the Dome to prevent rain water retention and/or intrusion.
