**2017 Annual Inspection and
Status Report for the Boiling
Nuclear Superheater
(BONUS) Decommissioned
Reactor Site,
Rincón, Puerto Rico**

July 2017

U.S. DEPARTMENT OF
ENERGY

Legacy
Management

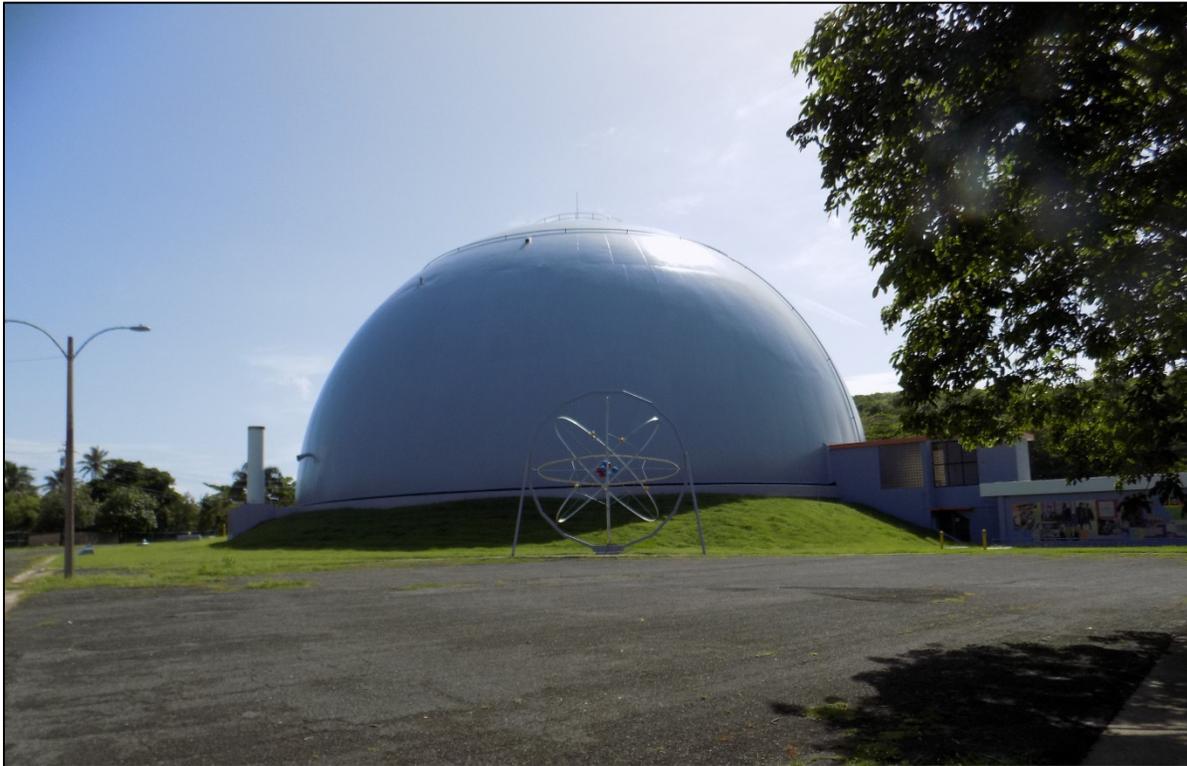
The outer surface of the dome was reconditioned and painted in 2013 (PL-1). The freight door (on the east side of the containment dome) is sealed shut. A small raised platform of concrete is

PL-1. Looking northeast toward the containment dome

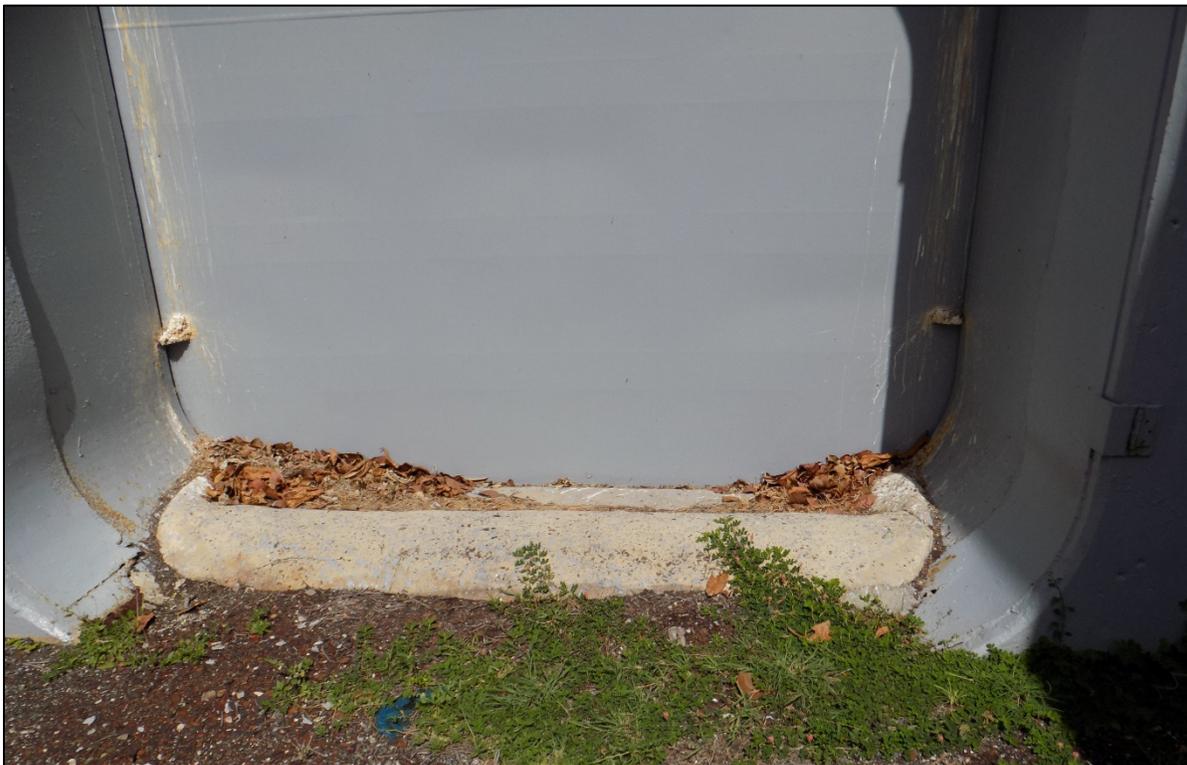
installed at the base of the freight door to provide added protection against water seeping beneath the door (PL-2).

PL-2. Freight door on east side of containment dome with concrete lip installed at the base of the door to provide added protection against water seeping beneath the door

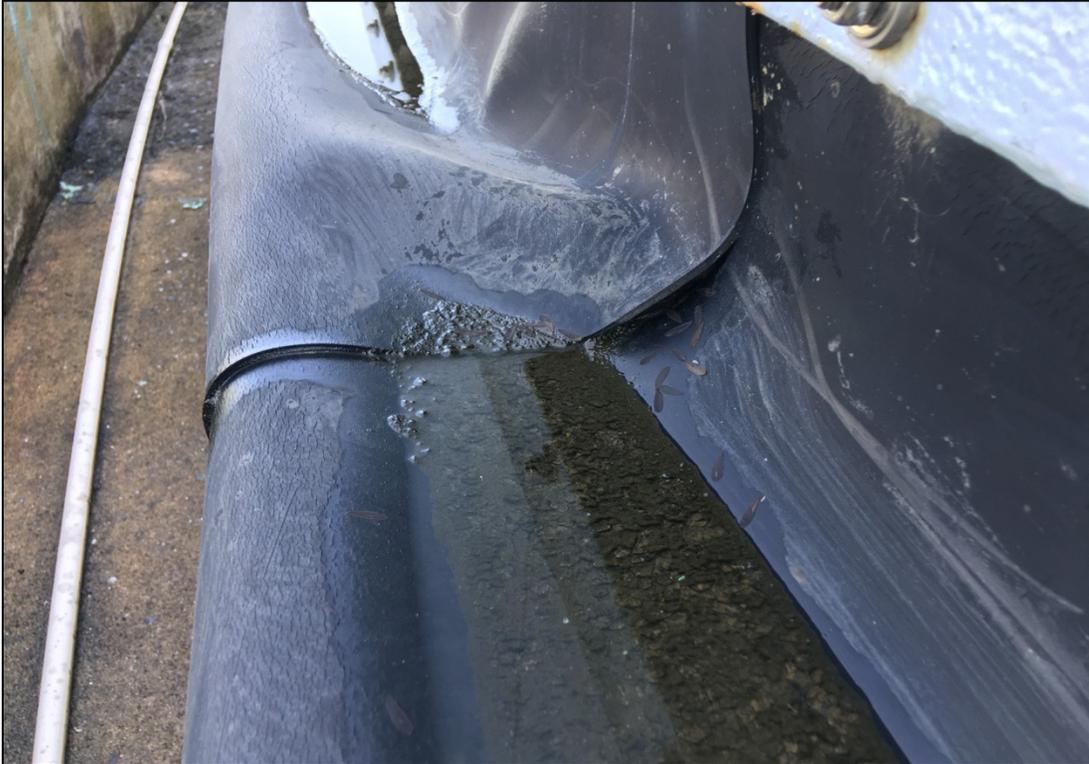
A rubber seal is installed around the base of the containment dome to keep water from seeping into the building. In 2010, the seal was observed to be cracked, ripped, and missing in some spots. Evidence of water seepage was observed in a few spots along the top of the basement wall inside the containment dome, which indicated that the seal was leaking in those areas. PREPA then installed a secondary rubber seal over the damaged primary seal to carry water away from the underlying damaged seal. Inspectors noted that overlaps of the secondary seal should be caulked (PL-3) and the ends of the secondary seal need to be trimmed and better secured to the dome, perhaps using a caulking compound (PL-4). No evidence of recent water seepage was observed along the top of the basement wall in the containment building during this year's inspection, which indicates that the secondary seal is functioning properly.

PL-3. Overlap of secondary seal at base of containment dome

Better seal overlaps and ends of the secondary rubber seal installed at the base of the containment dome to keep moisture out. Perhaps caulk the seal overlaps and trim, caulk, and better attach the ends of the rubber seal to the wall of the containment building dome.

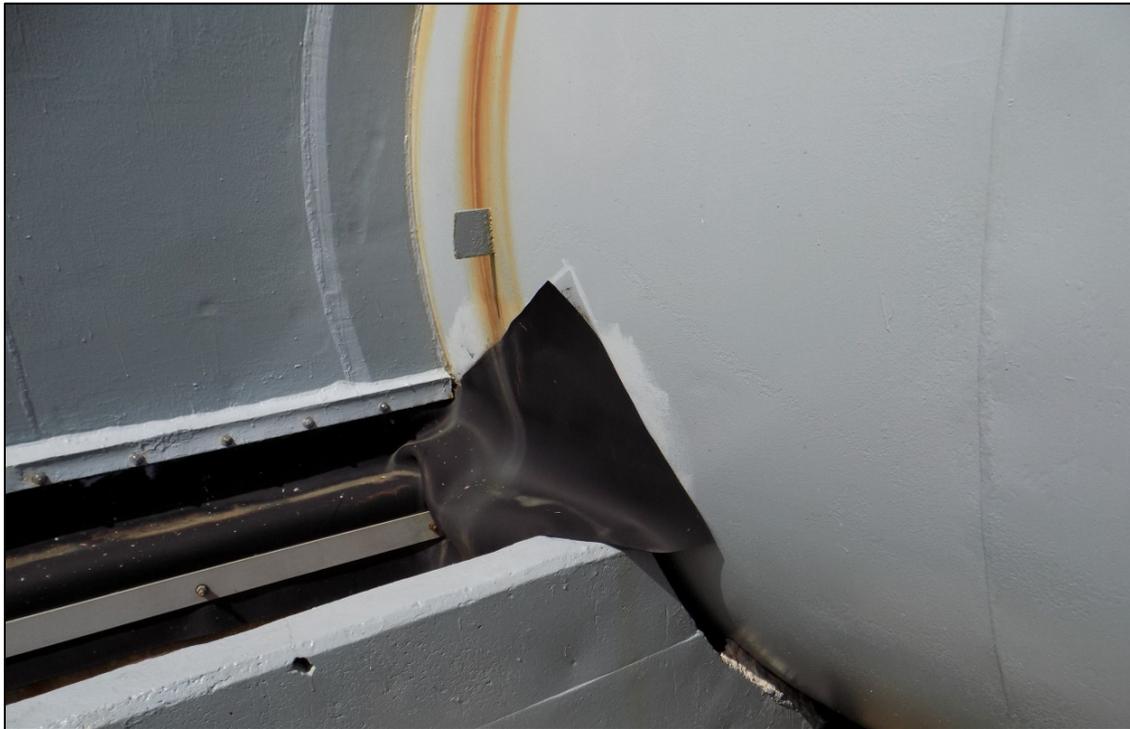
PL-4. Corner of rubber seal on the east side of the north air lock. Ends need to be trimmed and better secured to wall of the containment building dome to help keep moisture out.

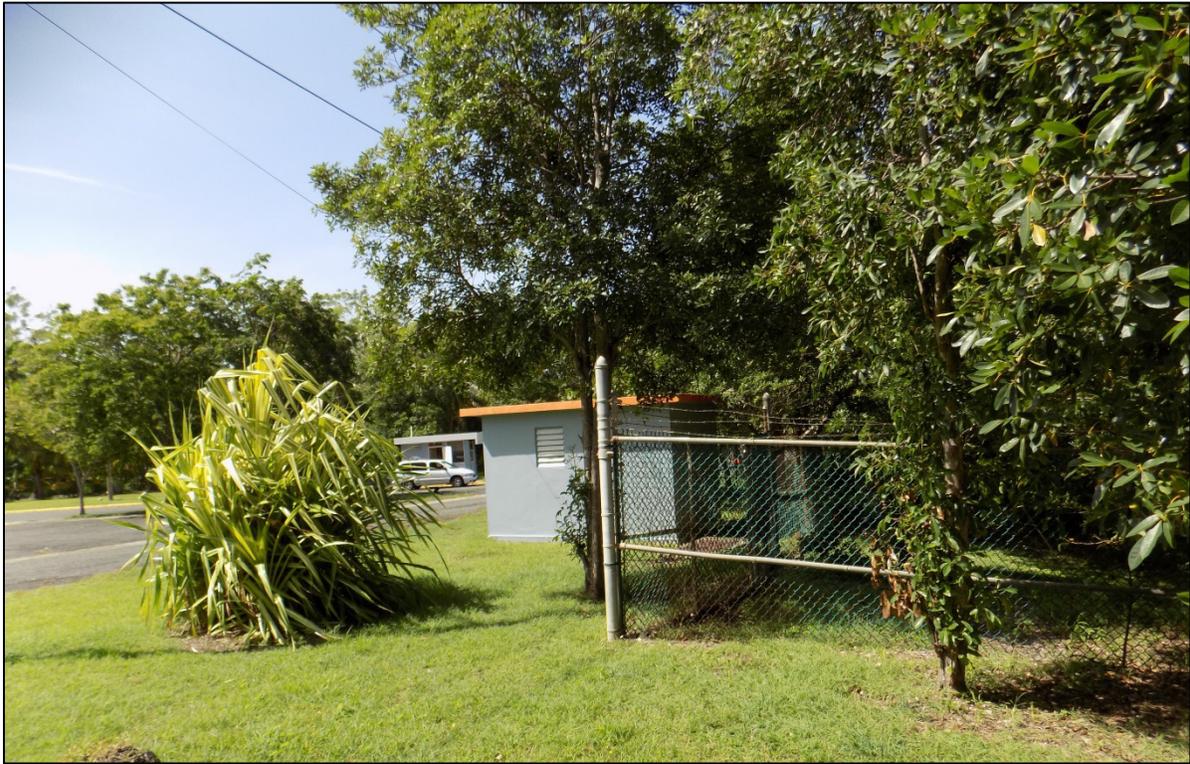
General housekeeping around the site was good. Areas between buildings and along the fence line were free of trash. Except for vegetation encroaching upon the security fence in areas, the landscaping is well maintained (PL-15 and PL-16).

PL-15. Looking southeast at the guard shack

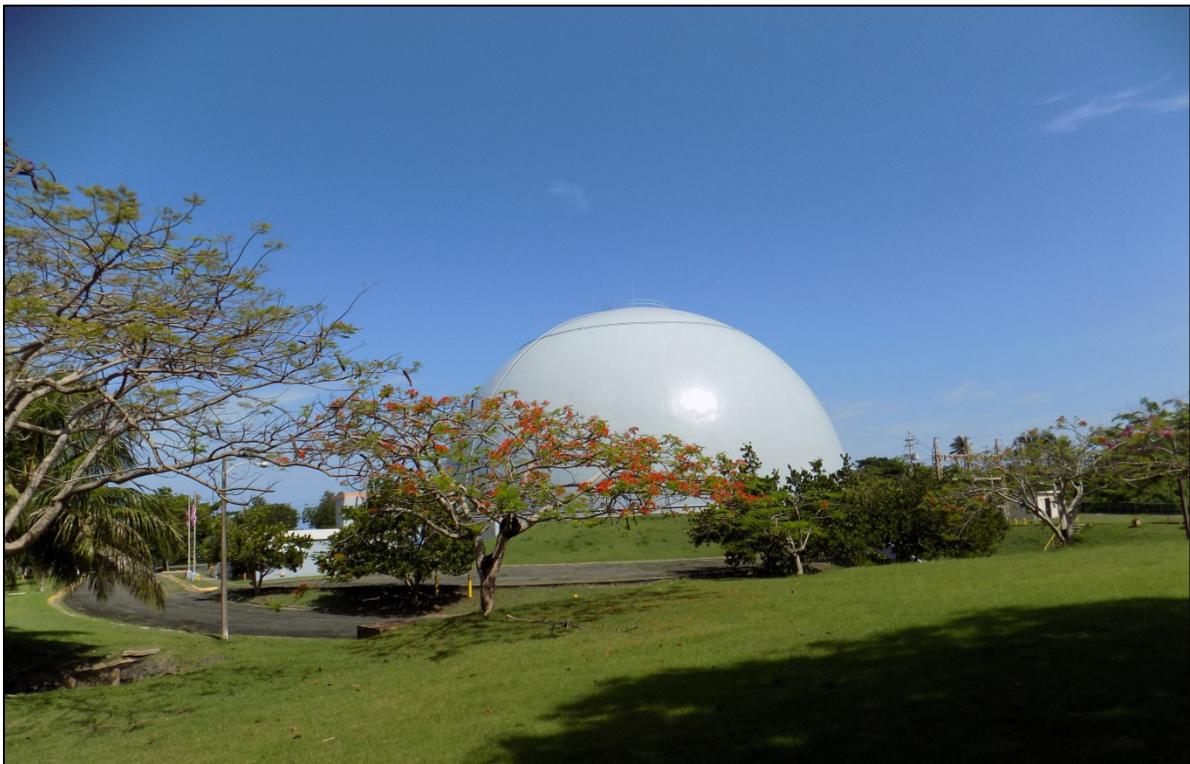
PL- 16. Looking northwest at the containment dome

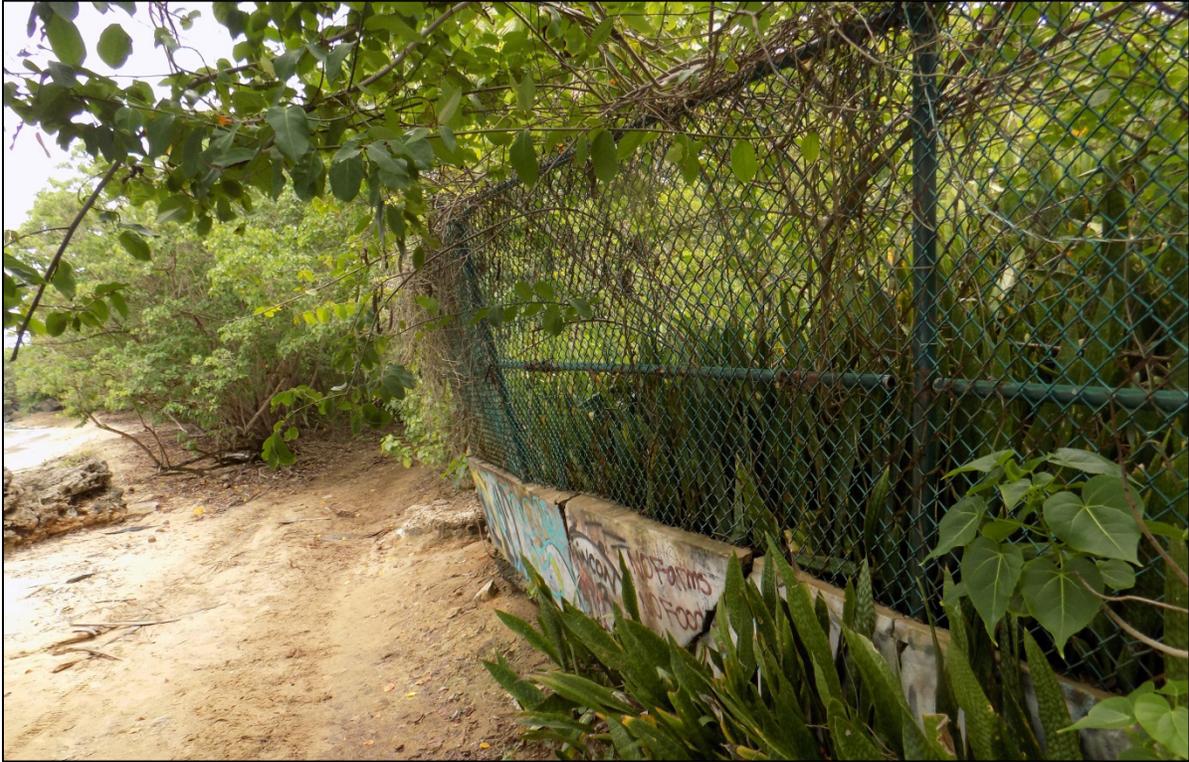
No significant changes to the surrounding area that might impact the long-term sustainability of the facility were noted during the inspection. The retaining wall on the west side of the facility, near the beach, is leaning, broken in several areas, and will eventually fall (PL-17 and PL-18). The wall remains serviceable, and continued monitoring is all that is required at this time. Storm drains leading from the site were found to be clear and free of debris (PL-19).

PL-17. Retaining wall at base of security fence along beach on west side of property. Wall is leaning, heavy vegetation is on fence fabric, and the barbed wire is bent.

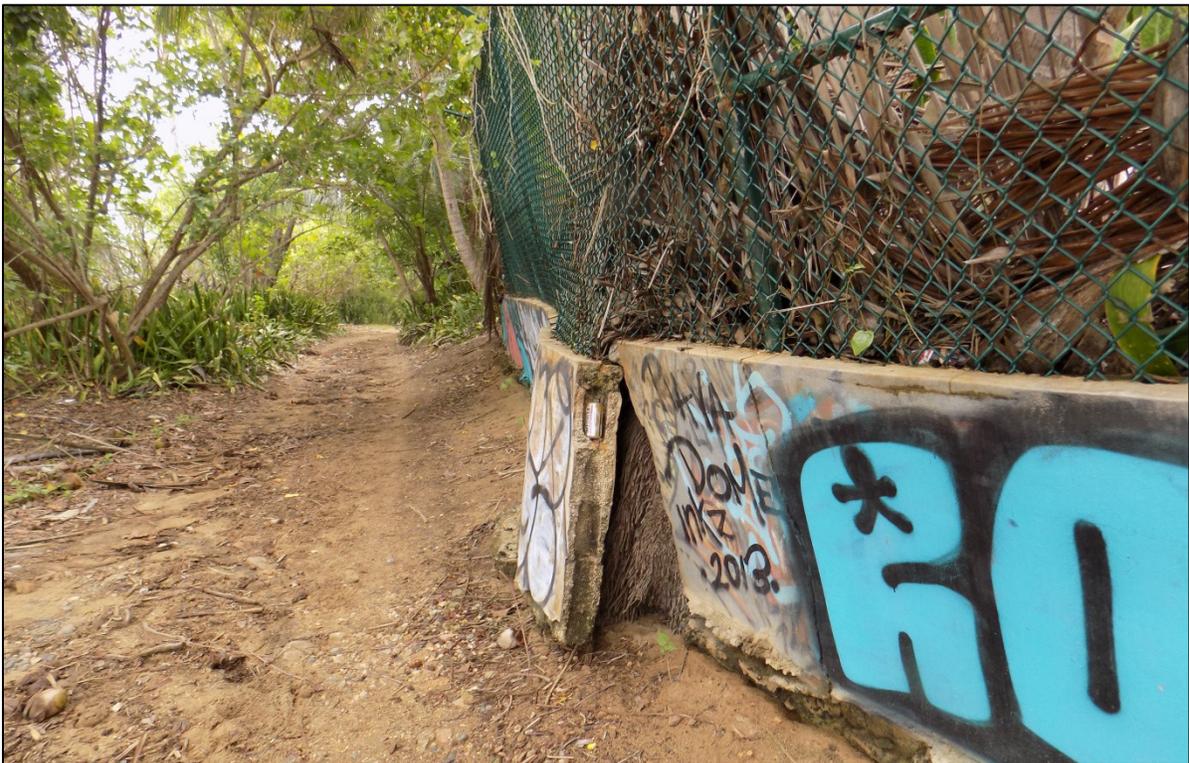
PL-18. Broken section of retaining wall on west side of property due to tree growth

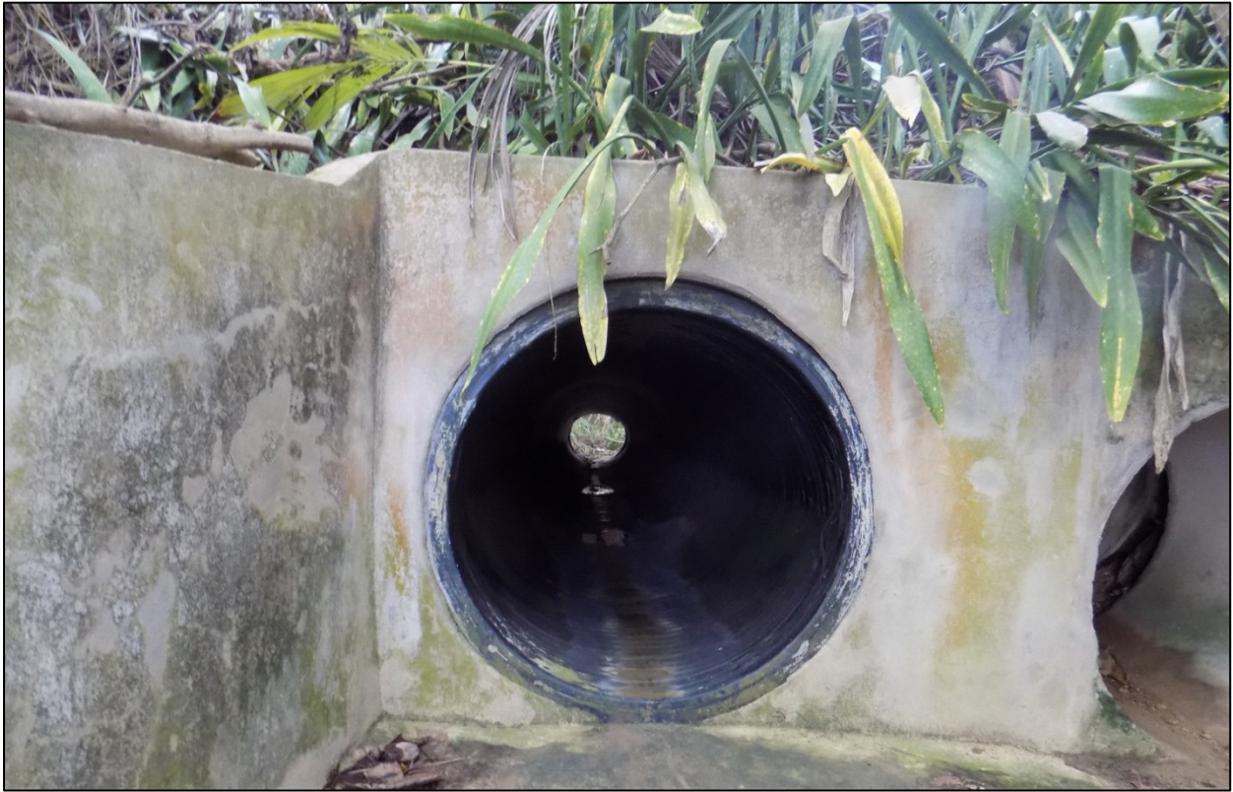
PL-19. Storm drain outlets clear of debris
