CLOSURE REPORT

DECONTAMINATION OF THE FORMER BLISS & LAUGHLIN FACILITY

BUFFALO, NEW YORK

30 SEPTEMBER 1999
USACE CONTRACT NUMBER DACA31-96-D-0026
DELIVERY ORDER 026
PROJECT NO. 80003626

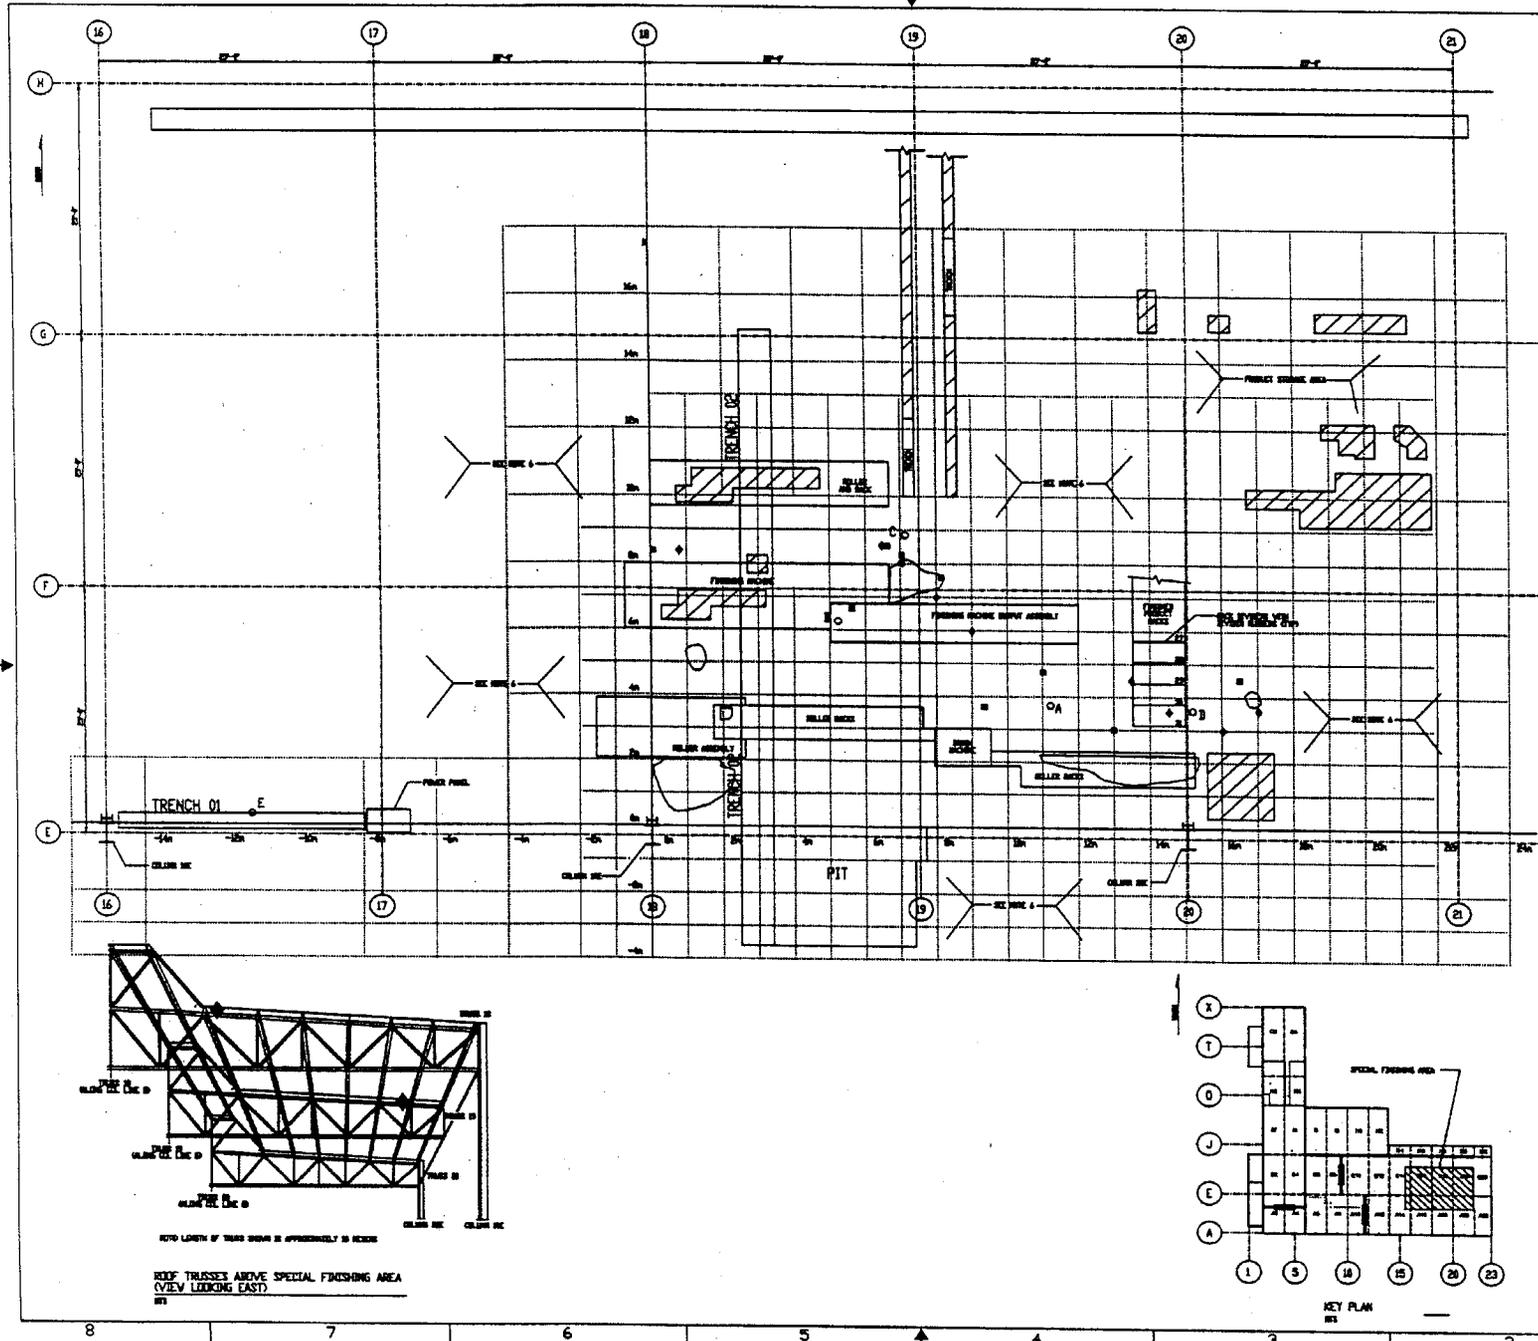
**Figure 1
Bliss & Laughlin
Plan View**

A site characterization was performed by Bechtel National Inc. (BNI) for the DOE. The results of this radiological and chemical characterization are described in a 1995 Technical Memorandum (BNI, 1995). In summary, locations of elevated activity were noted on the overheads and floor surfaces of the former Special Finishing Area.

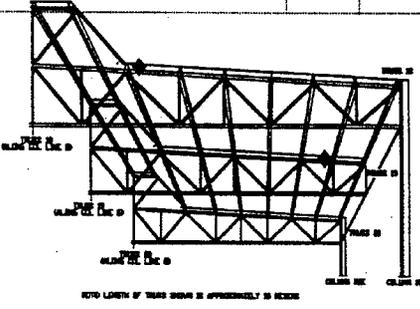
ROOF TRUSSES ABOVE SPECIAL FINISHING AREA
(VIEW LOOKING EAST)

As described in the Record of Decision, trusses 18, 19 & 20, which are located above the Special Finishing Area, were contaminated (USACE, 1998). In the initial assessment of the trusses approximately 53 linear ft. (16 linear meters) was found to be contaminated. Upon a re-survey of the area, additional areas on the trusses and on perpendicular cross members were found to be contaminated above the cleanup level.

The ceiling trusses and perpendicular members were decontaminated. Personnel in man lifts were used to access the ceiling trusses. Those areas as determined by the pre-remediation survey that had surface contamination in excess of 2,000 dpm/ 100cm² total activity were decontaminated by scraping and using a HEPA vacuum and, when needed, were wiped with maselin. Once the areas were vacuumed, the radiological control technician confirmed that the area was less than 2,000 dpm/100 cm². The trusses and cross members were then surveyed and found to be less than 2,000 dpm/100 cm². Following Radian's survey, the USACE performed a confirmation survey of the truss areas. Of the six areas, three did not meet the cleanup level. These areas were re-vacuumed and resurveyed by USACE and found to meet the cleanup level.
