2017 Annual Inspection Report of the Burris Park, California, Site

February 2018

U.S. DEPARTMENT OF
ENERGY

Legacy
Management

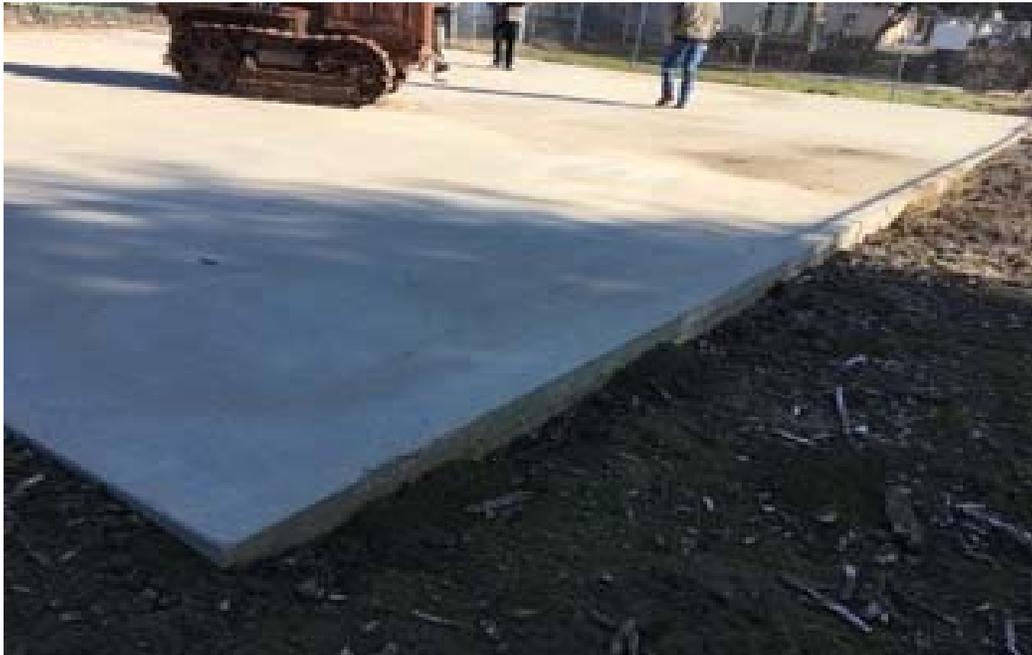
One antique farm tractor remains on the concrete pad due to its immobility and age. The surface of the concrete pad has minor surface cracks, which do not pose a health risk since in 2014 these same cracks were scanned by a radiological control technician and no results were above background. Photograph PL-1 represents the current condition of the IC.

PL-1. Concrete pad surface looking northeast with no vegetation around the pad.

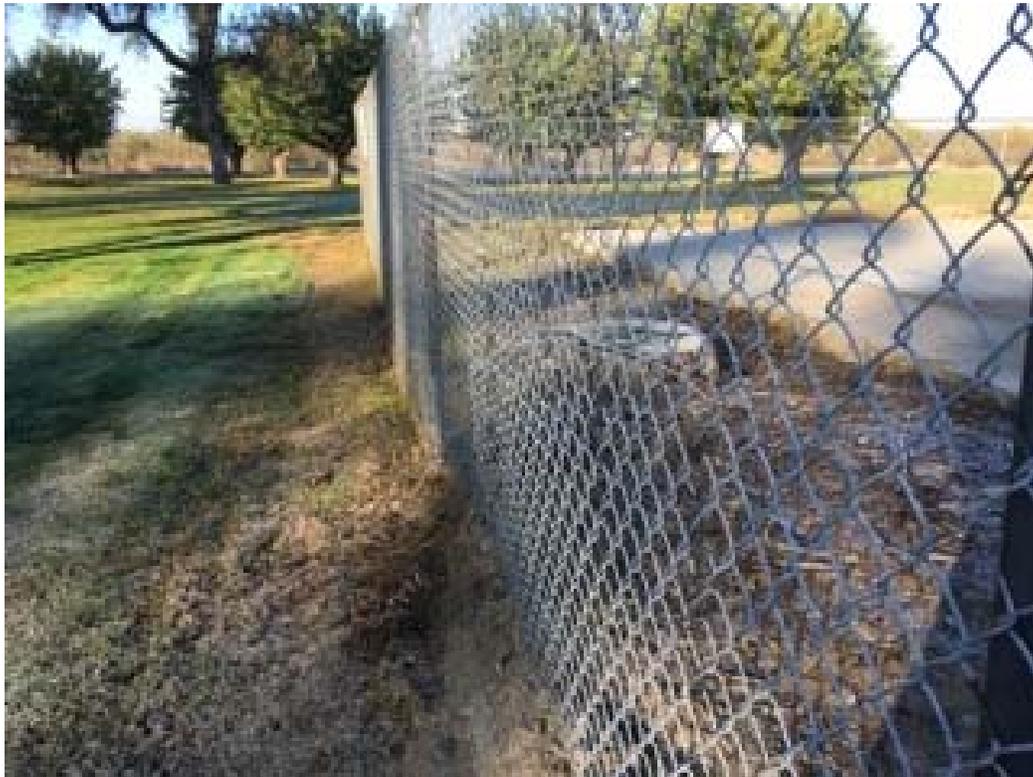
As reported in the 2016 inspection, fence maintenance occurred to restore this asset to a protective condition. The expected longevity of the fence is about 25 years. During the 2017 inspection, a closer look at the age of the fence revealed a replacement is necessary within the next 10 years. As such, LM will plan to replace the entire fence and gate in 2025. Furthermore, at the base of the fence, erosion and animal burrowing has caused the fence to bow or reveal gaps between the ground and the fence. As such, LM will address this condition by installing a bottom fence rail during its planned maintenance in March 2018. PL-2 through PL-5 show the current condition of this IC.

PL-2. Fence looking west.

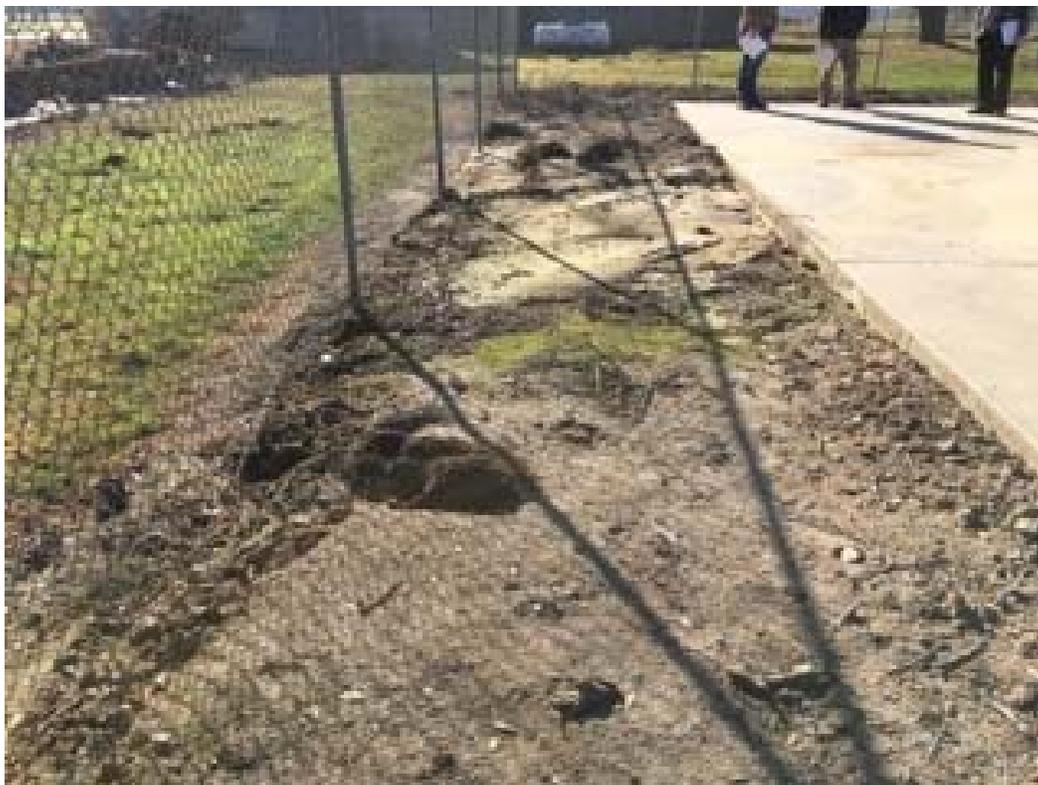
Overall, the site was found to be in good condition. The vegetation growth has been successfully deterred park maintenance staff by applying herbicide as needed around the pad year-round. However, the concerns observed in 2016 of rodent burrowing remain. As indicated earlier, LM has scheduled maintenance at the site in March 2018 to deter animal burrowing and vegetation growth around the pad and improve the unfavorable condition with the lower section of the fence. LM shared the proposed statement of work with Kings County Parks and Grounds superintendent for review and comment.

PL-3. Fence and animal burrowing looking north.

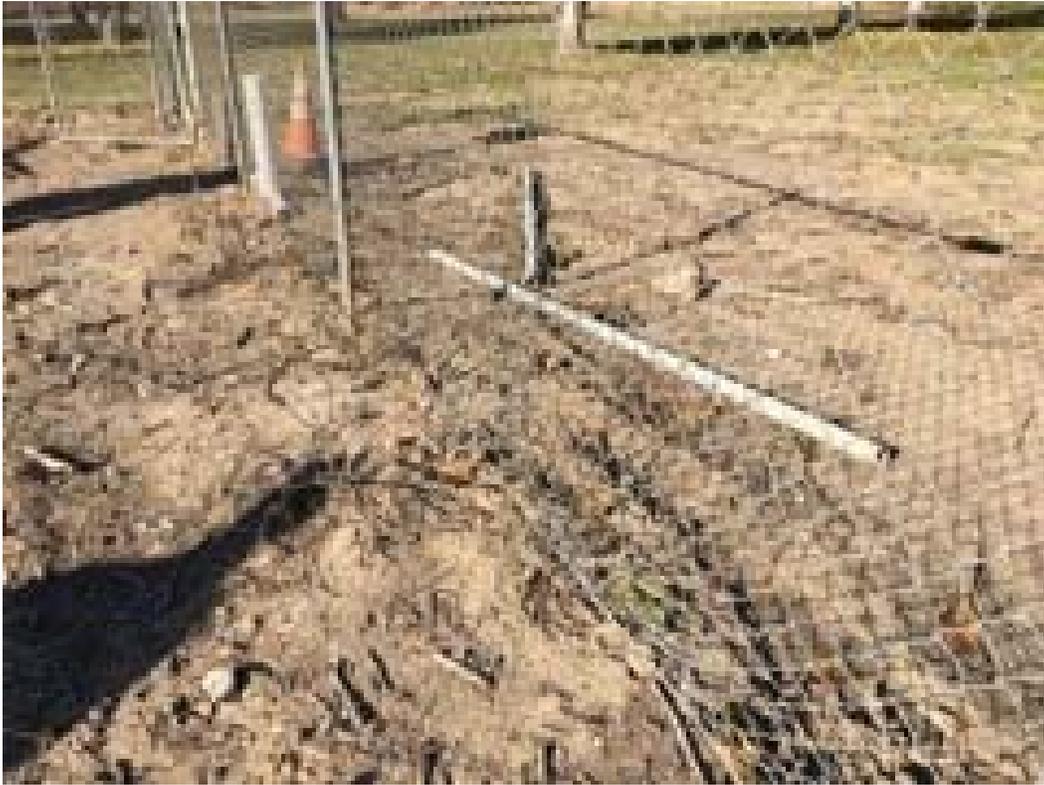
PL-4. Fence condition at grade looking south.

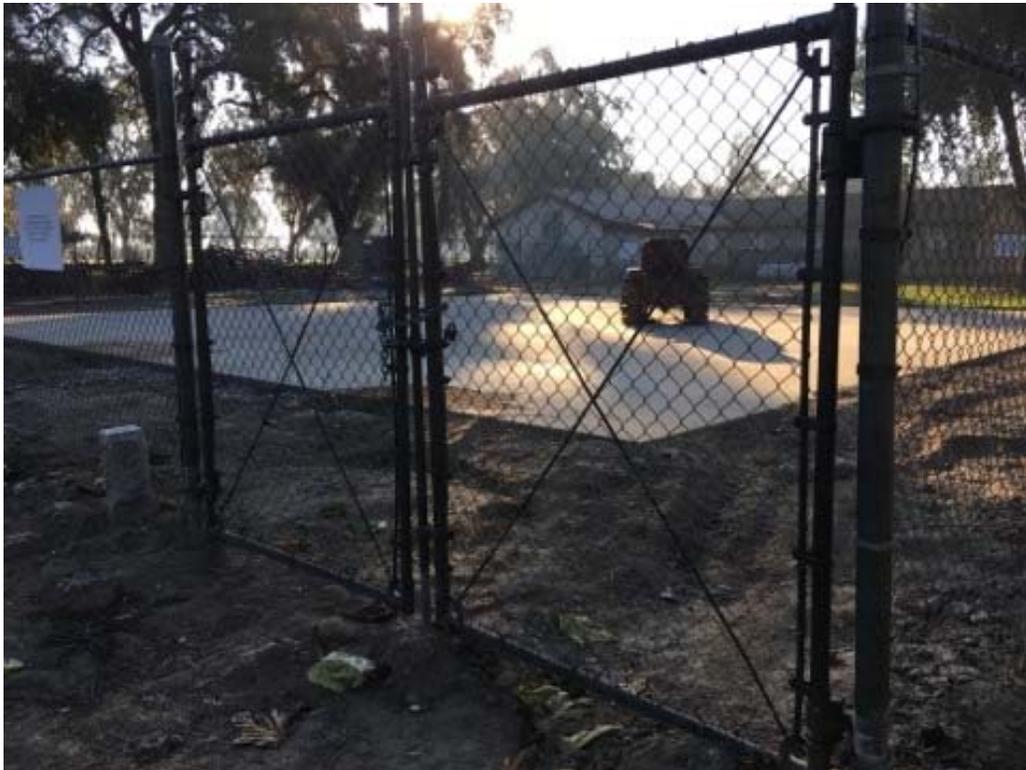
PL-5. Fence gate looking northeast.

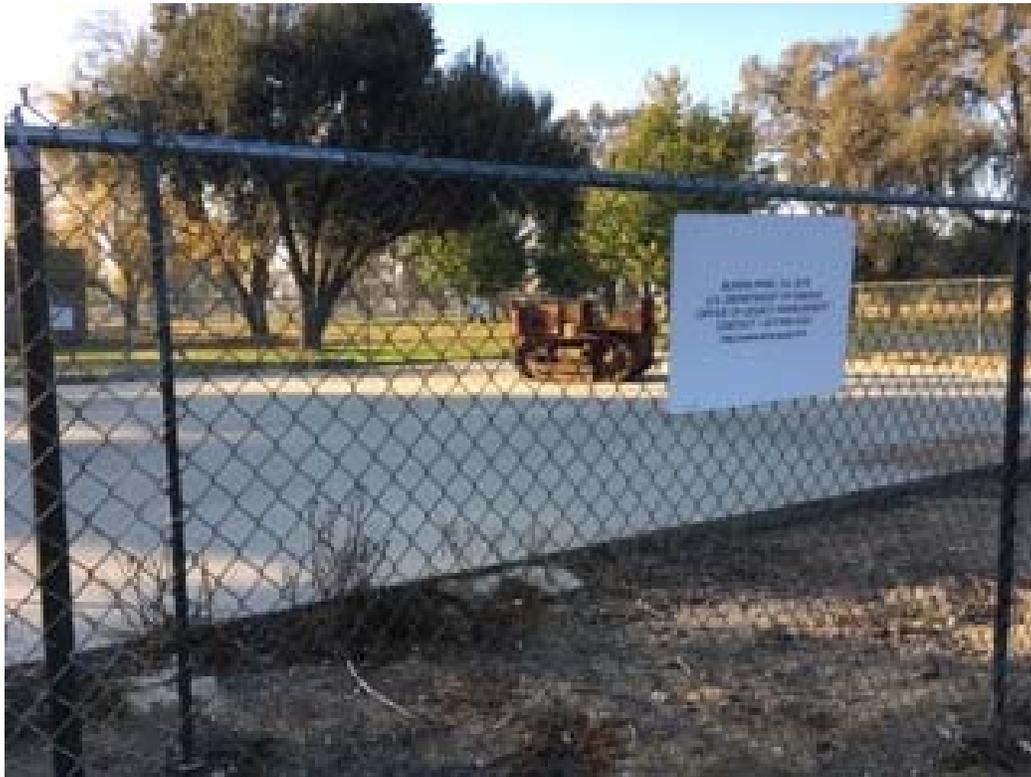
Signs on each side of the fenced area were present and found to be in good condition with no maintenance needs or cause for a follow-up inspection identified. Refer to PL-6.

PL-6. Verified signage posted on all sides of fencing.
