**Post-Closure Inspection and
Monitoring Report for
Corrective Action Unit 417:
Central Nevada Test Area
Surface,
Hot Creek Valley, Nevada**

October 2009

U.S. DEPARTMENT OF
ENERGY

Legacy
Management

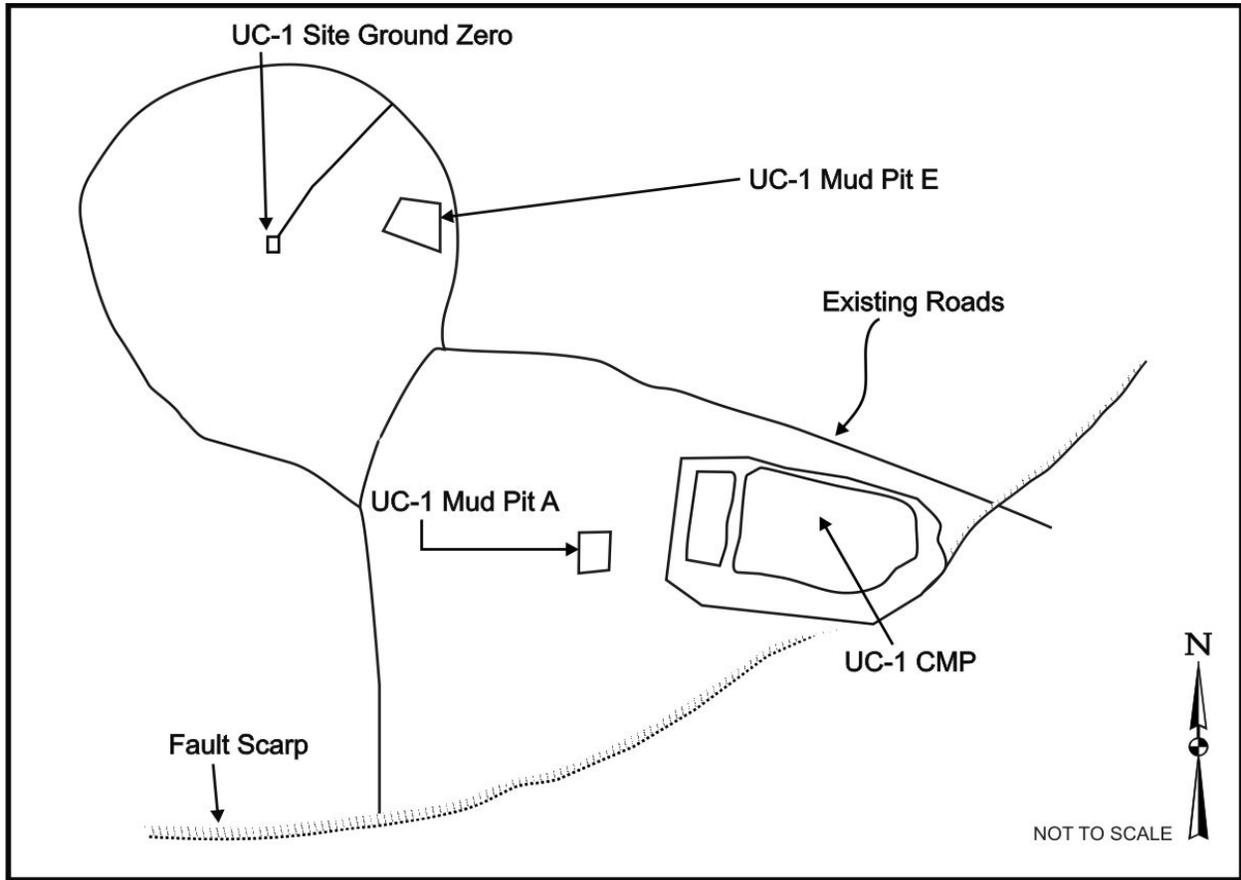
Figure 3-1. Location of UC-1 Significant Features

The locks, fencing, SMs, and signs associated with the CMP were in good order, with the exception of one sign that had fallen along the southeast side of the fence line. Three cracks in the cover showing lateral expansion were observed and repaired at the time of the inspection. The vegetation on the cover continues to look healthy. All other signs and monuments at Mud Pits A and E (Figure 3-1) were in excellent condition.

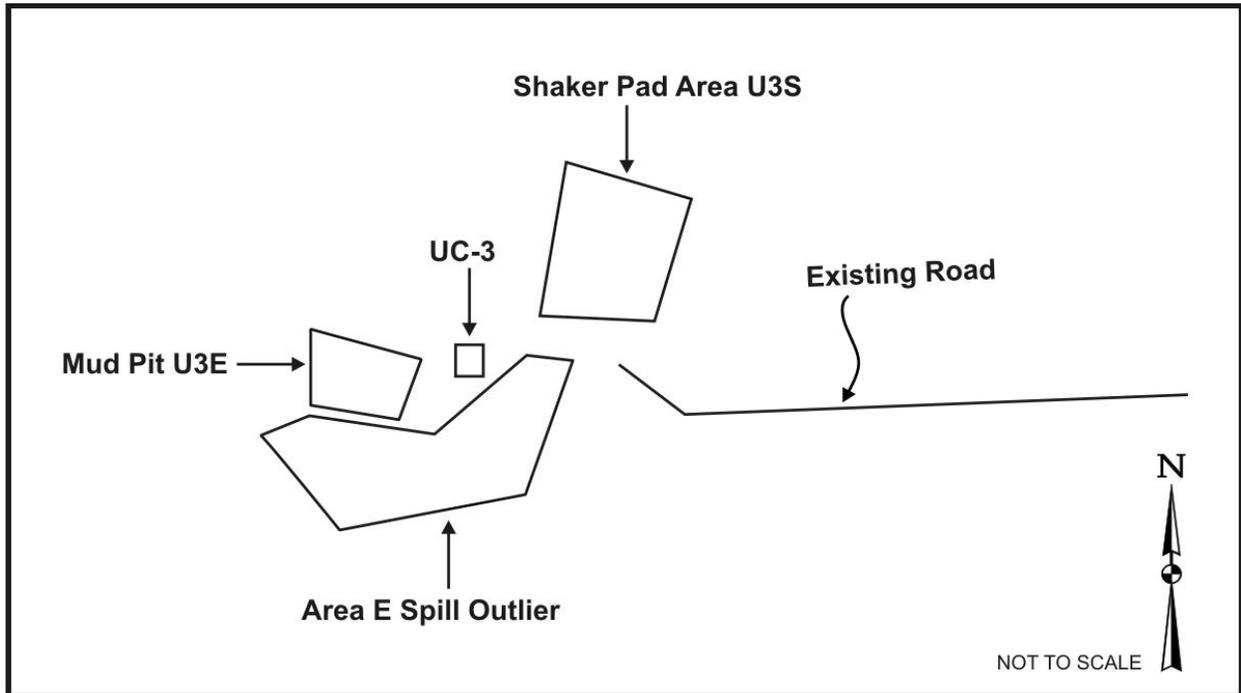
Figure 3-2. Location of UC-3 Significant Features

The site was in excellent condition (Figure 3-2). No issues were identified with the monuments or signs, and no maintenance or repairs were recommended.

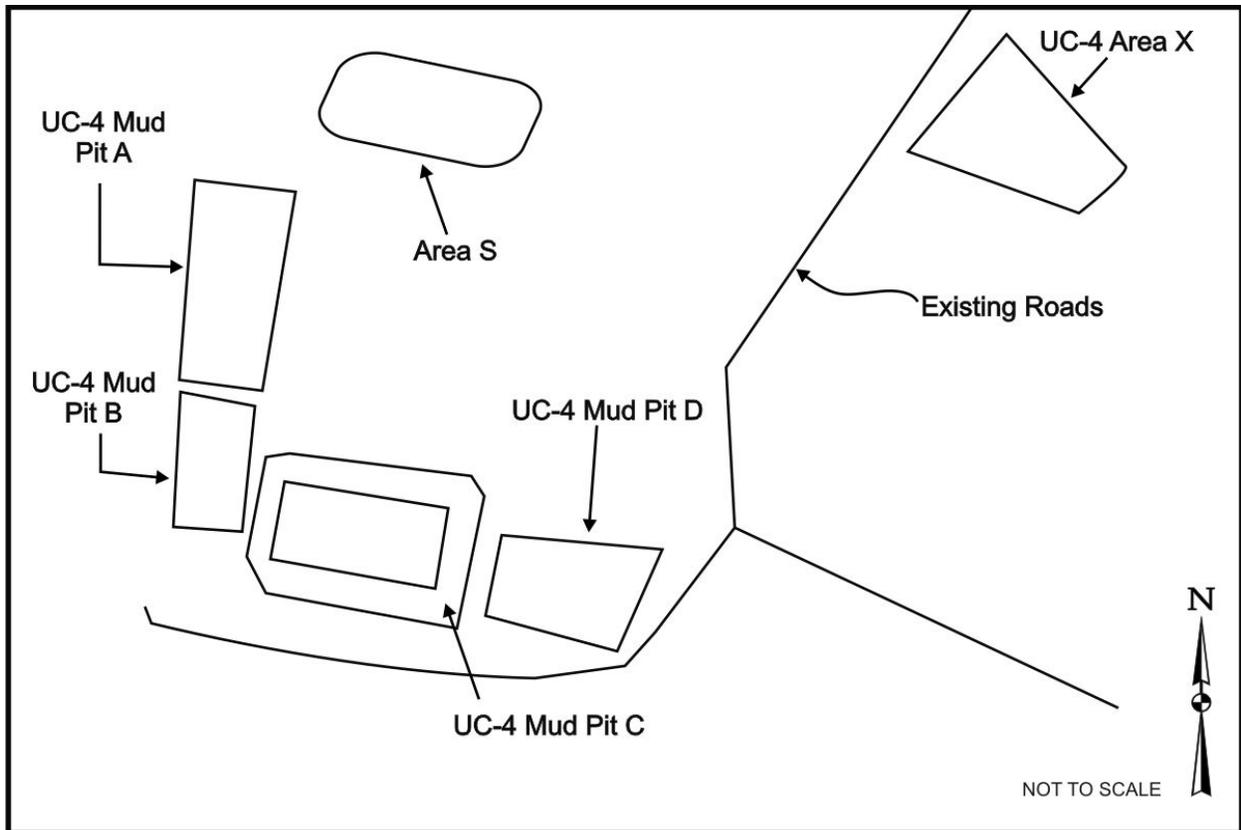
Figure 3-3. Location of UC-4 Significant Features

The Mud Pit C fence and SMs were in good condition. A pin on the gate lock hasp was missing, but it does not affect the integrity of the locking mechanism. Two small erosion rills were identified at the time of the inspection and repaired. One of the small rills was near the northwest corner, and a slightly more significant rill was near the steeper southwest corner. Mud Pits A, B, and D were in excellent condition, and no issues were identified with Area S or Area X (Figure 3-3). The overall condition of the site was good; however, some vegetation is growing on the cap. No issues were noted that affected the integrity of the cover and appurtenances.

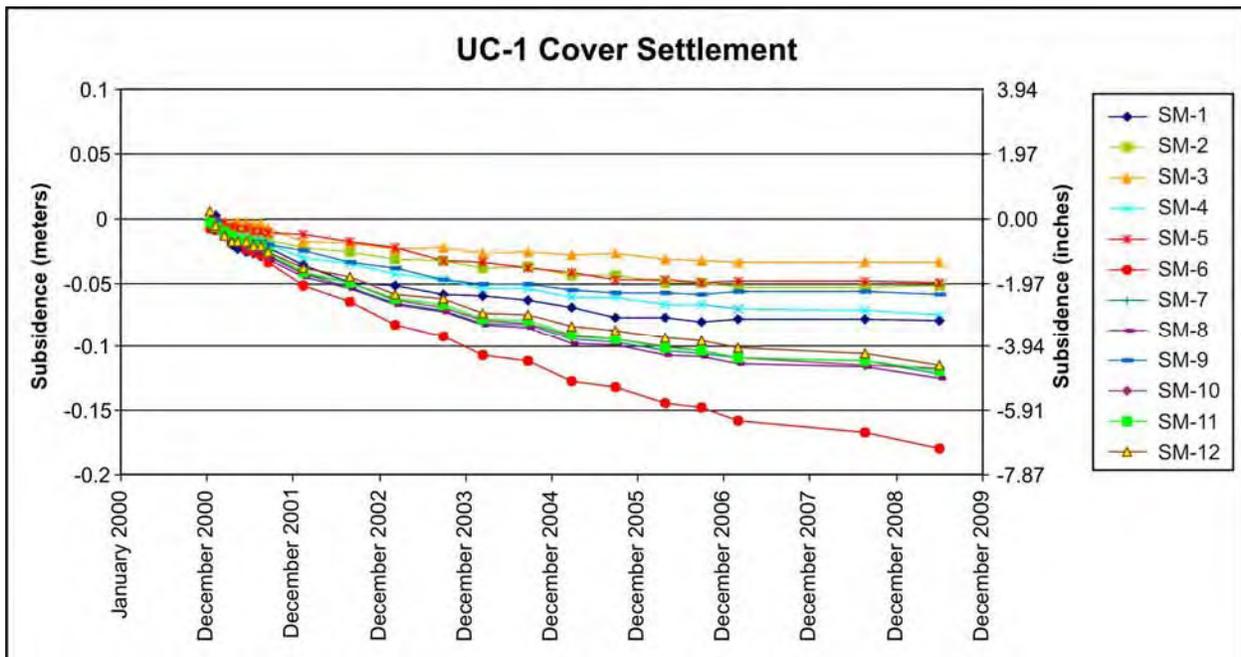
Figure 3-4. UC-1 Cover Settlement

The degree of settlement in the relocation trench and CMP is within the predicted range and shows no unusual subsidence. The data collected over the CMP section of the cover indicate that the largest subsidence is along the centerline of the CMP, including SM-6, SM-7, and SM-8 and along the southern portion of the cap at SM-10, SM-11, and SM-12. This was expected because of the thicker layer of underlying mud in these areas. The northern monuments SM-2, SM-3, and SM-4, along with the westernmost monuments, SM-1, SM-5 and SM-9, show the least subsidence because of the thinner layer of underlying mud along these margins of the cover. The greatest degree of settlement continues to be on SM-6, which has subsided a total of 0.179 m (7.05 inches) since the baseline survey in December 2000.

The UC-1 settling trend that has been occurring since December 2000 continued to show a slight decrease in cover elevation during the current monitoring period. The degree of settling in both the relocation trench and the CMP is within the predicted range and shows no unusual subsidence.

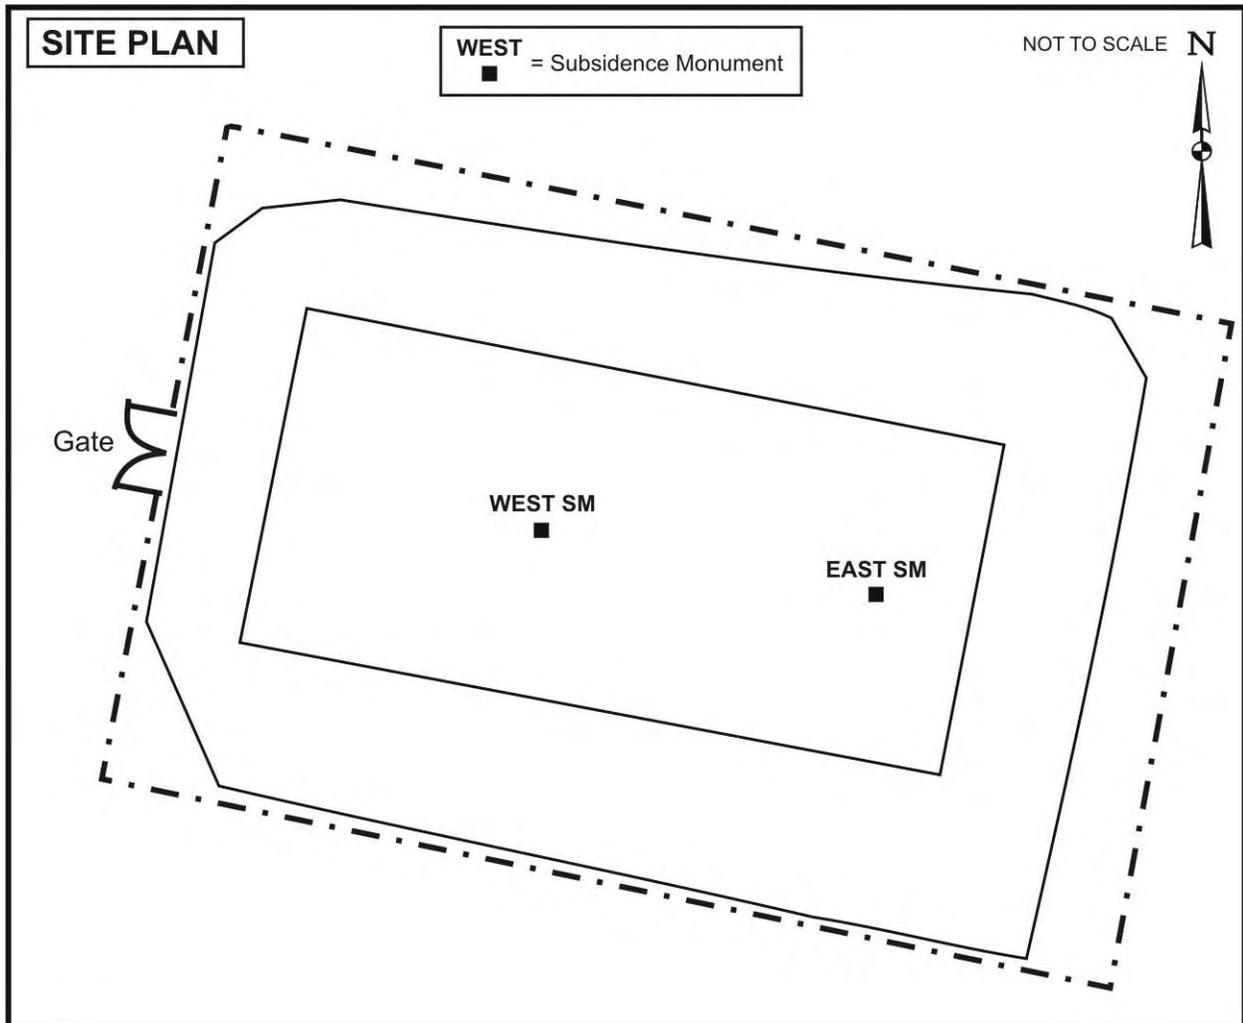
Figure 3-5. UC-4 West and East Monuments

Two SMs (west and east monuments) were installed in the UC-4 cover to provide elevation control for measuring the subsidence of the cover. These SMs are shown in Figure 3–5. The baseline subsidence survey was completed on October 12, 1999, and is used as the reference survey to calculate subsidence. The UC-4 baseline survey locations and elevations are provided in Appendix B, Table 2 and are presented in graphical form in Figure 3–6. Since the last subsidence survey in 2008, both subsidence markers showed increases in elevation ranging from 0.010 m (0.39 inches) to 0.013 m (0.51 inches) from the east and west SMs, respectively. Settling of the west SM is still slightly greater than the predicted settling of 5 cm (2 inches); the total subsidence is 0.051 m (2.01 inches) since the baseline survey in October 1999. The east SM has subsided a total of 0.017 m (0.67 inches) since the baseline survey. The largest changes occurred within the first year.

In the annual survey, measurements at the UC-4 east monument indicated a slight increase in elevation. Subsidence at the west monument is still slightly greater than the predicted settling; the total subsidence was 6.6 cm (2.6 inches) since the baseline survey in October 1999. The cause of the increase in elevation of the two UC-4 monuments is unknown.

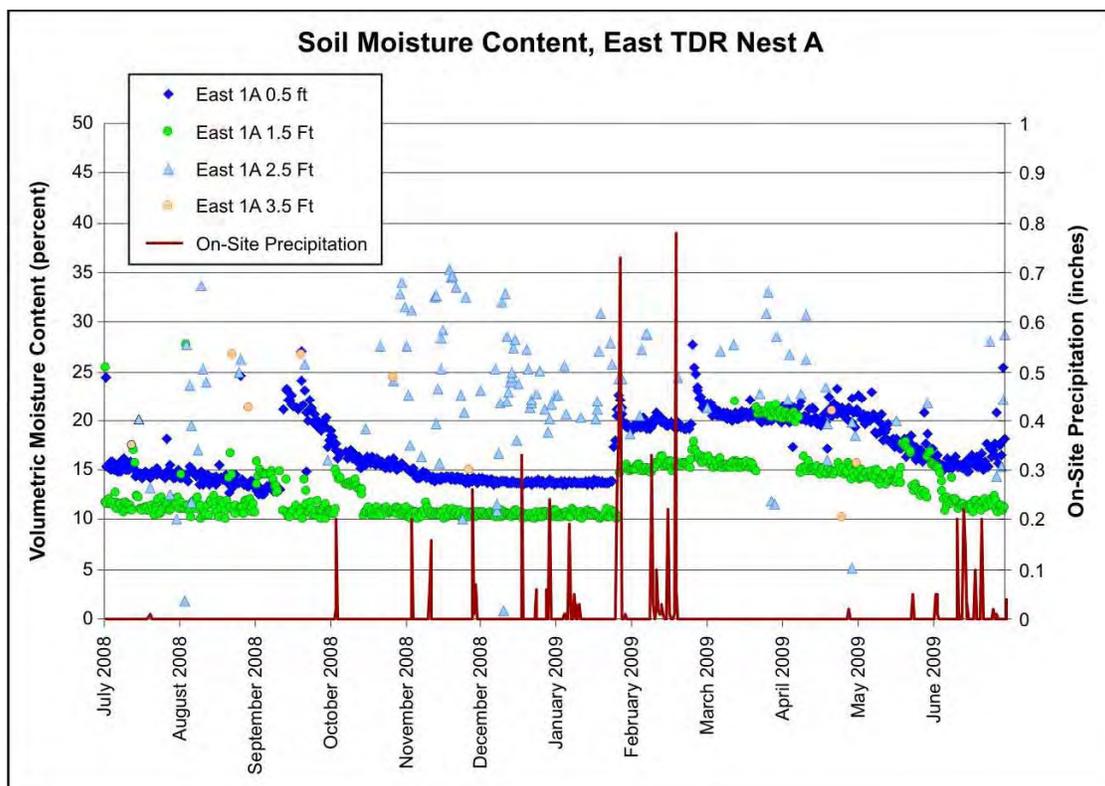
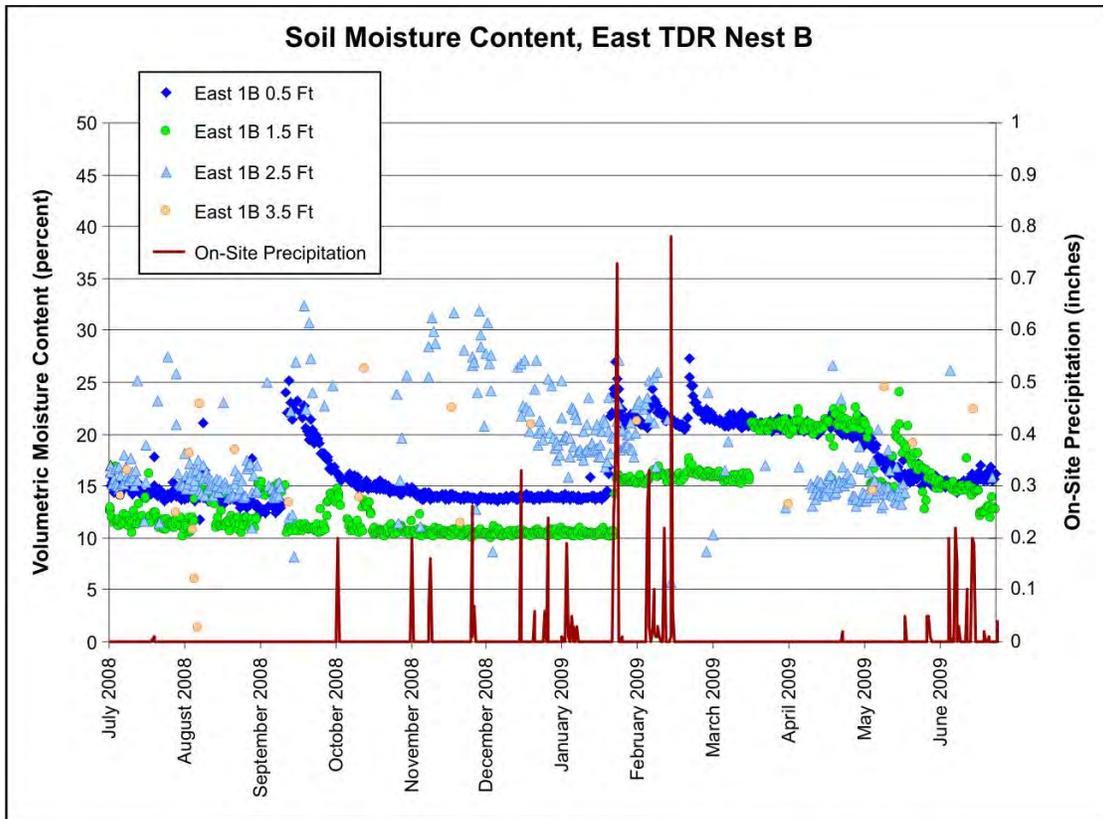
TDR data obtained for the east nests, measured at depths of 0.76 m and 1.07 m (2.5 and 3.5 ft), were entirely corrupted from an unknown cause. Previously, the lengthy cable created a problem in measuring the reflected signal from the TDR probes (NNSA/NV 2007). Inappropriate signal responses from the two lower stations in the east TDR nest make interpretation of the data difficult. The TDR data from all depths are presented on the respective graphs, but only the two TDR sensors at the shallower depths appear to be responding to the infiltrating moisture. From these data it appears that VMC fluctuates by approximately 5 percent in the upper 1.5 ft of the cap.

- Continue site inspections annually as scheduled to observe the condition of the covers, fence, vegetation, signs, and monuments.
- Continue annual subsidence surveys on UC-1 and UC-4.
- Conduct a vegetation survey in 2011 to comply with the agreement to perform the vegetation survey biennially.
- Remove large vegetation from UC-4 cover during the 2010 inspection.
- Continue soil moisture data collection from the west TDR nest and, when possible, from the east TDR nest.
- Respond to reports from the public of detrimental conditions at the site within 90 days.
- Meet with NDEP after the 2010 annual inspection and report to discuss the closure plan with respect to historical site data collected, present site conditions, repair of the lower two sensors at the East TDR nest, and future path forward.

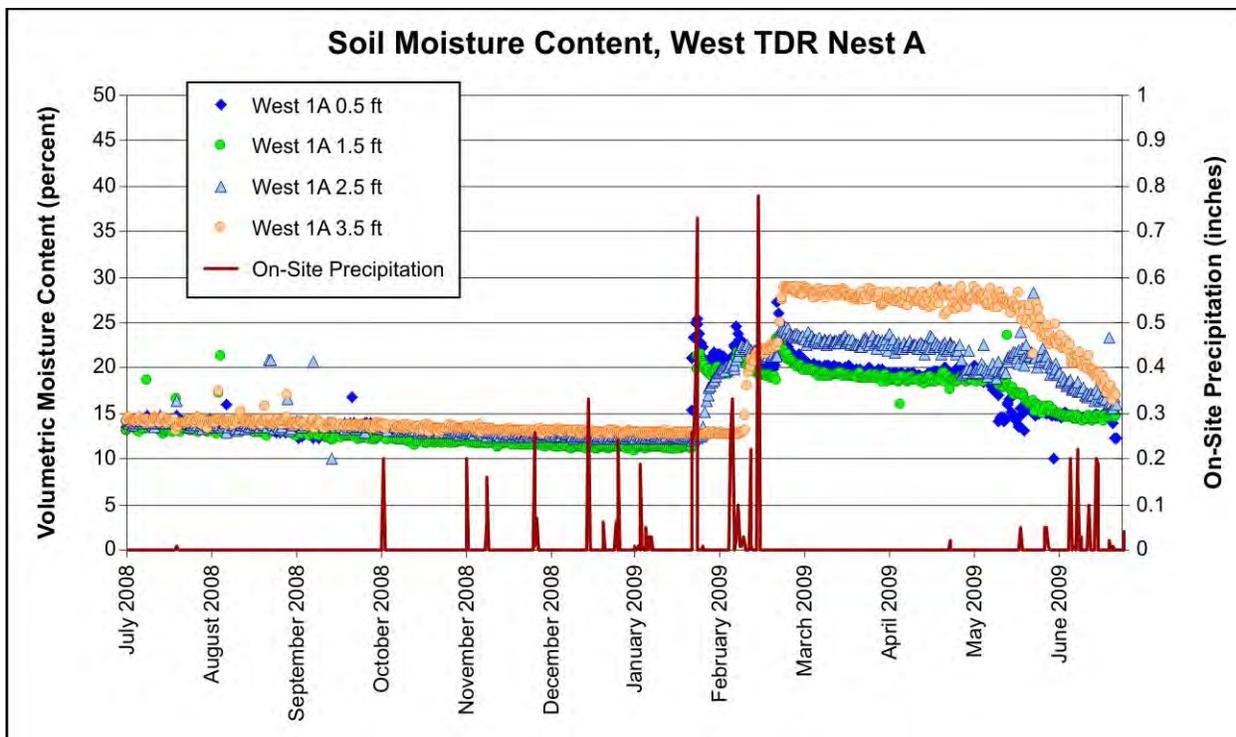
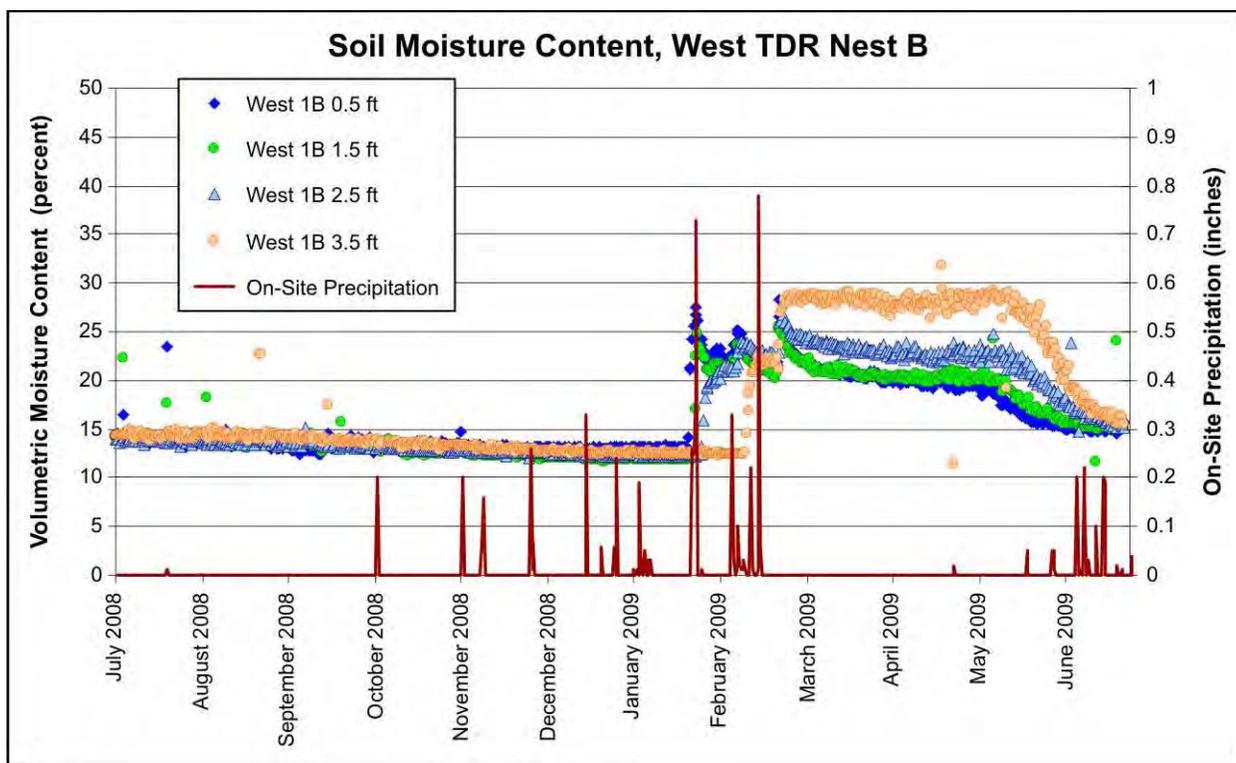
Moisture content measurements indicate steady-state conditions throughout most of the year with VMC varying by less than one percent in the upper 2.5 ft of the cap. Significant moisture events in late January to early-mid February 2009 sent a slug of moisture through the cover, and VMC varied from 0 to 2 percent down to 1.5 ft and up to approximately 8 percent at depth, 3.5 ft. These trends extended into mid-May when surface temperatures increased, and evapotranspiration once again became effective at removing moisture from the cover.

With the exception of the lower two stations in the east TDR, both nests present similar profiles and indicate that the cover is performing as designed, with evapotranspiration effectively removing water from the cover. The moisture content at the two deeper profiles of the west TDR nest appears to be approaching steady-state conditions at between 10 to 15 percent VMC. The moisture sensors in the two deeper profiles of the east TDR nest are not functioning.
