Postclosure Inspection and Monitoring Report for Surface Corrective Action Unit 417 at the Central Nevada Test Area, Nevada, Site

February 2020

Legacy
Management

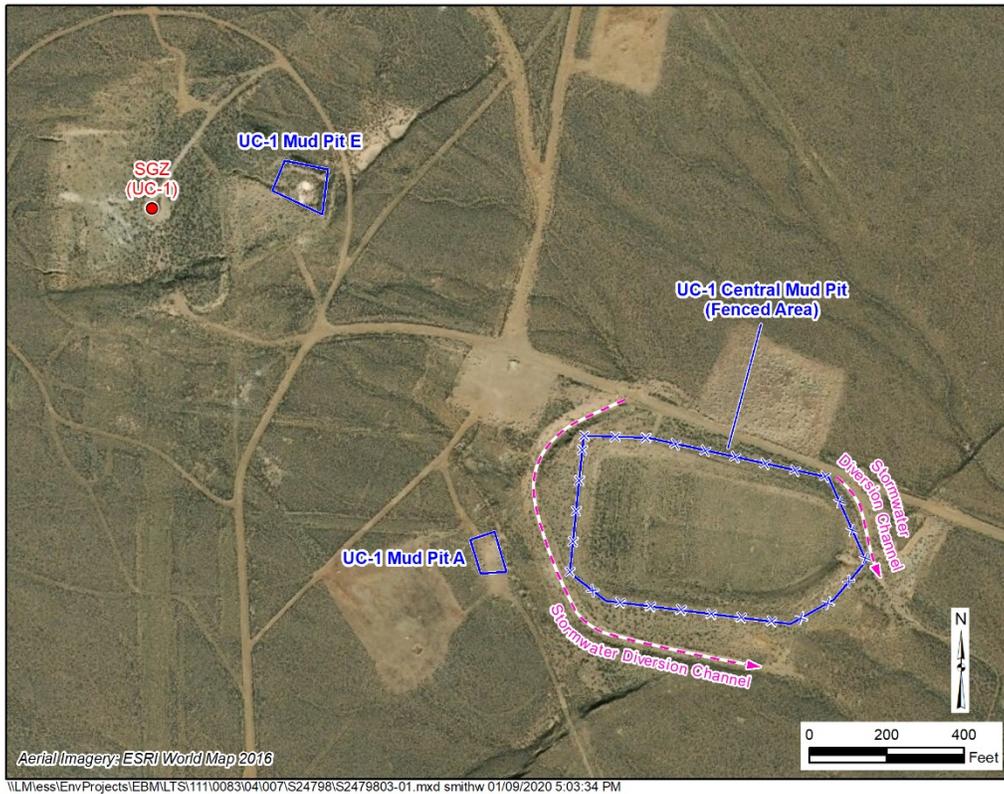
Figure 4. UC-1 Site Map, Showing the Surface Use-Restricted Areas

The UC-1 site (Figure 4) was in good condition at the time of the inspection, which was completed on June 27, 2018. The locks, fencing, and signs associated with the CMP were in good condition. A few minor cracks on the CMP cover were repaired during the inspection. No issues that affected the integrity of the cover, including new cracks, fractures, or extensions of existing cracks and fractures, were noted. The vegetation on the cover continued to look healthy and stable. All signs and monuments at Mud Pits A and E (Figure 4) were in good condition. No additional maintenance or repairs are recommended. Photographs 1 through 3 in Appendix B show the condition of the UC-1 site at the time of the inspection.

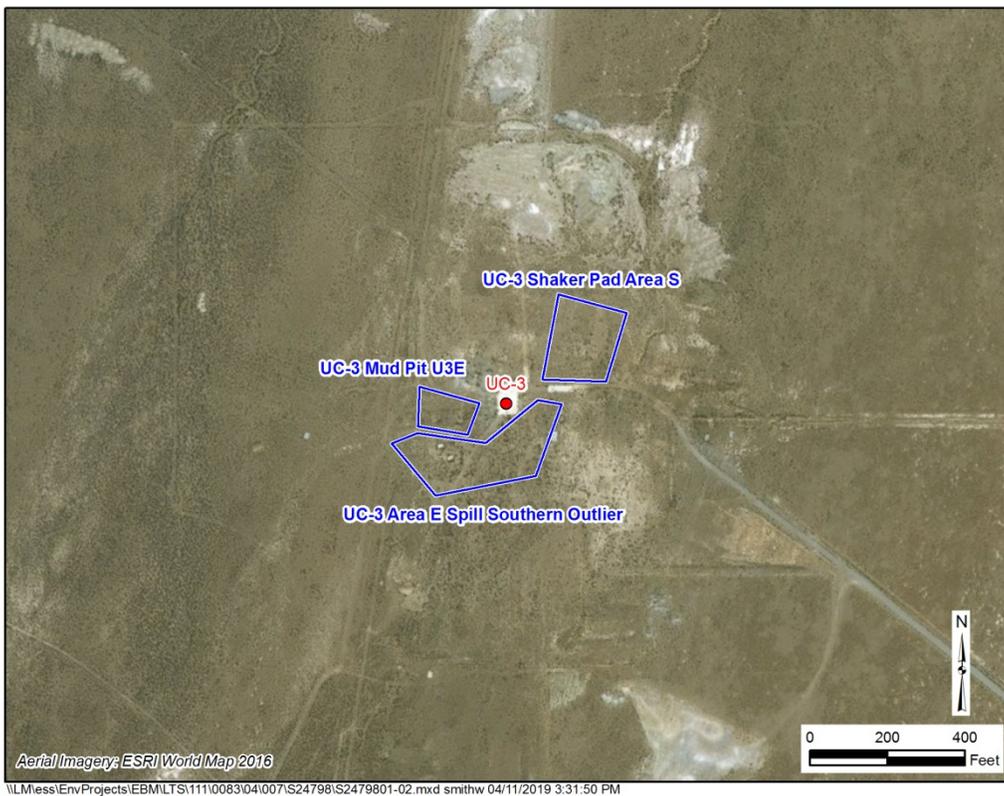
Figure 5. UC-3 Site Map, Showing the Surface Use-Restricted Areas

The UC-3 site (Figure 5) was in good condition at the time of the inspection, which was completed on June 26, 2018. The concrete monument at the northeast corner of Mud Pit U3E had some damage near the top of the monument (Appendix B, photograph 5). The damage appears to be the result of water that entered cracks in the concrete and through the freeze thaw process fractured and separated from the monument. The concrete monument and survey pin at the top of the monument still function as designed, but LM will repair the monument during the next inspection, planned for 2020. No other issues with the monuments or signs were identified at the time of the inspections, and no maintenance or repairs are recommended at this time. Photographs 4 through 6 in Appendix B show the condition of the UC-3 site at the time of the inspection.

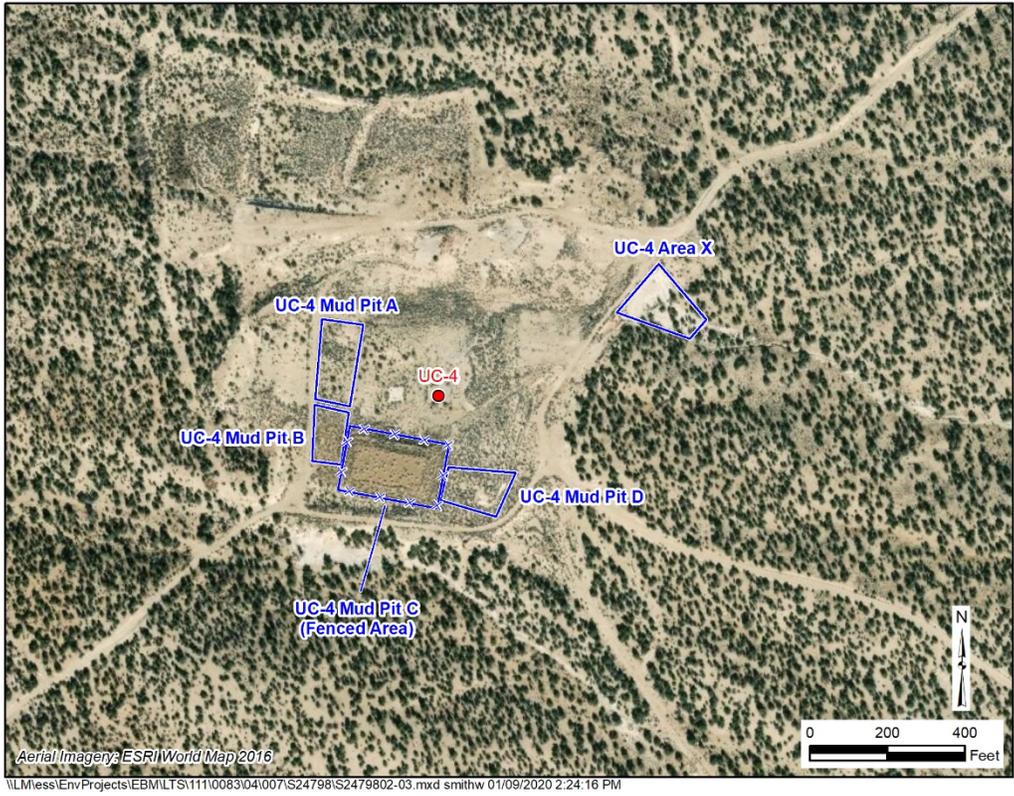
Figure 6. UC-4 Site Map, Showing the Surface Use-Restricted Areas

The UC-4 site (Figure 6) was in good condition at the time of the inspection, which was completed on June 26, 2018. The Mud Pit C fence, signs, and monuments were in good condition at the time of the inspections. No erosion rills were identified and areas where previously identified rills showed no further signs of erosion. No issues that affected the integrity of the cover, including new cracks or fractures or extensions of existing cracks or fractures, were observed. All signs and monuments at Mud Pits A, B, and D, and Area X were in good condition (Figure 6). No maintenance or repairs are recommended. Photographs 7 through 12 in Appendix B show the condition of the UC-4 site at the time of the inspection.

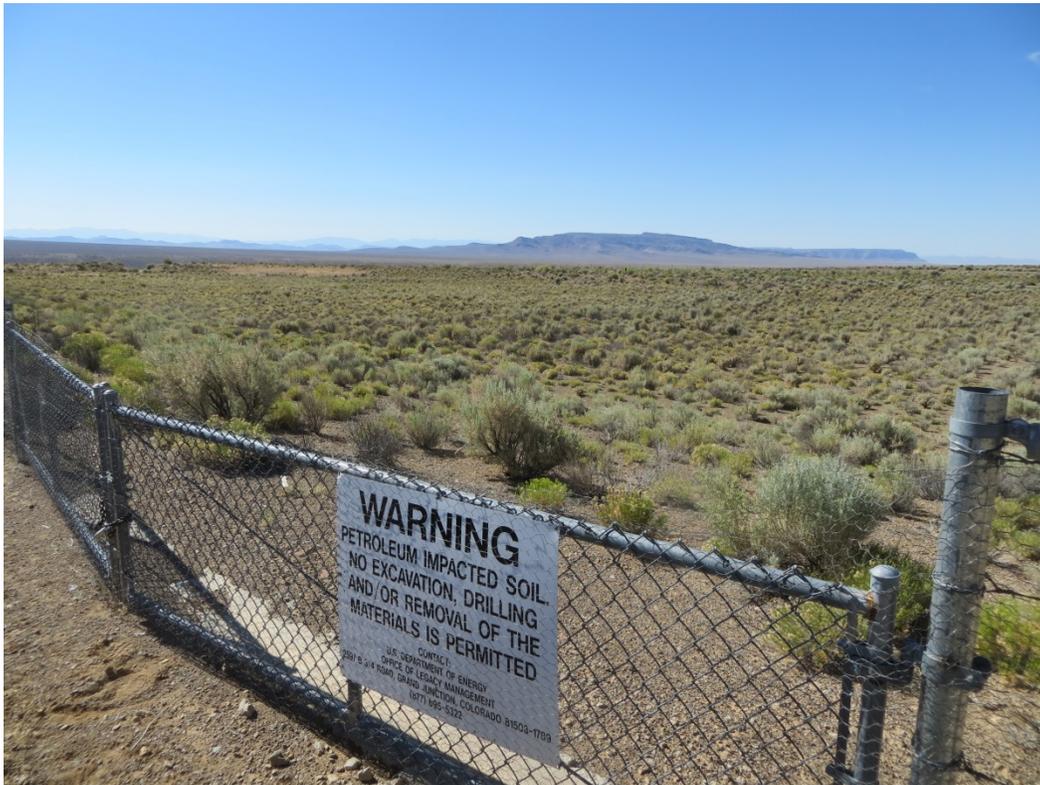
Photograph 1. UC-1 CMP, view from entrance gate on north fence line, looking southeast

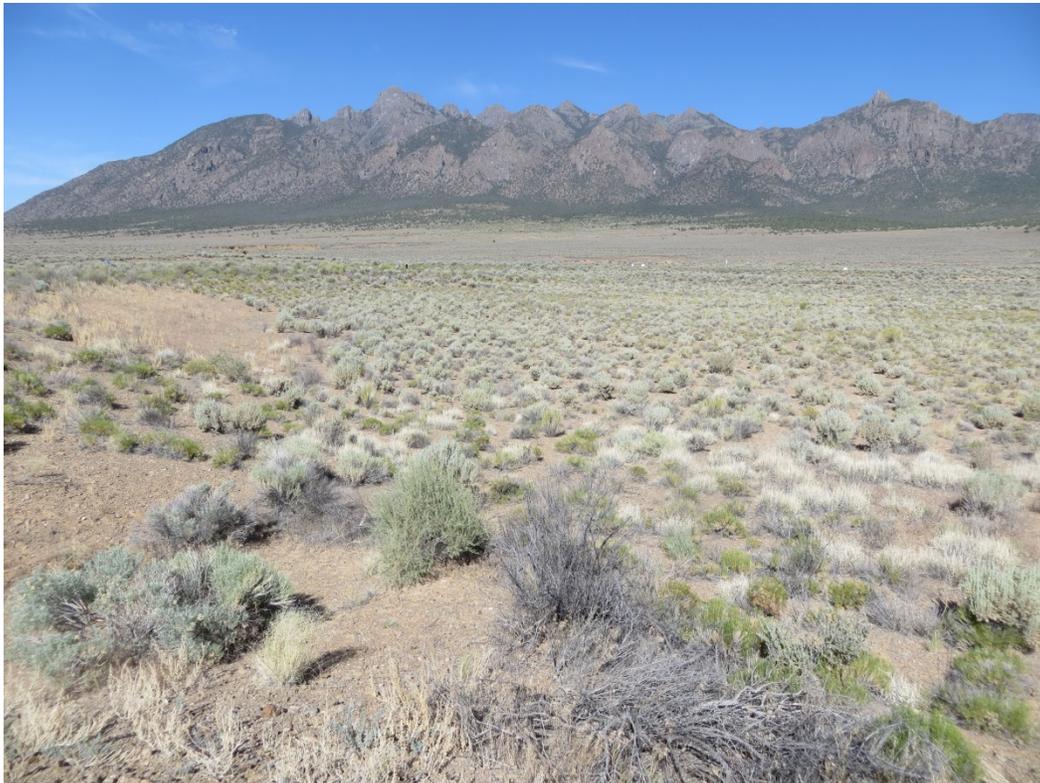
Photograph 2. UC-1 CMP, view from southeast end of CMP, looking west

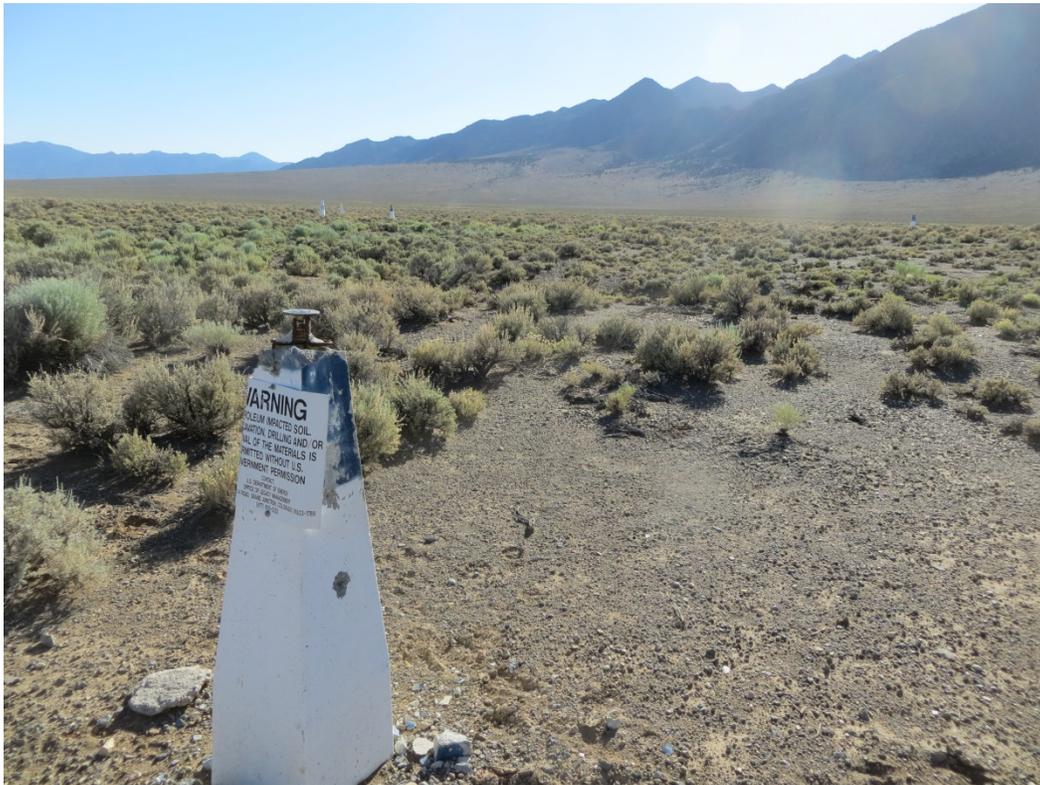
The inspection of UC-3 indicated that the site was in good condition. The concrete monument at the northeast corner of Mud Pit U3E had some damage near the top of the monument. The damage has not impacted the functionality of the survey pin at the top of the monument, but LM will repair the monument during the next inspection to prevent further deterioration. All other monuments and signs were in good condition. No other issues were identified, and no additional maintenance or repair activities are recommended at this time.

No displacements were observed, but the top of the concrete boundary marker at the northeast corner of Mud Pit U3E is damaged (see photograph 5).

Photograph 5. UC-3 Mud Pit U3E, view from northeastern monument, looking west (notice damage to the top of the monument)

- Continue site inspections biennially, as scheduled, to observe the condition of the covers, fence, vegetation, signs, and monuments, with the next report to be produced in 2021
- Repair the concrete monument at the northeast corner of Mud Pit U3E (Appendix B, photograph 5) during the inspection planned for 2020
- Continue the biennial reporting through the year 2020, in accordance with the 2015 ROTC
- Work with NDEP to establish a new postclosure inspection and reporting frequency to be implemented after 2020
- Continue to respond within 90 days to any reports from the public about detrimental conditions at the site
