3.0 Canonsburg, Pennsylvania, Disposal Site

Figure 3-1. 2016 Annual Inspection Drawing for the Canonsburg Disposal Site

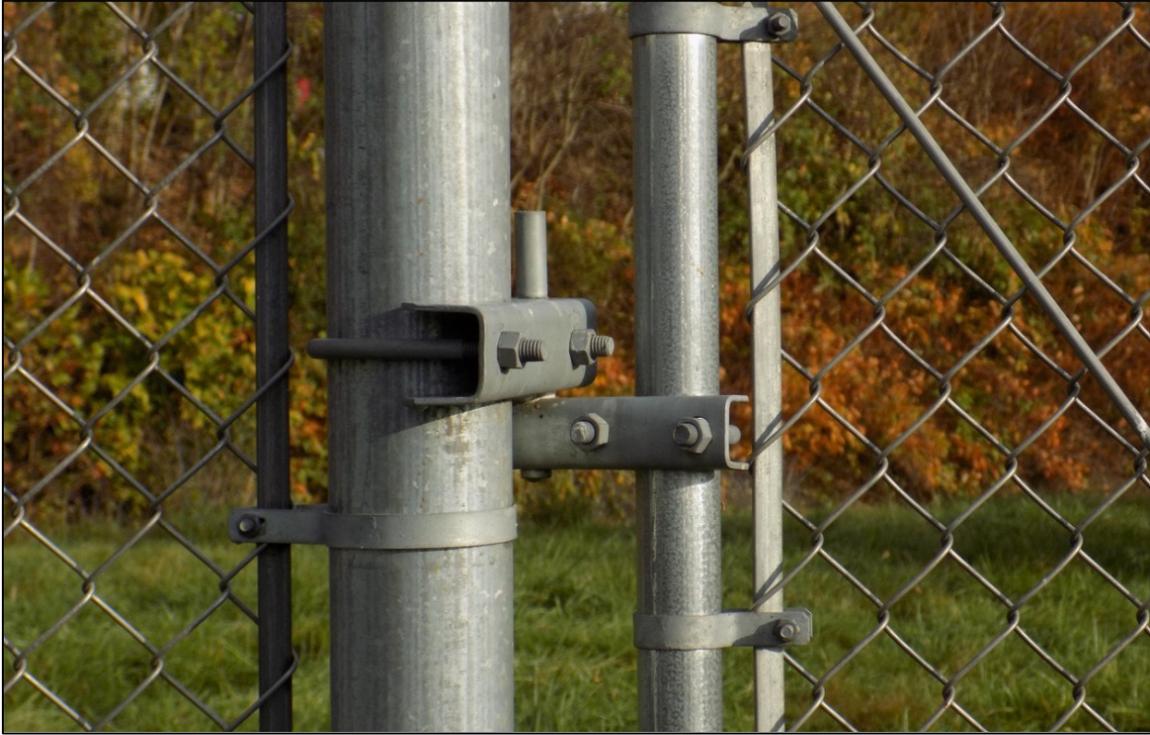
The Canonsburg, Pennsylvania, Uranium Mill Tailings Radiation Control Act (UMTRCA) Title I Disposal Site (site) was inspected on October 26, 2016. No changes were observed in the disposal cell or associated diversion and drainage features. The north vehicle gate hinge is damaged and will be repaired in 2017. Inspectors believe boundary monument BM-1 is buried under gravel; it will be found in 2017. Steel pins protrude from a concrete footer near BM-1; the city will be contacted to cut them off before the 2017 inspection. A small area of erosion (noted during the 2015 inspection) along the bank of Chartiers Creek north of the disposal cell, believed to be caused by surface water runoff to the creek, was a little larger this year. A routine follow-up inspection will be completed by engineering staff in spring 2017 to evaluate the erosion and collect design specifications for mitigation actions. Inspectors identified no other maintenance needs.

PL-1. Misaligned Hinge on North Vehicle Gate

The north vehicle gate hinge will be adjusted next spring to ensure proper alignment and continued functionality. Inspectors believe boundary monument BM-1 was buried under gravel during the last stream-bank stabilization action along Chartiers Creek. The site maintenance contractor will locate boundary monument BM-1 before the 2017 inspection. The steel pins that protrude from an unused concrete footer near BM-1 present a tire hazard. The city will be contacted to address this before the 2017 inspection. No other maintenance needs were identified.

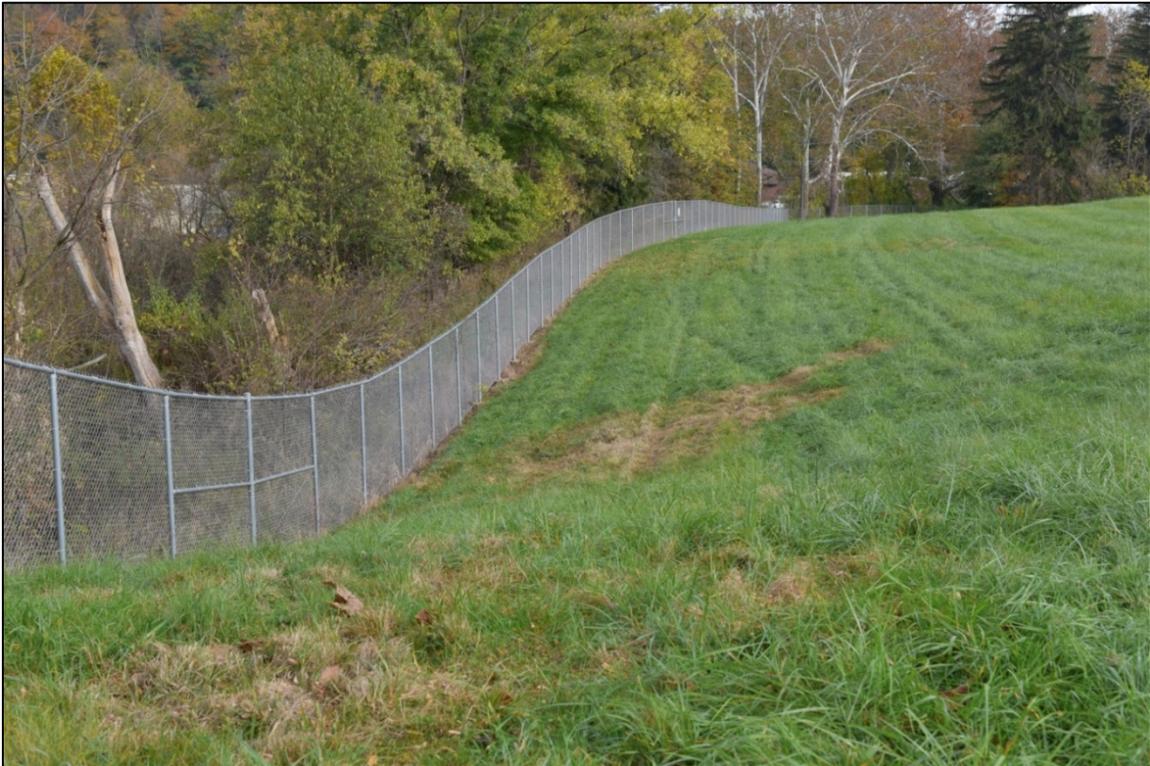
Most of the site is enclosed by a 7-foot-high chainlink fence, which replaced the previous fence in 2007 (PL-2). A vegetation-free buffer zone is being maintained around the entire site security fence. An area of erosion under the west security fence remains (see Figure 3-1). The area appears to be stable and has not grown in several years. For added security, slats were installed across the area beneath the fence to help fill in the gap. There are 11 perimeter signs attached to the security fence. No maintenance needs were identified.

PL-2. Inside of the West Security Fence

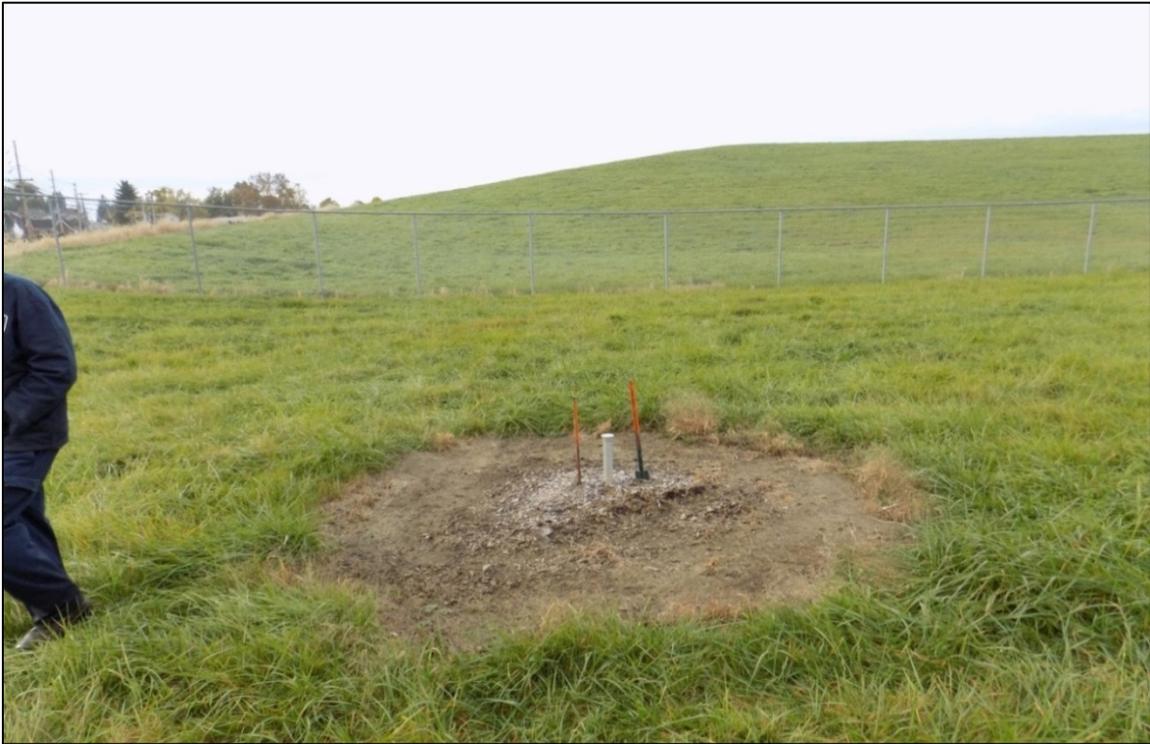
The site has four pairs of erosion control markers (PL-4) along the bank of Chartiers Creek. No maintenance needs were identified.

PL-4. Erosion Control Marker 4

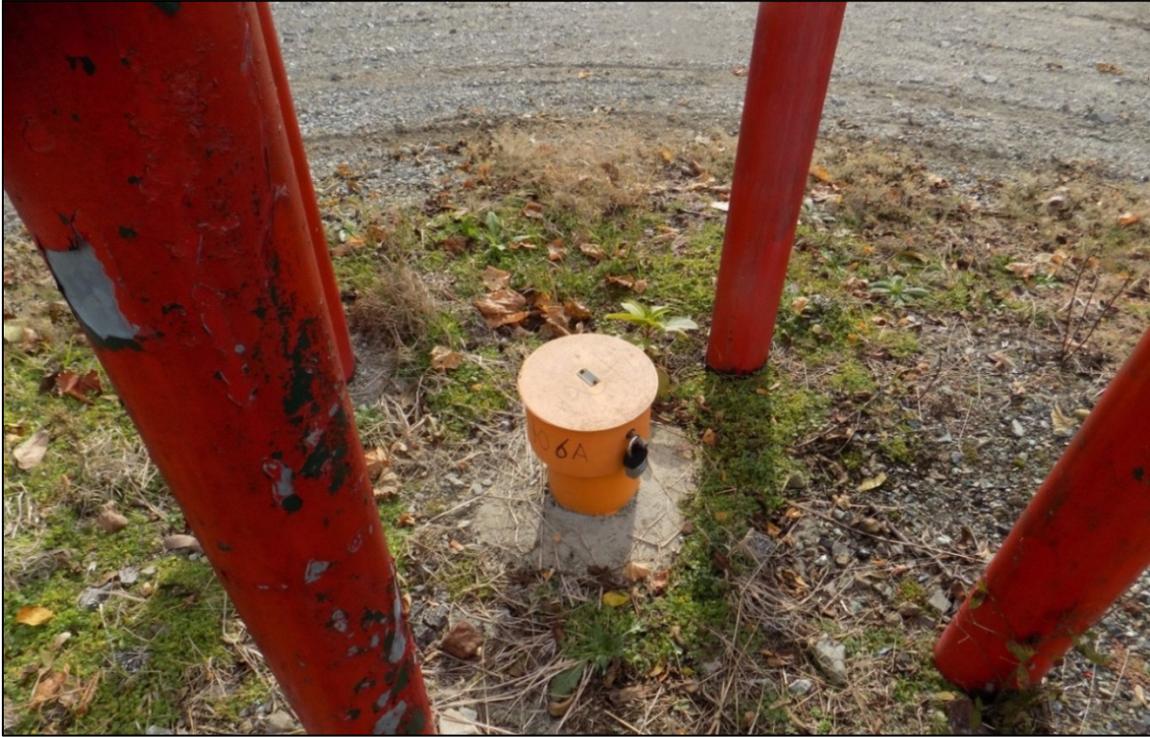
The site has five groundwater monitoring wells (0406A, 0412, 0413, 0414B, and 0424), which are inspected when the wells are sampled. The monitoring wells were last sampled in November 2013 and are scheduled for sampling again in 2018. All wellhead protectors that were observed during the annual inspection were undamaged and locked (PL-5). No maintenance needs were identified.

PL-5. Monitoring Well 0406A

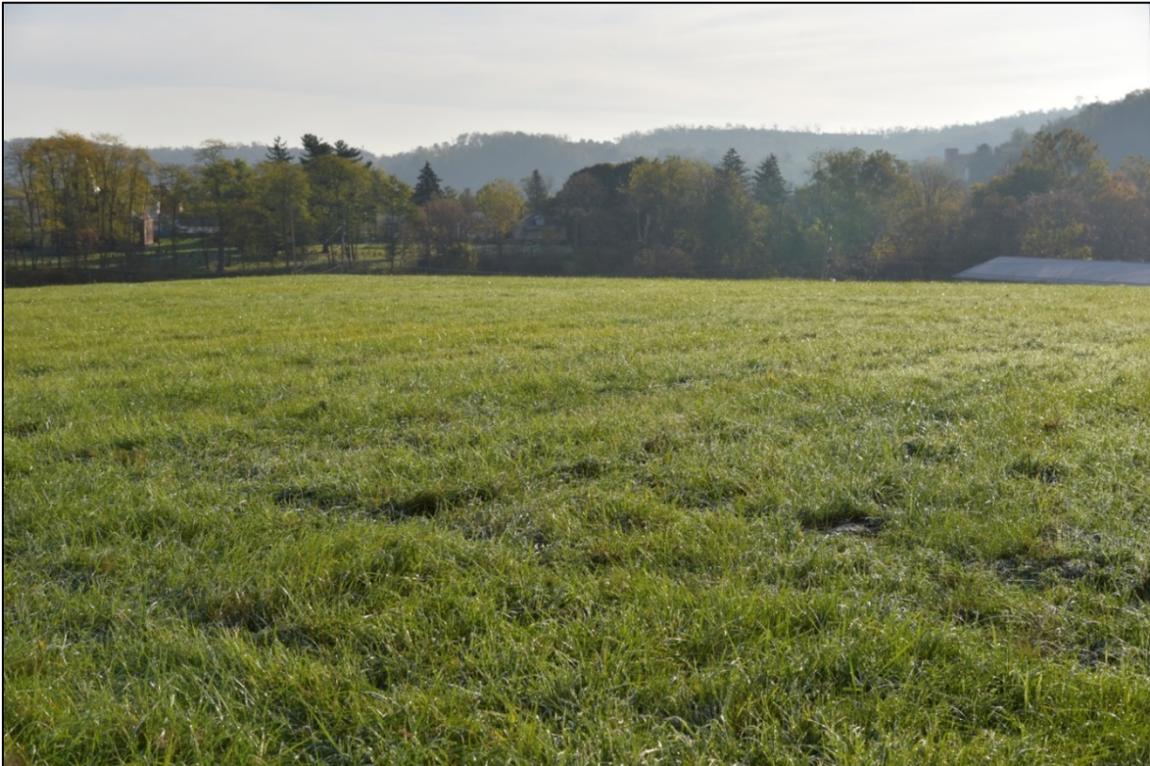
The disposal cell, completed in 1985, occupies 6.8 acres and is covered in grass. There was no evidence of erosion or slope instability (PL-6). Animal burrows occur on the disposal cell cover. Because the buried tailings are overlain by a 36-inch-thick clay layer (radon barrier), an 18-inch-thick rock layer, and a 12-inch-thick topsoil layer, biointrusion down to or through the radon barrier is unlikely. Therefore, such burrows should not pose a risk to disposal cell integrity or public health. Inspectors will continue to monitor the location and significance of burrows. No new burrows were noted on the disposal cell during the inspection. No maintenance needs were identified.

PL-6. Top of the Disposal Cell Cover

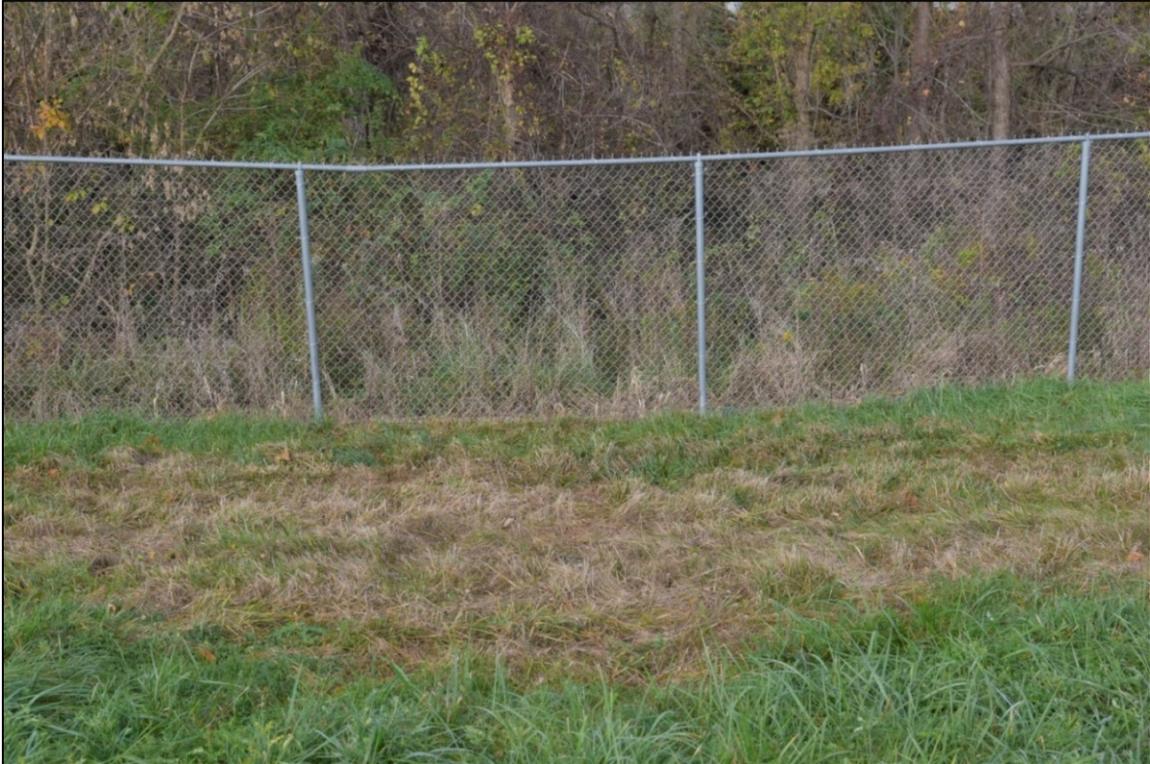
The site consists primarily of mowed grasses within the security fence and on the disposal cell cover, with seeded fescues and crown vetch present across the site. The spray-and-mow approach to vegetation management at the site continues to be effective. Noxious weeds within the fenced area are limited to resprouting seedlings that were observed in portions of mowed areas. Several patches of dead grass were observed along the western edge of the grassland area (PL-7). It is anticipated this is a temporary condition due to overspray of glyphosate herbicide and that vegetation will reestablish over time. Inspectors will continue to monitor this area.

PL-7. Brown Area in Grass

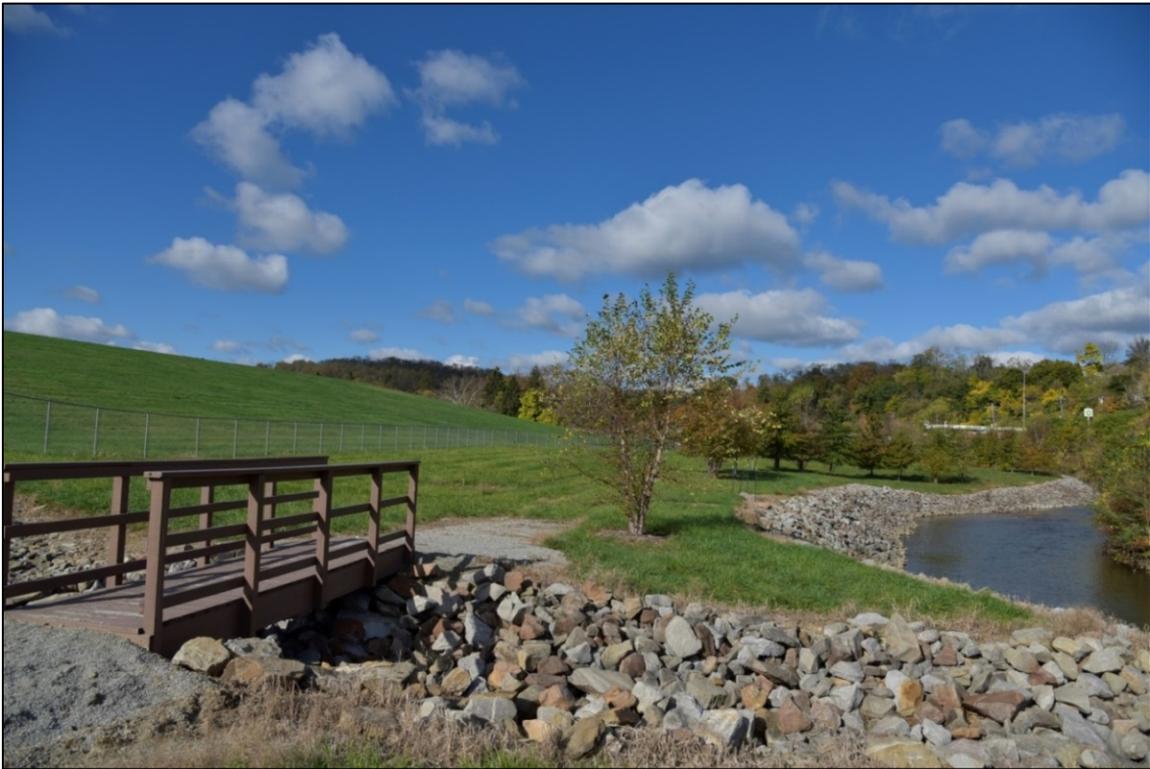
A small pedestrian bridge was installed northeast of the disposal cell in 2010 (PL-8). Inspectors painted the footbridge in 2014. Some of the bridge deck paint is now peeling. The bridge will probably need to be repainted within the next 2 years. No other bridge maintenance needs were identified.

PL-8. North Side of the Footbridge

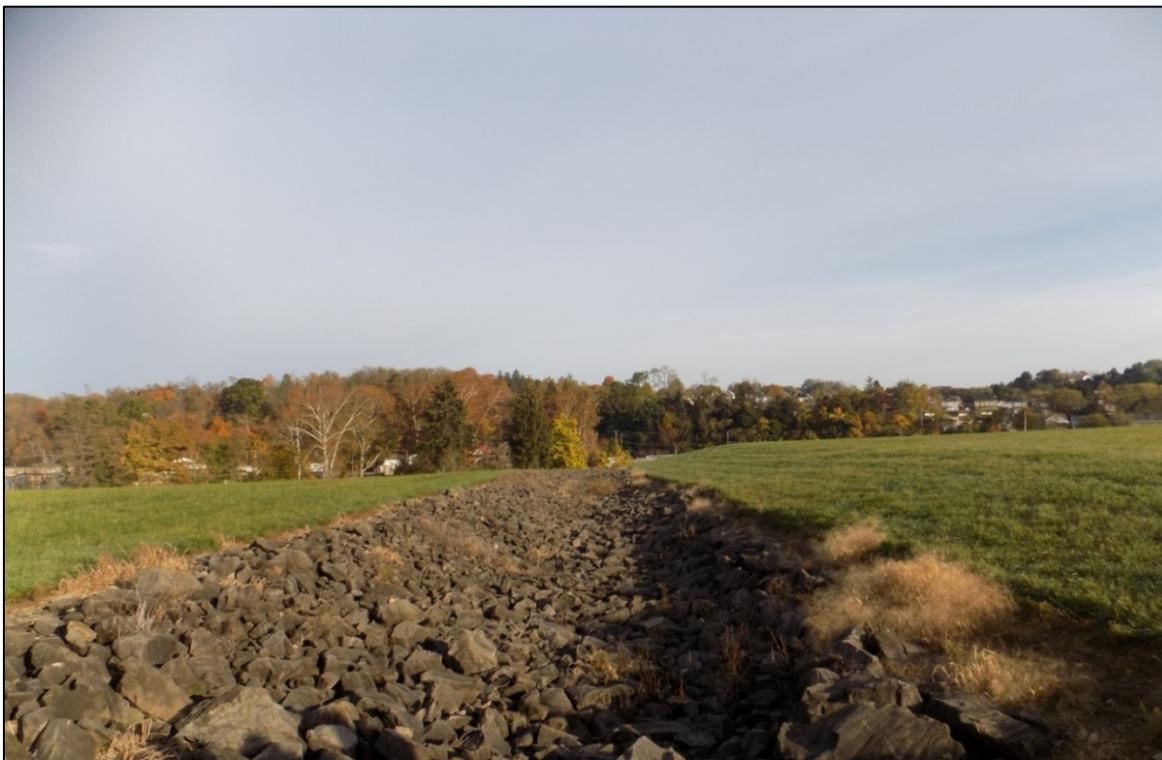
No woody vegetation was observed in the channels and ditches (PL-9). Periodic physical removal and spot herbicide applications have been effective at reducing woody vegetation and will continue to be conducted as needed. No maintenance needs were identified.

PL-9. Riprap-Armored Perimeter Ditch

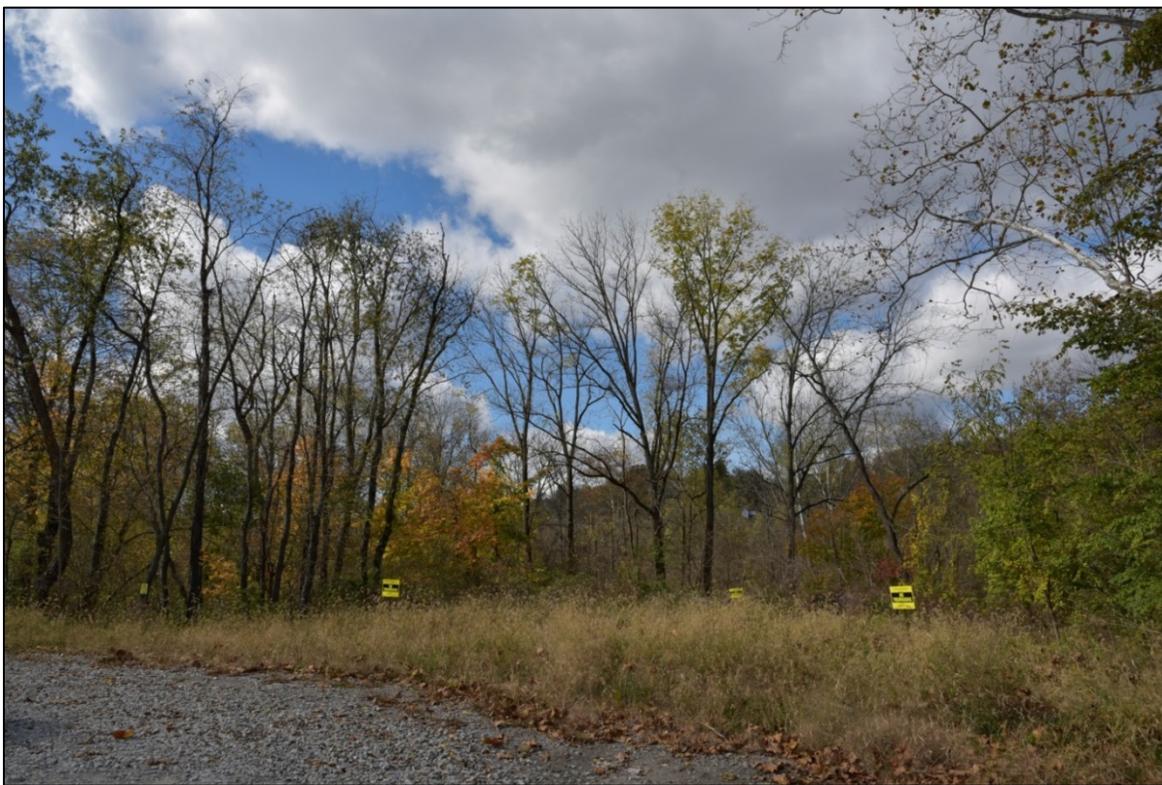
A local plastics company has cleared some of DOE's property north of the railroad tracks and spread gravel to create a turnaround for its trucks. No-trespassing signs were posted around this area so the gravel area will not become any larger (PL-10). An access agreement is being established for the turnaround area.

PL-10. No-Trespassing Signs Posted in Area of Gravel Turnaround

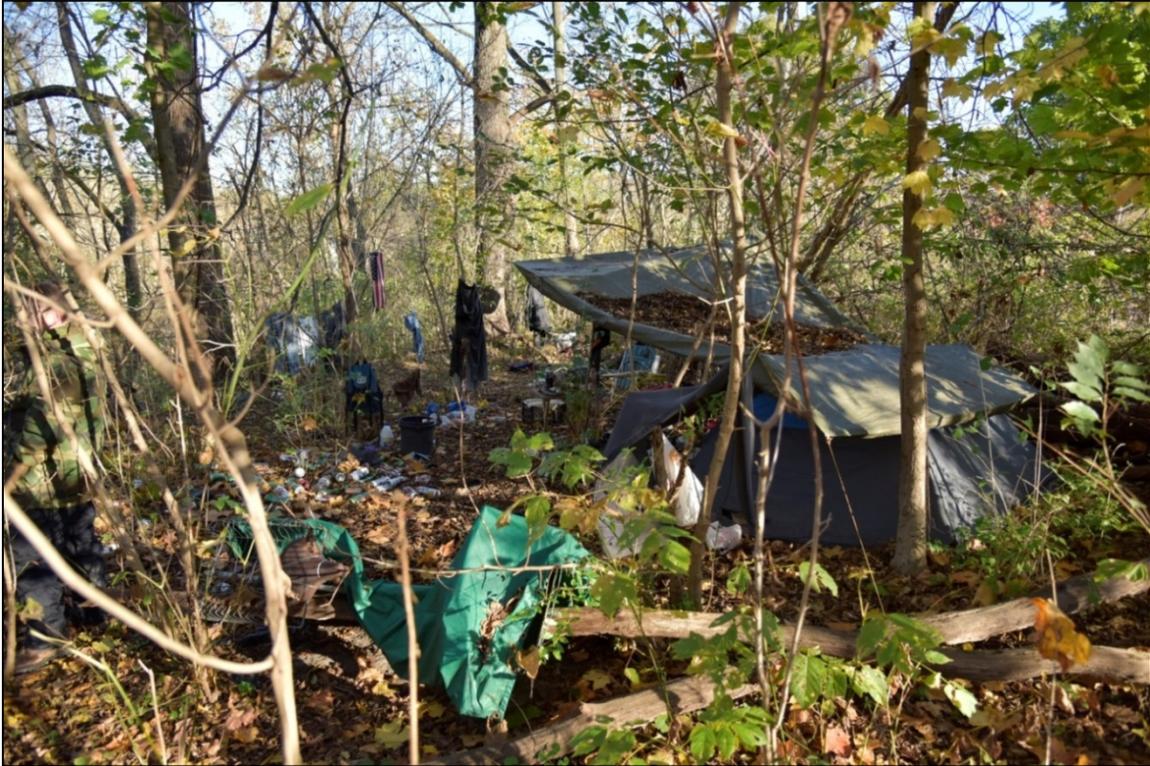
Trespass was observed during the inspection. A campsite was hidden among the trees (PL-11) in the southwest corner of the site, outside the locked perimeter fence. The Canonsburg Police Department was called, and three officers were dispatched. The occupant of the campsite could not be found. DOE is working with the Canonsburg Police Department to remove the trespasser. No-trespassing signs were posted around the campsite and within the campsite to clarify that the land is DOE property (PL-12 and PL-13). No other maintenance needs were identified.

PL-11. Trespass Camp

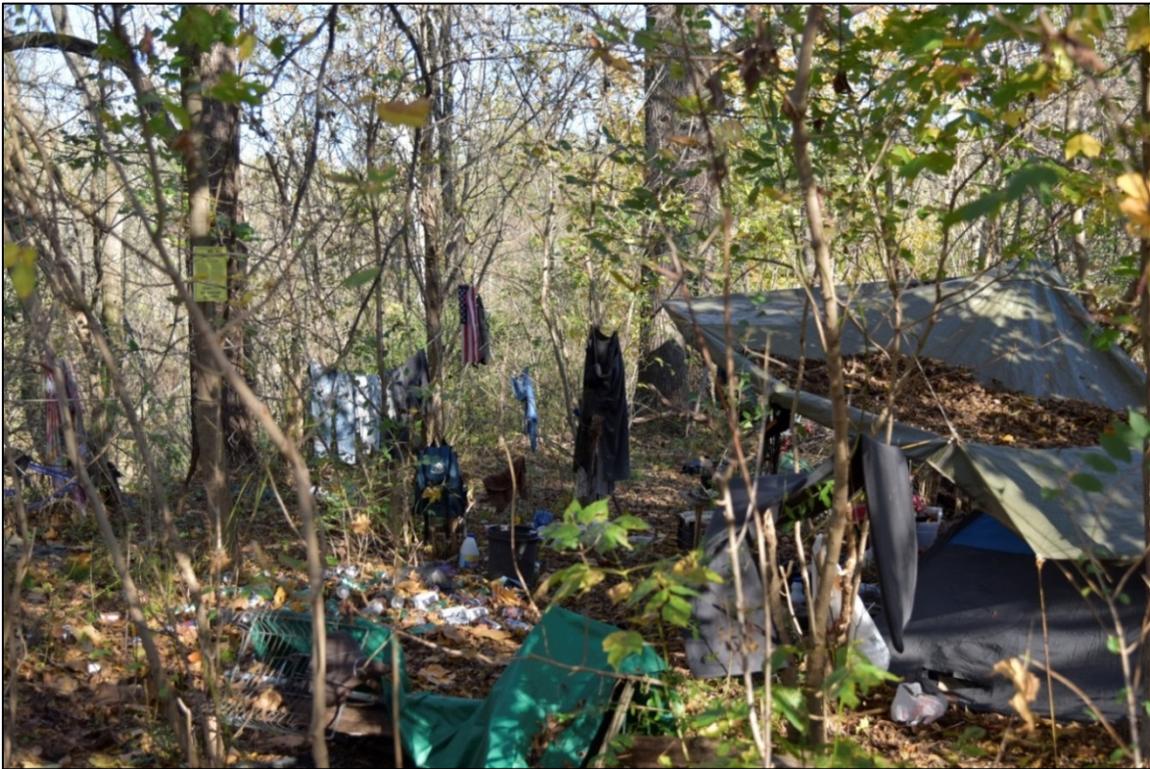
PL-12. No-Trespassing Sign Posted Within the Trespass Camp

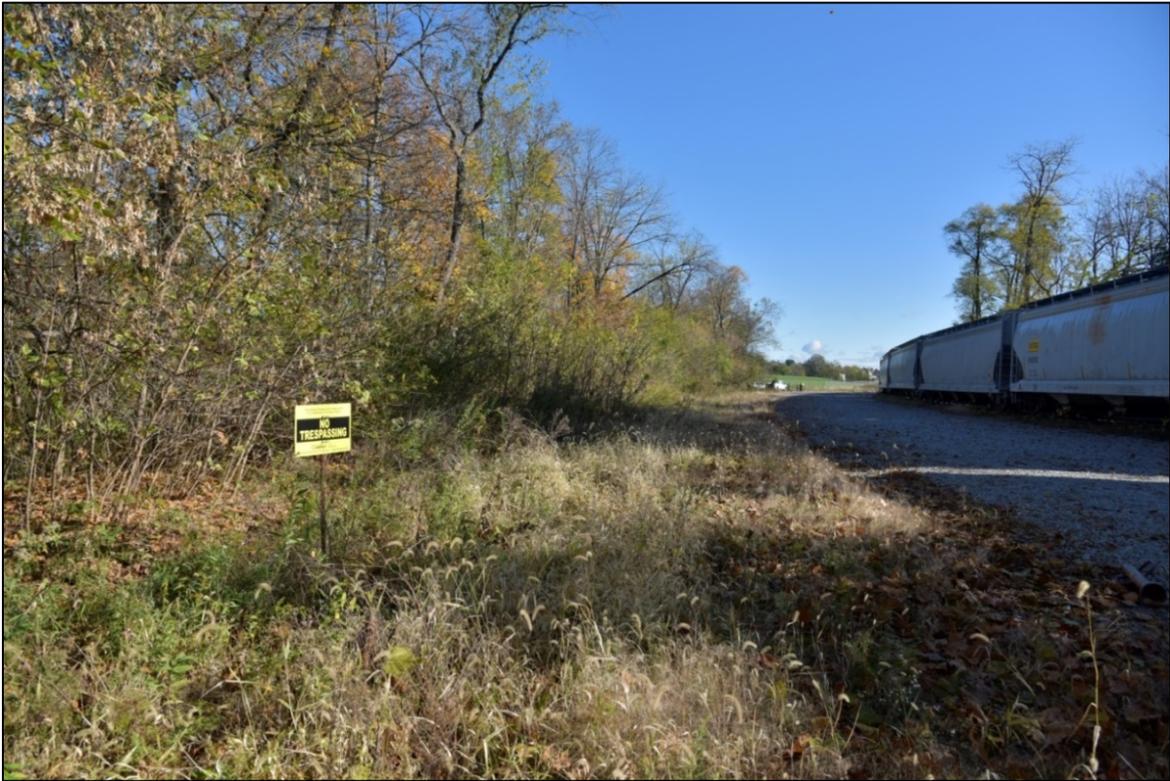
PL-13. No-Trespassing Sign Posted at Southwest Corner of DOE Property

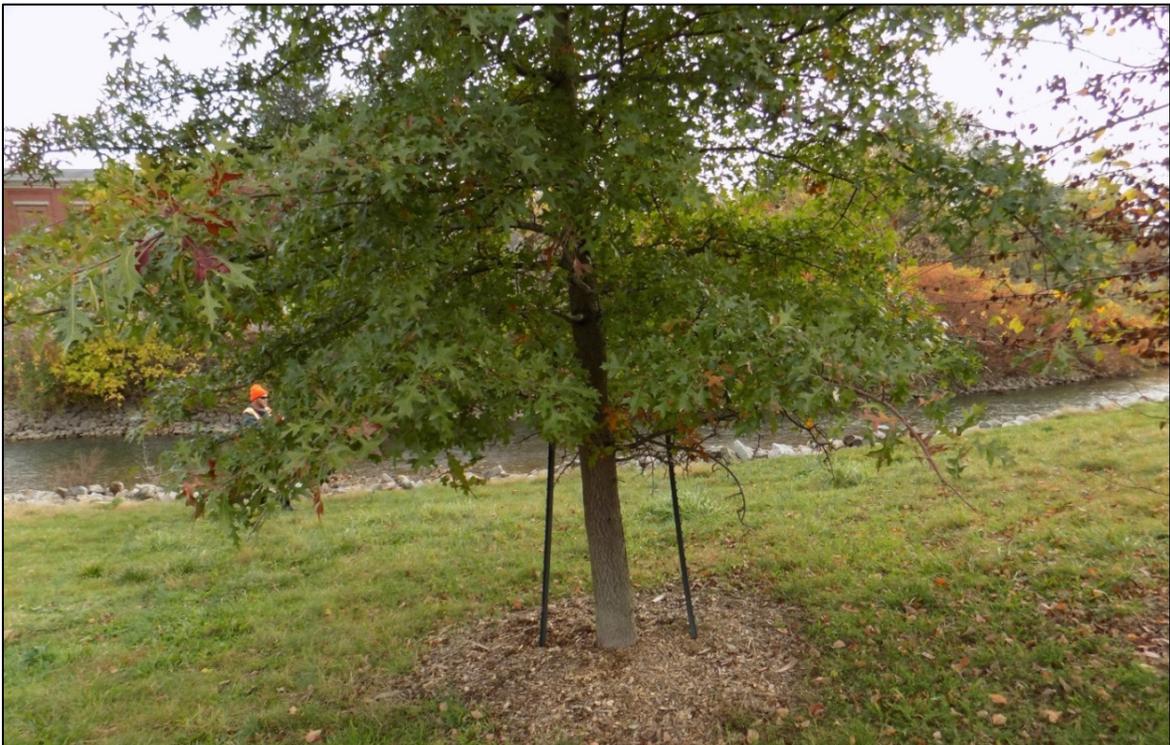
PL-14. Tree on the Floodplain

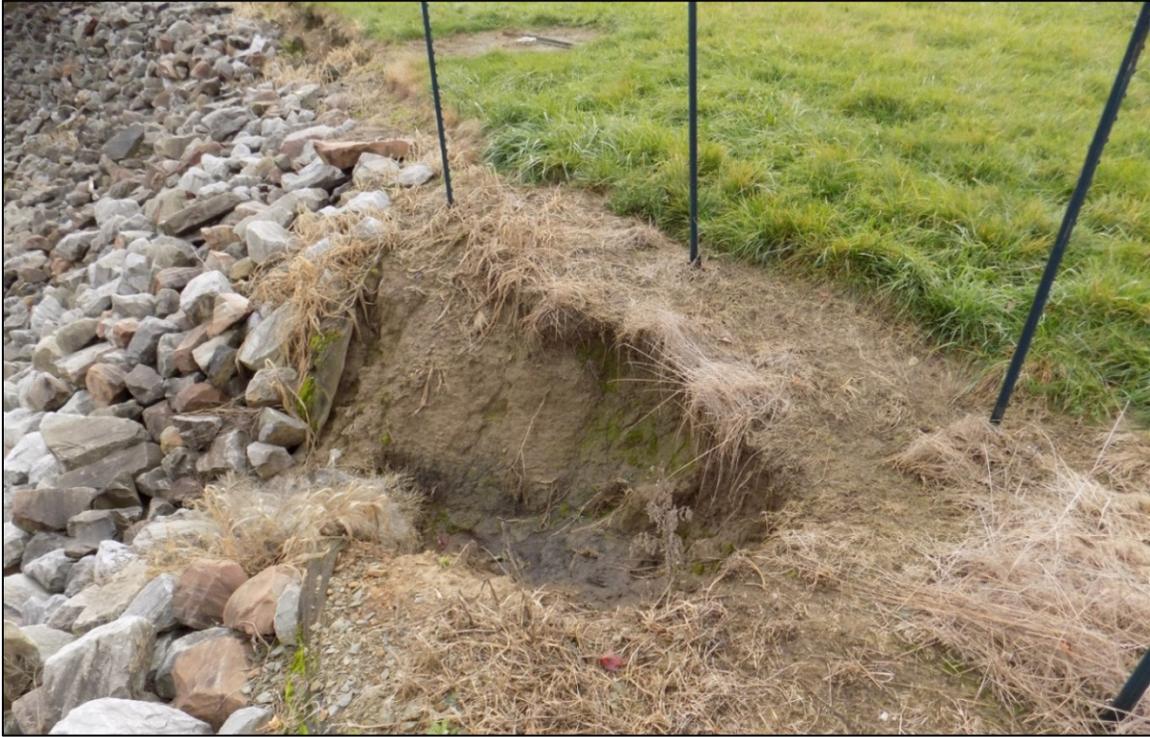
Bedrock outcrops and mature trees on the stream bank west of the security fence indicate that the bank is stable. The stream bank north of the perimeter fence is also stable. The planted vegetation within the floodplain appears to be well established. The trees are of sufficient size that the T-posts used to stabilize them at the time of planting can be removed (PL-14). A small area of erosion (noted during the 2015 inspection) along the stream bank north of the disposal cell, believed to be caused by surface water runoff to the creek, was a little larger this year (PL 15 through PL-17).

Heavy mowing equipment operating near the edge of the stream bank may have undermined the integrity of the bank. Inspectors installed four T-posts around the erosion area in 2015 to make it more visible to the mowing crews. Mowing crews have been instructed to keep heavy equipment back from the edge of the stream bank to avoid undermining the integrity of the bank. A routine follow-up inspection will be conducted by engineering staff in the spring of 2017 to evaluate the erosion and collect design specifications for mitigation actions. No other maintenance needs were identified.

PL-15. Bank of Chartiers Creek at Area of Erosion Along Armored Riprap Section

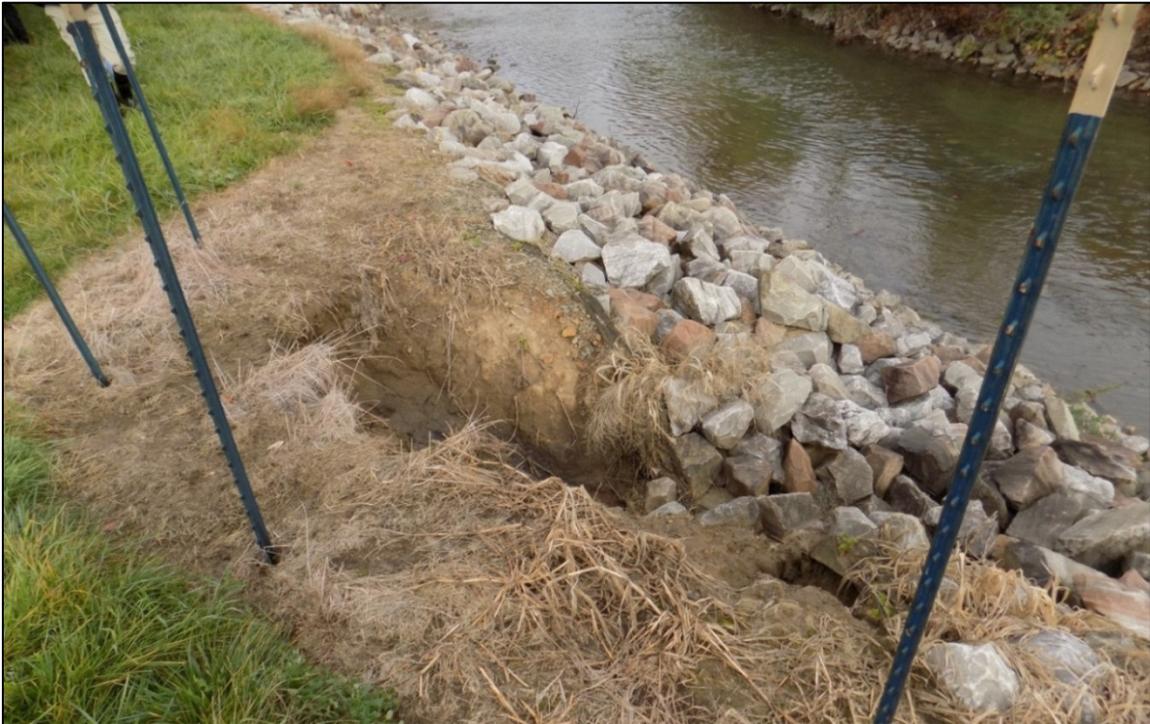
PL-16. Area of Erosion Along the Bank of Chartiers Creek

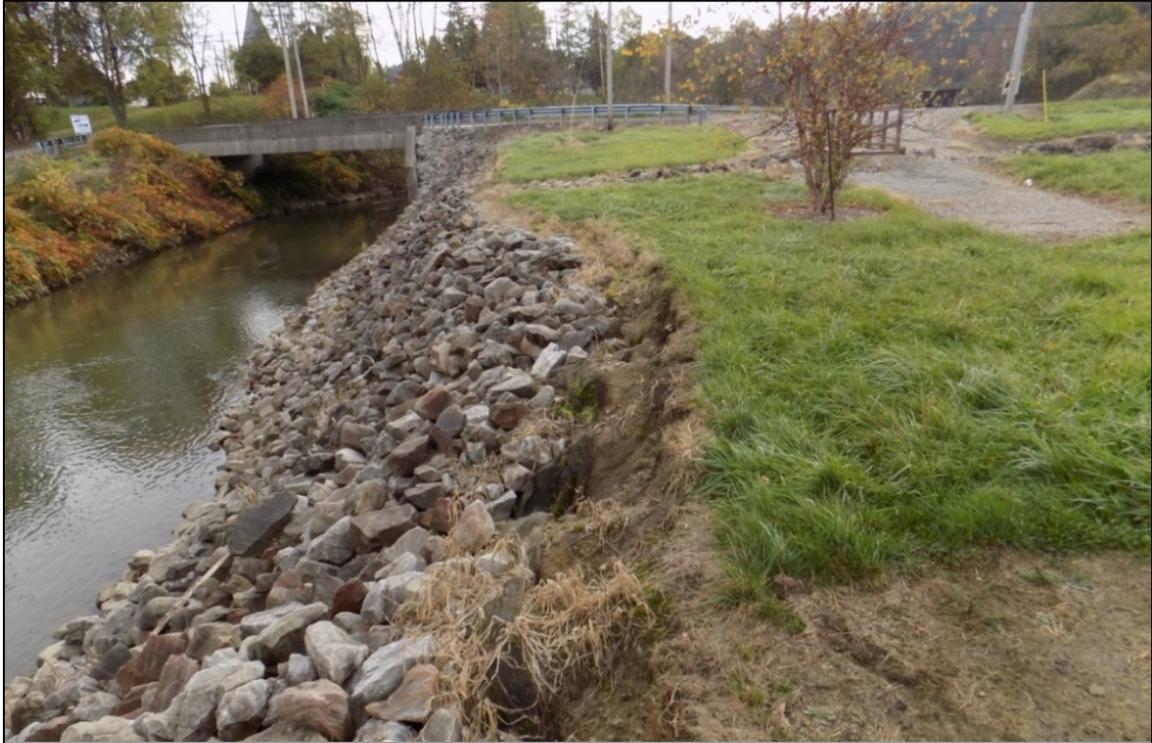
PL-17. Bank of Chartiers Creek Just East of Area of Erosion; Shows Further Erosion Along the Top of the Armored Riprap Section
