3.0 Canonsburg, Pennsylvania, Disposal Site

The Canonsburg, Pennsylvania, Uranium Mill Tailings Radiation Control Act (UMTRCA) Title I Disposal Site (site) was inspected on October 12, 2017. No changes were observed on the disposal cell or in the associated drainage features. Inspectors identified several routine maintenance needs. A follow-up inspection was conducted in May 2017 in response to stream bank erosion identified the 2016 annual inspection. Repairs to the riprap armoring of the stream bank were made in September 2017. Another follow-up inspection will be completed by engineering staff in spring 2018 to evaluate additional erosion along the stream bank identified during the 2017 annual inspection.

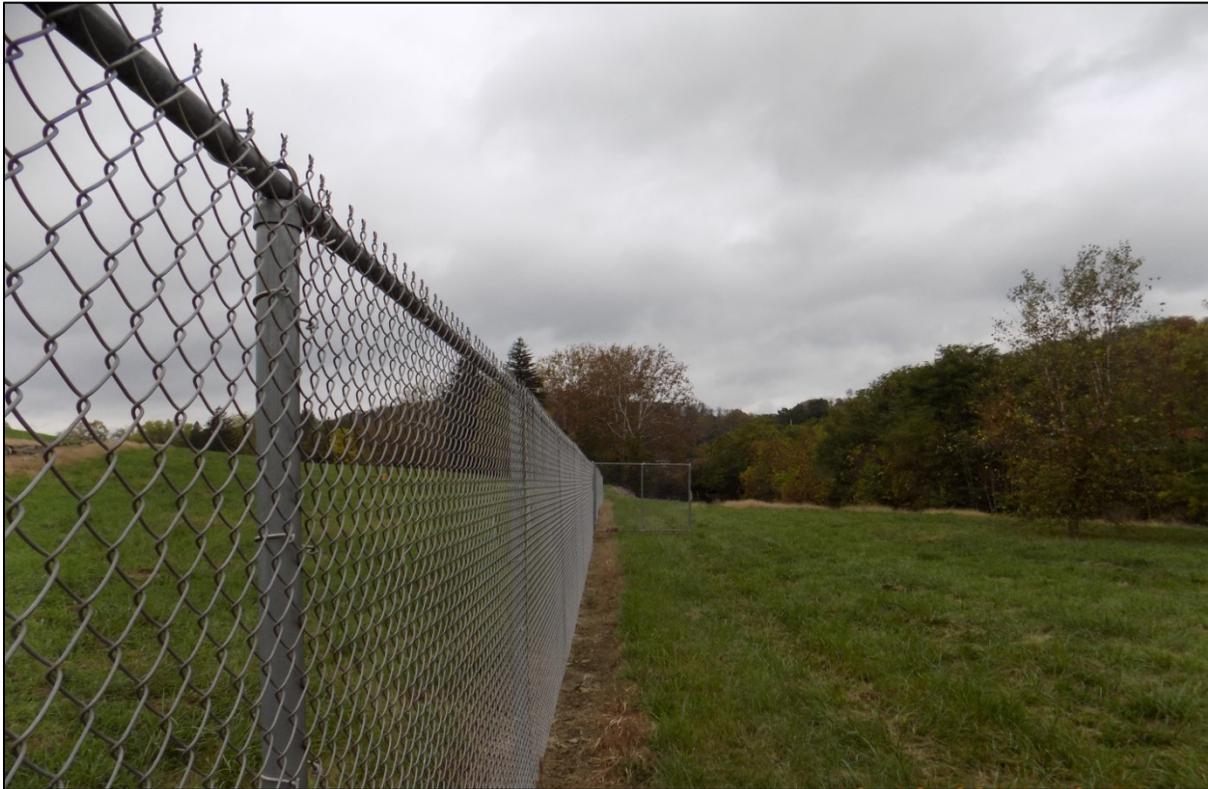
A chainlink security fence encloses most of the site (PL-1). A vegetation-free buffer zone is maintained around the entire security fence. An area of erosion under the west security fence remains. The area appears to be stable and has not grown in several years. For added security, slats were installed in 2016 across the area beneath the fence to help fill in the gap. There are 11 perimeter signs attached to the security fence (PL-2). No maintenance needs were identified.

PL-1. Northwest Down the Security Fence Line

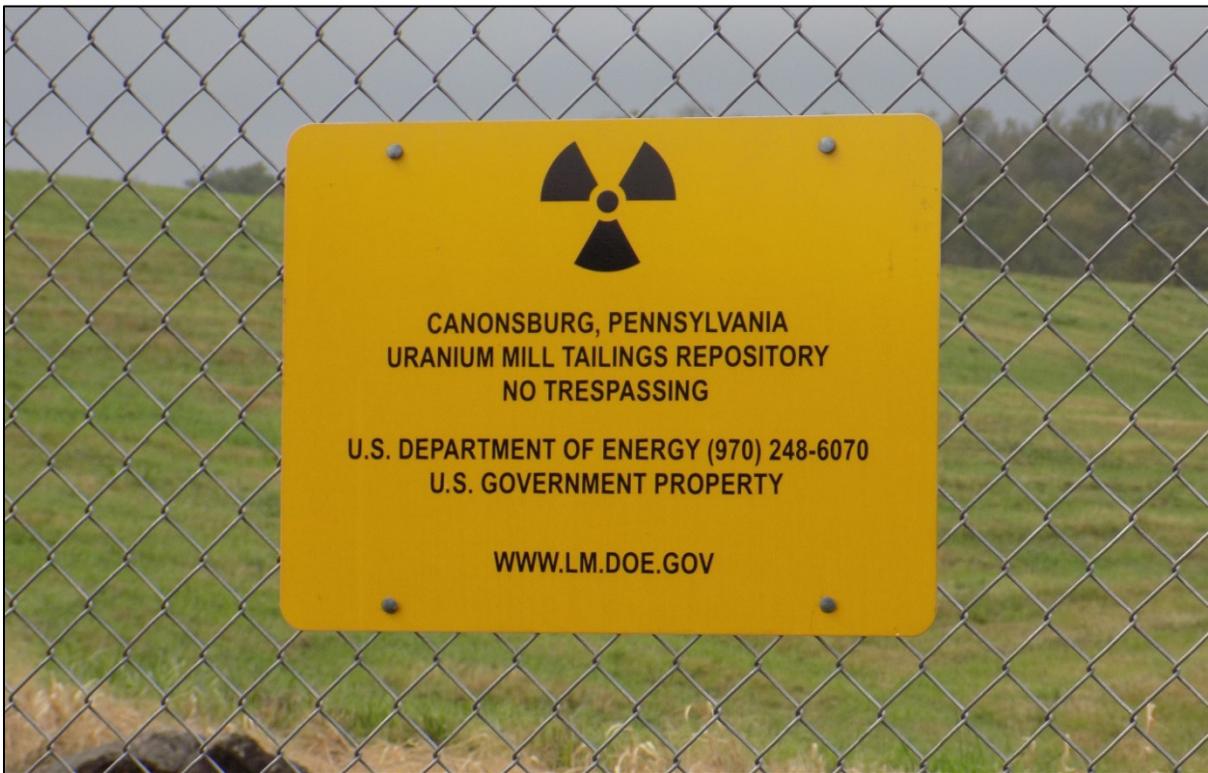
PL-2. Perimeter Sign P10

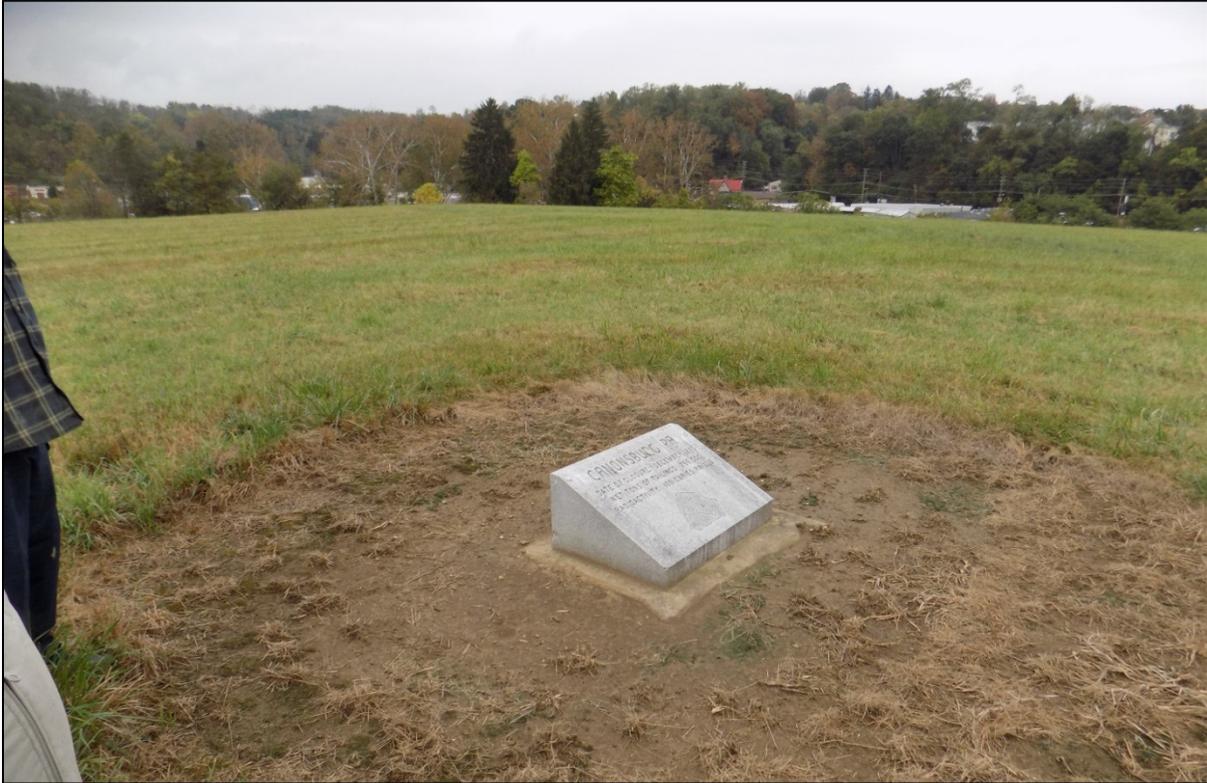
The site has two granite site markers. Site marker SMK-1 is just inside the main entrance gate, and site marker SMK-2 is on the top slope of the disposal cell (PL-3). A small chip was observed in site marker SMK-2 after the 2016 annual inspection. It is assumed that the marker was chipped during mowing. Mowing procedures will be reviewed with the mowing subcontractor to prevent similar damage in the future. Site marker SMK-2 remains legible, and the small chip does not impact the structural integrity. No maintenance needs were identified.

PL-3. Site Marker SMK-2

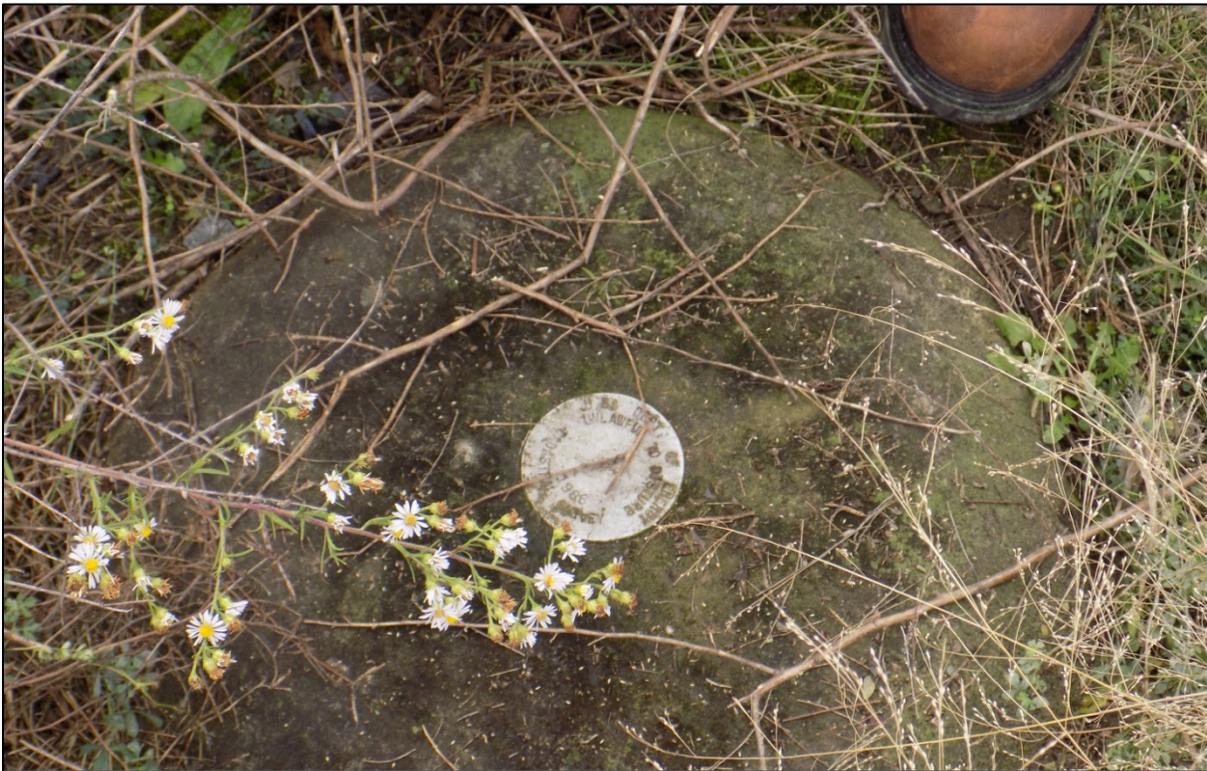
The site has three survey monuments and four boundary monuments (PL-4). Despite the use of GPS and a metal detector, boundary monuments BM-1 and BM-2 could not be located and need to be replaced; no other maintenance needs were identified.

PL-4. Survey Monument SM-3

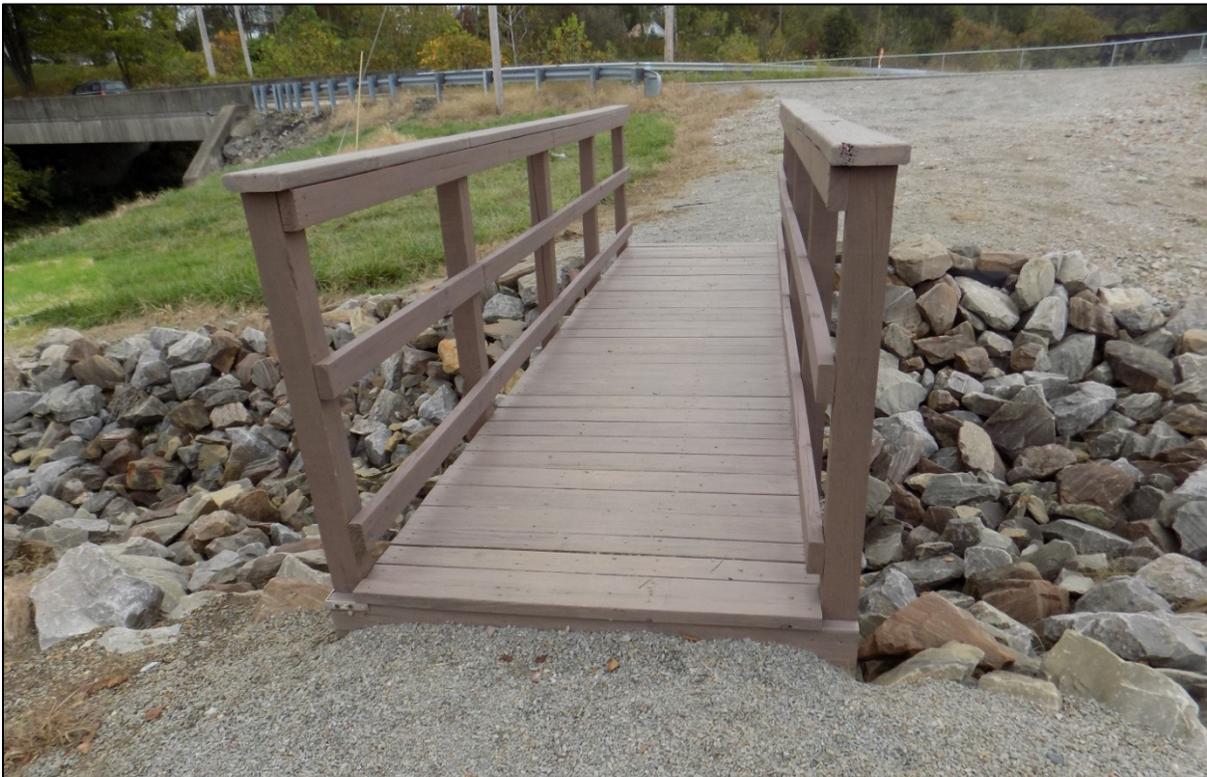
A small pedestrian bridge was installed northeast of the disposal cell in 2010. The deck and rails of the bridge were repainted in 2017 (PL-8). Minor repairs to the bridge are needed. A loose vertical handrail support was temporarily repaired in 2017 but requires a more permanent fix (PL-9), and the west end of the south handrail is beginning to rot (PL-10). These repairs will be made at a later date pending budget and schedule. No other maintenance needs were identified.

PL-8. Footbridge

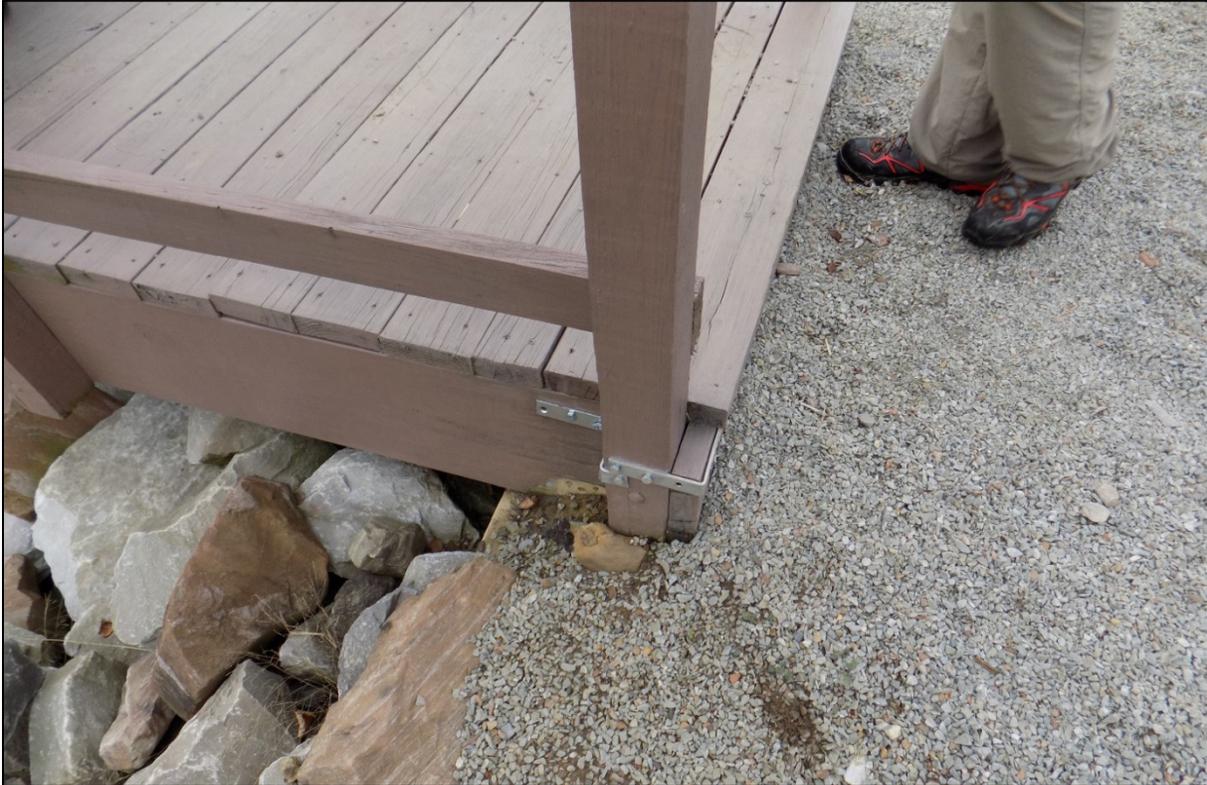
PL-9. Temporary Footbridge Repair to Northwest Rail Support

A loose hinge on the north vehicle gate and steel pins protruding from the concrete footer near BM-1, identified during the 2016 annual inspection, were repaired before the 2017 annual inspection. During the 2017 annual inspection boundary monuments BM-1 and BM-2 could not be located; both will be replaced. Minor repairs to the pedestrian bridge are needed, including fixing the loose handrail support and rotting south handrail. Trash remaining at an abandoned trespass camp will be removed, and a few no-trespassing signs will be repaired or replaced. All of these maintenance needs will be completed at a later date pending budget and schedule. No other maintenance needs were identified.

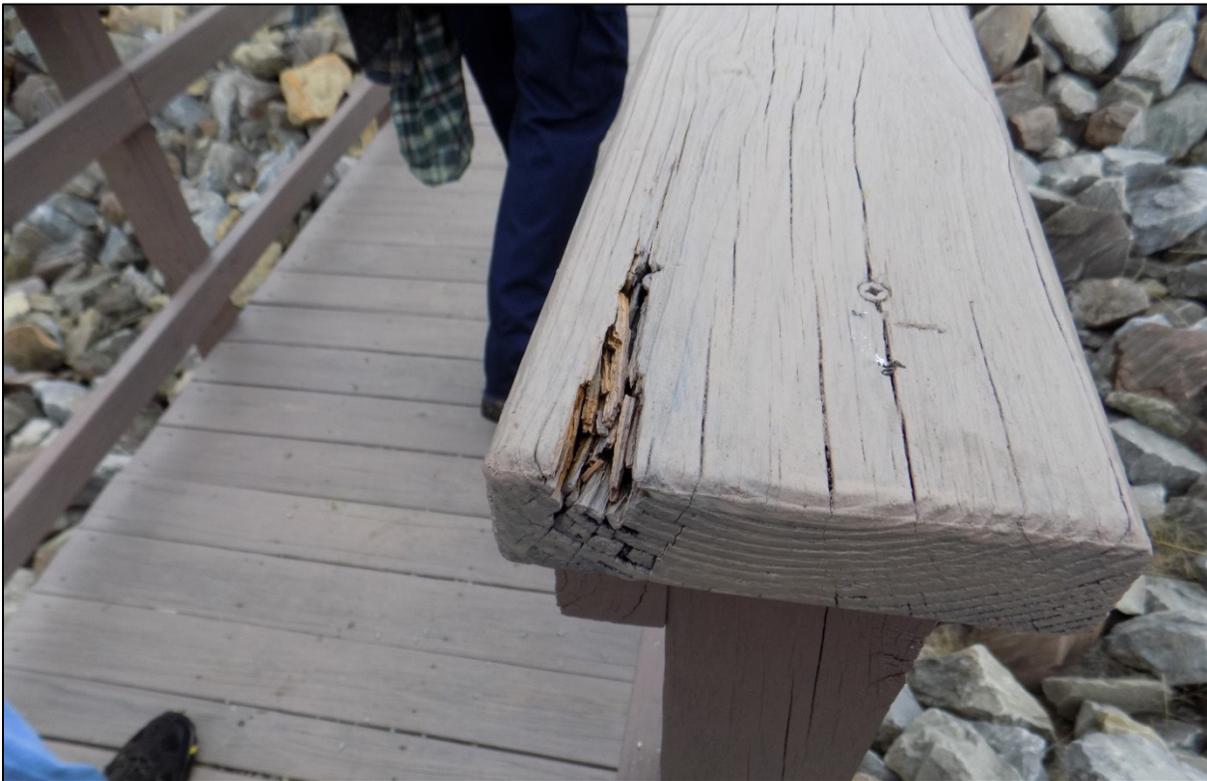
PL-10. Rot Developing on Top Rail of Footbridge

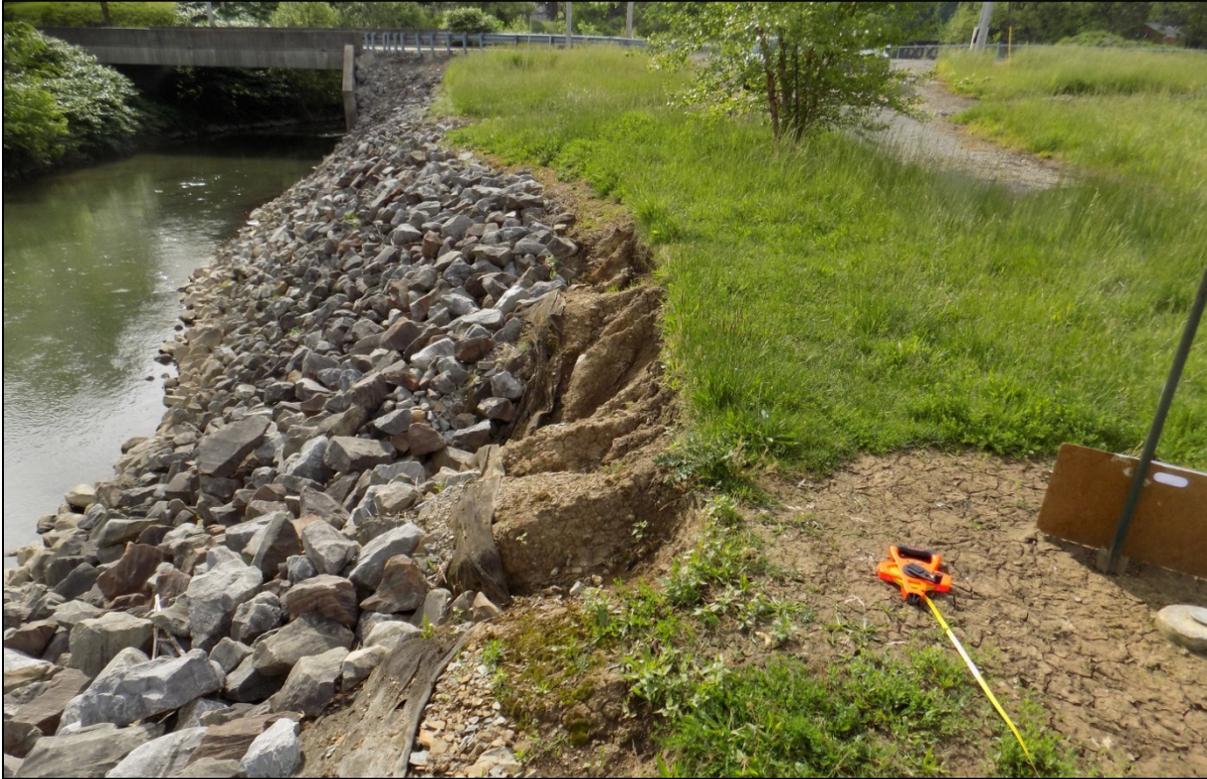
During the 2015 annual inspection, a small area of erosion was noted along the top of the riprap installed north of the site just west of Strabane Avenue. The erosion may be caused by surface water runoff to the creek. Runoff appears to have undermined the upper extent of the fabric beneath the riprap, resulting in removal of soil from beneath the riprap. The observation was also made that heavy mowing equipment operating near the edge of this area could contribute to the problem by undermining the surrounding soil. Four T-posts were installed around the erosion area to make it more visible to the mowing crews, who were instructed to keep heavy equipment back from the edge of the area to avoid further damage. In 2015, continued monitoring was deemed appropriate.

The area of erosion was larger during the 2016 annual inspection. A follow-up inspection was conducted by LMS engineering staff in May 2017 when it was determined that repairs were necessary (PL-11). Repairs to the riprap were completed in September 2017 (PL-12). It was also determined during the follow-up inspection that herbicide spraying along the top of the riprap was contributing to the onset of erosion by creating bare soil areas. The practice of spraying along the top of the riprap has since been ended. The mowing routine was also changed to allow a buffer strip of high, dense grass to remain along the stream bank. The high, dense grass helps baffle the flow of water down to the edge of the bank.

PL-11. Area Needing Repair Along Chartiers Creek (May 2017)

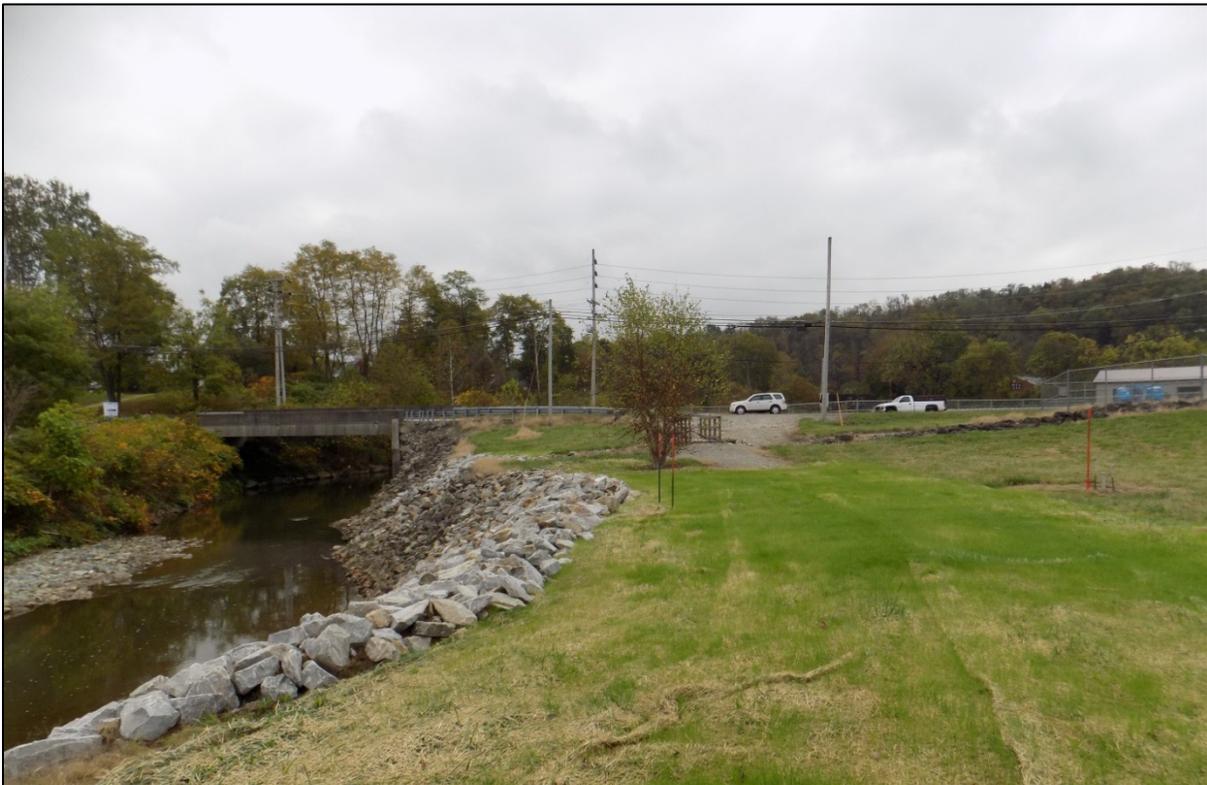
PL-12. Repaired Area Along Chartiers Creek (October 2017)

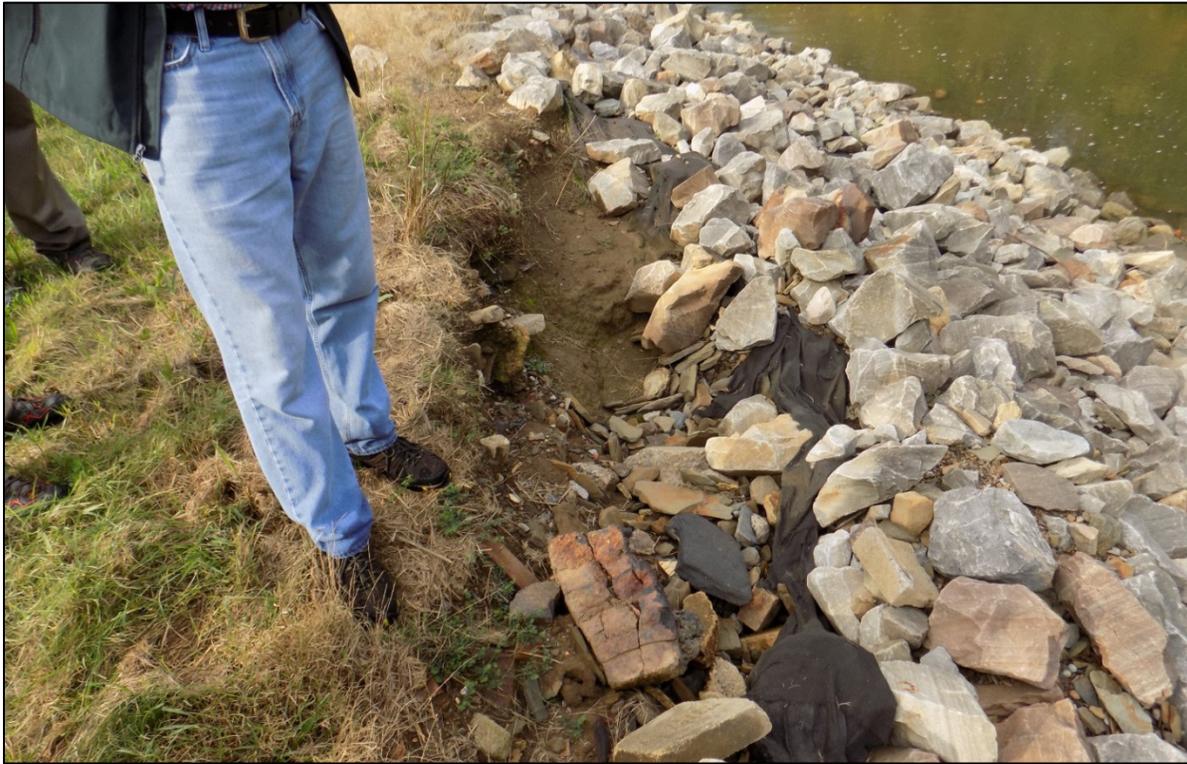
During the 2017 annual inspection, several other areas of the riprap bank (west of the 2017 repairs) were identified as needing to be evaluated for repair (PL-13 through PL-15). A follow-up inspection by LMS engineering staff will be completed to evaluate the erosion and collect design specifications for mitigation actions. No other maintenance needs were identified.

PL-13. Top of Riprap Bank Along Chartiers Creek Shows Fabric Pulled Loose From Bank, Erosion Forming

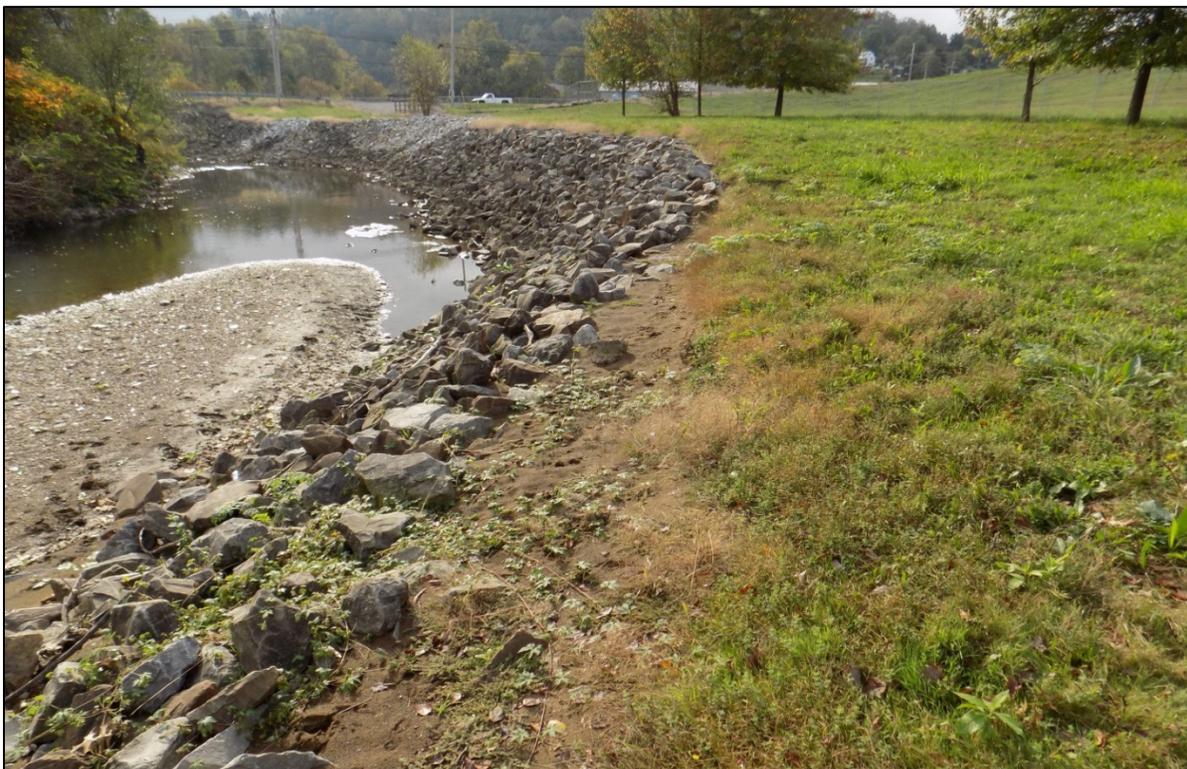
PL-14. Southeast Along Chartiers Creek

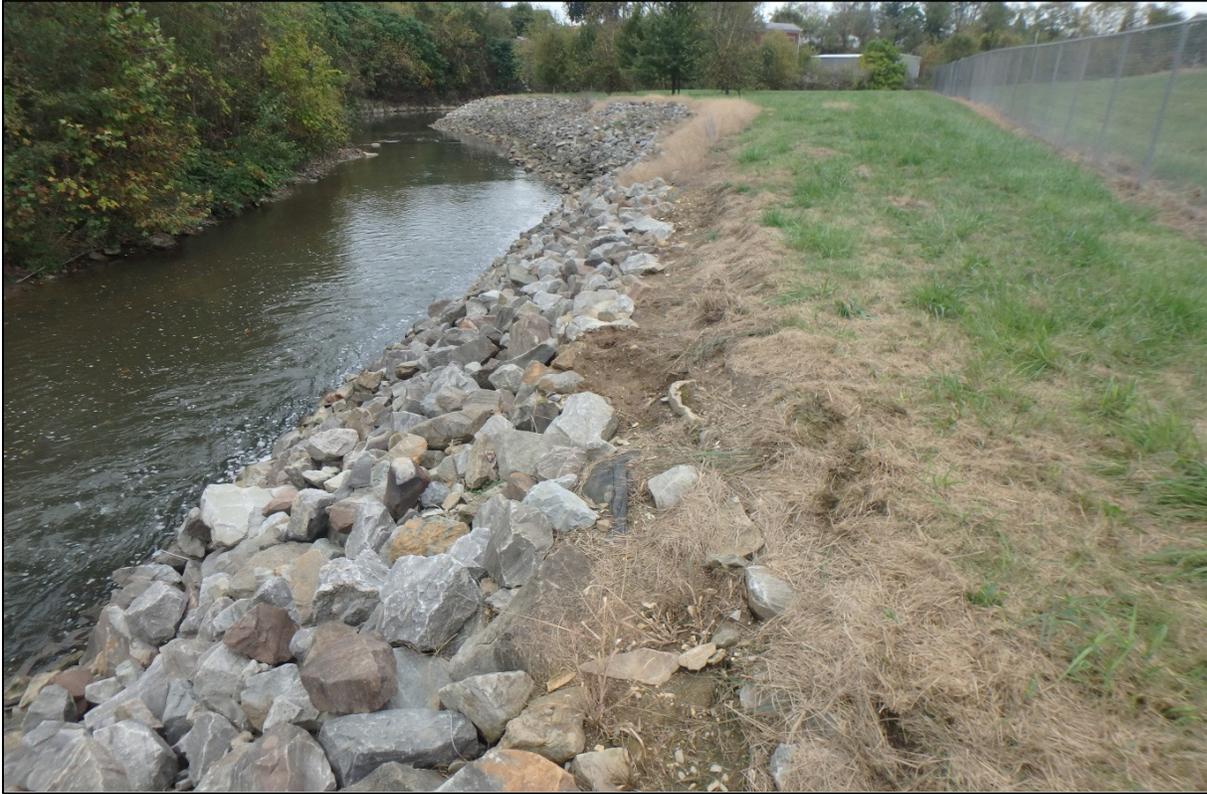
PL-15. Stream Bank Needing Erosion Repair

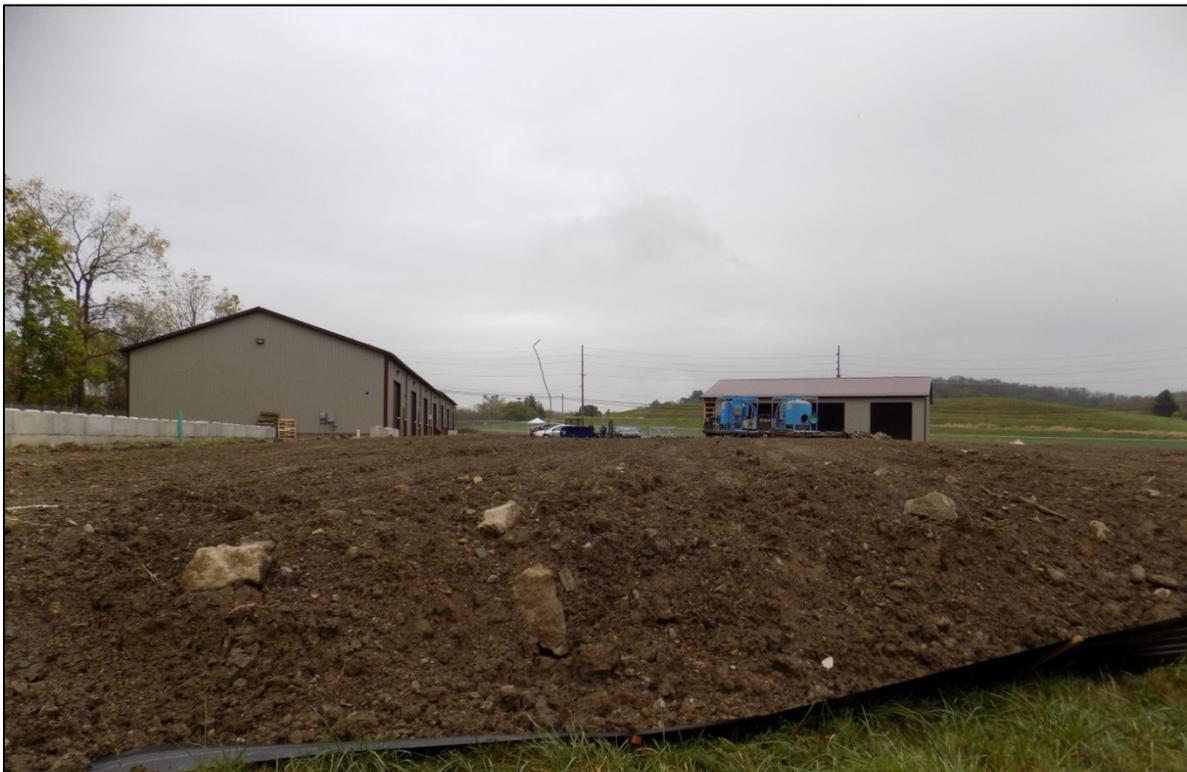
The landowner of Area C and Tract 117 continues to build aboveground storage units. ICs restrict structure excavations deeper than 4 feet and utilities excavation deeper than 6 feet. The storage units constructed so far do not violate these ICs (PL-16).

PL-16. New Fill Being Placed on Area C

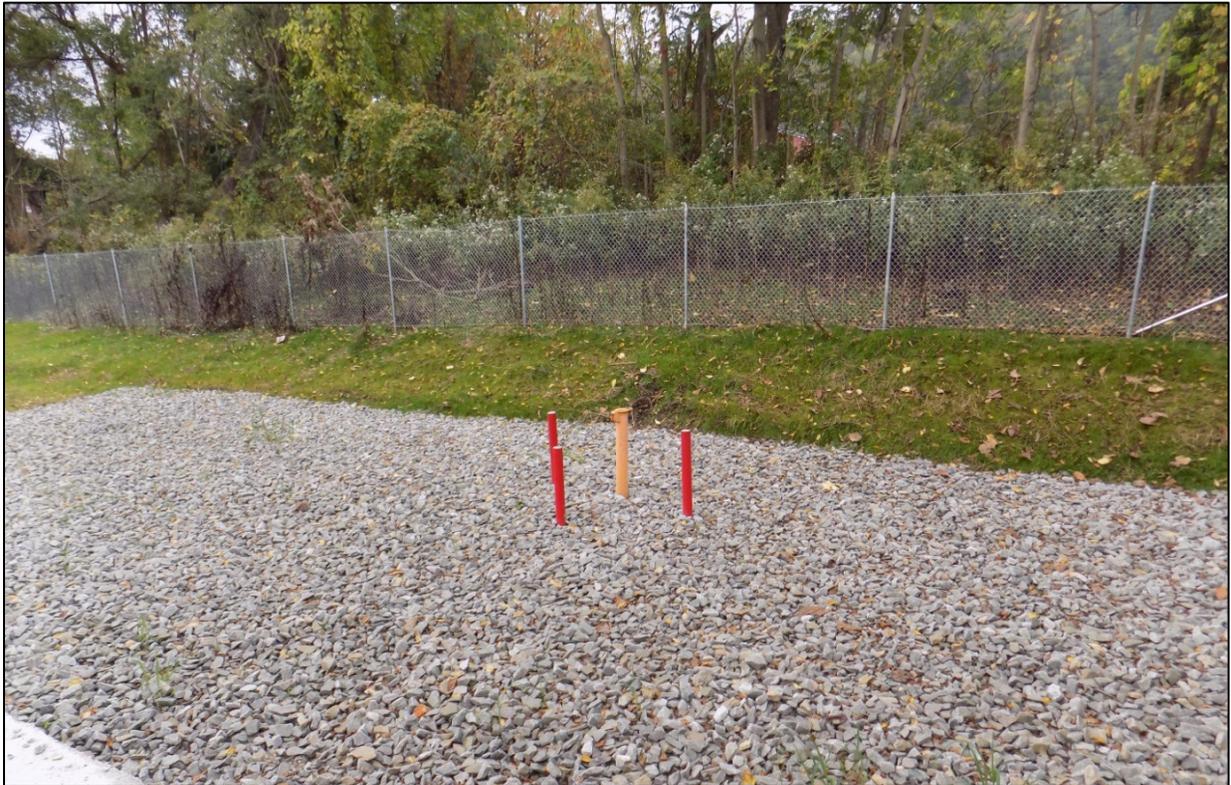
DOE has two groundwater monitoring wells in Area C and Tract 117 (0424 and 0414B, respectively) that are part of the groundwater monitoring network (PL-17). Inspectors noted that drainage from the storage unit foundation is directed behind monitoring well 0414B via a pipe. Inspectors will continue to monitor this area to assess if the drainage pipe will affect the monitoring well area. No maintenance needs were identified.

PL-17. Monitoring Well 0414B
