3.0 Canonsburg, Pennsylvania, Disposal Site

3.1 Compliance Summary

The Canonsburg, Pennsylvania, Uranium Mill Tailings Radiation Control Act (UMTRCA) Title I Disposal Site (site) was inspected on October 23, 2019. No changes were observed on the disposal cell or in the associated drainage features. Inspectors identified several minor maintenance needs.

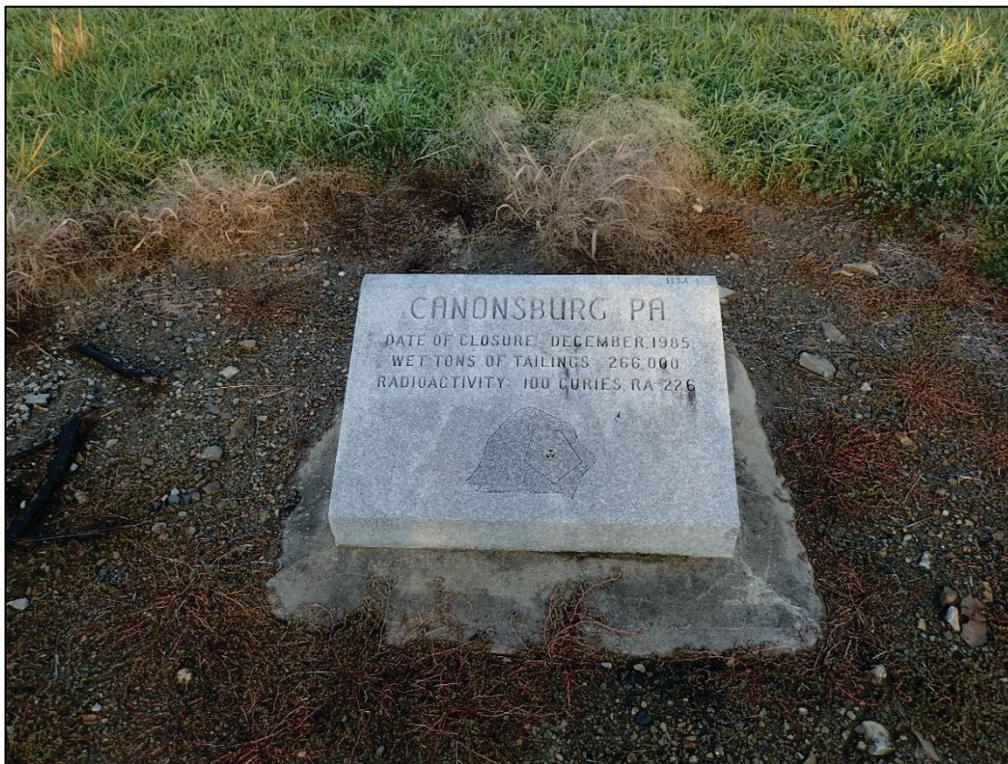
The site has two granite site markers. Site marker SMK-1 is just inside the main entrance gate (PL-1), and site marker SMK-2 is on the top slope of the disposal cell. No maintenance needs were identified.

PL-1. Site Marker SMK-1

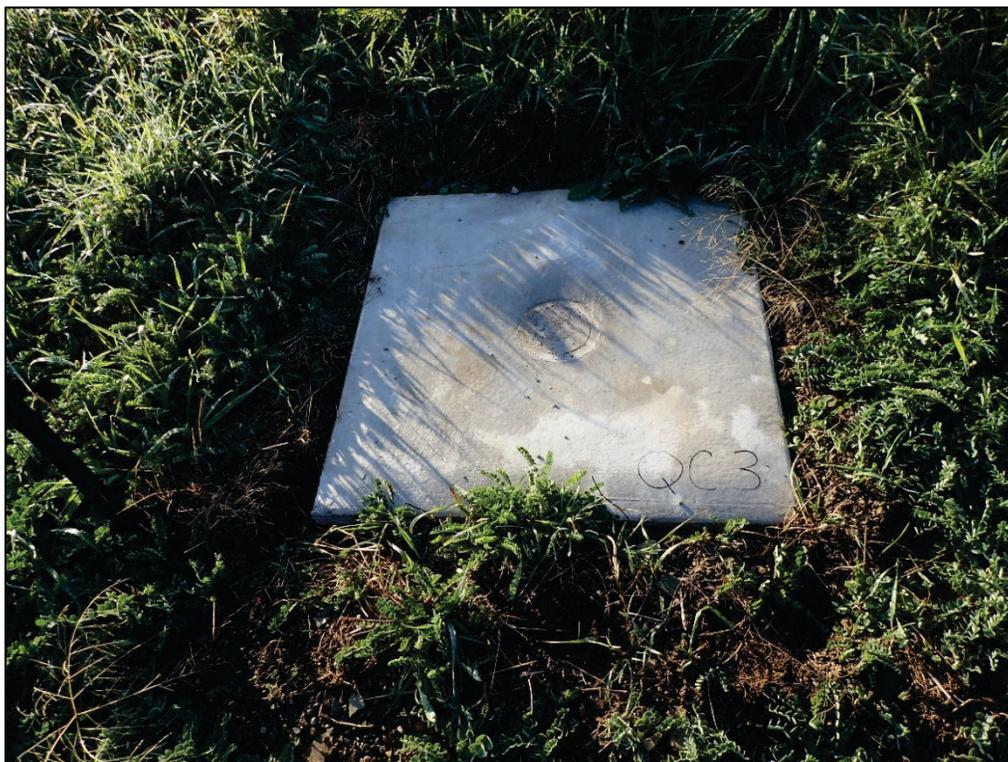
The site has three survey monuments, four boundary monuments, and four baseline aerial survey quality control monuments (PL-2). Boundary monuments BM-1 and BM-2 (noted as missing during the 2017 inspection) were not located and are scheduled to be replaced in 2020. Boundary monument BM-3 was not located in 2019. A metal detector will be used to try to locate it in 2020. No other maintenance needs were identified.

PL-2. Quality Control Monument QC3

- Replacing two “no trespassing” signs in the southwest corner of the site
- Locating boundary monument BM-3
- Replacing boundary monuments BM-1 and BM-2

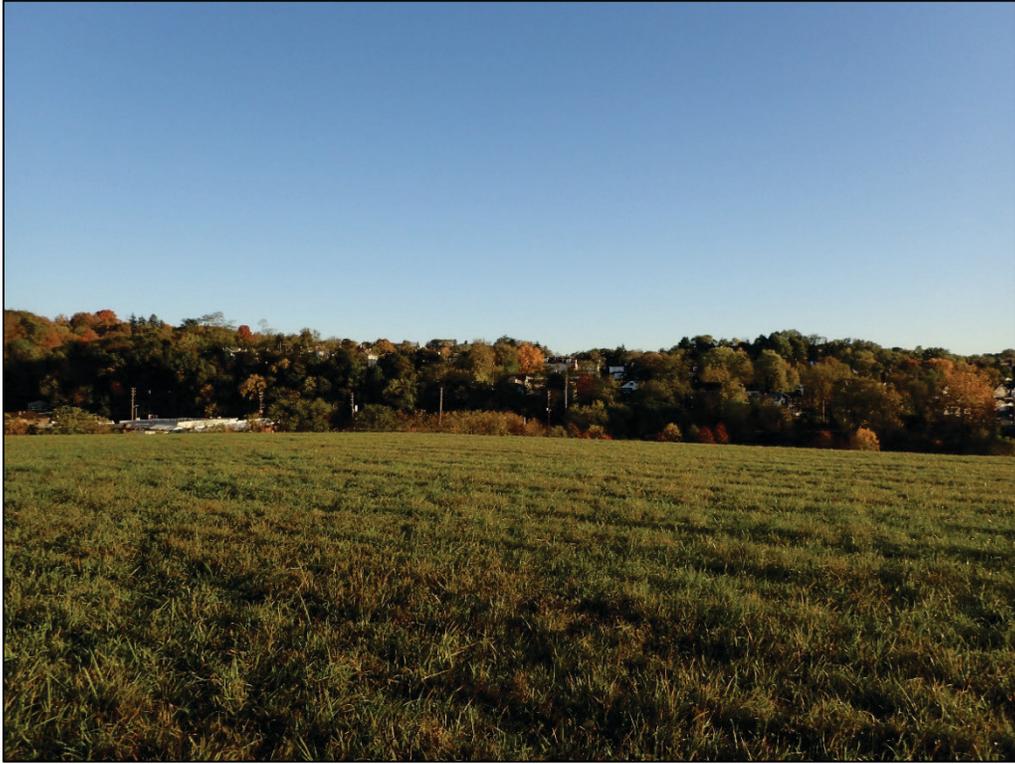
The disposal cell, completed in 1985, occupies 6.8 acres and is covered in grass (PL-3). There was no evidence of erosion, settling, slumping, or other modifying processes that might affect the integrity of the disposal cell. Animals burrow on the disposal cell cover, but such burrows should not pose a risk to disposal cell integrity or public health because the buried tailings are overlain by a 36-inch-thick clay layer (radon barrier), an 18-inch-thick biointrusion rock layer, and a 12-inch-thick topsoil layer. Biointrusion down to or through the radon barrier is unlikely. Inspectors will continue to monitor the location and the significance of burrows. No new significant burrows were noted on the disposal cell during the inspection. No maintenance needs were identified.

PL-3. North Side of Disposal Cell

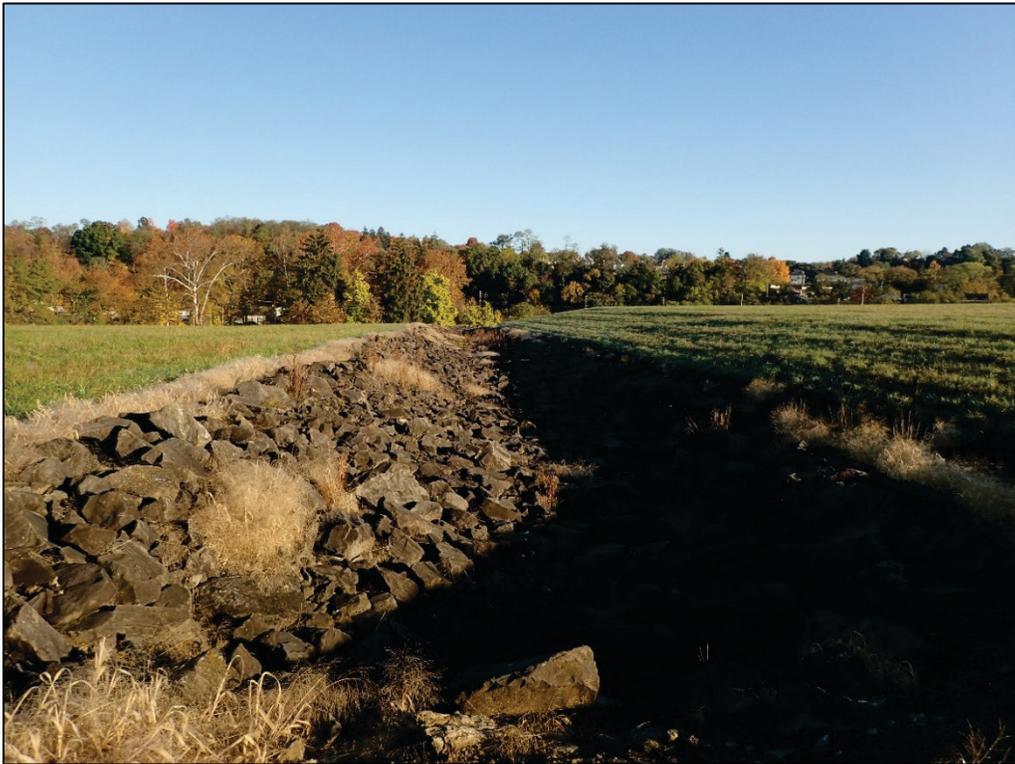
There was no evidence of rock deterioration or woody vegetation in the diversion channels and perimeter ditches (PL-4). Periodic physical removal and spot herbicide applications have been effective at reducing woody vegetation and will continue to be conducted as needed.

PL-4. West Section of Riprap-Armored Diversion Ditch

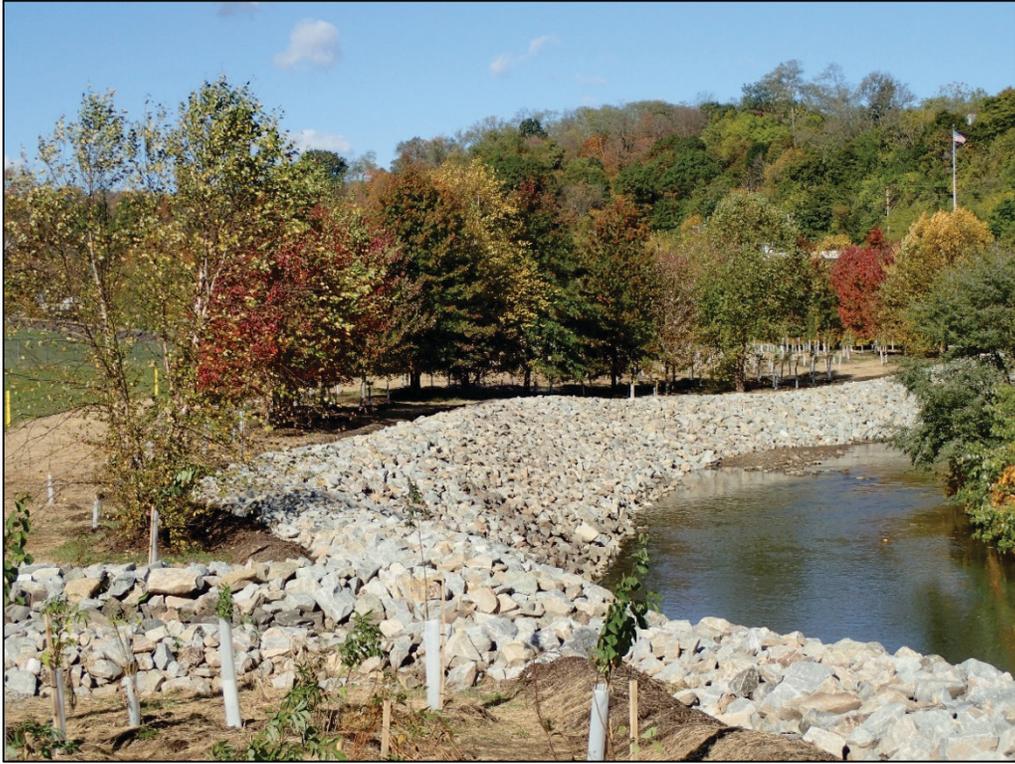
Between 2001 and 2008, several streambank-stabilization projects were conducted north and east of the site. The projects consisted of installing riprap armoring along the streambanks. Age and heavy flow events in Chartiers Creek in late 2017 and early 2018 damaged those riprap installations. In late summer 2019, the entire length of the riprap embankment along Chartiers Creek north of the disposal cell (approximately 1200 linear feet) was repaired during low streamflow. The work consisted of minor grading, replacing geotextile filter fabric, and importing and placing 2-foot-thick R6 riprap slopes (PL-5 and PL-6).

PL-5. Newly Repaired Riprap Embankment

The Chartiers Creek project, executed in 2019, included engineered repairs to the riprap-armored embankment north of the disposal cell and areas of erosion identified in the 2018 inspection. A riparian forest buffer was planted above and along the embankment to help stabilize the bank. Additional minor maintenance needs identified by the inspectors during the 2018 annual inspection and completed in 2019 include:

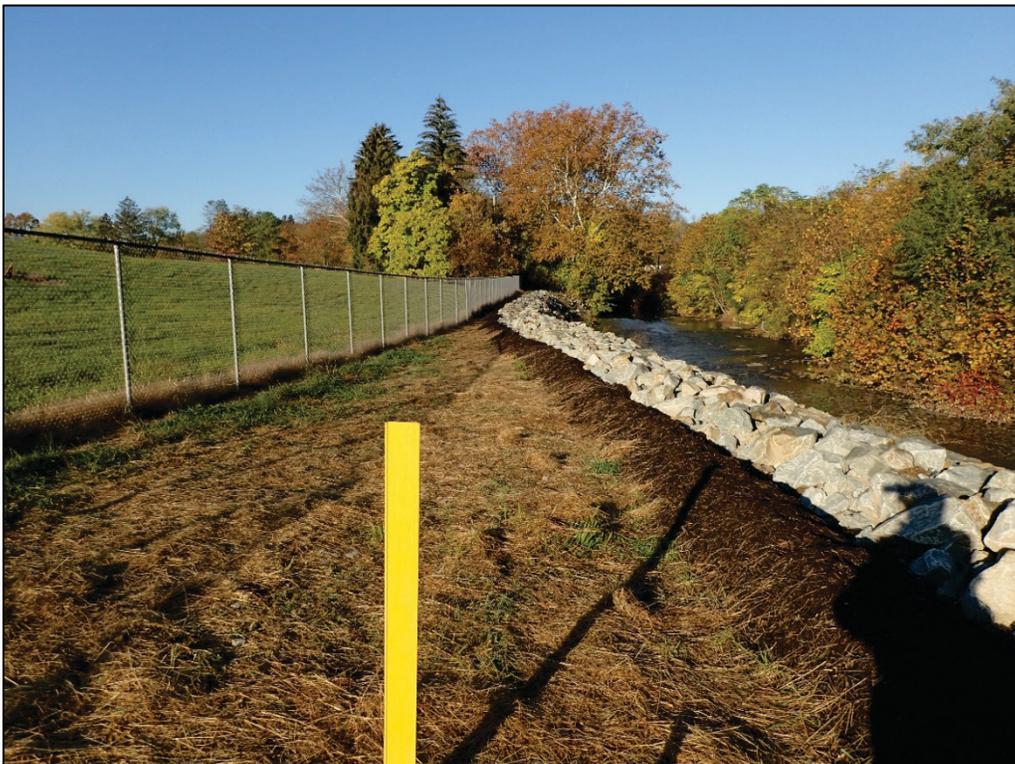
PL-6. West End of Riprap Embankment

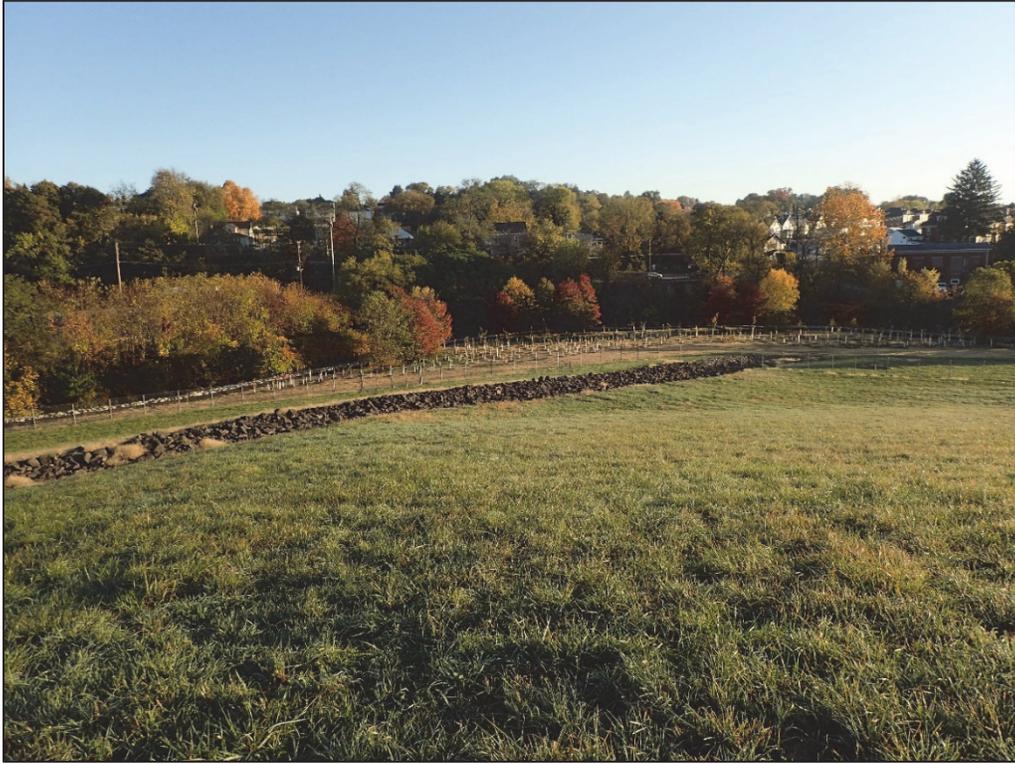
A conservation reuse initiative was included as part of the streambank stabilization repair project. A riparian forest buffer was planted following the riprap slope repair; it consisted of 525 new native trees and shrubs within a 1.7-acre corridor adjacent to Chartiers Creek. Disturbed areas were then seeded with a pollinator-friendly native grass and wildflower mix (PL-7 and PL-8). This corridor will further protect the Chartiers Creek streambank and help prevent erosion above the riprap embankment. The riparian forest buffer is recognized as a means to improve stream quality. The Commonwealth of Pennsylvania has a goal to establish 95,000 acres of riparian forest buffer by 2025. The Pennsylvania Department of Conservation and Natural Resources was notified of the project.

PL-7. Newly Planted Riparian Area

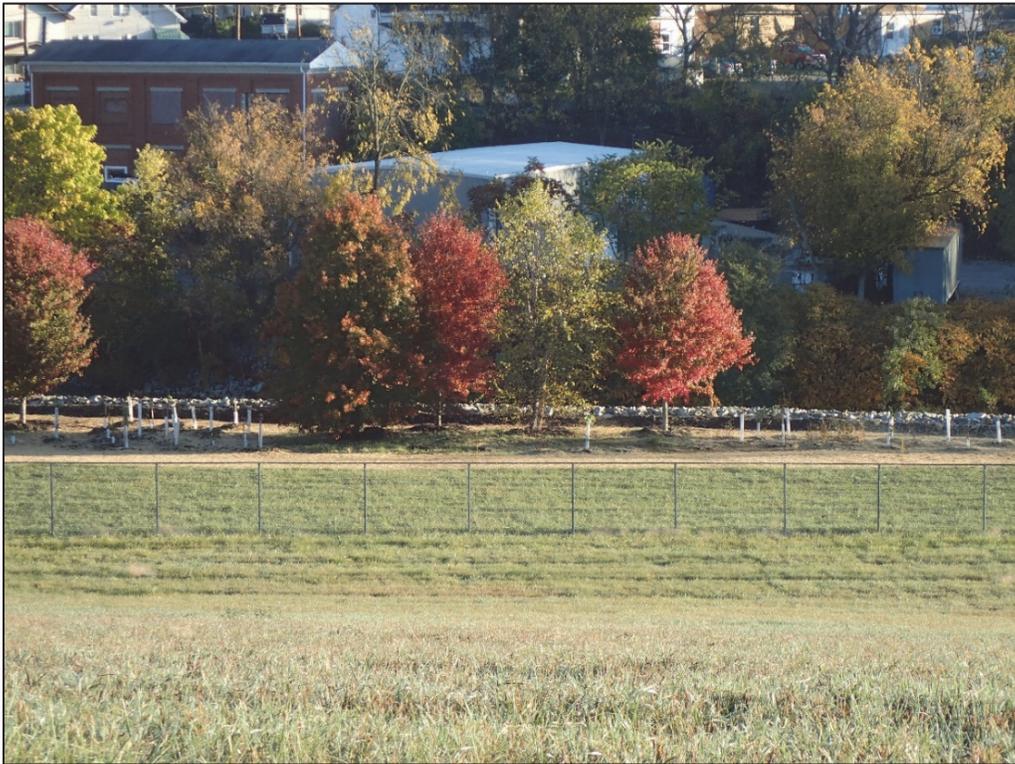
PL-8. Newly Planted Riparian Area

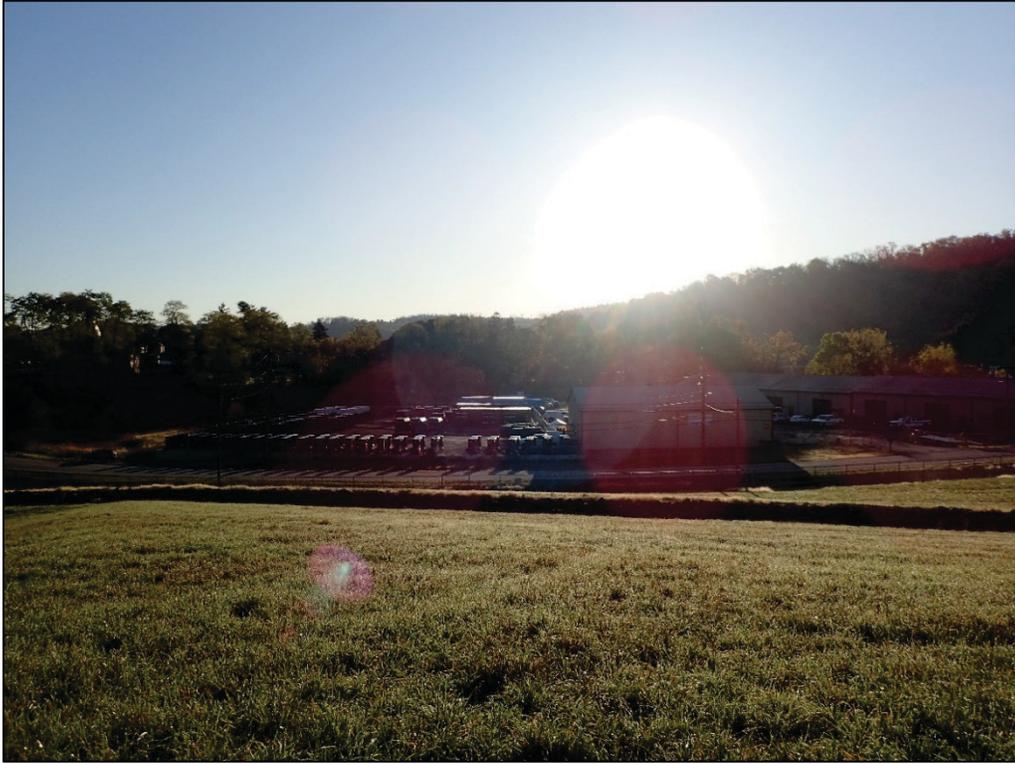
Area C and Tract 117: Area C and Tract 117 form a triangular parcel of property east of the site bounded by Strabane Avenue, Chartiers Creek, and the Pittsburgh and Ohio Central Railroad. Area C and Tract 117 are included in the annual inspection to ensure compliance with ICs put in place to address land use and site access requirements (PL-9). There was no evidence that any of the ICs in place for Area C and Tract 117 had been violated.

PL-9. Area C from Disposal Cell
