LMS/CIS/S31187

**2020 Annual Inspection
Colonie, New York, Site
July 13–17, 2020**

December 2020

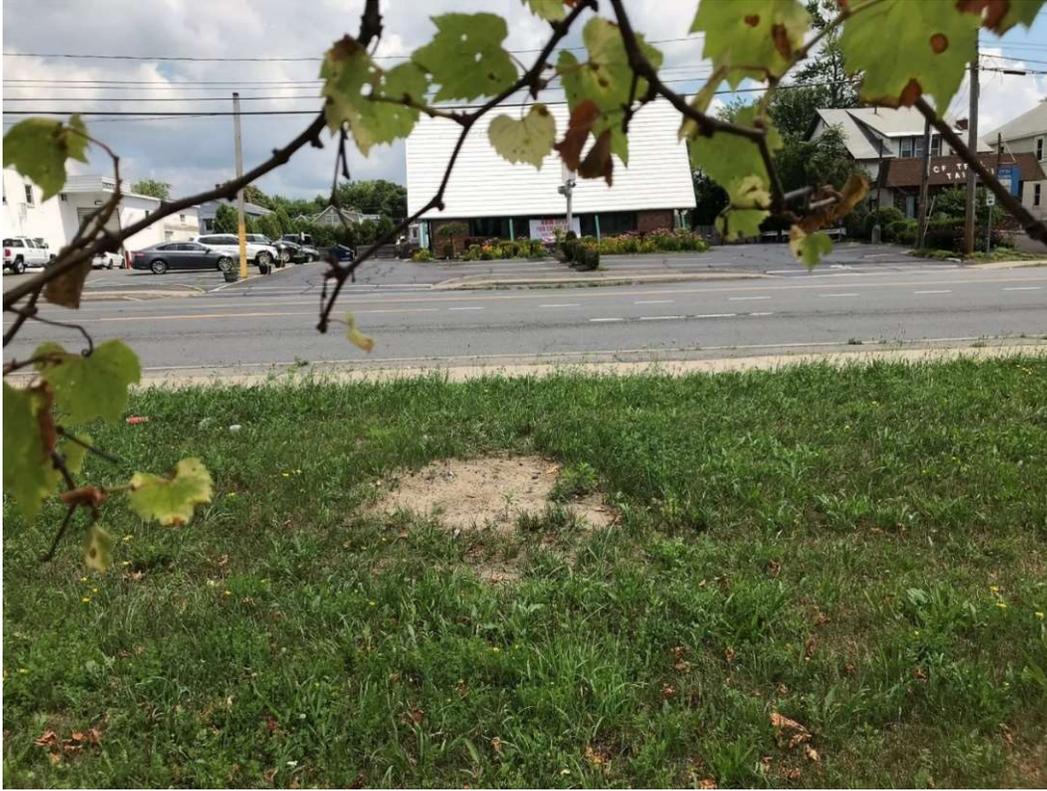
Figure 3. North Lawn Easement Area Looking North

Inspection Results: The inspector performed a walkdown of the site and the easement areas to verify the integrity of the institutional controls. It was determined that the institutional controls at the site were properly implemented and fully enforced. There was no evidence that the soil in the easement areas had been disturbed and no signs of gardening or farming. There were no signs of new construction, digging, soil excavation, dumping, staining, or vegetative stress within the easement areas beyond yellowing of the grass due to lack of precipitation.

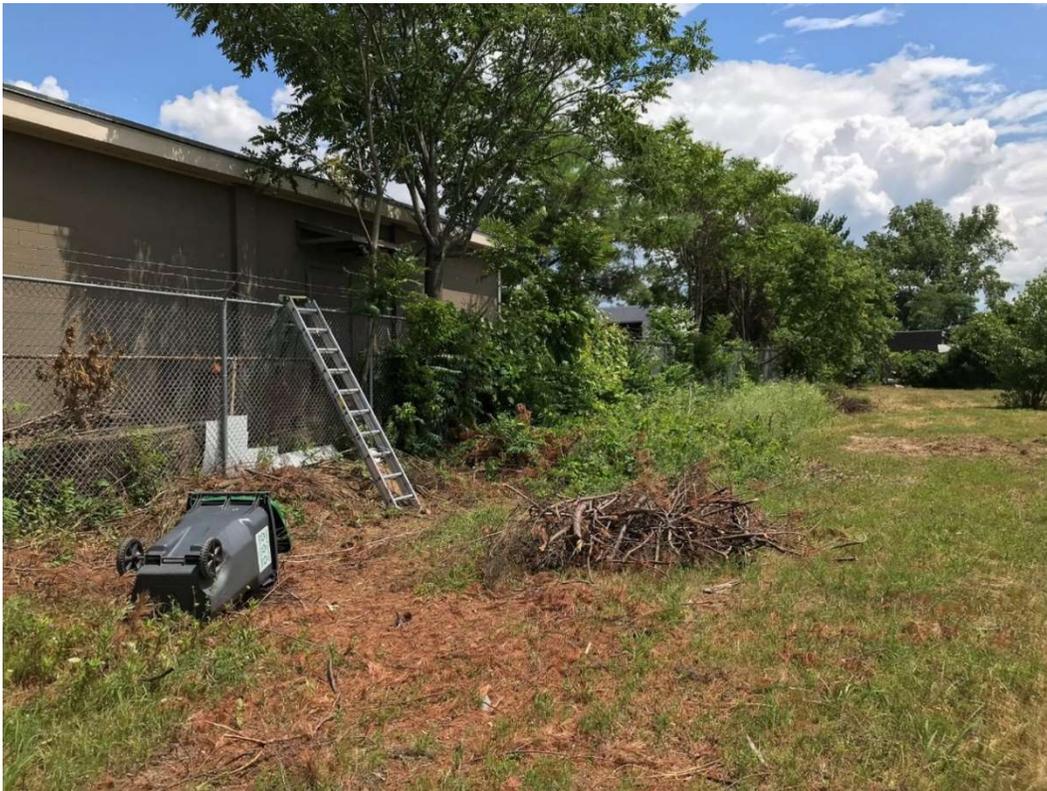
Figure 4. Restaurant Waste Includes a Waste Bin and Ladders

- Trash and branches have been dumped onto the site from the neighboring restaurant (Figure 11 and Figure 4). See Section 2.2 for further discussion.
- The lawn shows scarring in the center of the site caused by a skid steer during mowing. The grass is very thin, and mowing during the drought apparently does not allow enough time for the vegetation to recover. There is no evidence of erosion at this location (Figure 12).

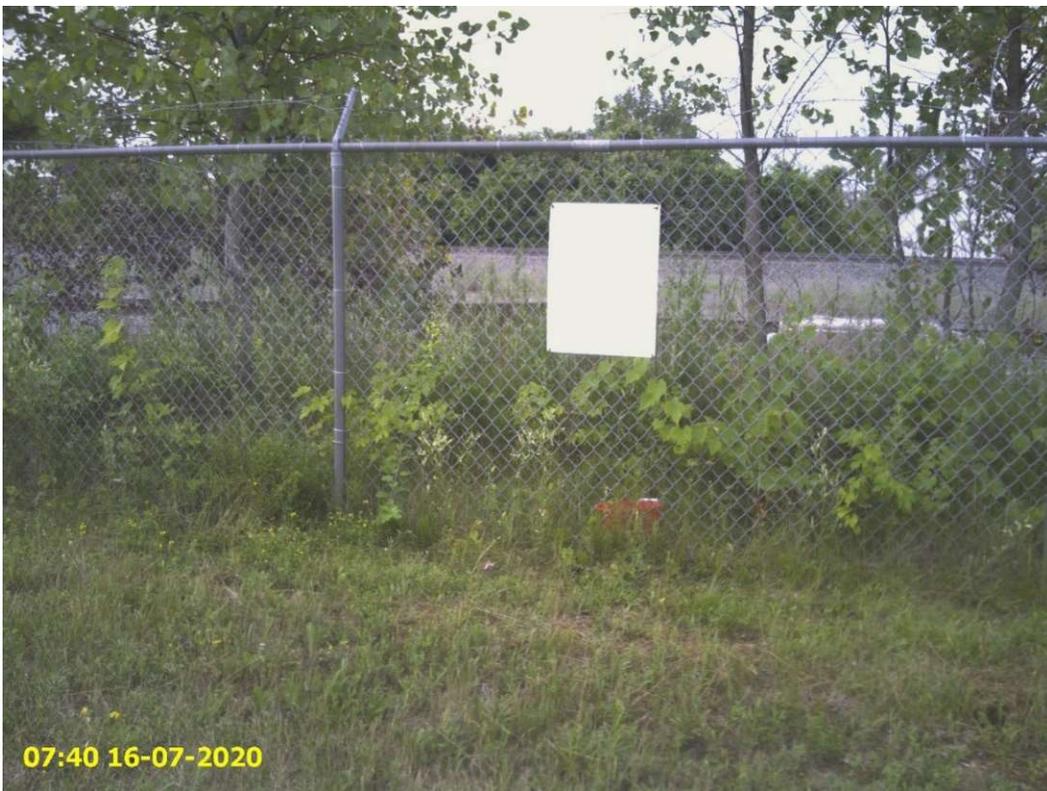
Figure 5. Cut Barbed Wire Near Monitoring Well MW-41S

- All three strands of barbed wire at the top of the chain link fence have been cut in one part of the south fence near monitoring well MW-41S (Figure 5). The incident was entered into the OpEx database as issue number I-1517. The damage was not present during the October transfer inspection. A report has been filed with the Colonie Police Department as report number 20045608. In accordance with DOE Order 221.1B, *Reporting Fraud, Waste and Abuse to the Office of Inspector*, the DOE Office of Inspector General was notified of the incident (Keeler 2020). The site lead contacted three fencing contractors to determine a price estimate for repairing the damage.

- Vandalism to the rear fence should be repaired. The unburdened subcontract price for this work has been estimated to be \$500 (Stewart 2020).
- Clear vegetation from the rear gate that is partially blocked from opening by overgrown shrubs.
- The tree limb on the fence should be cut away during grubbing of the vegetation on the western side of the site. Note that the adjacent property owner has no liability for the fallen tree unless the owner knew that tree was compromised in advance or was given constructive notification in advance of the tree's deficiency (Wei 2020).

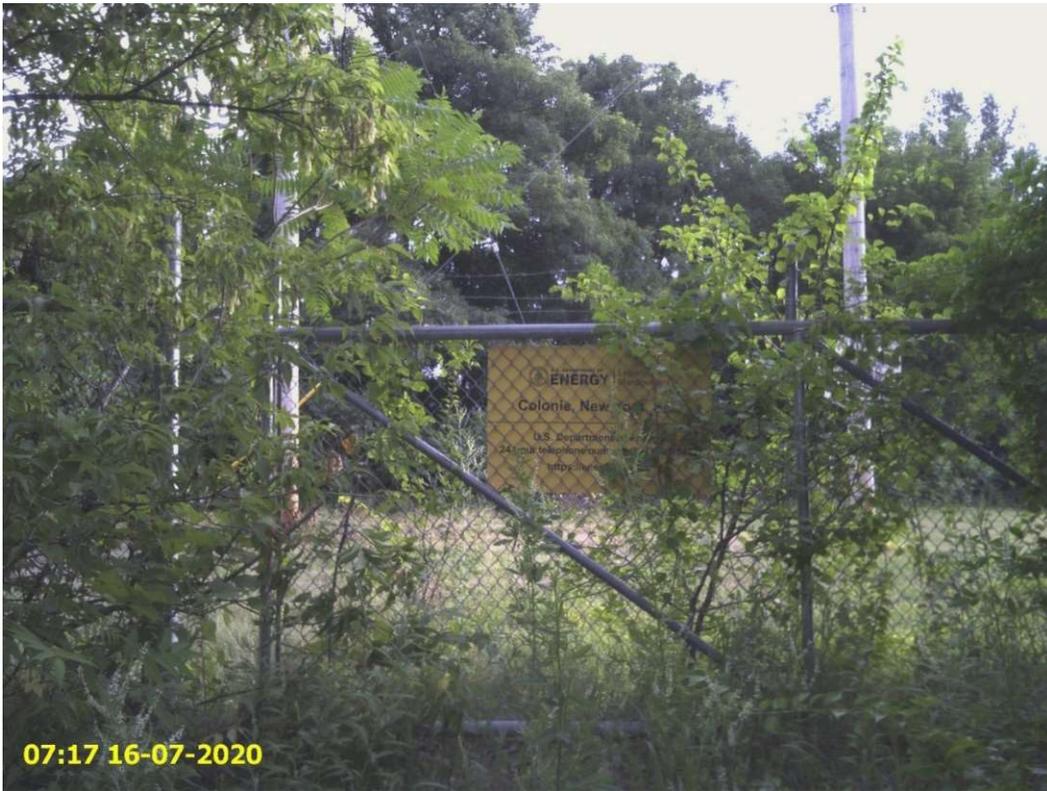
Figure 6. Looking North at South Gate

- The south gate is blocked and overgrown with trees (Figure 6). See Section 3.0 for further discussion.
- A tree is resting on the top rail of the fence and pushing the barbed wire down along the southwest fence line (Figure 7). There does not appear to be permanent damage to the top rail or barbed wire. The tree has fallen from the Z. Ipek & Sons General Contracting lot at 7 Railroad Avenue.

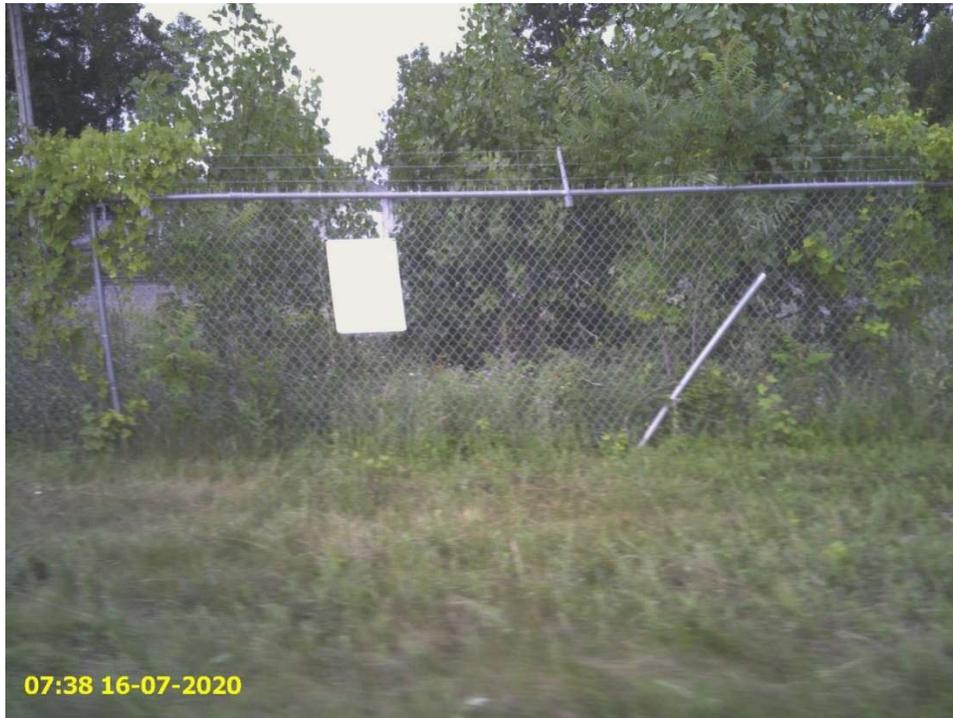
Figure 8. Broken Fence Post near Monitoring Well MW-42S

- There are four bent or broken fence posts along the south fence line (Figure 8 and Figure 9).

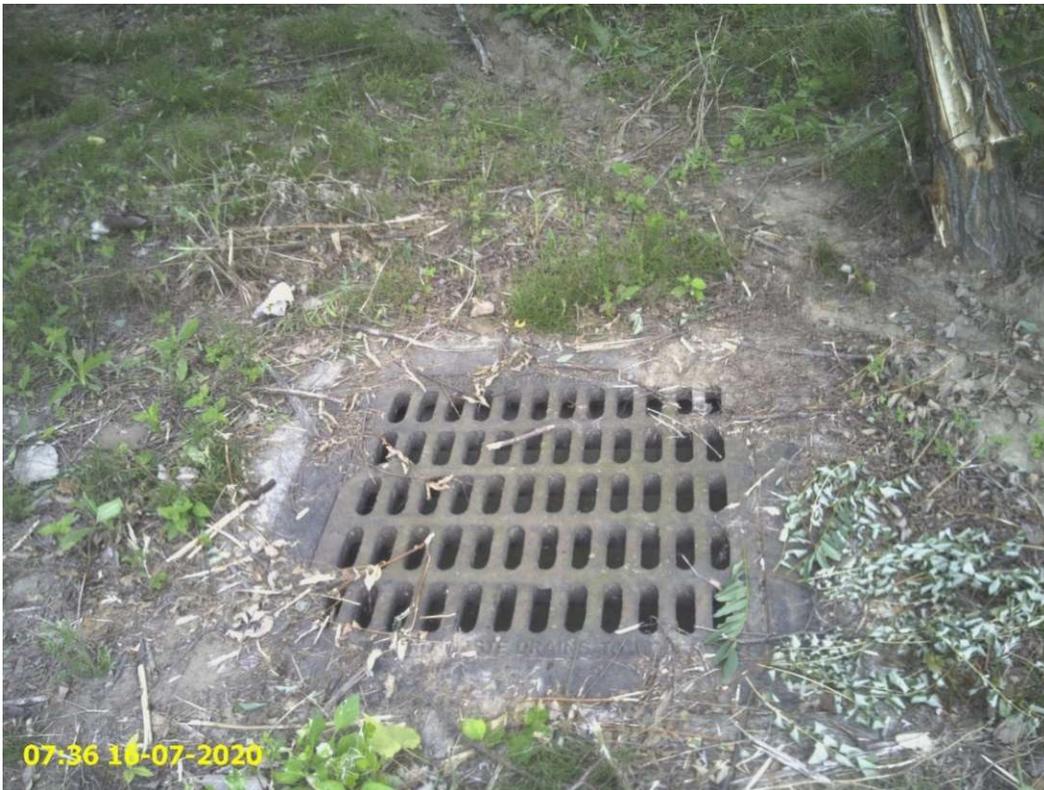
Figure 15. Eastern Catch Basin

- The eastern catch basin was inspected and added to the site base map (Figure 2) as a 2-foot by 2-foot square structure. The basin was dry (Figure 15).
- The northern catch basin was free of obstructions and dry.
- At the center catch basin, the sound of water flow from the captured unnamed tributary was distinct, as in previous visits.
- The unnamed tributary was captured on video. The flow rate was much slower than a previous springtime observation. The water was cloudy but without foam. No obstructions to flow were observable (Figure 16).

Recommendations: The site base map should be updated prior to the next annual inspection as the eastern drainage basin was not indicated on the map.

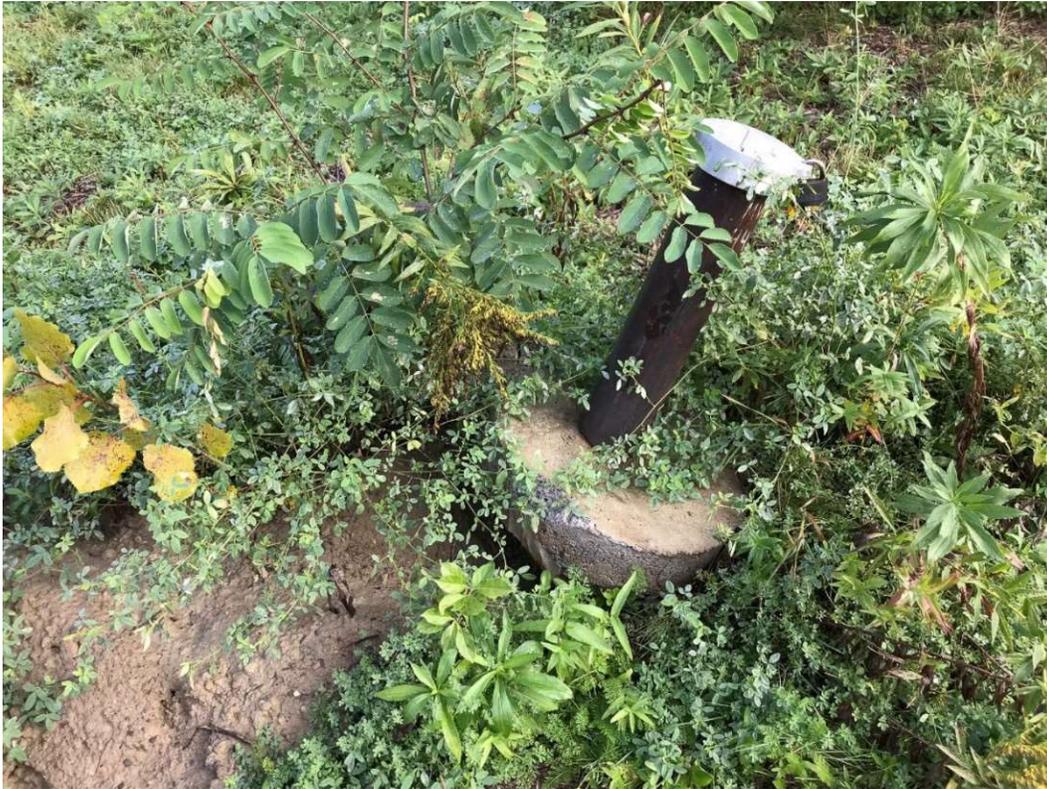
Figure 17. Monitoring Well MW-44S Before Repair

Damage to monitoring well MW-44S was found during the October 2019 site transfer inspection (DOE 2019a). The well pad was broken, and the protective casing was off from vertical by approximately 30 degrees (Figure 17). The well needed to be either repaired or replaced in keeping with New York State regulations (NYSDEC 2009; NYSDEC 2010).

A local, licensed well drilling company was contracted to make the repairs. The driller mobilized to the site on July 13, 2020, cleared away the soil surrounding the broken pad and observed that the PVC casing was snapped off entirely at the approximate depth of the protective steel casing (Figure 18). Coincidentally, this location had a threaded casing joint, which is a weak point. The pneumatic pump was still in the well and could not be pulled out, probably because of sand locking caused by dirt ingress into the PVC casing. While the pump's pneumatic tubing was being cut, the tubing slipped through the site lead's grasp, and the pump dropped to the bottom of the well. The driller was directed to repair the surface completion (Figure 19). The construction report is included as Appendix D.

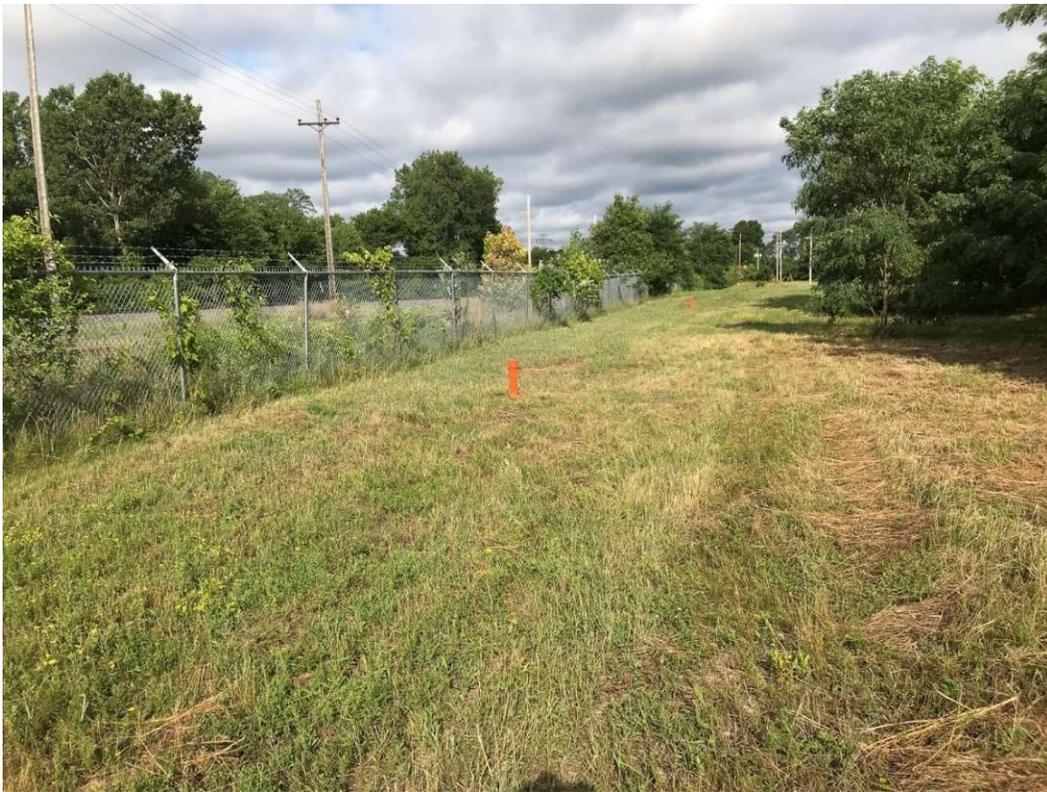
Figure 20. Orange Painted Monitoring Wells MW-42S and MW-41S

The onsite wells that were not protected by bollards. Monitoring wells MW-08S, MW-41S, MW-42S, and MW-44S were painted orange to make them more visible (Figure 20).

Recommendations: To protect the monitoring wells from future damage, protective bollards should be installed around all monitoring wells. Currently, only one onsite well (MW-30S) has protective bollards. Monitoring well MW-08S is set close to the fence line and therefore could be protected by two bollards. The other three onsite wells need four bollards each, meaning that 18 bollards would need to be installed to protect the monitoring wells. In addition, one of the installed bollards at monitoring well MW-30S should be brought back to vertical. Well MW-32S (on CSX property) serves no purpose to the program and is a liability. It should be decommissioned.

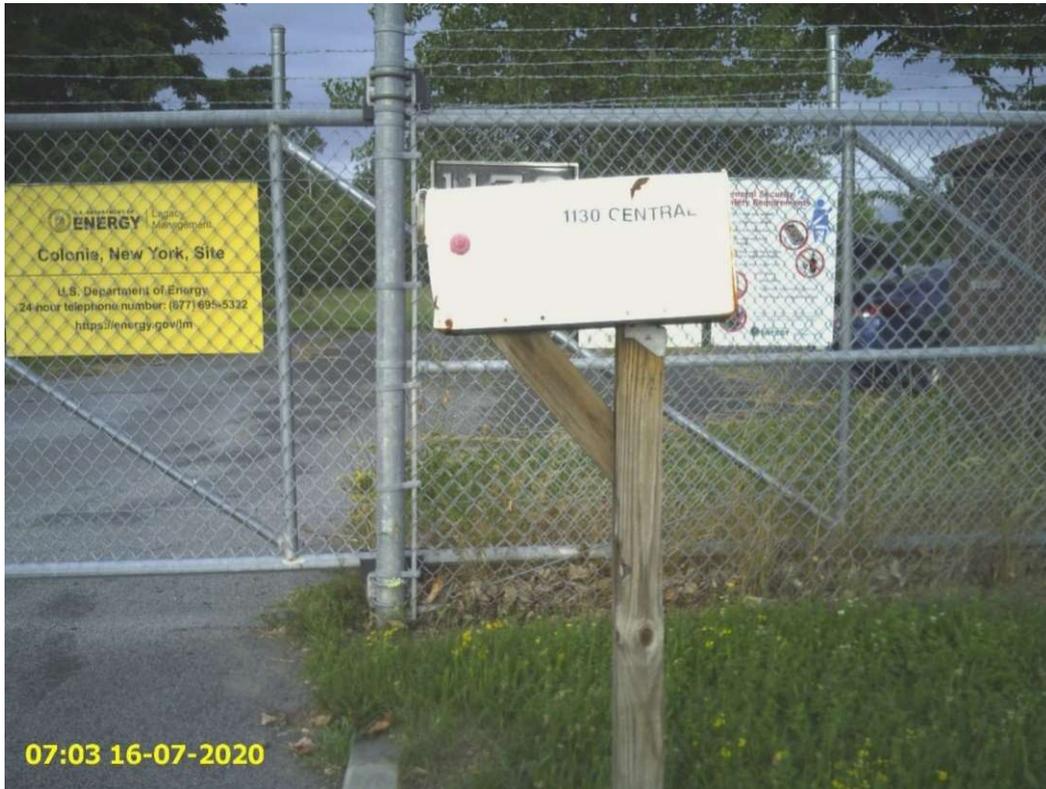
Figure 21. The Mailbox Is Damaged But Serviceable

Inspection Result: The mailbox has been damaged from a strike but is functional (Figure 21). No mail was in the box.

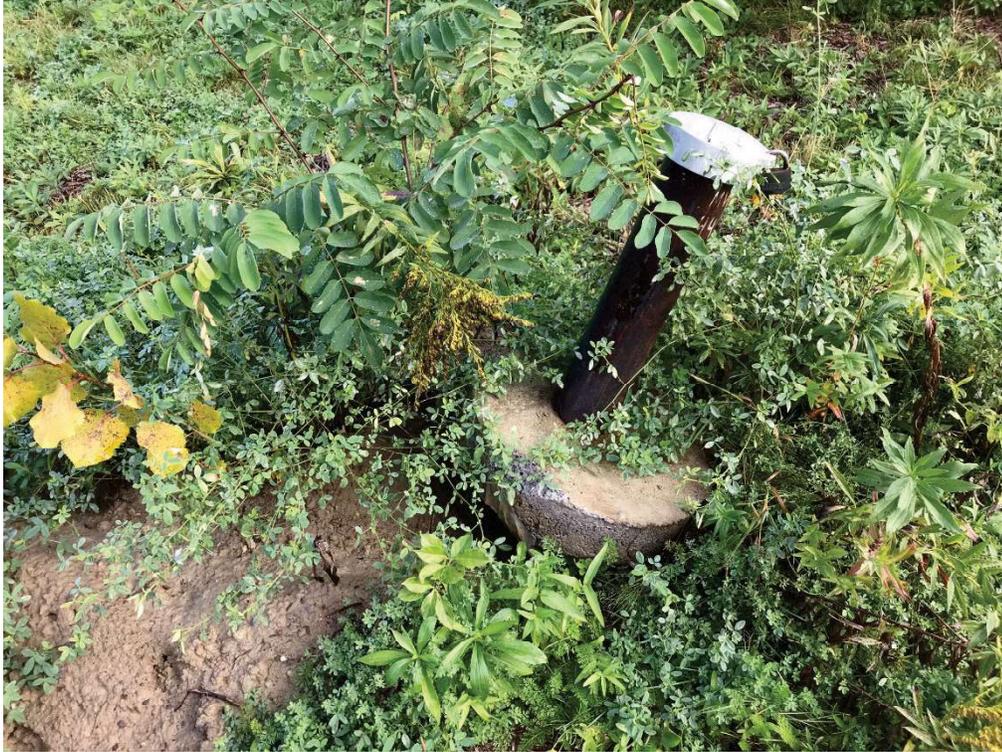
1. MW-44S as found in October 2019

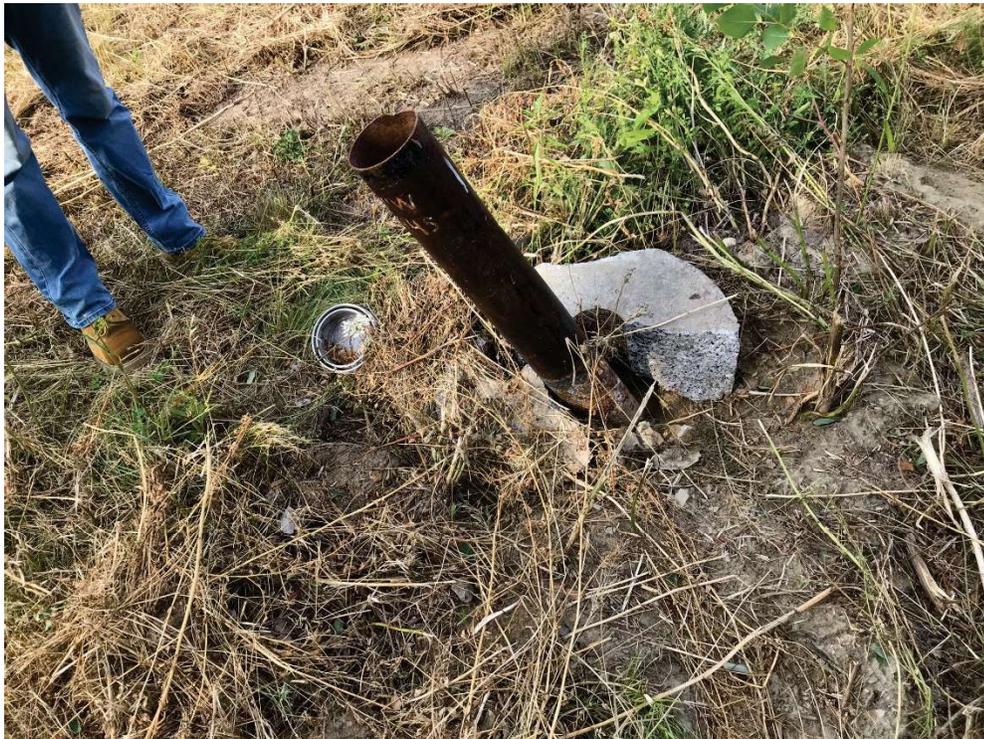
2. MW-44S as found on July 13, 2020
