## 4.0 Durango, Colorado, Disposal Site

### 4.1 Compliance Summary

Figure 4-1. 2015 Annual Inspection Drawing for the Durango Disposal Site

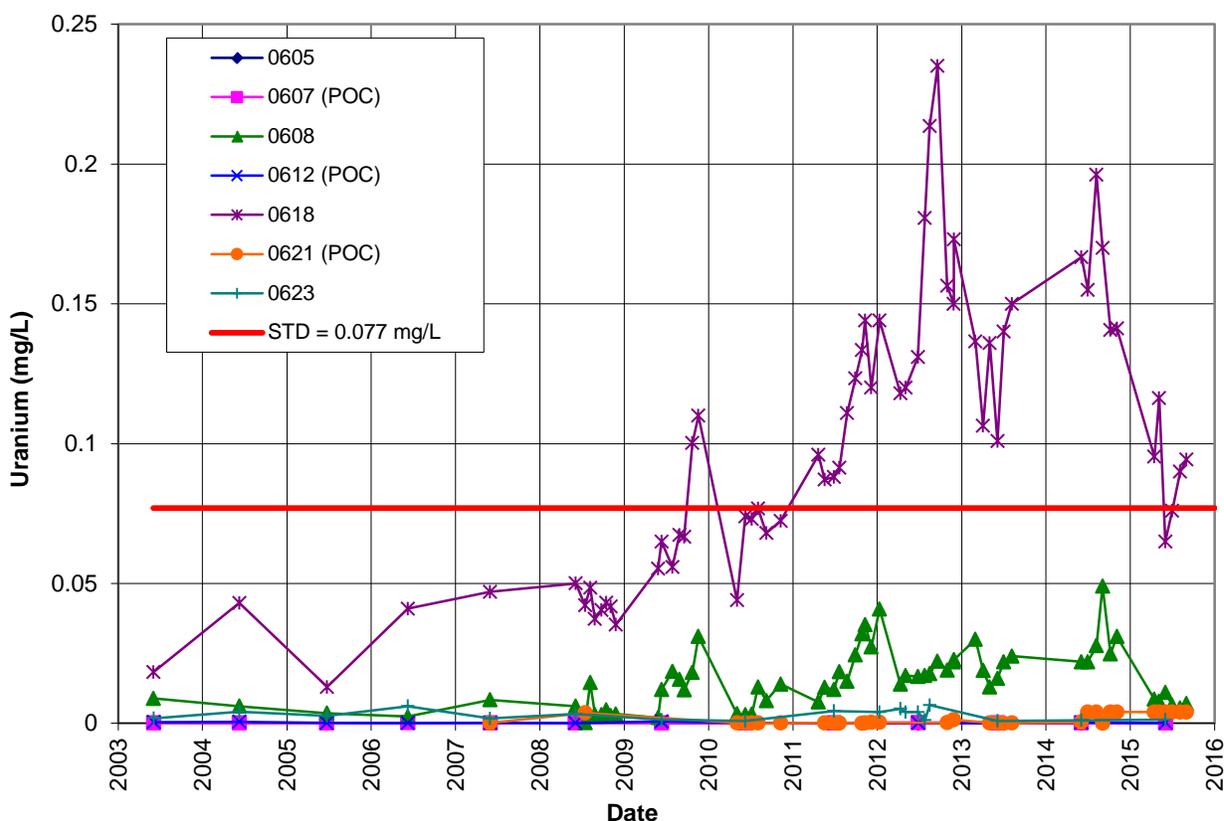
Figure 4-2. Time-Concentration Plot of Uranium in Groundwater at the Durango Disposal Site

Beginning in 2014, POC wells 0607 and 0612 have shown a slight increase in selenium concentrations (Figures 4-2 through 4-4). Even so, uranium, molybdenum, and selenium concentrations in the POC wells in the uppermost aquifer are well below the respective standards. Therefore, the aquifer is in compliance with the LTSP groundwater monitoring requirements.

Though not required for compliance, wells completed in the alluvium are also monitored. Uranium concentrations in well 0618 have consistently been higher than concentrations in the other wells onsite. To monitor the increased uranium observed in well 0618, wells 0608, 0618, and 0621 are sampled monthly as weather permits. Figure 4-2 shows an overall increasing trend in uranium concentrations in well 0618 since 2008. Uranium concentrations had been increasing slightly in well 0608, but returned to average concentrations in 2015. Because well 0618 is not a POC well and not screened in the uppermost aquifer, the concentrations in this well do not affect compliance with the LTSP and do not pose a risk to human health and the environment. However, the potential cause of this increase continues to be investigated.

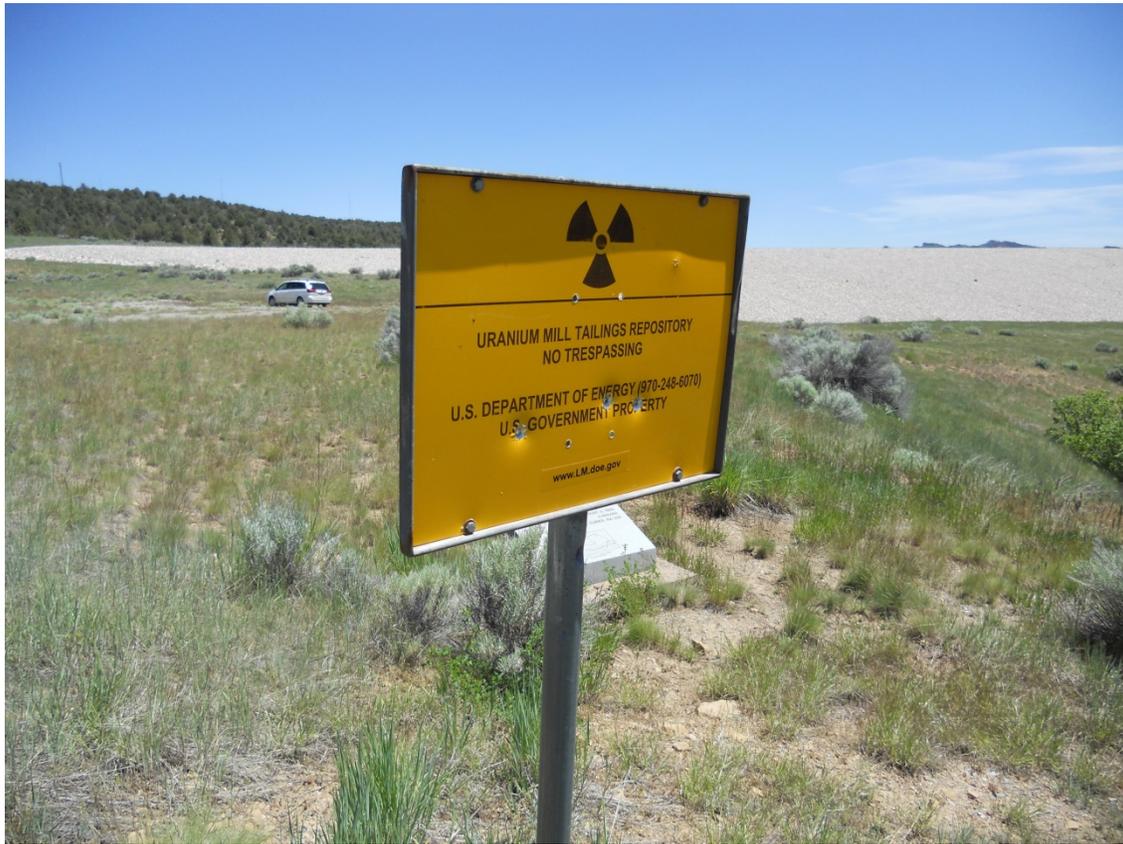
The entrance gate along County Road 212 was locked and in good condition, and the older, original entrance gate was also locked and in good condition. The entrance sign was damaged by bullets but still legible (PL-1).

*DUD 6/2015. PL-1. Entrance sign, damaged by bullets.*

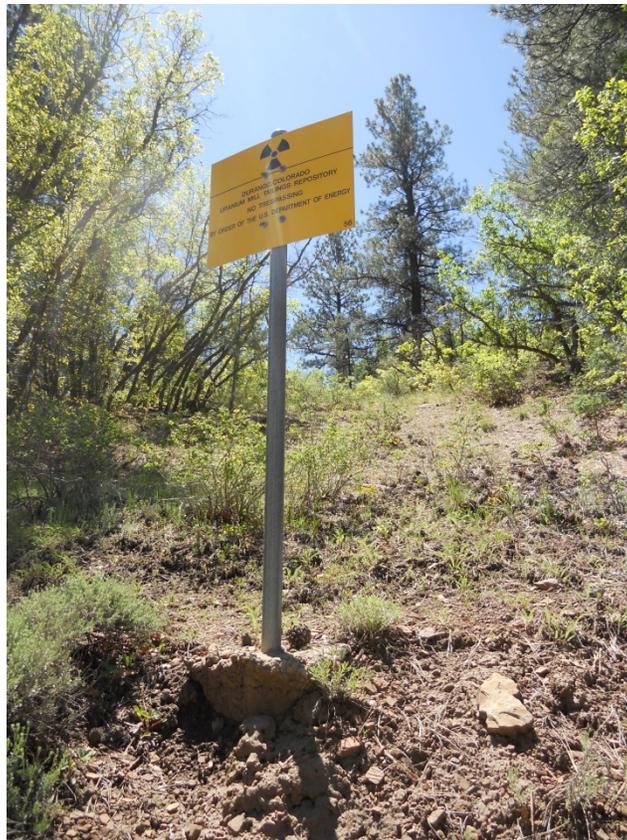
Eighty-four perimeter signs mark the unfenced site boundary (PL-2). Two signs (P83 and P84) were installed after the 2014 annual inspection. Numerous perimeter signs have bullet holes or other markings. Although they remain legible, they are beginning to weather and will need to be replaced in the next few years. Damaged signs are shown on Figure 4-1.

Some perimeter signs, slightly undercut by erosion, were monitored. Perimeter sign P2 has been missing for several years and will not be replaced, as adjacent signs are within sight. In accordance with the updated LTSP, signs P40 through P43 were not observed. Due to time constraints, signs P13, P44, P45 (undercut by erosion), and P46 were also not observed in 2015. Sign P1, missing in 2014, has been replaced.

*DUD 6/2015. PL-2. Perimeter Sign P56, slightly undercut.*

- 4A No maintenance issues were identified, although some perimeter signs will need to be replaced in the next few years. A separate event was completed following the inspection to treat the noxious weeds and shrubs growing on the side slopes of the cell with herbicides.

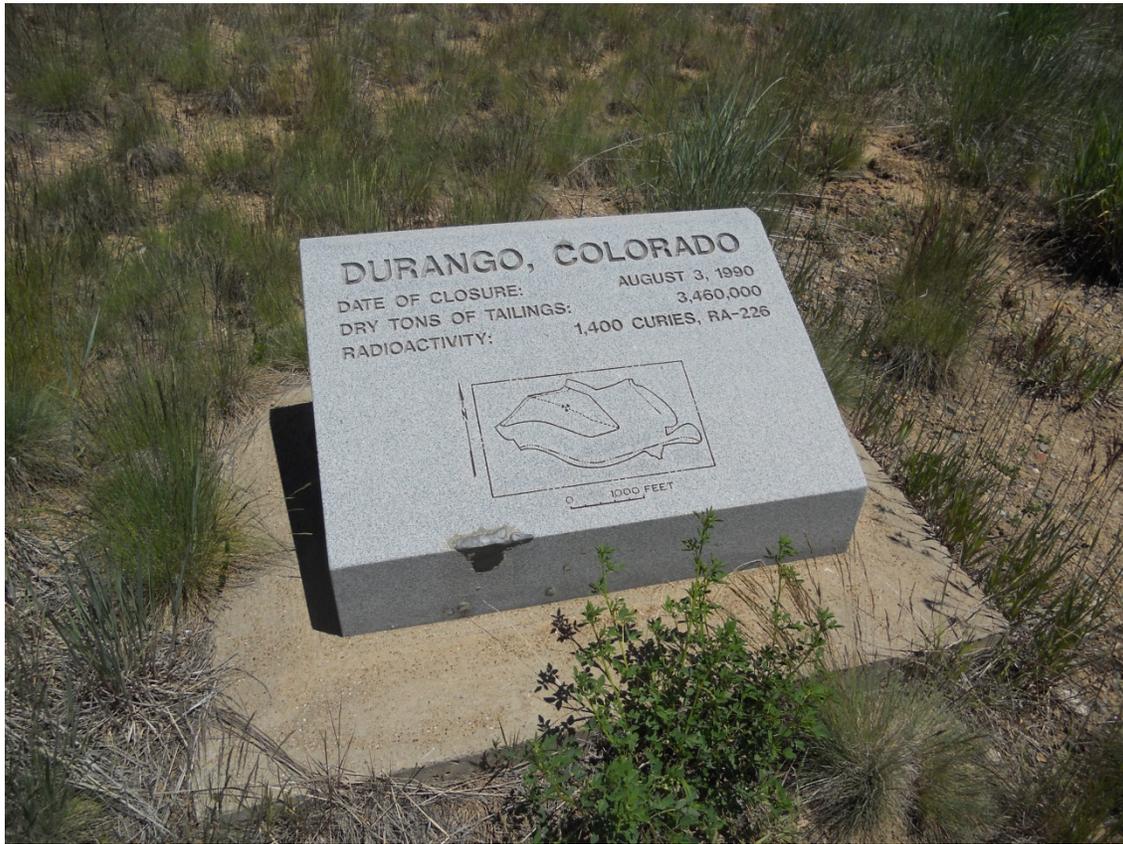
Site marker SMK-1 was historically damaged by gunfire and was repaired (PL-3). Site marker SMK-2 was in good condition.

*DUD 6/2015. PL-3. Site marker SMK-1, repaired in 2015.*

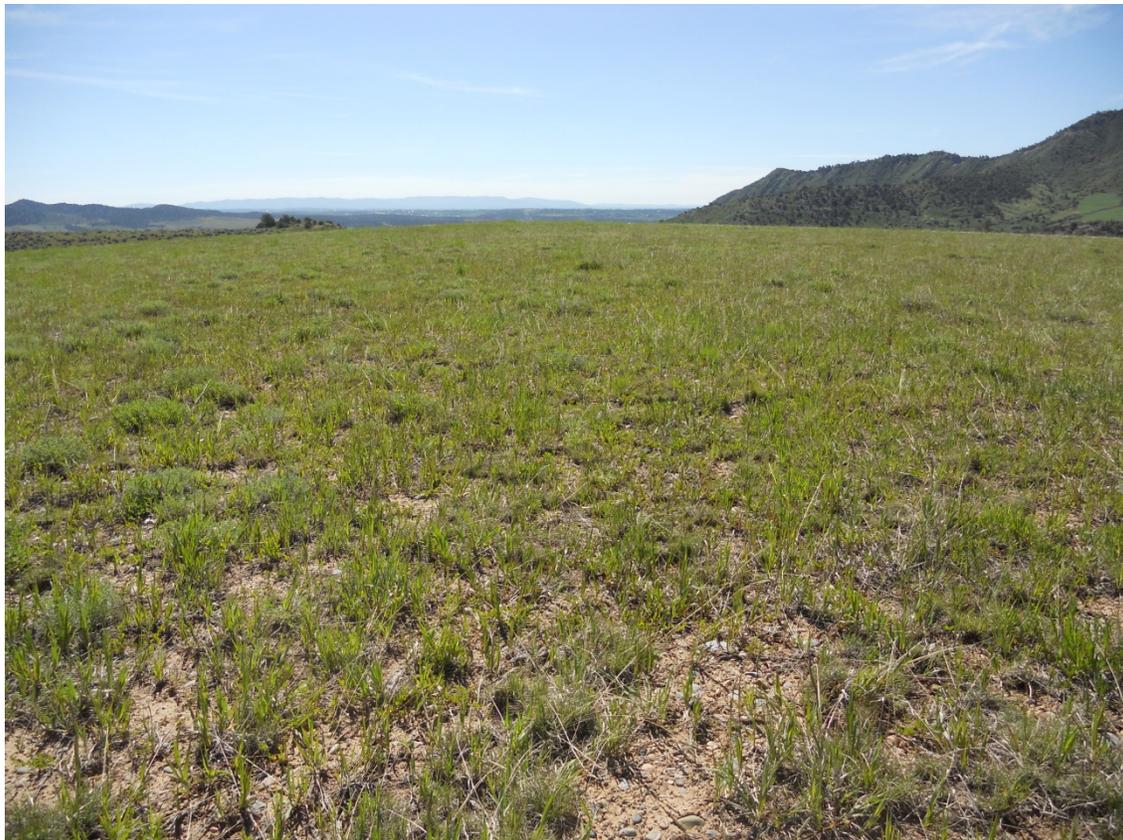
The top of the disposal cell has a vegetated cover and is in excellent condition (PL-4). No evidence of settling, slumping, erosion, or deep rooted vegetation was observed.

*DUD 6/2015. PL-4. Vegetation on disposal cell cover.*

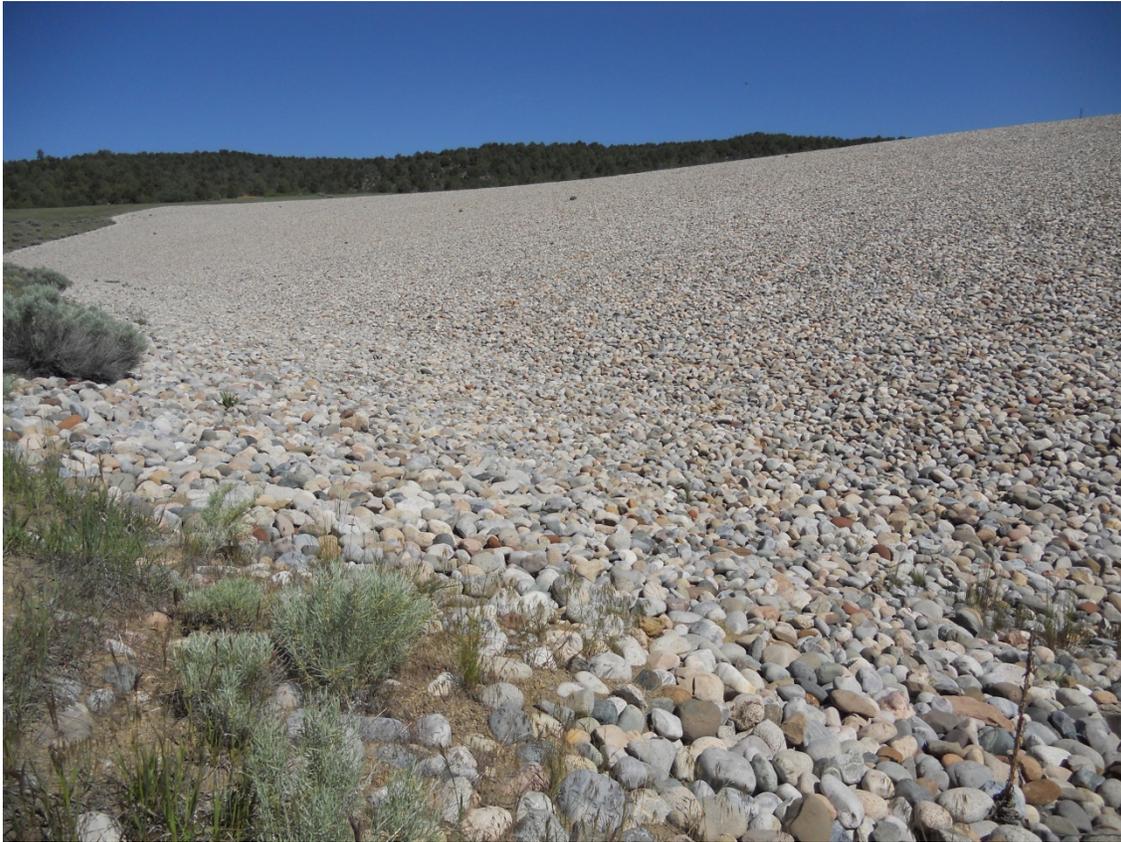
The riprap-covered side slopes of the disposal cell are in good condition (PL-5). Significant disturbances resulting from natural processes, such as subsidence, rock deterioration, or slope failure, were not observed. Some rocks have moved at the toe of the slope on the north side of the cell, creating a linear depression approximately 18 feet long and 2.5 feet deep (PL-6). This area will continue to be monitored.

*DUD 6/2015. PL-5. Side slope of the cell.*

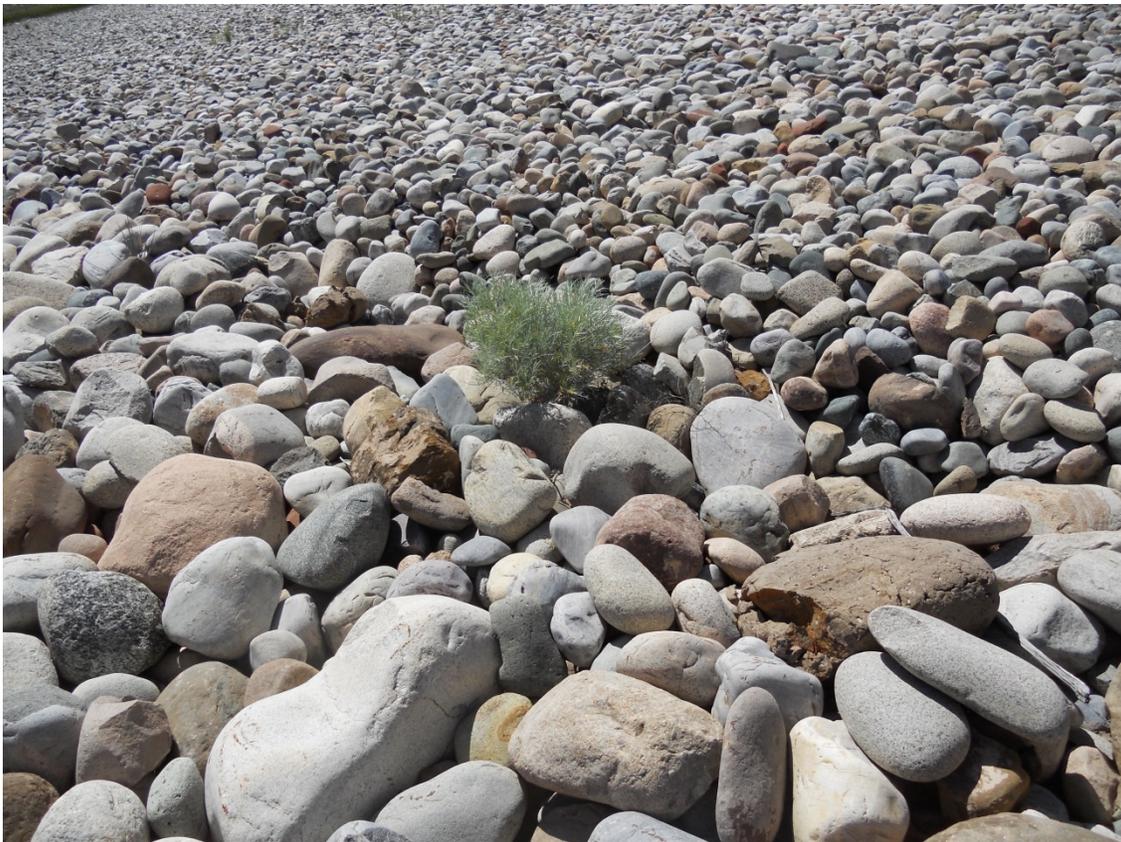
*DUD 6/2015. PL-6. Rock displacement on cell.*

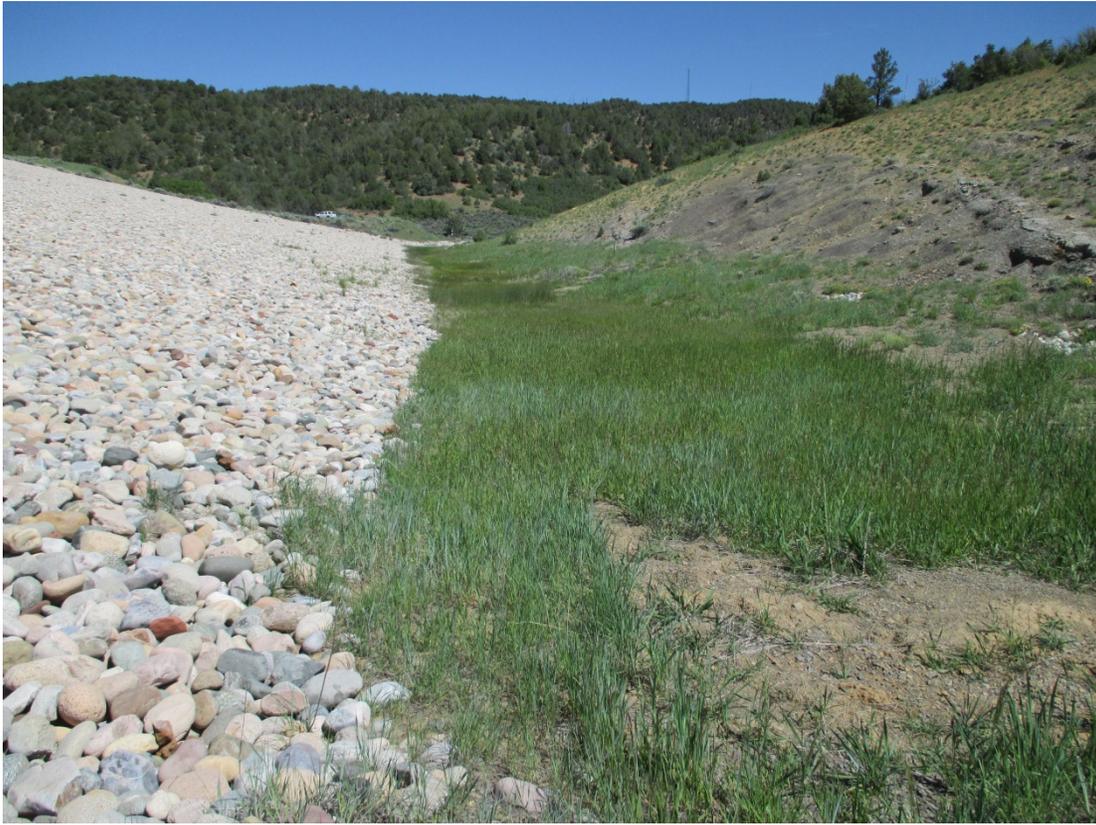
Rock-armored drainage ditches are constructed beneath the toe of the side slope on the northwest, south, and east sides of the disposal cell. Storm water is directed into these ditches and conveyed away from the disposal site into natural drainages. The ditches have sufficient depth and rock protection to carry runoff from a probable maximum precipitation (PMP) event. Erosion and mass wasting occurs on some of the steep slopes above these channels. These gullies occasionally become active during large storms, but they do not threaten the integrity of the disposal cell. The eroded sediment is deposited in the rock-armored channel, creating locales favoring plant growth (PL-7). As no excessive sediment deposits or vegetation were observed during the inspection, the performance of the drainage ditches would not be compromised in a PMP event. The ditches will continue to be monitored.

*DUD 6/2015. PL-7.Ditch No. 1.*

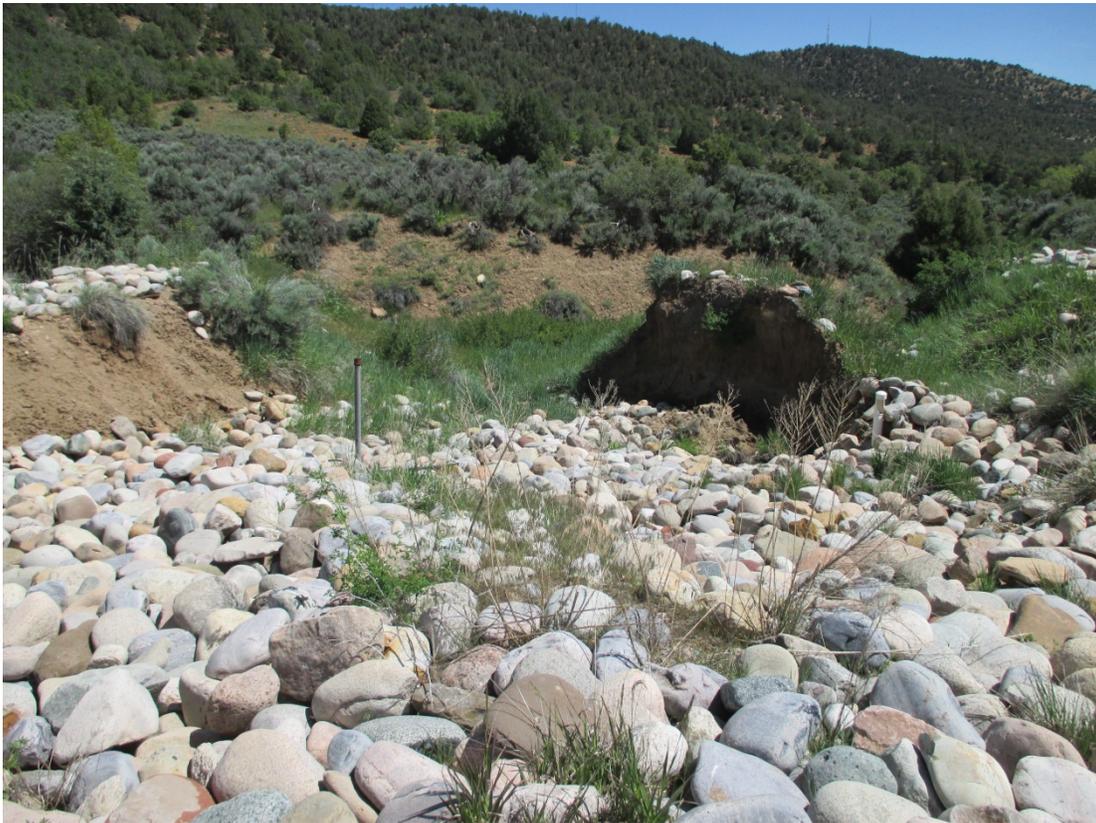
The riprap-covered outflows of the ditches were designed to self-armor, and no significant changes to these areas were observed in 2015 (PL-8). Channels below the outflows are also monitored, and they were stable and in good condition (PL-9).

*DUD 6/2015. PL-8. Self-armoring outlet of Ditch No. 1.*

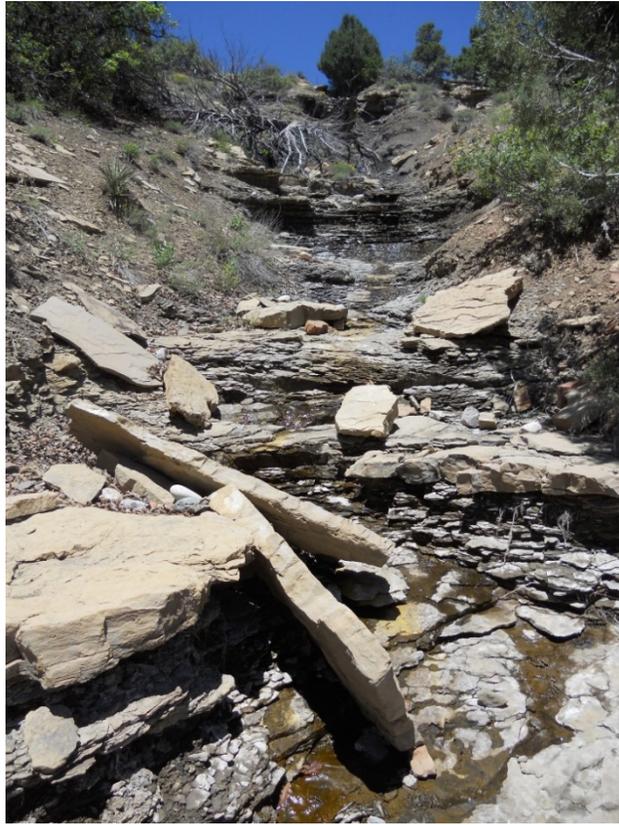
*DUD 6/2015. PL-9. Outlet of southeast outflow.*

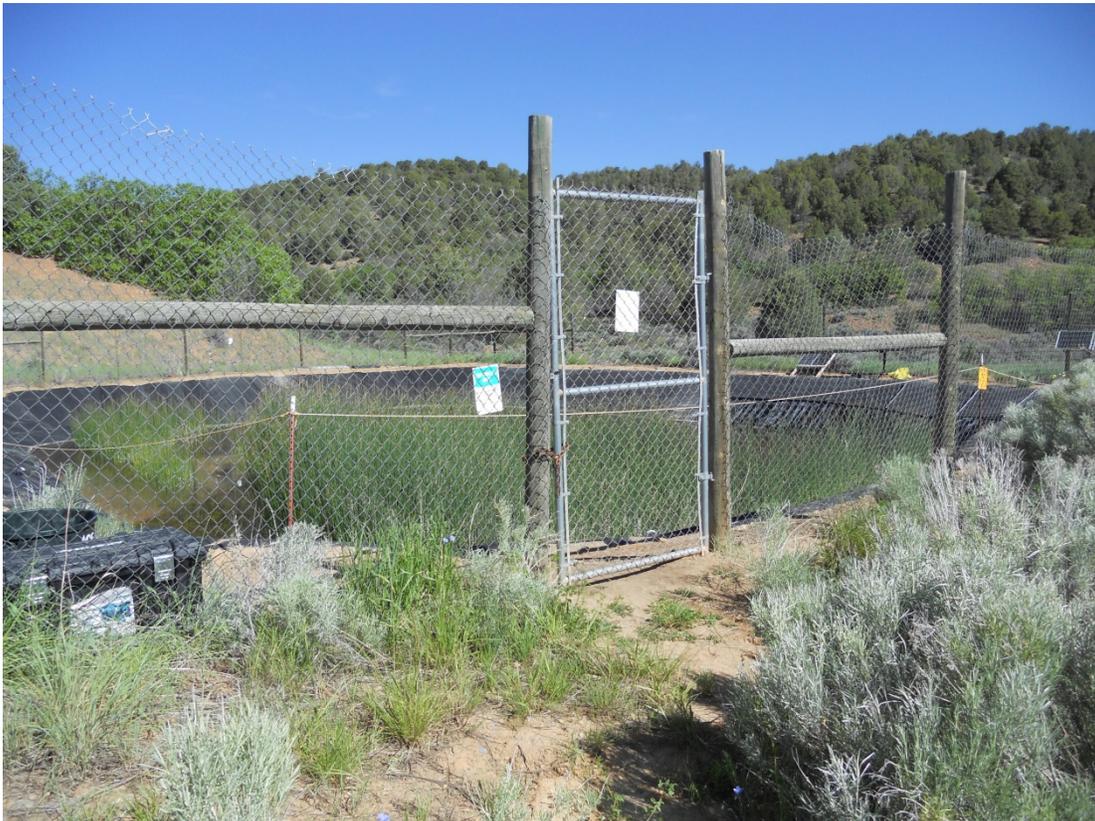
The holding pond in the northeast corner of the disposal cell was in good condition (PL-10). The fence was bent in one place, but no sign of access was evident. A shed that previously housed the pond's pump and instruments had been demolished, but the cases enclosing the instruments were in good condition. The holding pond system is scheduled to be removed in 2016.

*DUD 6/2015. PL-10. Holding pond and fence.*
