2.0 Edgemont, South Dakota, Disposal Site

2.1 Compliance Summary

2.4 Inspection Results

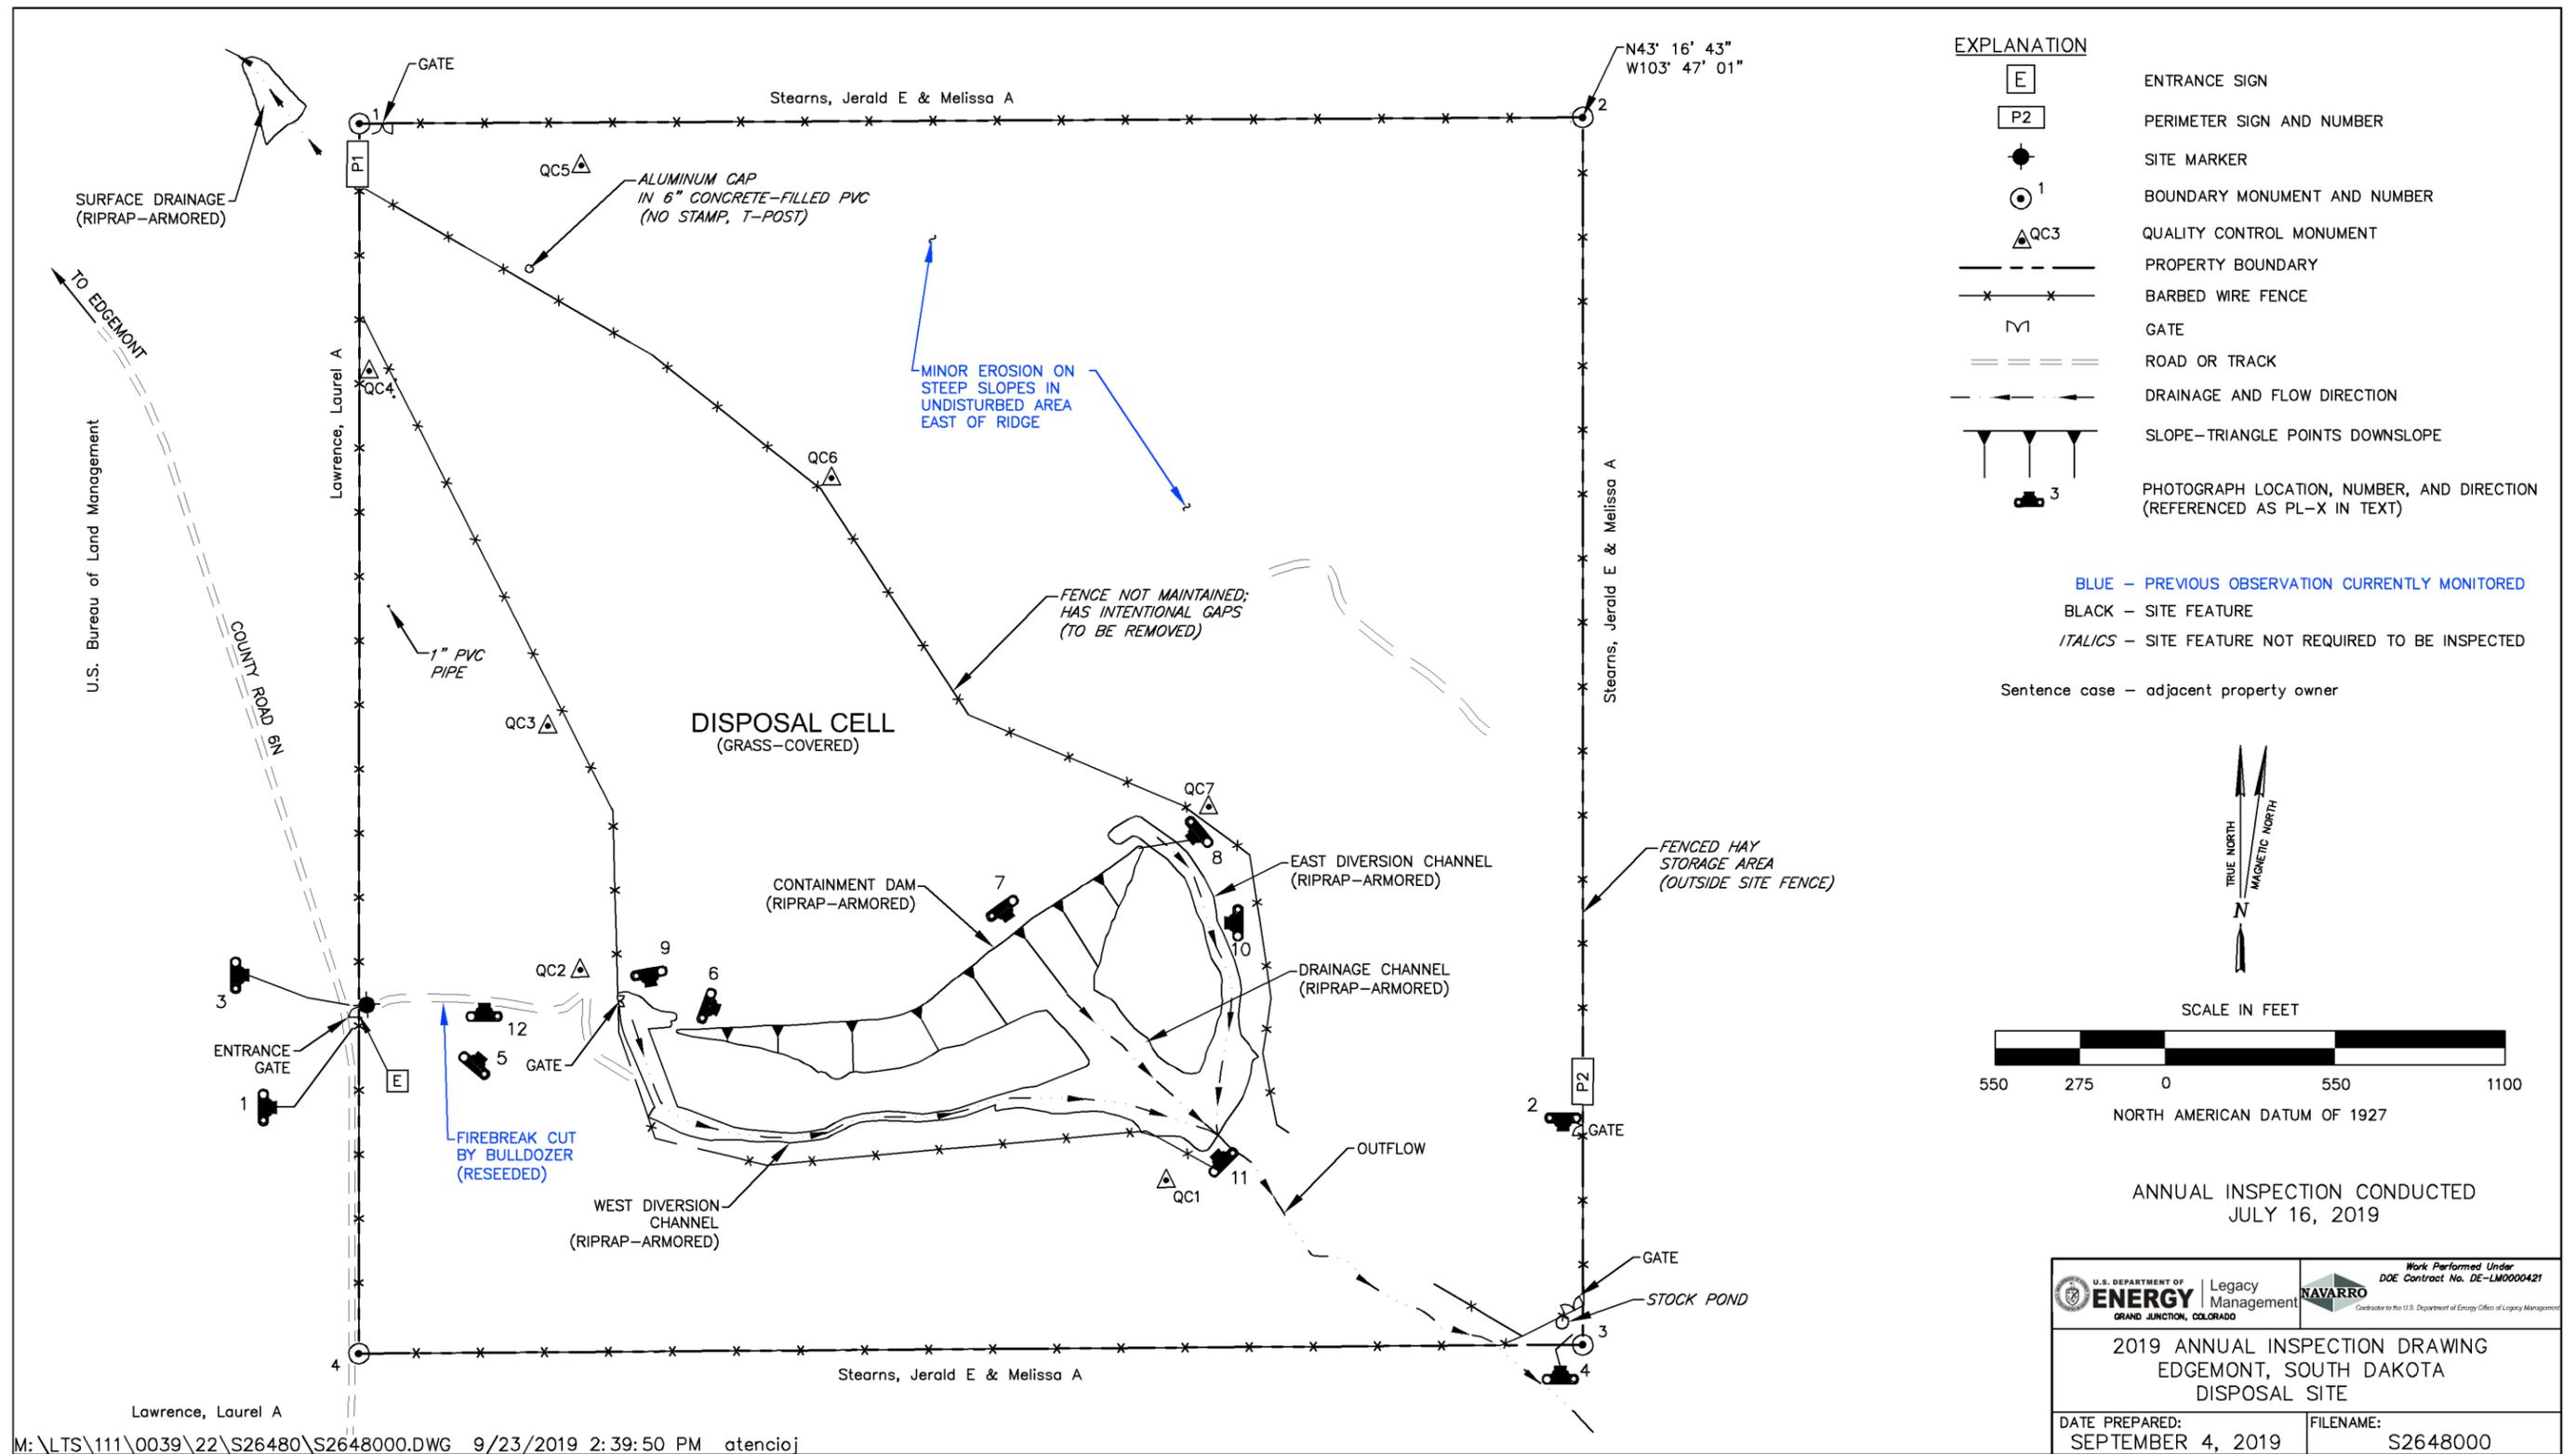
Figure 2-1. 2019 Annual Inspection Drawing for the Edgemont, South Dakota, Disposal Site

Figure 2-1 shows the locations of site features in black, including site surveillance features and inspection areas. Site features that are present but not required to be inspected are shown in italic font. Observations from previous inspections that are currently monitored are shown in blue text. There were no new observations in 2019. Inspection results and recommended maintenance activities associated with site surveillance features are included in the following subsections. Photographs to support specific observations are identified in the text and in Figure 2-1 by photograph location (PL) numbers. The photographs and photograph log are presented in Section 2.9.

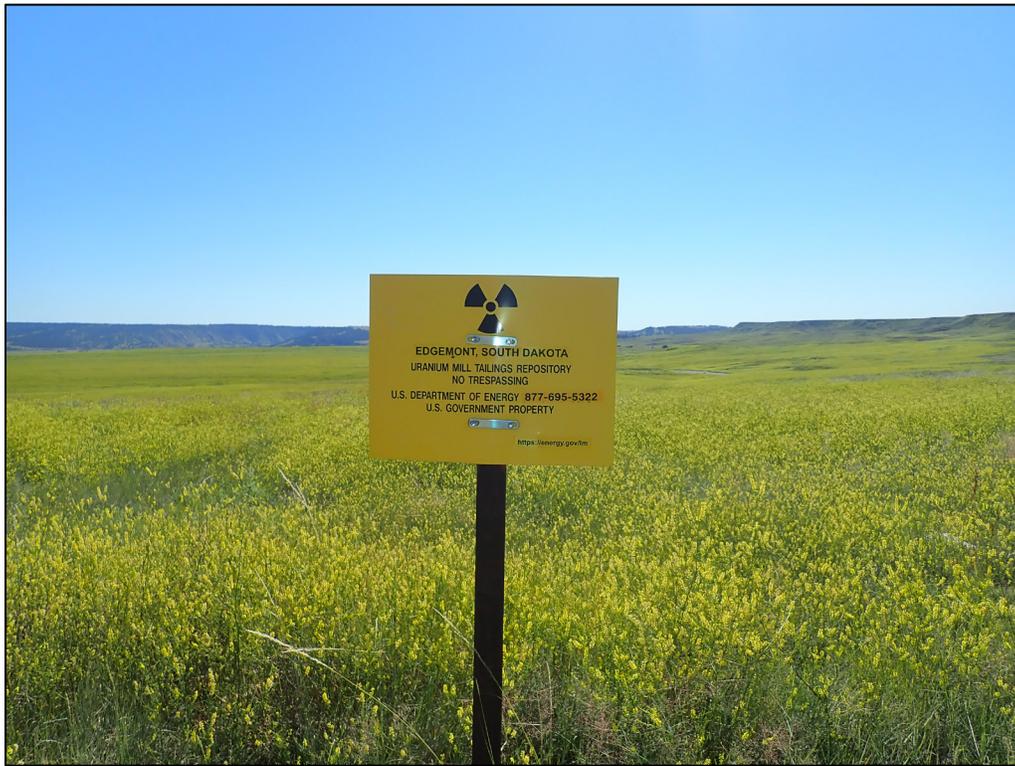
PL-1. Entrance Sign

Access to the site is from Fall River County Road 6N. The entrance sign is mounted on a steel post set in concrete (PL-1). The tubular metal entrance gate was secured by a locked chain and was intact. The perimeter fence features three additional wire gates (1) at the northwest corner of the property, (2) approximately 700 feet north of the southeast corner, and (3) at the southeast corner of the site. All gates were closed and intact. The telephone number posted on the entrance sign was updated during the inspection. No maintenance needs were identified.

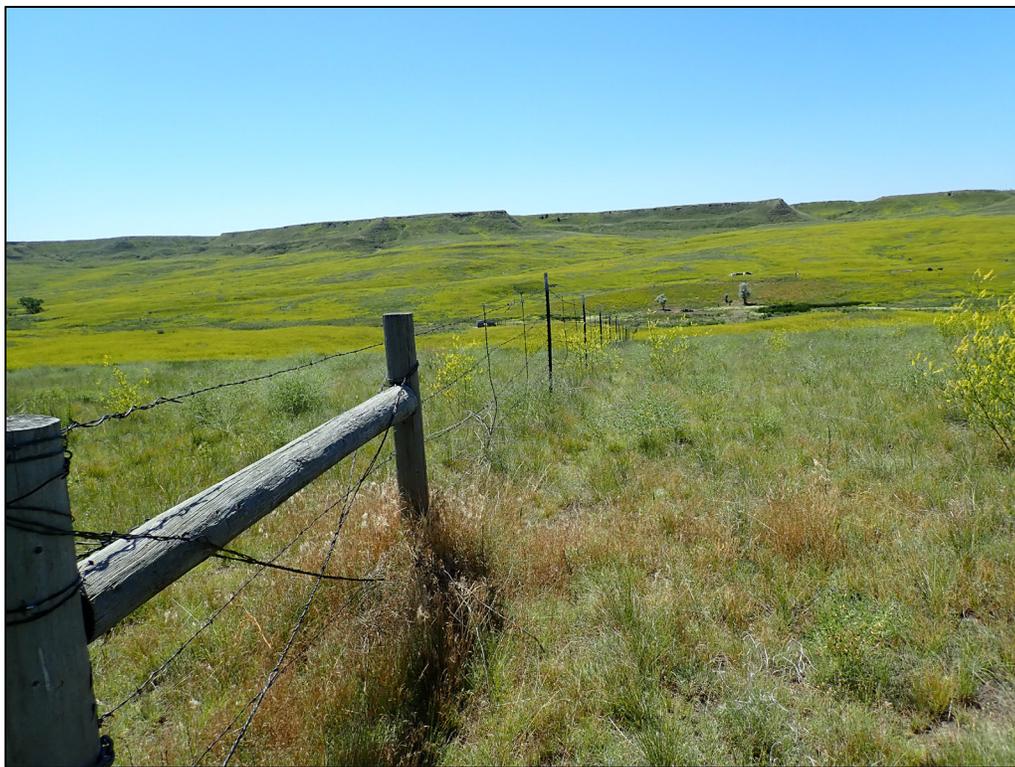
PL-2. East Fence Line

A four-strand barbed-wire fence encloses the site, truncating at the southeast corner to allow livestock access to a preexisting stock pond (PL-2). Two perimeter signs are attached to the perimeter fence. No maintenance needs were identified.

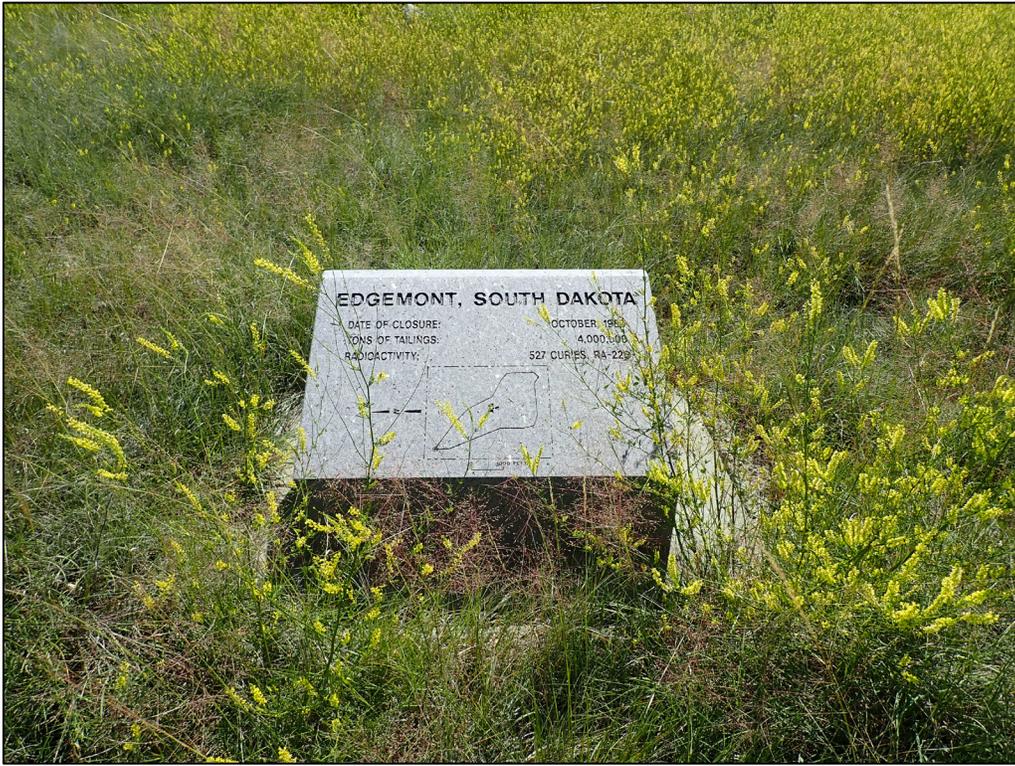
PL-3. Site Marker

The site has one granite site marker just inside the site entrance gate (PL-3). No maintenance needs were identified.

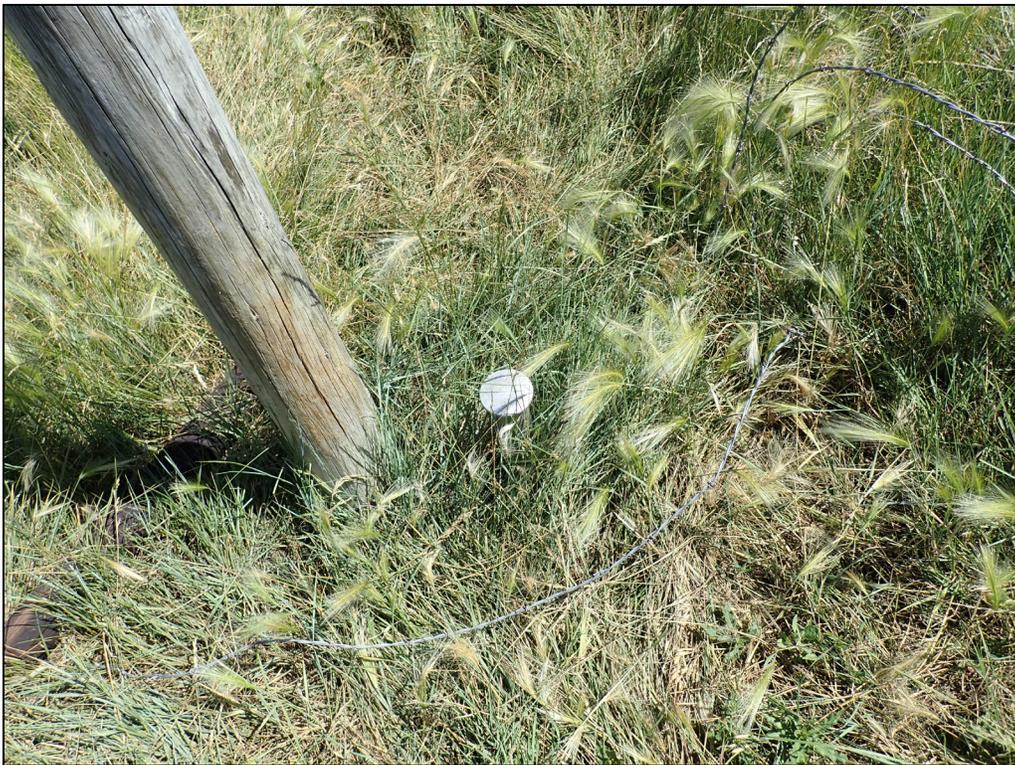
PL-4. Boundary Monument BM-3

There are four boundary monuments, each at a corner of the property (PL-4). All boundary monuments were inspected, and no maintenance needs were identified.

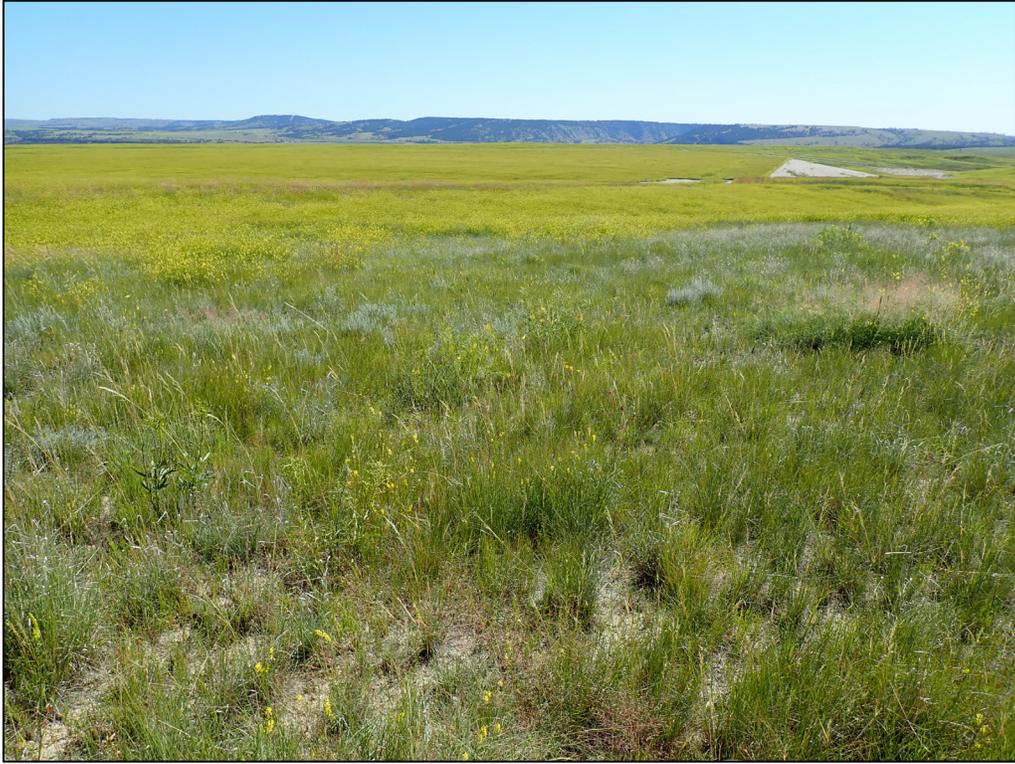
PL-5. Southwest View of Disposal Cell

The grass-covered disposal cell, completed in 1989, occupies 100 acres (PL-5). It showed no signs of erosion, settling, or other modifying processes that might affect its integrity. No maintenance needs were identified.

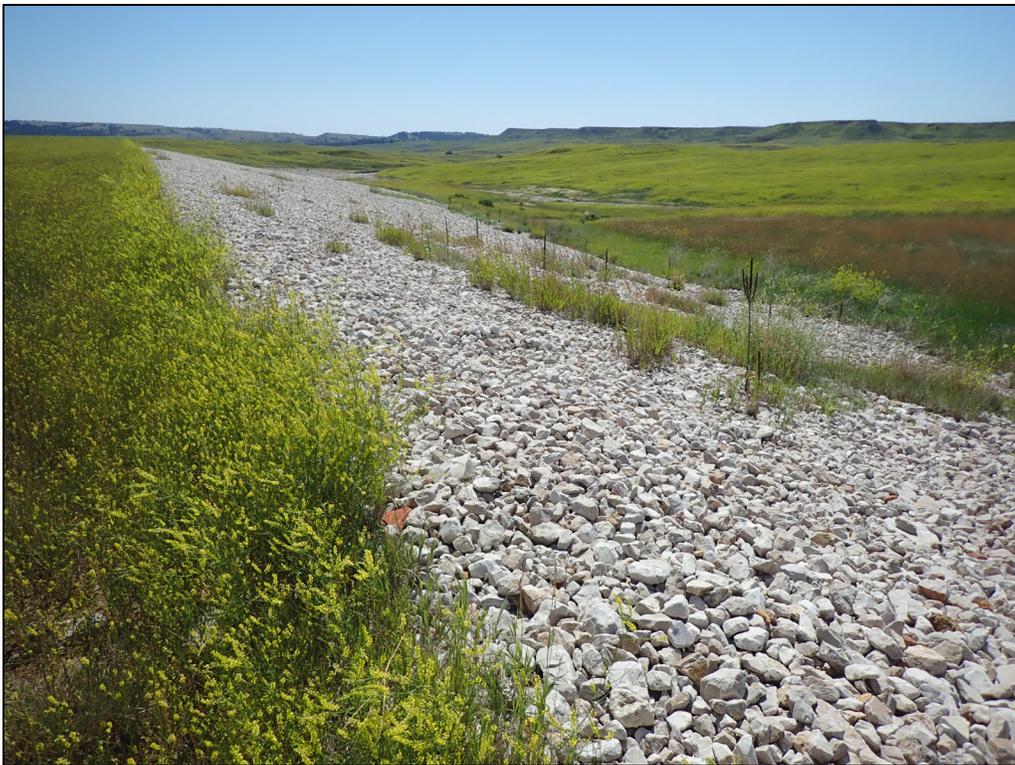
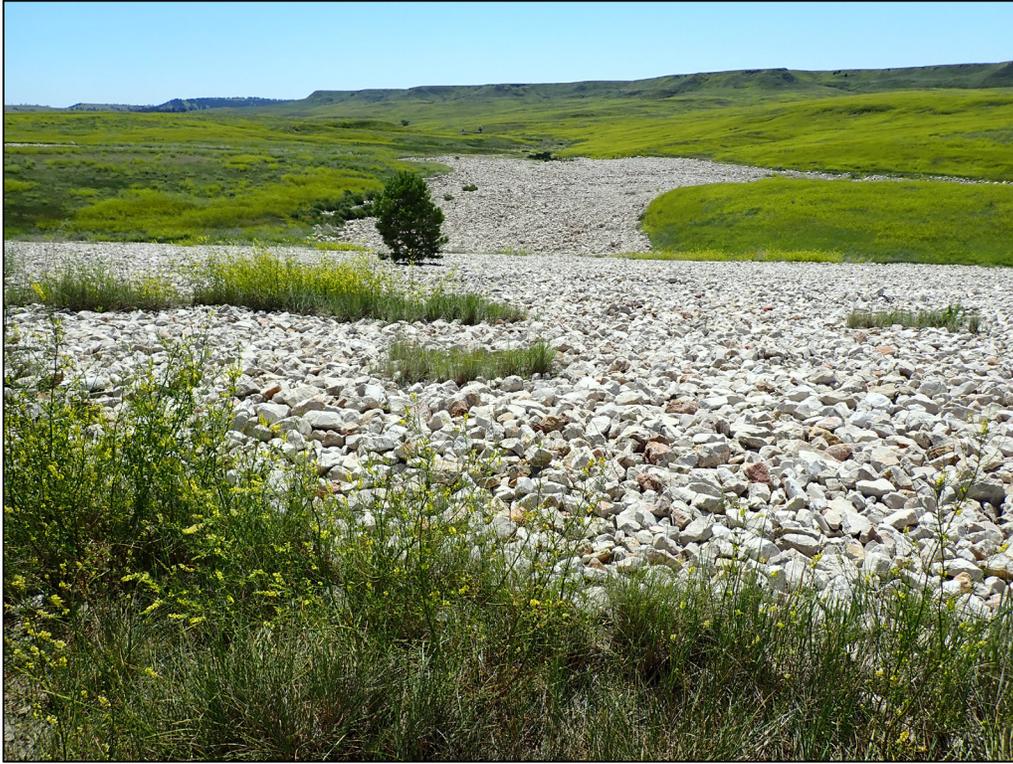
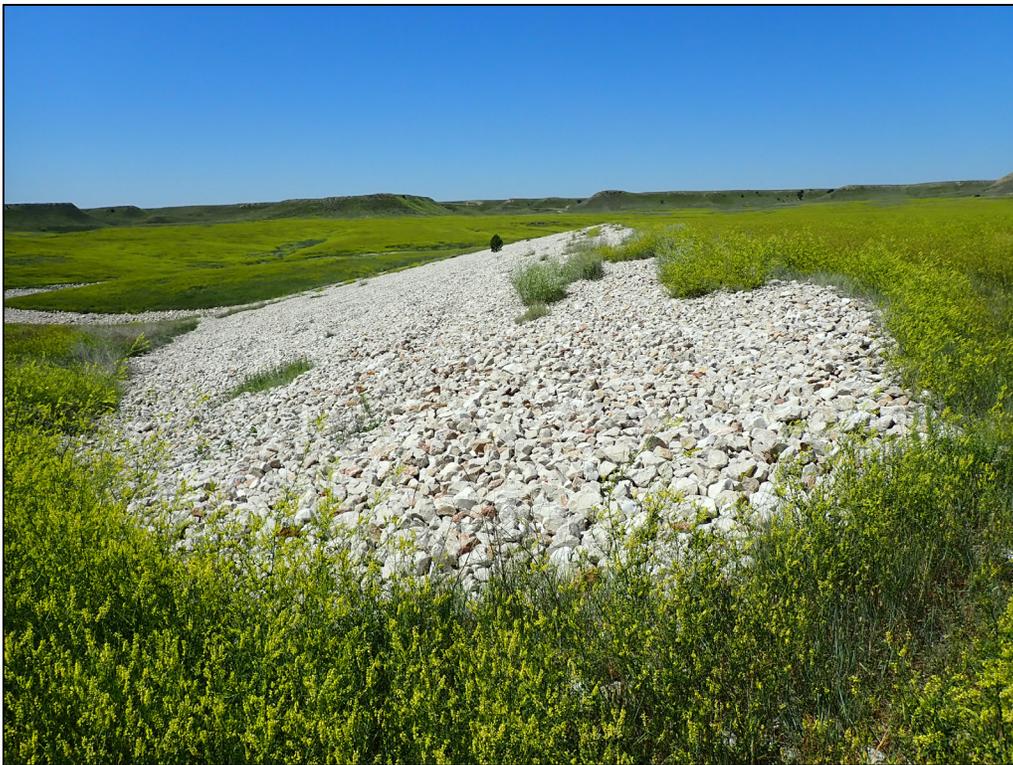
The face of the containment dam, the steepest man-made slope onsite, is covered with riprap and showed no evidence of erosion, settling, slumping, or other modifying processes (PL-6, PL-7, and PL-8). Scattered plants, mostly grass and annual weeds, grow in the riprap. These plants do not threaten the stability or function of the containment dam.

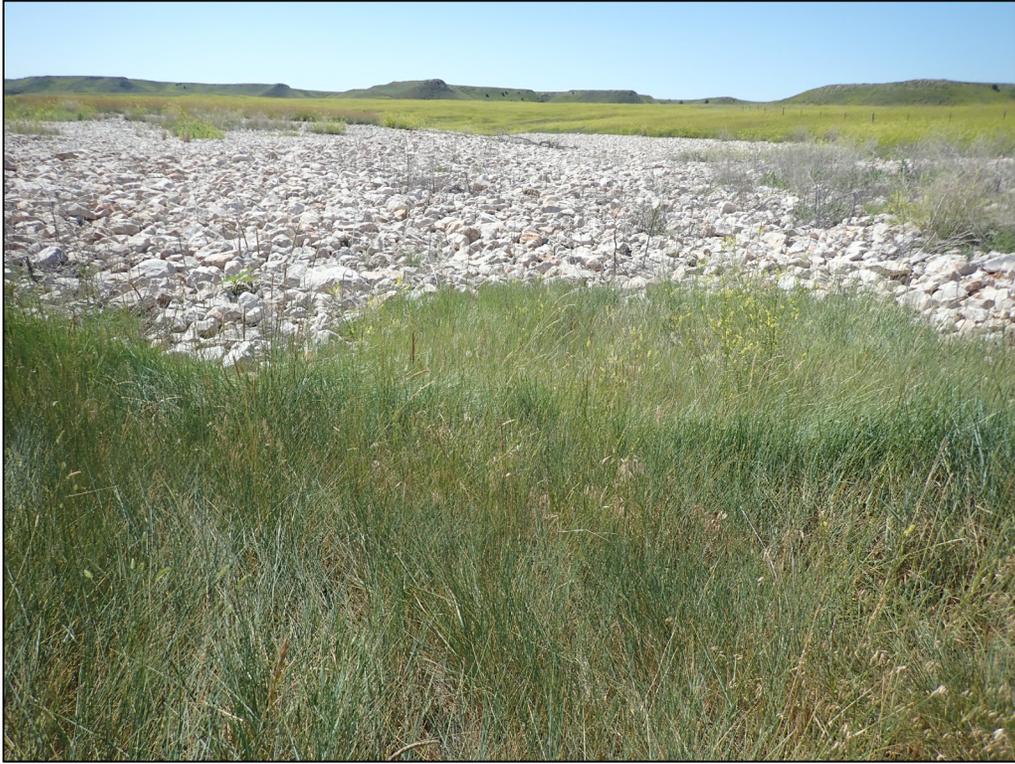
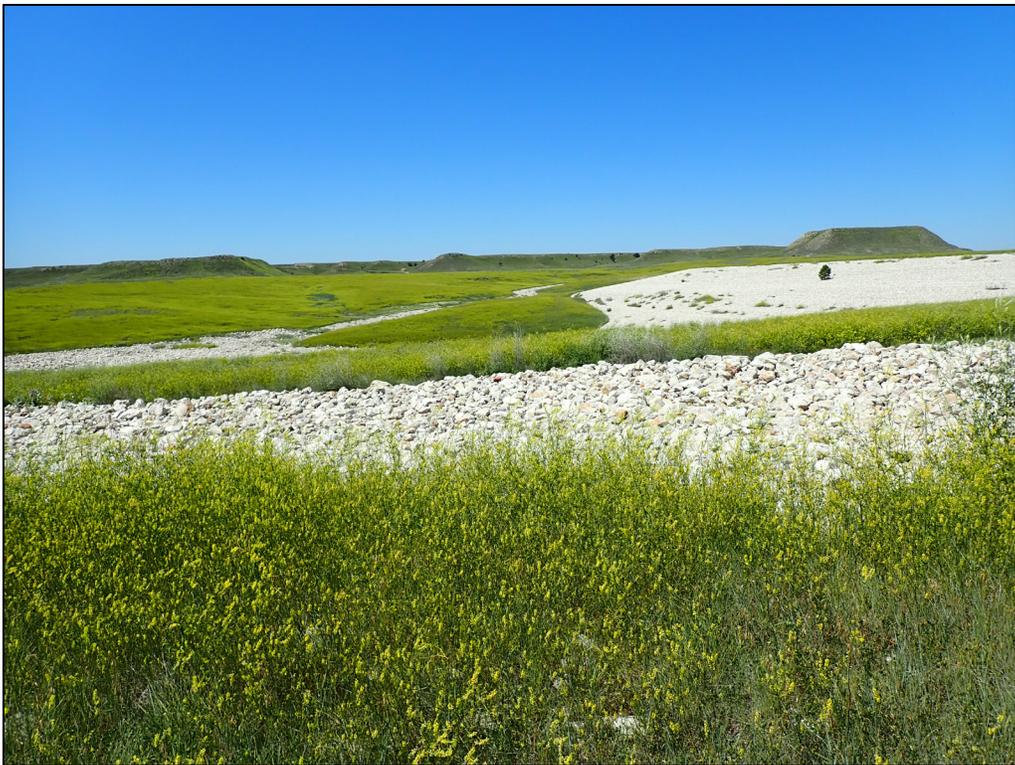
The diversion and drainage channels are covered with grass on their upslope portions (these are gentle swales on each side of the disposal cell) and armored with riprap on their downslope portions and on steeper slopes (PL-9 and PL-10). Minor amounts of vegetation are present in the riprap. The vegetation helps to stabilize these areas and does not impair the function of the channels. Wetland vegetation is present at the base of the drainage channel outflow (PL-11). No maintenance needs were identified.

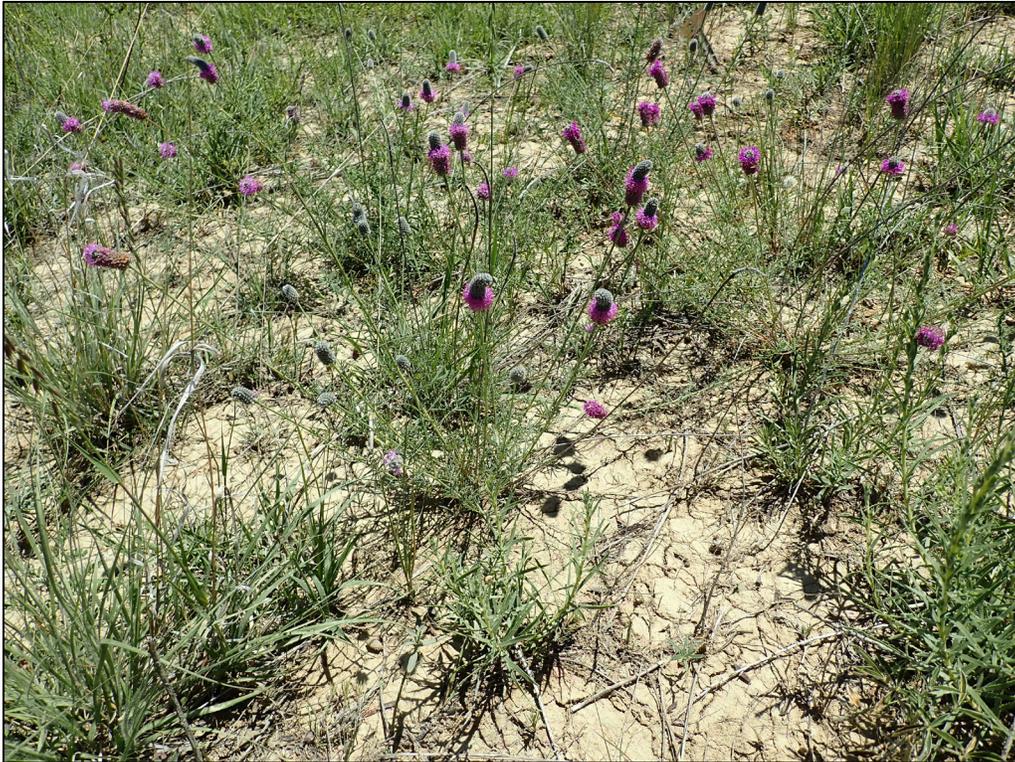
PL-12. Pollinator Plant Species Blooming

The balance of the site consists of undisturbed areas covered with native shrubs, grasses, and forbs and formerly disturbed areas covered primarily with seeded grasses and annual weeds. Blooming pollinator species were also observed (PL-12). Some minor erosional features are present on steep slopes in an area isolated from the disposal cell; these features were stable. No maintenance needs were identified.
