SUBJECT: Transmittal of the September 2011 Fernald Preserve On-Site Disposal Facility Inspection Forms

On-Site Disposal Facility Inspection Report

September 2011

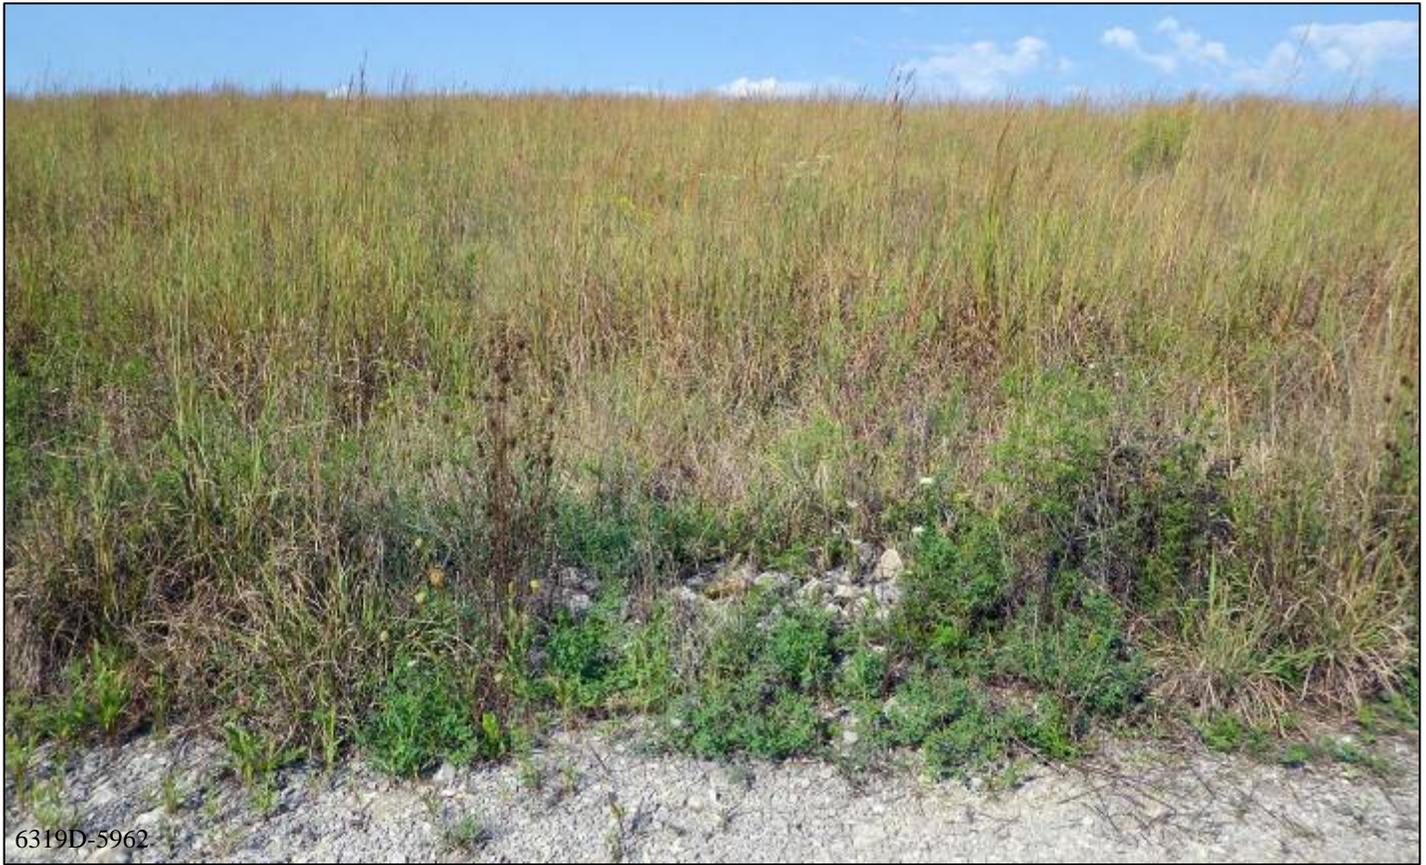
6319D-5962

East Face Cell 1

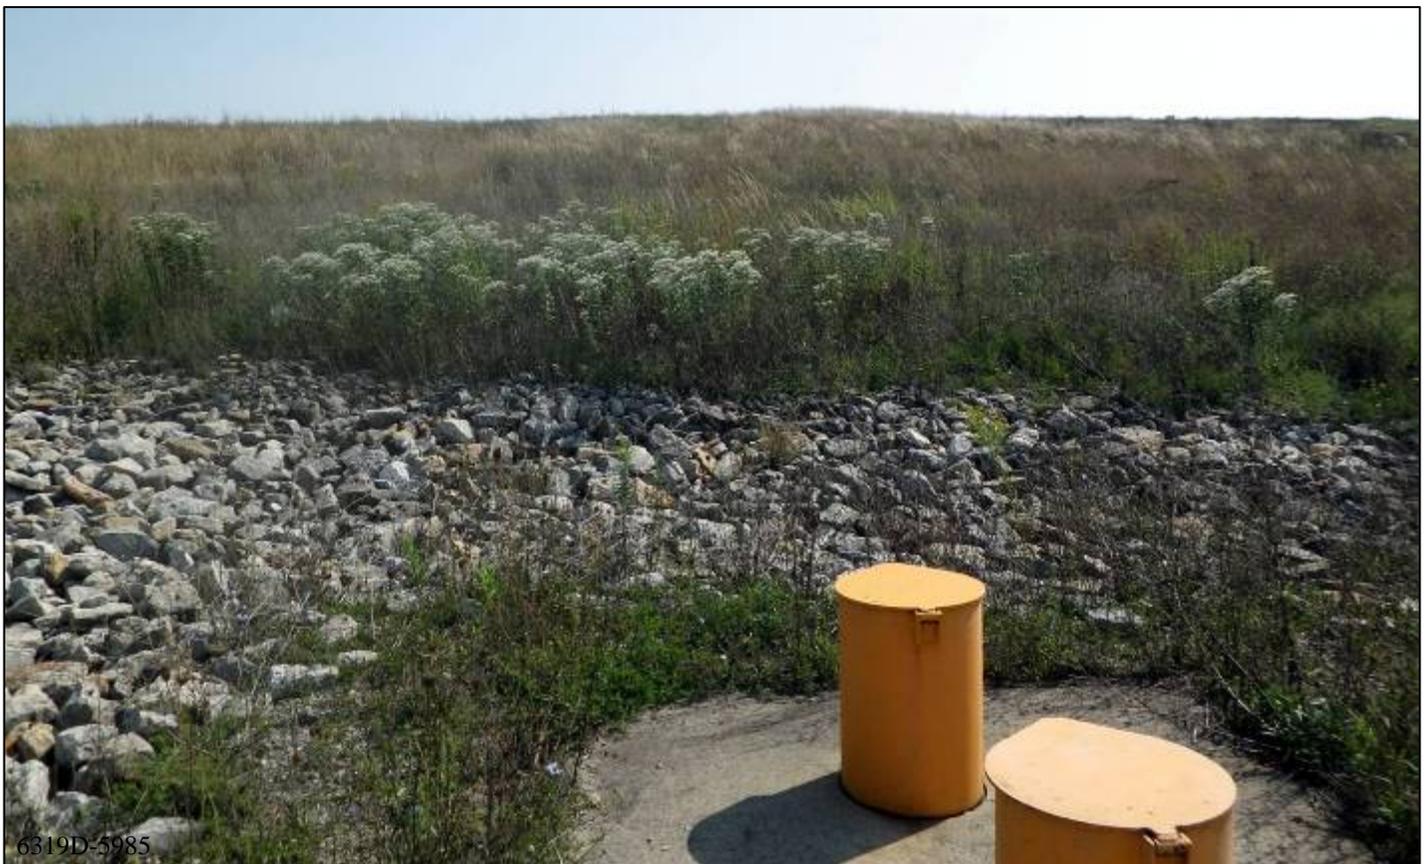
6319D-5985

West Face Cell 1

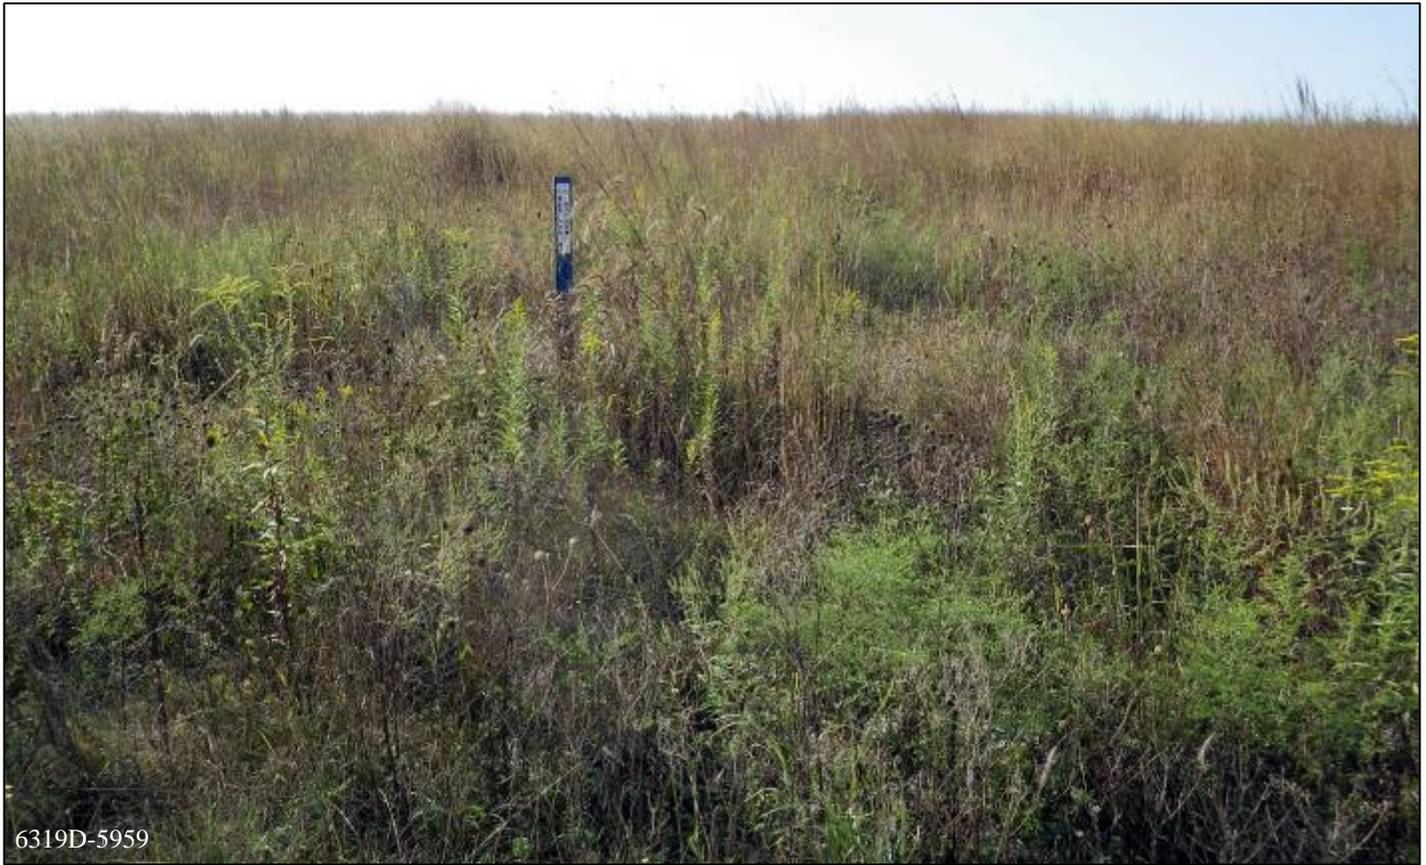
6319D-5959

North Face Cell 1

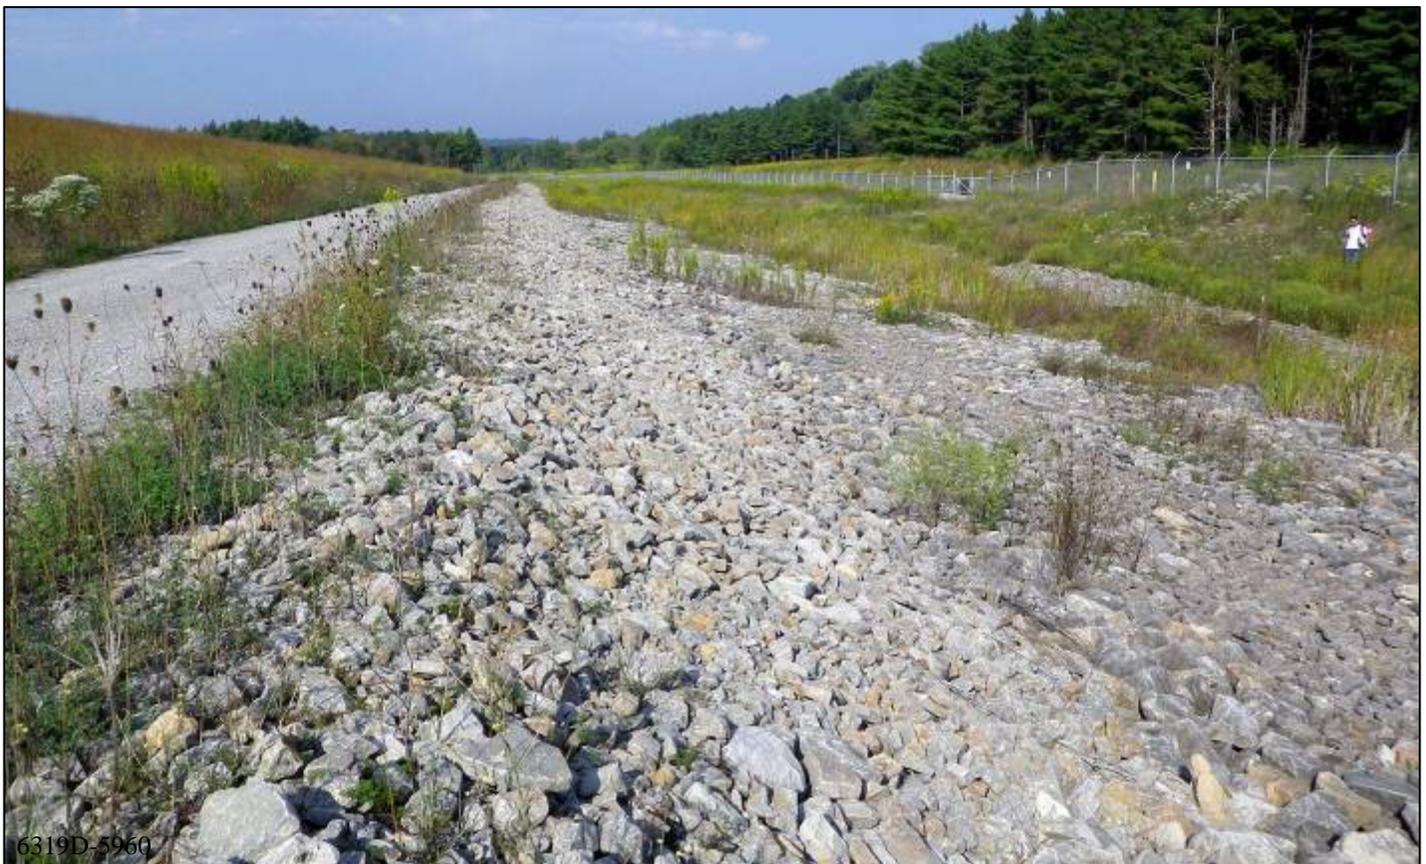
6319D-5960

North Drainage (looking west)

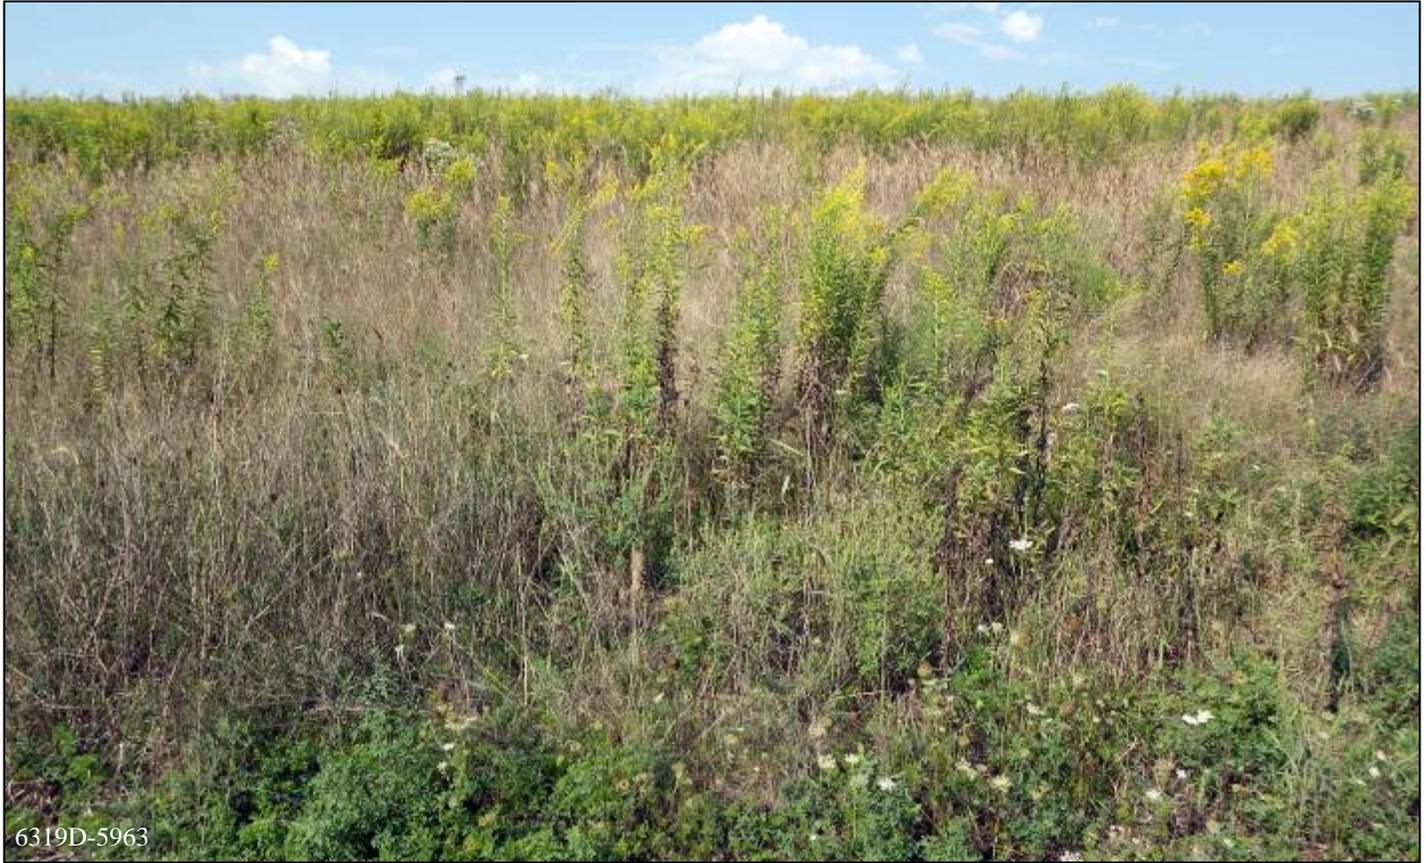
East Face Cell 2

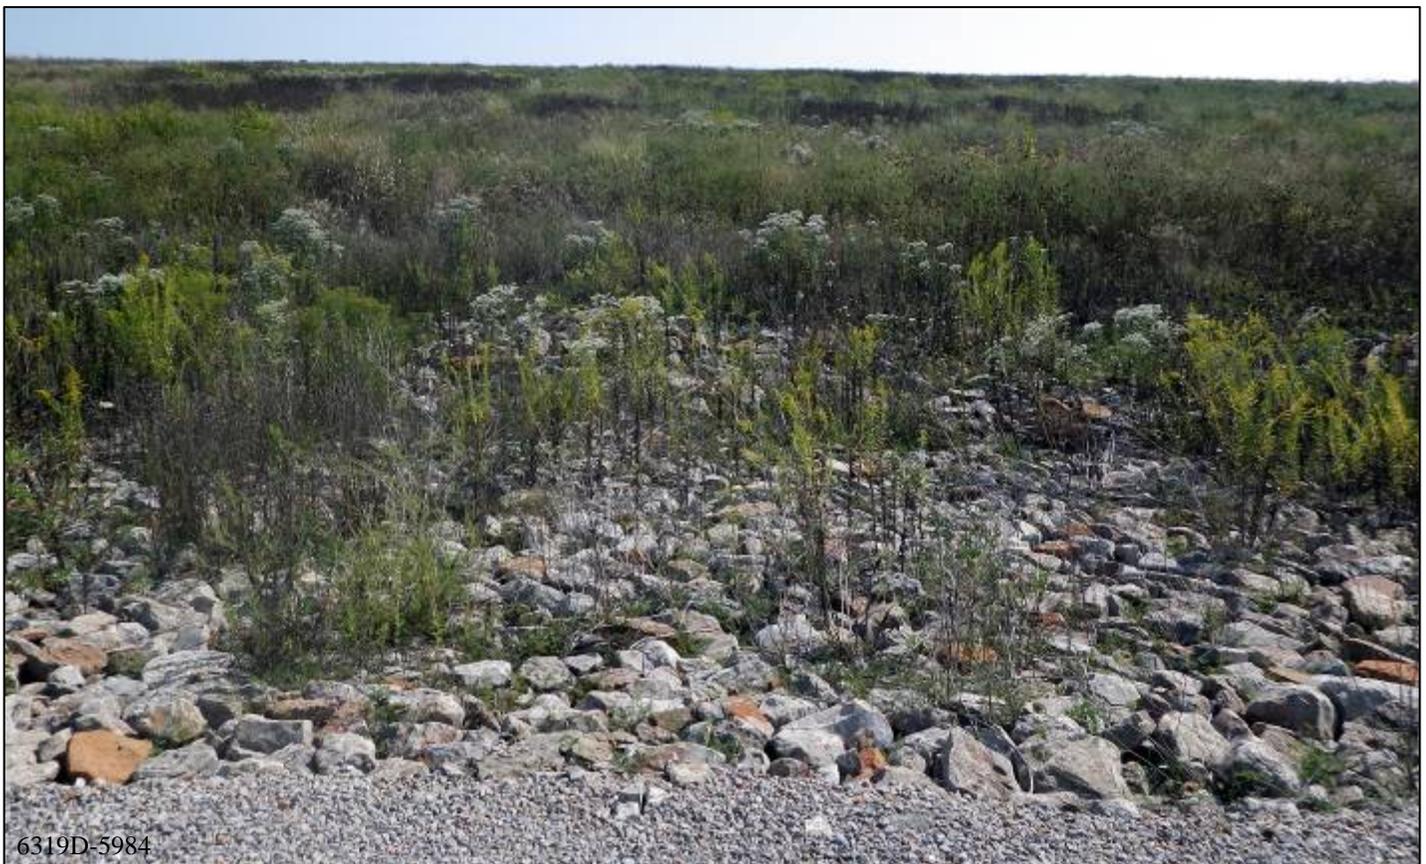
West Face Cell 2

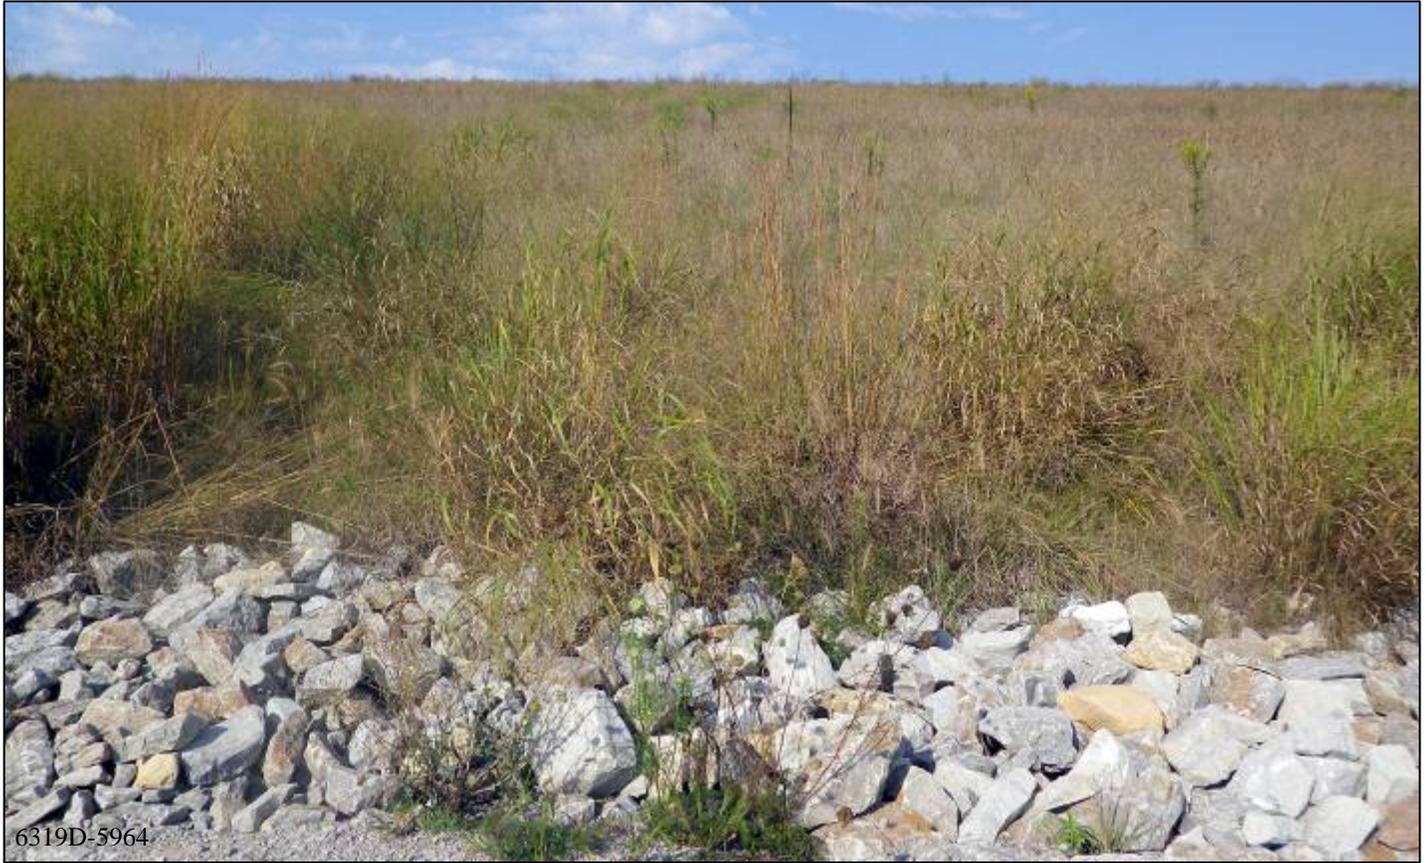
6319D-5964

East Face Cell 3

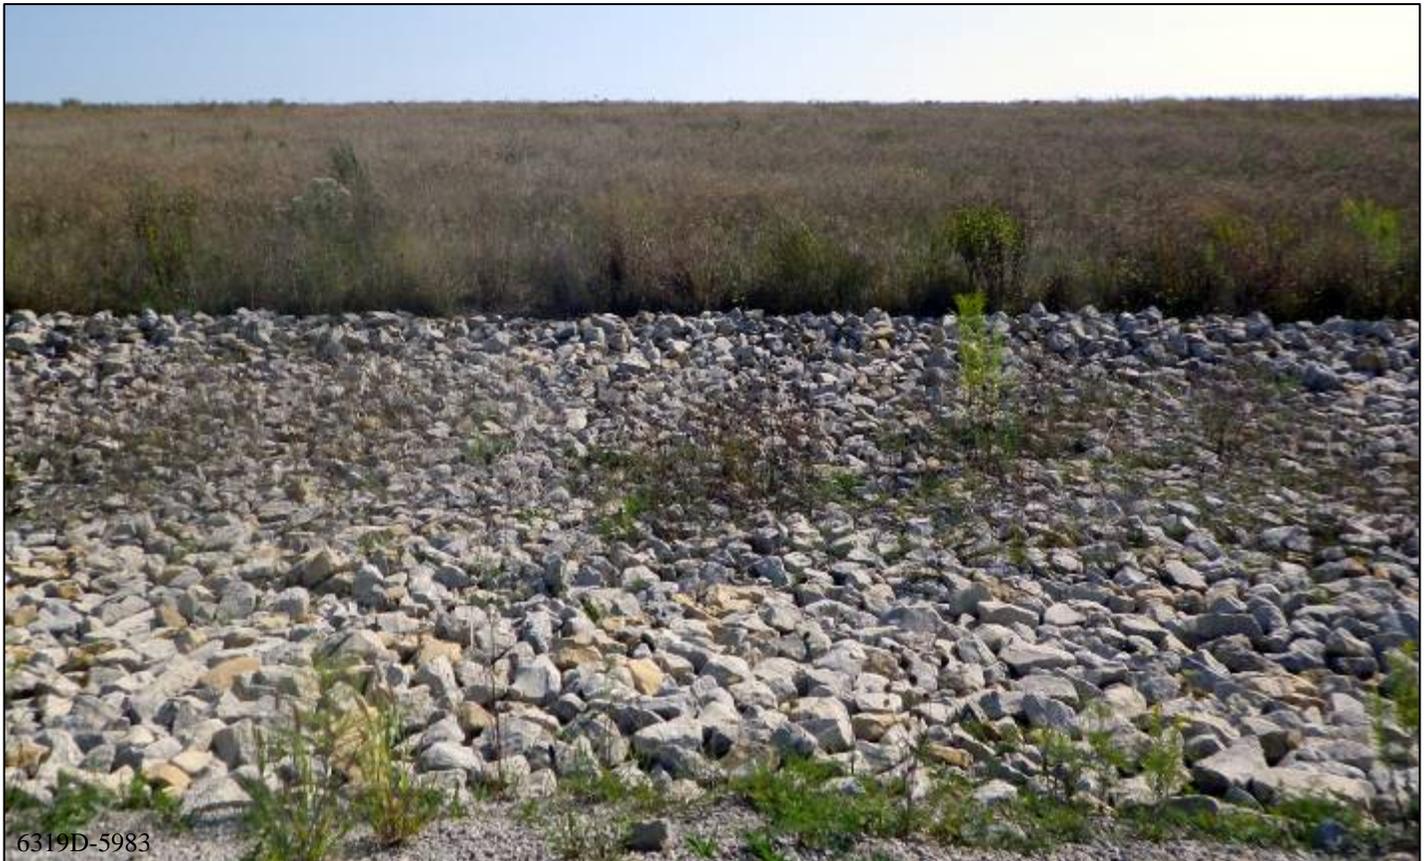
6319D-5983

West Face Cell 3

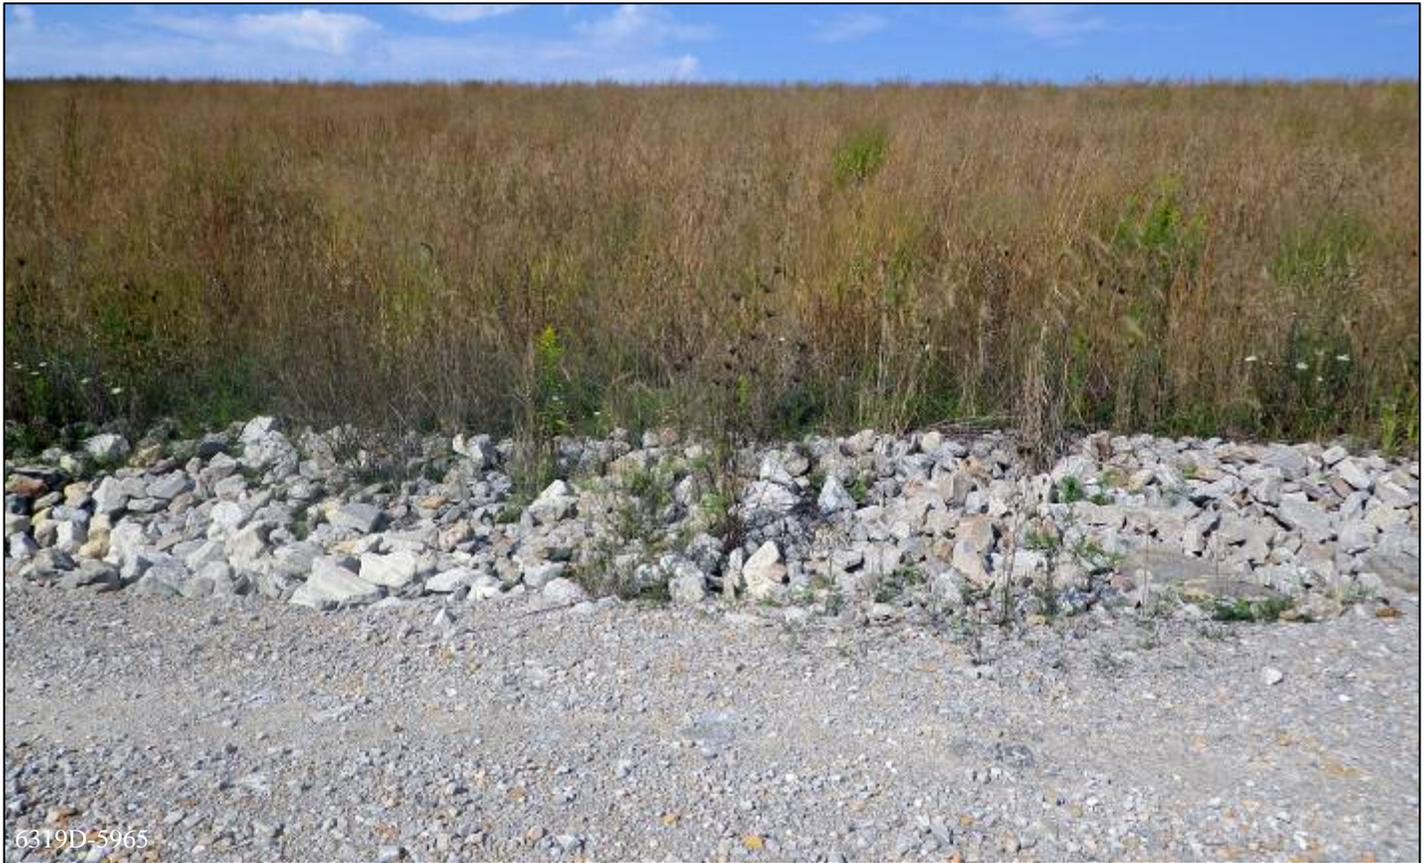
East Face Cell 4

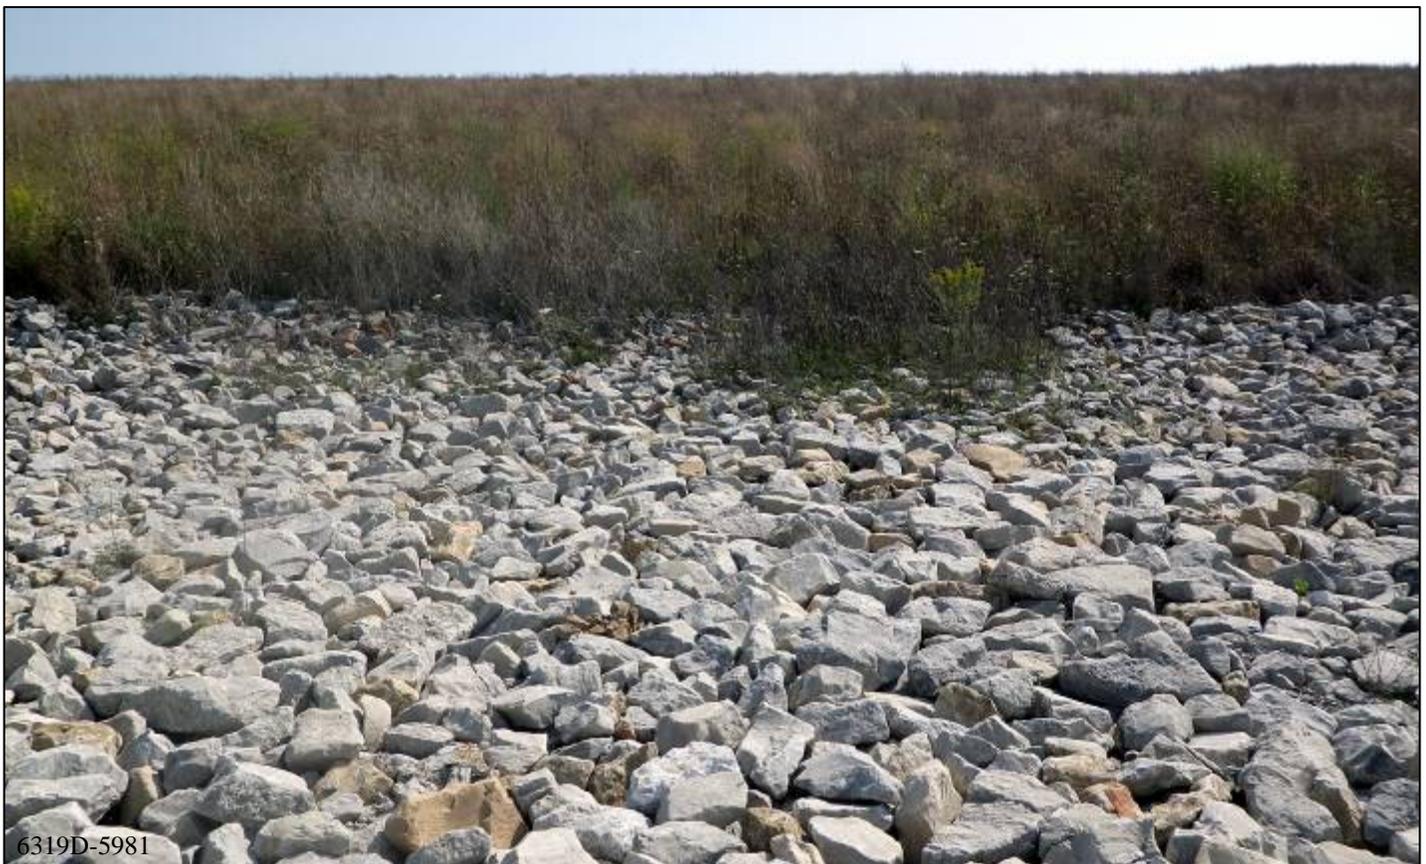
West Face Cell 4

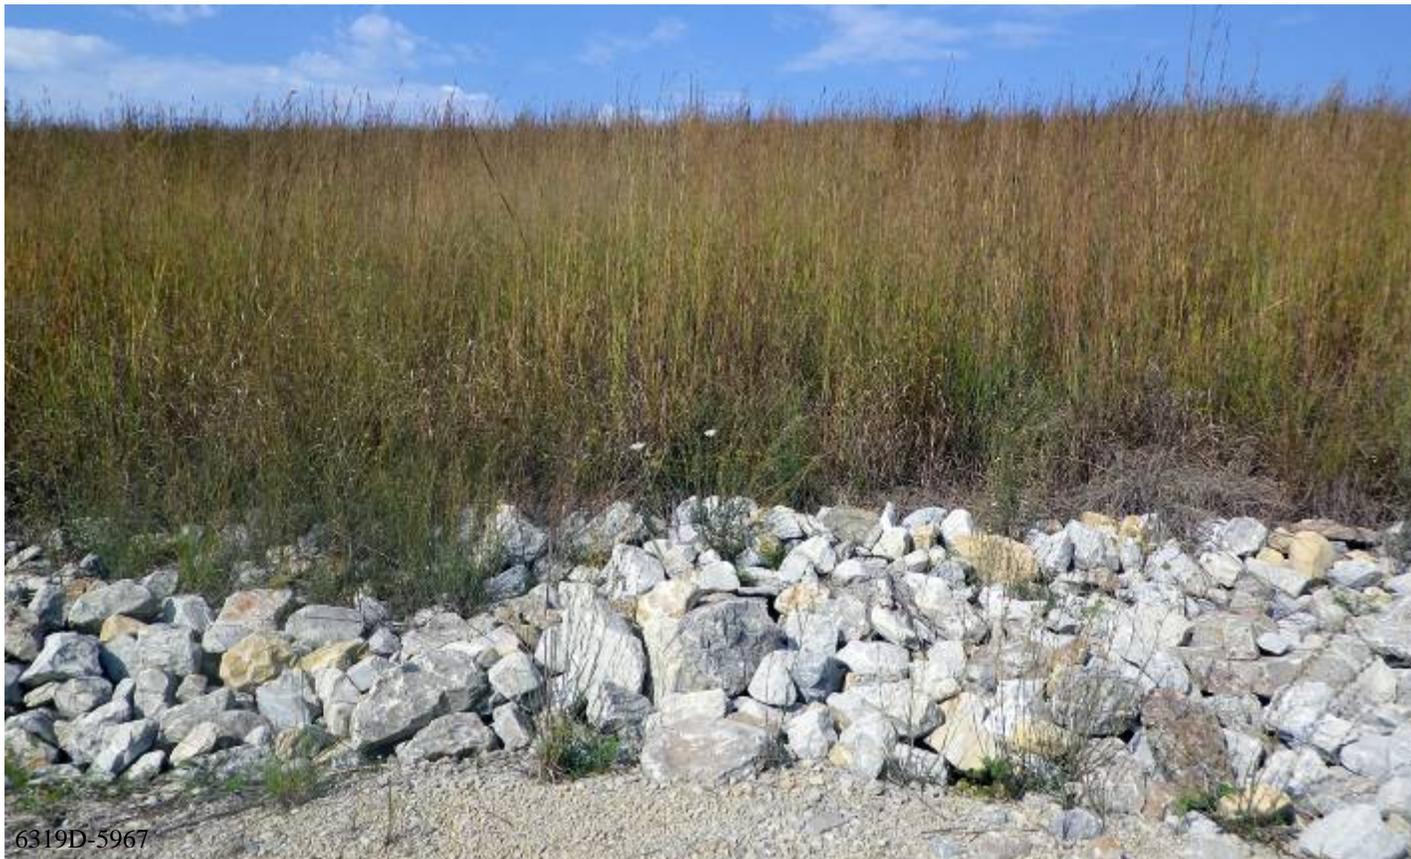
East Face Cell 5

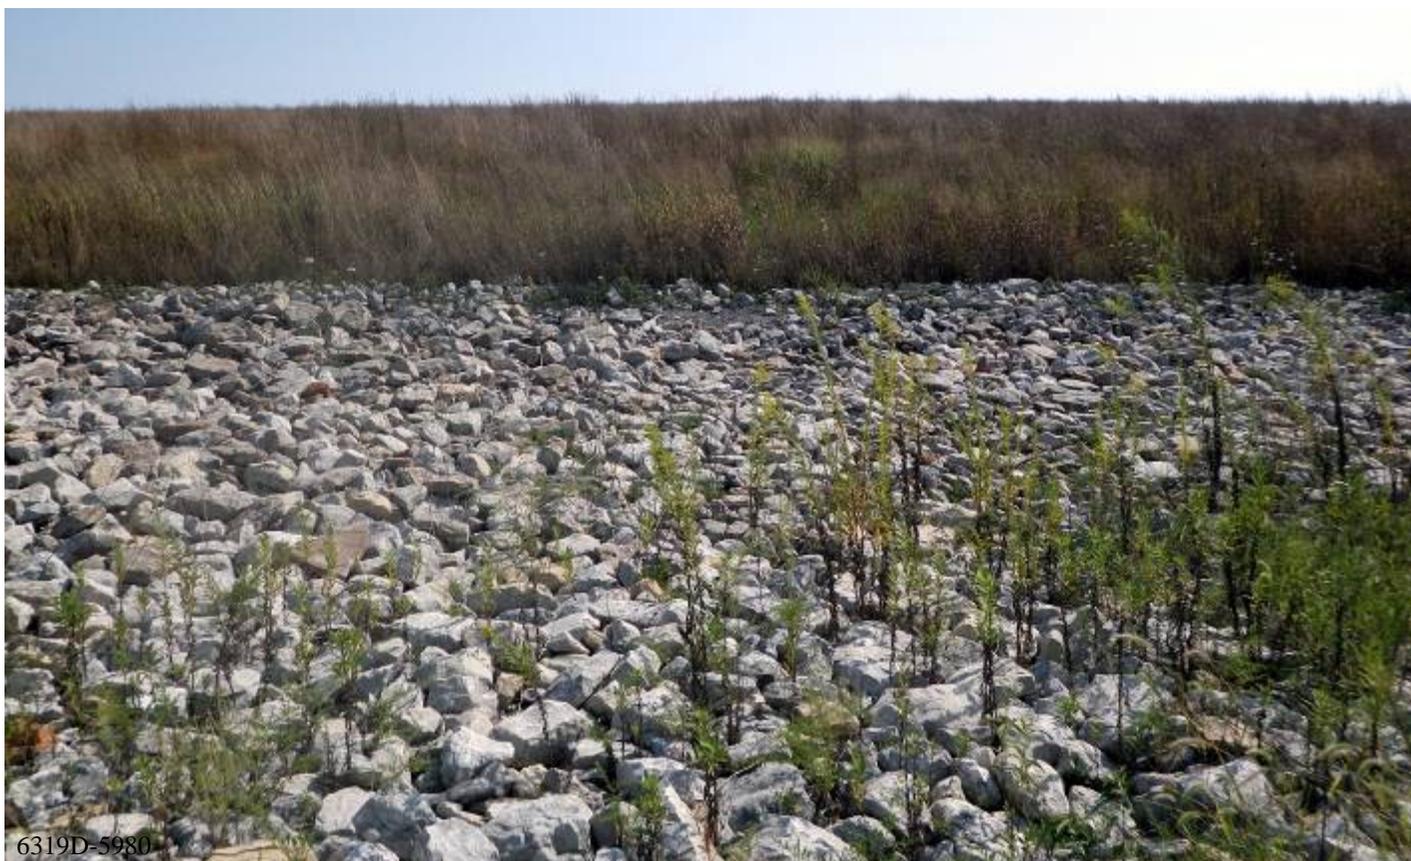
West Face Cell 5

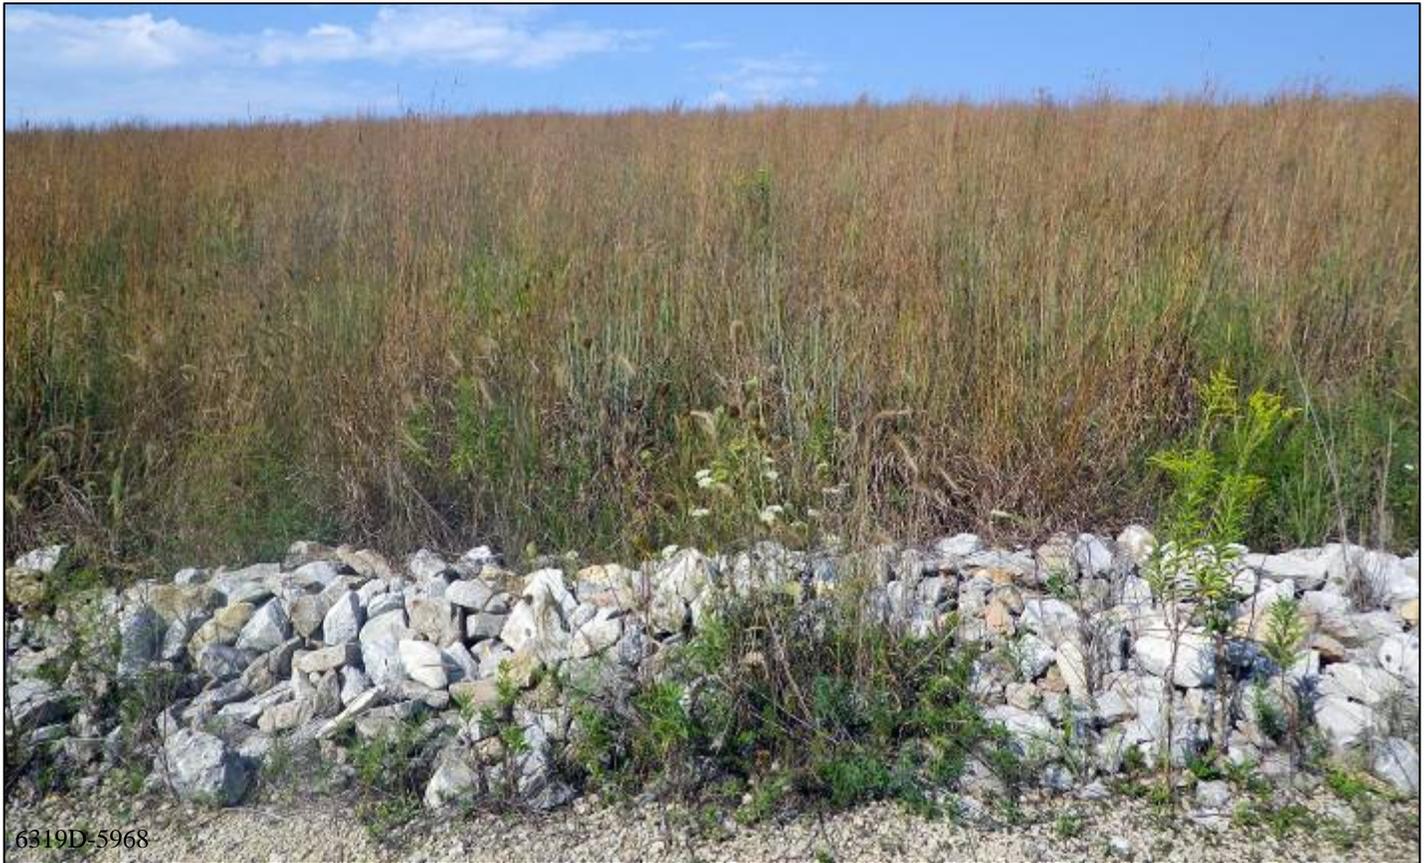
6319D-5968

East Face Cell 6

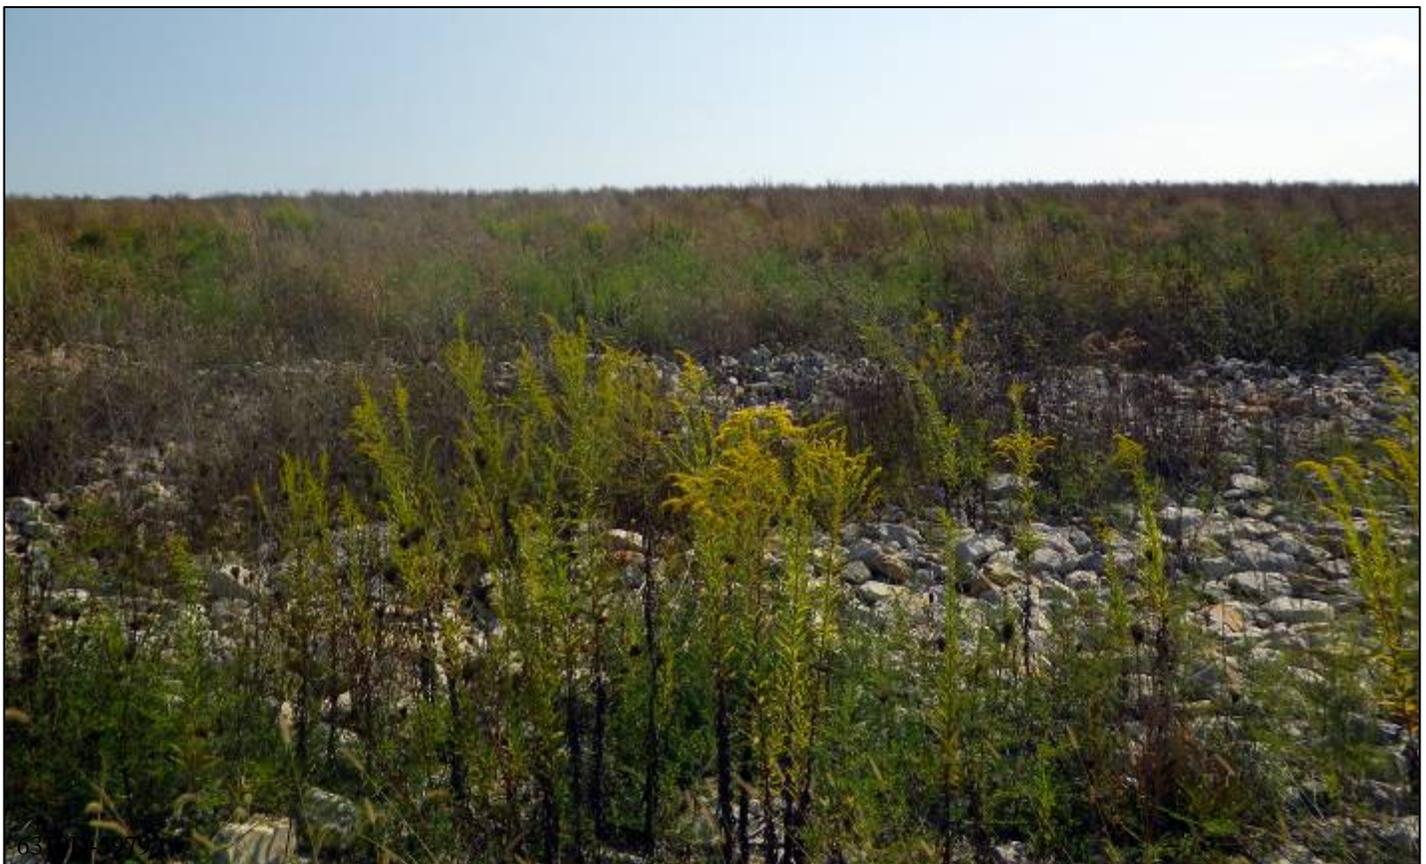
West Face Cell 6

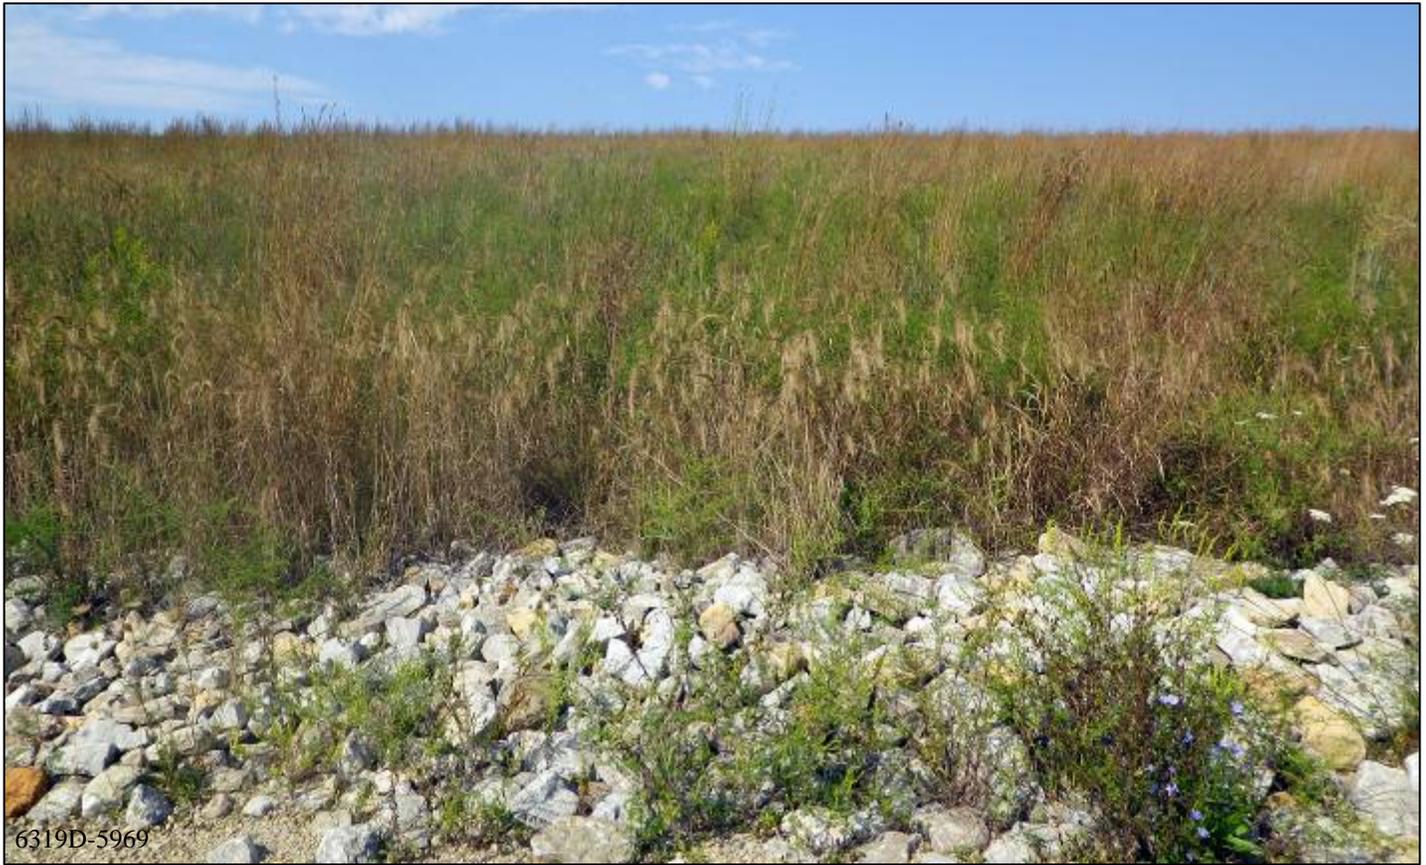
East Face Cell 7

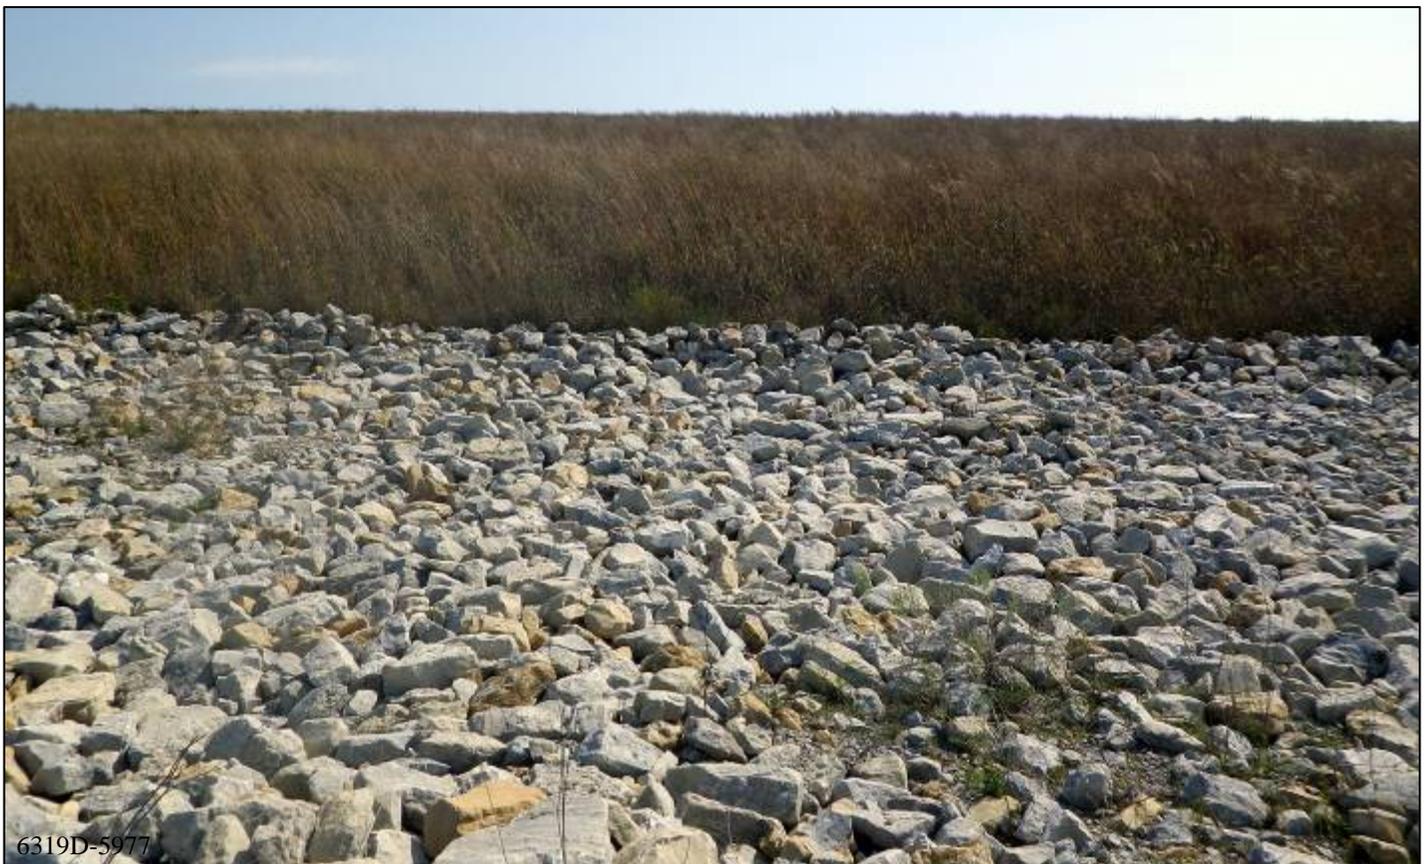
West Face Cell 7

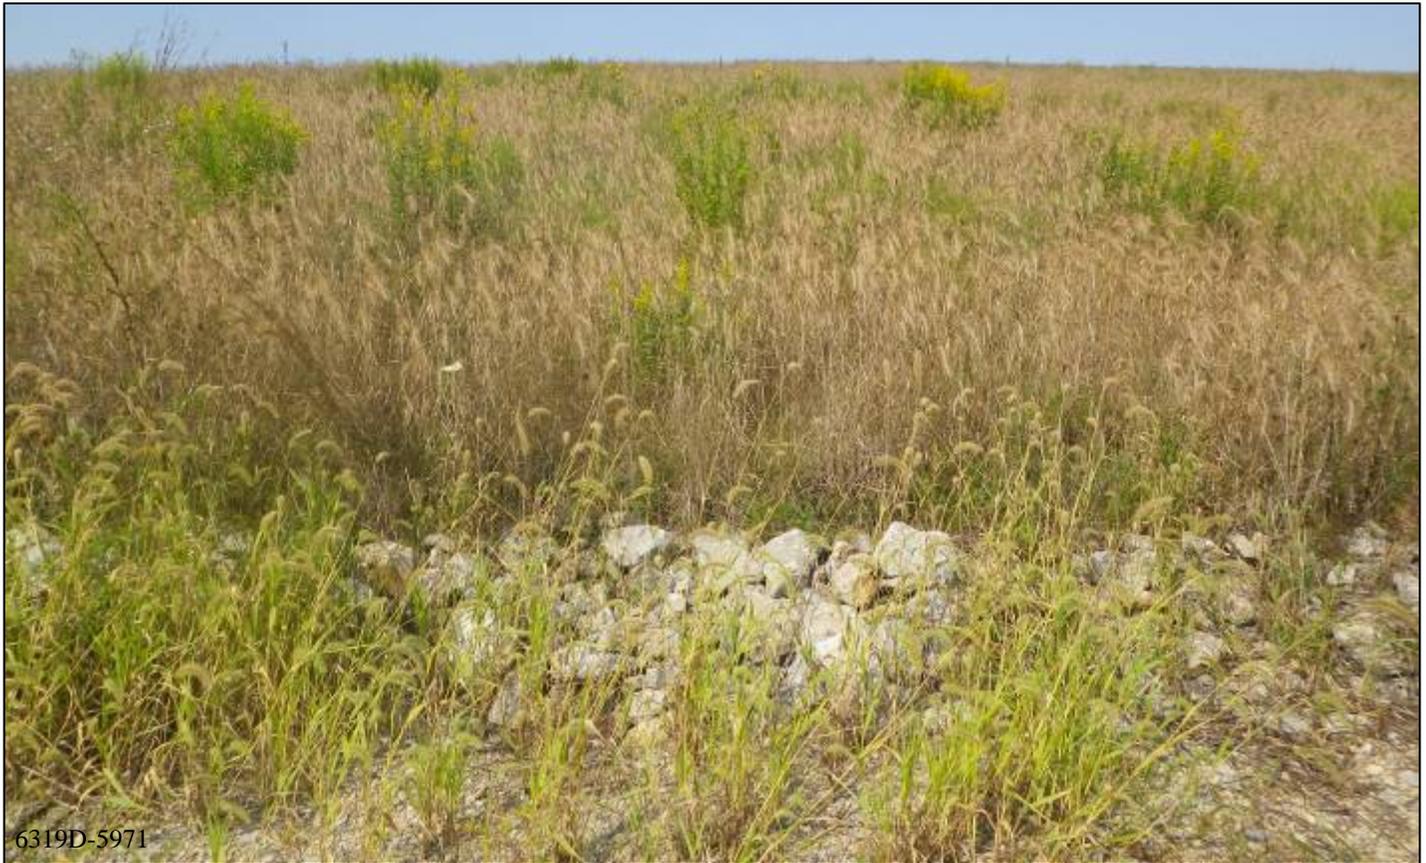
6319D-5971

East Face Cell 8

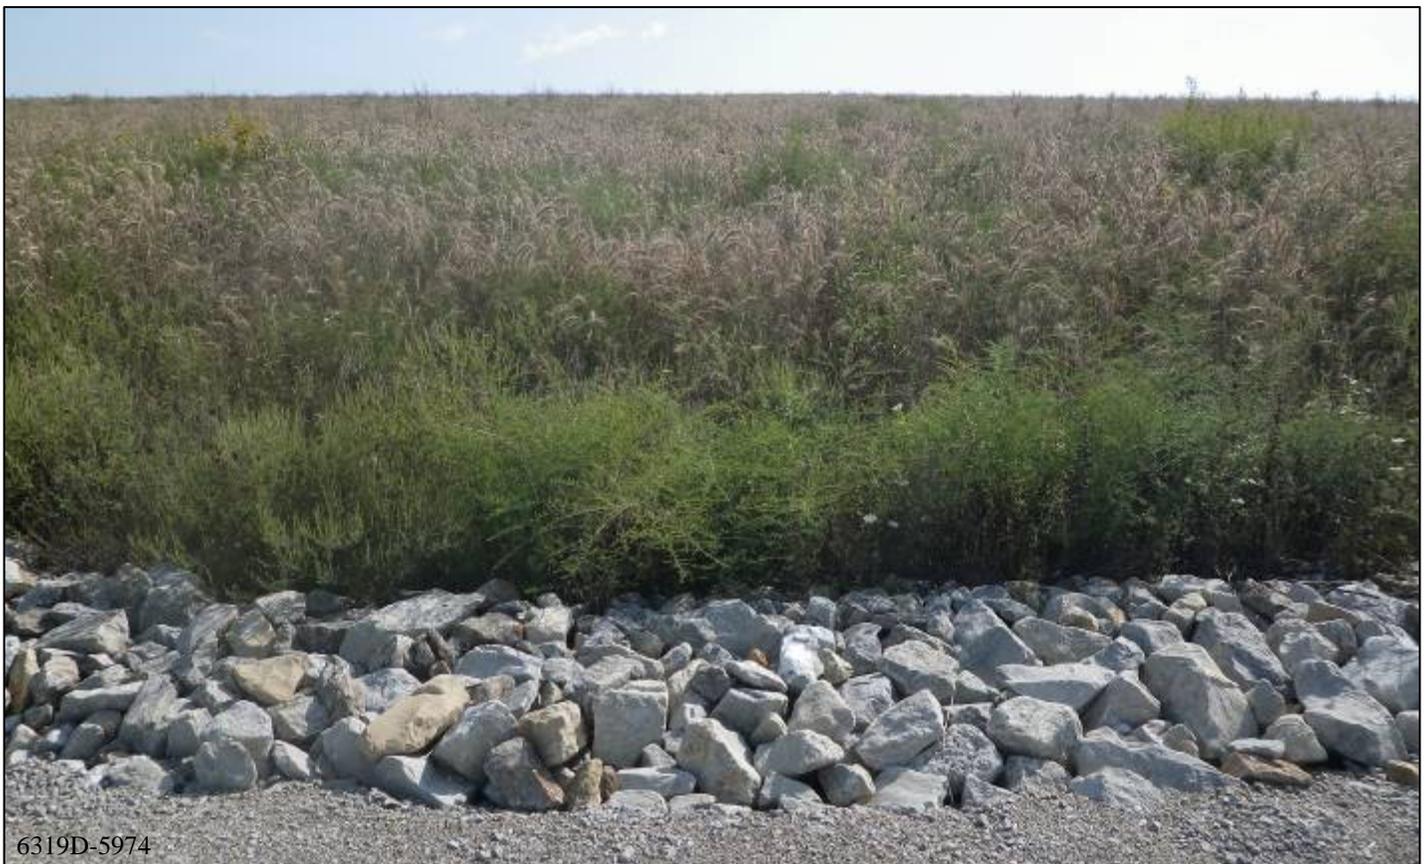
6319D-5974

West Face Cell 8
