SUBJECT: Transmittal of the September 2011 Fernald Preserve On-Site Disposal Facility Inspection Forms

On-Site Disposal Facility Inspection Report

September 2011

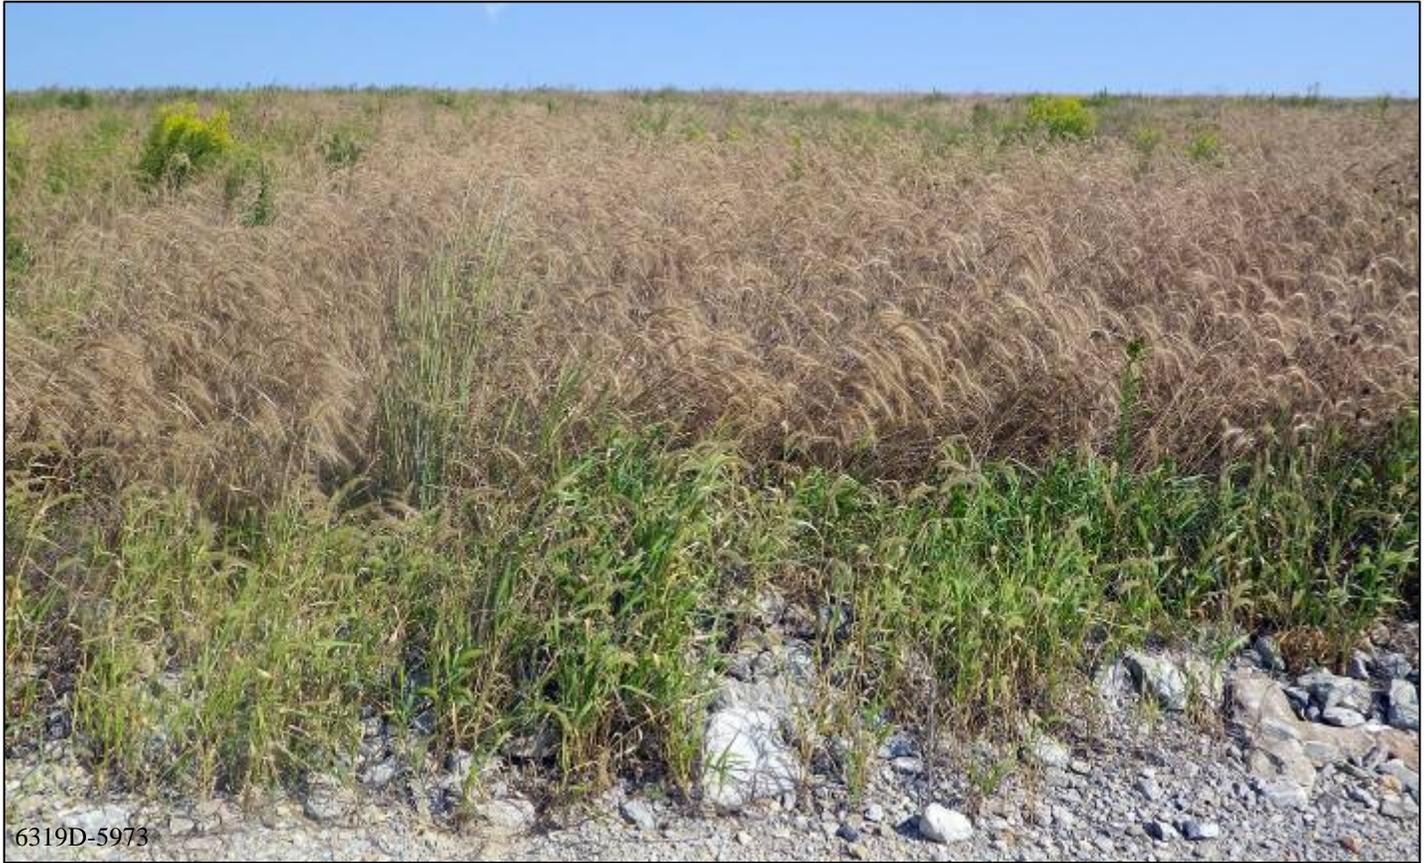
6319D-5973

South Face Cell 8

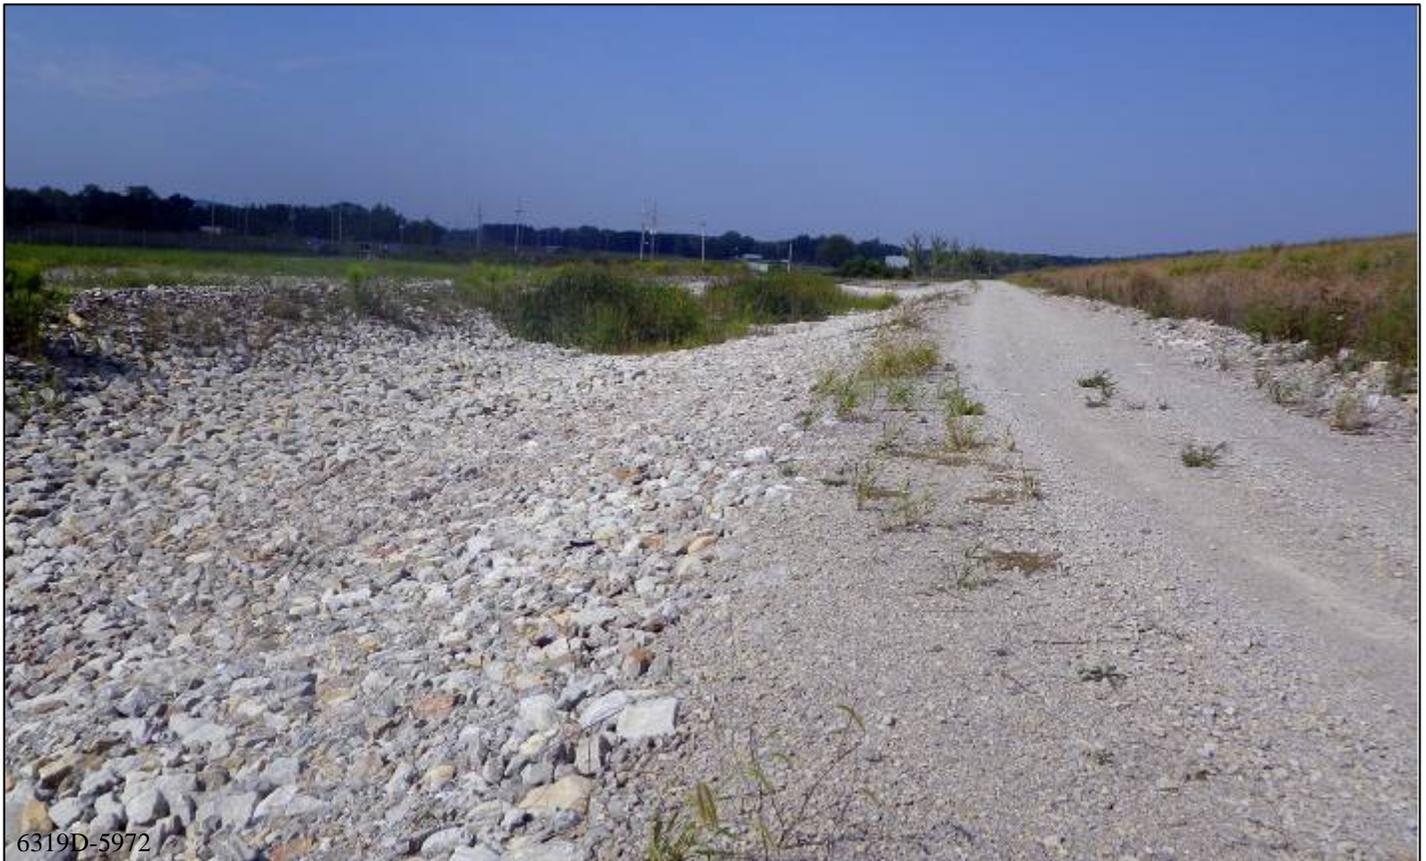
6319D-5972

South Drainage (looking west)

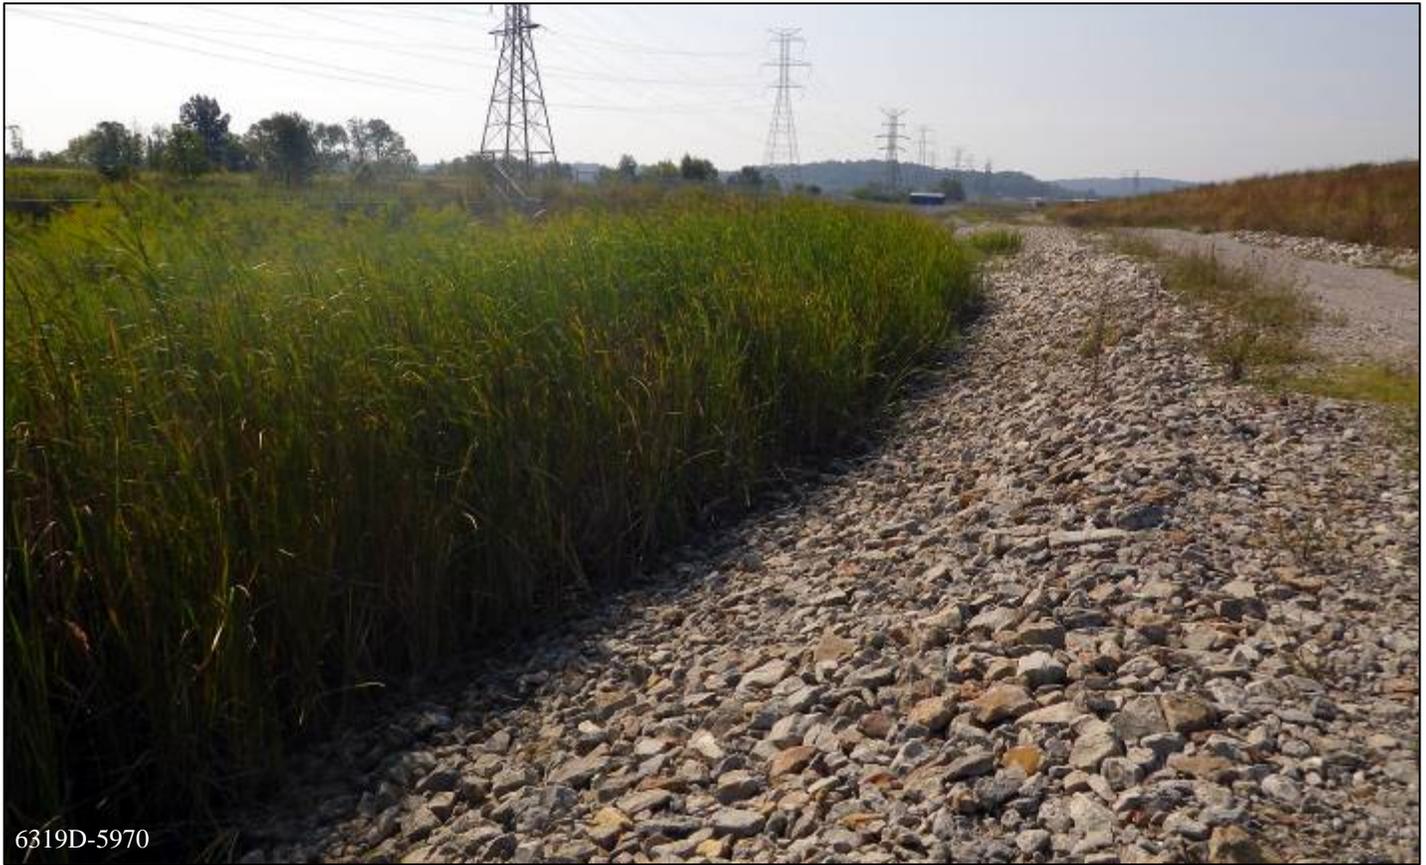
6319D-5970

East Drainage Cell 7 (looking south)

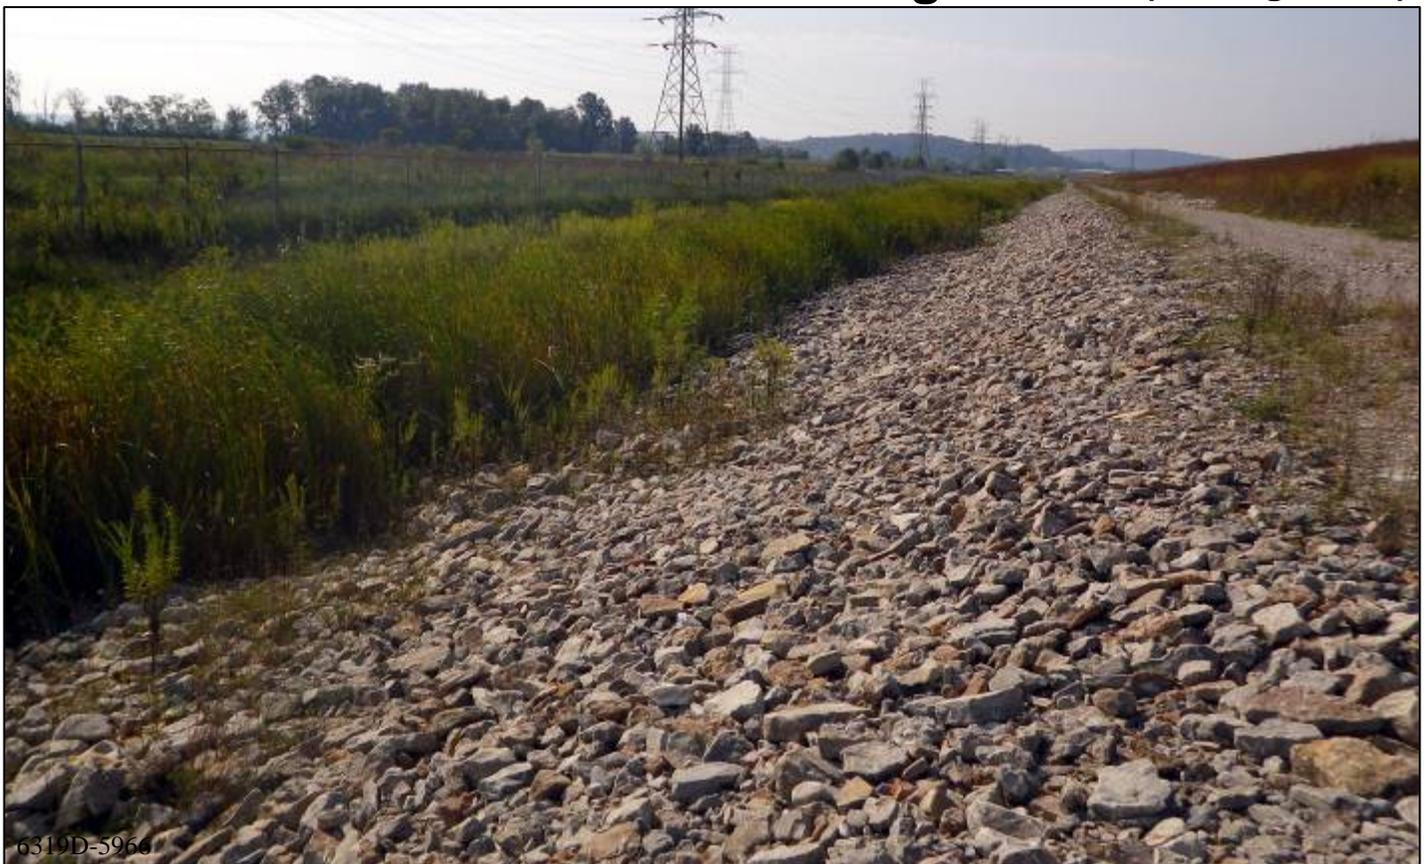
6319D-5966

East Drainage Cell 4 (looking south)

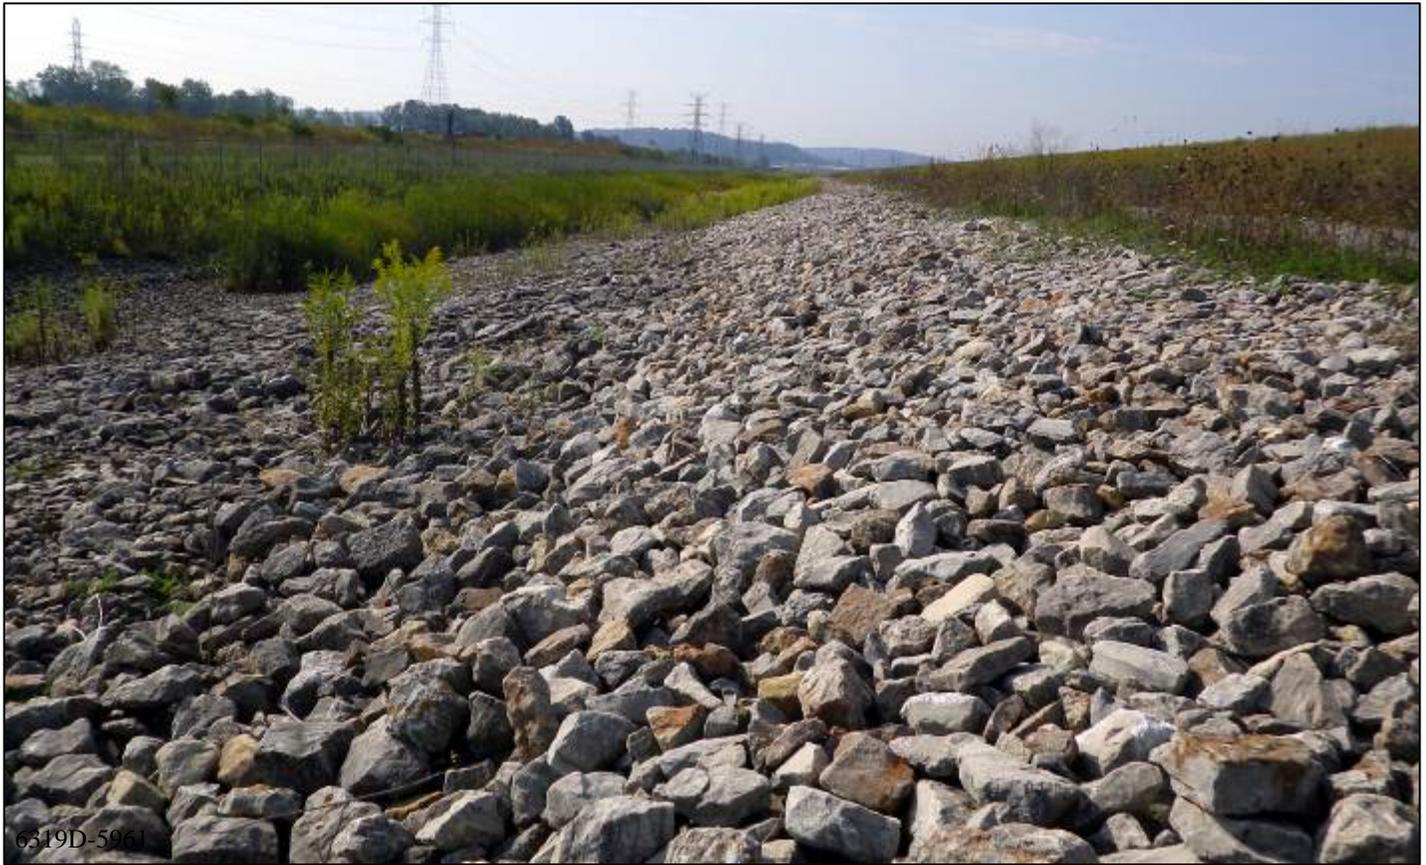
East Drainage Cell 1 (looking south)

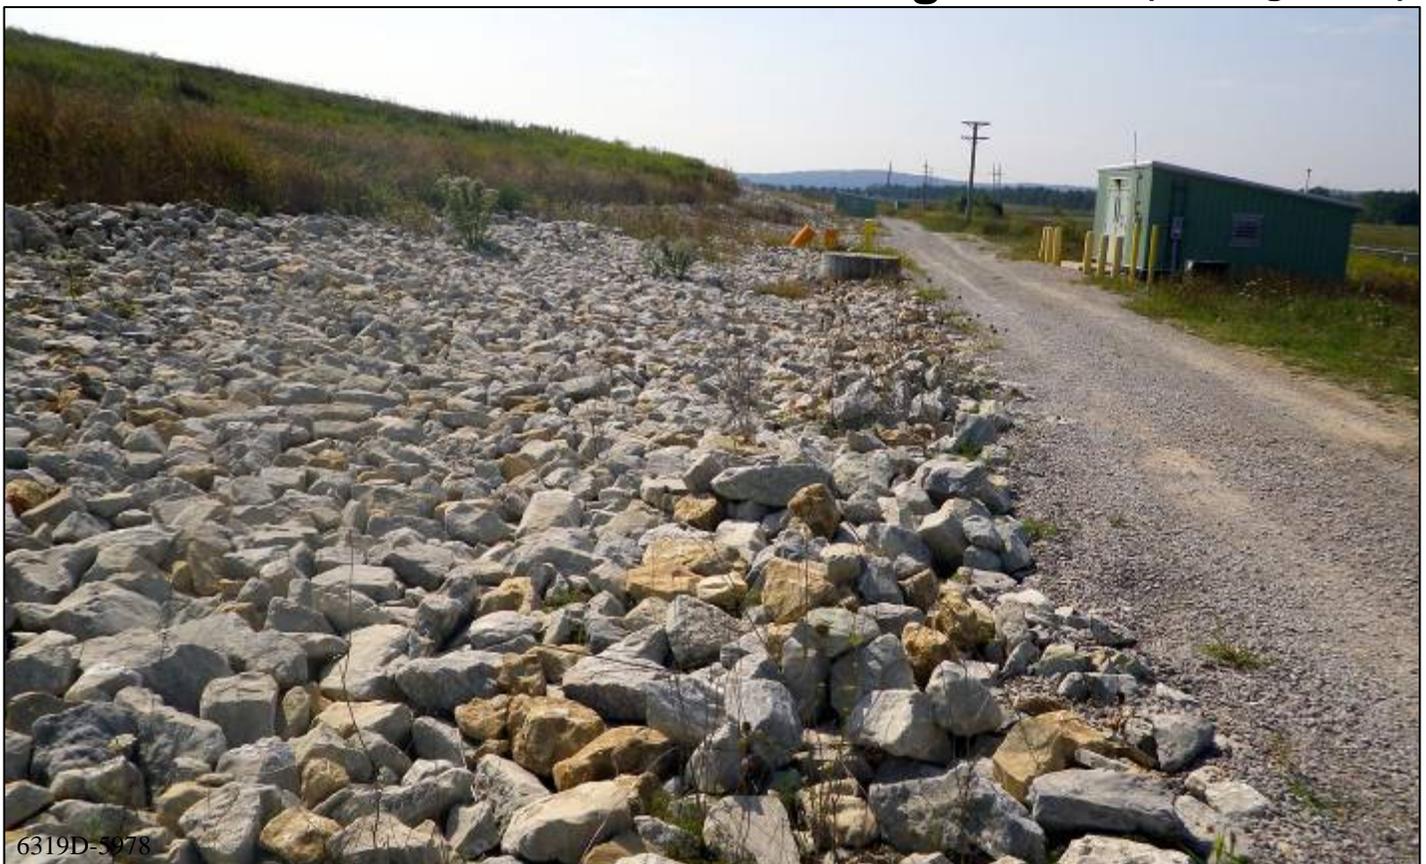
West Inner Drainage Cell 7 (looking south)

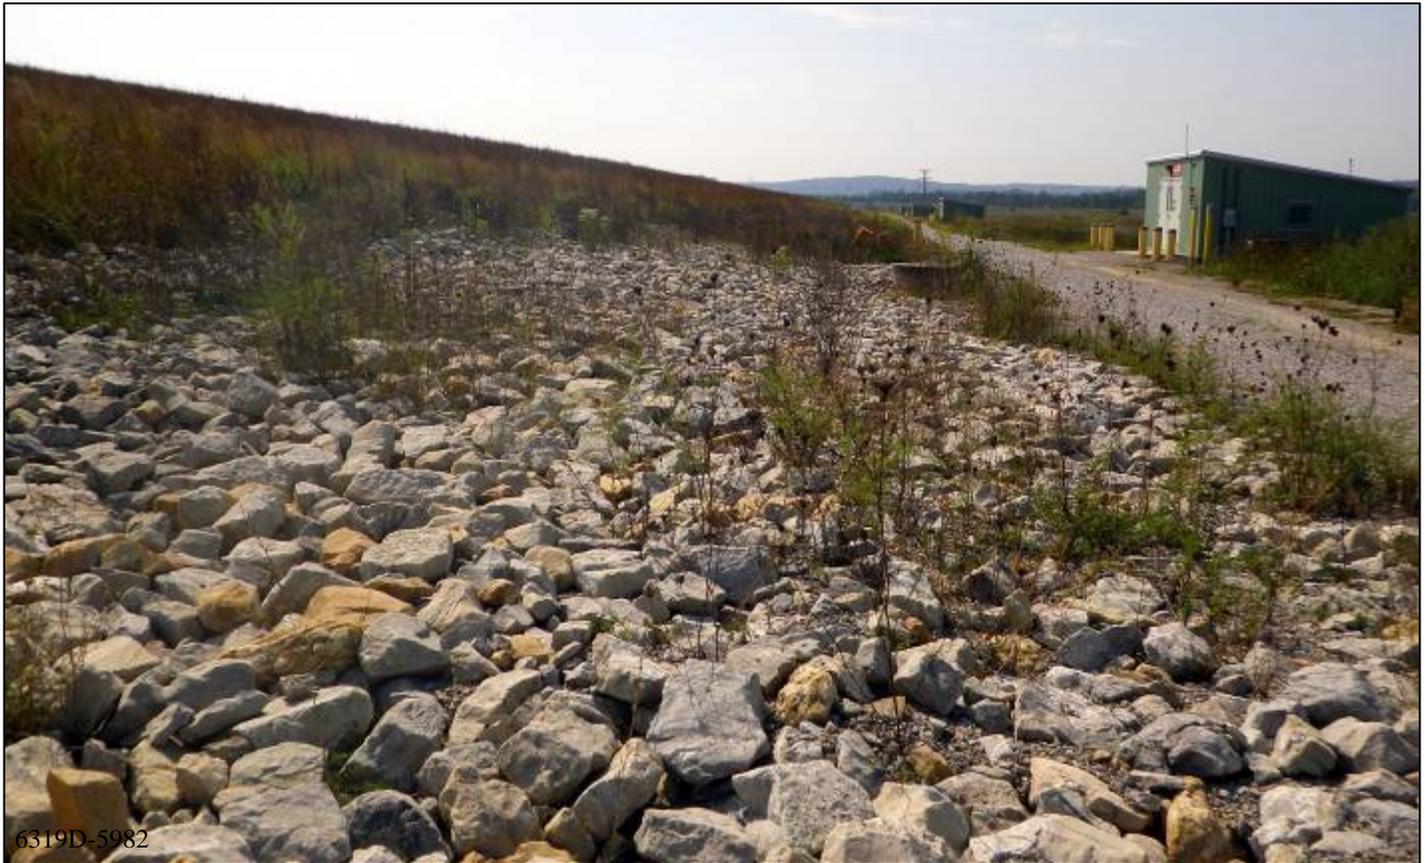
6319D-5982

West Inner Drainage Cell 4 (looking south)

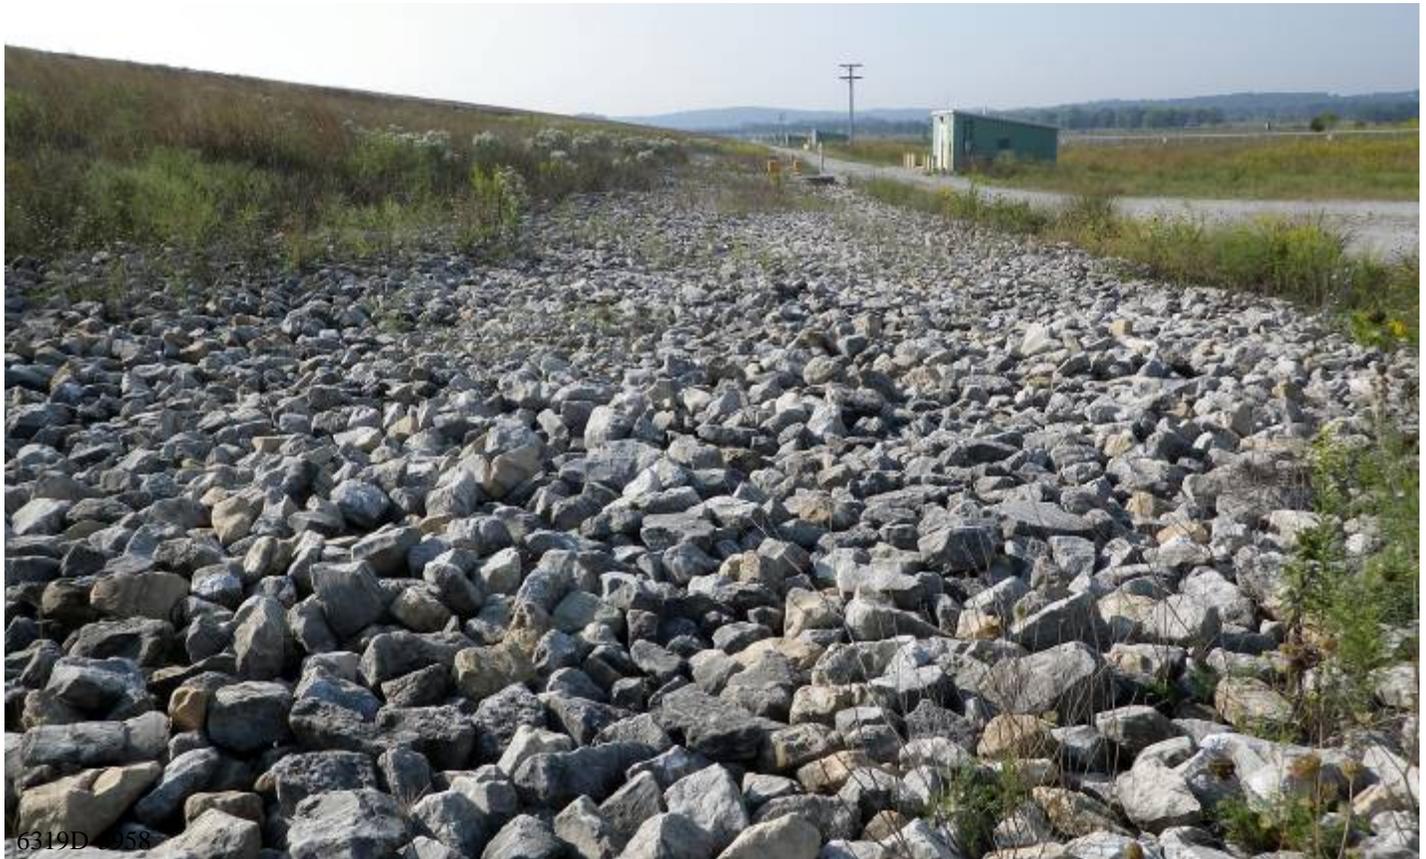
6319D-558

West Inner Drainage Cell 1 (looking south)

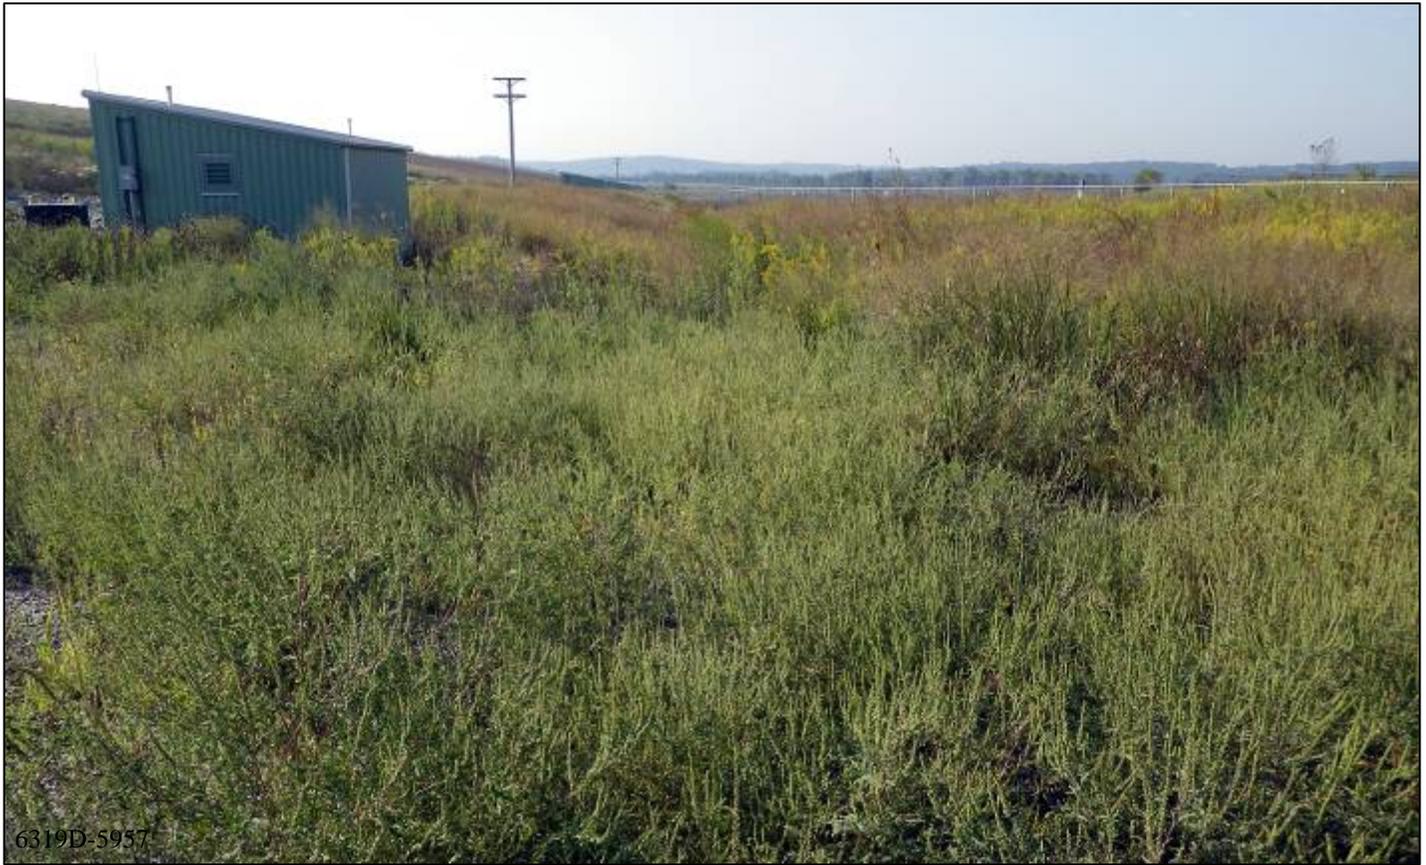
West Outer Drainage Cell 1 (looking south)

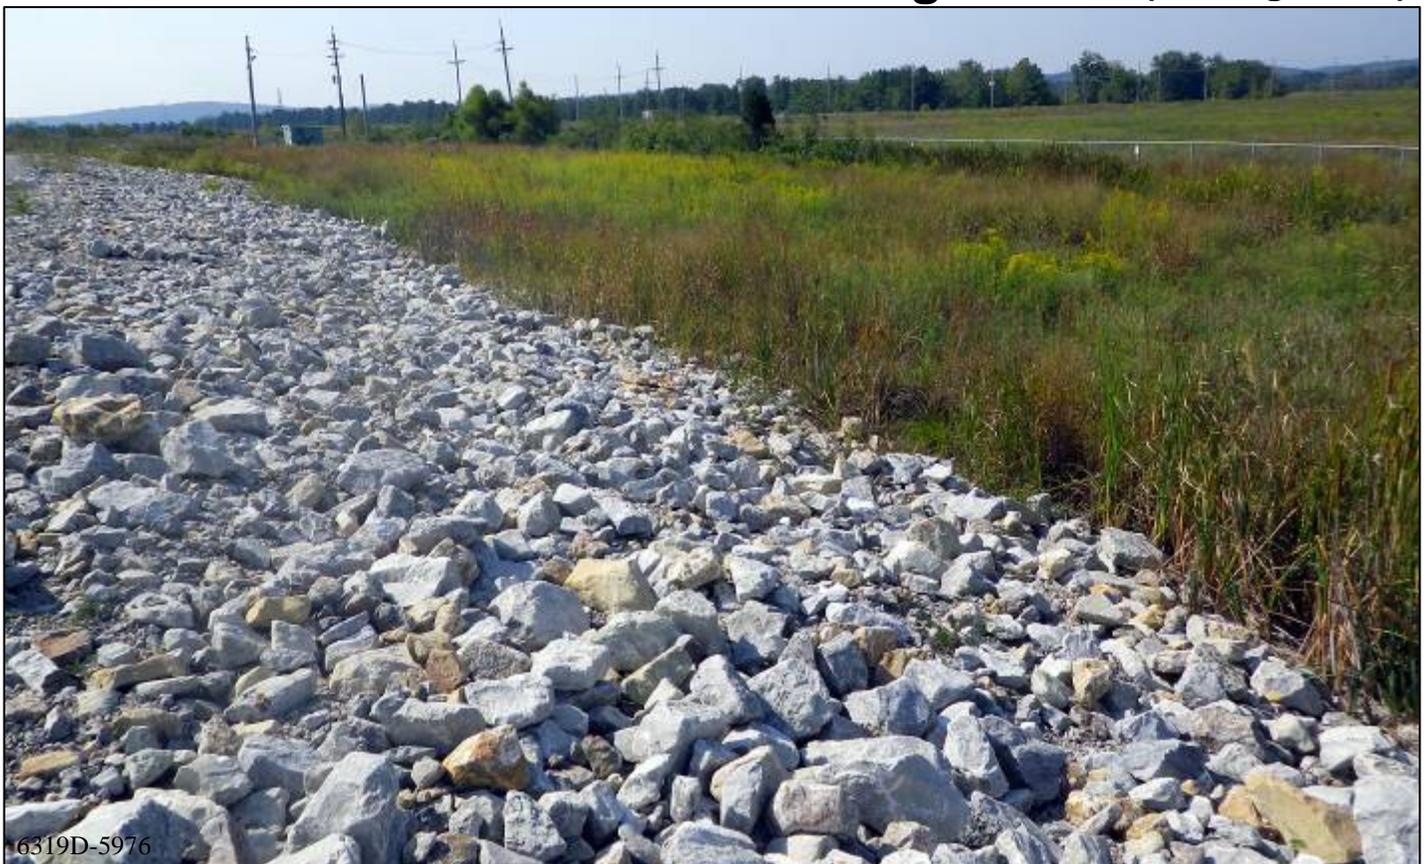
West Outer Drainage Cell 8 (looking south)

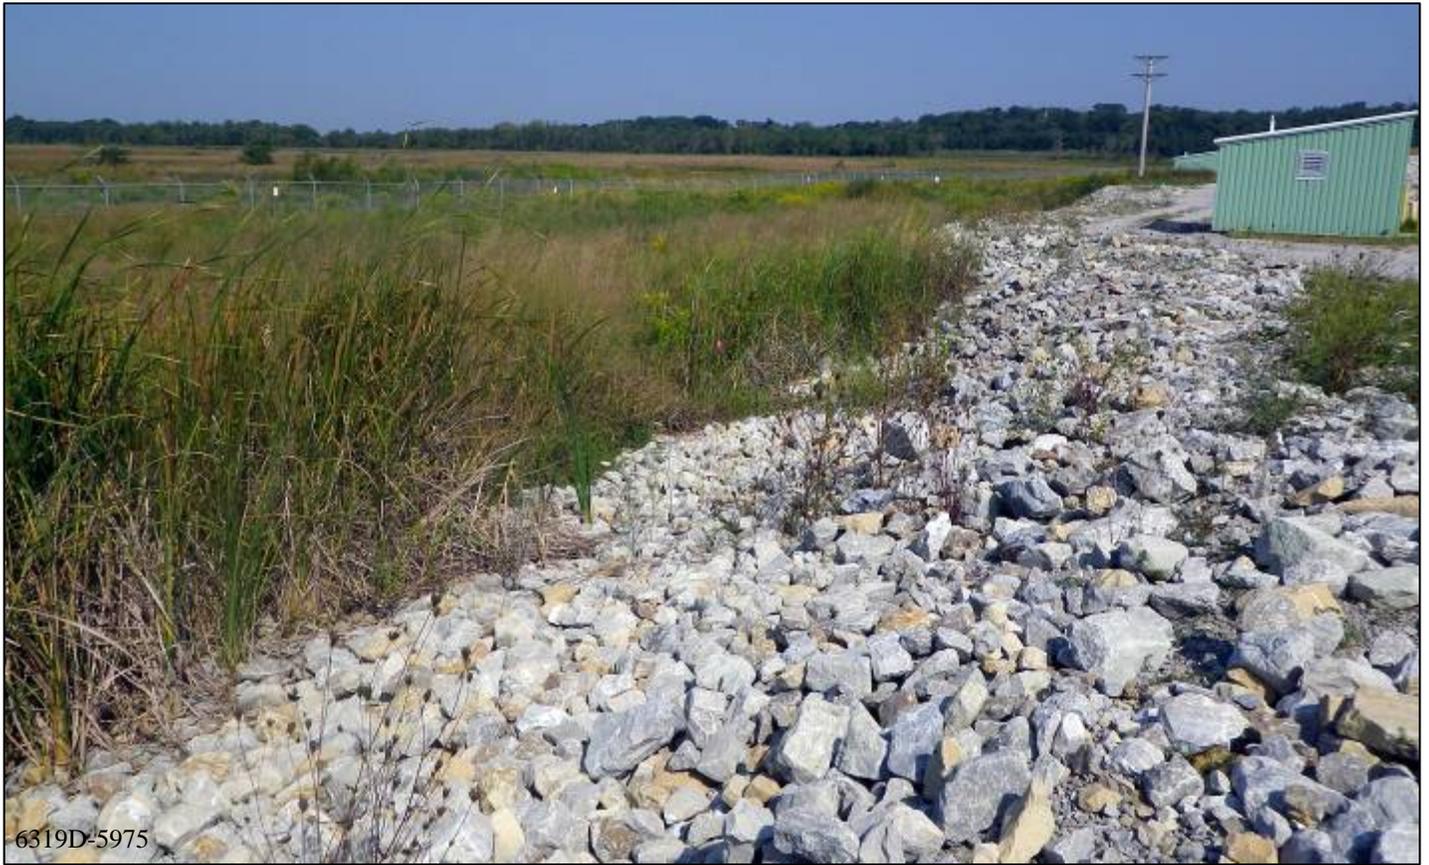
West Outer Drainage Cell 8 (looking north)

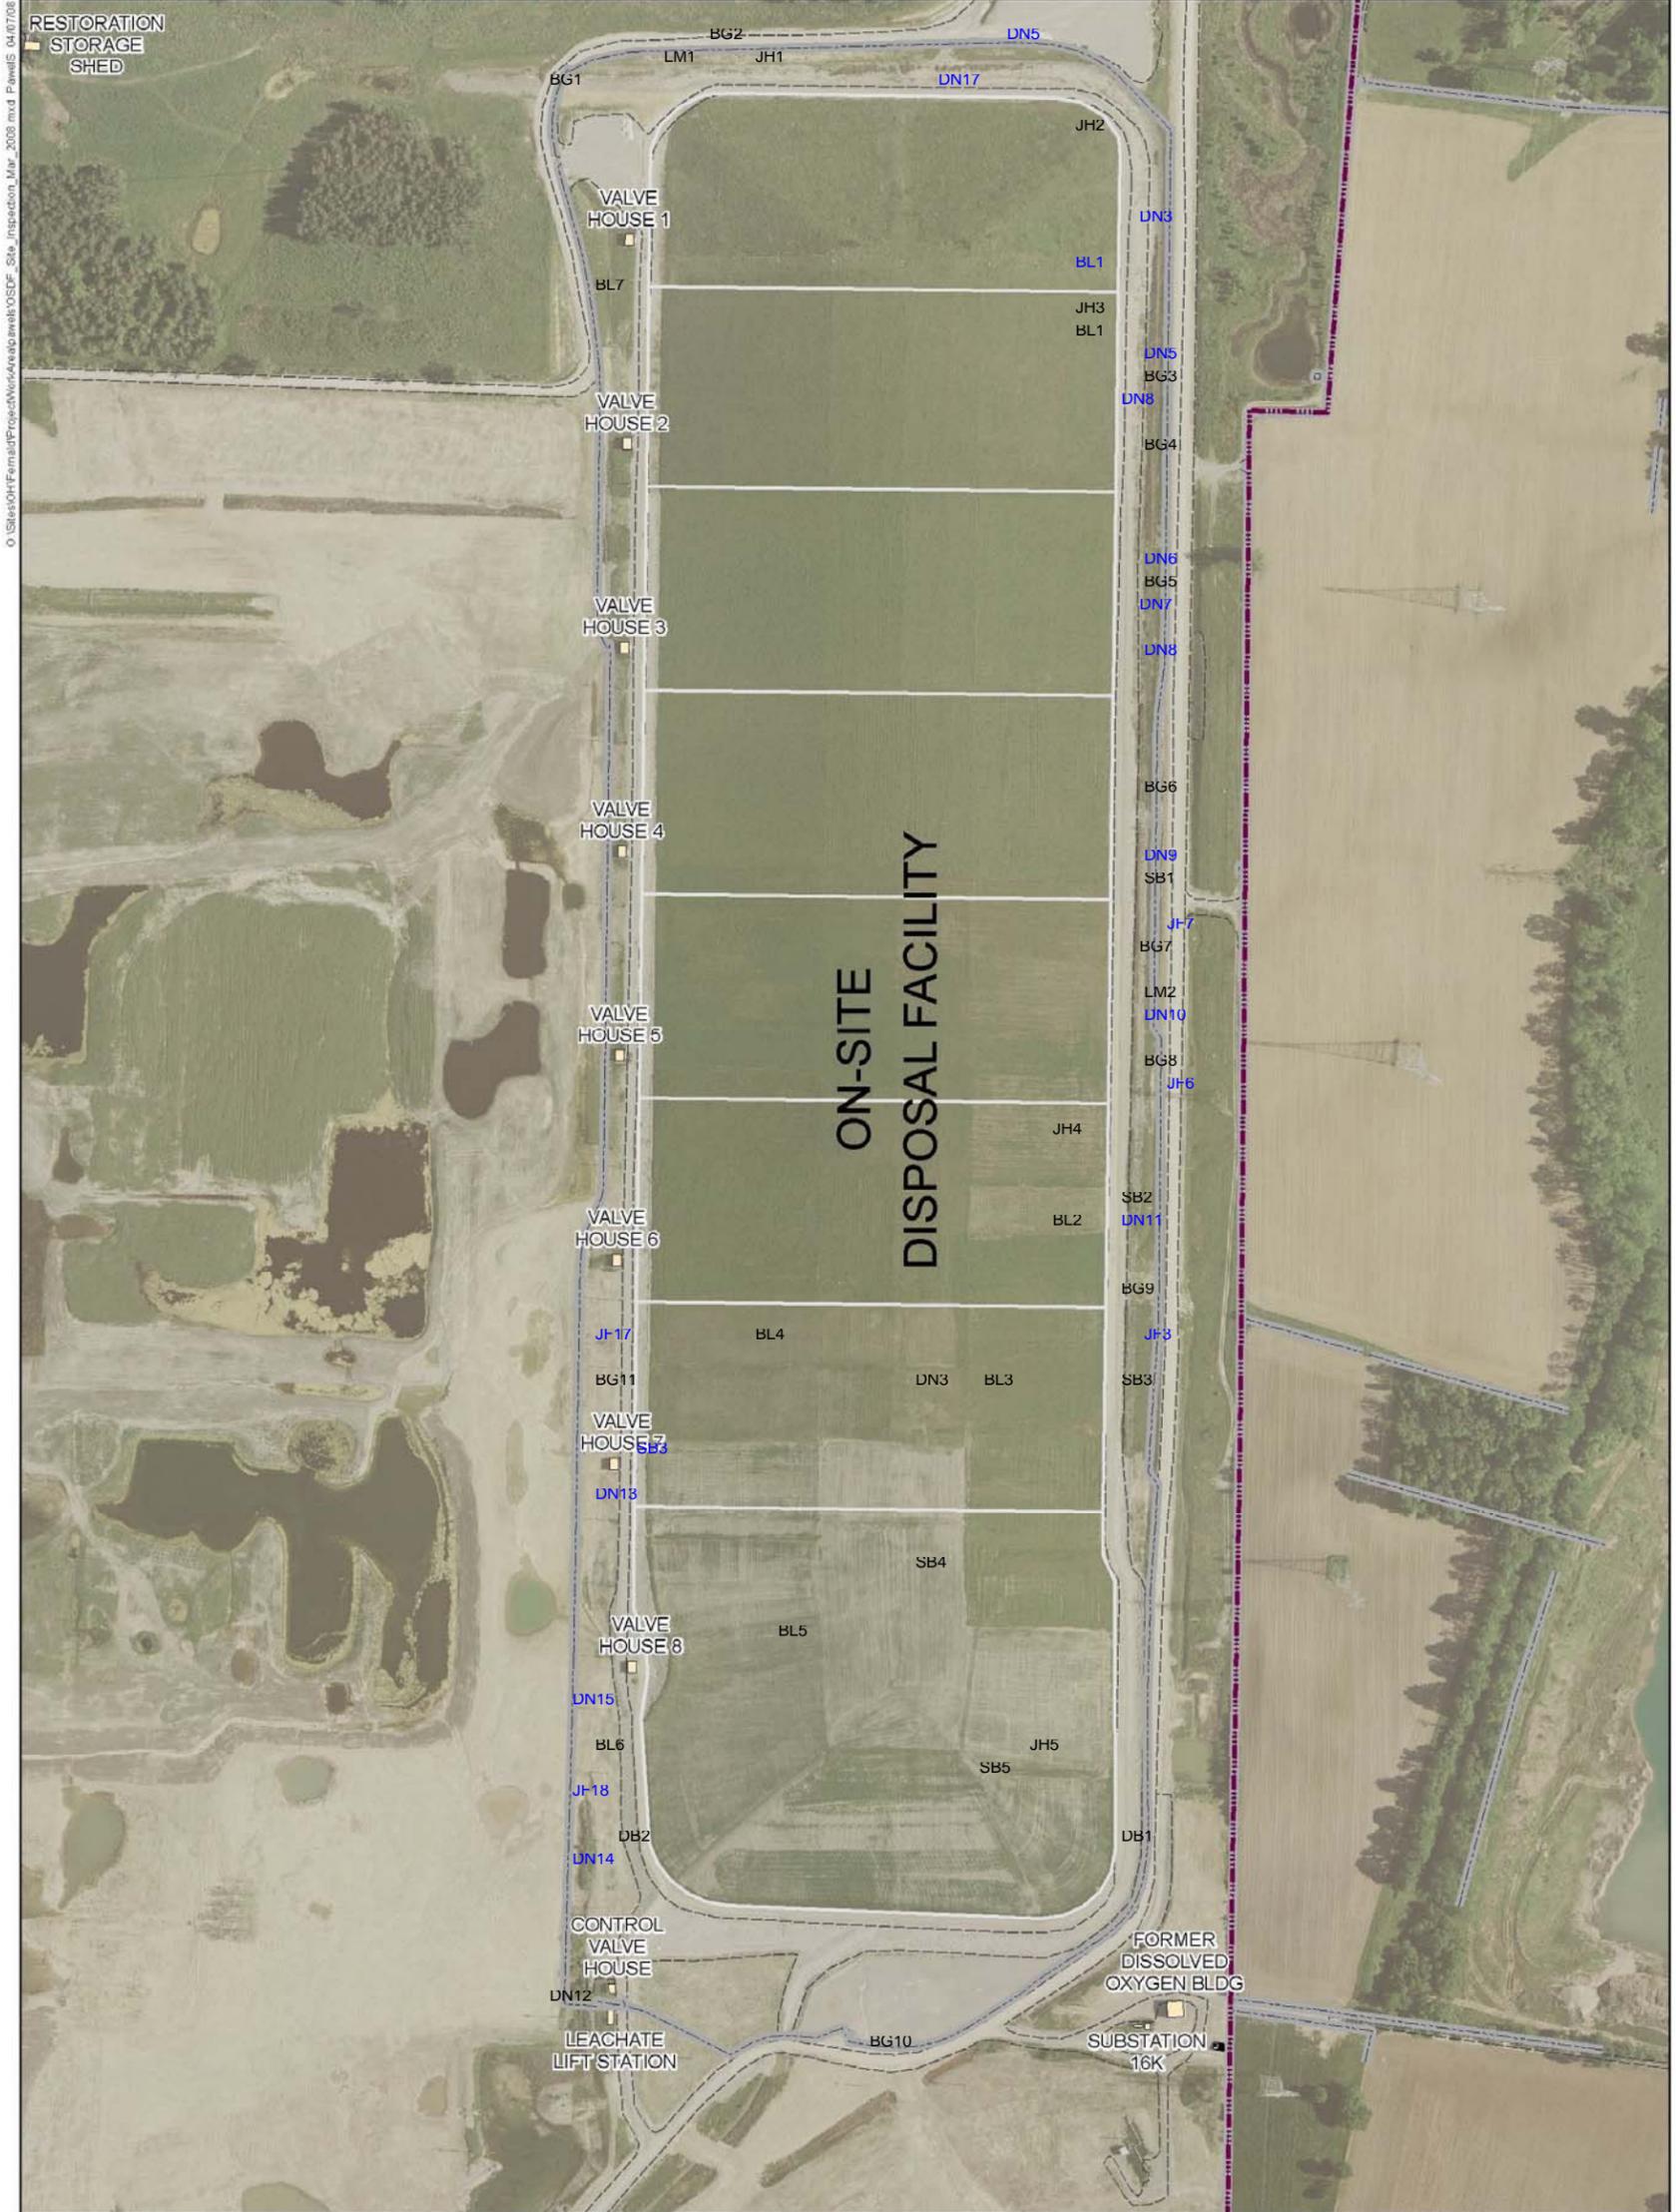
Fernald Preserve
OSDF (On-Site Disposal Facility)
September 2011 Inspection Findings
Previous Findings Requiring
Maintenance or Follow-up

No.	Location (Use Map Whenever Possible)	GPS?	Type of Finding					Description	Photo? (File No.)	Follow Up	
			Erosion	Settlement	Vegetation	Biointrusion	Drainage			Other	Corrected
SB1	East drainage, Cell 4				X			Willows in drainage		X	
SB2	East drainage, Cell 6				X			Willows in drainage		X	
SB3	East drainage, Cell 7				X			Willows in drainage		X	
SB4	NE top, Cell 8				X			Sumac		X	
SB5	Eastern slope, Cell 8				X			Honeysuckle		X	
BL1	East Cell 2, 6:1				X			Johnson grass		X	
BL2	East Cell 6, 6:1				X			12' x 4' bare area		X	
BL3	East Cell 7, 6:1				X			12' x 4' bare area		X	
BL4	West Cell 7, 6:1 (top)				X			Woody vegetation, honeysuckle		X	
BL5	West Cell 8, 6:1 (top)				X			Woody vegetation, honeysuckle		X	
BL6	West drain, south of VH8				X			Woody vegetation, cottonwood		X	
BL7	West drain, north of VH2				X			Woody vegetation, honeysuckle		X	
DB1	East drain, Cell 8				X			Cottonwood next to fence		X

DB2	West drain, Cell 8				X			Cottonwood next to fence		X	
JH1	North drain				X			Woody vegetation		X	
JH2	NE corner Cell 1				X			Woody vegetation		X	
JH3	Toe, east Cell 2		X					Erosion		X	
JH4	Toe, east Cell 6				X			Woody vegetation		X	
JH5	East Cell 8, 6:1				X			Woody vegetation		X	
LM1	North drain				X			Phragmites		X	
LM2	East drain, Cell 5				X			Phragmites		X	
BG1	NW corner of fence						X	Burrowing under fence		X	
BG2	North fence						X	Fence bracing damage		X	
BG3	East fence, Cell 2		X					Under fence wire		X	
BG4	East drain, Cell 2				X			Thistle (thorny w/ purple flower)		X	
BG5	East fence, Cell 3		X					Under fence wire		X	
BG6	East fence, Cell 4		X					Concrete base of post (10)		X	
BG7	East fence, Cell 5		X					Concrete base of post (2)		X	
BG8	East fence, Cell 5		X					Under fence wire		X	
BG9	East fence, Cell 6		X					Concrete base of post		X	
BG10	South fence		X					Concrete base of post		X

BG11	North of VH7						X	Faded signage (Buried Leachate)		X

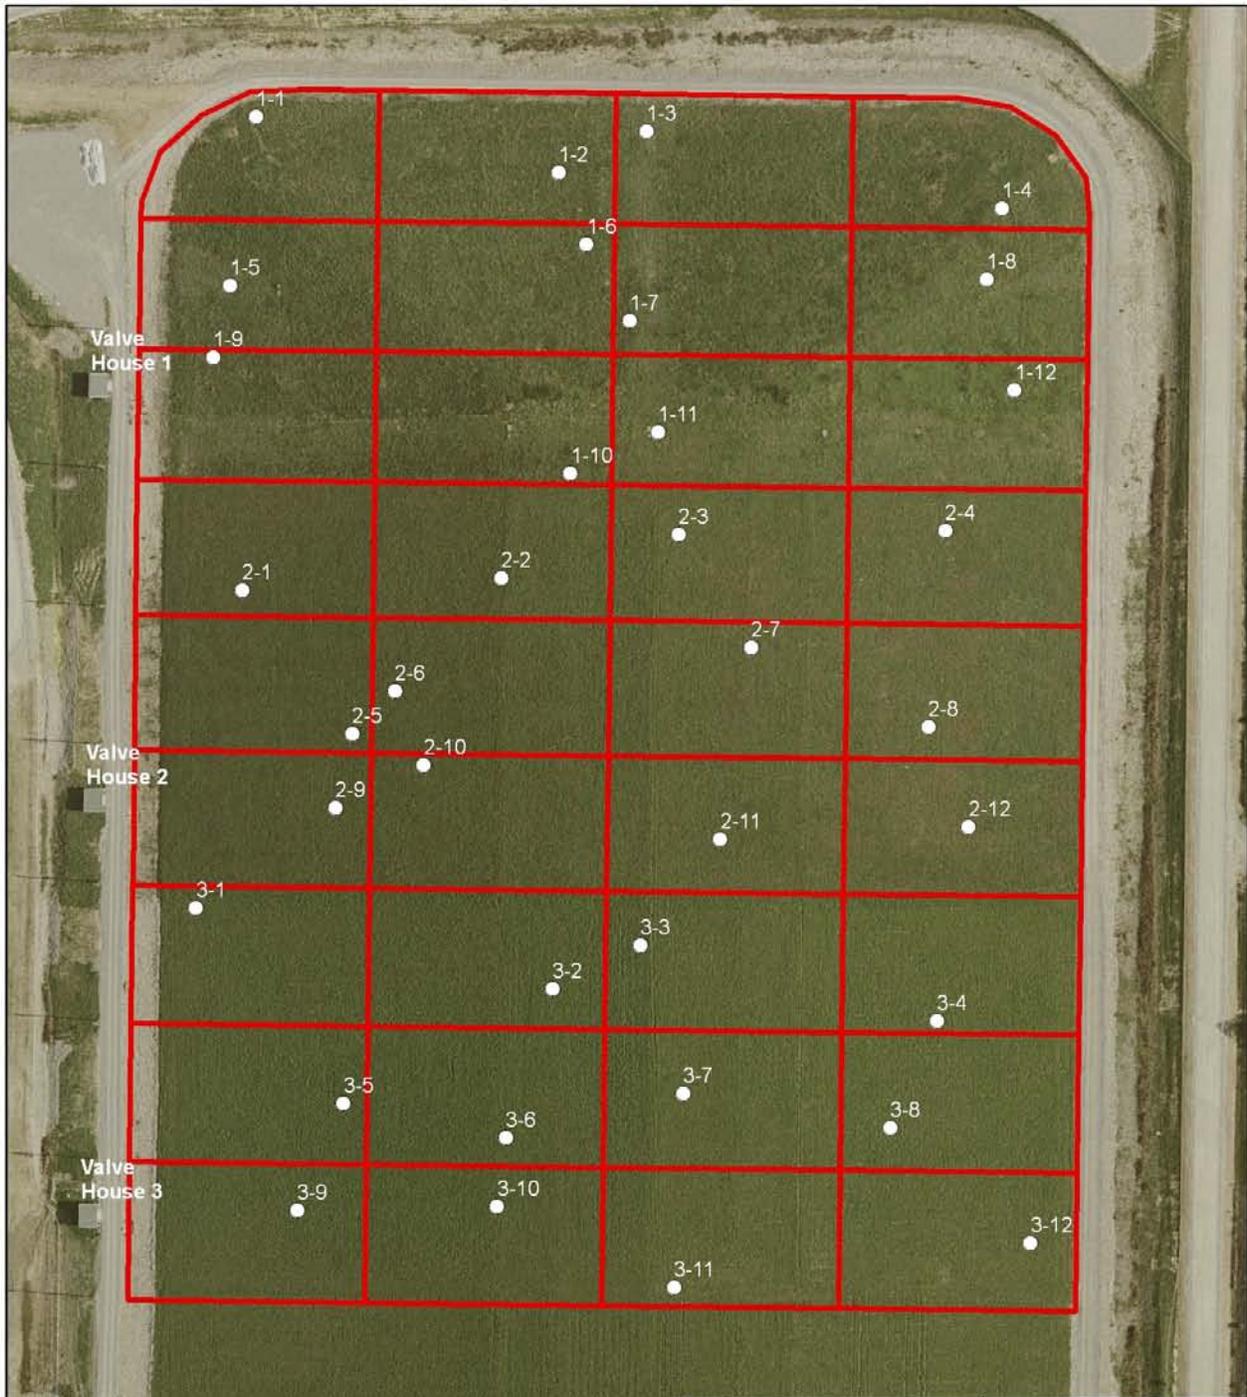
Cell Cap	Total Cover	Native Species Composition	Relative Frequency of Native Species
1	97%	50%	68%
2	97%	64%	64%
3	97%	44%	46%

The LMICP goals for the OSDF cap include 90% total cover and 50% native species composition. Results are mixed for Cell Caps 1 to 3. Total cover across all three cells is well established. All but 2 of the 36 quadrats sampled were assigned a total cover class of 10 (95% to 99% total cover). These findings are generally supported by inspection findings and accompanying photos.

The native species composition goal is met for two of the three cells surveyed. Prairie grasses and forbs have been successfully re-established on Cell 1, with 68% relative frequency of native species. On Cell 3, both native species composition and relative frequency of native species did not meet the 50% goal. It appears that there is increased competition from the cool season grass, redtop (*Agrostis gigantea*), which was found in all 12 quadrats sampled within Cell 3. As a sod-forming grass, redtop may be limiting establishment of seeded vegetation. Cell 2 also has a high relative frequency of redtop, but this is countered for now by increased diversity of native seeded vegetation.

Similar observations were noted on Cell 1 in 2007. In response, a selective herbicide was applied in an effort to limit the cool-season grass competition. This eradicated redtop and other cool season grasses, but left too much area unvegetated and susceptible to erosion. As a result, several erosion repairs were required in 2008. This experience leads to the conclusion that no major effort at controlling redtop on Cells 2 and 3 should be undertaken at this time. Instead, monitoring of Cells 2 and 3 should continue, in order to determine longer-term trends. With total cover well established, there are no issues with respect to erosion or cap integrity.
