SUBJECT: Transmittal of the March 2013 Fernald Site Inspection Forms

Fernald Preserve Field Walkdown Inspection

U.S. DEPARTMENT OF ENERGY HAMILTON, OHIO		Work Performed by S.M. Stoller Corporation Under DOE Contract No. DE-AM01-07LM00060	
FERNALD PRESERVE MARCH 2013 SITE INSPECTION			
DATE PREPARED: March 18, 2013		FILENAME: inspection_areas_1stqtr_2013_findings

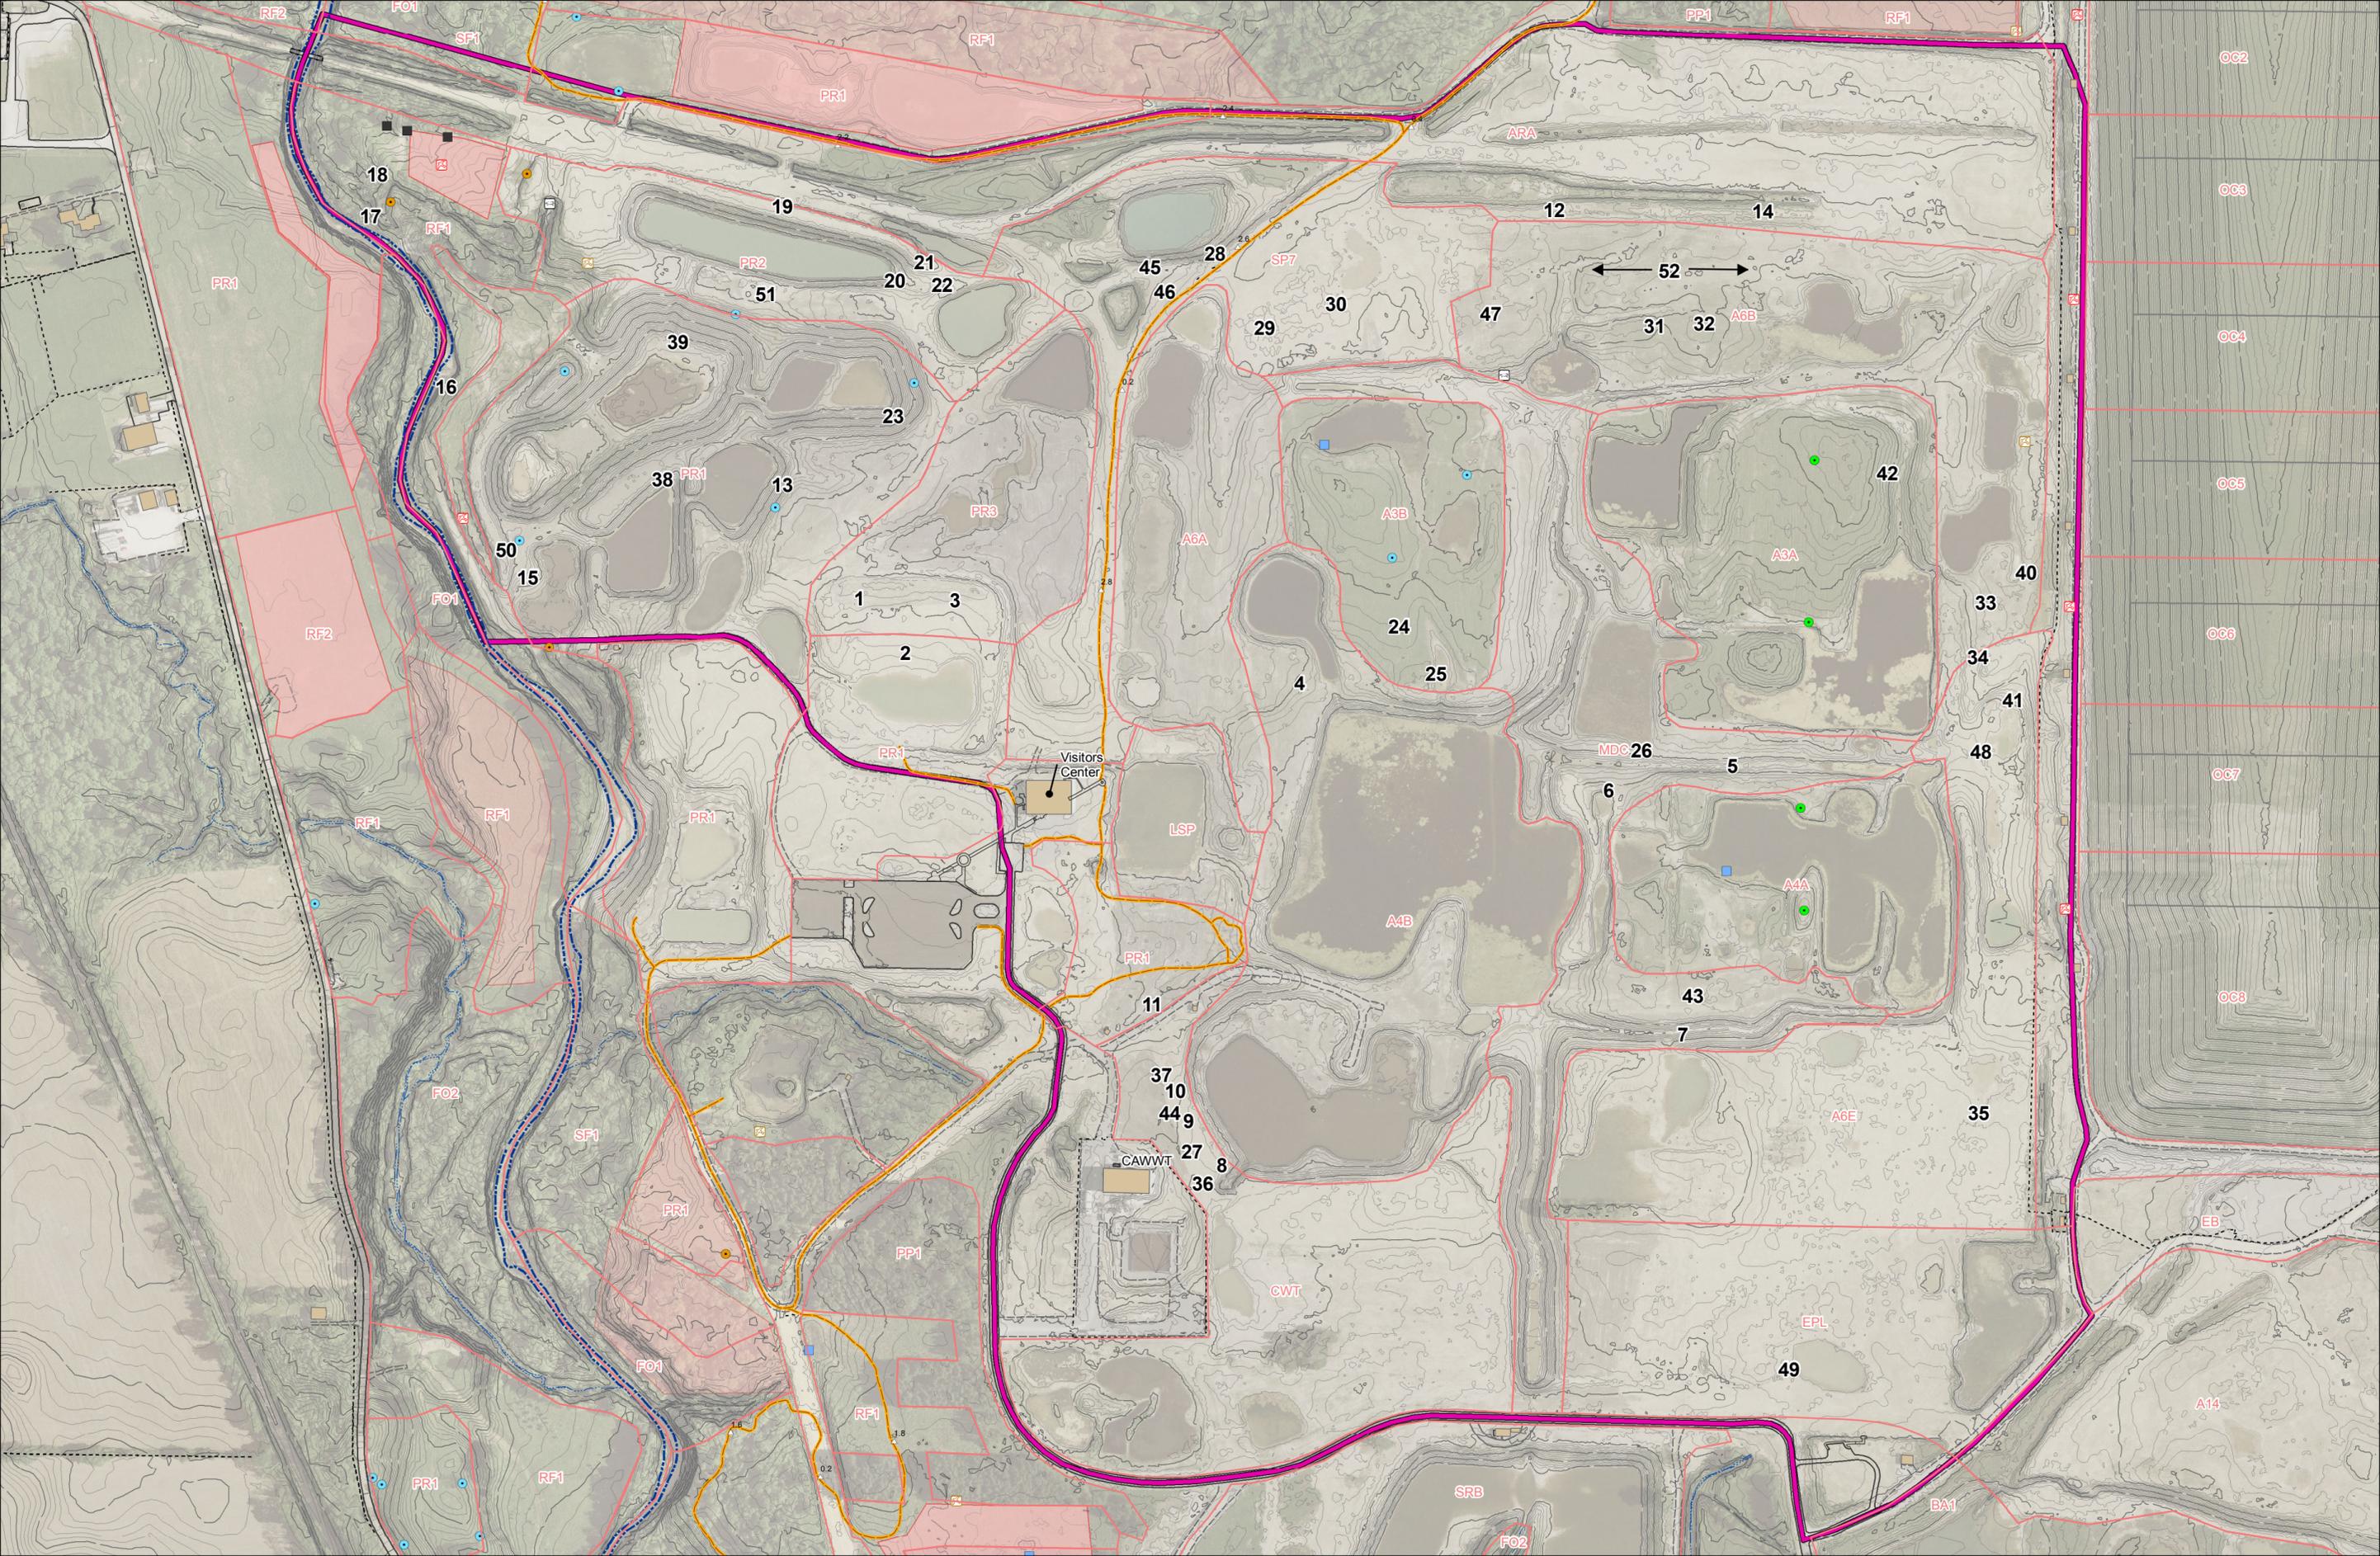
No.	Location (Use Map Whenever Possible)	GPS?	Type of Finding				Description	Photo? (File No.)	Follow Up		
			Unauthorized Use	Disturbance	Vegetation	Other			Corrected	Maintenance Req'd	Cont. Observation
1	North of Bio-wetland	NO				X	Concrete debris		X		
2	North of Bio-wetland	NO				X	Asphalt debris		X		
3	North of Bio-wetland	NO				X	Concrete debris		X		
4	A4B	NO				X	Concrete debris		X		
5	Main drainage corridor	NO				X	Concrete debris		X		
6	Main drainage corridor	NO				X	Concrete debris		X		
7	Main drainage corridor	NO				X	Asphalt debris		X		
8	CAWWT	NO				X	Concrete		X		
9	CAWWT	NO				X	Concrete		X		
10	CAWWT	NO				X	Concrete		X		
11	CAWWT	NO				X	Asphalt		X		
12	FPA ARA South of S drainage	NO				X	Erosion		X		
13	Former WP PR1	NO				X	Erosion		X		
14	FPA ARA South of S drainage	NO				X	Debris, glazed tile		X		
15	West of well house 33	NO				X	Metal and concrete debris		X		
16	PR1 RF1	NO				X	Fence post with concrete		X

17	RF1	NO				X	Concrete		X		
18	RF1	NO				X	Graphite and fencepost		X		
19	PR2	NO				X	Transite		X		
20	PR2	NO				X	Graphite		X		
21	PR2	NO				X	Acid brick/Graphite		X		
22	PR2	NO				X	Graphite, field of debris		X		
23	East of burn pit WPA PR1	NO				X	Erosion		X		
24	East of skillet pond	NO				X	Debris (no flag)		X		
25	East of skillet pond	NO				X	Debris (no flag)		X		
26	South of FPA	NO				X	Erosion at outfall		X		
27	East of CAWWT	NO				X	Debris		X		
28	West of Hickory trail	NO				X	Debris		X		
29	East of Hickory trail	NO				X	Debris		X		
30	East of Hickory trail	NO				X	Debris		X		
31	By head of swan pond	NO				X	Debris		X

No.	Location (Use Map Whenever Possible)	GPS?	Type of Finding				Description	Photo? (File No.)	Follow Up		
			Unauthorized Use	Disturbance	Vegetation	Other			Corrected	Maintenance Req'd	Cont. Observation
32	By head of Swan Pond	NO				X	Debris		X		
33	West of OSDF between VH5 & 6	NO				X	Debris		X		
34	West of OSDF between VH5 & 6	NO				X	Debris		X		
35	SW of VH 8	NO				X	Debris		X		
36	East of CAWWT fence	NO				X	Debris		X		
37	North of CAWWT fence	NO				X	Debris		X		
38	PR1 north corner of pond	NO			X		Thistle		X		
39	PR1 north face	NO				X	Erosion		X		
40	A3A 75 ft from OSDF fence	NO				X	Erosion		X		
41	A6E North end at cell 7	NO				X	Debris		X		
42	A3A	NO				X	Concrete		X		
43	MDC	NO				X	Concrete		X		
44	CAWWT	NO				X	Concrete		X		
45	NDA SP7 north east pond	NO				X	Debris		X		
46	NDA SP7 north east pond	NO				X	Debris		X		
47	FPA A6B	NO				X	Debris		X		
48	NDA A6E – on firebreak	NO				X	Debris		X		
49	NDA EPL west side of pond	NO				X	Debris		X

50	PR1 – waste pits	NO				X	Ropes down along erosion area		X		
51	PR2 – Pit 5 (south side of)	NO			X		Thistle		X		
52	A6B	NO			X		Large areas of teasel		X
