**SUBJECT: Transmittal of the June 2013 Fernald Site Inspection Forms**

Fernald Preserve Field Walkdown Inspection

**Fernald Preserve  
2nd Quarter 2013  
Site Inspection**

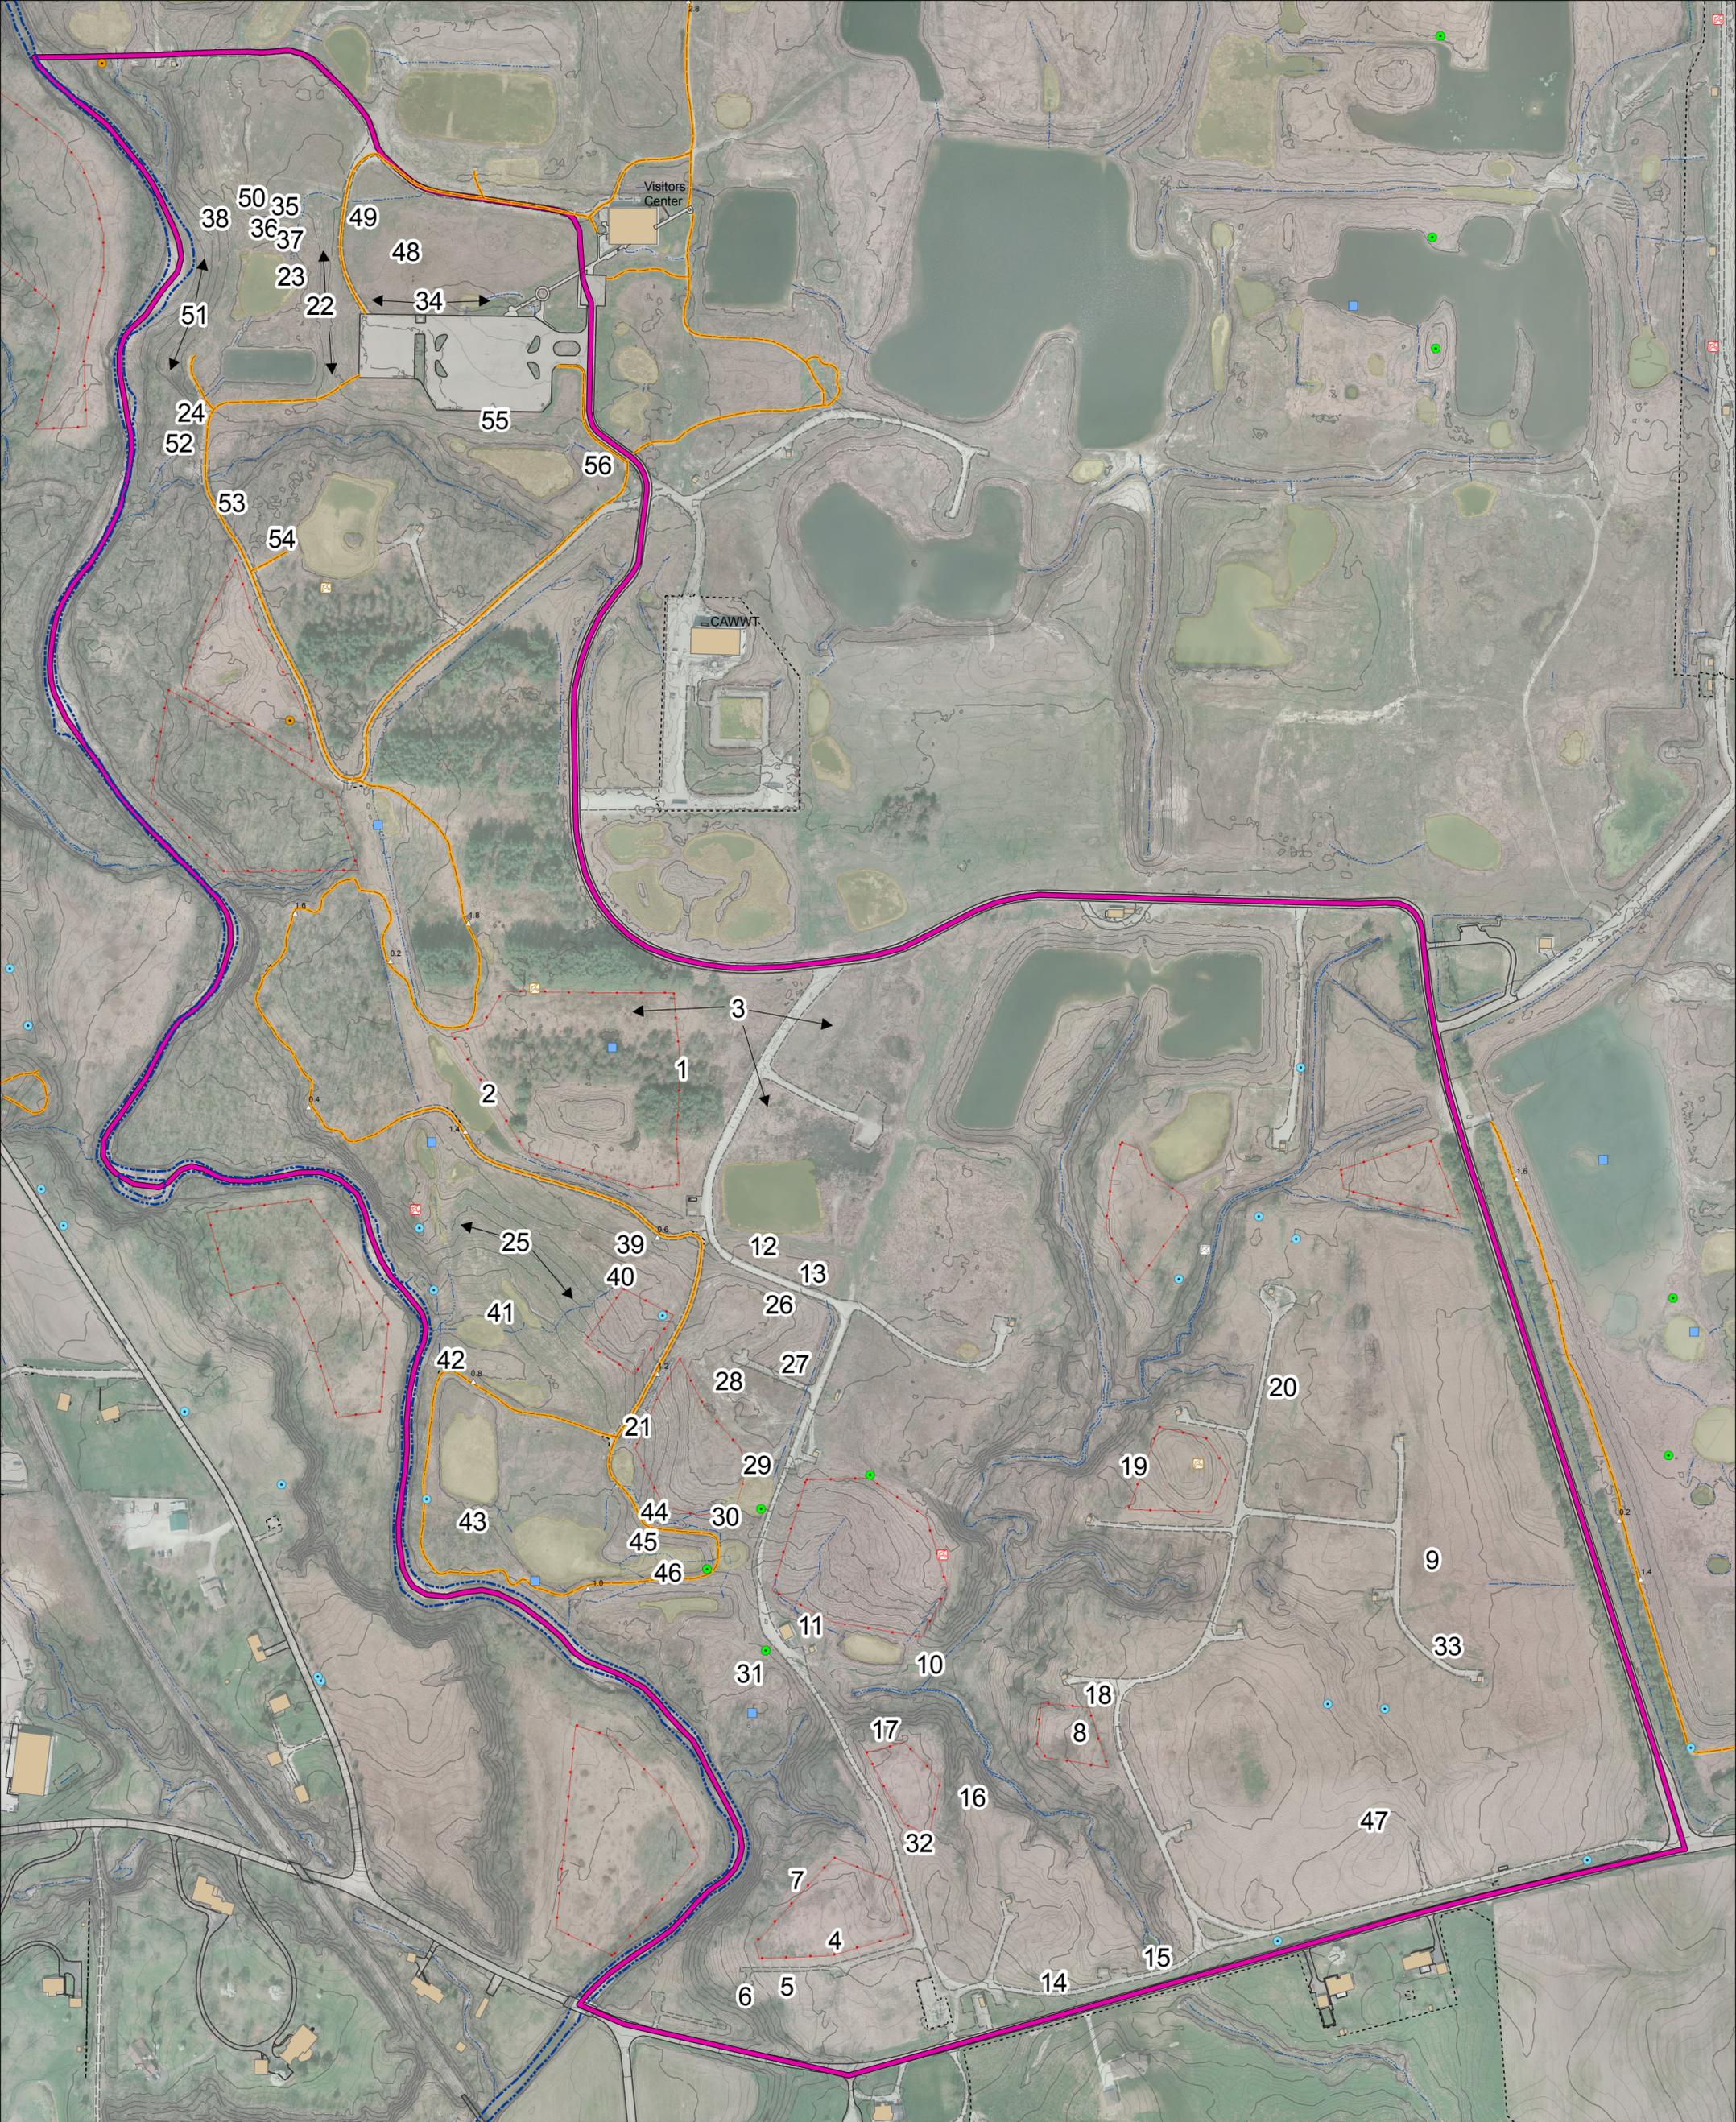
No.	Location (Use Map Whenever Possible)	GPS?	Type of Finding				Description	Photo? (File No.)	Follow Up		
			Unauthorized Use	Disturbance	Vegetation	Other			Corrected	Maintenance Req'd	Cont. Observation
1	South pines deer fence					X	Hole in fence		X		
2	South pines deer fence					X	Hole in fence		X		
3	South pines/PRE				X		Reed canary grass		X		
4	South field – west				X		Deer fence gate missing		X		
5	Well 22108 well pad				X		Exposed wires	1-130612	X		
6	Well 33253				X		Miscellaneous debris on pad	2-130612	X		
7	South field deer fence – west				X		Fence down		X		
8	South field deer fence – east				X		Fence overgrown – remove		X		
9	Borrow area west prairie			X			Reed canary grass		X		
10	East of 'dance hall' at creek			X			Bull thistle patch		X		
11	Berm behind dance hall			X			Bull thistle patch		X		
12	South berm of pond			X			Canada thistle		X		
13	North edge of road at vernal pool			X			Canada thistle		X

14	North of gravel road and east of power station			X			Teasel and Canada thistle		X		
15	Outfall from drain under Willey Road		X		X		Vegetation kill, concrete, bricks	3735 to 3739	X	X	
16	Berm on north edge of field			X			Bull thistle		X		
17	North end of deer fence				X		Fence down on pole		X		
18	West of road at well house entrance			X			Canada thistle, callary pear		X		
19	West end of deer fence				X		Empty cages		X		
20	East side of road			X			Canada thistle		X		
21	SWU along Sycamore trail			X			Bull thistle and teasel		X		
22	East bank of silo ponds			X			Crown vetch		X		
23	East edge of north silo pond			X			Phragmites		X		
24	Shingle Oak trail overlook			X			Vegetation overgrown at sign		X		
25	SWU			X			Thistle and teasel on bank north of Sycamore loop		X		
26	South bank of gravel road			X			Phragmites and teasel		X		
27	North of well access			X			Teasel		X		
28	South of well access			X			Teasel		X

29	East of deer fence			X			Bare area				X

No.	Location (Use Map Whenever Possible)	GPS?	Type of Finding				Description	Photo? (File No.)	Follow Up		
			Unauthorized Use	Disturbance	Vegetation	Other			Corrected	Maintenance Req'd	Cont. Observation
30	South east corner of deer fence				X		Thistle and teasel		X		
31	Across road from 'dance hall'				X		Thistle and teasel		X		
32	Deer fence south of 'dance hall' and north of substation			X			Deer fence gate open	X			
33	South field prairie				X		Canada thistle		X		
34	North edge of VC parking lot				X		Pear and honeysuckle		X		
35	North of silo ponds				X		Crown vetch		X		
36	North of silo ponds				X		Downed cages		X		
37	North of silo ponds				X		Bare spot			X	
38	East bank PR, NW of silo ponds				X		Thistle		X		
39	Downhill from well 3046				X		Debris		X		
40	Northwest corner of deer fence				X		Post down on deer fence		X		
41	North of sycamore trail				X		Johnson grass	X			
42	On the trail near fence post				X		Asphalt		X

43	Inside trail loop, south				X		Cages down		X		
44	Inside trail loop, north				X		Cages down		X		
45	Along trail loop, east				X		Cages down		X		
46	Inside trail loop, east				X		Cages down		X		
47	South field				X		Sink hole			X	
48	Prairie north of parking lot				X		Pear and crown vetch		X		
49	Prairie along Bio-wetland trail				X		Felt matting		X		
50	North of silo ponds				X		Debris		X		
51	East bank Paddys Run				X		Thistle, pear, olive		X		
52	East bank Paddys Run				X		Multiflora rose		X		
53	Woods along Shingle Oak				X		Multiflora rose		X		
54	Overlook on Shingle Oak at pond				X		Pear		X		
55	South edge of parking lot				X		Debris (rebar)		X		
56	Southeast of parking lot				X		Thistle		X
