**SUBJECT: Transmittal of the September 2013 Fernald Preserve On-Site Disposal Facility  
Inspection Forms**

The purpose of this letter is to transmit the completed forms for the September 2013 inspection of the On-Site Disposal Facility (OSDF). The inspection was conducted on September 10, 2013. Photographs of the OSDF and the surrounding area were taken to accompany the inspection and are included with this report. The inspection was conducted by Stoller and the Ohio Environmental Protection Agency (Ohio EPA).

# On-Site Disposal Facility Inspection Report September 2013

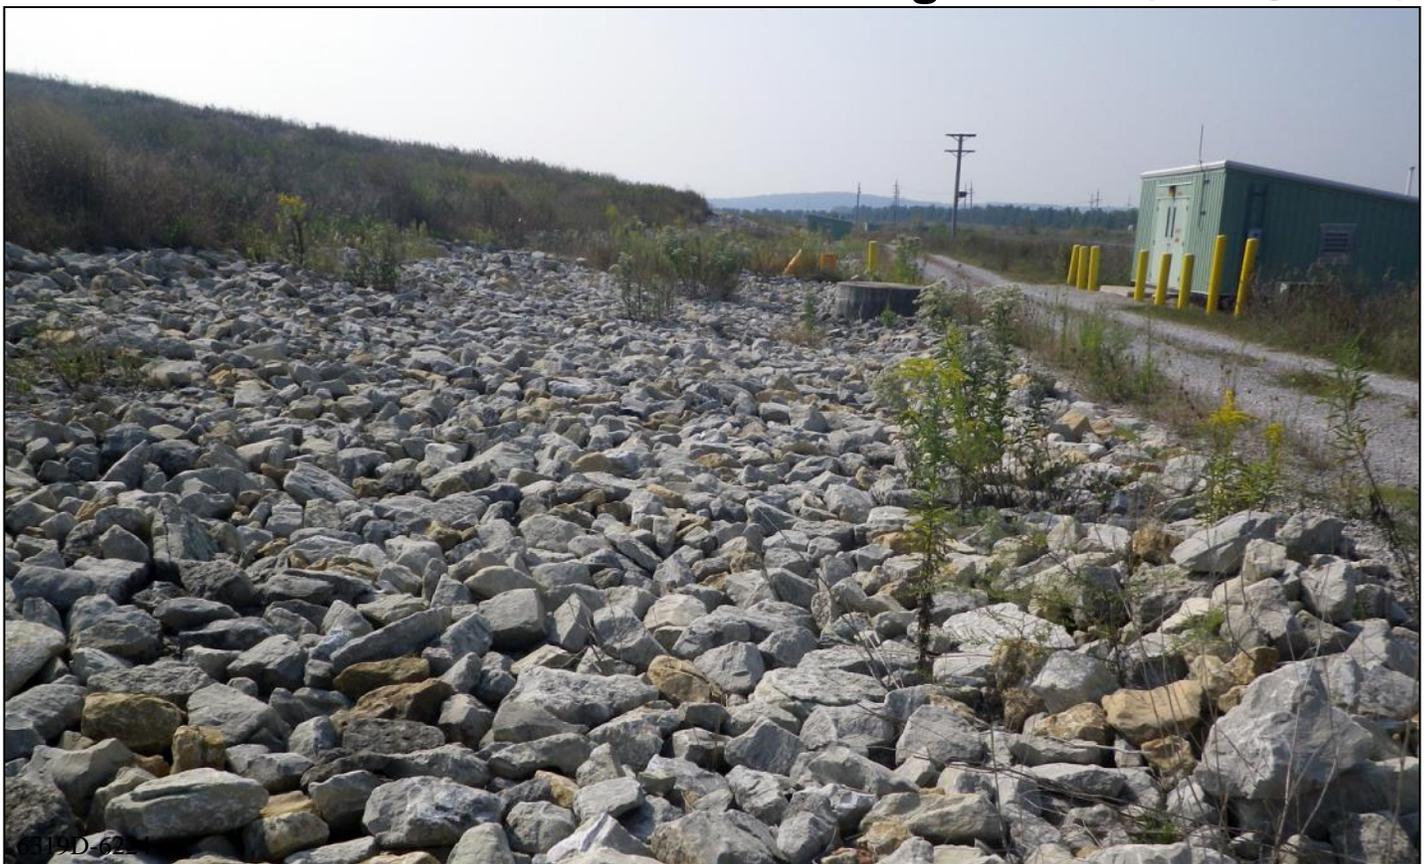
**West Inner Drainage Cell 7 (looking south)**

Inspectors continued to observe restricted flow in several locations along the west inner drainage. Repair efforts in February 2013 were successful in restoring flow at one location near Valve House 6. Small-size angular stone and fines (from the adjacent gravel road) were constricting flow. The stone and sediment was removed with a skid steer and flow was improved. This same approach was attempted at a second location in June 2013, but more sediment was encountered than anticipated. In addition, it appeared that the concrete outfall structure was not draining as designed. Water was draining into the structure, but from a concrete seam rather than the inlet.

Upon discovery of this, it was determined to discontinue maintenance activities and evaluate the need for further action. A "follow-up" inspection of the issues associated with the west inner drainage will be provided separately, pursuant to Section 7.2 of the Post Closure Care and west inner drainage will be provided separately, pursuant to Section 7.2 of the *Post Closure Care and Inspection Plan*.

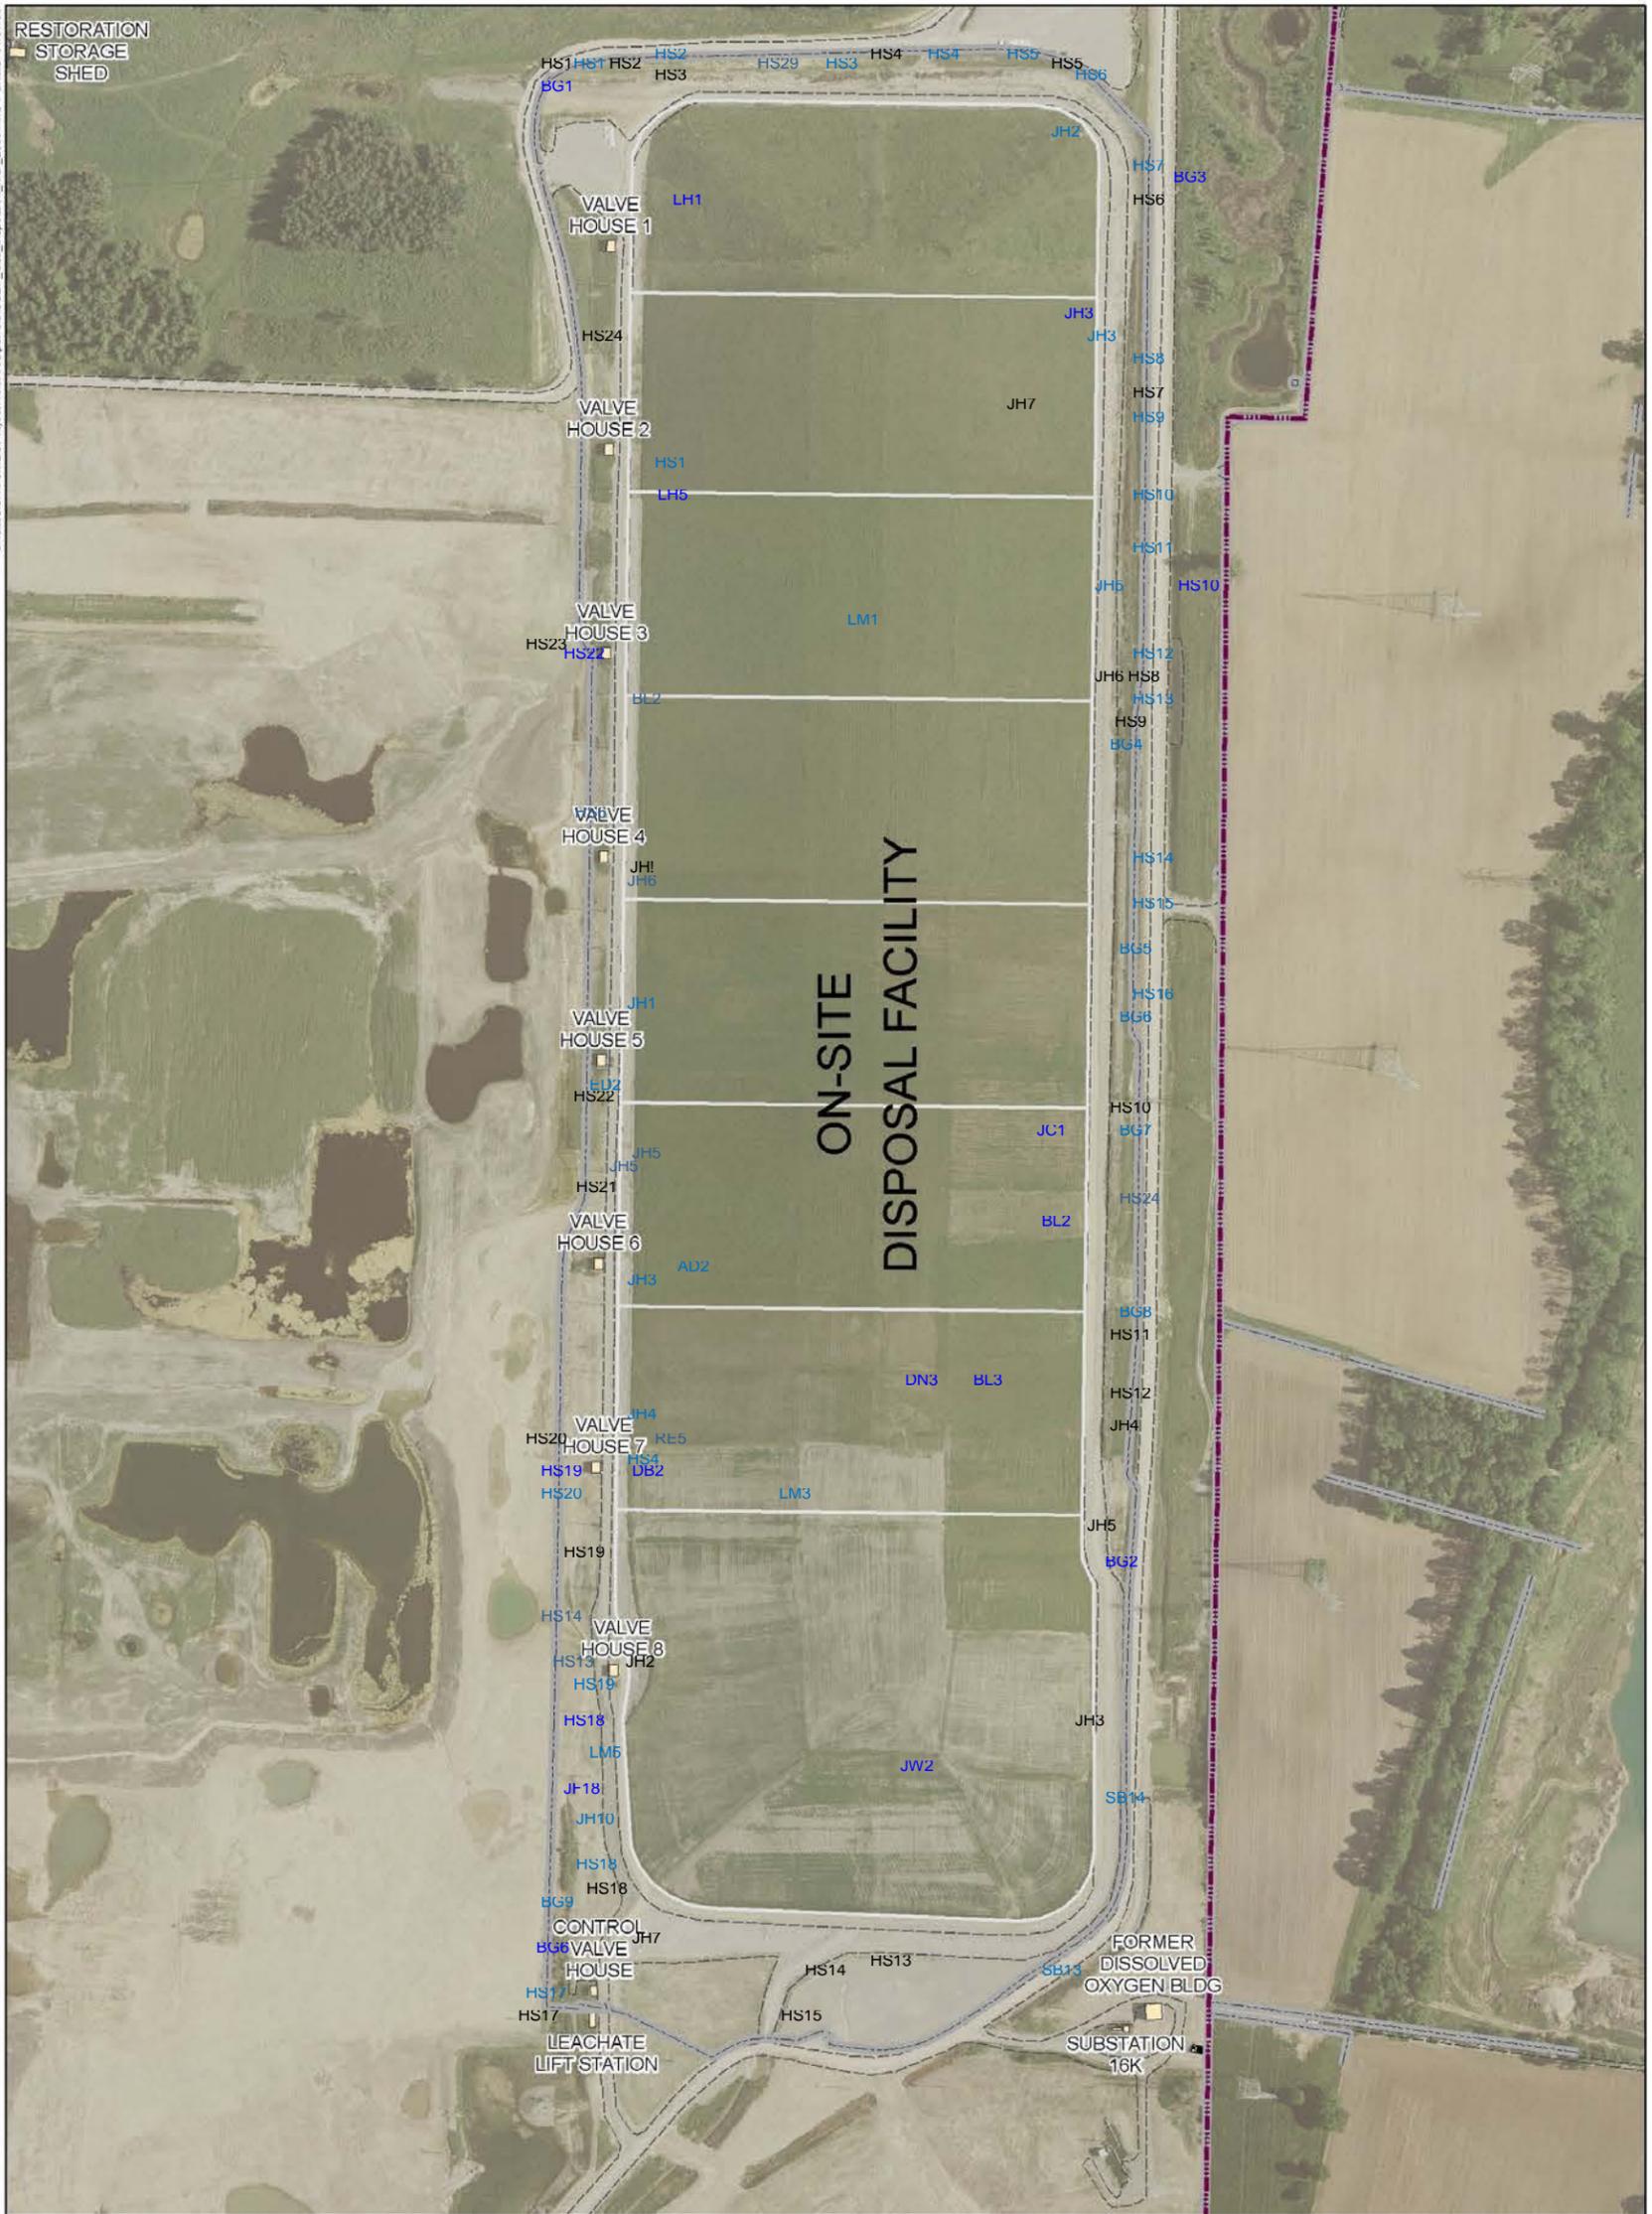
**Fernald Preserve  
OSDF (On-Site Disposal Facility)  
September 2013 Inspection Findings  
(Previous findings requiring follow-up or  
maintenance)**

Individuals recorded their findings on the Fernald Preserve OSDF Walkdown Inspection form and indicated the locations of those findings on a map of the OSDF. A consolidated form and map is included with this report. Most findings were related to the presence of woody and invasive vegetation. No major changes were observed in the status of erosion along the toe of the slope or the fence line. These findings have been noted during previous inspections and maintenance at these locations is ongoing.

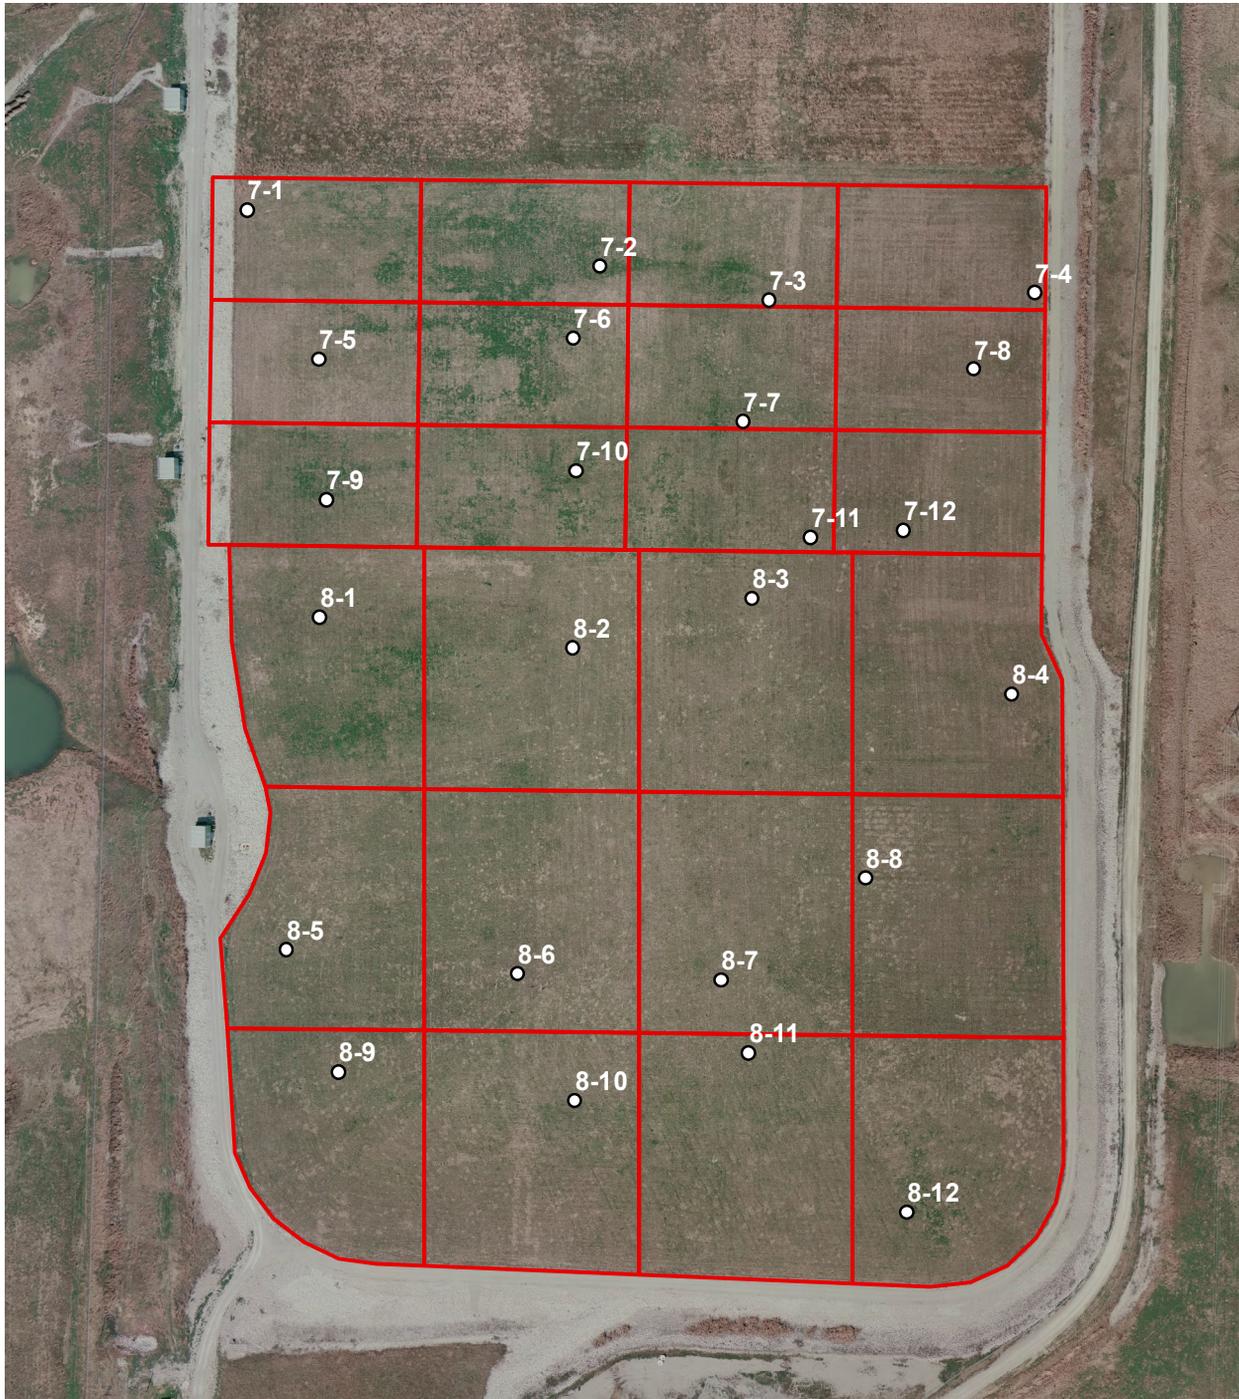
**Fernald Preserve  
OSDF Implementation  
Monitoring**

Pursuant to Volume II of the LMICP, herbaceous cover data was collected for Cell Caps 7 and 8. For each cell cap, 12 one-meter square quadrats were randomly located using a three by four grid. The enclosed figure shows the grid and quadrat locations for each cell cap. Field surveys were conducted on August 23 and August 27. Total cover and species richness data were collected for each quadrat. From this information, total cover, native species composition and relative frequency of native species were calculated. The table below summarizes the findings. The enclosed data tables present cap-specific species lists.

The LMICP goals for the OSDF cap include 90% total cover and 50% native species composition. The data collected on Cells 7 and 8 demonstrate that native vegetation is being maintained across both cells. Native species composition is above 50% for both caps. Total cover is close to 90% for Cell Cap 7, but less than expected for Cell Cap 8. It is suspected that yellow sweet clover (*Melilotus officinalis*) contributed to reducing total cover on Cell 8. A large number of plants were observed in bloom earlier in the year. By the time the field data was collected in August, the plants had died off. These plants may have shaded out other species that did not re-establish later in the season, resulting in less total cover in August. Nevertheless, the integrity of the cap appeared intact, as no erosion was observed on either cap.
