**SUBJECT: Transmittal of the September 2013 Fernald Site Inspection Forms**

**Fernald Preserve Field Walkdown Inspection**

**Fernald Preserve  
3rd Quarter South 2013  
Site Inspection Findings**

**Fernald Preserve**  
Consolidated Finding Locations for North Section  
of September 2013 Site Inspection

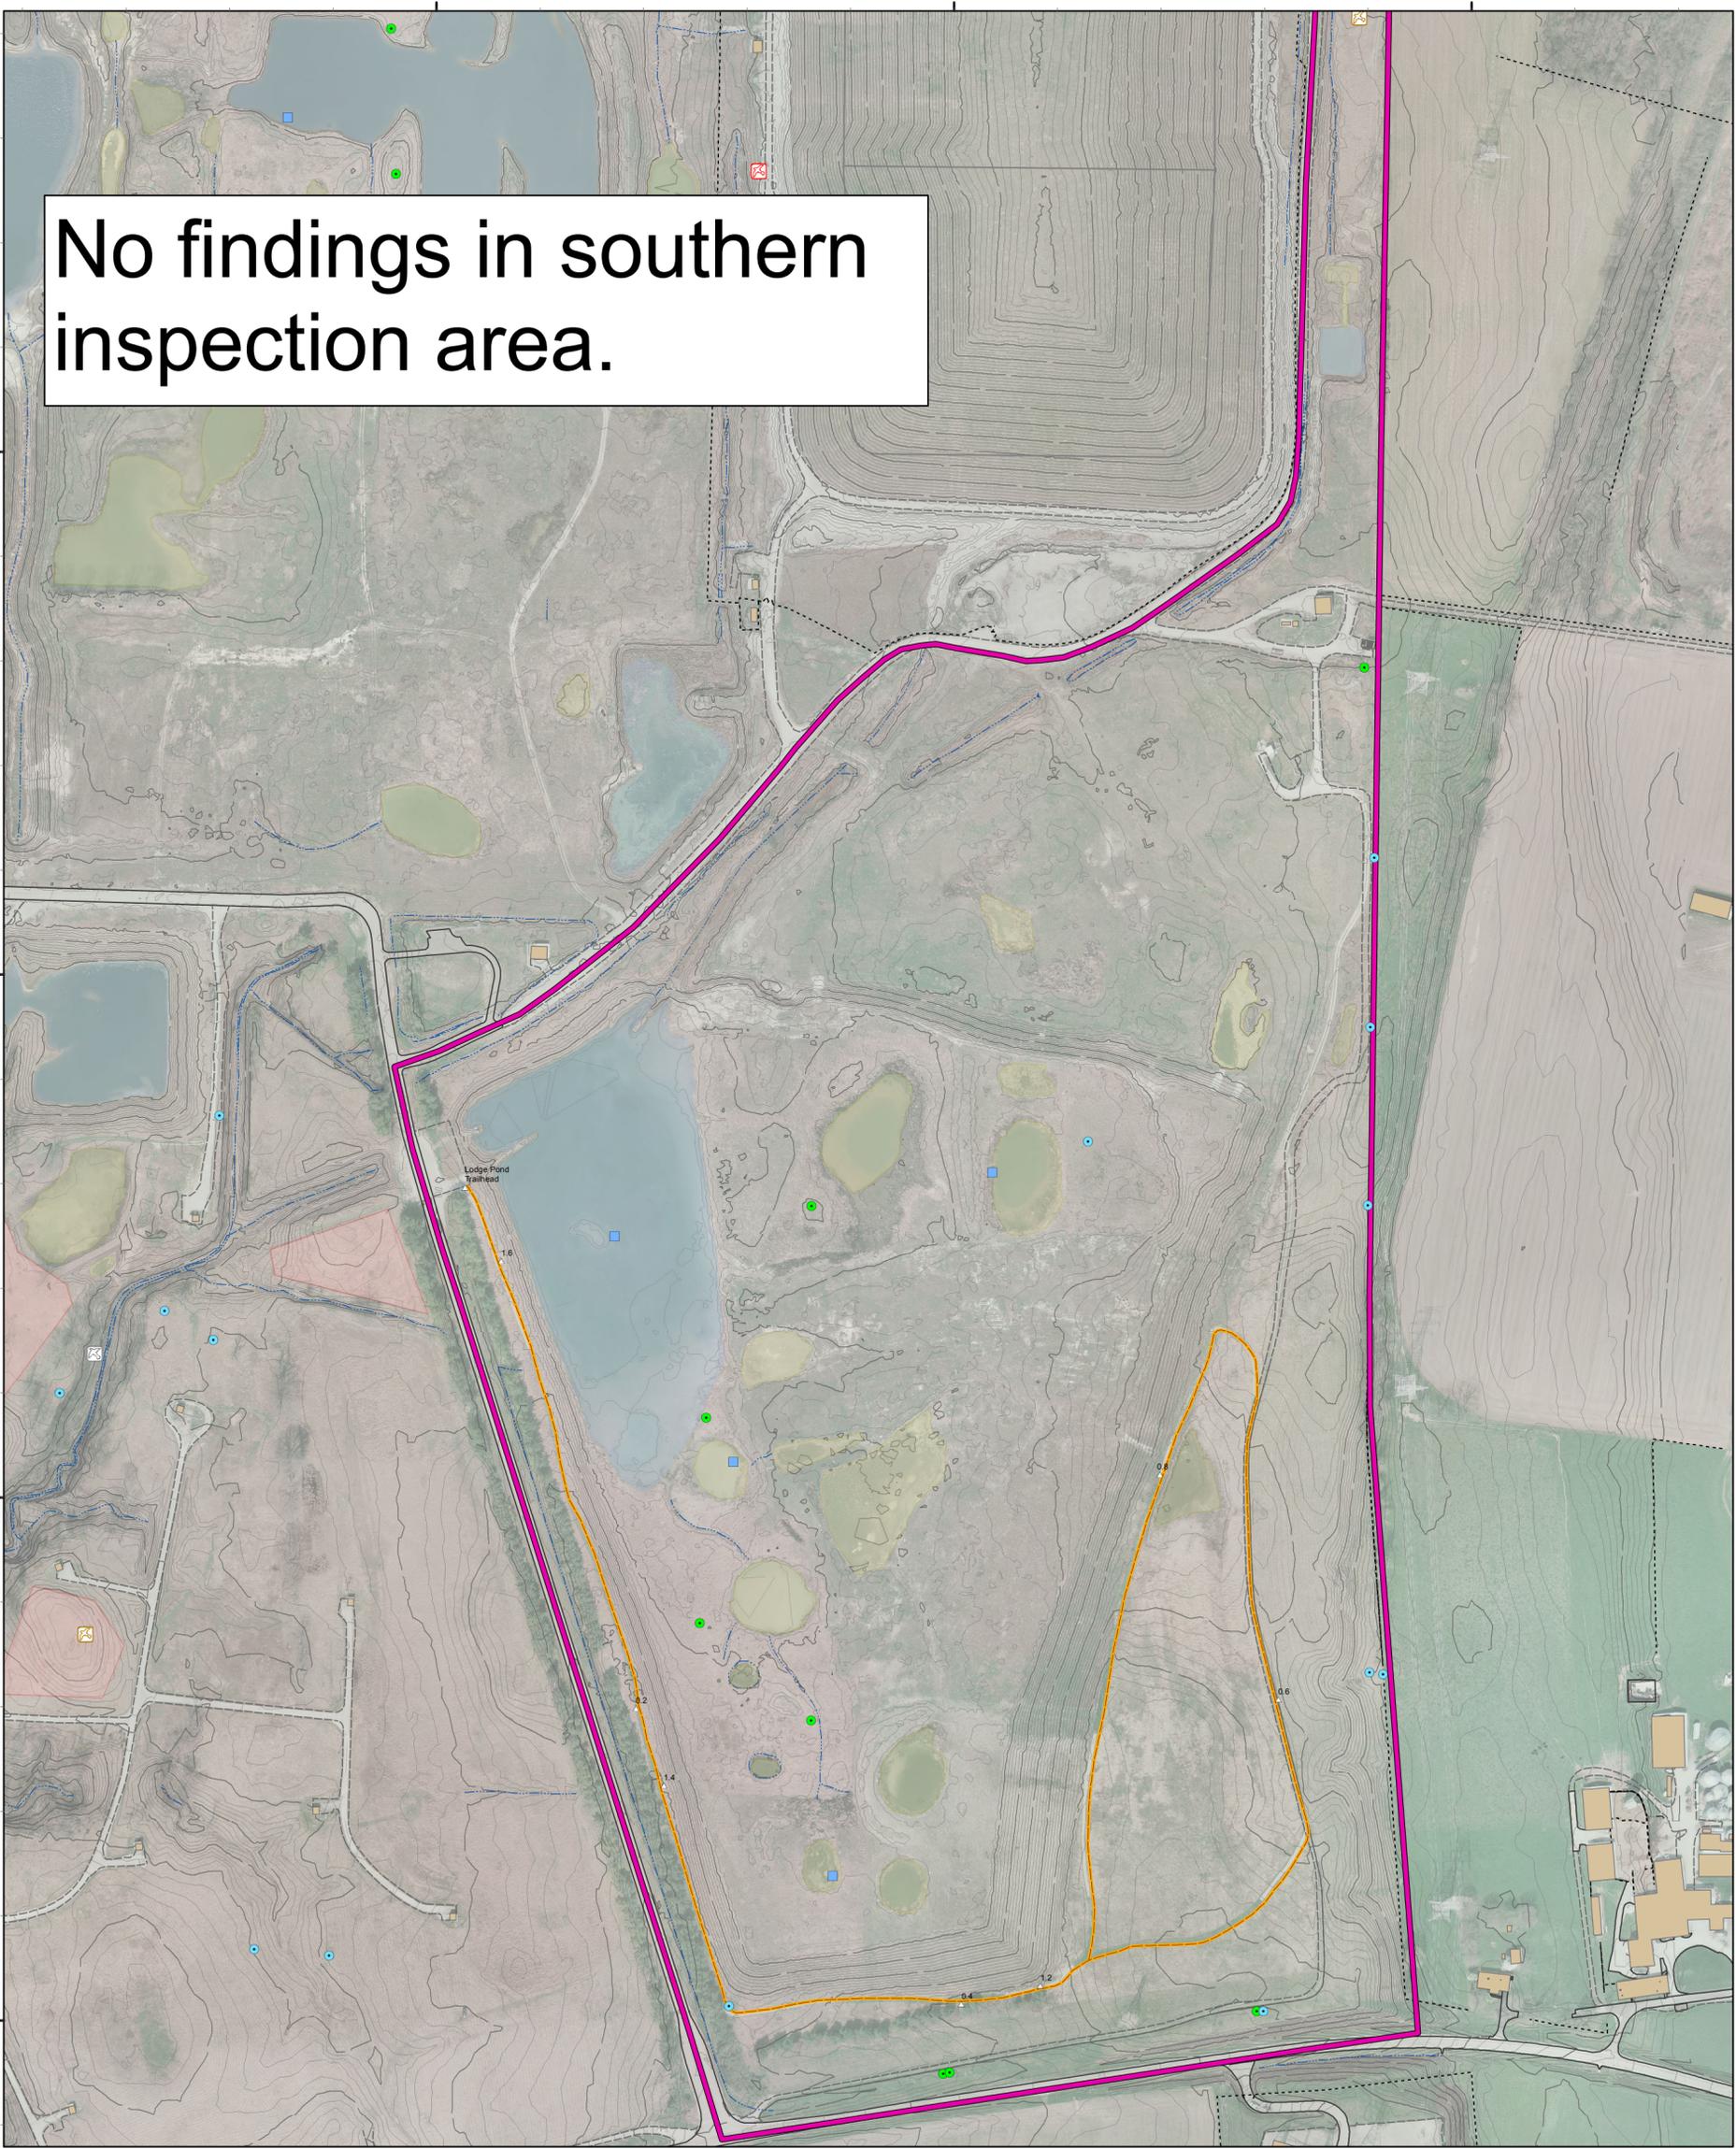
No findings in southern inspection area.

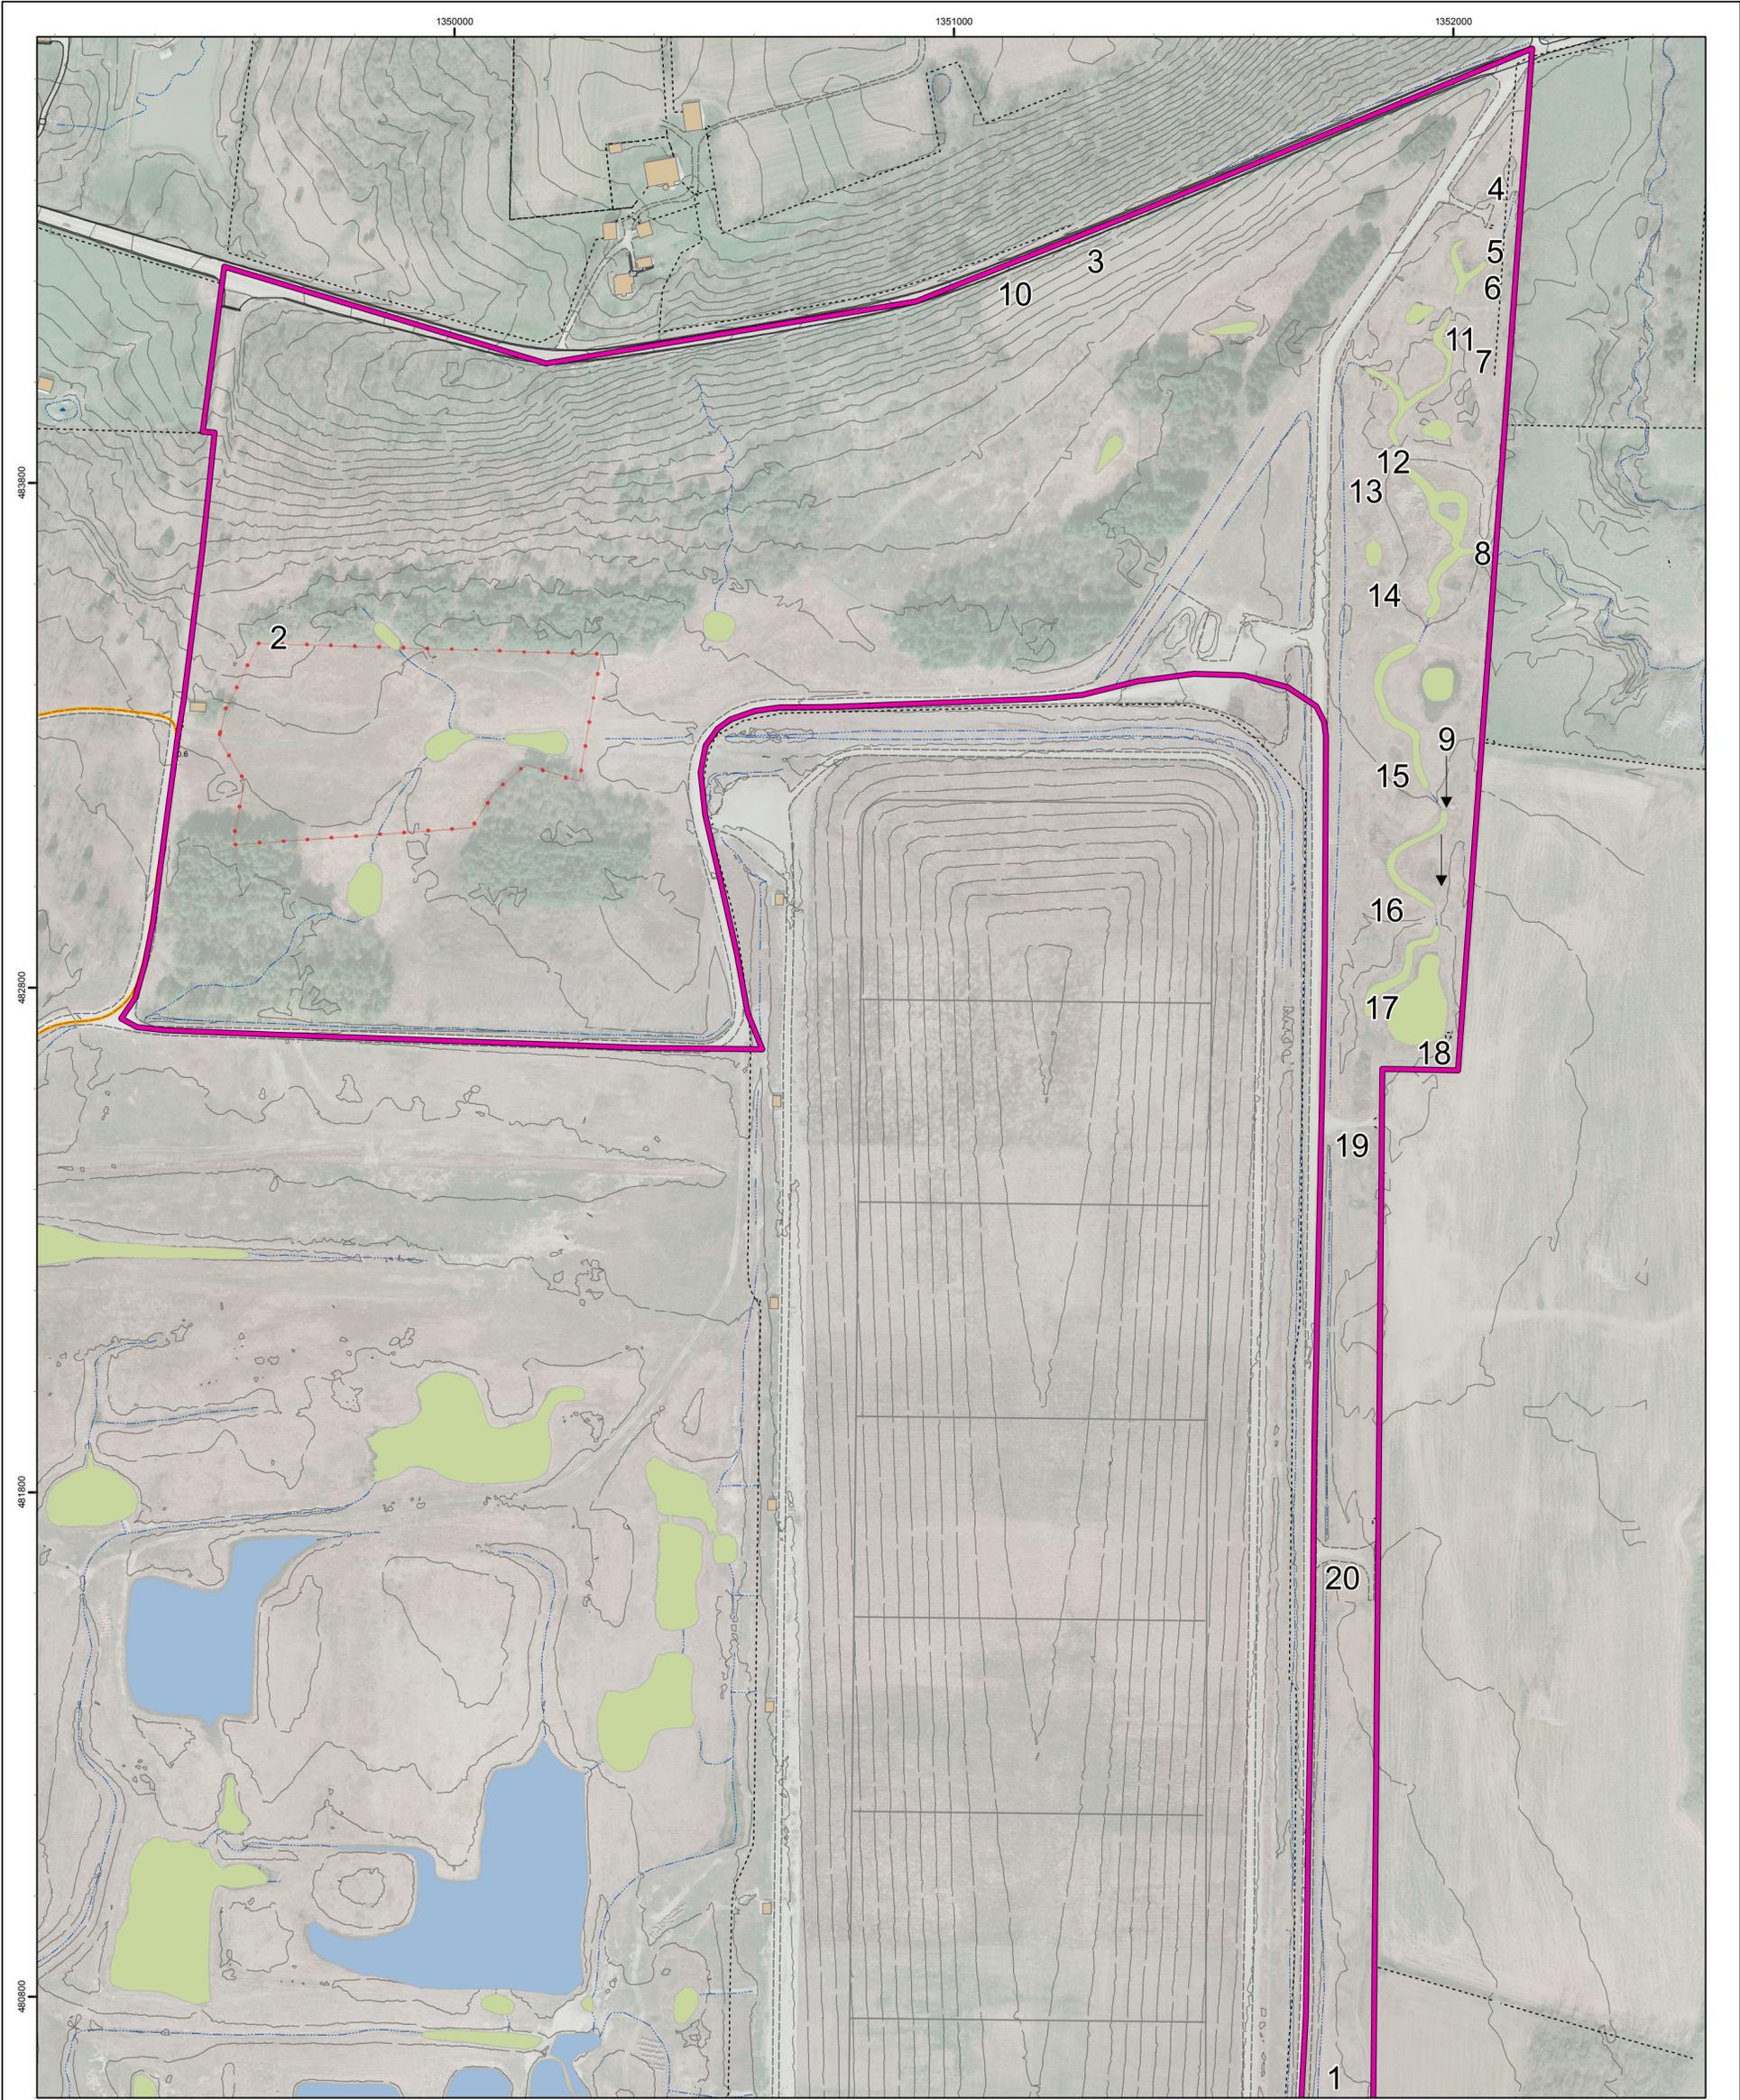
NOTE: Findings are numbered and provided on the September 2013 Field Walkdown Form.
