SUBJECT: Transmittal of the June 2015 Fernald Quarterly Inspection Report

Fernald Preserve OSDF Walkdown Inspection Report

### OSDF Inspection, June 2015

# FERNALD PRESERVE

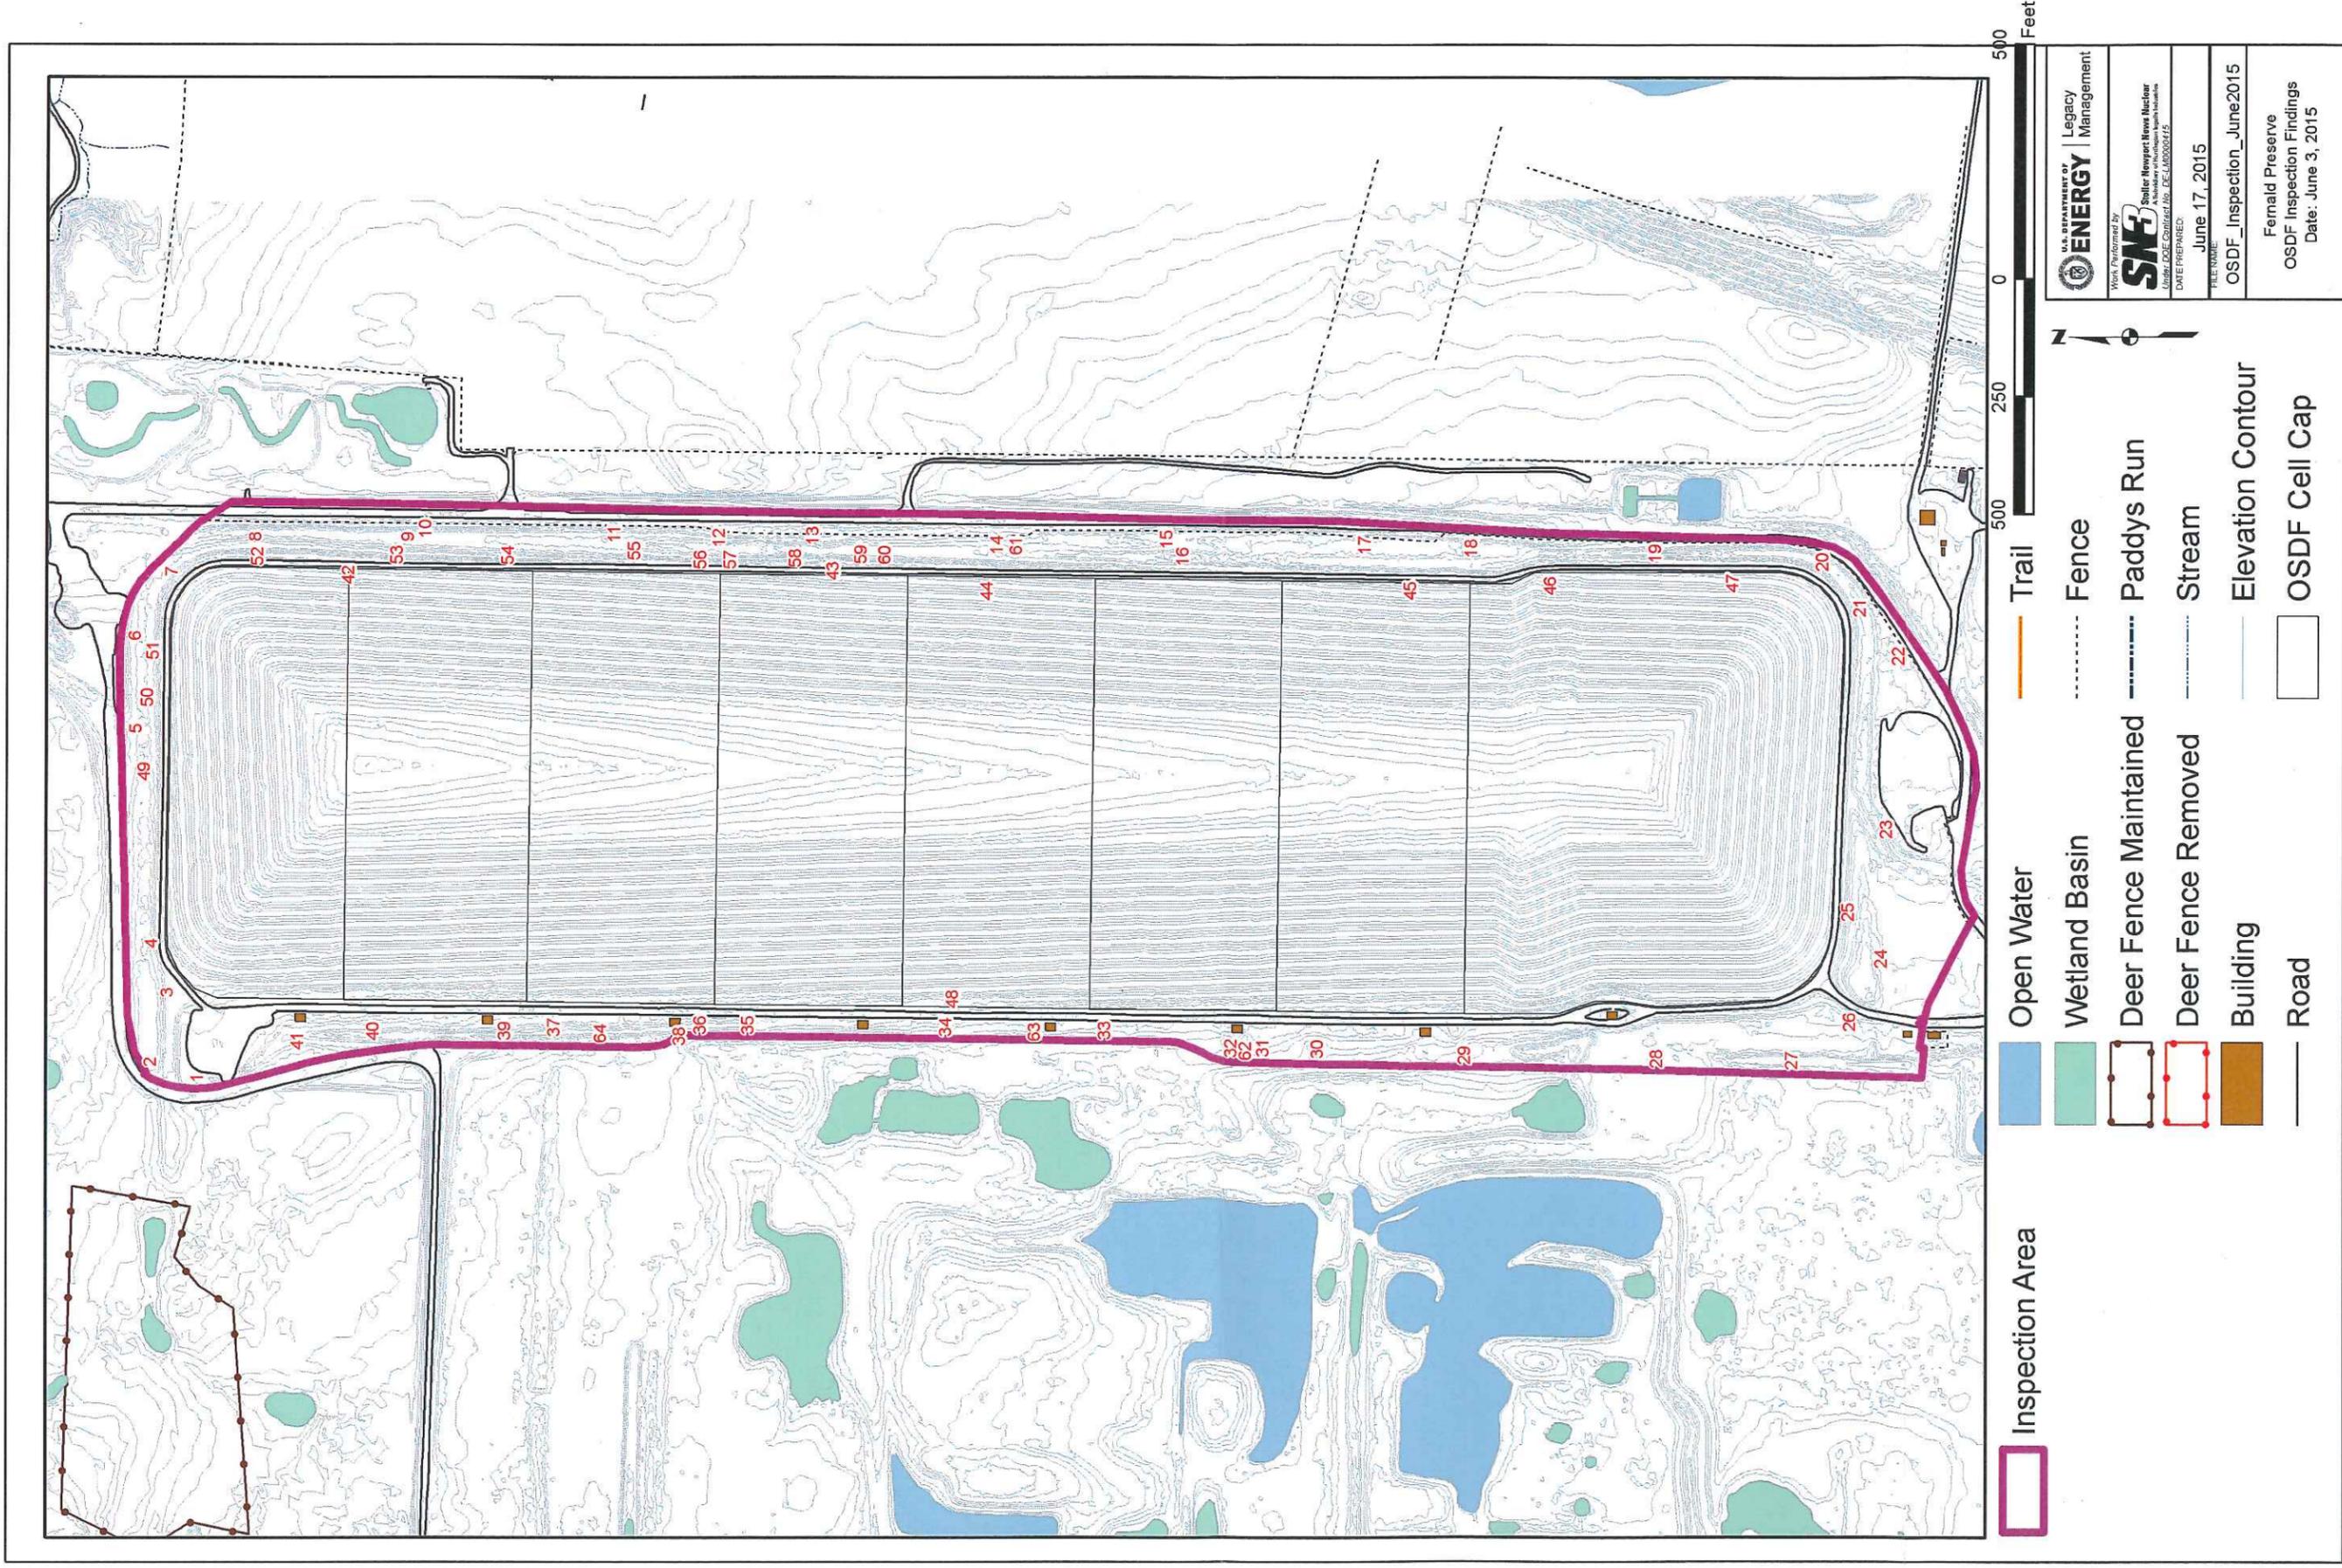
Map No.	Location	GPS?	Type of Finding	Description	Photo? (File No.)
1	Perimeter, northwest corner	No	Vegetation	Teasel patch	
2	Perimeter, northwest corner	No	Vegetation	Honeysuckle and pear	
3	Rocks west of Cell 1 corner	No	Vegetation	Cedar and ash trees	
4	North drainage	No	Vegetation	Honeysuckle and pear	
5	North drainage at old gate location	No	Vegetation	Pear trees, teasel, thistle and a metal gate stop	
6	Perimeter, northeast corner	No	Vegetation	Teasel patch	
7	Perimeter, northeast corner	No	Vegetation	Hackberry, honeysuckle, pear trees	
8	East Perimeter at cell 1	No	Vegetation	Bull thistle, teasel, pear	
9	East perimeter at cell 2 at fence	No	Vegetation	Pear trees and honeysuckle	
10	East perimeter at fence	No	Vegetation	teasel	
11	East perimeter at cell 3, north of midpoint	No	Vegetation	bull thistle, pear, honeysuckle, canada thistle	
12	East perimeter at 3/4 boundary at fence	No	Vegetation	canada thistle, honeysuckle, pear, musk thistle

13	East perimeter at cell 4 at fence	No	Vegetation	Pear, honeysuckle, cherry, thistle	
14	East perimeter at cell 5 at fence	No	Vegetation	Pear, honeysuckle, thistle

Map No.	Location	GPS?	Type of Finding	Description	Photo? (File No.)
15	East perimeter at Cell 6 at fence	No	Vegetation	Box elder, willow, thistle, pear, honeysuckle	
16	East perimeter at cell 6 in cattails	No	Vegetation	Ash, cottonwood, poison ivy	
17	East perimeter at cell 7 at fence	No	Vegetation	Honeysuckle, pear, willow, cottonwood	
18	East perimeter at cell 7/8 boundary	No	Vegetation	Japanese honeysuckle, ash, pear, cedar, canada thistle	
19	East perimeter at cell 8 at fence	No	Vegetation	Pear and honeysuckle	
20	East perimeter, southeast corner	No	Vegetation	Pear, cherry, dogwood	
21	Southeast perimeter in rocks near laydown area	No	Vegetation	Canada thistle	
22	Southeast perimeter at fence in laydown area	No	Vegetation	Musk thistle	
23	South drainage extension in rocks	No	Vegetation	Thistle, pear, honeysuckle, cedar	
24	South prairie area near gate	No	Vegetation	Scattered musk thistle	
25	South drainage (east/west)	No	Vegetation	Honeysuckle, canada thistle, pear, musk thistle, multiflora rose

26	Southwest corner along west side of OSDF road just north of gate	No	Vegetation	honeysuckle	
27	Southwest perimeter along drainage	No	Vegetation	Woody species, invasives, thistle	
28	West perimeter at cell 8	No	Vegetation	Scattered musk thistle	
29	West perimeter at cell 7/8 boundary	No	Vegetation	Teasel	
30	West perimeter at cell 7	No	Vegetation	Scattered musk thistle

Map No.	Location	GPS?	Type of Finding	Description	Photo? (File No.)
31	West perimeter at cell 7 outfall - north end of cell 7	No	Other	ends of abandoned leachate are open	
32	Behind VH 6	No	Vegetation	musk thistle	
33	West perimeter at cell 6 at fence	No	Vegetation	Teasel	
34	West perimeter at cell 5 at fence	No	Vegetation	Teasel and thistle	
35	West perimeter at cell 4 at fence	No	Vegetation	Teasel, thistle, honeysuckle	
36	West perimeter at cell 3/4 boundary	No	Vegetation	Woody vegetation	
37	West perimeter at cell 3	No	Vegetation	Scattered musk thistle	
38	West perimeter behind VH 3 in cattails	No	Vegetation	Pear	
39	West perimeter at cell 2/3 boundary	No	Vegetation	pear, teasel, ash	
40	West perimeter at Cell 2 at fence	No	Vegetation	Woody species and teasel	
41	West perimeter behind VH1	No	Vegetation	Honeysuckle	
43	East perimeter road at cell 4	No	Vegetation	Bull thistle	
44	East perimeter road at cell 5	No	Vegetation	Honeysuckle

45	East perimeter road at cell 7	No	Vegetation	Honeysuckle	
46	East perimeter at cell 8 near fence	No	Vegetation	Honeysuckle	
47	East perimeter at Cell 8 near fence	No	Vegetation	honeysuckle	
48	West perimeter road at cell 5	No	Vegetation	Honeysuckle	
49	North drainage, midpoint	No	Vegetation	Cedar

Map No.	Location	GPS?	Type of Finding	Description	Photo? (File No.)
50	North drainage, east of midpoint	No	Vegetation	2 cherry trees and 1 ash further east	
51	North perimeter, just west of northeast corner	No	Vegetation	Woody vegetation	
52	East drainage at cell 1	No	Vegetation	Honeysuckle	
53	East drainage at cell 2	No	Vegetation	Grape vine, Virginia creeper, honeysuckle	
54	East drainage at Cell 2, south end	No	Vegetation	Honeysuckle, virginia creeper	
55	East drainage at Cell 3	No	Vegetation	Honeysuckle	
56	East drainage at Cell 3, south end	No	Vegetation	Tree	
57	East drainage at Cell 4, north end	No	Vegetation	Willow	
58	East drainage at Cell 4	No	Vegetation	Honeysuckle	
59	East drainage at Cell 4	No	Vegetation	Thistle	
60	East drain at cell 5	No	Vegetation	Woody vegetation x 2	
61	East perimeter at Cell 6	No	Vegetation	Woody vegetation x 3 (cottonwood)	
62	West perimeter behind VH 6	No	Vegetation	Thistle

63	West perimeter around VH 5	No	Vegetation	Thistle	
64	West perimeter between VH 2 and VH 3	No	Vegetation	Thistle, teasel, honeysuckle, crown vetch	
NA	along west edge of road, south of VH 8	No	Vegetation	callery pear	
NA	West side of cell 8	No	Vegetation	3 plants within 10 feet	
NA	West side of cell 6	No	Vegetation	Honeysuckle 10 feet in on cell side

Map No.	Location	GPS?	Type of Finding	Description	Photo? (File No.)
NA	West side of cell 5, 10 feet toward cell	No	Vegetation	Honeysuckle	
NA	West side of cell 5, 10 feet toward cell	No	Vegetation	Honeysuckle	
NA	east toe of cell 1	No	Vegetation	callery pear tree	
NA	along rock at east side cell 2	No	Vegetation	callery pear	
NA	edge of road at east side cell 7	No	Vegetation	callery pear tree	
NA	East perimeter road edge at Cell 2/3 boundary	No	Vegetation	Japanese honeysuckle	
NA	edge of road at east side of cell 7	No	Vegetation	callery pear tree	
NA	along road in rocks on east or south side of cell 8	No	Vegetation	callery pear	
NA	North side of cell 1	No	Vegetation	honeysuckle	
NA	east drainage at cell 2	No	Vegetation	callery pear tree	
NA	West edge of riprap at Cell 2	No	Vegetation	Box elder	
NA	West edge of riprap at Cell 6	No	Vegetation	Honeysuckle. Three in riprap.	
NA	West edge of riprap at cell 8	No	Vegetation	Honeysuckle

NA	West edge of riprap at Cell 8	No	Vegetation	Honeysuckle	
NA	West toe at Cell 8	No	Vegetation	Honeysuckle	
NA	South toe at Cell 8	No	Vegetation	Honeysuckle	
NA	Southeast corner along road edge	No	Vegetation	2 honeysuckle - one on road edge and one on east bank riprap

Map No.	Location	GPS?	Type of Finding	Description	Photo? (File No.)
NA	East toe at cell 7/8 boundary.	No	Vegetation	Grape vine	
NA	East toe at Cell 5/6 boundary	No	Vegetation	Elm seedling	
NA	East perimeter road edge at Cell 2	No	Vegetation	Honeysuckle	
NA	East perimeter road, northeast corner, east road edge	No	Vegetation	2 honeysuckle seedlings	
NA	Across from VH 5	No	Vegetation	Honeysuckle	
NA	East toe at Cell 7	No	Vegetation	cherry seedling
