SUBJECT: Transmittal of the March 2015 Fernald Quarterly Inspection Report

Fernald Preserve Field Walkdown Inspection Report

Fernald Preserve OSDF Walkdown Inspection Report

FERNALD PRESERVE

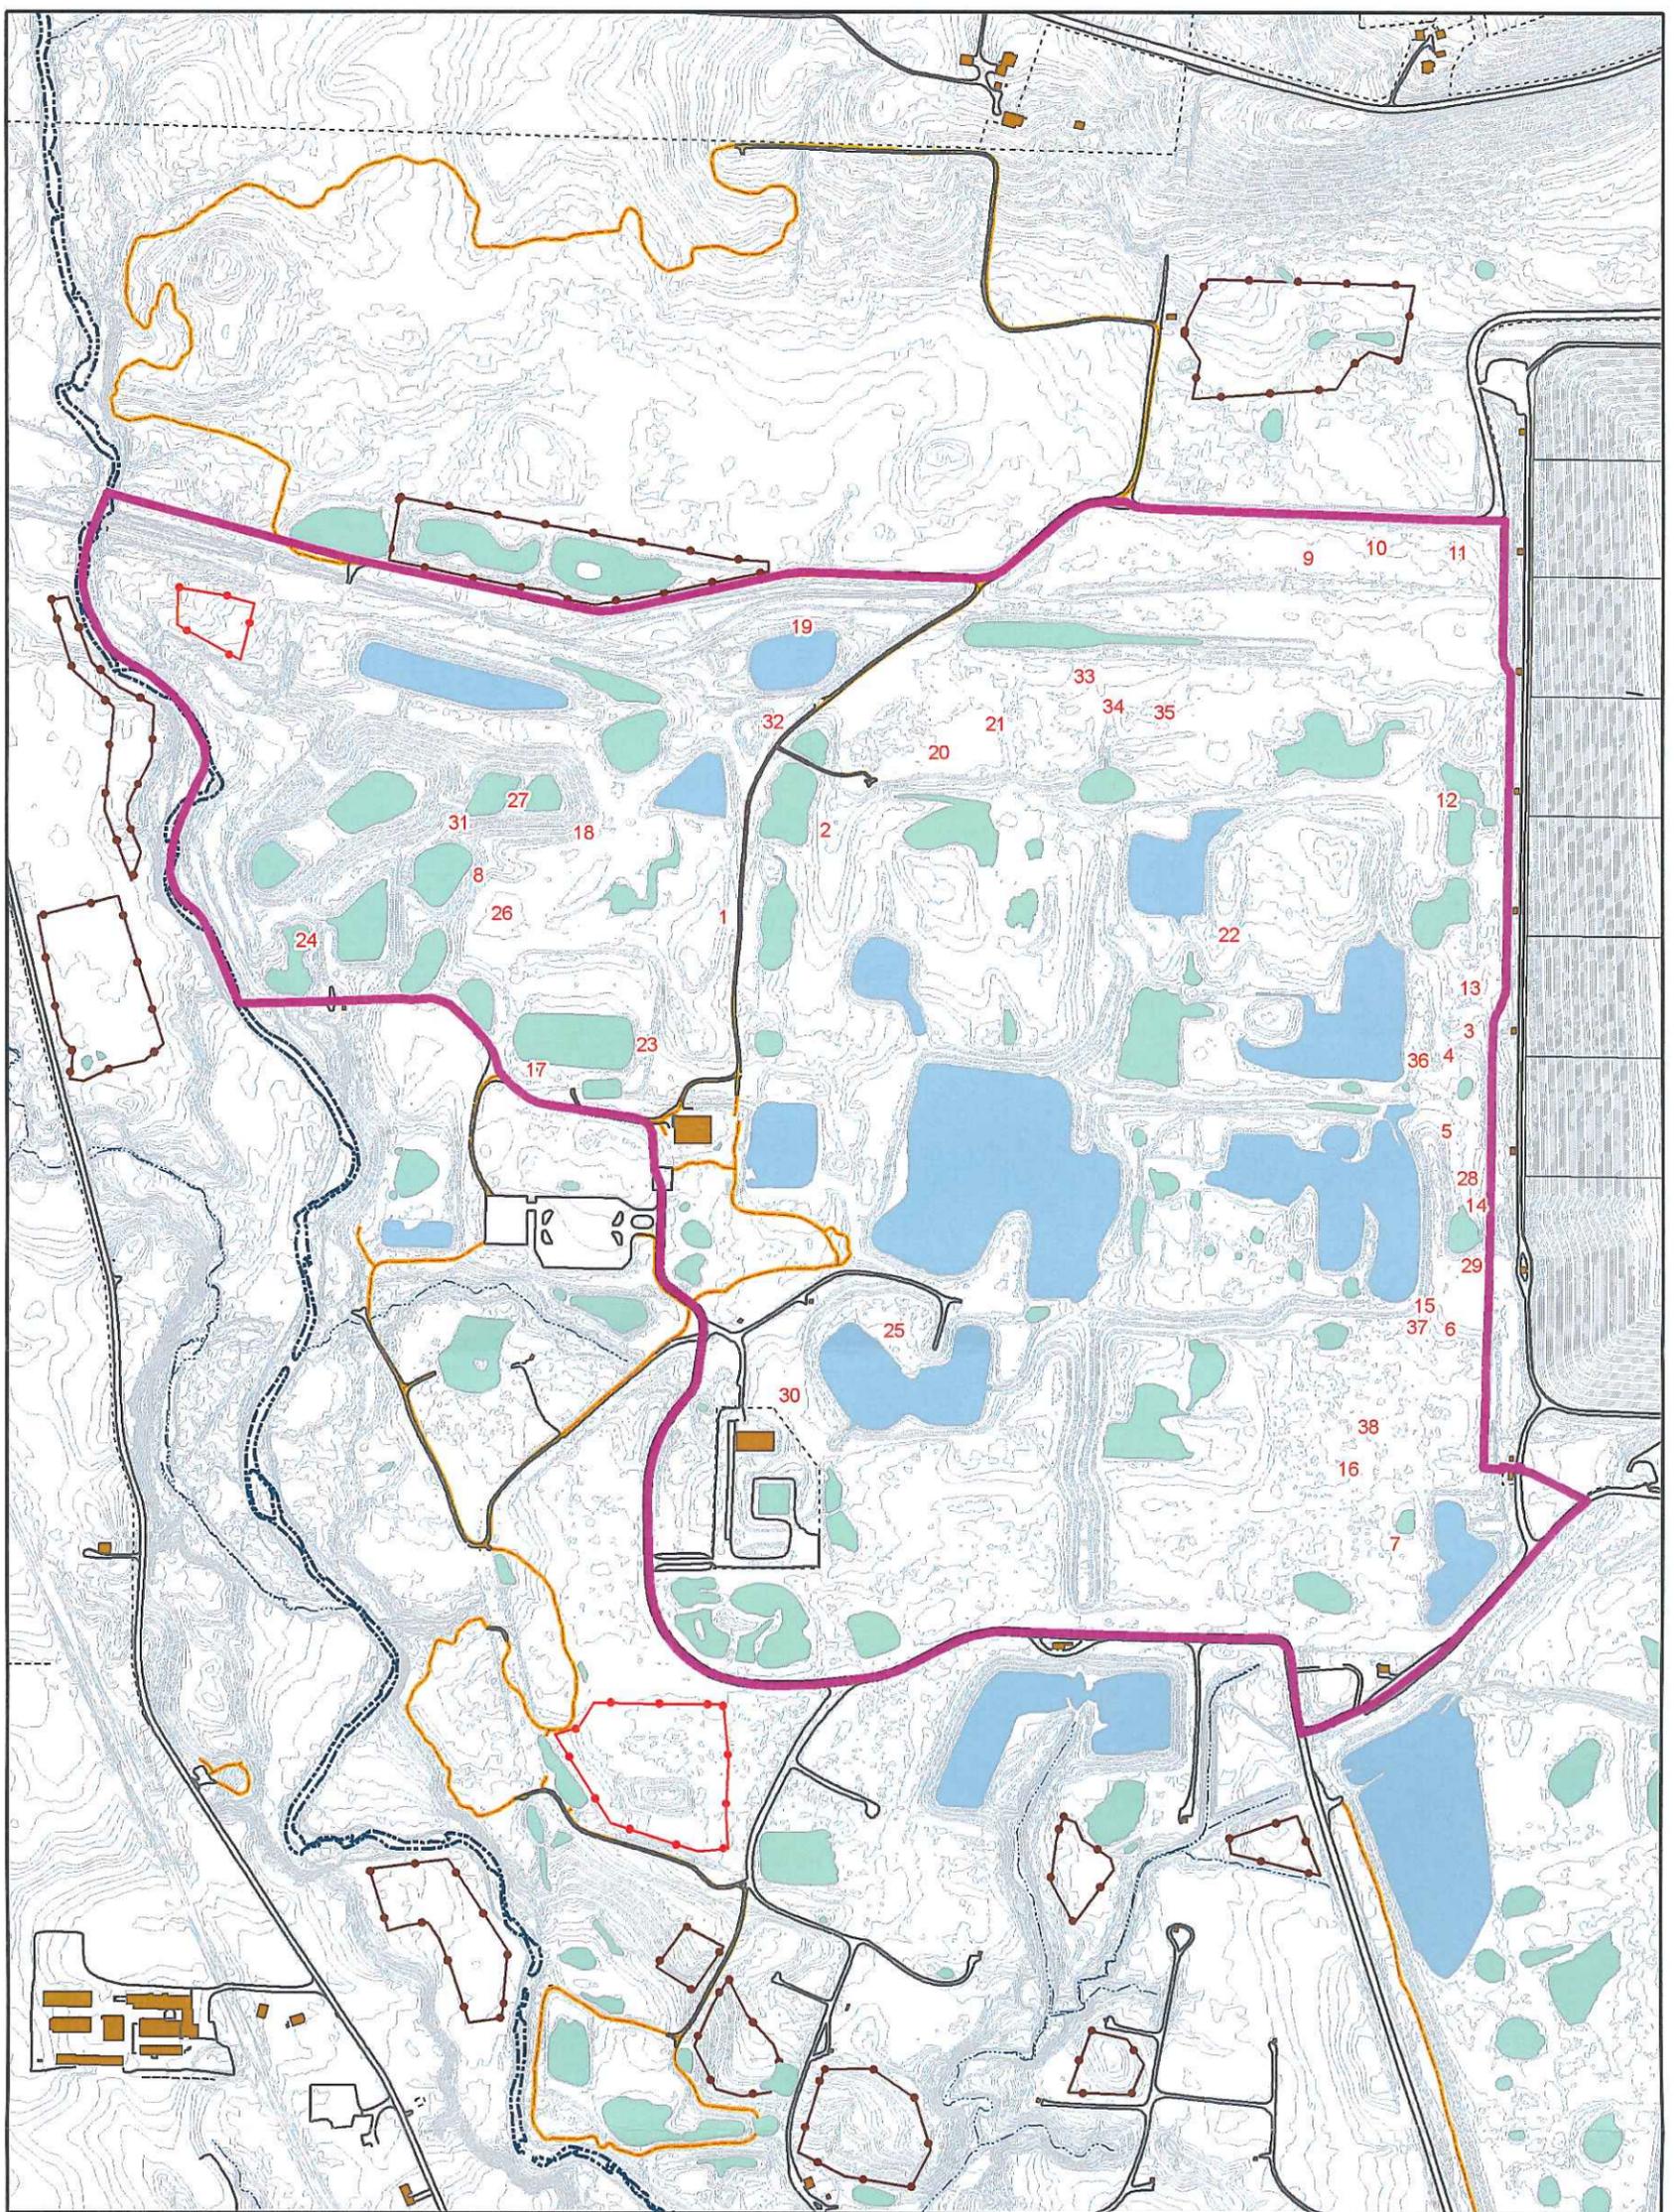
Central Quadrat Inspection Findings - January 14, 2015

The findings from the Central Quadrant inspection in January were mostly related to debris (concrete, asphalt) and erosion findings. The debris findings are typical for this area. Findings from the South Quadrant and the West Quadrant in February were more varied and included debris, deer fence repair, and invasive vegetation findings. The March inspection of the East Quadrant resulted in more deer fence repair and trash findings.

Map No.	Location	GPS?	Type of Finding	Description	Photo? (File No.)
1	West of Hickory trail	No	Debris	Patch of debris	
2	North of bird blind	No	Debris	Concrete	
3	West of VH6, East of firebreak	No	Debris	Debris patches	
4	West of VH6, east of firebreak	No	Debris		
5	West of VH7, east of firebreak	No	Debris	Concrete	
6	Southwest of VH 8, east of firebreak	No	Debris	Concrete	
7	West of pond, east of firebreak	No	Debris	Very large embedded concrete	
8	Northeast corner of waste pit	No	Erosion	Large erosion rill	
9	100 yards west of OSDF Cell 1/2	No	Debris	Large concrete block	
10	75 yards west of OSDF VH2	No	Debris	asphalt, fabric matting	
11	20 yards west of OSDF VH 2	No	Debris	asphalt, fabric matting	
12	Due west of OSDF VH 4	No	Debris	large chunks of asphalt	
13	Due west of OSDF between VH 5 and VH 6	No	Debris	small concrete

Map No.	Location	GPS?	Type of Finding	Description	Photo? (File No.)
14	West of OSDF hump. 40 yards west of fence.	No	Debris	small concrete/random rubble throughout area	
15	West of Cell 8	No	Erosion	asphalt, small concrete area	
16	West of power station	No	Debris	clay tile (brown glazed) and random asphalt and rubble	
17	Southwest side of bio-wetland	No	Erosion	Muskrat den? Erosion	
18	East side of pond	No	Erosion	Erosion (gully) and tree cages knocked down	
19	North slope of pond	No	Debris	Concrete	
20	East of blind	No	Debris	Concrete	
21	East end SP7	No	Other	Geo textile	
22	East of FPA W7	No	Debris	Concrete	
23	East edge of bio-wetland	No	Erosion	animal burrow	
24	40 feet north of road	No	Other	2 fiberglass stakes	
25	75 yards east of well house 28	No	Debris	glazed tile	
26		No	Debris	Debris	
27		No	Erosion	Erosion	
28		No	Debris	Debris	
29		No	Debris	Debris	
30		No	Debris	Debris	
31	FWP W7	No	Erosion	Erosion, hole

Map No.	Location	GPS?	Type of Finding	Description	Photo? (File No.)
32	West of Hickory trail	No	Debris	Cable buried in ground	
33		No	Debris	partial brick	
34	Parallel to ravine in line with VH 2	No	Debris	Exposed concrete (8" x 5")	
35	Parallel to ravine in line with VH 2	No	Debris	Green and black plastic	
36	Diagonal to VH 6/7 - firebreak	No	Debris	Consolidated debris	
37	Perpendicular to VH 8	No	Debris	2 - 3" concrete debris	
38	Near end of OSDF - parallel	No	Debris	2" - 6" concrete debris

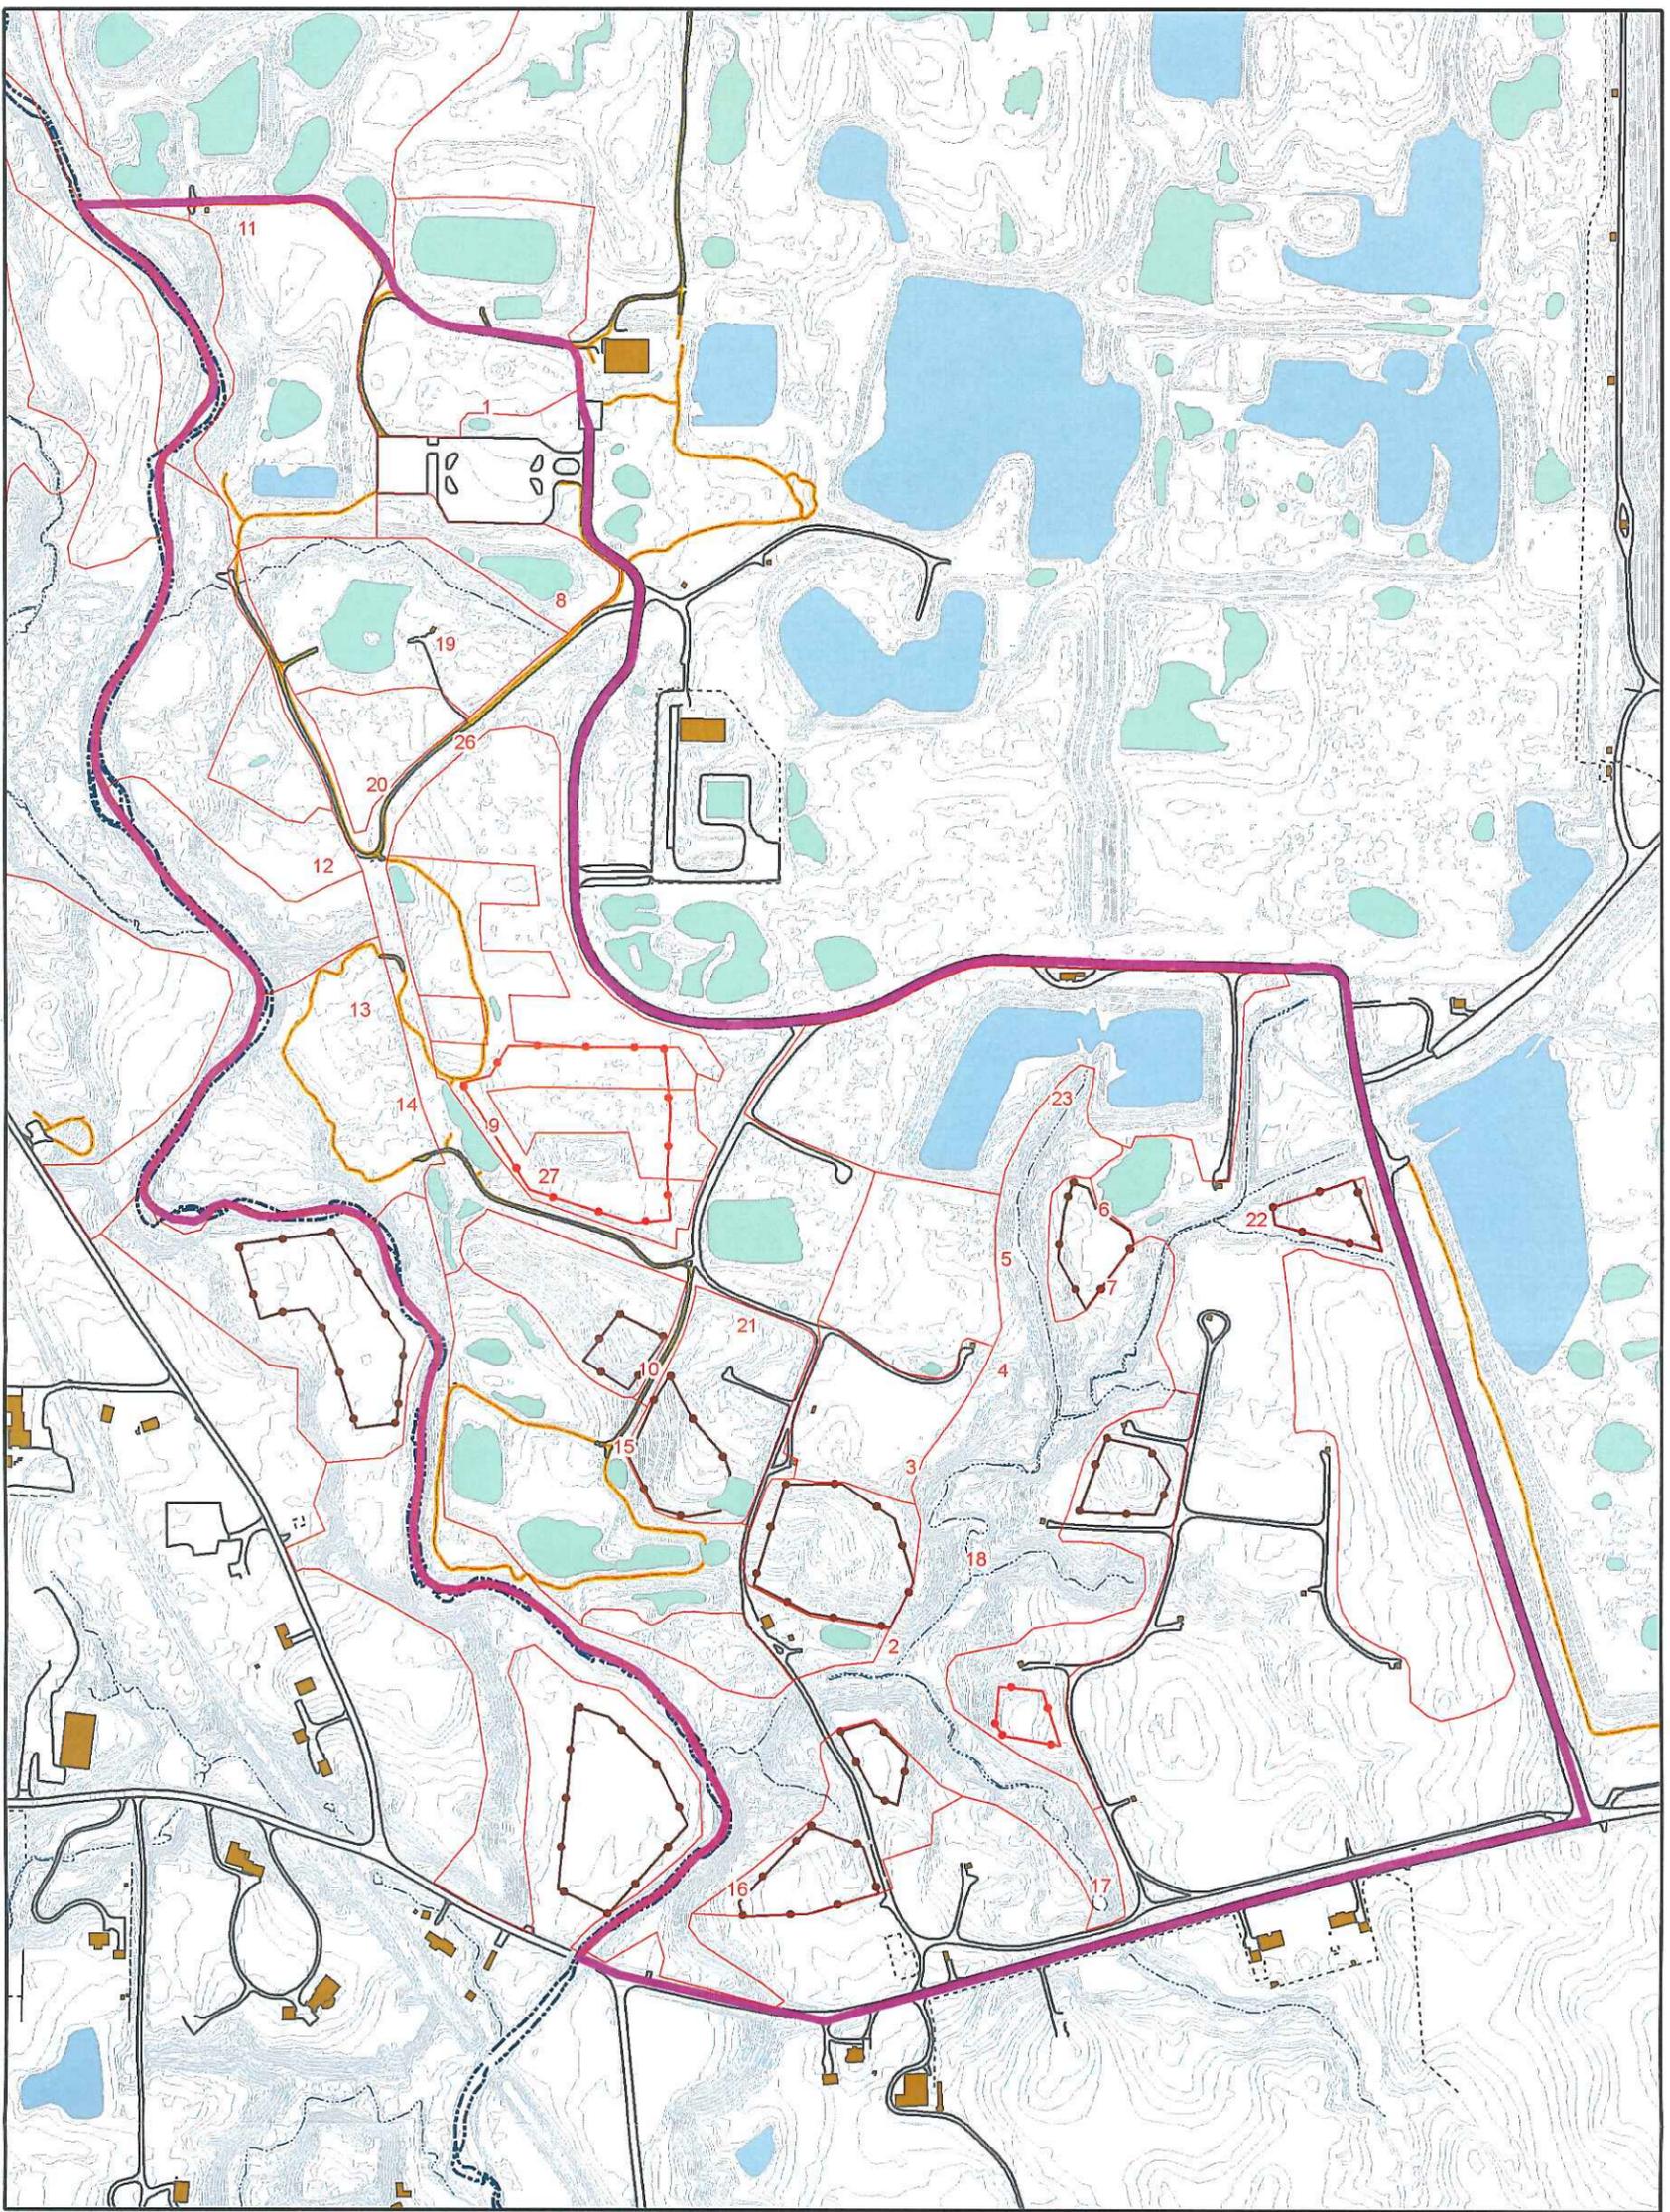
South Quadrant Inspection Findings - February 10, 2015

Map No.	Location	GPS?	Type of Finding	Description	Photo? (File No.)
1	West of visitors center	No	Debris	concrete	
2	SSOD	No	Debris	glazed tile	
3	North of Southern waste units near SSOD	No	Erosion	Erosion	
4	West bank of SSOD, south of storm water retention basins, east of well house	No	Debris	Brick	
5	West bank of SSOD, south of storm water retention basin	No	Debris	Drum lid	
6	Deer fence south of SWRB, northeast side	No	Fencing	Hole in deer fence	
7	Deer fence south of SWRB, southeast side	No	Fencing	Hole in deer fence	
8	West of glacial erratic	No	Erosion	Erosion	
9	East side of boardwalk pond	No	Other	Felt	
10	Between trail and deer fence west of trail.	No	Vegetation	Phragmites

Map No.	Location	GPS?	Type of Finding	Description	Photo? (File No.)
11	North of silos near gravel road to well 33, near hay bales	No	Other	Old cages	
12	West of trail intersection	No	Vegetation	Young honeysuckle growing	
13	Area inside wooded loop of Sycamore trail, west of pines	No	Other	old cages	
14	Are inside wooded loop of Sycamore trail, west of boardwalk	No	Unauthorized Use	Beer can	
15	West of deer fence on east side of trail, between trail and fence at start of the trail loop.	No	Debris	concrete	
16	West side of deer fence just north of on-site electrical substation	No	Fencing	Fence hanging, ties broken	
17	50 yards from culvert	No	Debris	Metal and brick	
18	SSOD, below well house	No	Other	Cages next to creek	
19	West of blue pump station	No	Other	metal stakes with fencing	
20	Inside pines at "v" of Shingle Oak trail	No	Debris	Concrete x 3	
21	SWU, south edge of gravel road	No	Debris	Brown glazed tile (plus terra cotta)

22	West of PRE-RF2 deer fence along access road, near ravine of SSOD	No	Other	Previously flagged brown gloop	
23	North hillside of ravine	No	Debris	concrete chunks	
24	southeast side of deer fence at the rainbow bridge field.	No	Fencing	Tree fell on deer fence

Map No.	Location	GPS?	Type of Finding	Description	Photo? (File No.)
25	East side of deer fence at the rainbow bridge field	No	Other	Metal stakes	
26	East of Shingle Oak trail between PRE-PP1 sections	No	Debris	Asphalt	
27	On mound west of boardwalk, south of pines and north of drain along trail	No	Debris	Concrete	
28	south side of slope of former rail road bed	No	Debris	Metal band

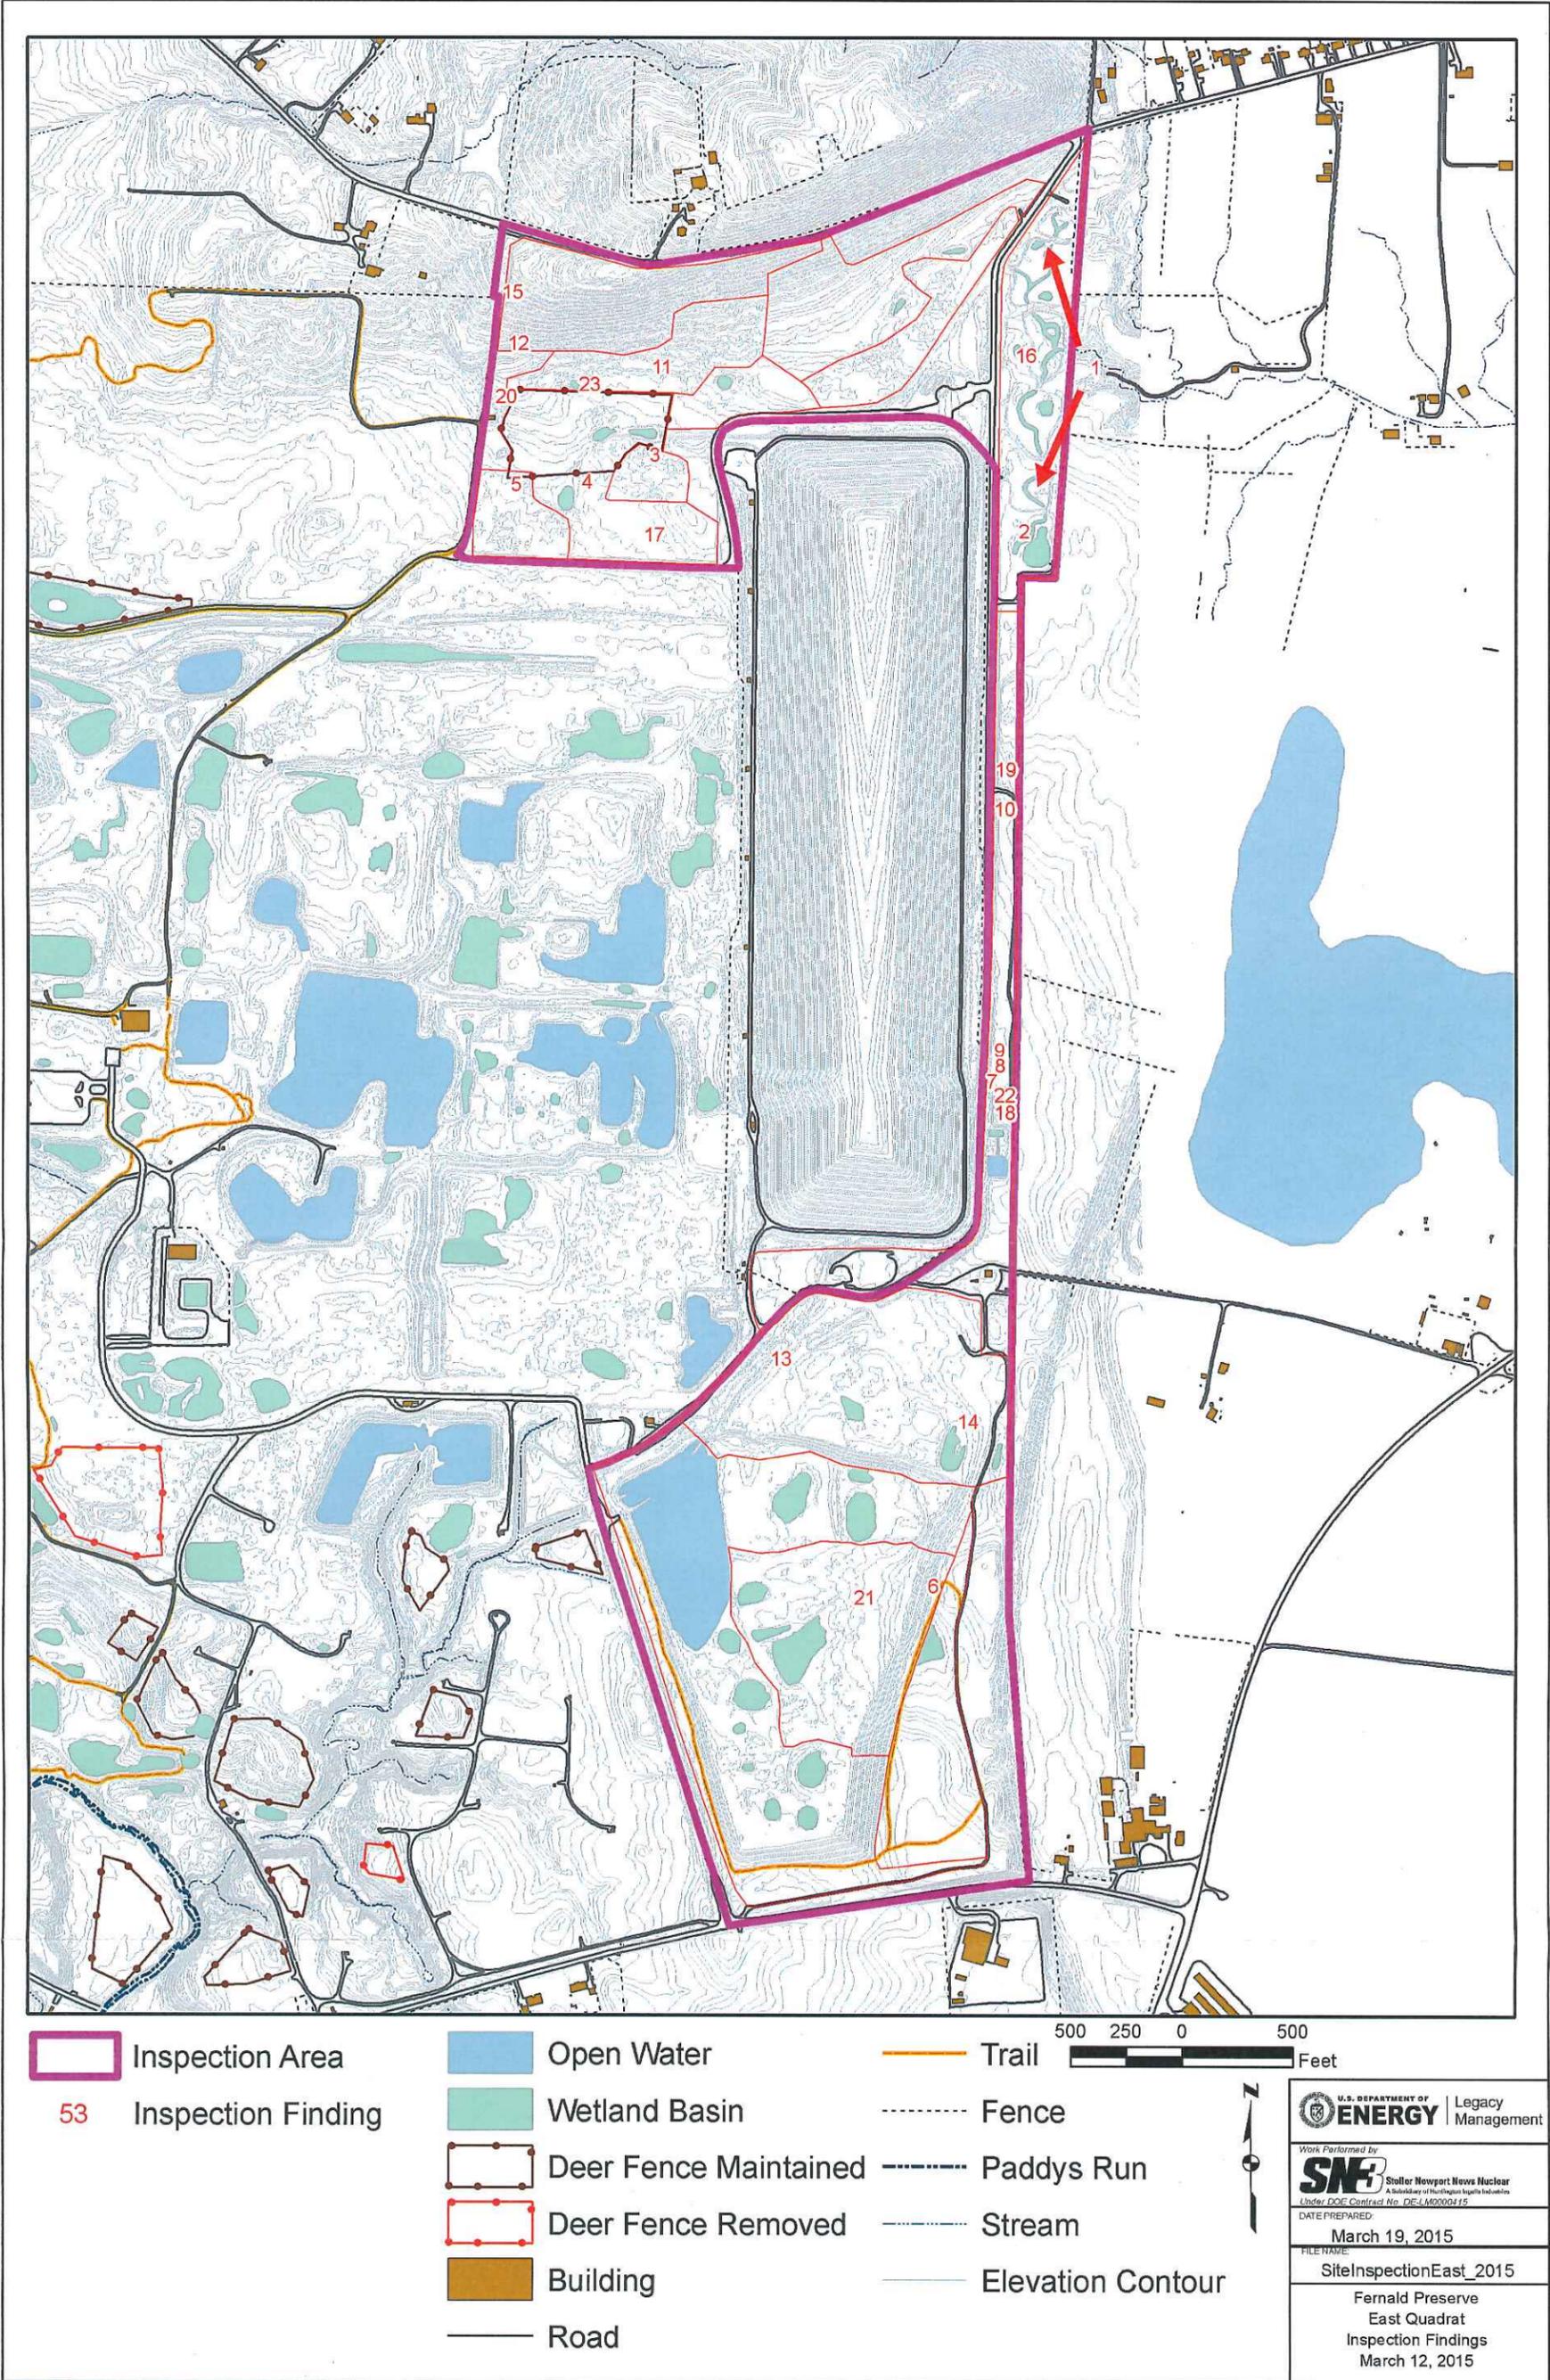
East Quadrat Inspection Findings - March 12, 2015

Map No.	Location	GPS?	Type of Finding	Description	Photo? (File No.)
1	Throughout the WM1 wetland.	No	Other	Black tubes on trees need to be removed	
2	W4 swale	No	Vegetation	Honeysuckle	
3	South side of SE corner of deer fence	No	Fencing	Hole in lower half of deer fence	
4	Midway along south side of deer fence	No	Fencing	Hole in middle of deer fence	
5	SW corner of south side of deer fence	No	Fencing	Hole in the middle of the deer fence at the tree	
6	North end of Lodge Pond trail loop.	No	Signage	"Uneven Terrain" sign is broken	
7	Former Sewerage Treatment Plant drainage ditch	No	Other	CP drain pipe into drainage ditch - note on map for Configuration Management	
8	West of power line tower	No	Other	Geotextile - needs cleaned up but it is stuck in the ground	
9	Northwest of power line tower along ditch	No	Erosion	Fresh erosion on bank. Muskrats?	
10	West of gravel road	No	Other	Trash - burried	
11	North of deer fence	No	Vegetation	Thick ground cover. Japanese stiltgrass?

12	Edge of pine plantation	No	Debris	Concrete	
13	East side of drainage that feeds SSOD	No	Debris	old road cone/damaged culvert concrete

Map No.	Location	GPS?	Type of Finding	Description	Photo? (File No.)
14	Monitoring wells 2431 and 3431	No	Other	Water collecting around well pads...terrain needs altered to drain surface water away from wells.	
15	Along road cut in ditch	No	Other	discarded clothing	
16	Between W1 and W5	No	Other	Broken piece of pipe	
17	North of road just inside pines	No	Debris	plastic bands	
18	East of cell 8	No	Fencing	Fence is down	
19	Just south of well monitoring road entrance	No	Debris	concrete	
20	North pines, just north of restoration shed	No	Debris	asphalt pile overgrown	
21	bottom of slope	No	Other	Geotextile material	
22	East of cell 8, north of STP pond	No	Debris	Concrete slab	
23	North side of deer fence	No	Fencing	Big hole in fence

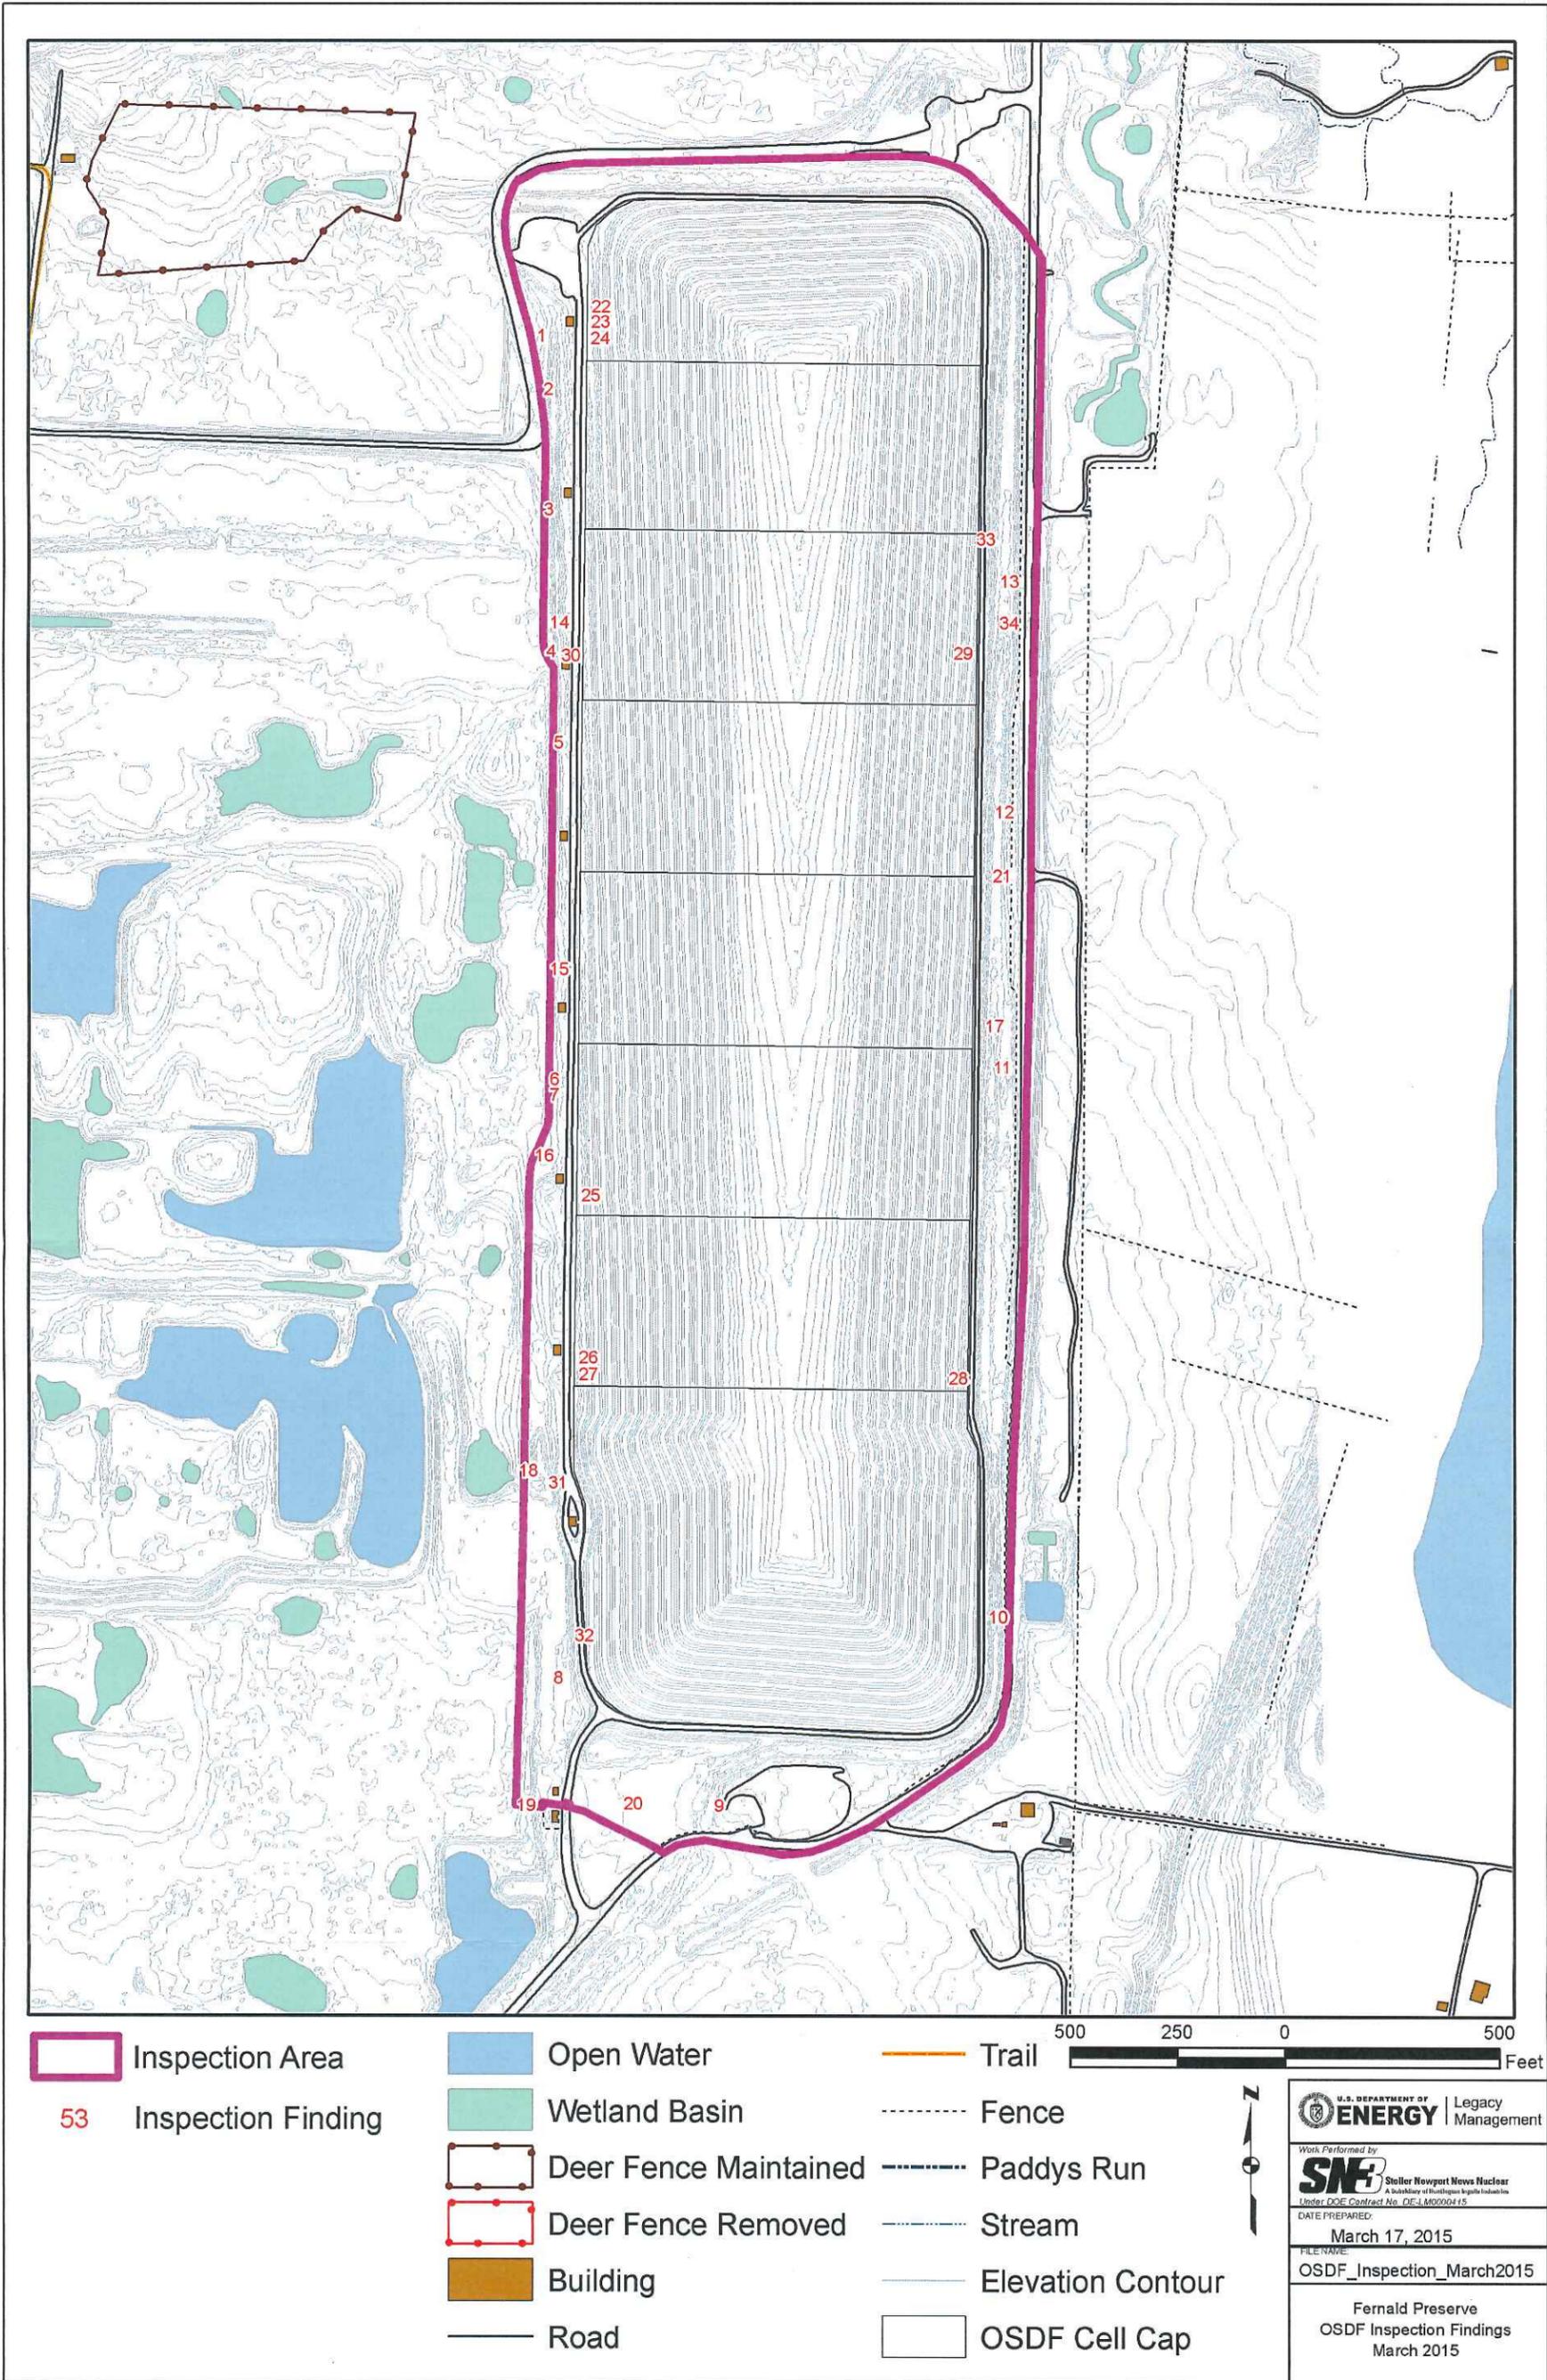
OSDF Inspection Findings, March 2015

Most findings were related to the presence of invasive woody vegetation. There were a few animal burrow and debris findings. As stated above, the site radiological control technician scanned debris that was identified during the inspection. All debris from the OSDF was free released. No major changes were observed to the status of erosion along the east fence line. These findings have been noted during previous inspections and they will continue to be monitored and maintained as necessary.

Map No.	Location	GPS?	Type of Finding	Description	Photo? (File No.)
1	West perimeter, on bank behind VH 1	No	Vegetation	Cedar	
2	West perimeter, by fence 1/2 way between VH 1 and VH 2	No	Vegetation	Cedar	
3	West perimeter on fence just south of VH 2	No	Other	2 ft. section of barb wire	
4	West perimeter behind VH 3 at fence	No	Vegetation	Cedar	
5	West perimeter 1/2 way between VH 3 and 4 at fence/culvert	No	Vegetation	Cedar	
6	West perimeter 1/2 way between VH 5 and VH 6 at fence	No	Vegetation	Cedar	
7	West perimeter 1/2 way between VH 5 and VH 6 at fence	No	Other	Asphalt	
8	West perimeter southwest corner drainage at fence	No	Vegetation	trees, shrubs, vines in fence	
9	South perimeter, top of drainage at edge of rip rap.	No	Other	Geo membrane material	
10	East perimeter, southeast corner at fence	No	Vegetation	Dogwood

Map No.	Location	GPS?	Type of Finding	Description	Photo? (File No.)
11	East perimeter, next to fence	No	Vegetation	Cedar	
12	East perimeter at fence	No	Other	Metal pipe in ground. Hole under fence.	
13	East perimeter next to fence	No	Other	rebar, base of post exposed.	
14	West perimeter north of VH 3 between the road and the cattails	No	Vegetation	Thistle	
15	West perimeter north of VH 5 between road and fence	No	Vegetation	Thistle	
16	West perimeter north of VH 6 between road and fence	No	Vegetation	Teasel	
17	East perimeter at fence	No	Erosion	Erosion under fence post	
18	West perimeter near fence	No	Biointrusion	Large burrowing animal hole	
19	West perimeter drainage southwest corner	No	Other	Concrete, asphalt, metal	
20	South perimeter field between fence and gravel road	No	Vegetation	Field of bull thistle	
21	East perimeter fence at cell 4/5 boundary	No	Vegetation	Thistle	
22	West toe edge of rip rap	No	Vegetation	Callery pear

23	West toe edge of rip rap	No	Vegetation	Woody vegetation (4)	
24	West toe edge of rip rap	No	Vegetation	Cedar	
25	West toe, edge of rip rap just south of VH 6	No	Other	Large piece of concrete

Map No.	Location	GPS?	Type of Finding	Description	Photo? (File No.)
26	West toe, edge of rip rap just south of VH 7	No	Biointrusion	Animal burrow	
27		No	Biointrusion	Animal burrow	
28	East toe, edge of rip rap	No	Vegetation	Cedar	
29	East toe, edge of rip rap	No	Vegetation	Cedar	
30	Valve house 3	No	Vegetation	woody vegetation	
31	Utility pole along gravel road	No	Bird Box	Owl box damaged	
32	West toe of cell 8	No	Vegetation	Woody vegetation	
33	East edge of gravel road at east cell 2/3 boundary	No	Other	asphalt	
34	East perimeter next to fence	No	Other	Brick
