2012 Annual Inspection Report for the Grand Junction, Colorado, Site

ANNUAL INSPECTION CONDUCTED
FEBRUARY 23, 2012

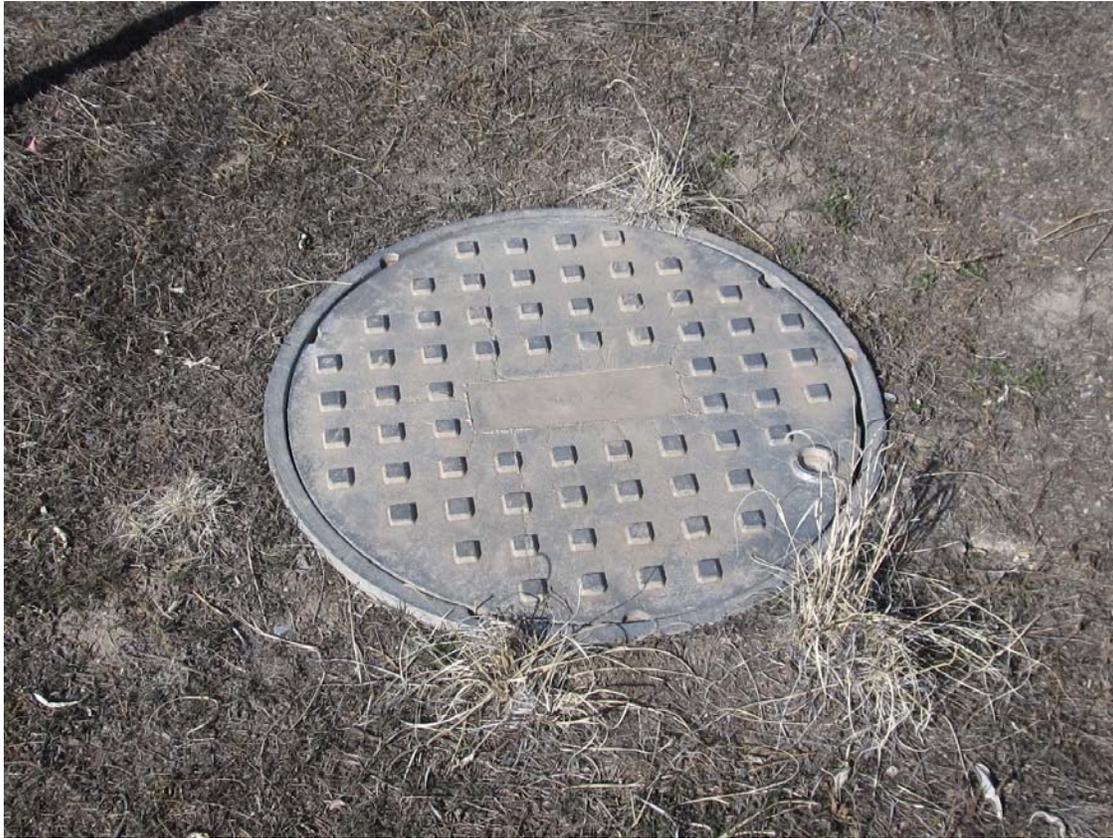
Monitoring Wells—DOE owns eight monitoring wells on the property to monitor the progress of natural flushing of contaminants from the alluvial aquifer. Wells 10–19N, 11–1S, 14–13NA, GJ01–02, and GJ84–04 are flush mounted and protected with standard monitoring well metal caps or manhole covers; well GJ84–04 is also protected by steel bollards (PL–1 through PL–5). Wells 6–2N, 8–4S, and GJ01–01 have above-ground steel well casing protectors; steel bollards are in place as further protection for well 6–2N and 8–4S (PL–6 through PL–8). The visible portions of all wells were in good condition, and no maintenance or deferred maintenance needs were identified for these real property assets.

GJO 2/2012. PL-1. Monitoring well 10-19N.

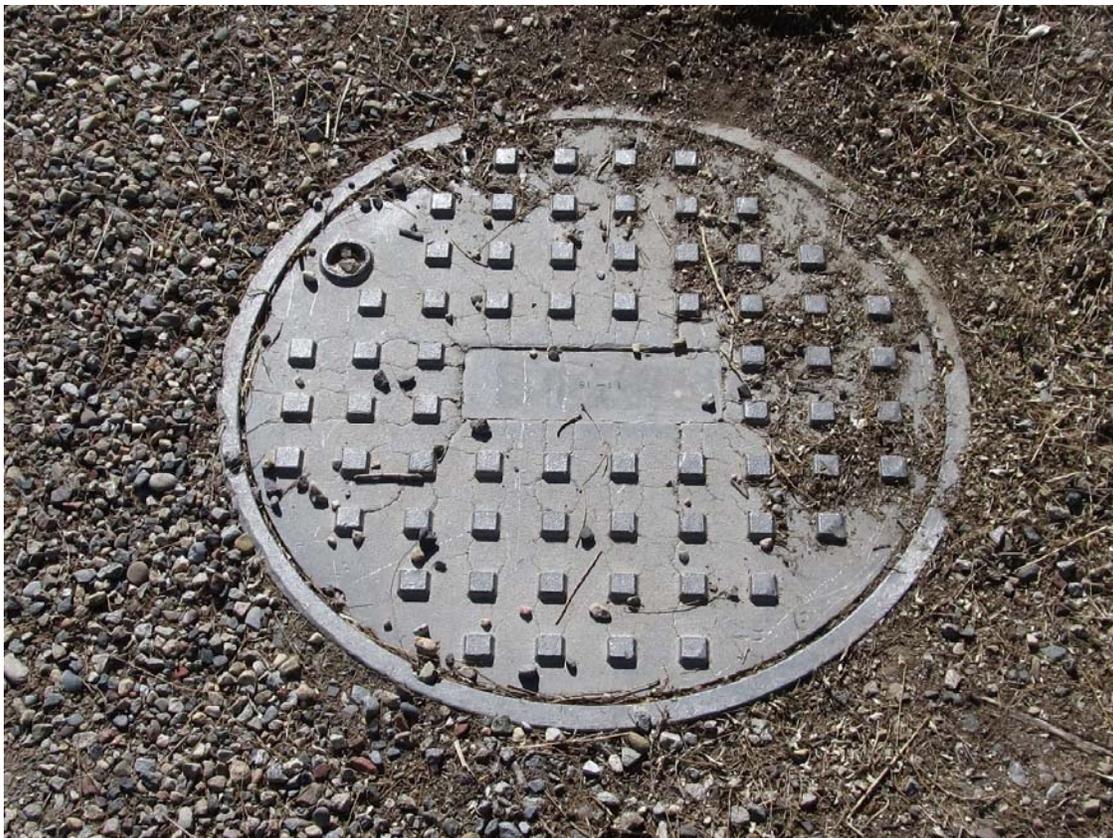
GJO 2/2012. PL-2. Monitoring well 11-1S.

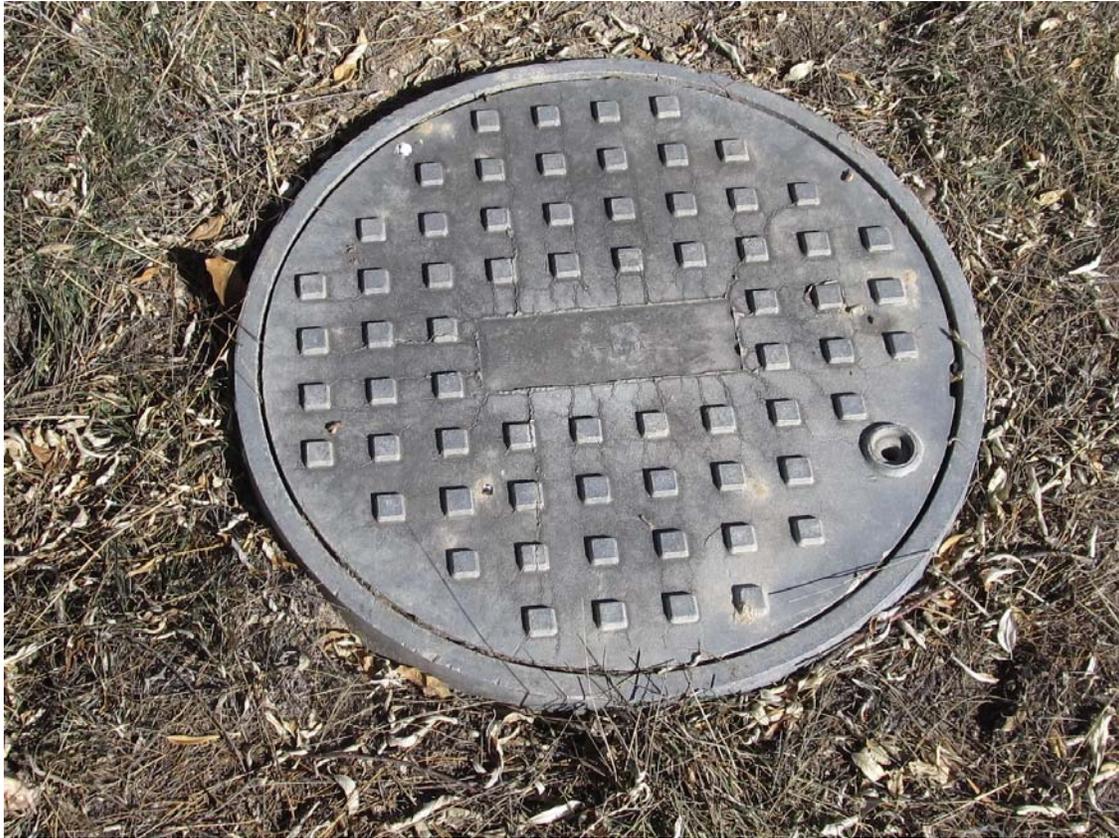
GJO 2/2012. PL-3. Monitoring well 14-13NA.

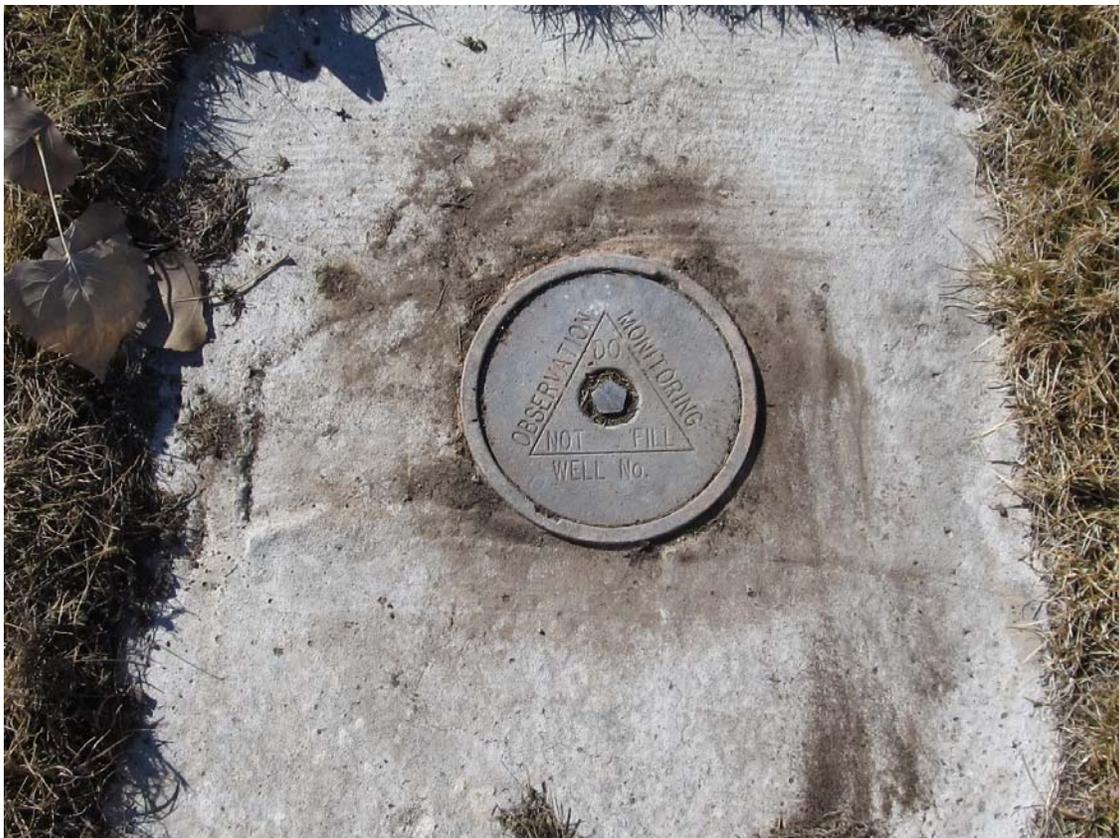
GJO 2/2012. PL-4. Monitoring well GJ01-02.

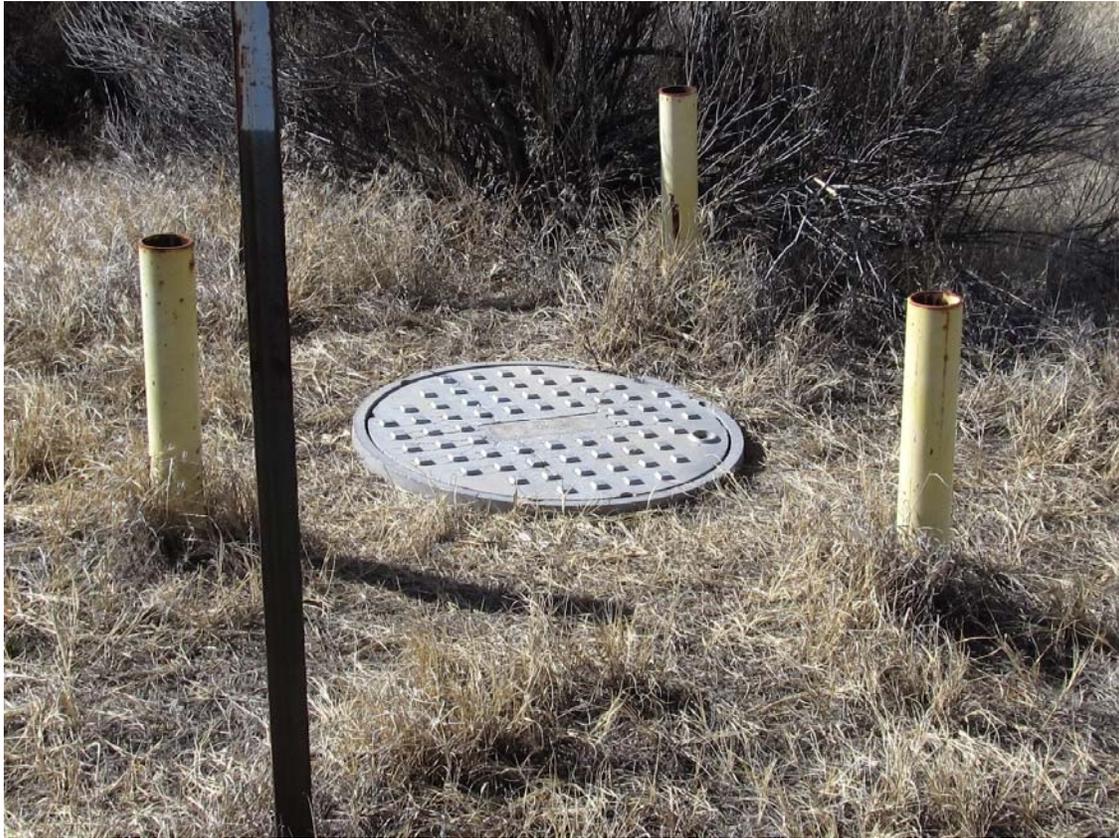
GJO 2/2012. PL-5. Monitoring well GJ84-04.

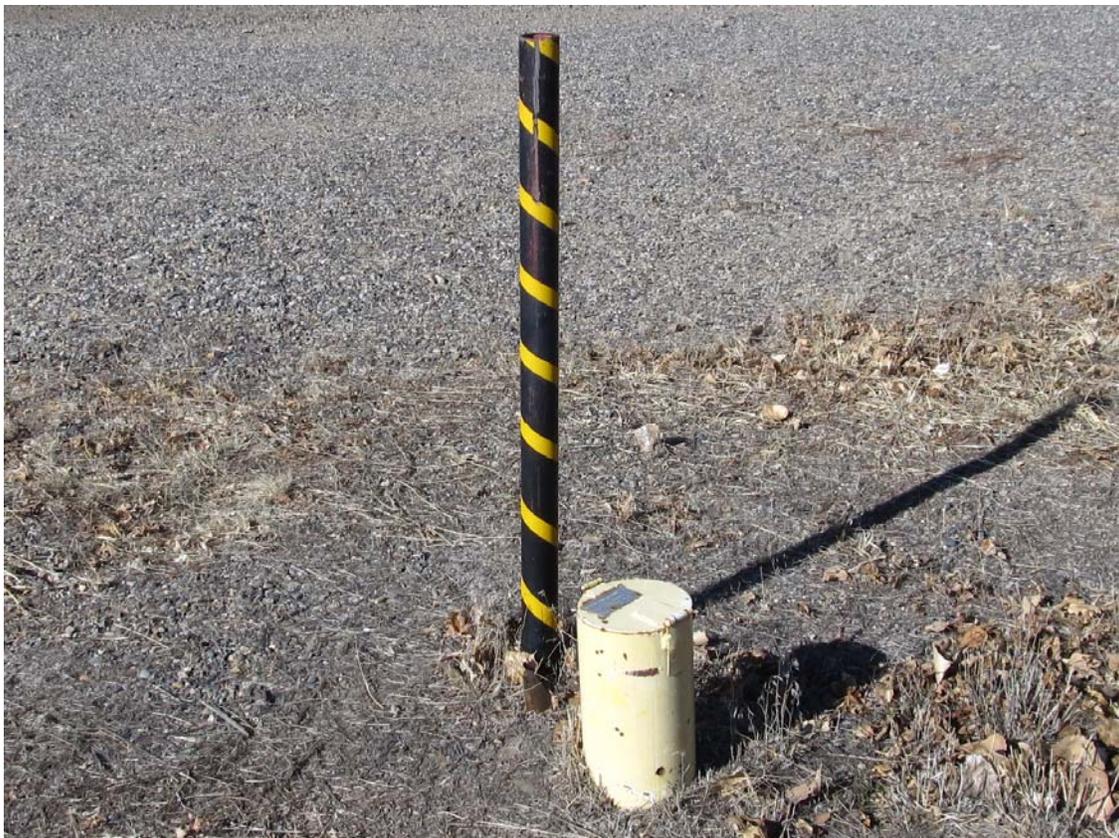
GJO 2/2012. PL-6. Monitoring well 6-2N.

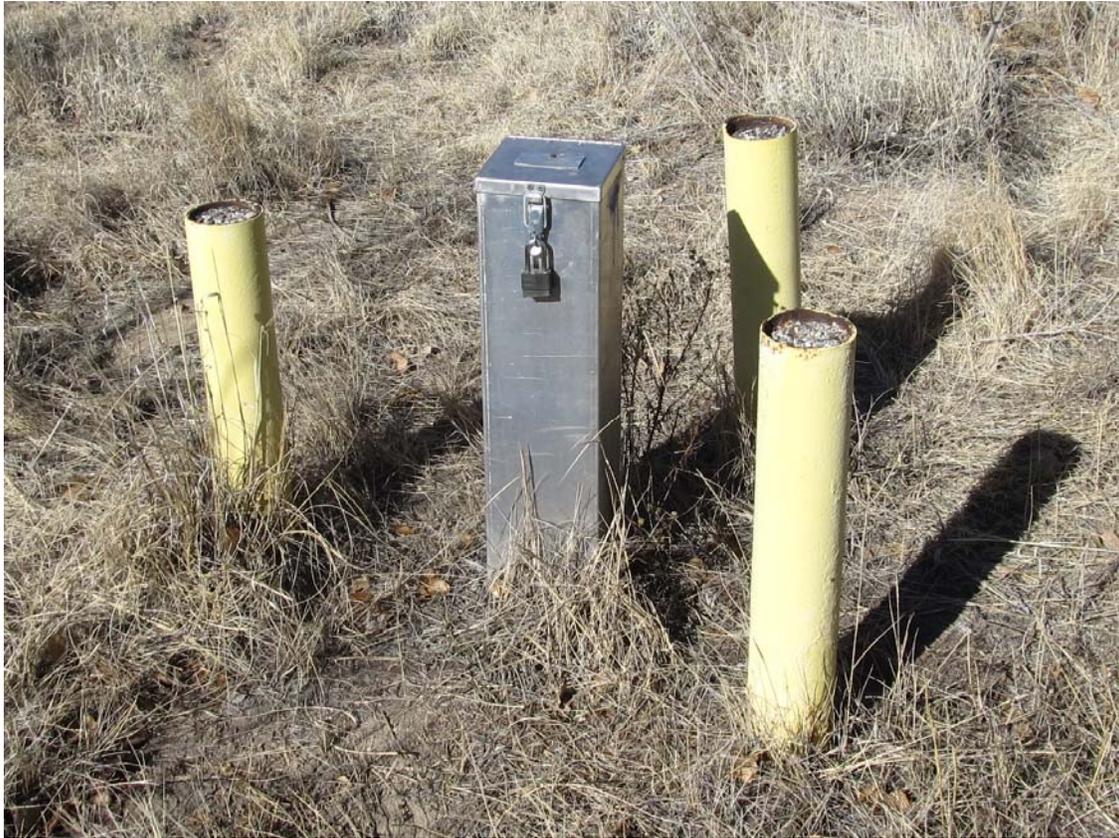
GJO 2/2012. PL-7. Monitoring well 8-4S.

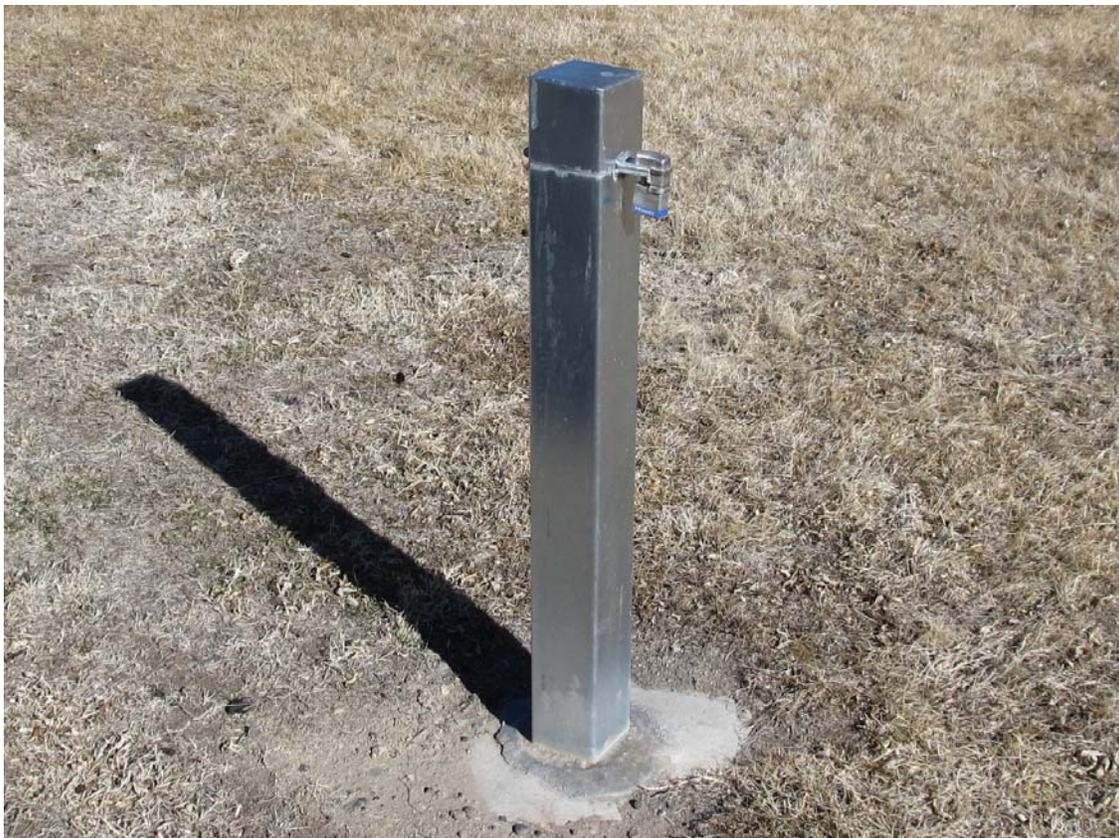
GJO 2/2012. PL-8. Monitoring well GJ01-01.

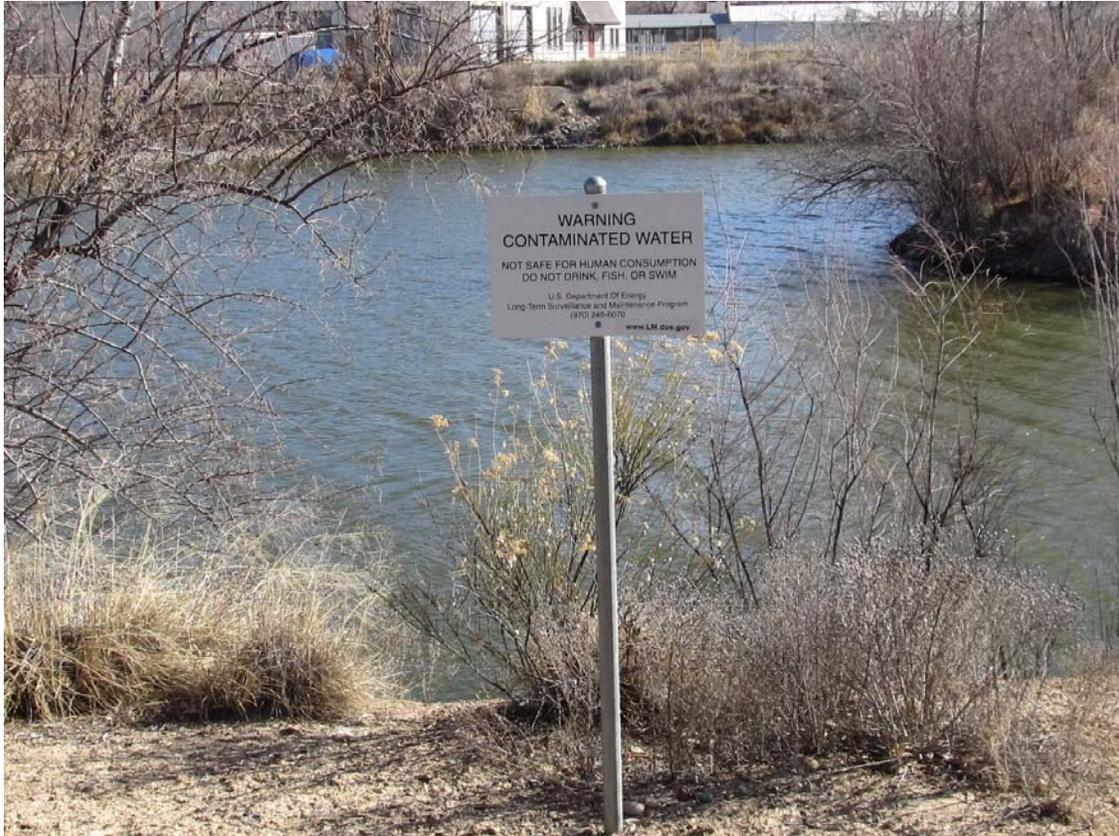
of reasonable access. All signs were undamaged and legible (PL-9). Warning sign S6 near South Pond had slid down the sign post and was resting on the ground; it was resecured in the proper position.

GJO 2/2012. PL-9. South Pond warning sign S2.

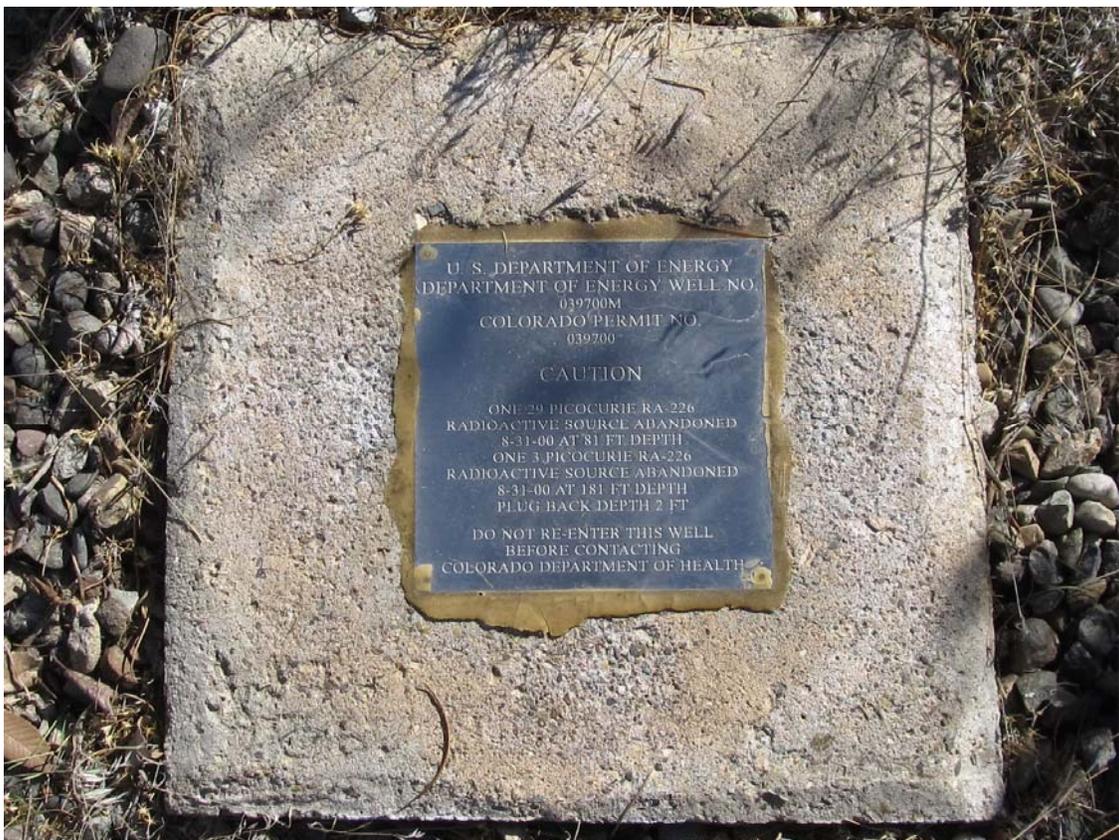
The borehole was decommissioned in place in 2000. DOE perforated the casing above and below each strip of foil and pressure-grouted the annulus with Portland cement to seal the foil in place. The borehole was filled with grout, and a metal plaque was mounted in concrete at ground level over the well. The metal plaque with the borehole information and warning engraved into the metal was in excellent condition (PL-10). Although the borehole is decommissioned in place, the metal plaque is considered to be a real property asset. No maintenance or deferred maintenance needs were identified for this real property asset.

GJO 2/2012. PL-10. Plaque at the decommissioned borehole containing radium foil.

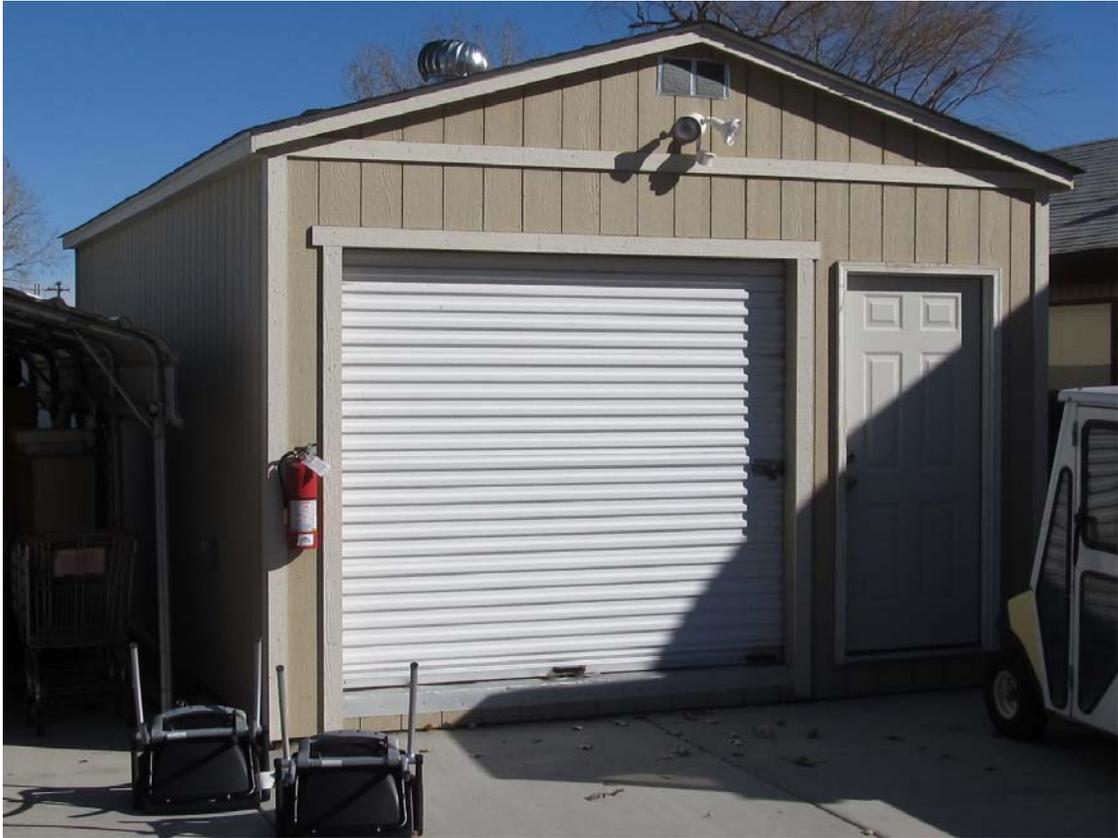
Storage Shed—The only building on the site owned by DOE is a storage shed located adjacent to Building 2. The exterior of the shed was in excellent condition (PL-11 and PL-12). No maintenance or deferred maintenance needs were identified for this real property asset.

GJO 2/2012. PL-11. Front side of DOE shed.

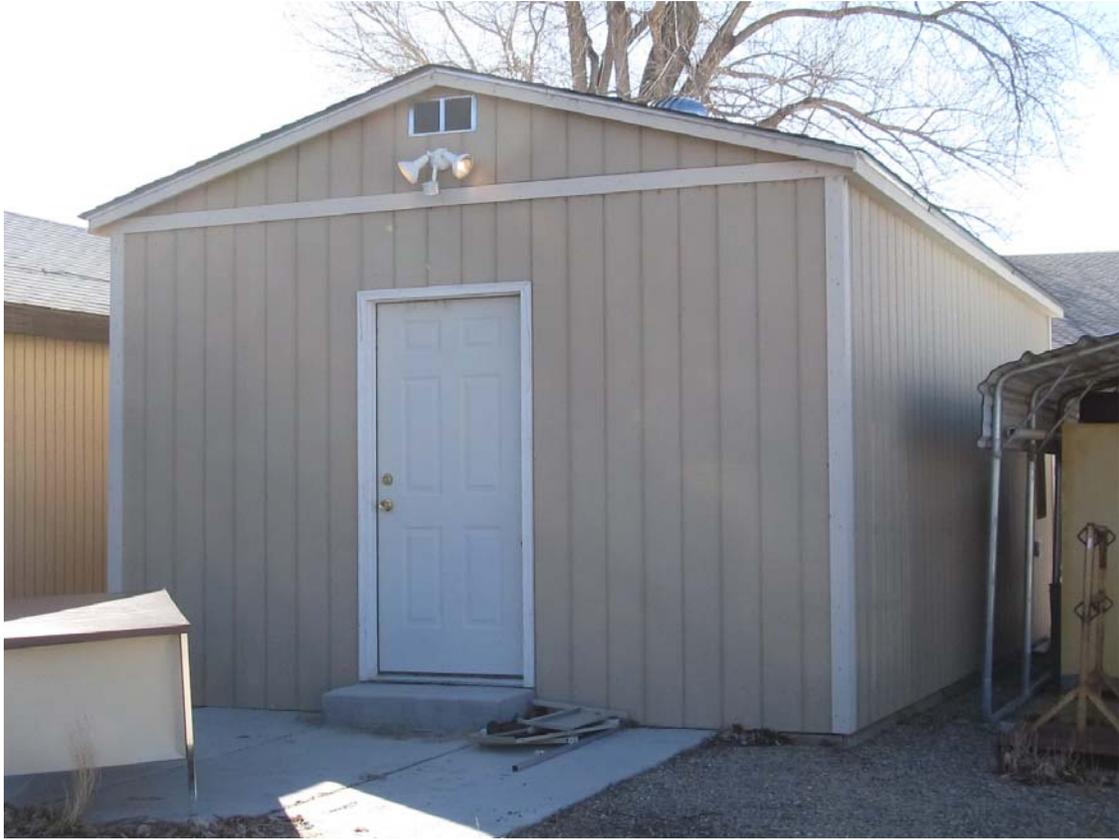
GJO 2/2012. PL-12. Back side of DOE shed.
