Annual Inspection of the Grand Junction, Colorado, Site

1.1 Inspection Summary

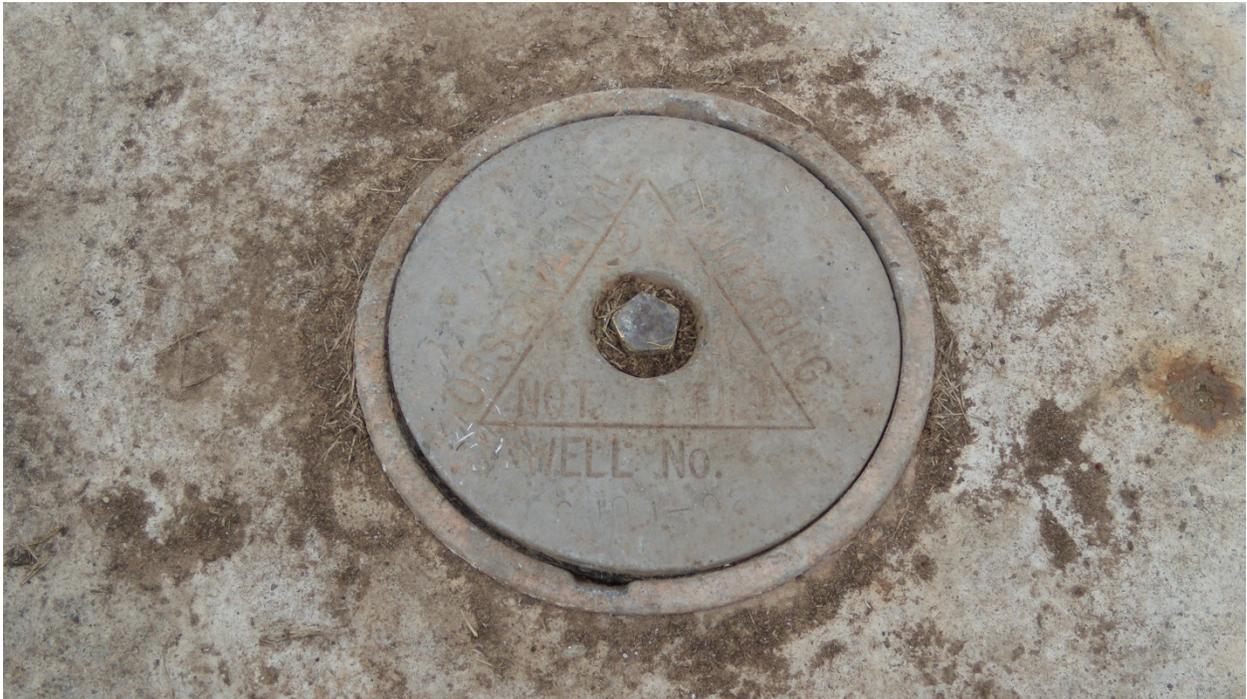
DOE owns eight monitoring wells on the property to monitor the progress of natural flushing of contaminants from the alluvial aquifer. Wells 10-19N, 11-1S, 14-13NA, GJ01-02 (PL-1), and GJ84-04 are flush mounted and protected with standard monitoring well metal caps or manhole covers; well GJ84-04 is also protected by steel bollards. Wells 6-2N, 8-4S, and GJ01-01 have above-ground steel well casing protectors; steel bollards are in place as further protection for wells 6-2N and 8-4S. The visible portions of all wells were in good condition.

GJO 2/2014. PL-1. Monitoring well GJ01-02.

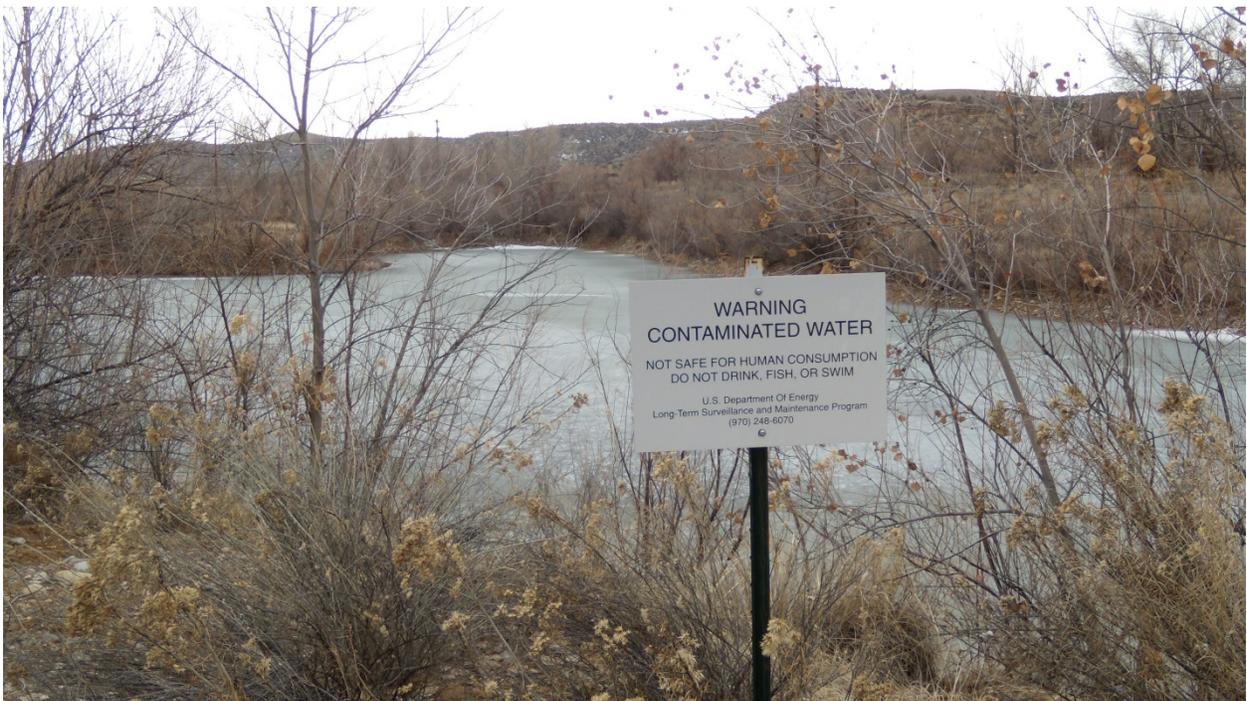
Fifteen warning signs installed on galvanized steel posts are positioned around the surface water areas so the warning will be visible to a person approaching from any direction of reasonable access. All signs were undamaged and legible (PL-2).

GJO 2/2014. PL-2. South Pond warning sign S5.

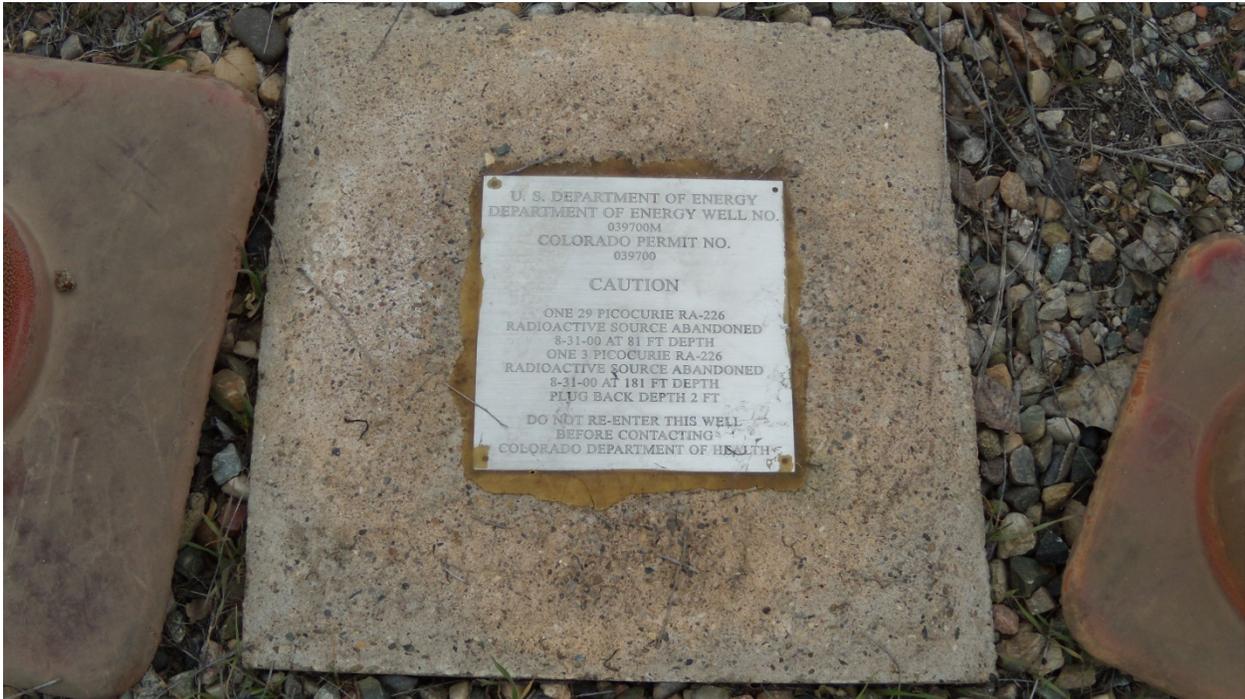
The borehole was decommissioned in place in 2000. DOE perforated the casing above and below each strip of foil and pressure-grouted the annulus with Portland cement to seal the foil in place. The borehole was filled with grout, and a metal plaque was mounted in concrete at ground level over the well. The metal plaque with the borehole information and warning engraved into the metal was in excellent condition (PL-3).

GJO 2/2014. PL-3. Plaque at decommissioned borehole containing radium foil.

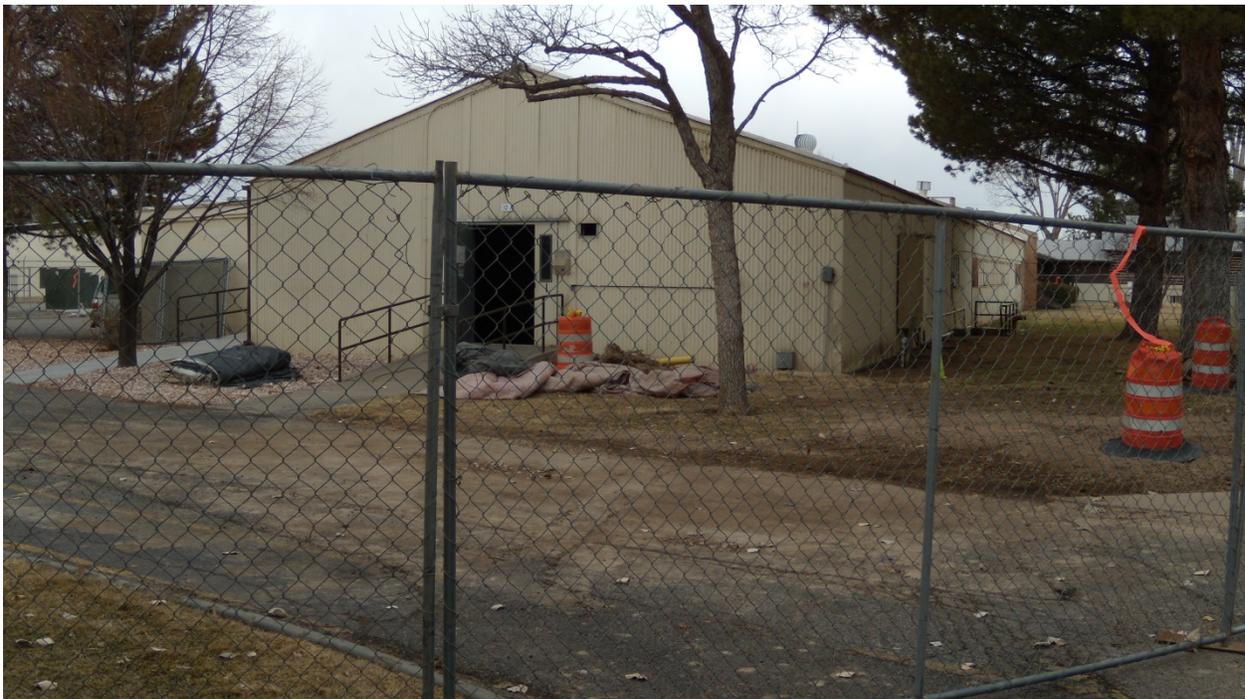
Due to the ongoing demolition activities of Building 12A, the interior floor area was not inspected. The building was viewed from outside the construction area and photos were taken to document the demolition (PL-4 and PL-5).

GJO 2/2014. PL-4. South entrance and east side of Building 12A during ongoing demolition.

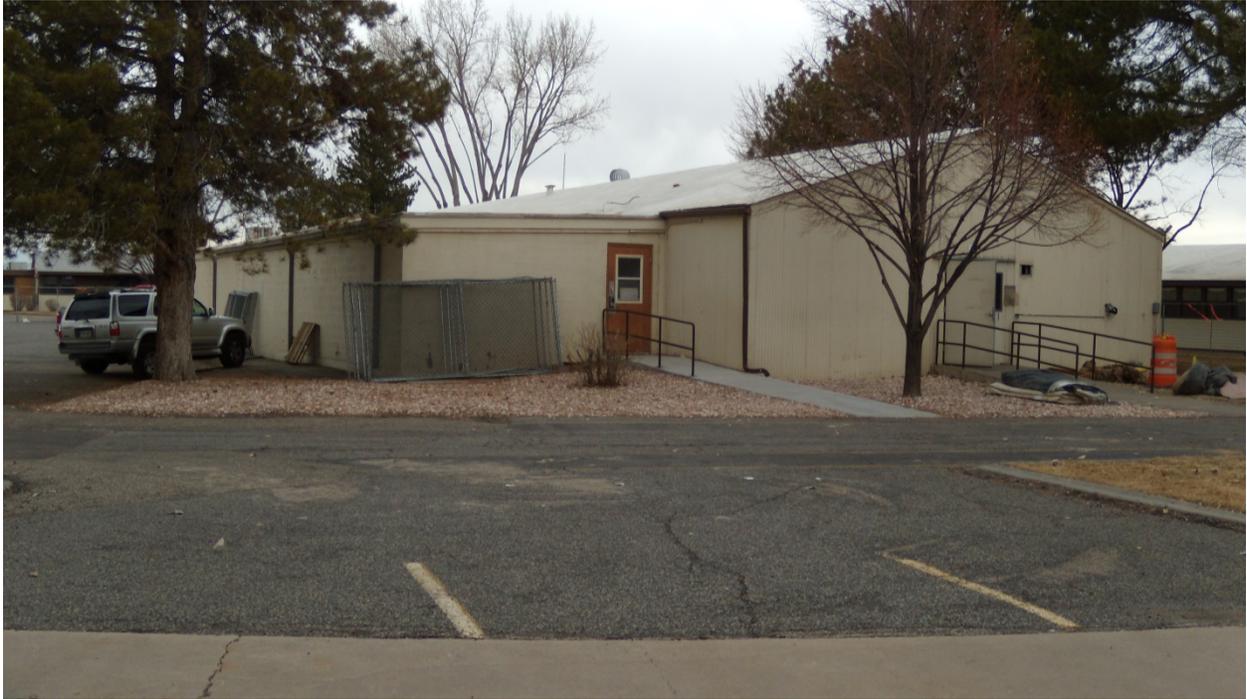
GJO 2/2014. PL-5. South entrance and west side of Building 12A during ongoing demolition.
