Annual Inspection of the Grand Junction, Colorado, Site

1.1 Inspection Summary

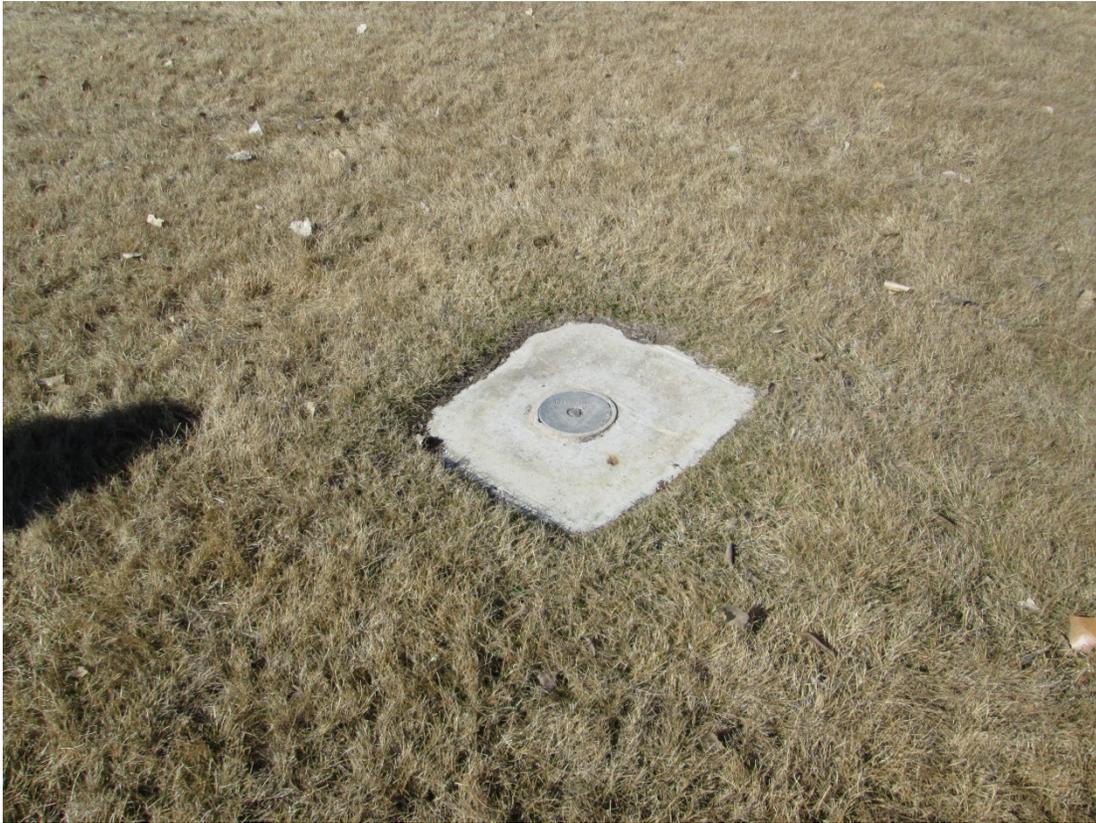
DOE owns eight monitoring wells on the property to monitor the progress of natural flushing of contaminants from the alluvial aquifer. Wells 10-19N, 11-1S, 14-13NA, GJ01-02 (PL-1), and GJ84-04 are flush mounted and protected with standard monitoring well metal caps or manhole covers; well GJ84-04 is also protected by steel bollards. Wells 6-2N, 8-4S, and GJ01-01 have above-ground steel well casing protectors; steel bollards are in place as further protection for wells 6-2N and 8-4S. The visible portions of all wells were in good condition.

GJO 2/2015. PL-1. Monitoring well GJ01-02.

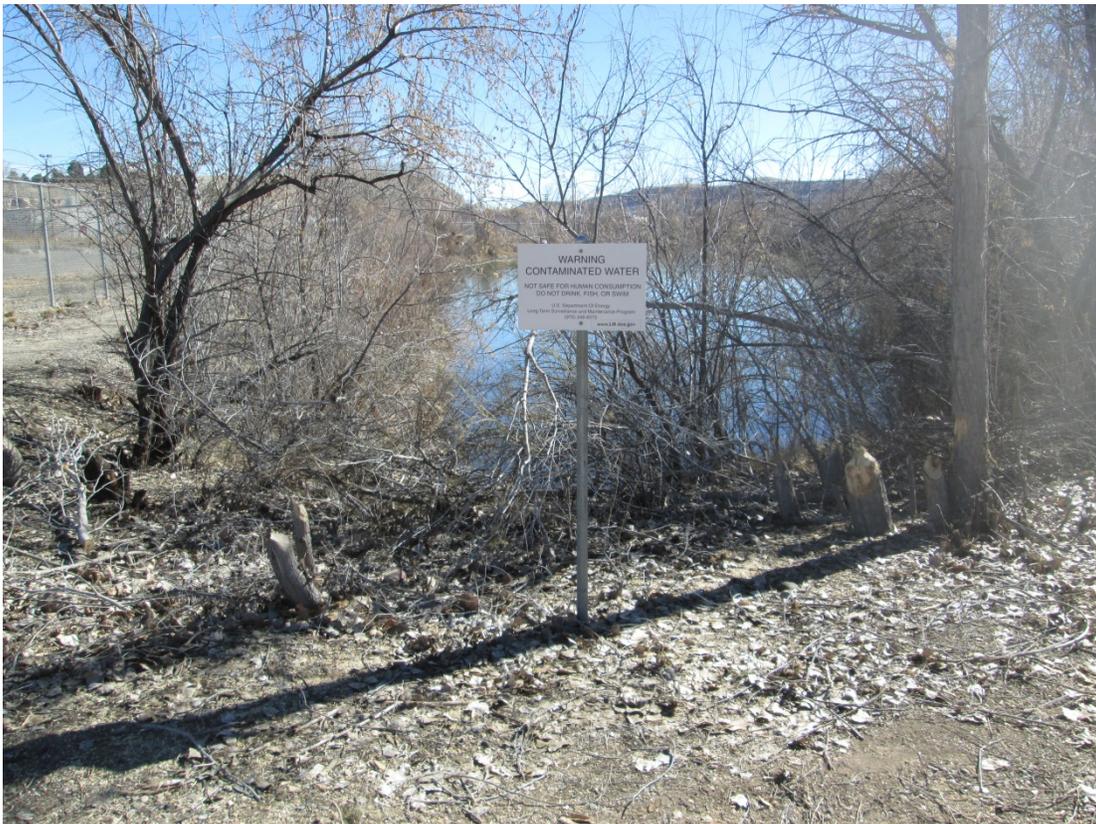
Fifteen warning signs installed on galvanized steel posts are positioned around the surface water areas so the warning will be visible to a person approaching from any direction of reasonable access. All signs were undamaged and legible (PL-2).

GJO 2/2015. PL-2. South Pond warning sign S4.

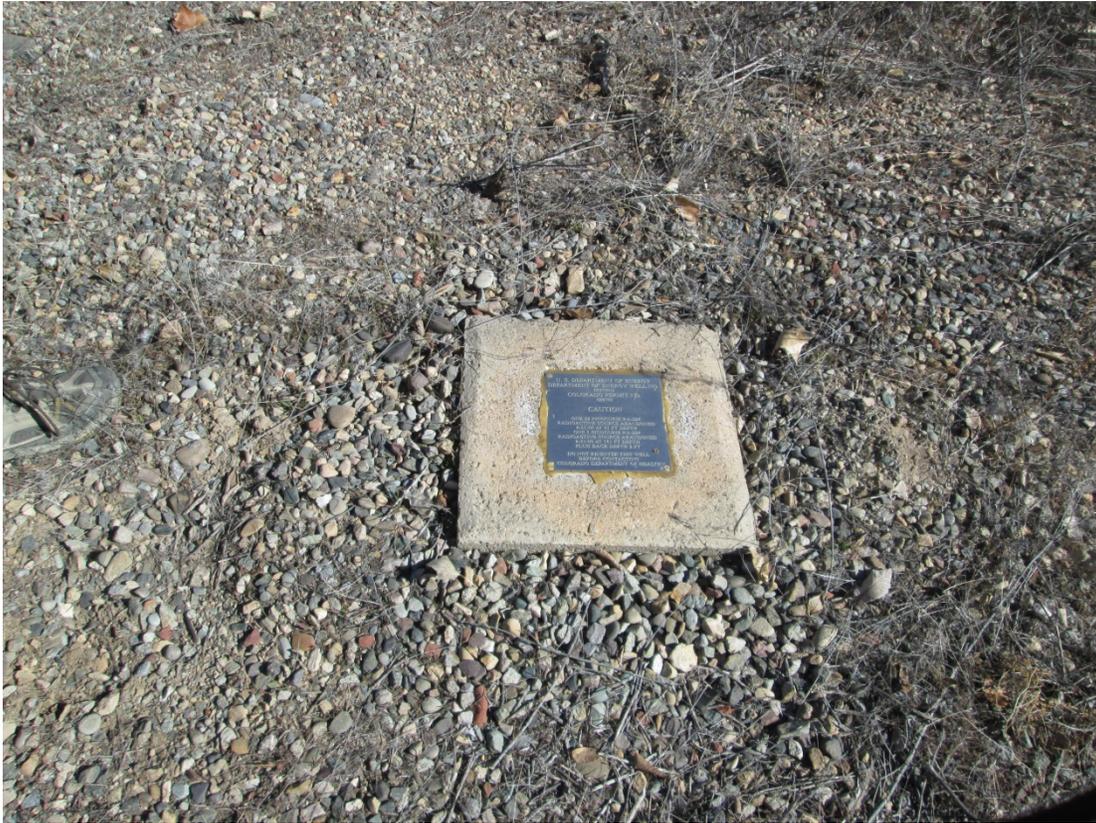
The borehole was decommissioned in place in 2000. DOE perforated the casing above and below each strip of foil and pressure-grouted the annulus with Portland cement to seal the foil in place. The borehole was filled with grout, and a metal plaque was mounted in concrete at ground level over the well. The metal plaque with the borehole information and warning engraved into the metal was in good condition (PL-3).

GJO 2/2015. PL-3. Plaque at decommissioned borehole containing radium foil.

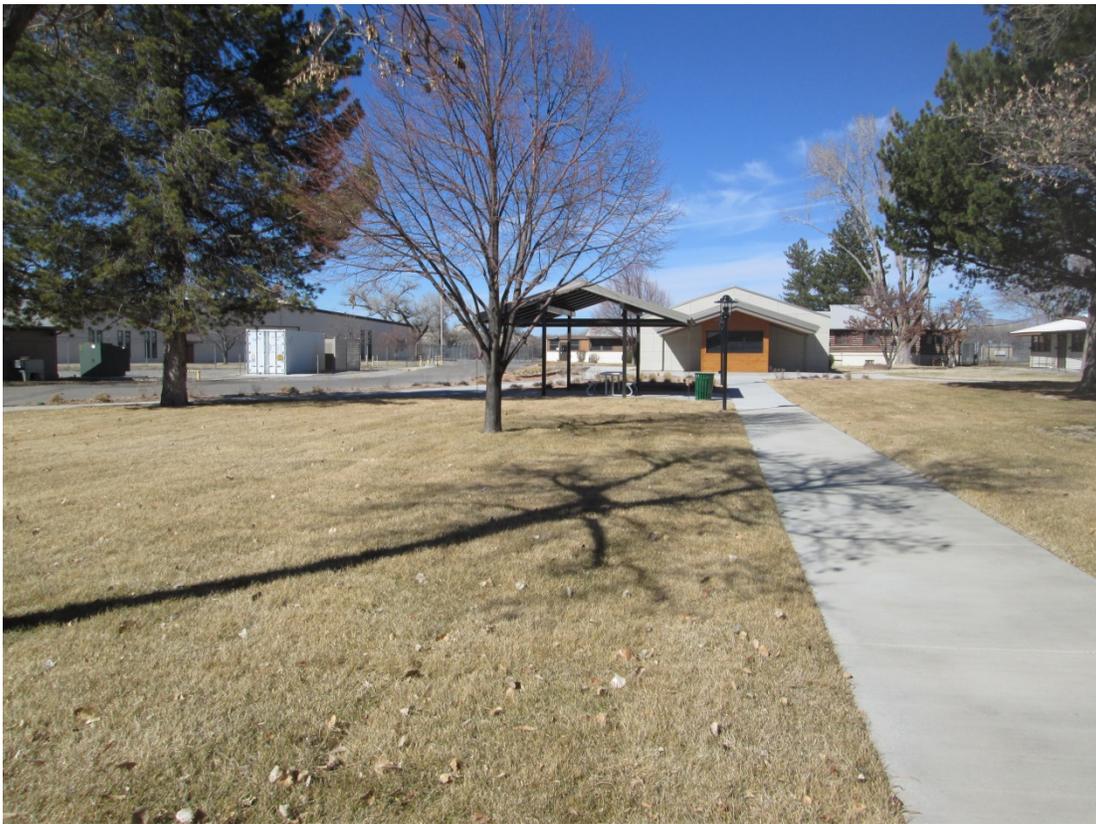
Building 12A was demolished and associated contamination was removed in 2014 and is no longer a requirement of the annual inspection. The demolition area was landscaped and revegetated (PL-4).

GJO 2/2015. PL-4. Former Building 12A location.

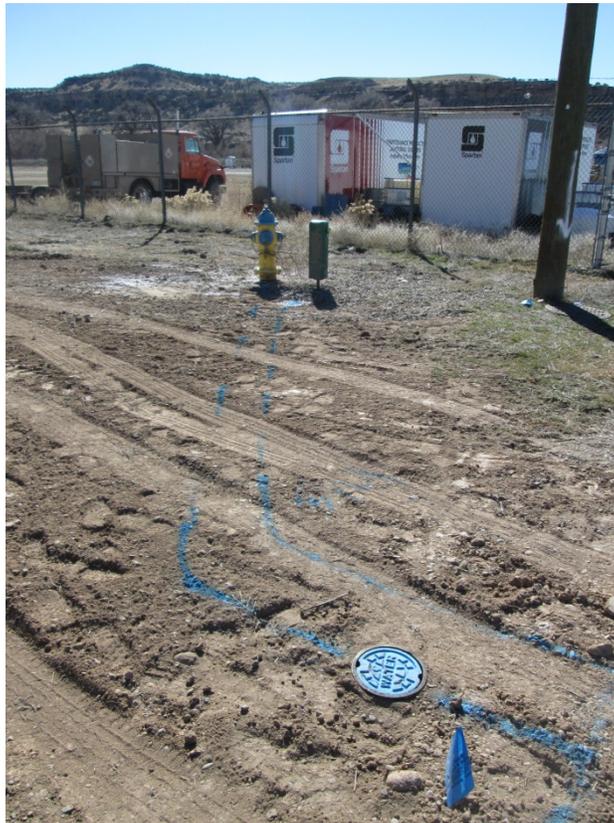
The City of Grand Junction installed a fire hydrant and testing station east of Building 28 to assist with issues surrounding the domestic water supply onsite (PL-5).

GJO 2/2015. PL-5. Fire hydrant installed by the City of Grand Junction; west of Building 28.
