8.0 Gunnison, Colorado, Disposal Site

8.1 Compliance Summary

The site, southeast of Gunnison, Colorado, was inspected on June 27, 2016. The inspection was conducted by R. Johnson and S. Campbell of the DOE Legacy Management Support (LMS)

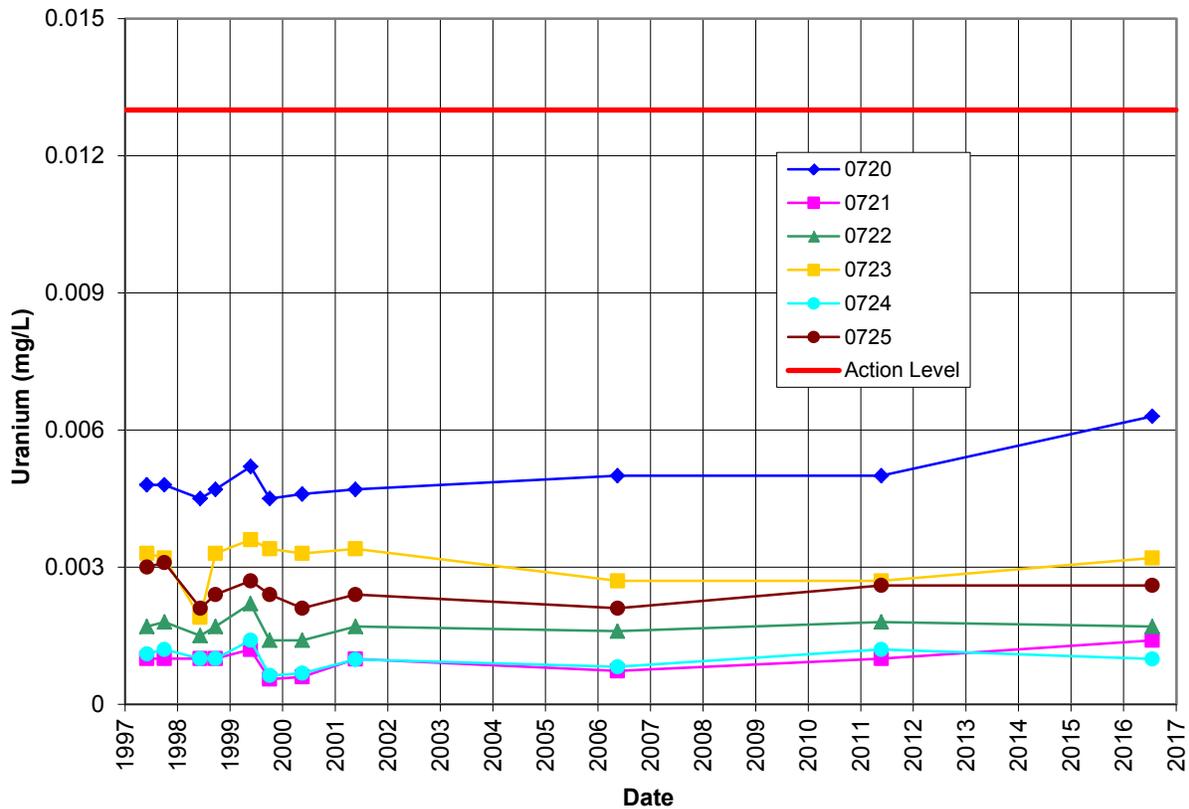
Figure 8-3. Time-Concentration Plots of Uranium in Groundwater at the Gunnison Disposal Site

Groundwater Quality Monitoring—Groundwater at the site was sampled in July 2016. The concentrations of uranium in samples collected from POC wells ranged from 0.001 mg/L to 0.006 mg/L as shown in the time-versus-concentration graph (Table 8-3 and Figure 8-3). Uranium concentrations were consistent with historical results in wells 0722, 0723, 0724, and 0725, but slightly exceeded historical maximums in wells 0720 and 0721. Uranium results from the POC wells were below the action level of 0.013 mg/L.

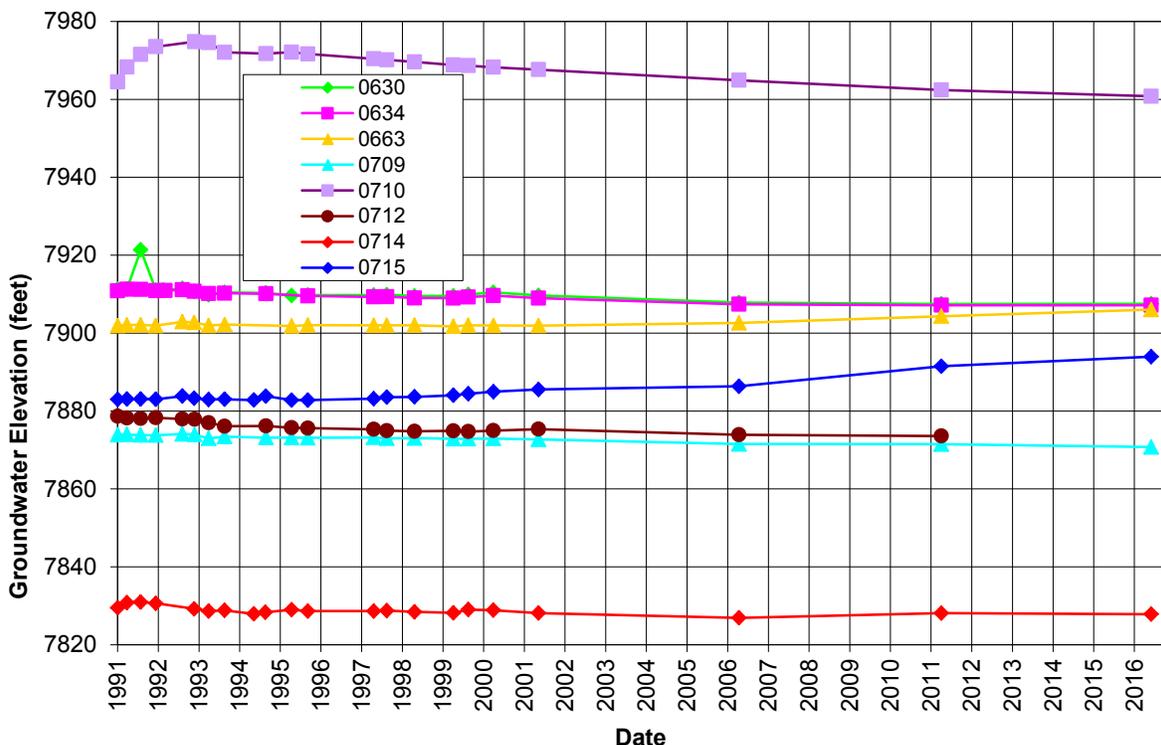
Figure 8-4. Groundwater Elevations at Selected Monitoring Wells at the Gunnison Disposal Site

Groundwater-Level Monitoring—Groundwater levels from the entire monitoring network were measured in July 2016. The measurements in general showed a gradual decrease in groundwater elevations since completion of the disposal cell in 1995; hydrographs from selected wells across the site illustrate this decrease in groundwater levels (Figure 8-4). Well 0715 is the exception as the groundwater level has risen approximately 11 feet since 1995.

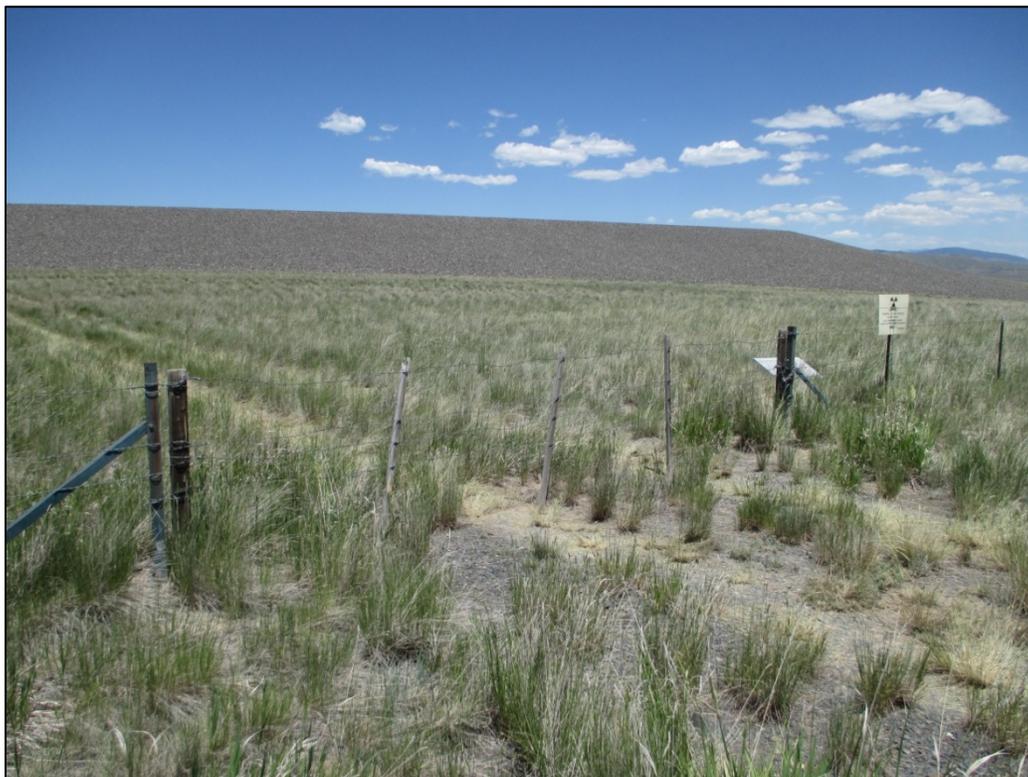
The barbed-wire entrance gate is part of the perimeter fence that encloses the site. The entrance gate, along the south portion of the perimeter fence, was locked and undamaged (PL-1). The entrance sign is bolted to a perimeter fence post next to the entrance gate (PL-2). No maintenance needs were identified.

PL-1. Entrance Gate

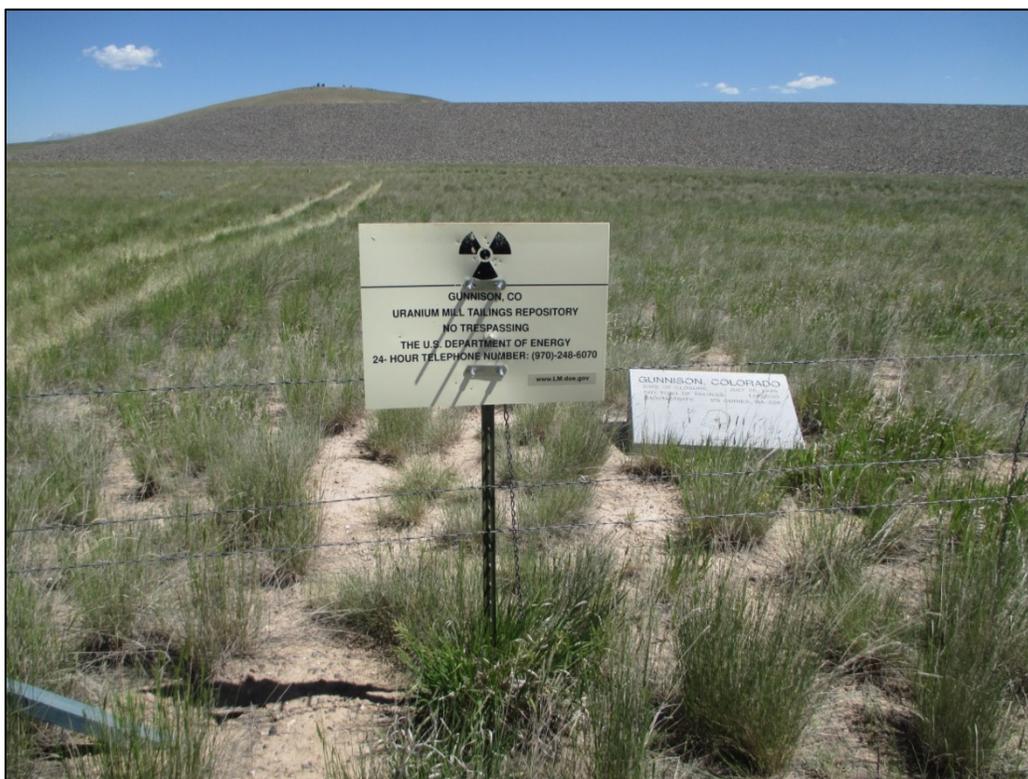
PL-2. Entrance Sign and Site Marker SMK-1

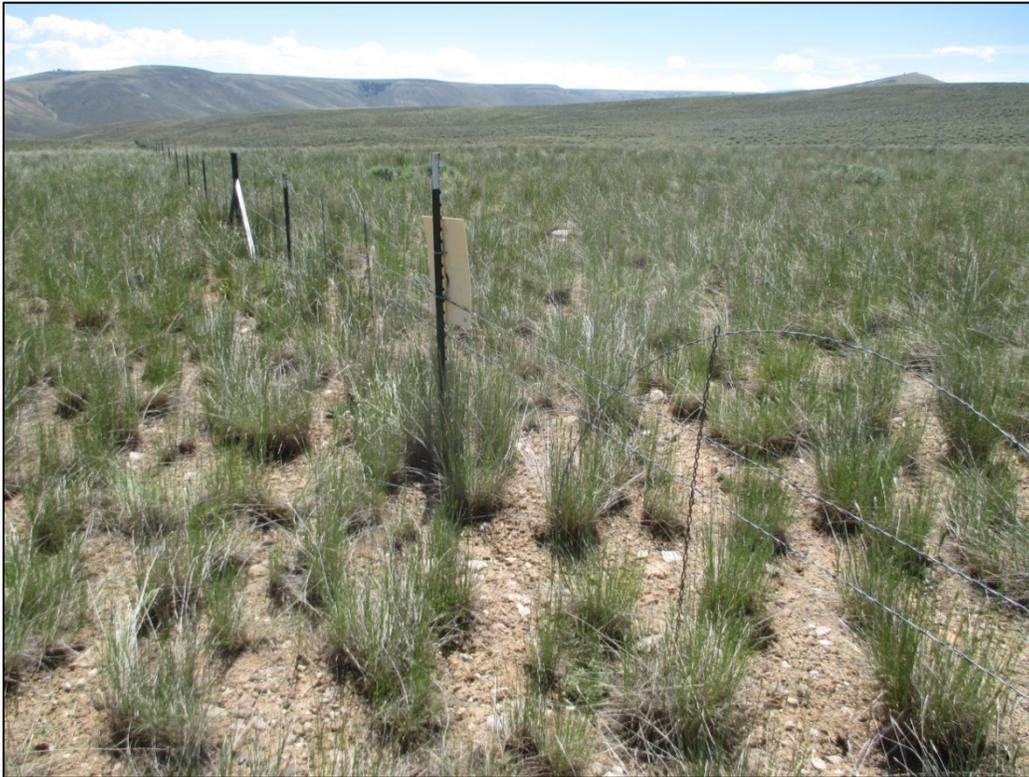
A three-strand barbed-wire fence encloses the site; most of it is set along the property boundary. The fence was intact except for one broken strand that was repaired during the inspection (PL-3). Two barbed-wire gates—one on the north fence line and the other on the east fence line—provide access to offsite monitoring wells; both gates were locked. There are 45 perimeter signs, which are bolted to perimeter fence posts. Several perimeter signs have bullet holes but were legible. One perimeter sign was missing and one was damaged and could not be properly secured to the fence post; replacement signs were installed during the inspection. No other maintenance needs were identified.

PL-3. Broken Fence Strand; Subsequently Repaired

A broken fence strand was repaired and two perimeter signs were replaced during the inspection. No other maintenance needs were identified.

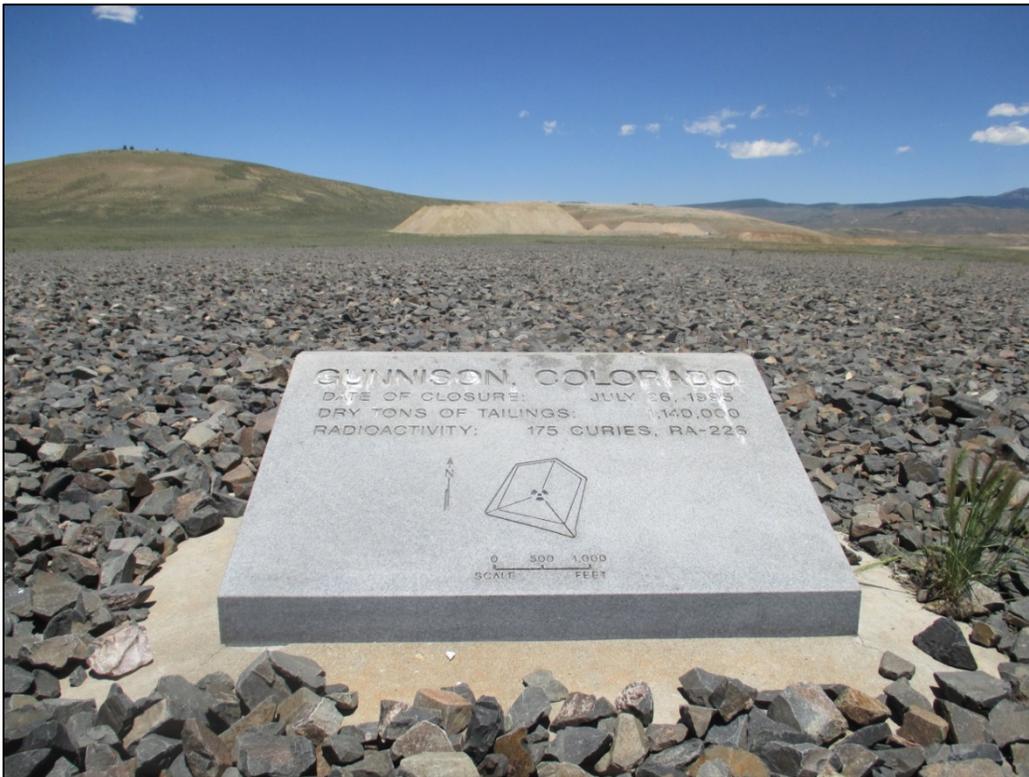
The site has two granite site markers. Site marker SMK-1 is just inside the site entrance gate and site marker SMK-2 is on the top slope of the disposal cell (PL-4). No maintenance needs were identified.

PL-4. Site Marker SMK-2

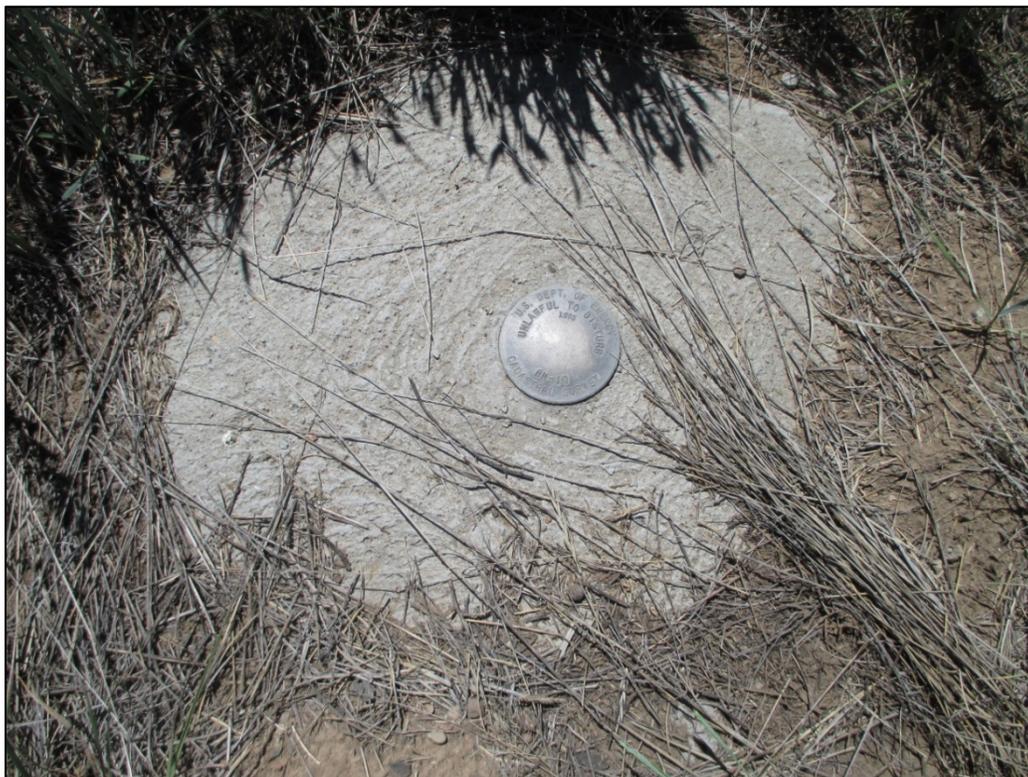
There are three combined survey and boundary monuments (SM-1/BM-1, SM-2/BM-2, and SM-3/BM-3) and eight additional boundary monuments (BM-4 through BM-11) along the site perimeter (PL-5). No maintenance needs were identified.

PL-5. Boundary Monument BM-10

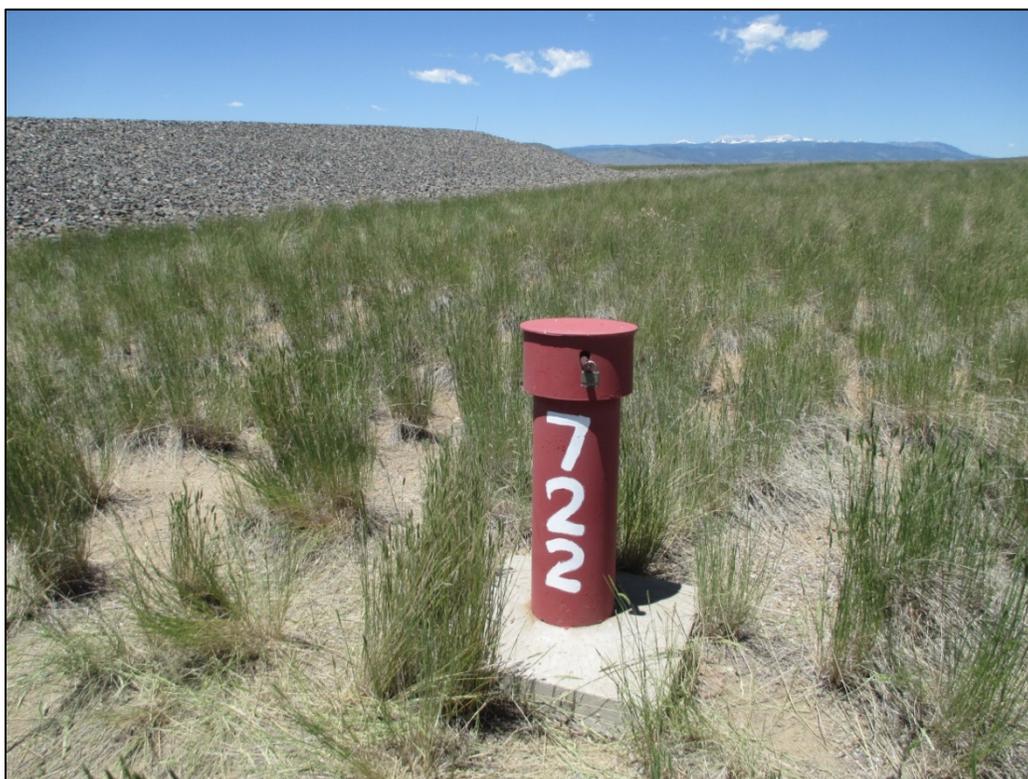
The site groundwater monitoring network consists of 16 wells. The wellhead protectors were undamaged and locked (PL-6). The Gunnison County landfill operators have placed concrete barriers to protect monitoring well 0716, which is on landfill property, from landfill activities (PL-7). The edge of an adjacent spoil pile, although close to the concrete barriers, does not impair access to the well. No maintenance needs were identified.

PL-6. Monitoring Well 0722

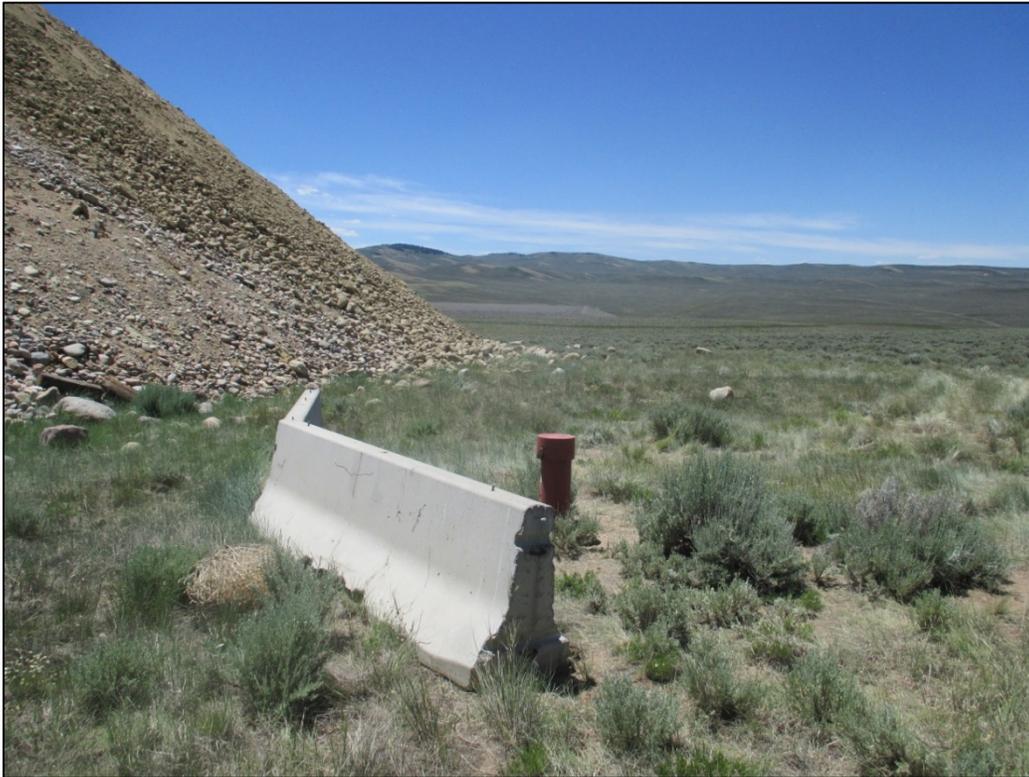
PL-7. Monitoring Well 0716 on County Landfill Property

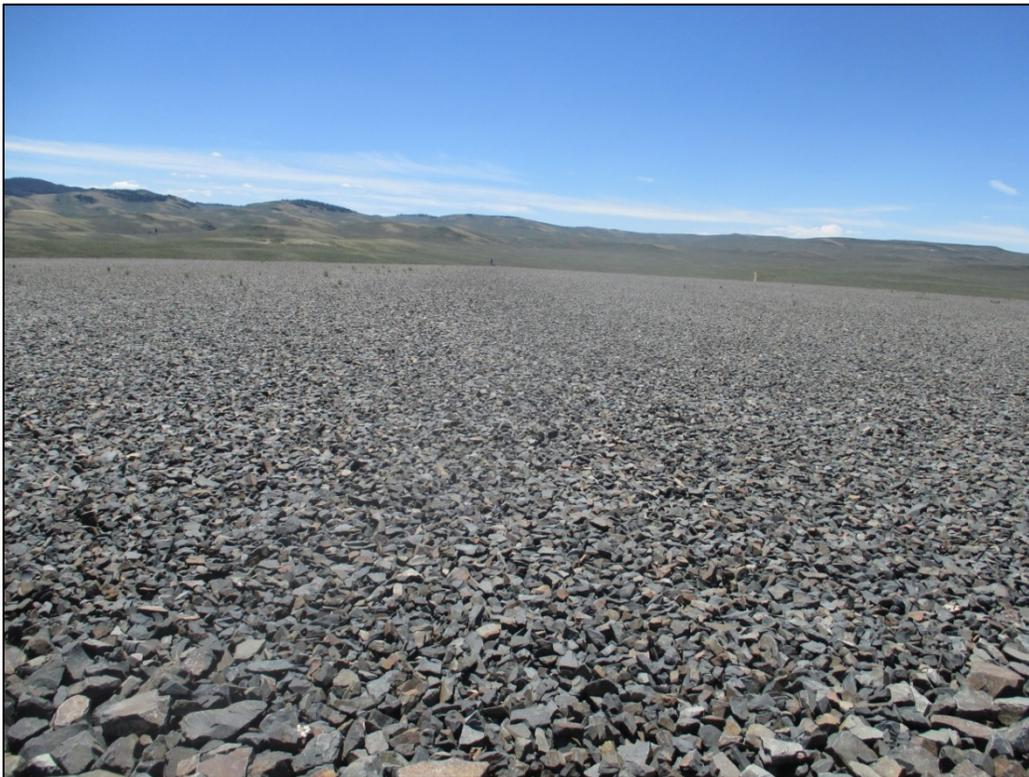
The disposal cell, completed in 1995, occupies 29 acres. It is covered with basalt rock to protect the disposal cell materials from erosion. Several isolated patches of grass have established on the top slope; however, these shallow-rooted plants do not degrade the performance of the radon barrier. There were no indications of erosion, settling, slumping, rock degradation, or other modifying processes that might affect the integrity of the disposal cell (PL-8). No maintenance needs were identified.

PL-8. Disposal Cell Top Slope

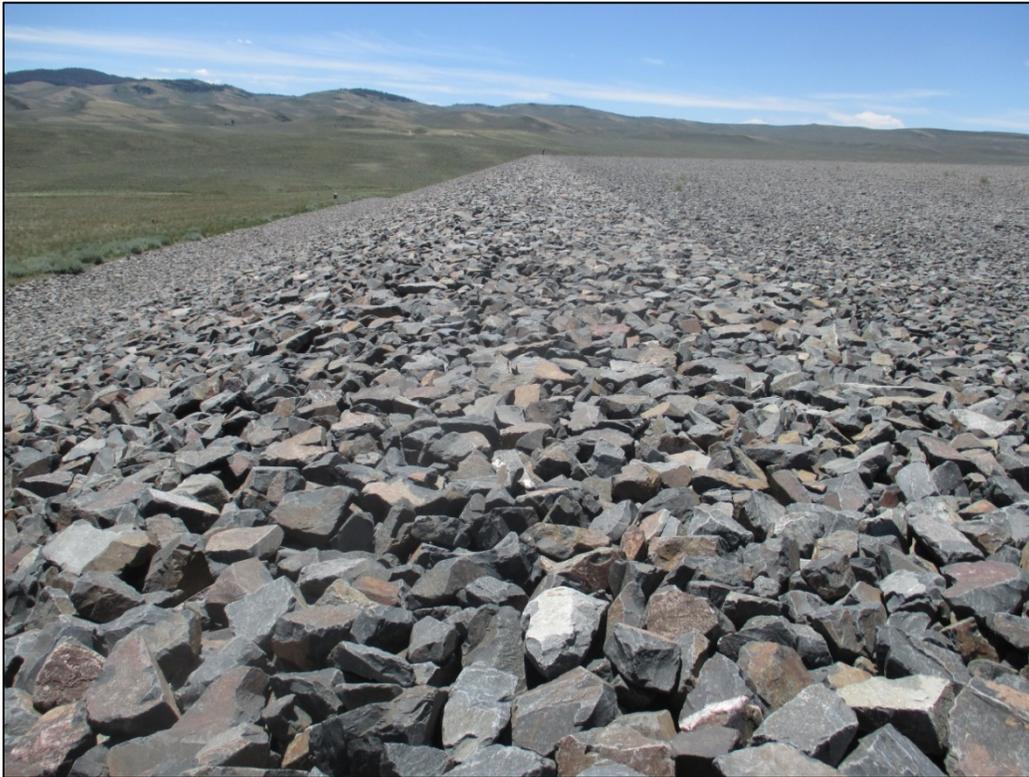
The disposal cell side slopes (PL-9), an apron to collect and divert precipitation runoff from the disposal cell (PL-10), and two diversion channels to protect the disposal cell from precipitation run-on (PL-11 and PL-12), are all protected by basalt riprap. There were no indications of erosion, settling, slumping, rock degradation, or other modifying processes that might affect the integrity of the disposal cell side slopes, apron, or diversion channels.

PL-9. Southeast Side of Disposal Cell

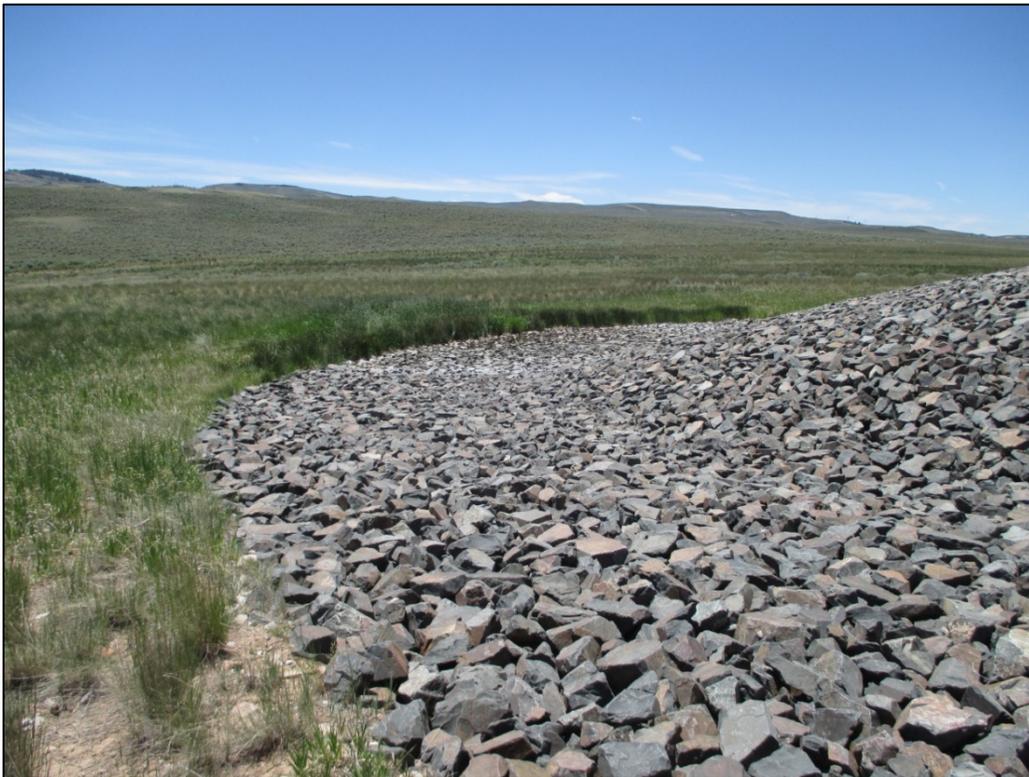
PL-10. Apron at Southeast Corner of Disposal Cell

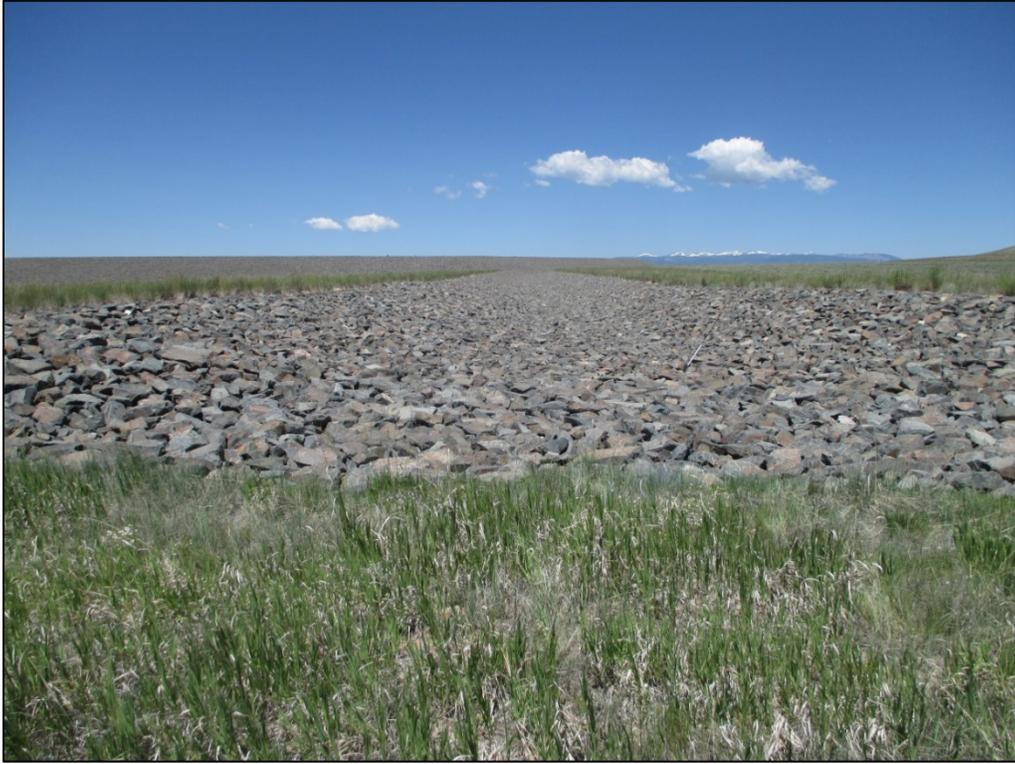
PL-11. East Diversion Channel

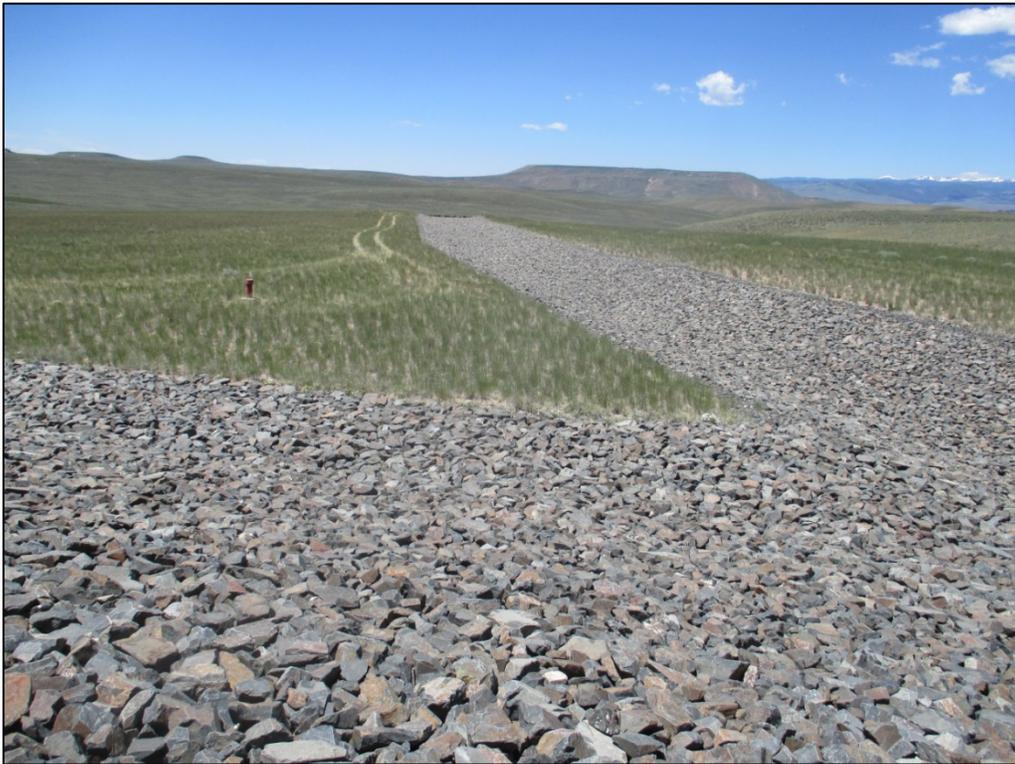
PL-12. West Diversion Channel

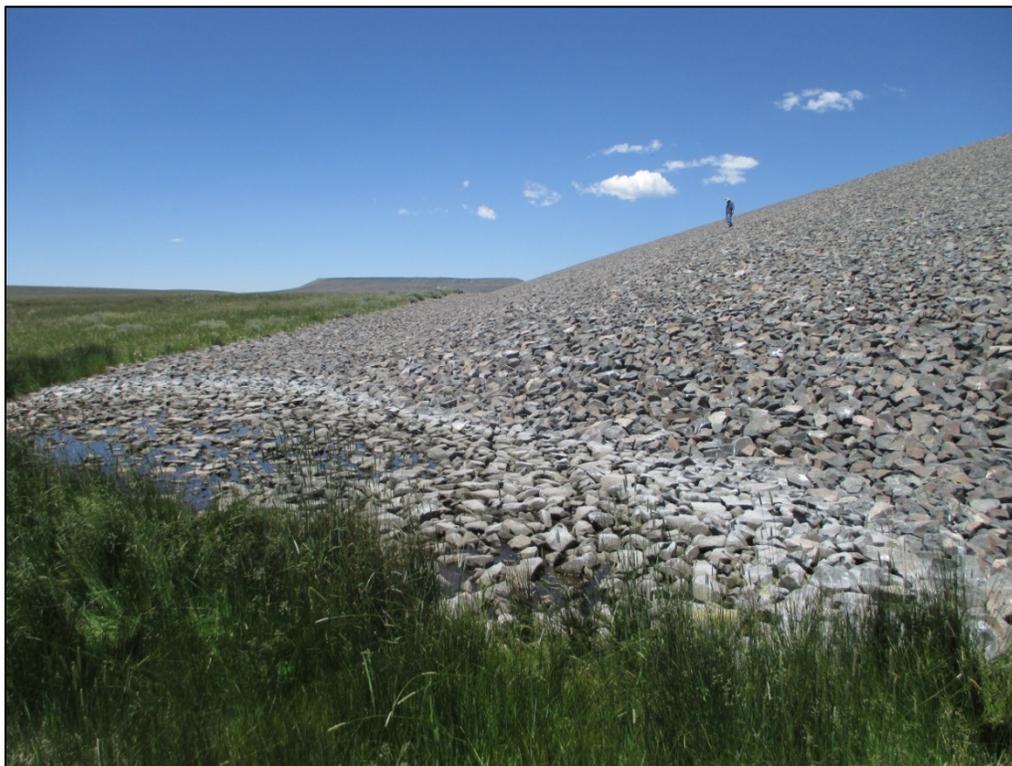
Precipitation runoff from the disposal cell occasionally ponds in a low-lying area at the southeast corner of the disposal cell; standing water was present at the time of the inspection (PL-13). The riparian-type vegetation that has become established there indicates that the area retains moisture much of the time. Water collection in this area does not pose a problem because the disposal cell is designed to drain to the southeast and any water that ponds there is below the elevation of the encapsulated tailings material. No maintenance needs were identified.

PL-13. Southeast Corner of Disposal Cell

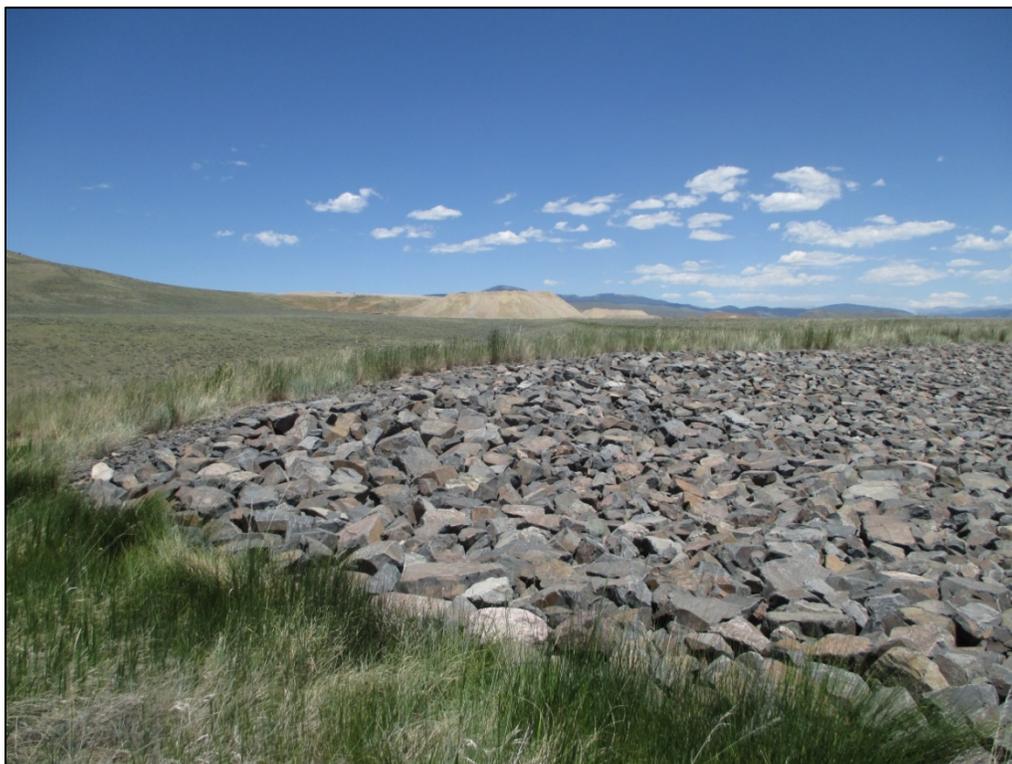
The area beyond the site boundary for a distance of 0.25 mile was visually observed for erosion, changes in land use, or other phenomena that might affect the long-term integrity of the site. Gunnison County owns the land that adjoins the site boundary to the north and east and uses the land for a municipal landfill. The nearest landfill operations continue to be approximately 400 feet north of the site (PL-14). Although landfill activities do not impact the site, inspectors will continue to monitor the level of activity occurring near the site boundary and surveillance features (e.g., fences and monitoring wells). The proximity of the spoils pile to monitoring well 0716 was the only current concern for activities that could impact a site asset. Inspectors will continue to monitor this area.

PL-14. Landfill Features North of Site
