8.0 Gunnison, Colorado, Disposal Site

8.1 Compliance Summary

Figure 8-1. 2017 Annual Inspection Drawing for the Gunnison, Colorado, Disposal Site

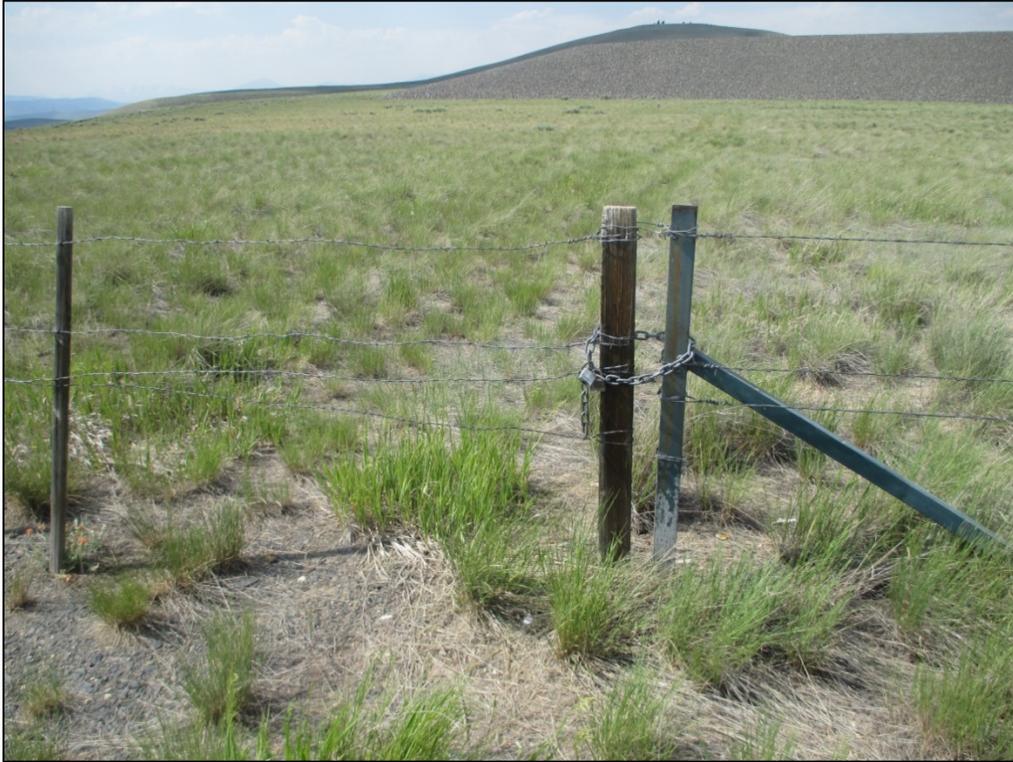
Access to the site is from Gunnison County Road 42 onto U.S. Bureau of Land Management (BLM) Road 3068. The road to the site is a gravel road maintained by BLM. Entrance to the site is through a locked gate that is part of the perimeter fence. The entrance gate was locked and functional (PL-1). The entrance sign is bolted to a perimeter fence post next to the entrance gate (PL-2). The entrance sign has bullet damage but remains legible. No maintenance needs were identified.

PL-1. Entrance Gate

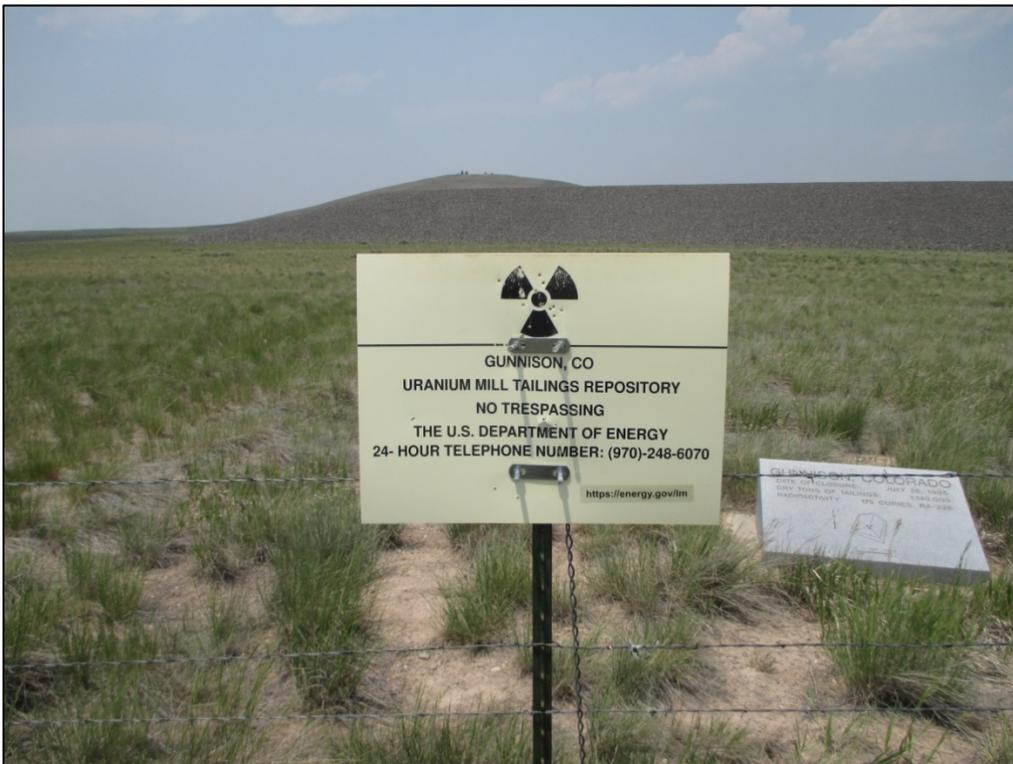
PL-2. Entrance Sign

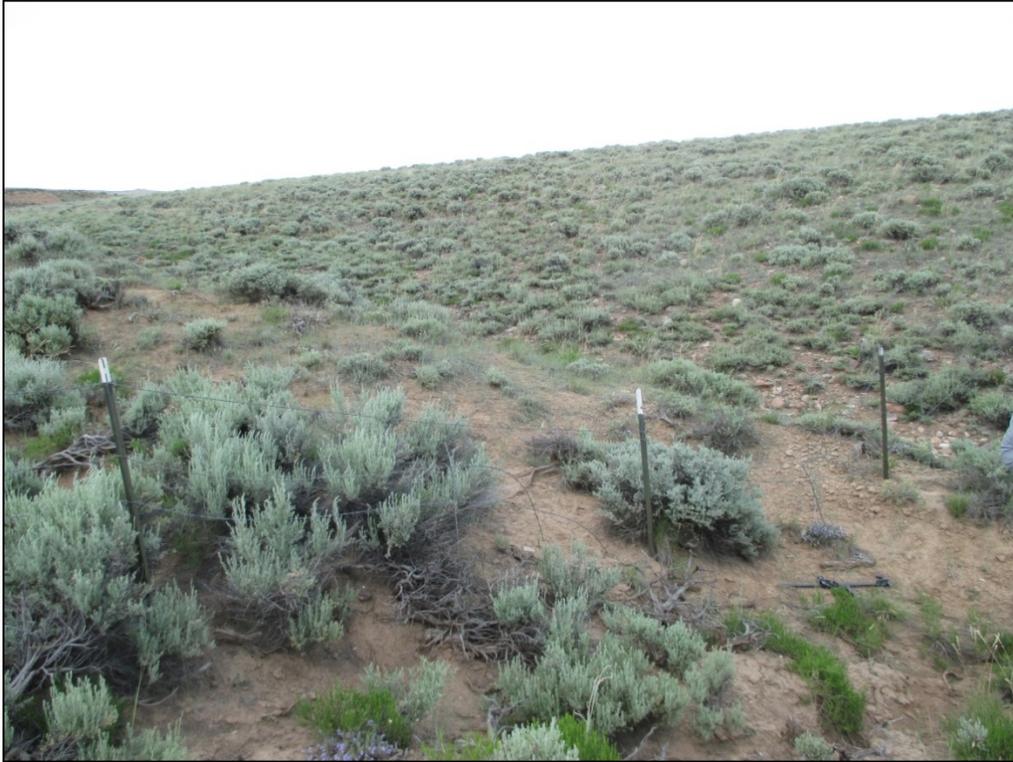
A three-strand barbed-wire perimeter fence encloses the site; most of it is set along the property boundary. The perimeter fence was intact except for three locations with broken strands that were repaired during the inspection (PL-3). Two barbed-wire gates—one on the north fence line and the other on the east fence line—provide access to offsite monitoring wells; both gates were locked. There are 45 perimeter signs bolted to the perimeter fence posts. Several perimeter signs (P3, P6, P38, and P43) have bullet damage but remain legible. Perimeter sign P45 was damaged, and perimeter sign P42 was faded; replacement signs were installed during the inspection (PL-4). No other maintenance needs were identified.

PL-3. Broken Perimeter Fence Strands; Subsequently Repaired

Three perimeter fence locations with broken strands were repaired, and two perimeter signs were replaced during the inspection; no other maintenance needs were identified.

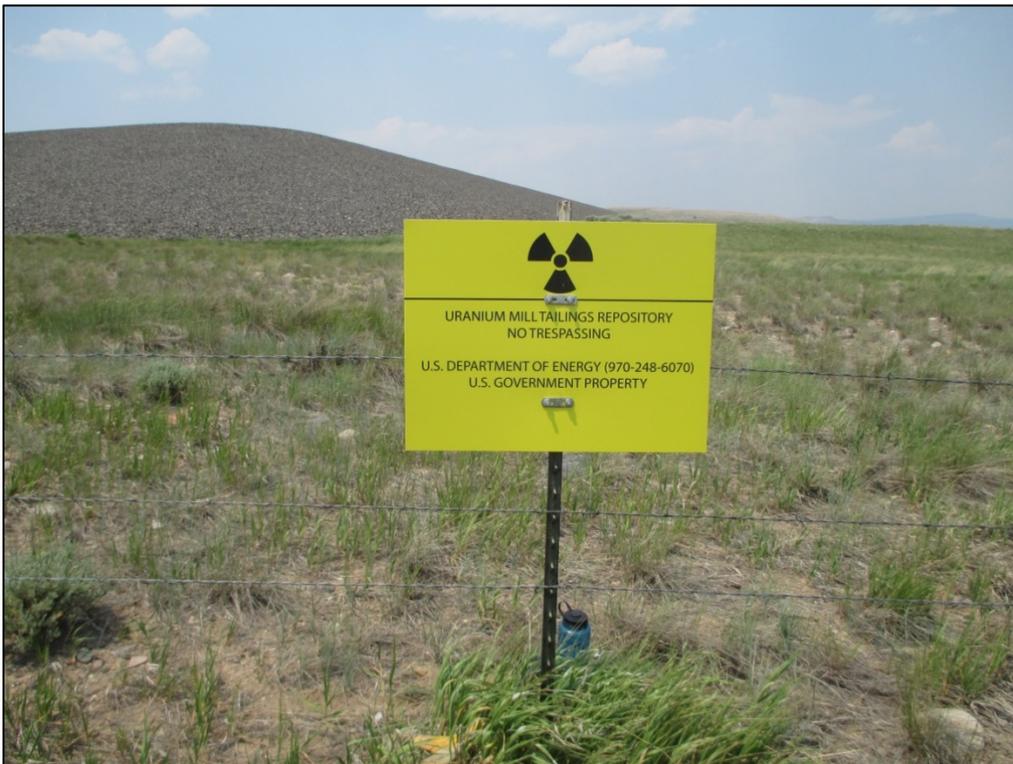
PL-4. New Perimeter Sign P45

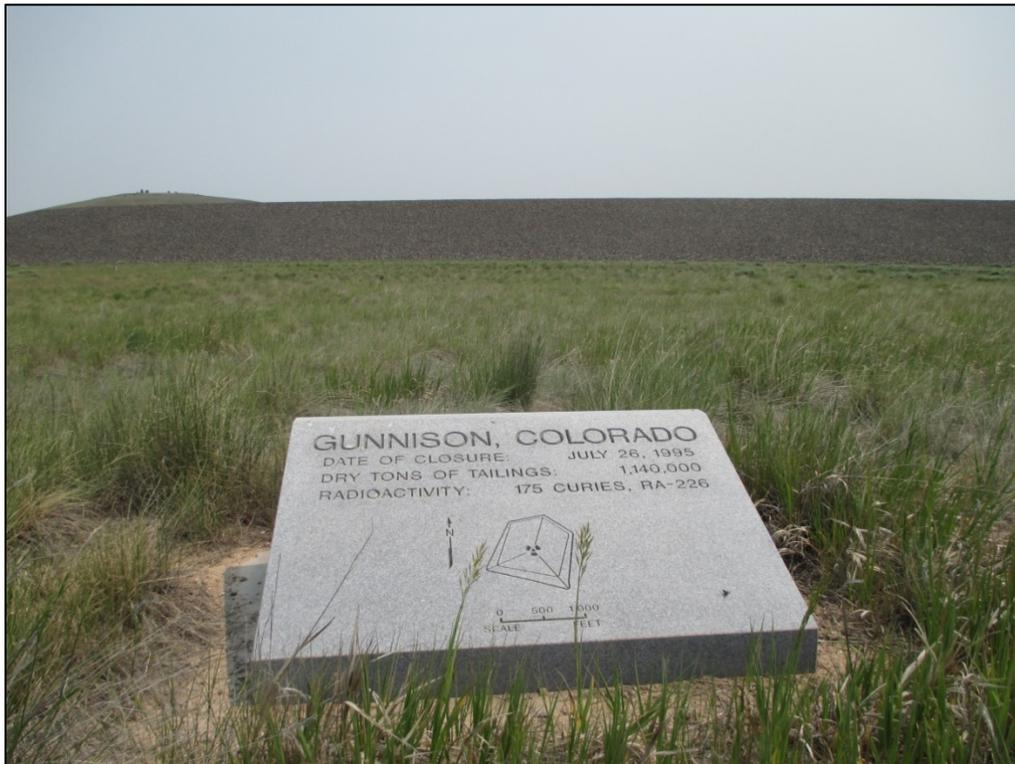
The site has two granite site markers. Site marker SMK-1 is just inside the entrance gate (PL-5), and site marker SMK-2 is on the top slope of the disposal cell (PL-6). No maintenance needs were identified.

PL-5. Site Marker SMK-1

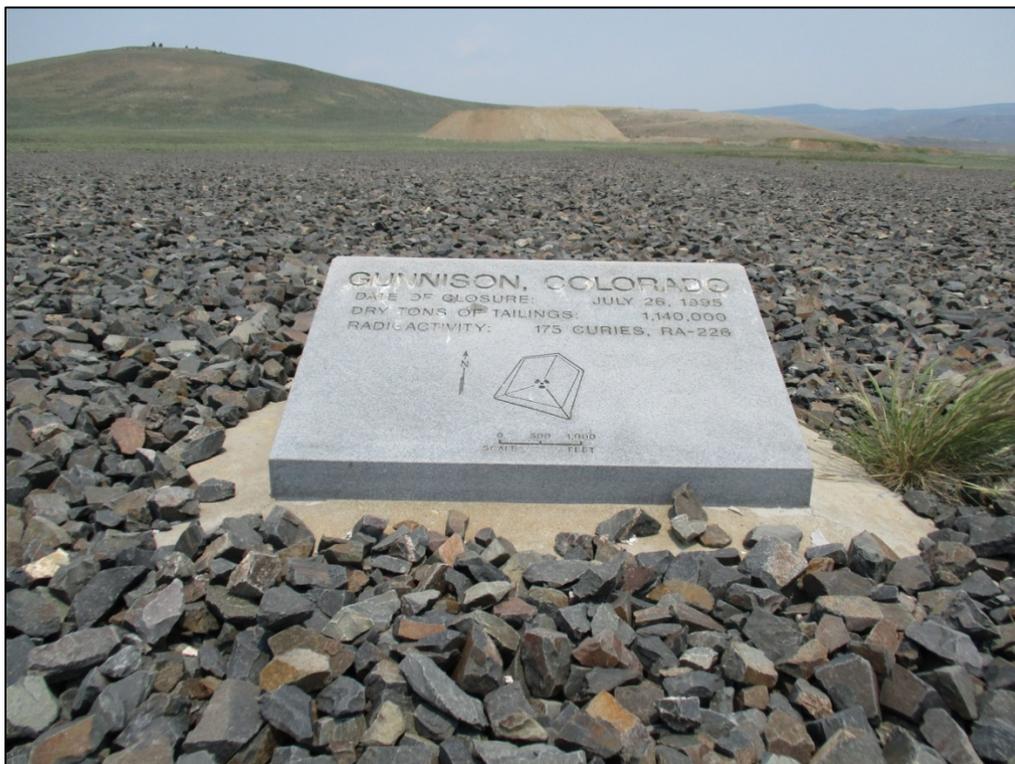
PL-6. Site Marker SMK-2

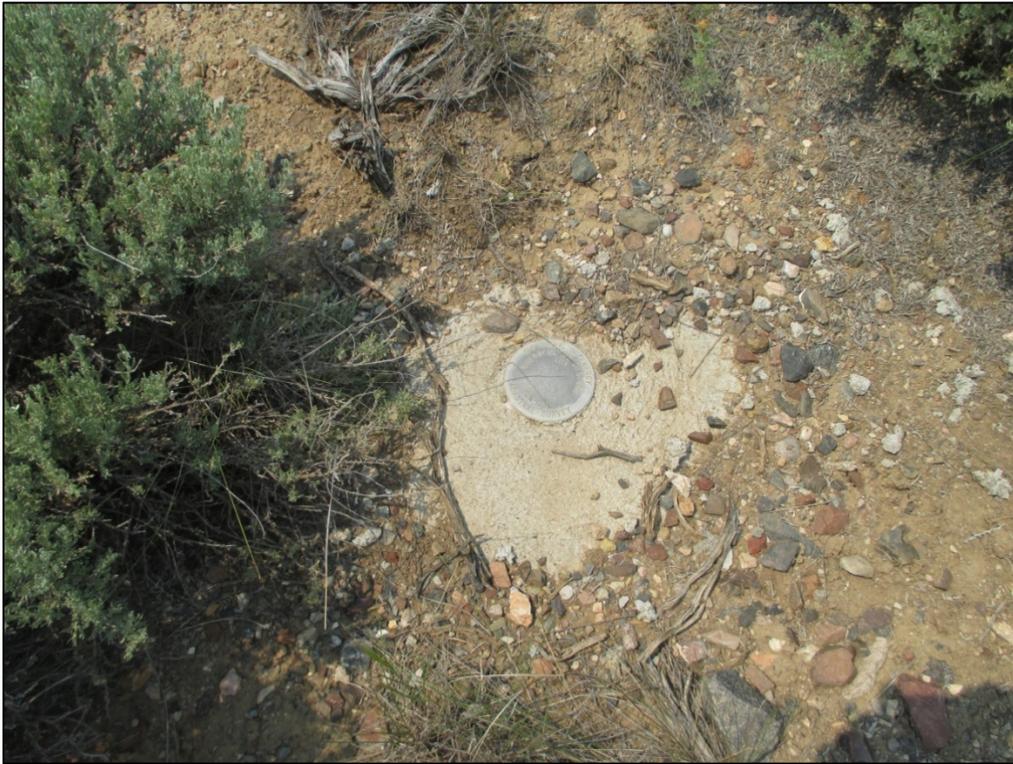
Three combined survey and boundary monuments and eight additional boundary monuments delineate the property boundary (PL-7). No maintenance needs were identified.

PL-7. Boundary Monument BM-11

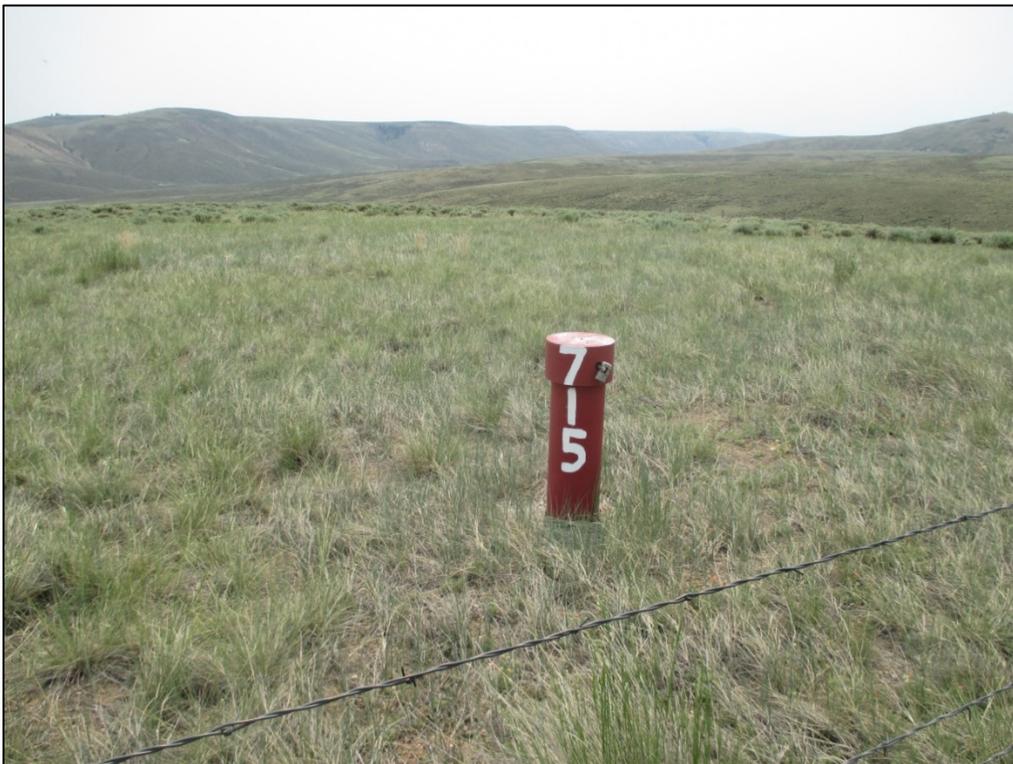
The site has 16 groundwater monitoring wells. The wellhead protectors were undamaged, properly labeled, and locked (PL-8). The Gunnison County landfill operators have placed concrete barriers to protect monitoring well 0716, which is on landfill property, from landfill activities (PL-9). The edge of an adjacent spoil pile, although close to the concrete barriers, does not impair access to monitoring well 0716. No maintenance needs were identified.

PL-8. Monitoring Well 0715

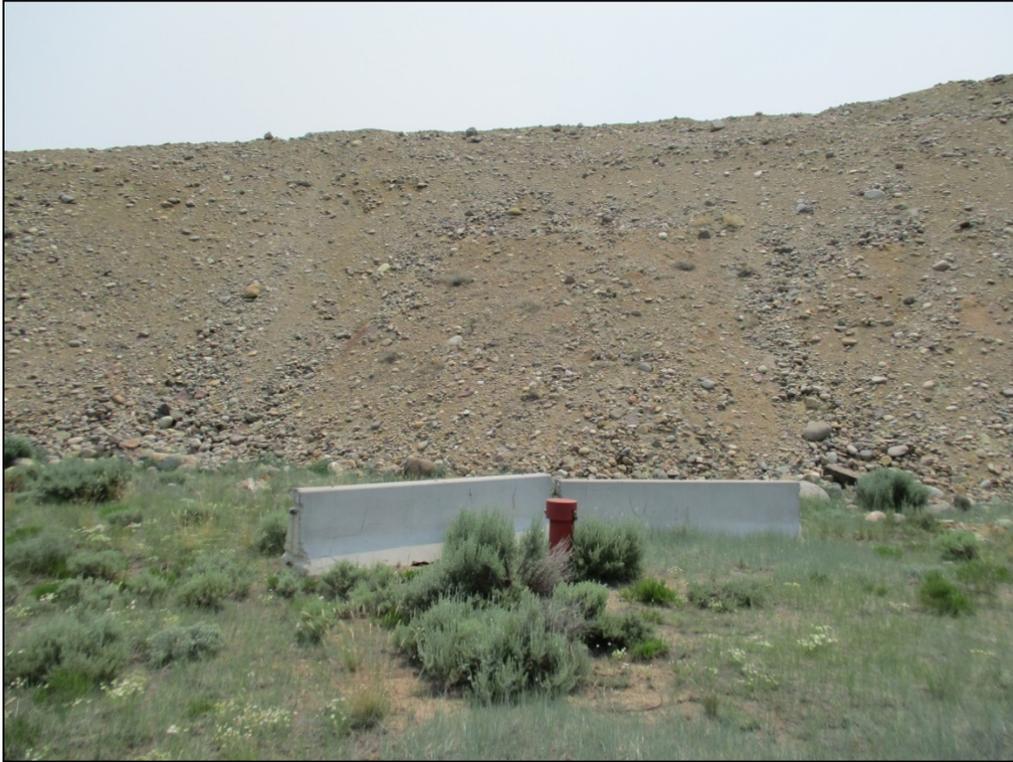
PL-9. Monitoring Well 0716 on County Landfill Property

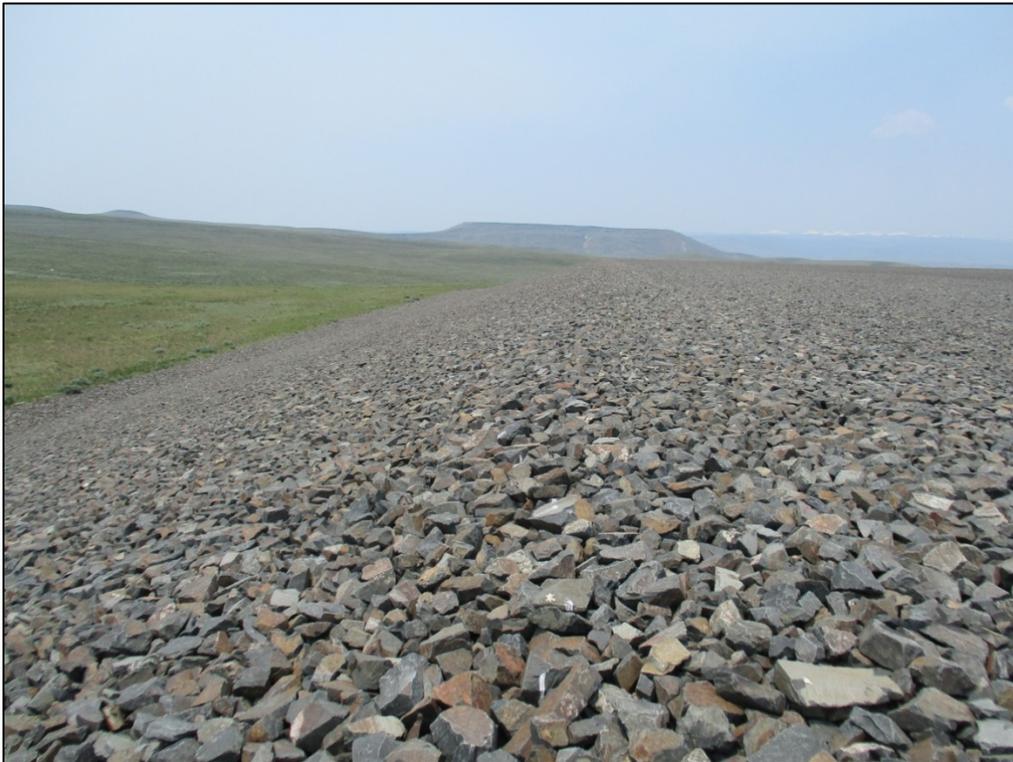
The disposal cell side slopes (PL-10), an apron to collect and divert precipitation runoff from the disposal cell (PL-11), and two diversion channels to protect the disposal cell from precipitation run-on (PL-12) are all armored with basalt riprap. There was no evidence of settling, slumping, erosion, or any other modifying process that might affect the integrity of the disposal cell side slopes, apron, or diversion channels. Six rock-monitoring test areas, each approximately 1 square meter in area (the corners are marked with orange paint), are in critical flow path locations in the apron and diversion channels. Annual photographing and comparing of these test areas was performed through 2002 in accordance with the LTSP; after that, the LTSP requires the test areas to be photographed every 5 years, with the final set of photographs taken in 2017. The riprap in all of the test areas showed no rock degradation. When the rocks were compared to the photos taken of them in 2012, there was no evidence that individual rocks had split or otherwise been degraded (PL-13 through PL-18A). No rock degradation has been observed in the test areas since monitoring began in 1998; therefore, in accordance with the LTSP, the test areas will no longer be monitored.

PL-10. Disposal Cell Top and Southwest Side Slope

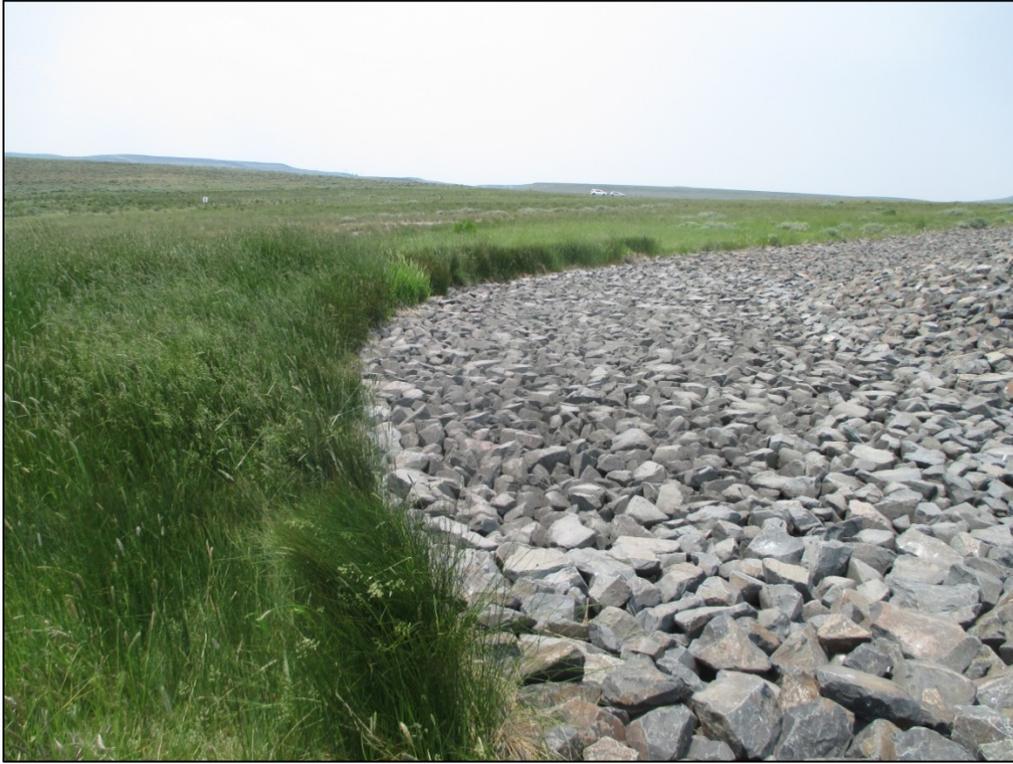
PL-11. Apron at Southeast Corner of Disposal Cell

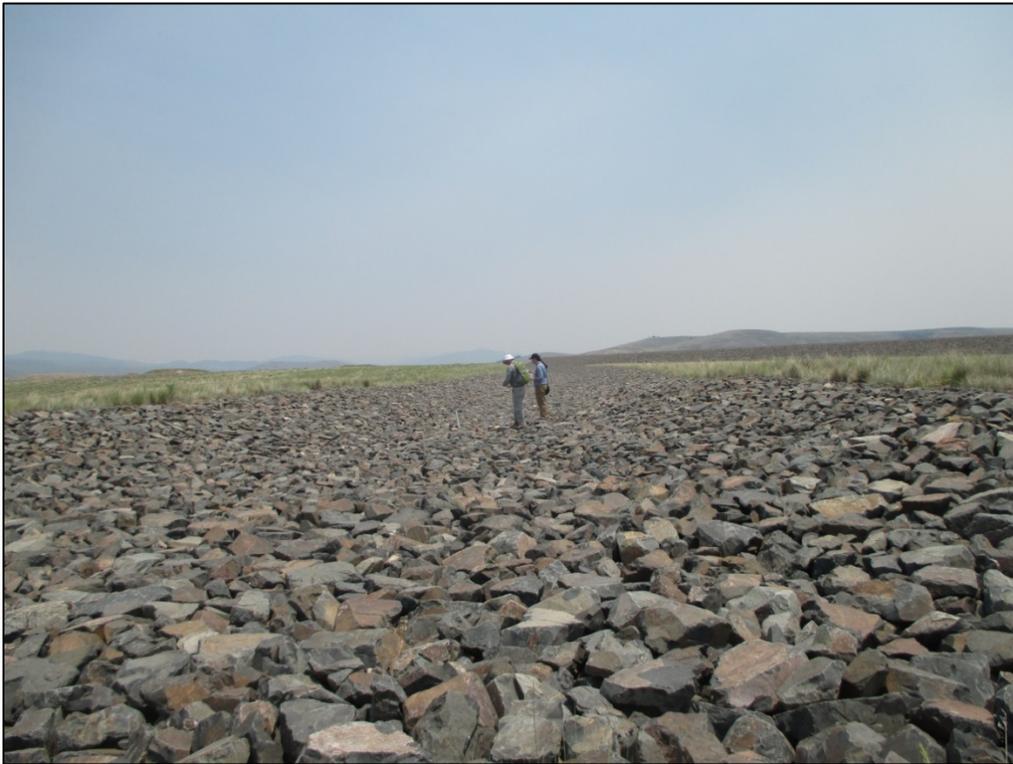
PL-12. West Diversion Channel

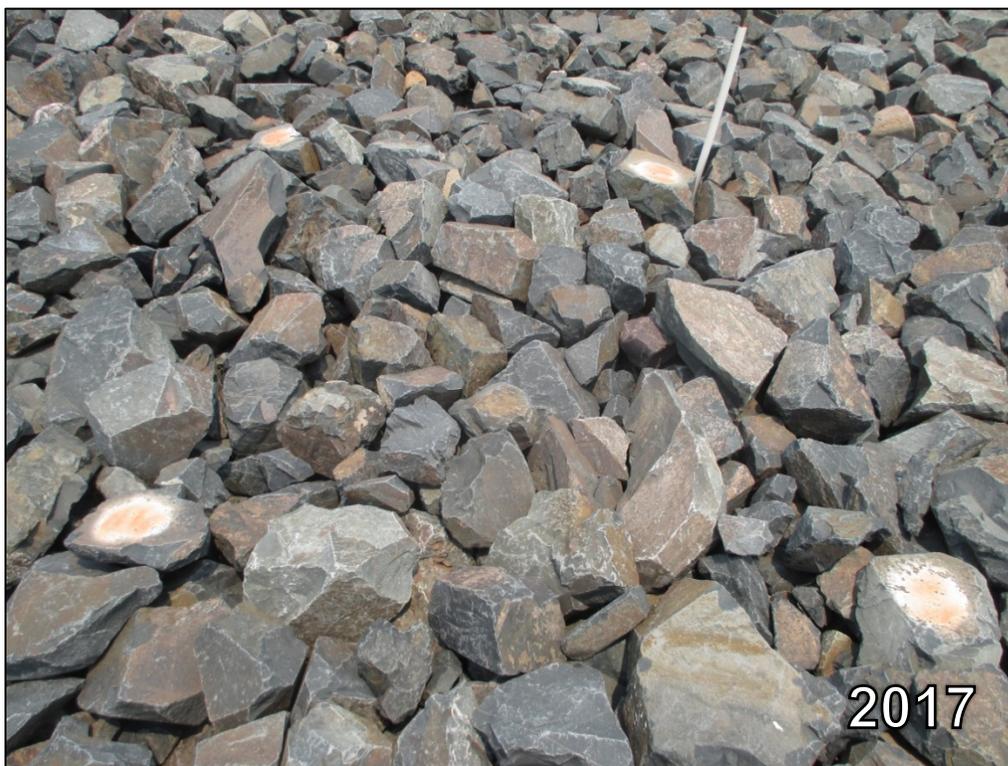
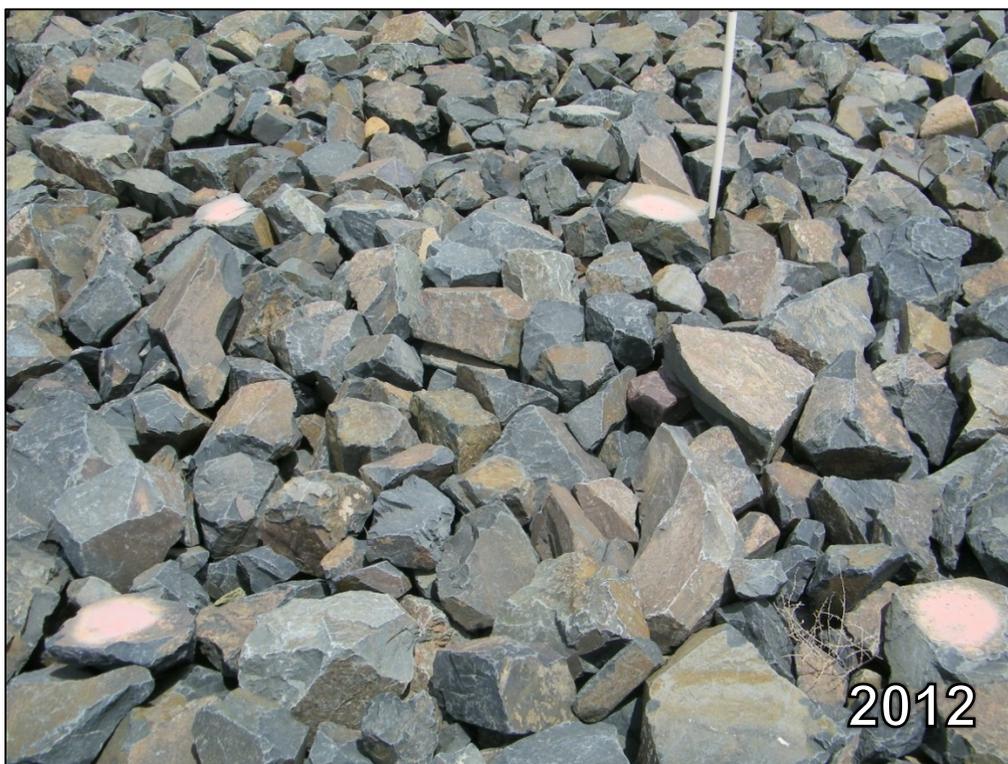
PL-13. (a) Riprap Test Area No. 1 (Type B Riprap) on the Disposal Cell's East Apron—June 22, 2017

PL-13. (b) Riprap Test Area No. 1 (Type B Riprap) on the Disposal Cell's East Apron—June 4, 2012, Photo for Comparison

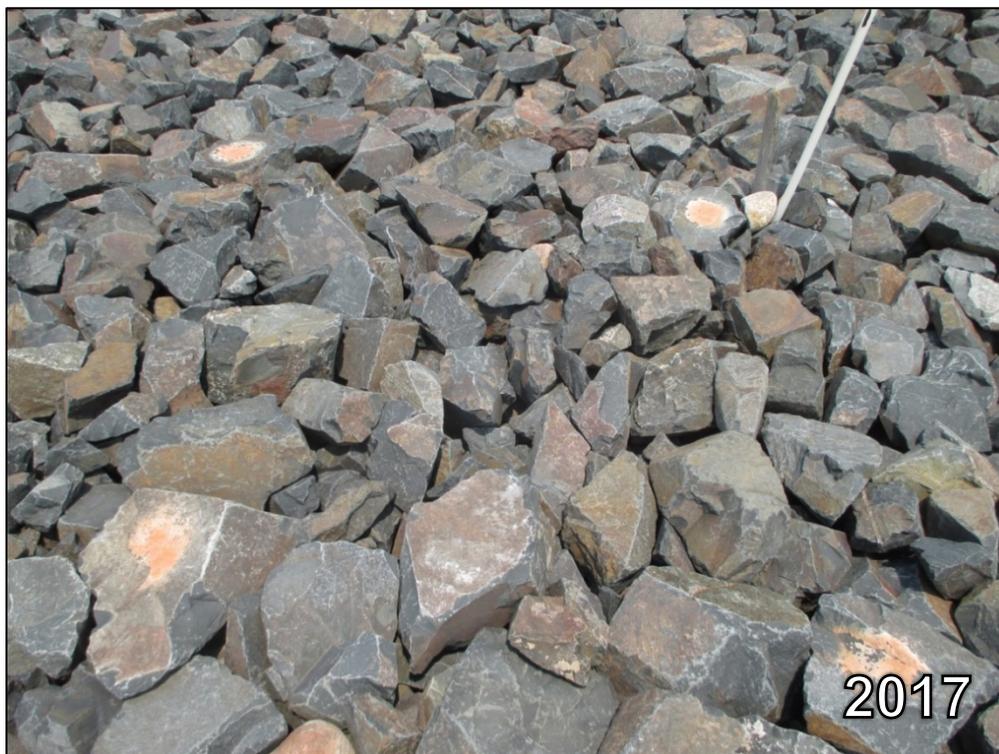
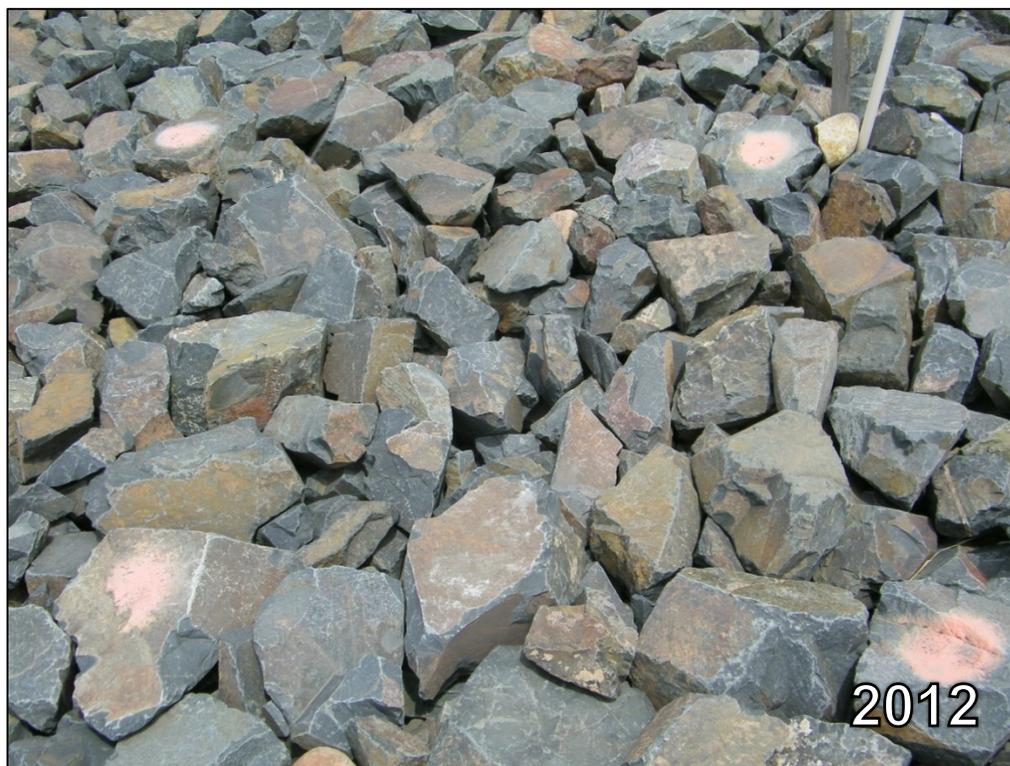
PL-14. (a) Riprap Test Area No. 2 (Type B Riprap) on the Disposal Cell's South Apron—June 22, 2017

PL-14. (b) Riprap Test Area No. 2 (Type B Riprap) on the Disposal Cell's South Apron—June 4, 2012, Photo for Comparison

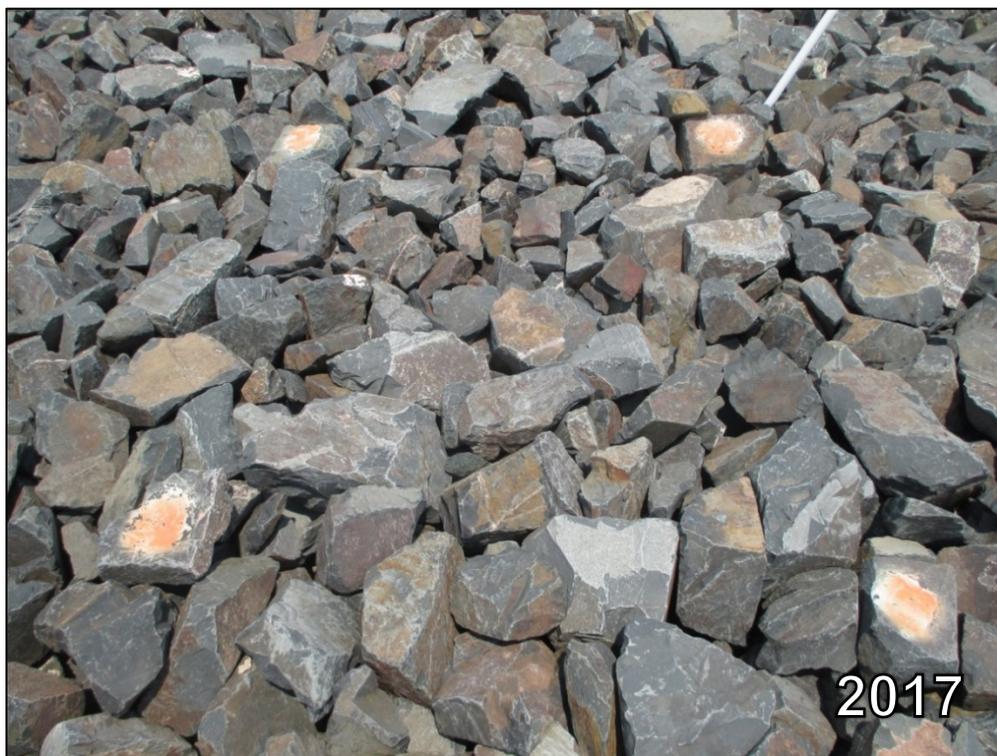
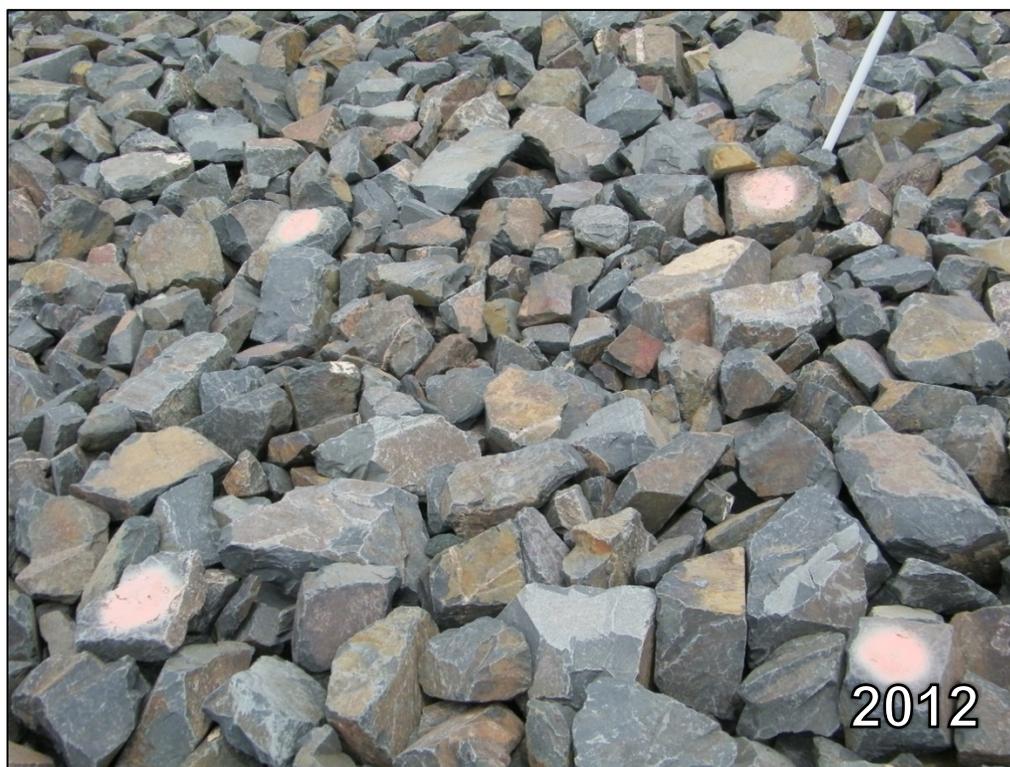
*PL-15. (a) Riprap Test Area No. 3 (Type B Riprap) on the Disposal Cell's Northwest Apron—
June 22, 2017*

*PL-15. (b) Riprap Test Area No. 3 (Type B Riprap) on the Disposal Cell's Northwest Apron—
June 4, 2012, Photo for Comparison*

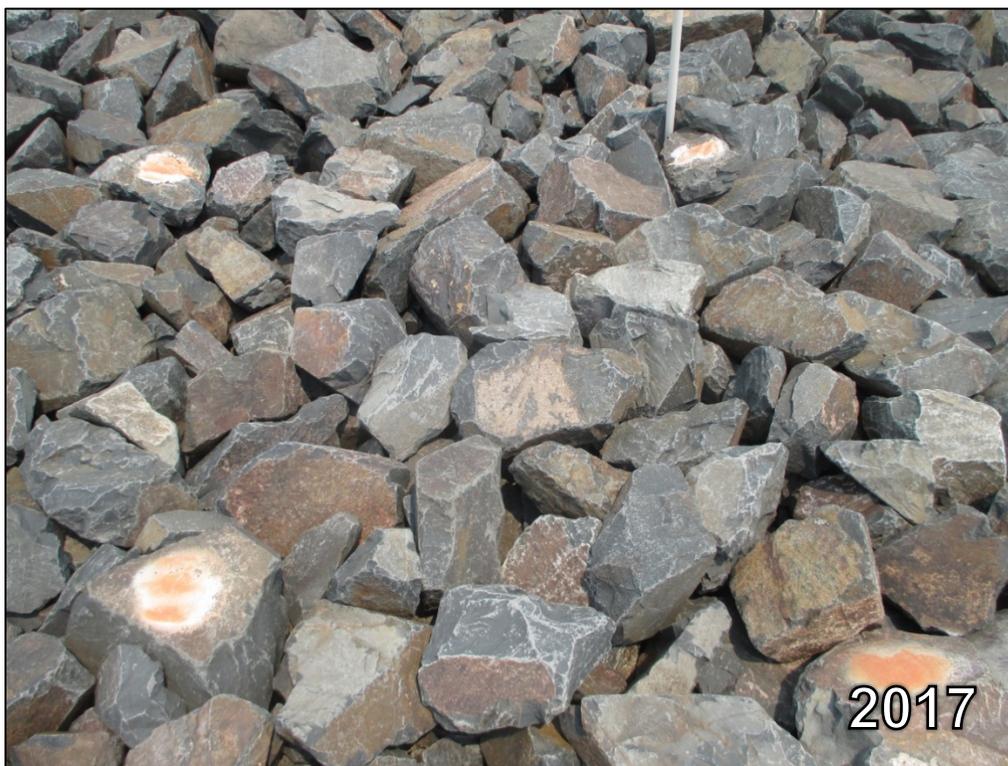
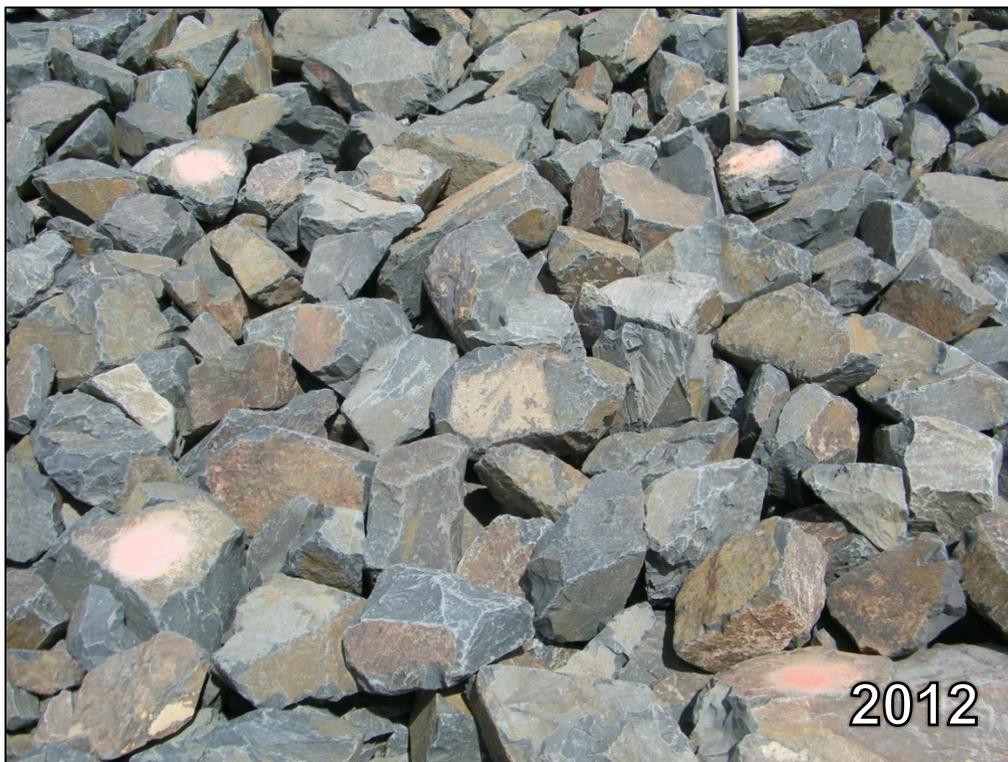
PL-16. (a) Riprap Test Area No.4 (Type C Riprap) in the East Diversion Channel–June 22, 2017

*PL-16. (b) Riprap Test Area No. 4 (Type C Riprap) in the East Diversion Channel–
June 4, 2012, Photo for Comparison*

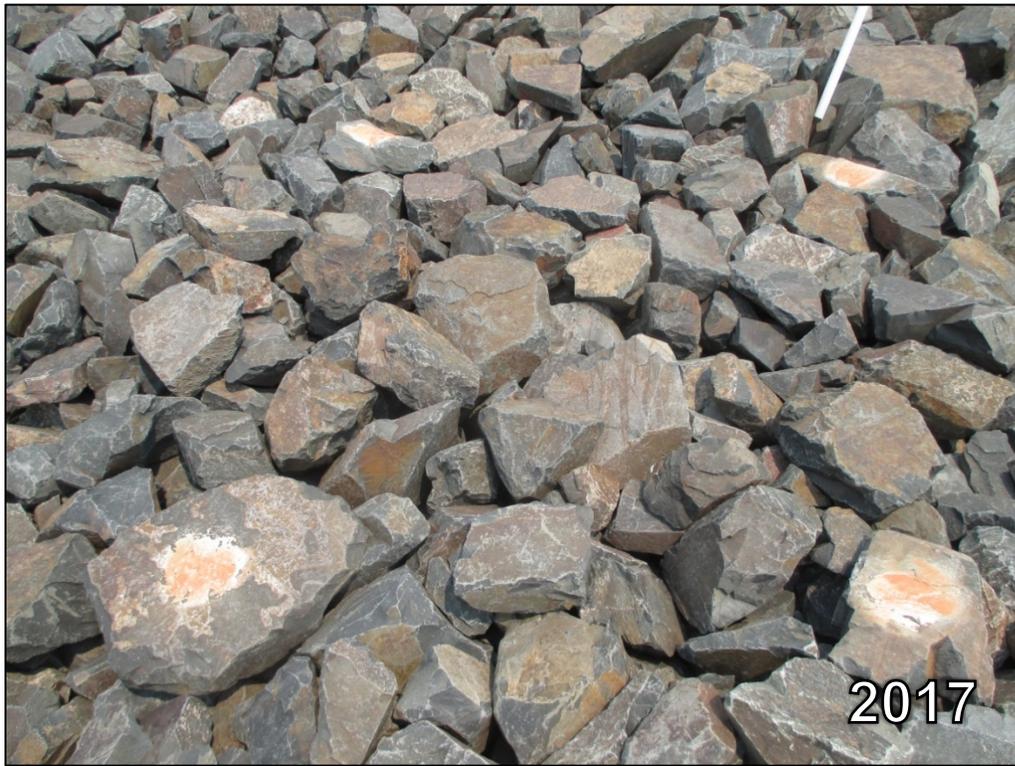
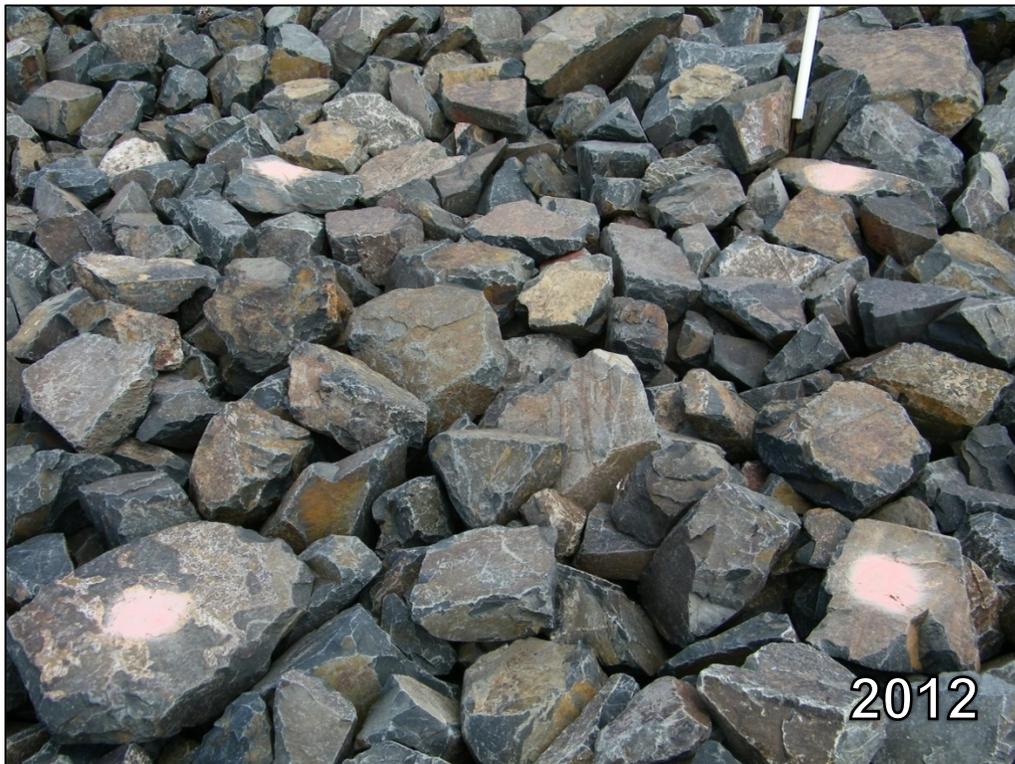
PL-17. (a) Riprap Test Area No. 5 (Type D Riprap) at the East Diversion Channel Outlet–June 22, 2017

*PL-17. (b) Riprap Test Area No. 5 (Type D Riprap) at the East Diversion Channel Outlet–
June 4, 2012, Photo for Comparison*

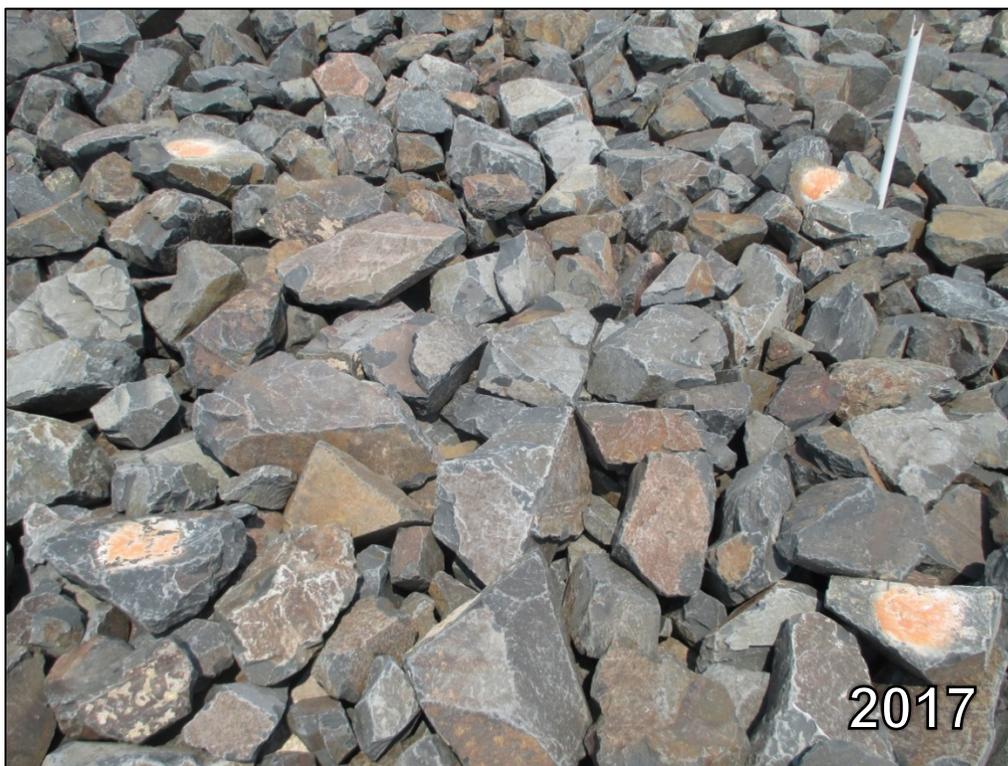
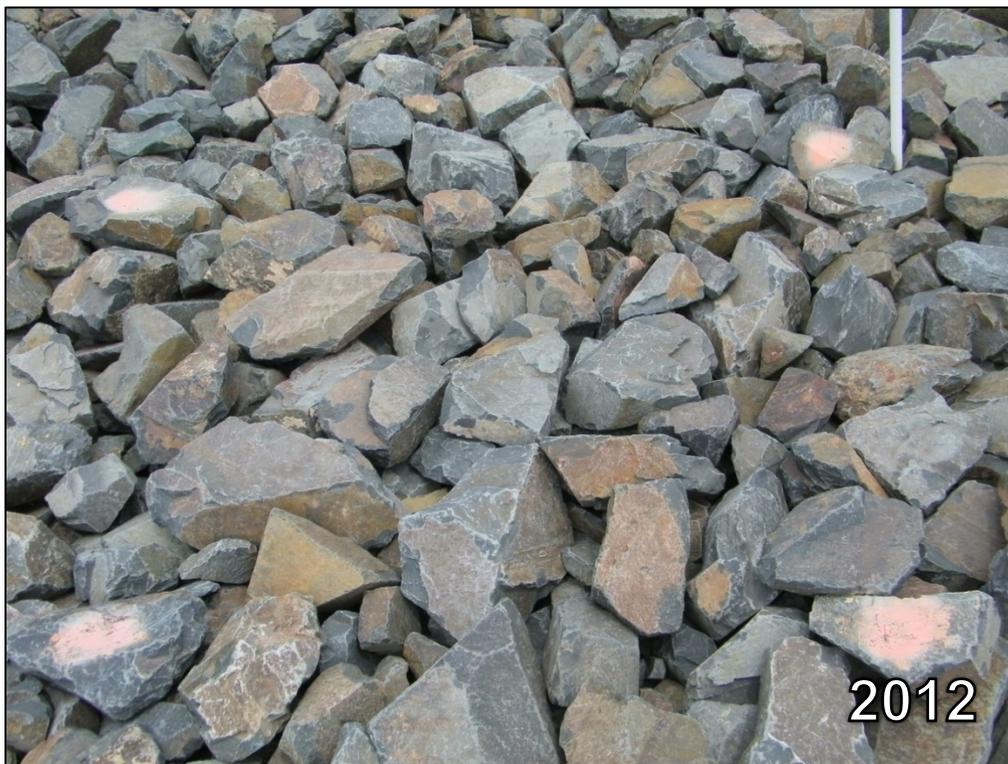
PL-18. (a) Riprap Test Area No. 6 (Type D Riprap) at the West Diversion Channel Outlet–June 22, 2017

PL-18. (b) Riprap Test Area No. 6 (Type D Riprap) at the West Diversion Channel Outlet–June 4, 2012, Photo for Comparison

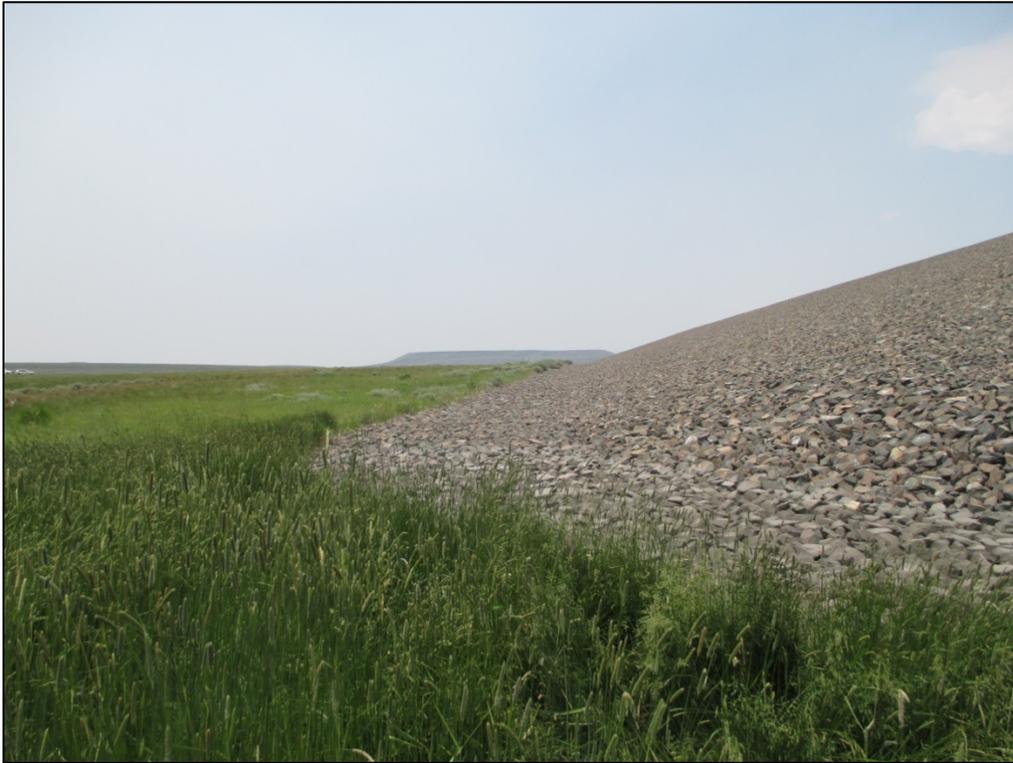
Precipitation runoff from the disposal cell occasionally ponds in a low-lying area at the southeast corner of the disposal cell; standing water was not present at the time of the inspection (PL-19). The riparian-type vegetation that has become established there indicates that the area retains moisture. Water collection in this area does not pose a problem because the disposal cell is designed to drain to the southeast, and any water that ponds there is below the elevation of the encapsulated tailings material. No maintenance needs were identified.

PL-19. Apron at Southeast Corner of Disposal Cell

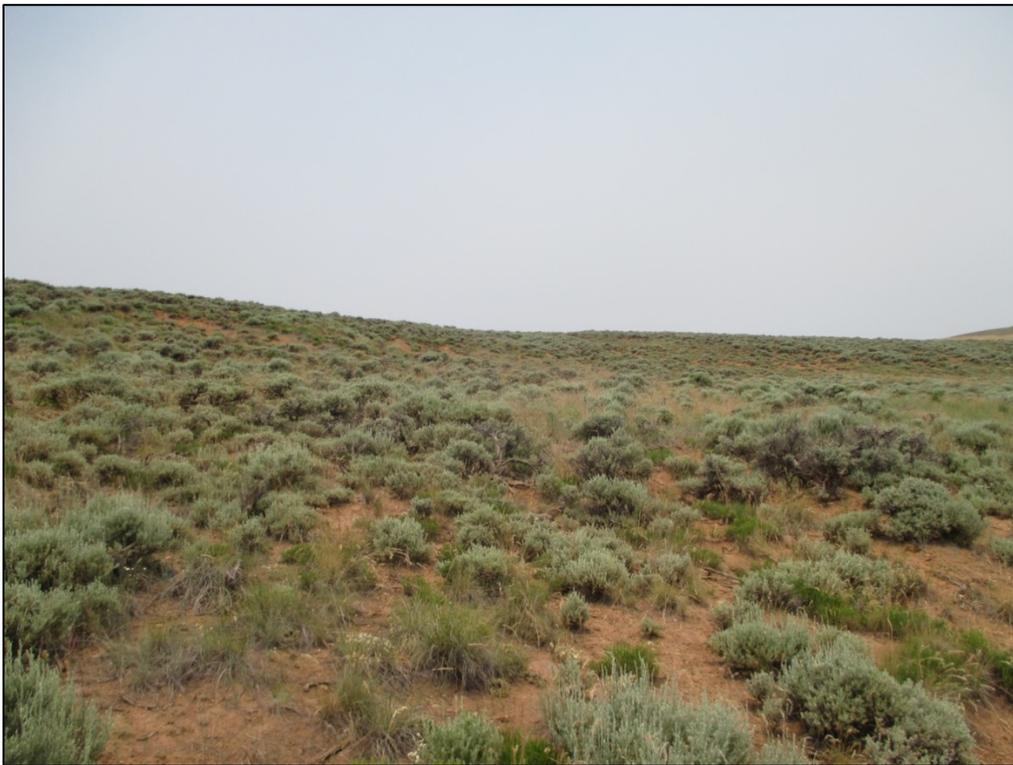
Reclaimed and undisturbed areas comprise the area between the disposal cell and the site boundary. In general, the vegetation in the reseeded, reclaimed areas consists of well-established grass; native plants are much less abundant and less diverse in reclaimed areas than they are in undisturbed areas. Former erosion areas continue to be stable and are naturally revegetating with native plant species (PL-20). No maintenance needs were identified.

PL-20. Stabilized Headcuts on Steep Hillside
