8.0 Gunnison, Colorado, Disposal Site

The U.S. Department of Energy (DOE) Office of Legacy Management (LM) conducted the Gunnison, Colorado, Uranium Mill Tailings Radiation Control Act (UMTRCA) Title I Disposal Site (site) annual site inspection on July 31, 2018 and the five-year groundwater monitoring event in July 2016. No cause for a follow-up inspection was identified.

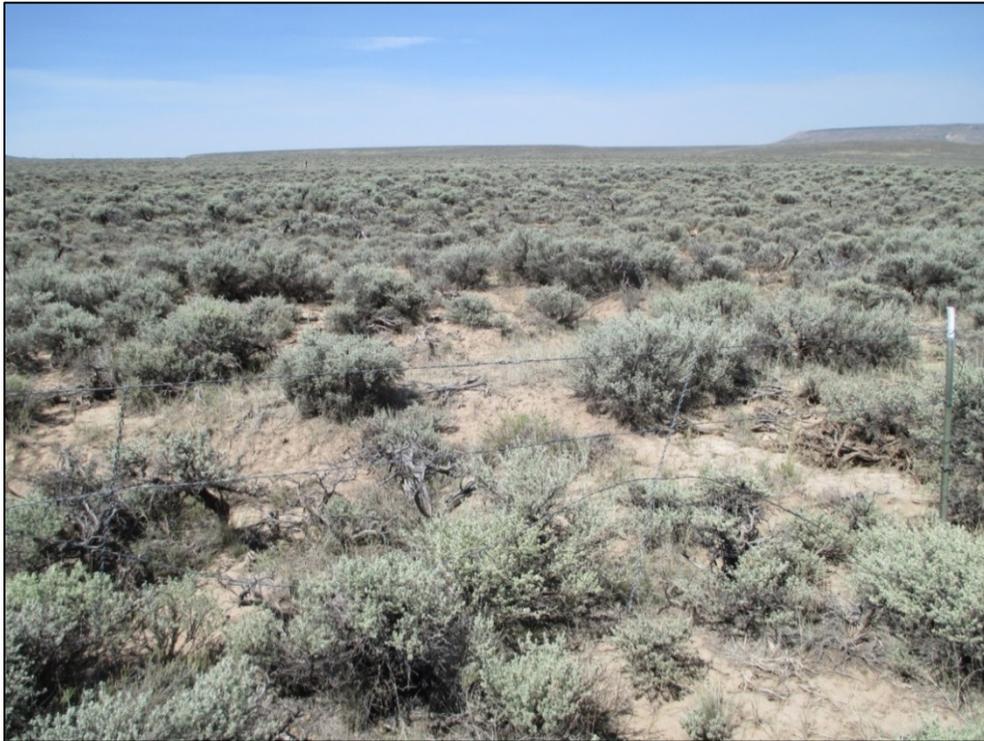
A three-strand barbed-wire perimeter fence encloses the site; most of it is set along the property boundary. The perimeter fence was intact except for one location with a broken strand that was repaired during the inspection (PL-1). Two barbed-wire gates—one on the north fence line and the other on the east fence line—provide egress from the site to offsite monitoring wells; both gates were locked.

PL-1. Broken Fence Strand near Perimeter Sign P8 (Repaired During Inspection)

A broken fence strand was repaired, and faded or damaged perimeter signs P2, P38, and P43 were replaced during the inspection. Perimeter signs P4–P13 along the west fence line are becoming illegible due to fading and should be replaced within the next couple of years. No other maintenance needs were identified.

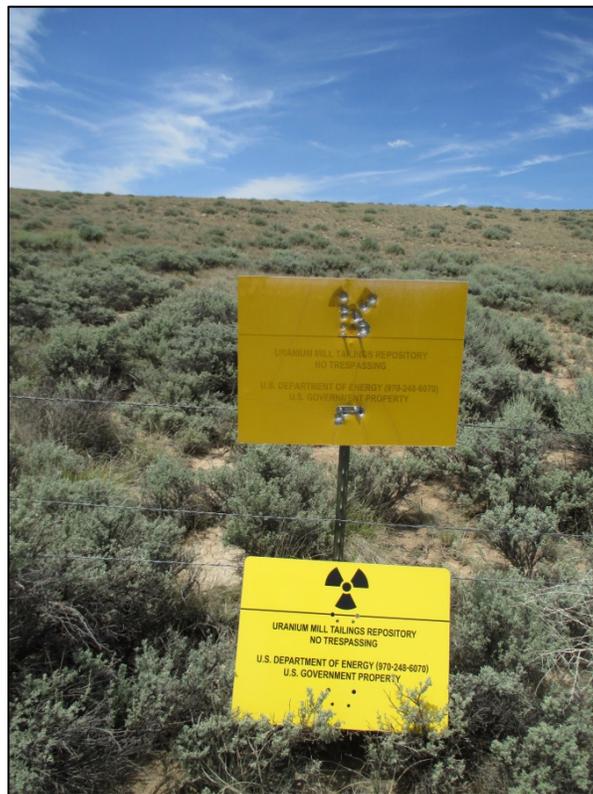
There are 45 perimeter signs bolted to the perimeter fence posts. Several perimeter signs have bullet damage but remain legible. Perimeter signs P2, P38, and P43 were faded or damaged; replacement signs were installed during the inspection (PL-2). Perimeter signs P4–P13 along the west perimeter fence line are becoming illegible due to fading and should be replaced within the next couple of years. No other maintenance needs were identified.

PL-2. Faded and Damaged Perimeter Sign P38 (Replaced During Inspection)

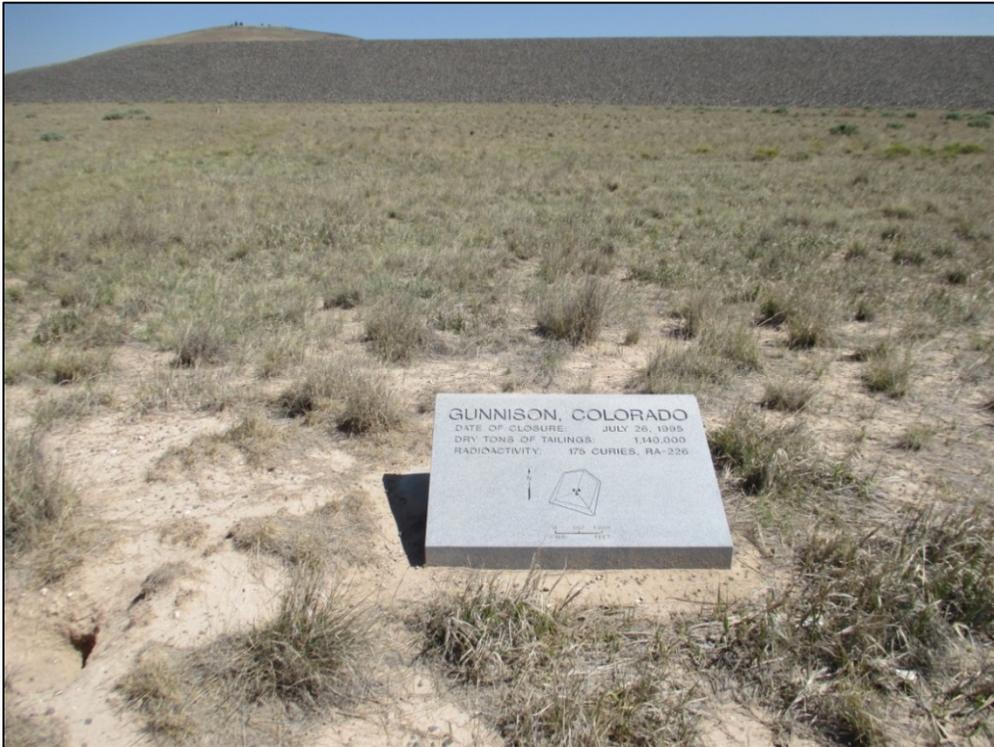
PL-3. Site Marker SMK-1

The site has two granite site markers. Site marker SMK-1 is just inside the entrance gate (PL-3), and site marker SMK-2 is on the top slope of the disposal cell. No maintenance needs were identified.

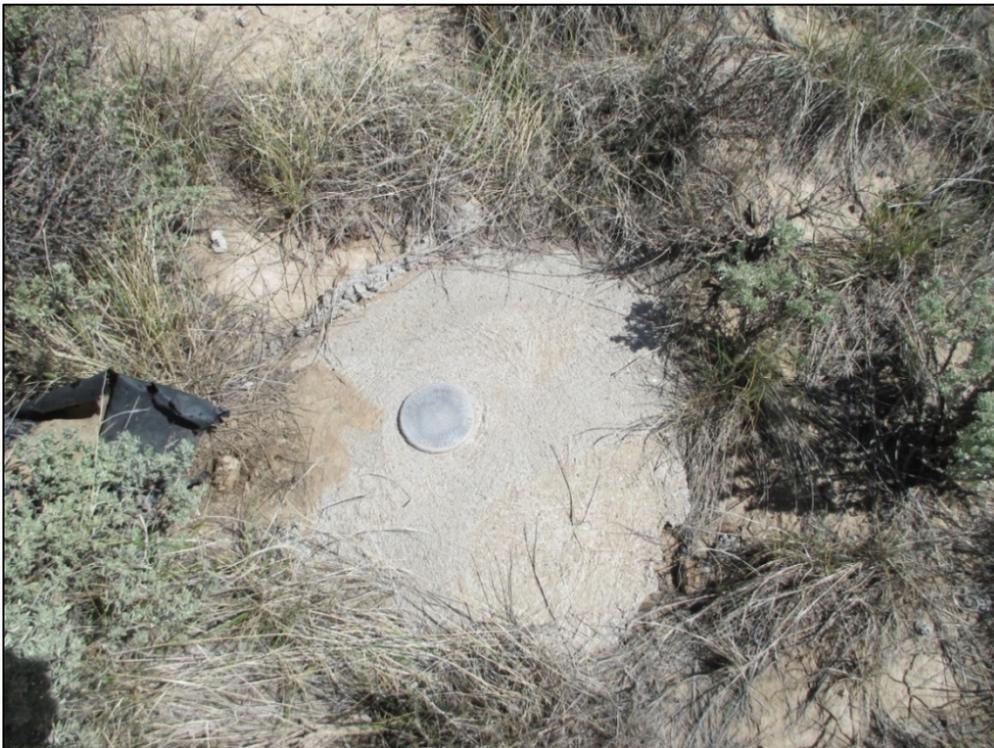
PL-4. Boundary Monument BM-7

Three combined survey and boundary monuments and eight additional boundary monuments delineate the property boundary (PL-4). No maintenance needs were identified.

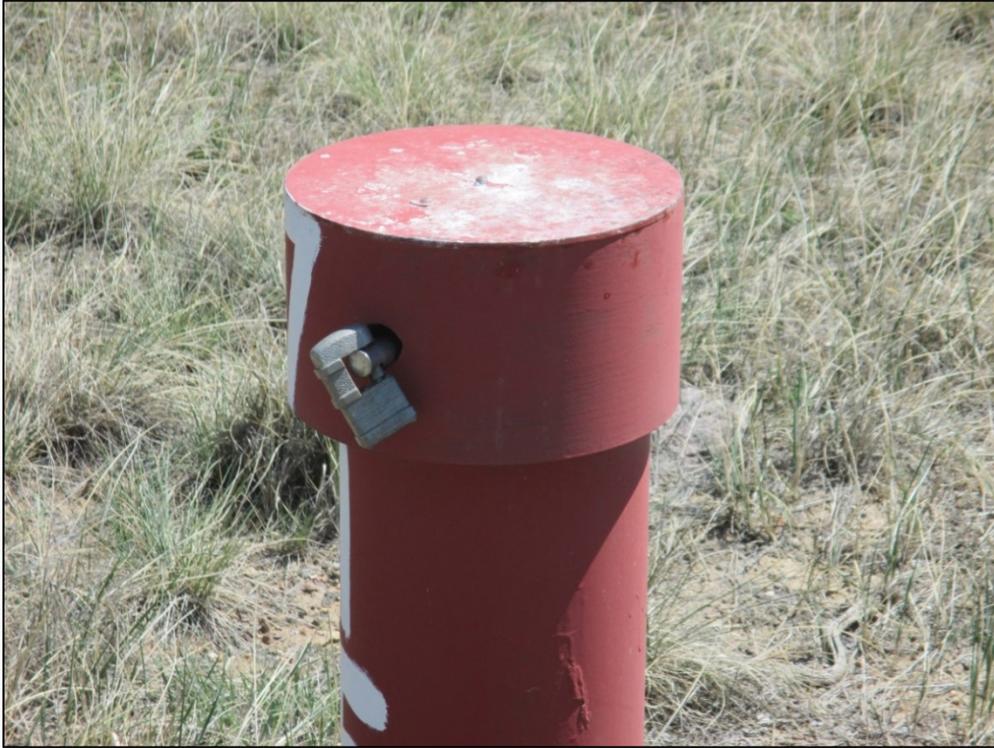
PL-5. Monitoring Well 0715

The site has 16 groundwater monitoring wells. The wellhead protectors were locked and properly labeled (PL-5). The wellhead protector for monitoring well 0634 had bullet damage but was secure. Gunnison County landfill operators have placed concrete barriers to protect monitoring well 0716, which is on landfill property, from landfill activities (PL-6). The edge of an adjacent spoil pile, although close to the concrete barriers, does not impair access to monitoring well 0716. No maintenance needs were identified.

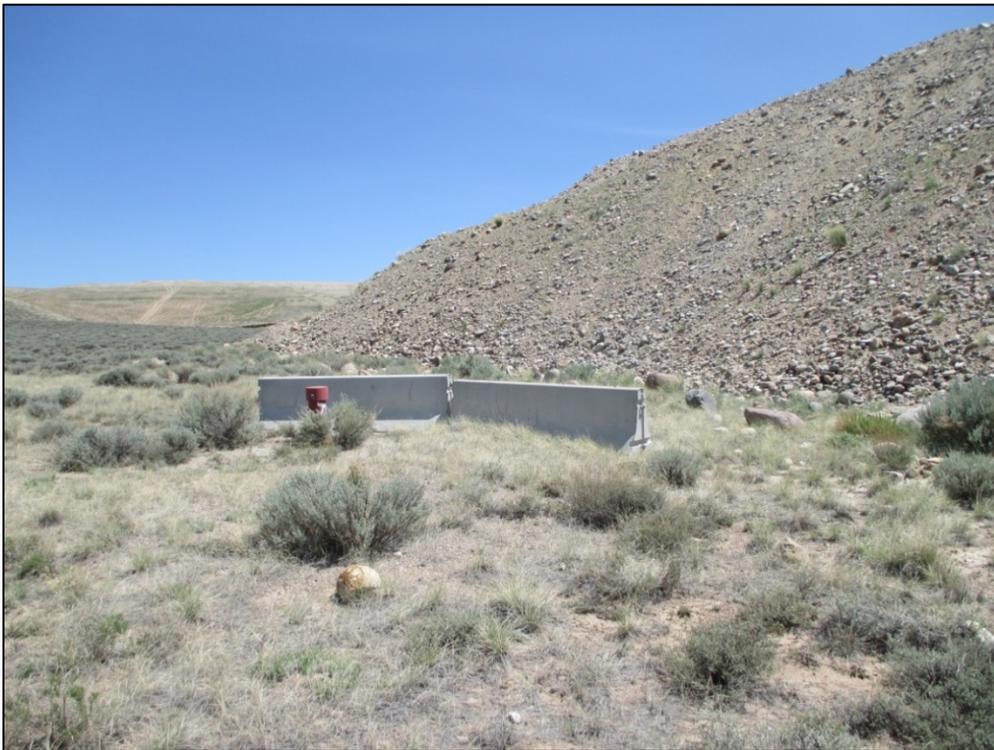
PL-6. Monitoring Well 0716 and County Landfill Spoil Pile

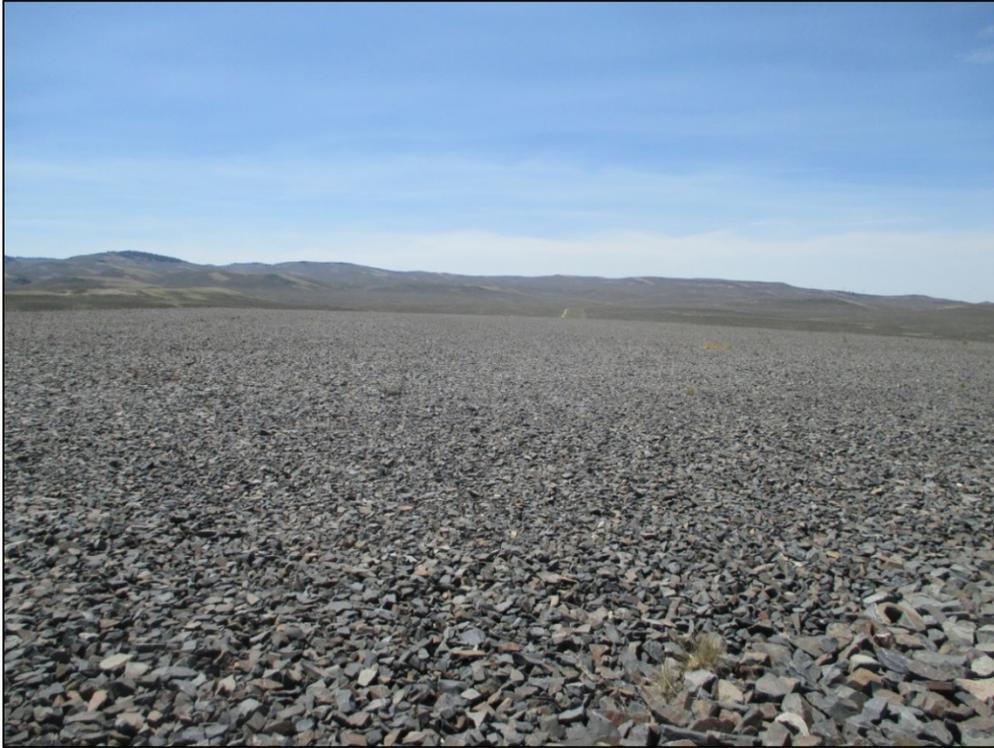
PL-7. Top Slope of Disposal Cell

The disposal cell, completed in 1995, occupies 29 acres and is armored with basalt riprap to control erosion. There was no evidence of settling, slumping, erosion, or any other modifying process that might affect the integrity of the top slope of the disposal cell (PL-7). Several isolated patches of grass have established on the top slope; however, these shallow-rooted plants do not degrade the performance of the radon barrier component of the disposal cell's engineered cover. No maintenance needs were identified.

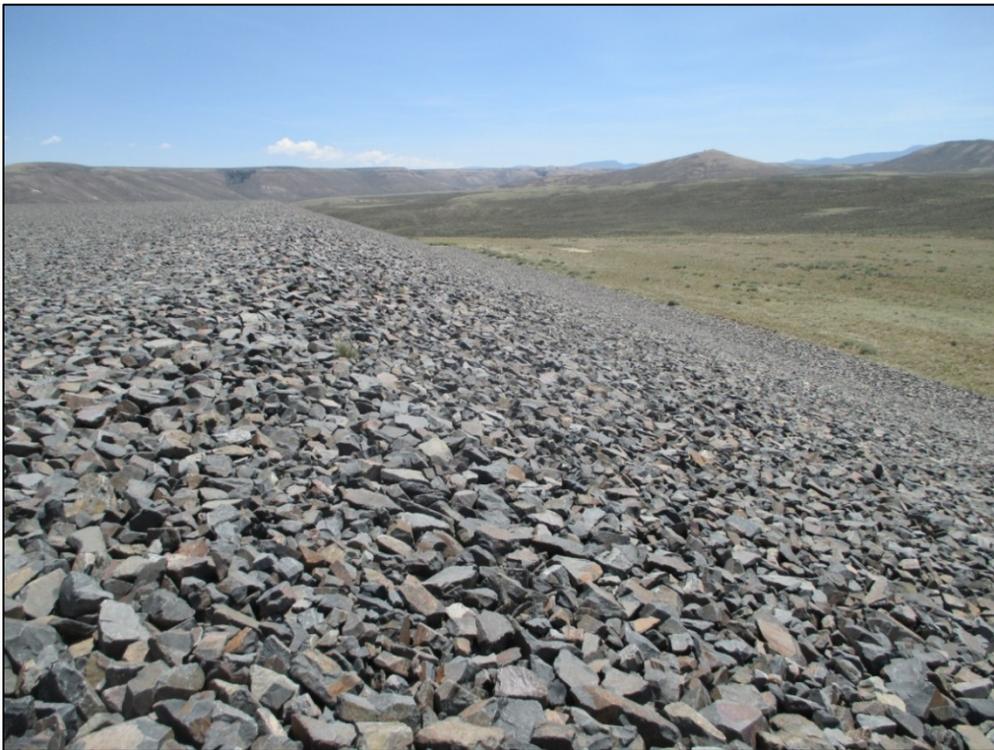
PL-8. Southwest Side Slope of Disposal Cell

The disposal cell side slopes (PL-8), an apron to collect and divert precipitation runoff from the disposal cell (PL-9), and two diversion channels to protect the disposal cell from precipitation run-on (PL-10) are all armored with basalt riprap. There was no evidence of settling, slumping, erosion, or any other modifying process that might affect the integrity of the disposal cell side slopes, apron, or diversion channels. Six rock-monitoring test areas were last inspected during the 2017 annual inspection; monitoring is no longer required in accordance with the LTSP because no rock degradation had been observed.

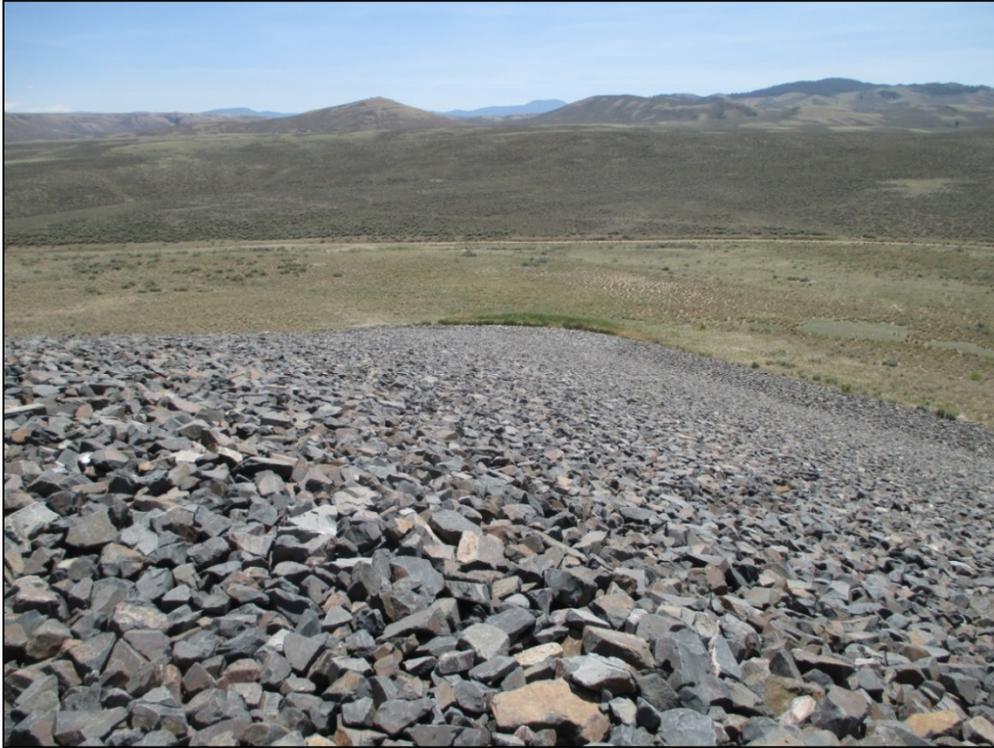
PL-11. Southeast Corner of Disposal Cell

Precipitation runoff from the disposal cell occasionally ponds in a low-lying area at the southeast corner of the disposal cell; standing water was not present at the time of the inspection (PL-11). The riparian-type vegetation that has become established there indicates that the area retains moisture. Water collection in this area does not pose a problem because the disposal cell surfaces are designed to drain to the southeast, and any water that ponds there is below the elevation of tailings placed under the engineered cover. No maintenance needs were identified.
