8.0 Annual Inspection of the Gunnison, Colorado, UMTRCA Title I Disposal Site

The Gunnison, Colorado, Uranium Mill Tailings Radiation Control Act (UMTRCA) Title I Disposal Site was inspected on June 4, 2012. The disposal cell and all associated surface water diversion and drainage structures were in excellent condition and functioning as designed. Six riprap test areas on the cell apron and diversion ditches were visually inspected and photographed; no apparent rock degradation was noted when compared to previous photos. Two damaged perimeter signs were replaced. No other maintenance needs or cause for a follow-up or contingency inspection was identified.

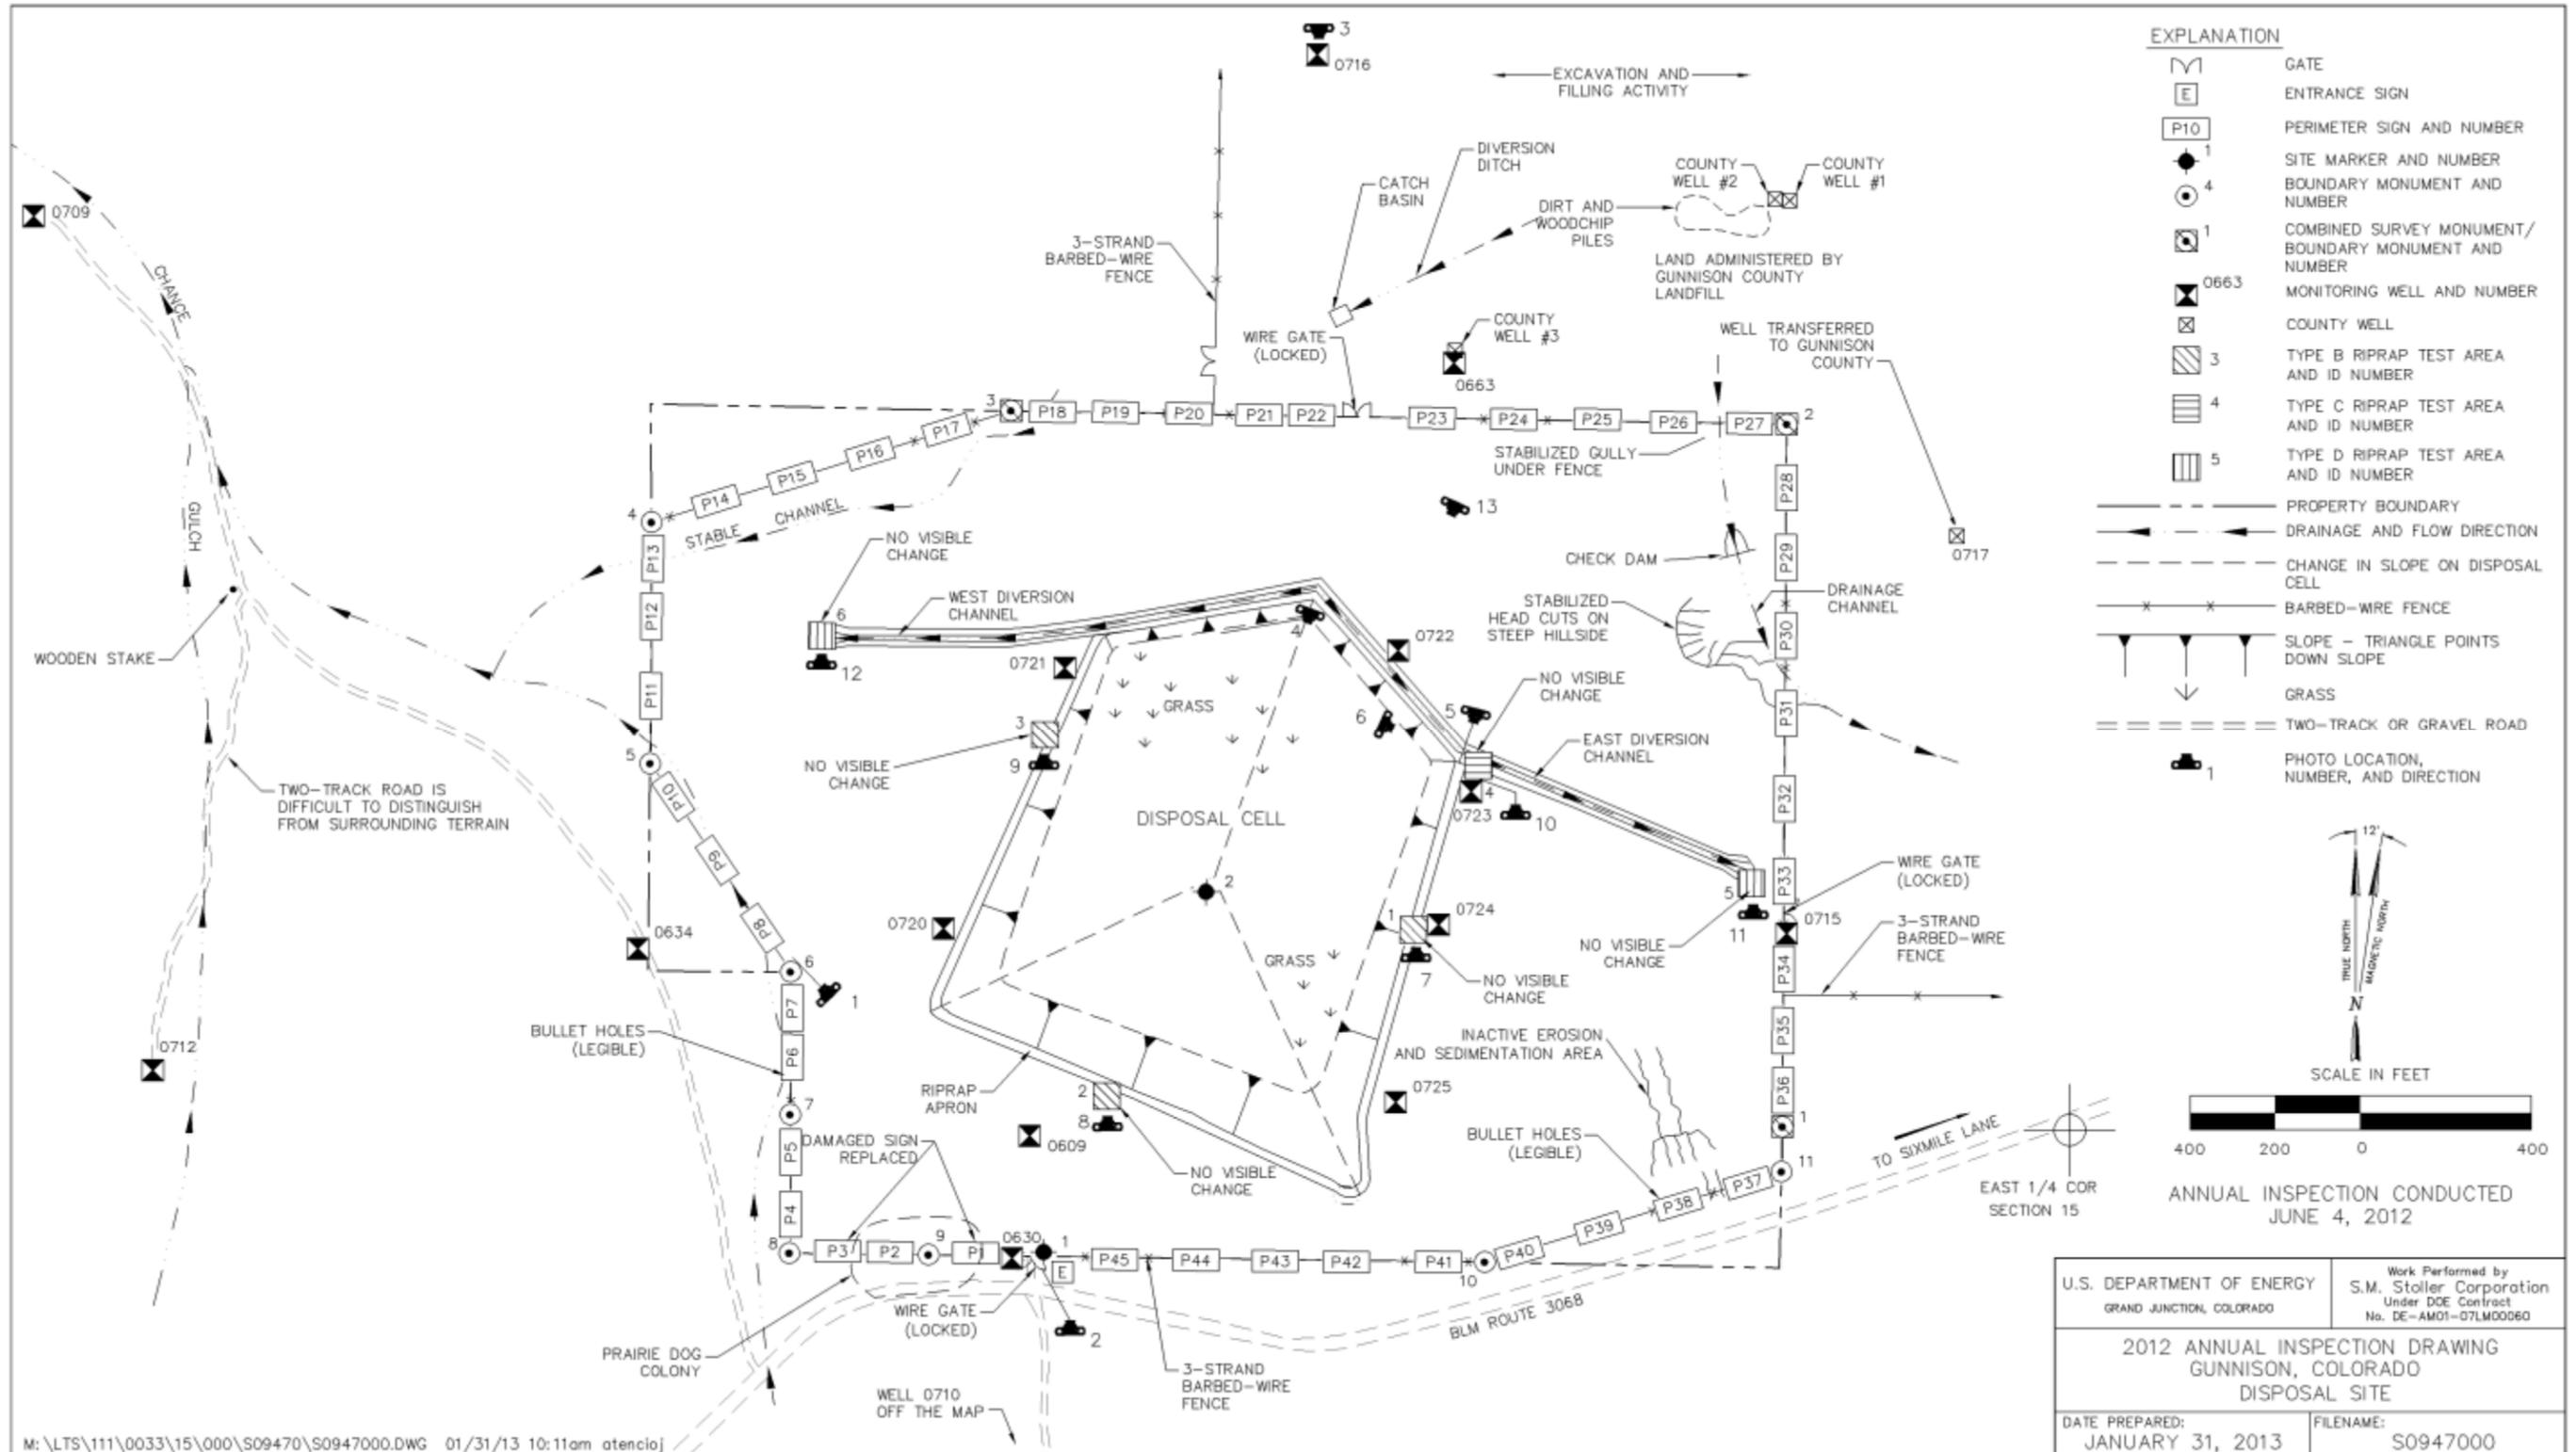
Figure 8-1. 2012 Annual Compliance Drawing for the Gunnison Disposal Site

The locations of site surveillance features are shown on Figure 8–1. Inspection results and recommended maintenance activities associated with site surveillance features are included in the following subsections. Photographs to support specific observations are identified in the text and on Figure 8–1 by photograph location (PL) numbers.

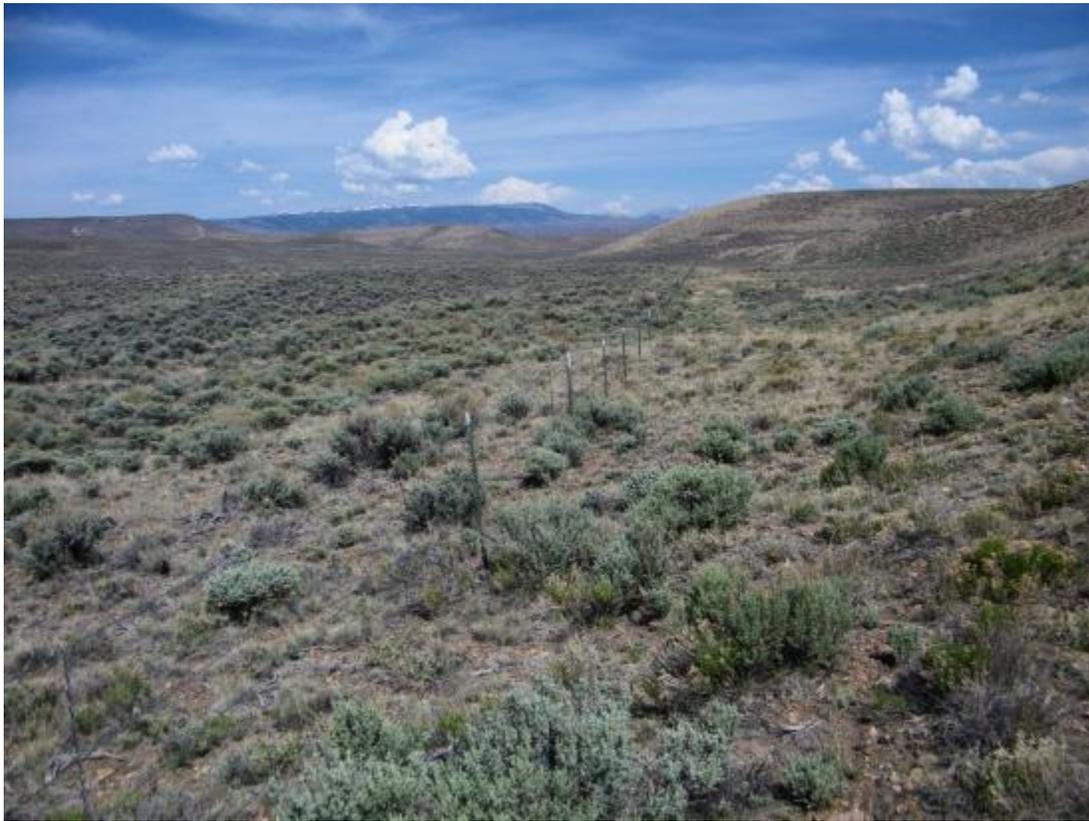
A three-strand, barbed-wire fence delineates the site; most of it is set along the property boundary. The fence was in good condition (PL–1). Two locked barbed-wire gates—one on the north fence line and the other on the east fence line—provide monitoring-well access. The gates were locked and in good condition.

GUD 6/2012. PL-1. Perimeter fence along the west side of the site.

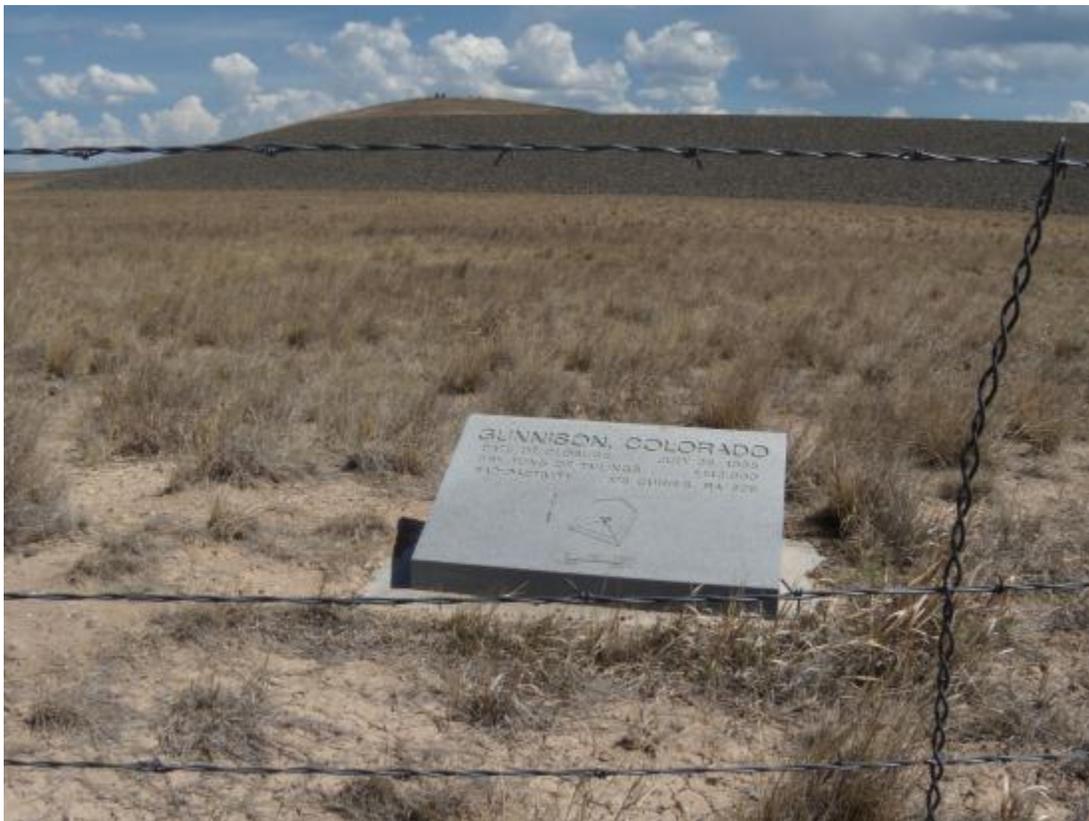
The site has two granite site markers. Site markers SMK–1 (just inside the entrance gate; PL–2) and SMK–2 (on top of the disposal cell) were in excellent condition.

GUD 6/2012. PL-2. Site marker SMK-1 at the site entrance.

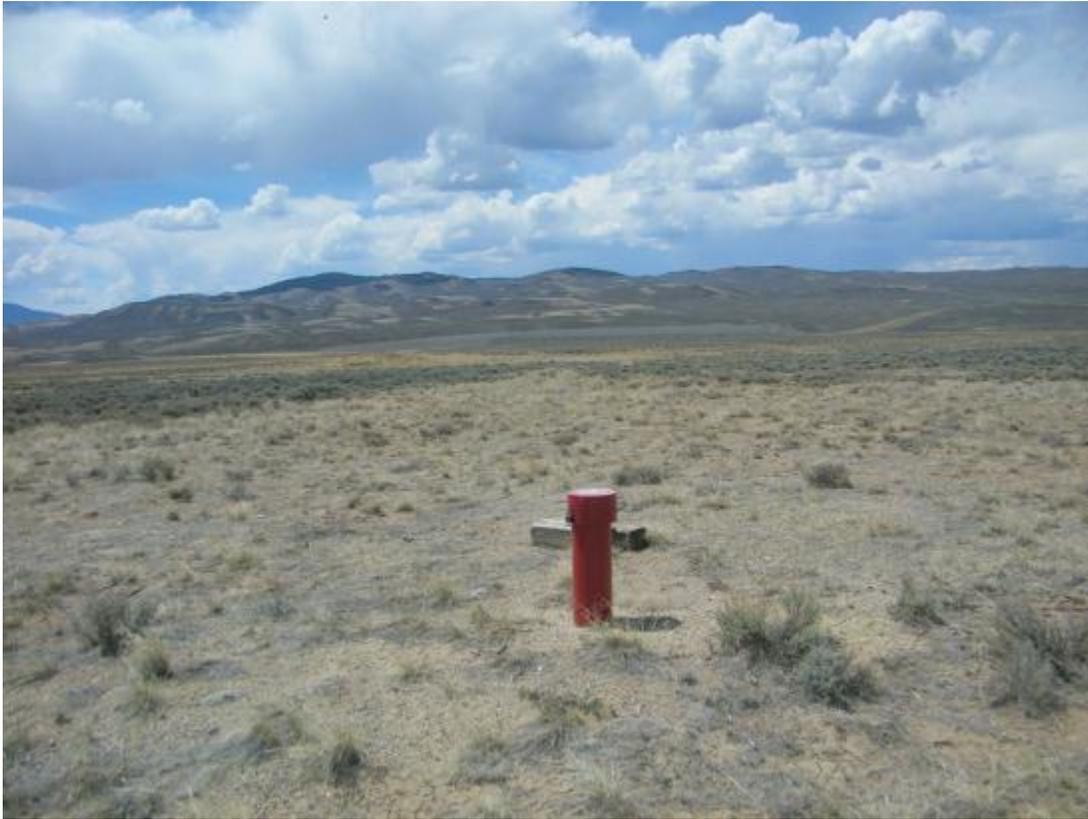
Sixteen wells constitute the groundwater monitoring network for the site. The wells were secure and in excellent condition (PL–3).

GUD 6/2012. PL-3. Monitoring well 0716 north of the disposal site.

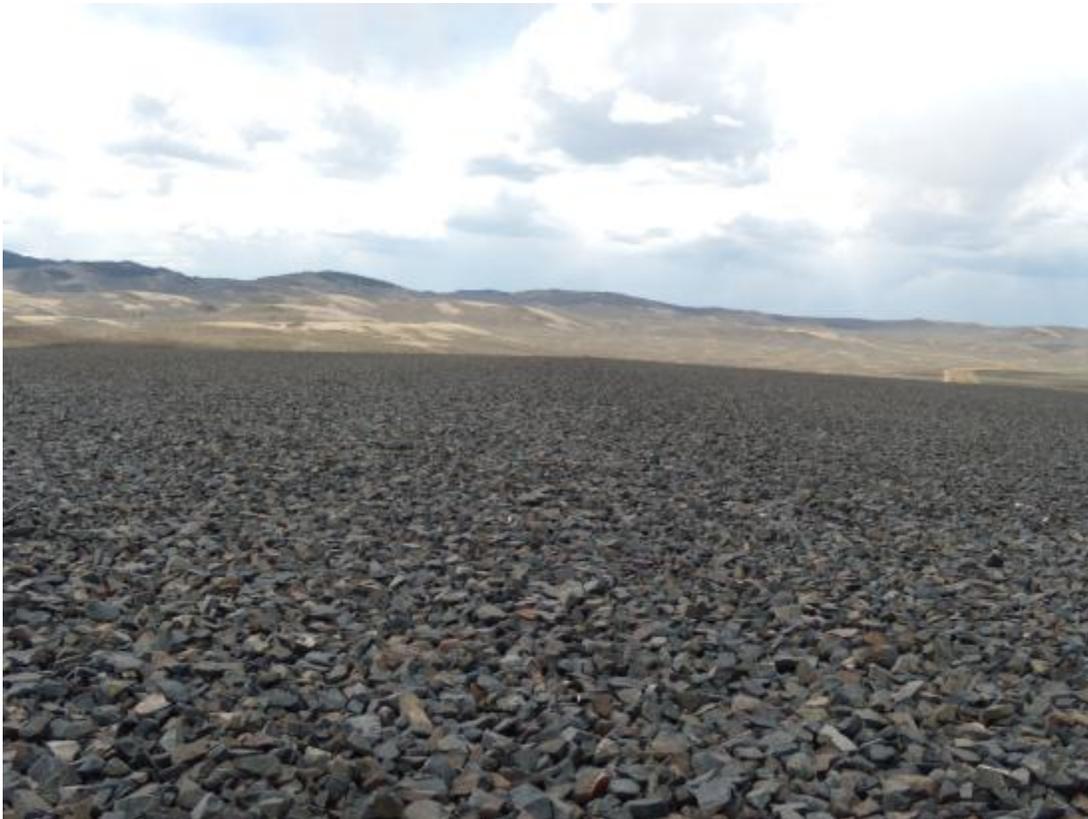
The rock-covered top of the disposal cell was in excellent condition (PL–4). There was no evidence of erosion, settling, slumping, or rock degradation. Several isolated patches of grass are randomly distributed over the disposal cell cover; however, these shallow-rooted plants are not a cause for concern.

GUD 6/2012. PL-4. View southwest across the top of the disposal cell.

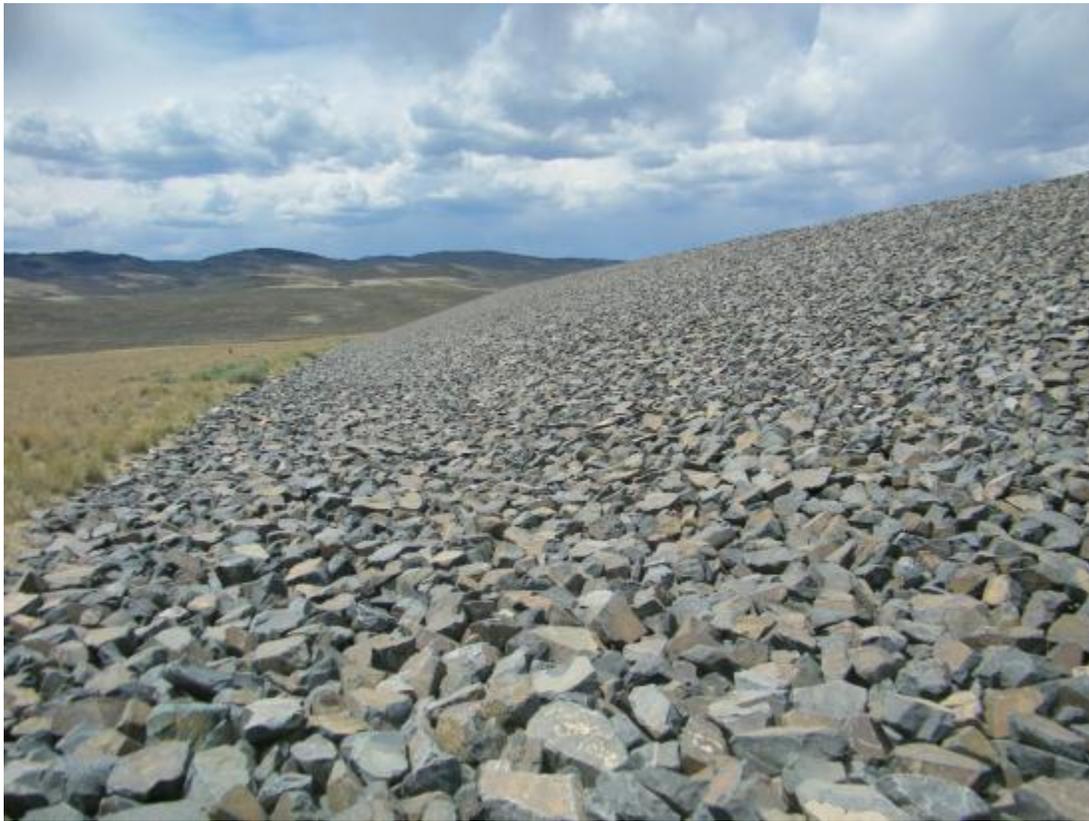
The riprap-covered side slopes, apron, and diversion channels were in good condition (PL–5 and PL–6). No evidence of slumping, settling, rock degradation, or encroachment of vegetation was observed.

GUD 6/2012. PL-5. East side slope and riprap apron of the disposal cell.

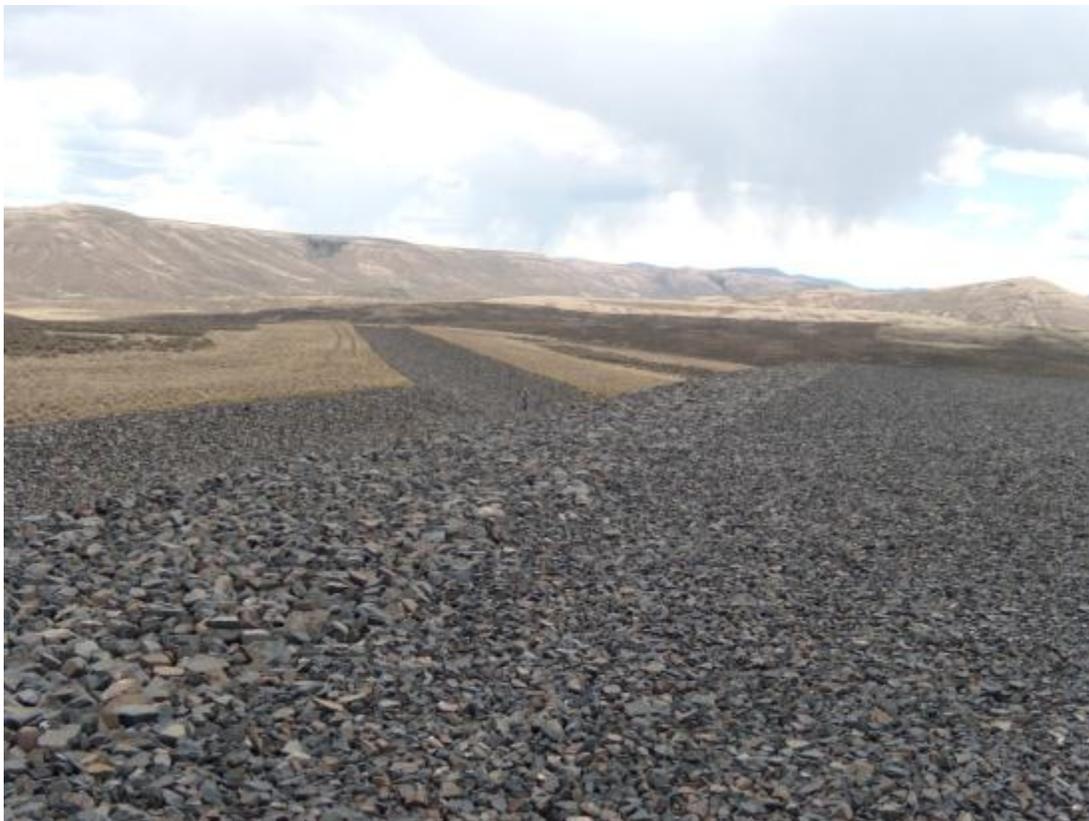
GUD 6/2012. PL-6. Northeast corner of the disposal cell and the east diversion channel.

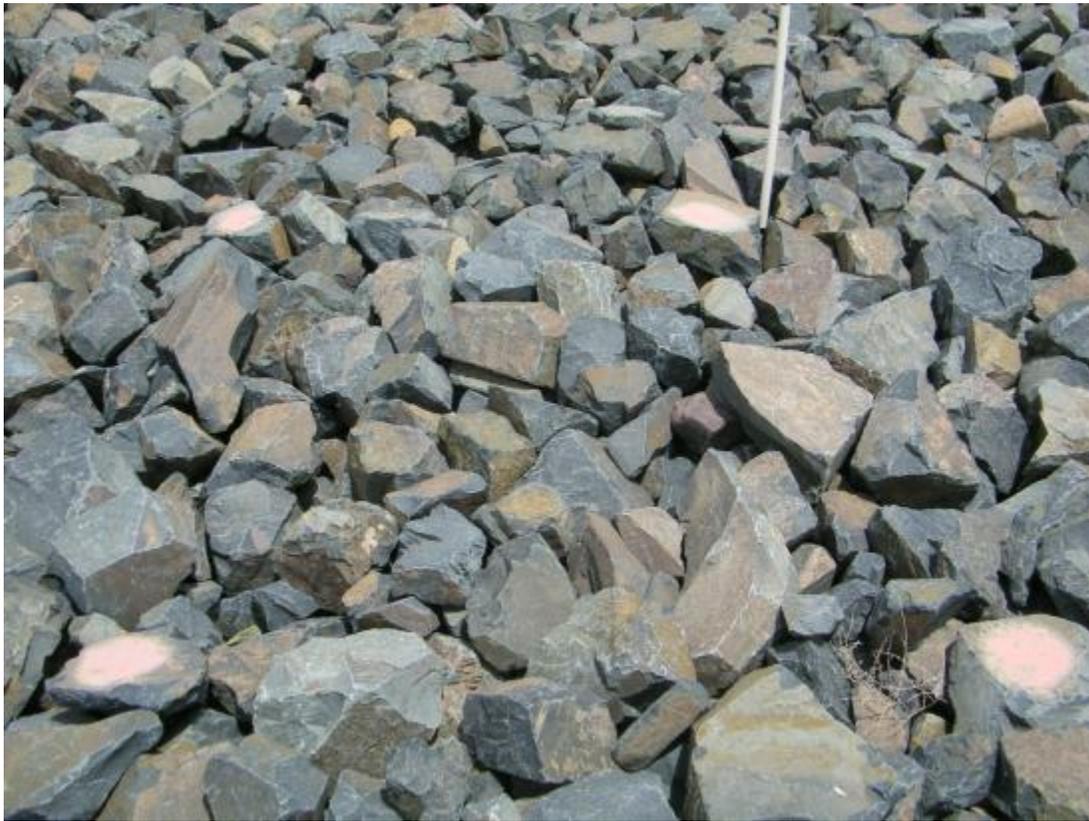
The condition of the riprap in six monitoring test areas was visually inspected and photographed. The test areas, each roughly 1 square meter in area, are in critical flow path locations in the apron and diversion channels. The corners of each monitoring plot are marked with orange paint. The riprap in all of the test areas was in excellent condition. When the rocks were compared to the photos taken of them in 2007, there was no evidence that individual rocks had split or otherwise been degraded (PL–7 through PL–12). As outlined in the LTSP, annual photographing and comparing of these test areas was performed through 2002; after that, the LTSP requires the test areas to be photographed every 5 years (through 2017). The next and final set of photos will be taken in 2017.

GUD 6/2012. PL-7. Riprap Test Area No. 1 (Type B riprap) on the cell's east apron (June 4, 2012).

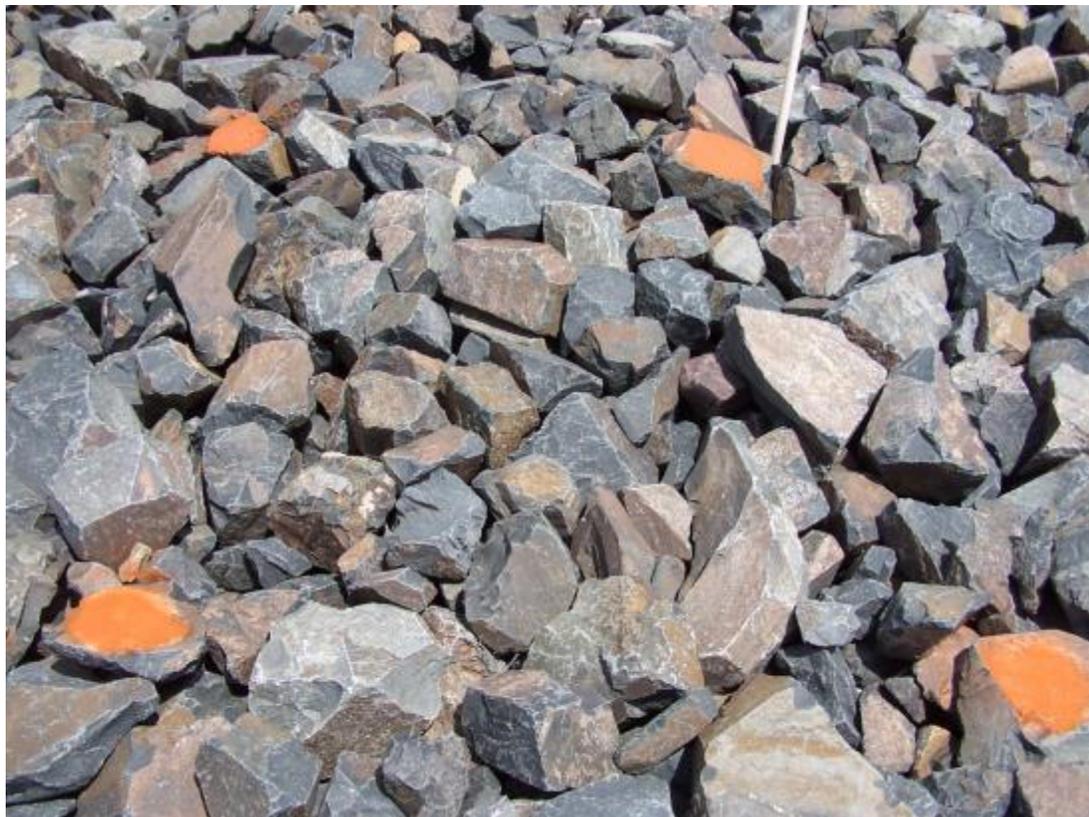
GUN 5/2007. PL-7A. Riprap Test Area No. 1 (Type B riprap) on the cell's east apron (May 21, 2007).

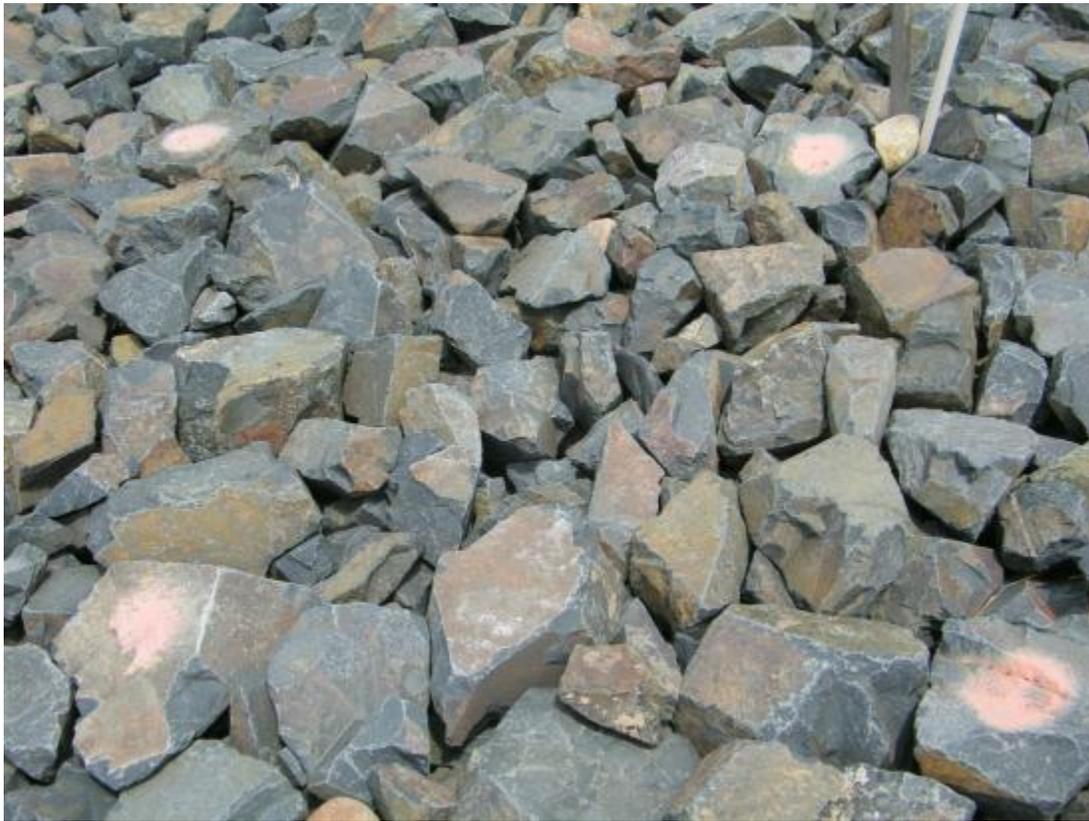
GUD 6/2012. PL-8. Riprap Test Area No. 2 (Type B riprap) on the cell's south apron (June 4, 2012).

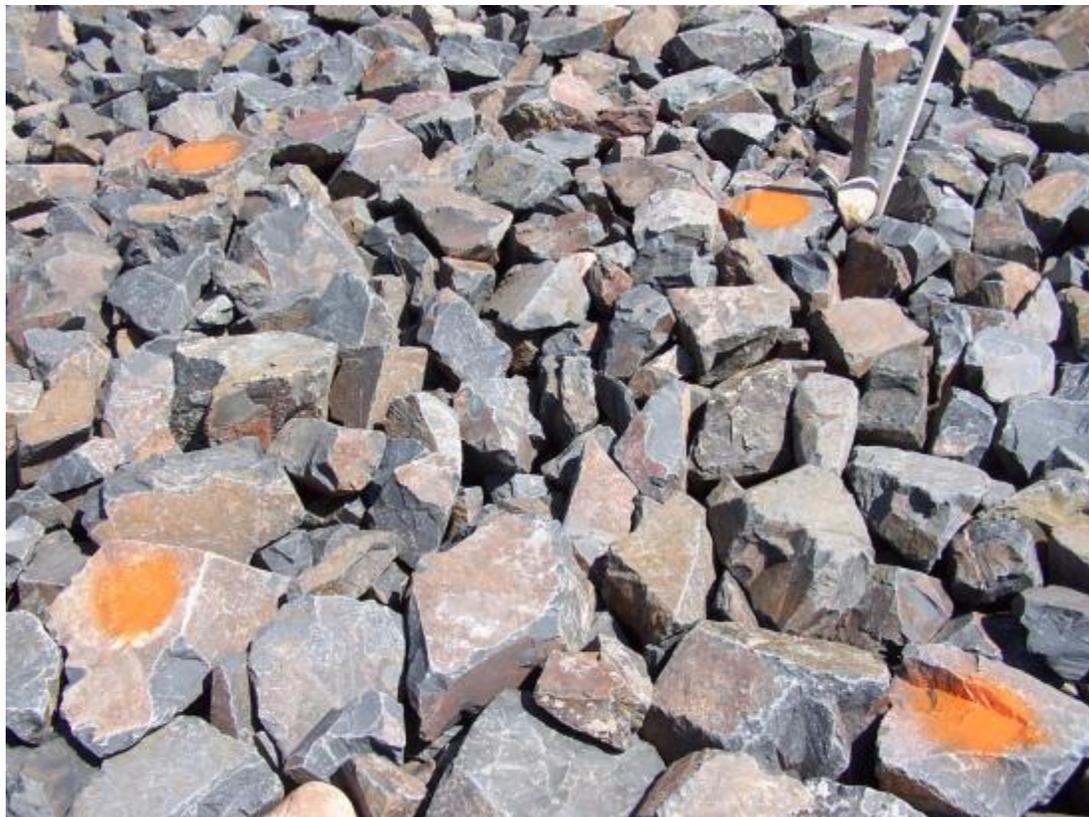
GUN 5/2007. PL-8A. Riprap Test Area No. 2 (Type B riprap) on the cell's south apron (May 21, 2007).

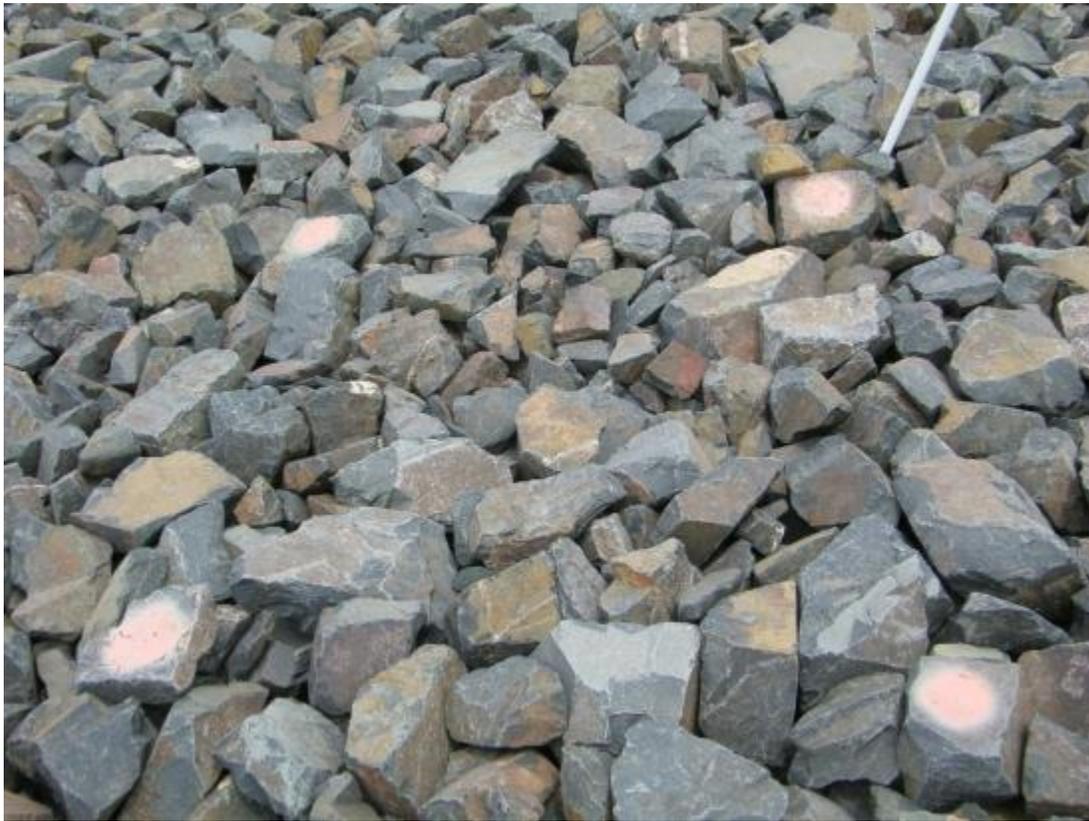
GUD 6/2012. PL-9. Riprap Test Area No. 3 (Type B riprap) on the cell's northwest apron (June 4, 2012).

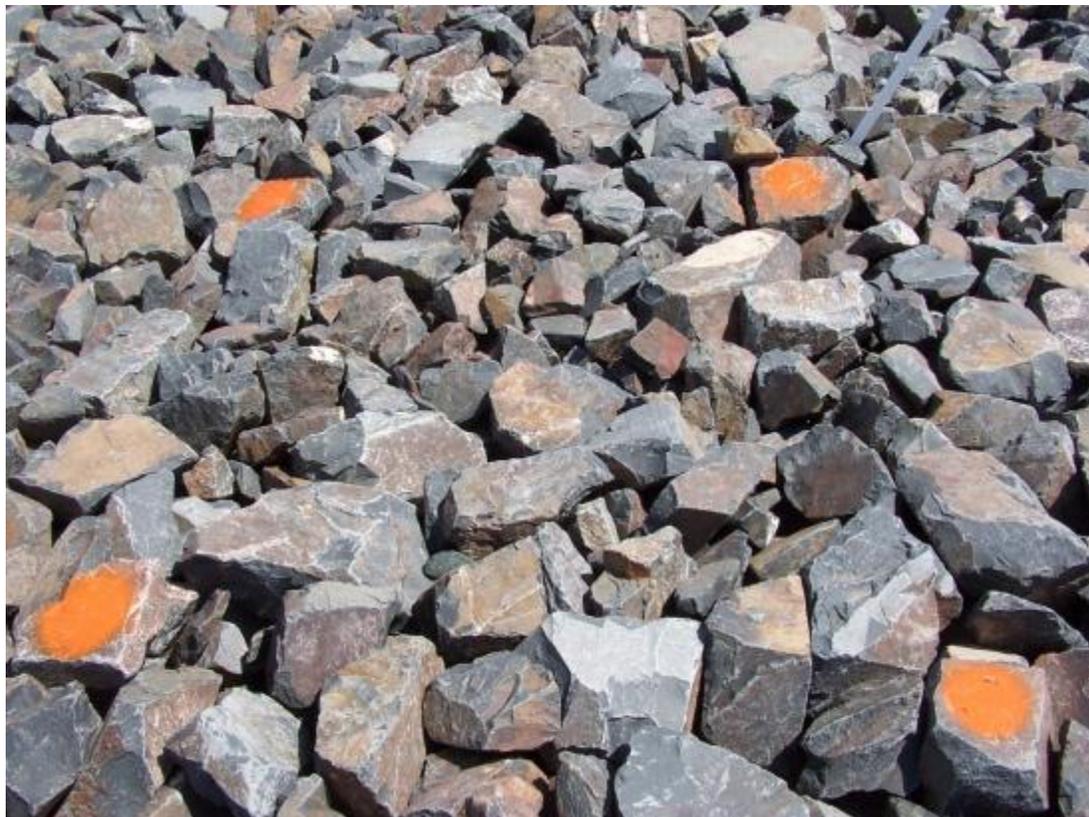
GUN 5/2007. PL-9A. Riprap Test Area No. 3 (Type B riprap) on the cell's northwest apron (May 21, 2007).

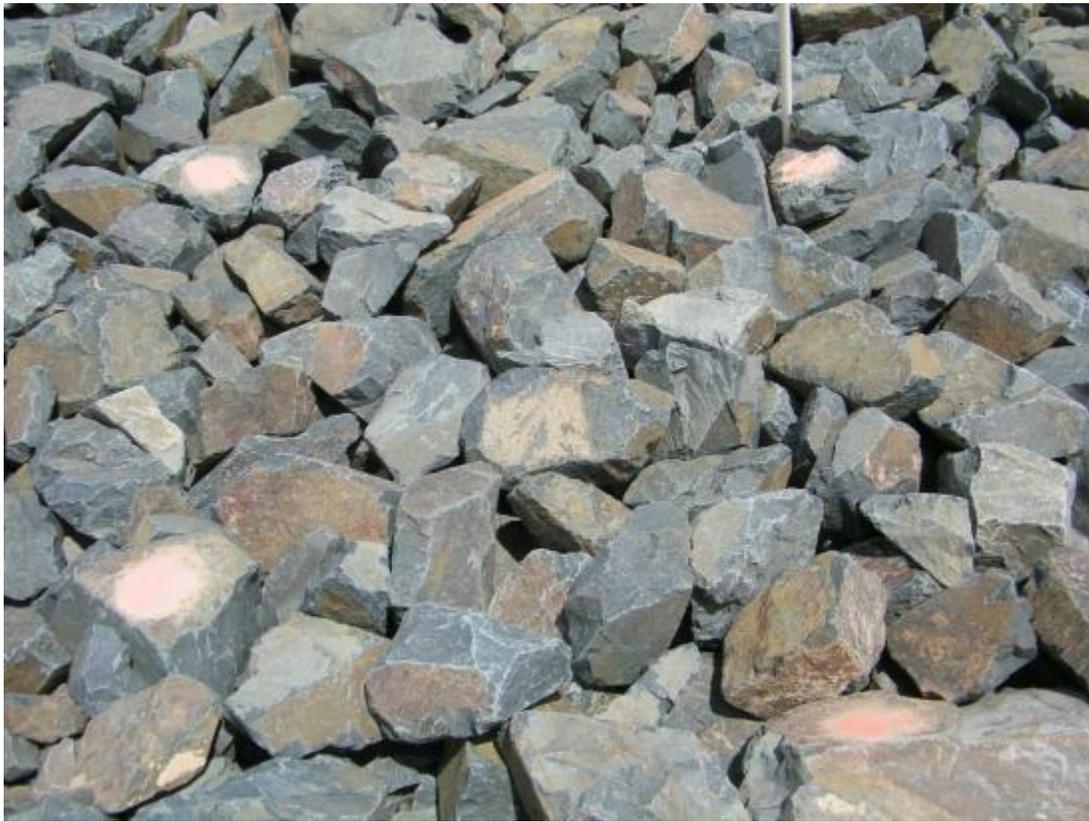
GUD 6/2012. PL-10. Riprap Test Area No. 4 (Type C riprap) in the east diversion channel (June 4, 2012).

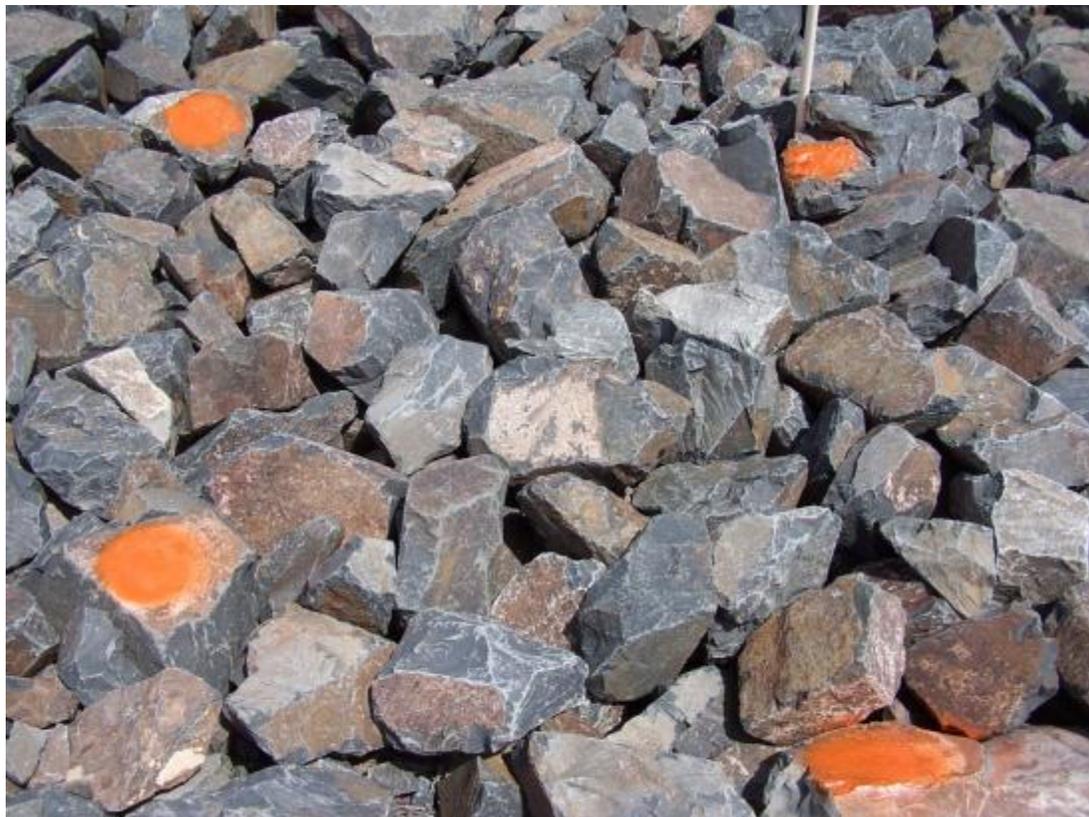
GUN 5/2007. PL-10A. Riprap Test Area No. 4 (Type C riprap) in the east diversion channel (May 21, 2007).

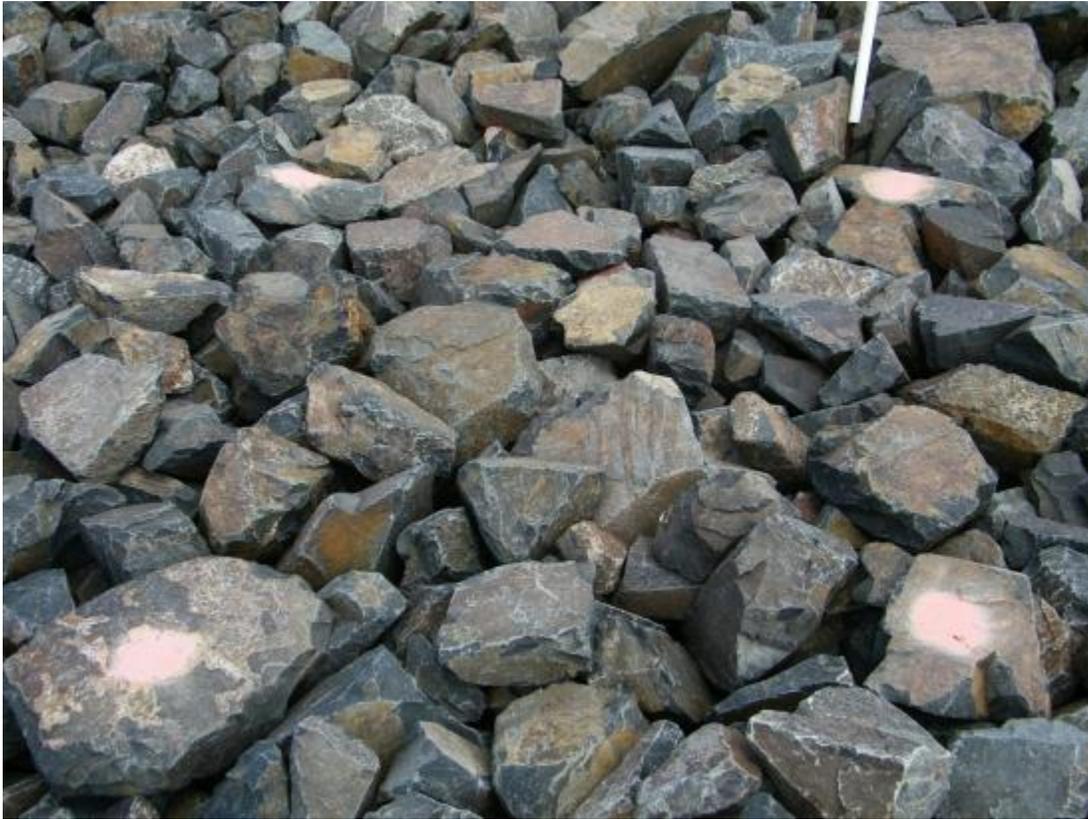
GUD 6/2012. PL-11. Riprap Test Area No. 5 (Type D riprap) at the east diversion channel outlet (June 4, 2012).

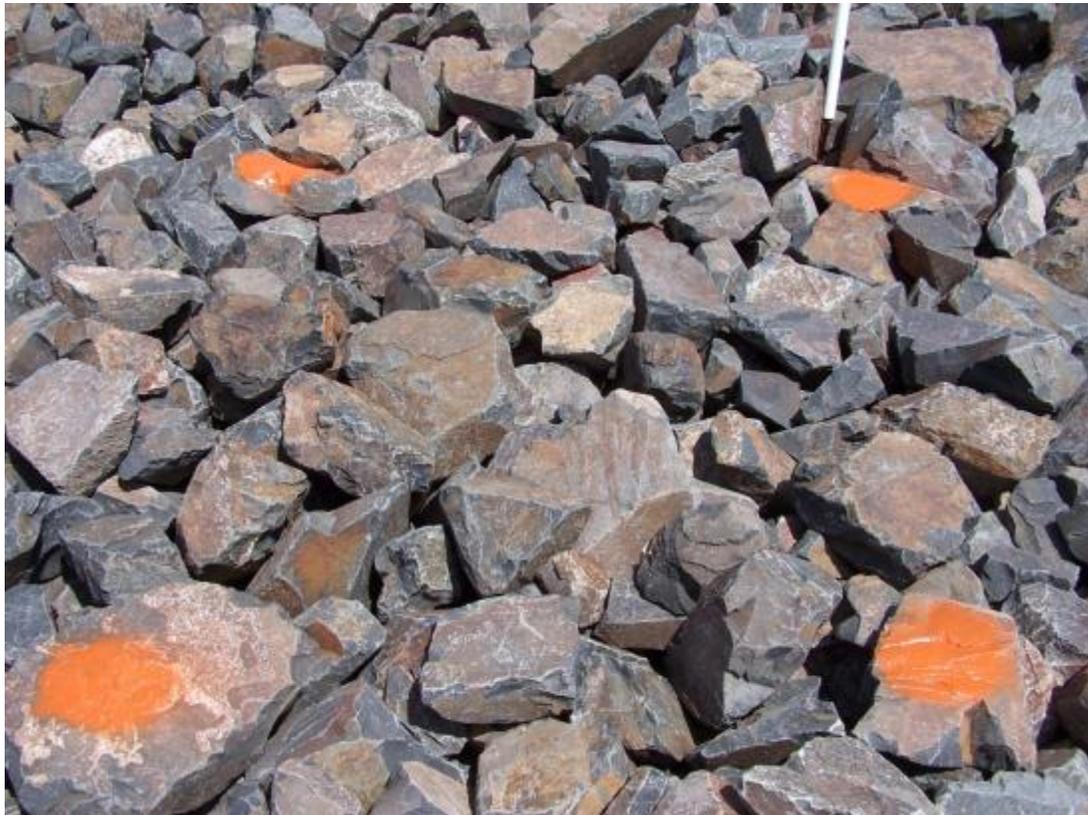
GUN 5/2007. PL-11A. Riprap Test Area No. 5 (Type D riprap) at the east diversion channel outlet (May 21, 2007).

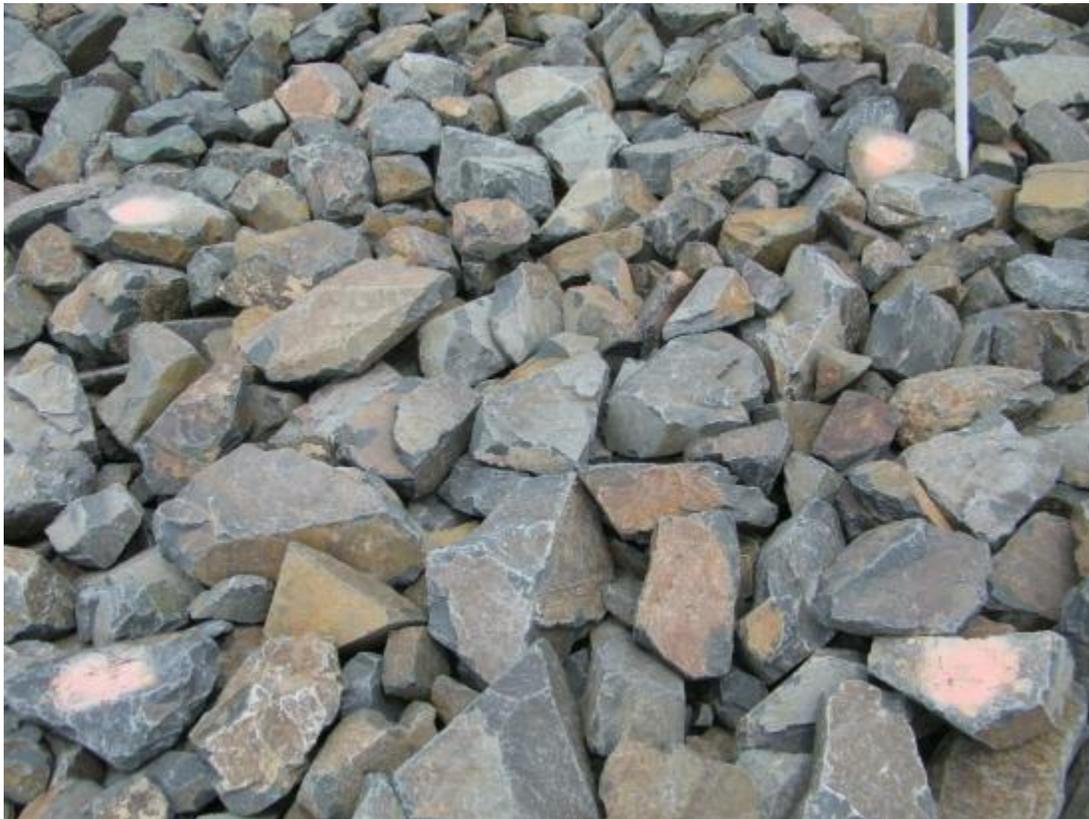
GUD 6/2012. PL-12. Riprap Test Area No. 6 (Type D riprap) at the west diversion channel outlet (June 4, 2012).

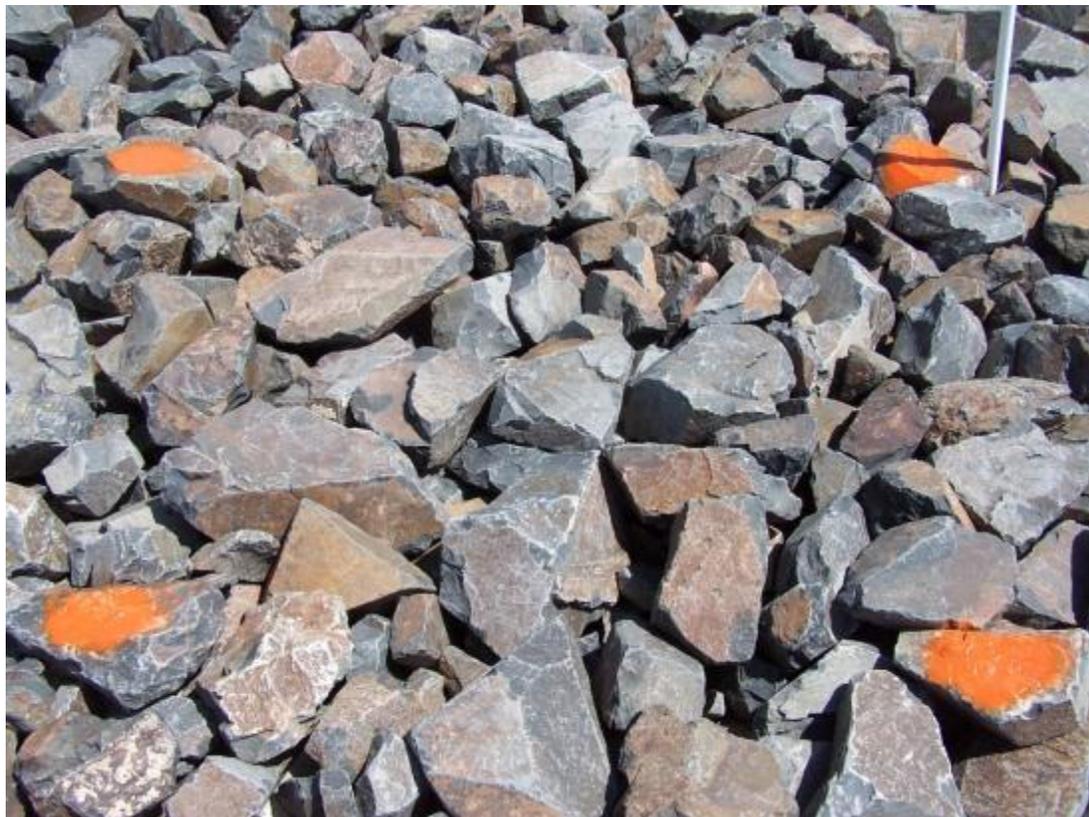
GUN 5/2007. PL-12A. Riprap Test Area No. 6 (Type D riprap) at the west diversion channel outlet (May 21, 2007).

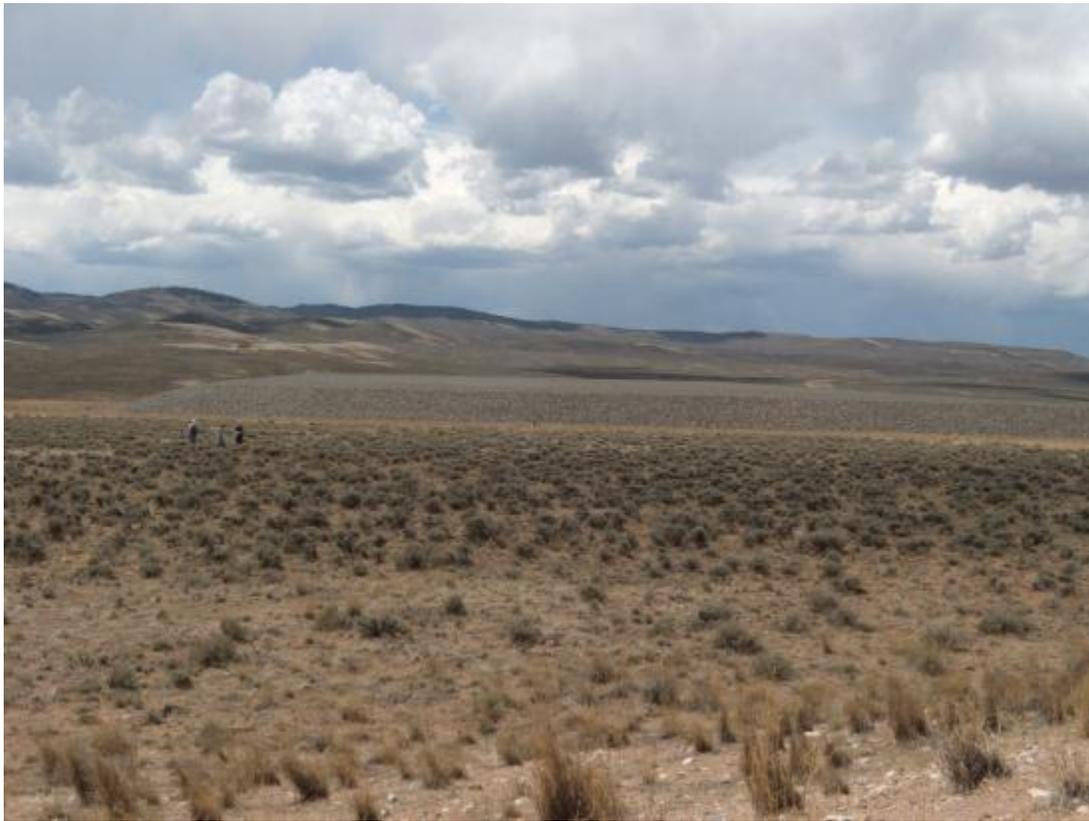
There are reclaimed and undisturbed areas between the disposal cell and the site perimeter. Both types of areas were in good condition (PL–13). No erosion concerns were observed. In general, reclaimed areas have good vegetation coverage, consisting mostly of grass. As expected, shrubs and forbs are much less abundant and less diverse in reclaimed areas than they are in undisturbed areas.

GUD 6/2012. PL-13. Reclaimed and undisturbed areas north of the disposal cell.
