8.0 Gunnison, Colorado, Disposal Site

8.1 Compliance Summary

Figure 8-1. 2006 Annual Compliance Drawing for the Gunnison, Colorado, Disposal Site

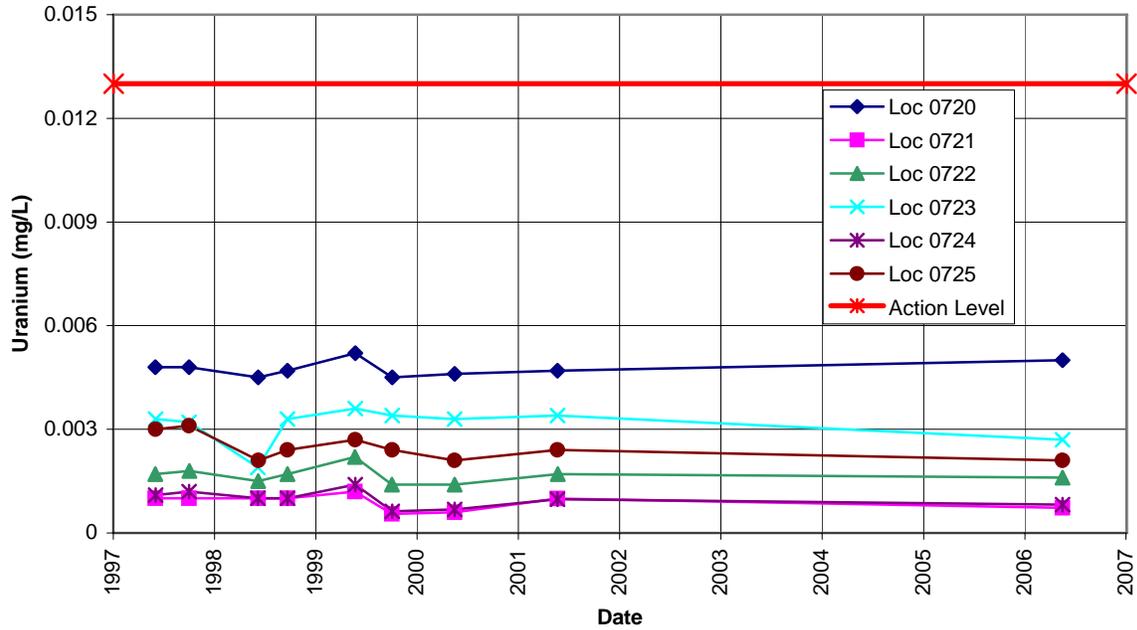
Figure 8–2. Time-Concentration Plots of Uranium in Ground Water at the Gunnison, Colorado, Disposal Site

Ground Water Quality Monitoring—Ground water at the Gunnison disposal site was sampled in May 2006. The concentration of uranium in samples collected at background wells MW-0609 and MW-0716 was 0.0012 mg/L and 0.0017 mg/L, respectively. The concentration of uranium in samples collected from point-of-compliance wells ranged between 0.00073 mg/L and 0.005 mg/L, which is consistent with historical results as shown in the time versus concentration graphs (Figure 8–2). Uranium results from the point of compliance wells were one to two orders of magnitude below the action level of 0.013 mg/L.

indicating no significant change in general water chemistry. The consistent general water-quality, along with the low uranium concentrations, indicate the disposal cell continues to perform as an efficient containment system.

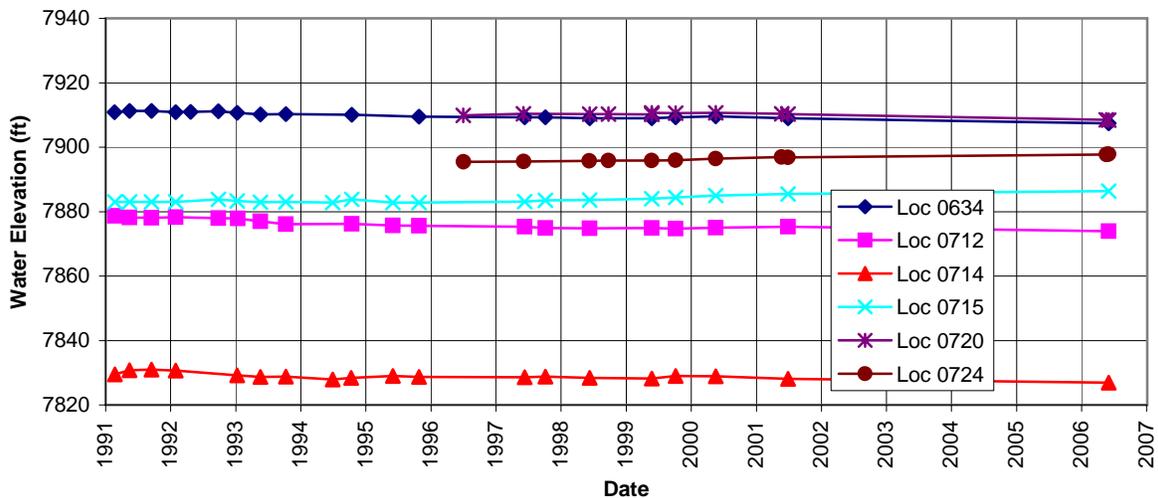
Figure 8-3. Water Level Measurements at Active Monitor Wells at the Gunnison, Colorado, Disposal Site

Ground Water Level Monitoring—Water levels from the entire monitoring network were measured in June 2006. Data from water-level measurements show only minor fluctuations in ground water elevations since completion of the disposal cell in 1995; hydrographs from selected wells across the site illustrate this consistency in water levels (Figure 8–3). Water level measurements indicate essentially steady-state ground water conditions at the site.

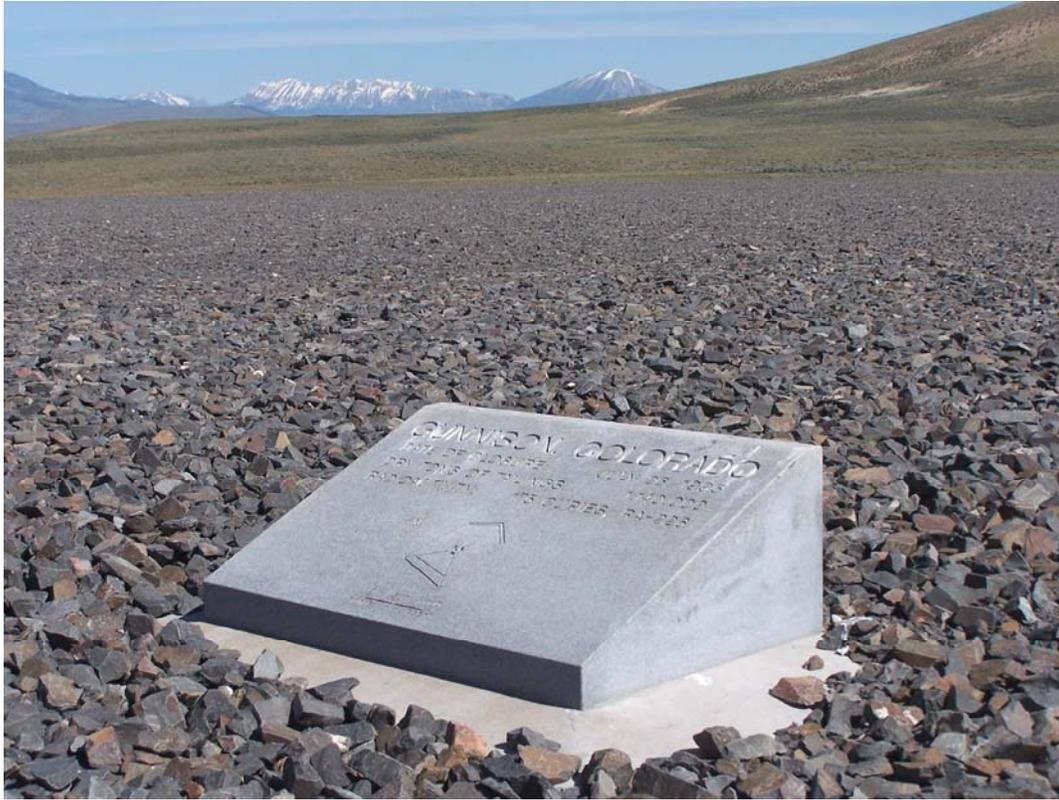
Site Markers, Survey Monuments, and Boundary Monuments—The two site markers, three combination survey/boundary monuments, and eight boundary monuments were in excellent condition (PL-1).

GUN 5/2006. PL-1. Site marker SMK-2.

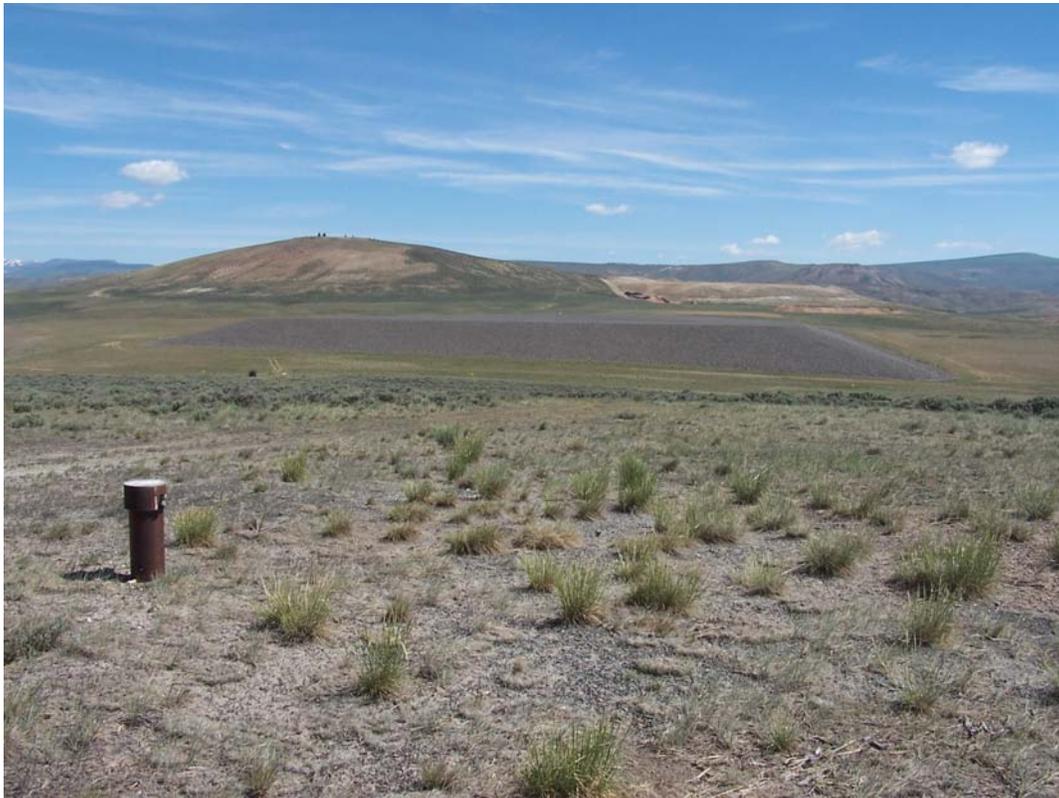
Monitor Wells— Sixteen wells comprise the ground water monitoring network at the disposal site. Six of the wells are for monitoring cell performance, two for monitoring background ground water quality, and eight for water level measurements. The wells were secure and in excellent condition (PL-2).

GUN 5/2006. PL-2. Disposal cell viewed from monitor well MW-0710.

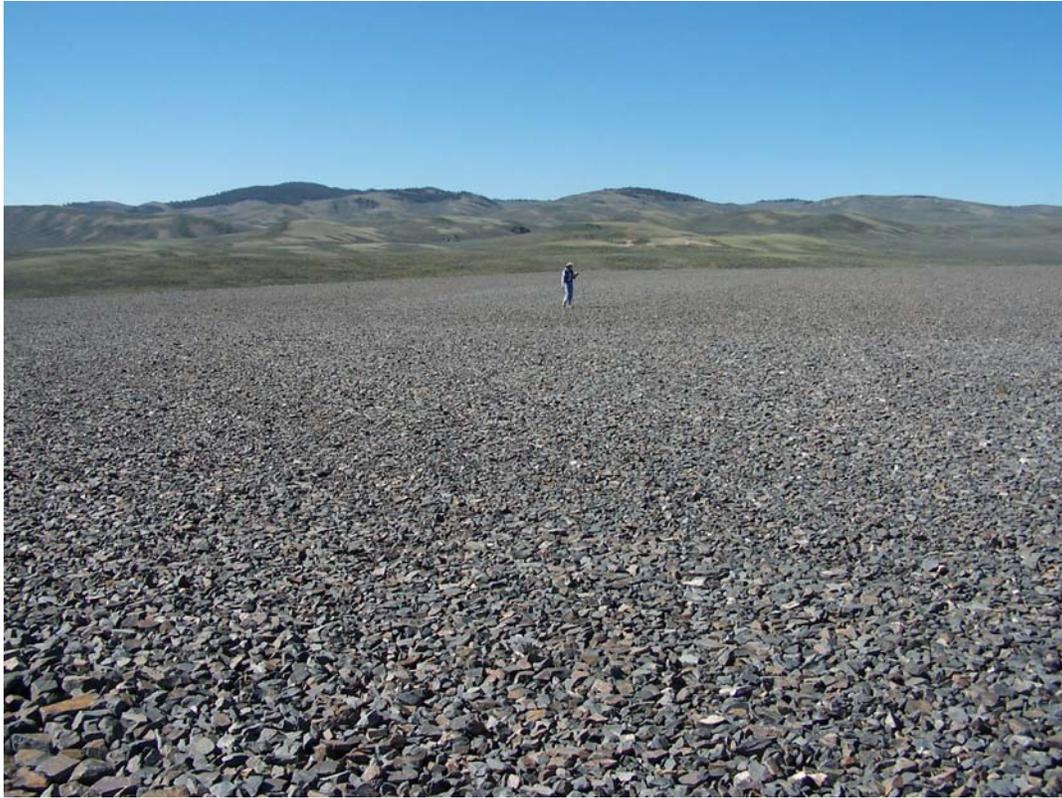
Top of Disposal Cell—The top of the disposal cell was in excellent condition (PL-3). There was no evidence of erosion, settling, slumping, or rock degradation. Several isolated patches of grass were observed on the disposal cell cover; however, these shallow-rooted plants do not impact the performance of the cover. Many small indentations were present on the cell cover. The indentations, with dimensions up to 4 inches across and up to 4 inches deep, appear to have been caused by pronghorn antelope. None of the indentations penetrate into the bedding layer under the rock cover and are not a cause for concern.

GUN 5/2006. PL-3. View south across of the disposal cell top.

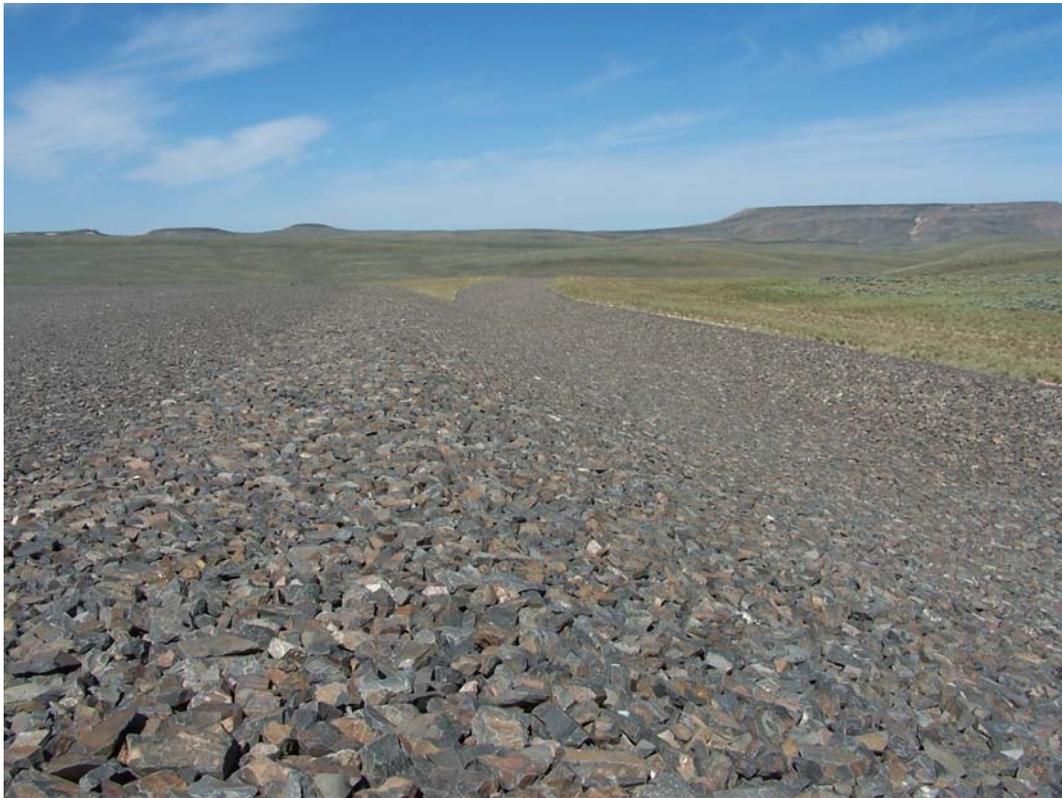
Side Slopes, Apron, and Diversion Ditches—The riprap-covered side slopes, apron, and diversion ditches were in excellent condition (PL-4). No evidence of slumping, settling, or significant encroachment of vegetation was observed.

GUN 5/2006. PL-4. View west of the north side slope, apron, and diversion ditch.
