8.0 Gunnison, Colorado, Disposal Site

8.1 Compliance Summary

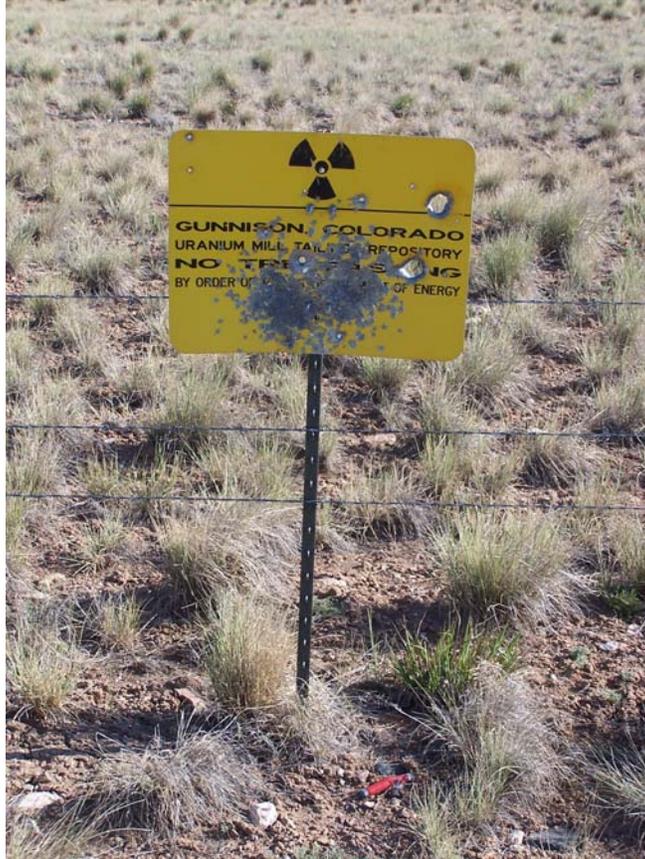
8A An entrance sign and 45 perimeter signs are attached to the posts of the perimeter fence. The entrance sign, found missing at the time of the inspection, was replaced. Perimeter signs P3, P4, P36, P40, P43, and P45 were also missing and replaced. Several other perimeter signs have gunshot damage but all were legible except P44 which was replaced (P-1). Perimeter sign P37 is bent and has cracked paint, but was still legible. The other perimeter signs were in excellent condition.

GUN 6/2005. PL-1. Perimeter sign P44 showing gunshot damage.

In 2005, DOE replaced the entrance sign and several perimeter signs, a broken strand on a section of the perimeter fence was repaired, and identification numbers were repainted on two monitor wells.

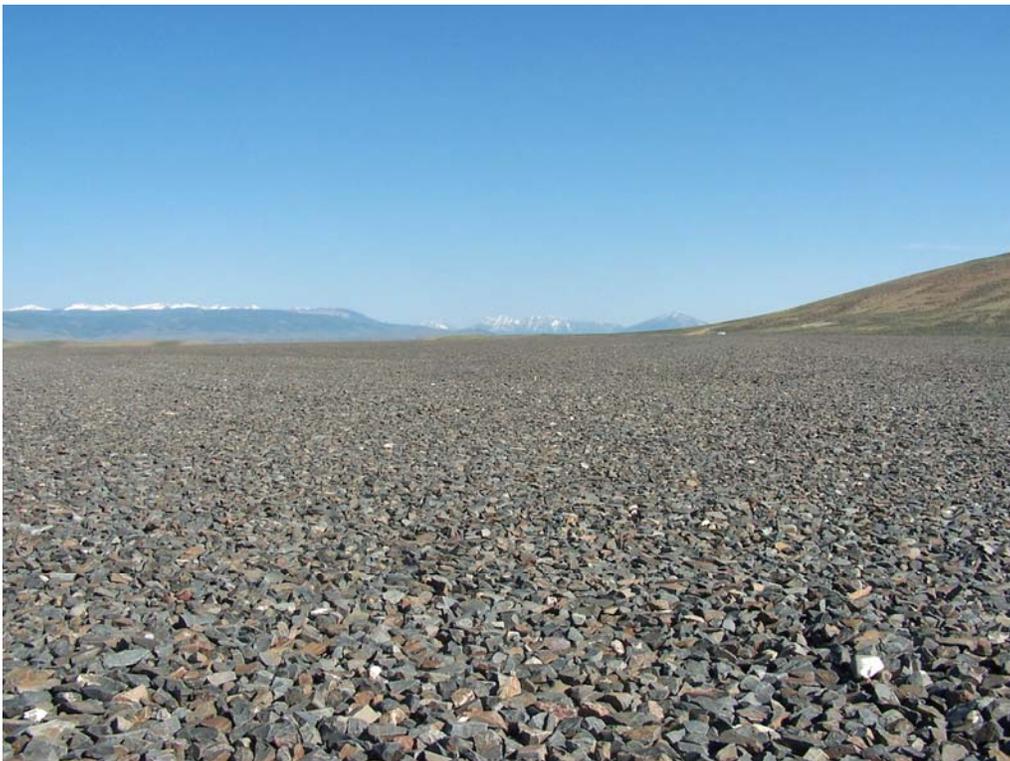
Top of Disposal Cell—The top of the disposal cell was in excellent condition (PL-2). There was no evidence of erosion, settling, or slumping. Several isolated patches of grass were observed on the disposal cell cover; however, these plants do not impact the performance of the cover.

GUN 6/2005. PL-2. Top slope of the disposal cell.

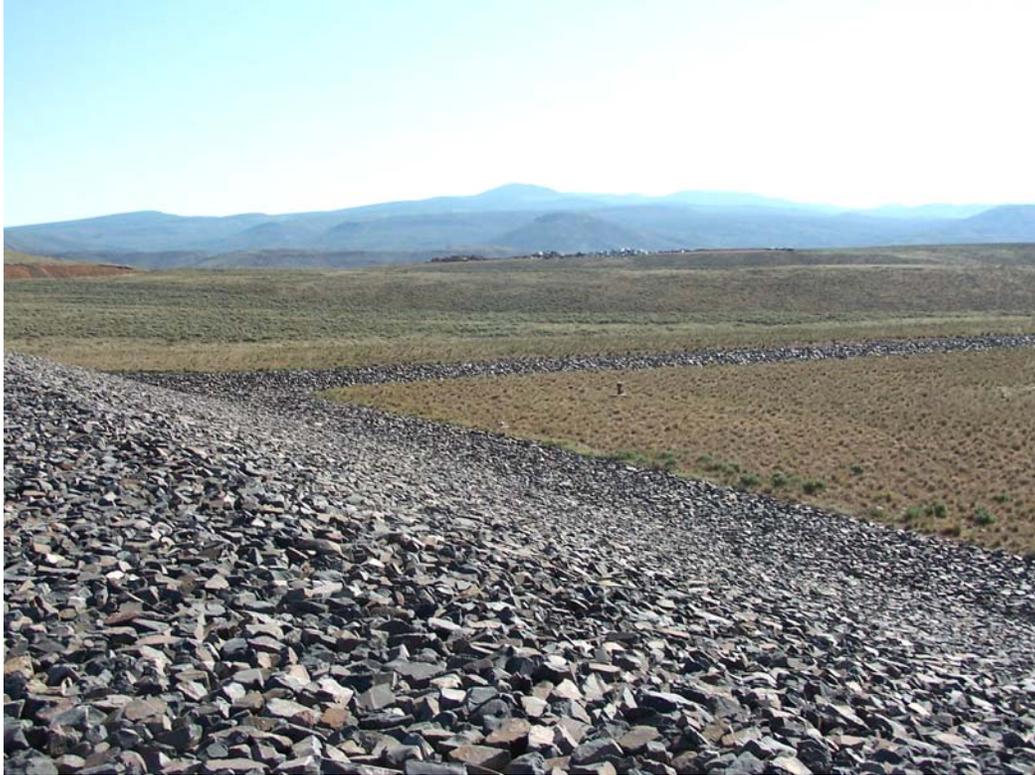
Side Slopes, Apron, and Diversion Ditches—The riprap-covered side slopes, apron, and diversion ditches were in excellent condition (PL-3). No evidence of slumping, settling, or significant encroachment of vegetation was observed.

Landfill operations have encroached to within approximately 400 feet of the northeast corner of the DOE property boundary (PL–3). A check dam was constructed on landfill property west of the disposal site, apparently to control sediment transport. Although landfill activities do not appear to pose a threat to the disposal site, DOE will continue to monitor the level of activity occurring near the site property boundaries and its outlying monitor wells.

GUN 6/2005. PL-3. East side slope and diversion channel, county landfill in background.

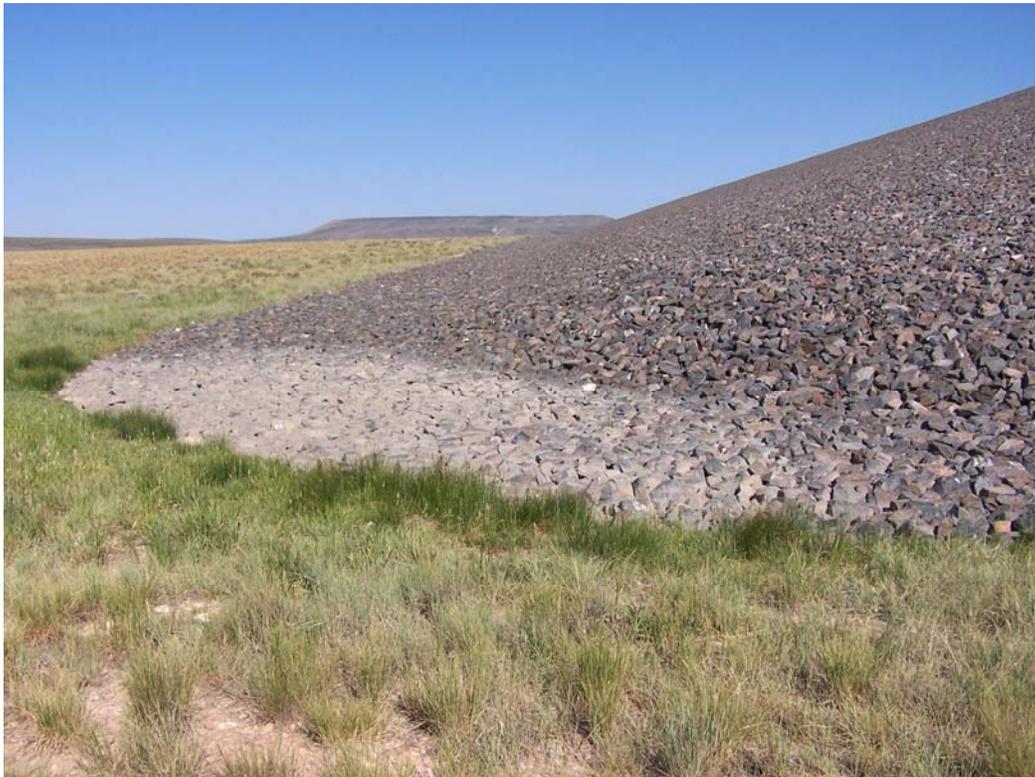
At the southeast corner of the cell apron, water draining from the cell occasionally ponds in a low-lying area along the edge of the riprap. The riparian-type vegetation that has established indicates this area retains moisture much of the time. Water collection in this area does not pose a problem because the cell is designed to drain to the southeast, and any water that ponds is below the elevation of the tailings. This area was dry at the time of the inspection (PL-4).

GUN 6/2005. PL-4. Southeast toe of the cell showing high water mark from ponded water.
