2018 Annual Inspection and Status Report for the Hallam, Nebraska, Decommissioned Reactor Site

July 2018

U.S. DEPARTMENT OF
ENERGY

Legacy
Management

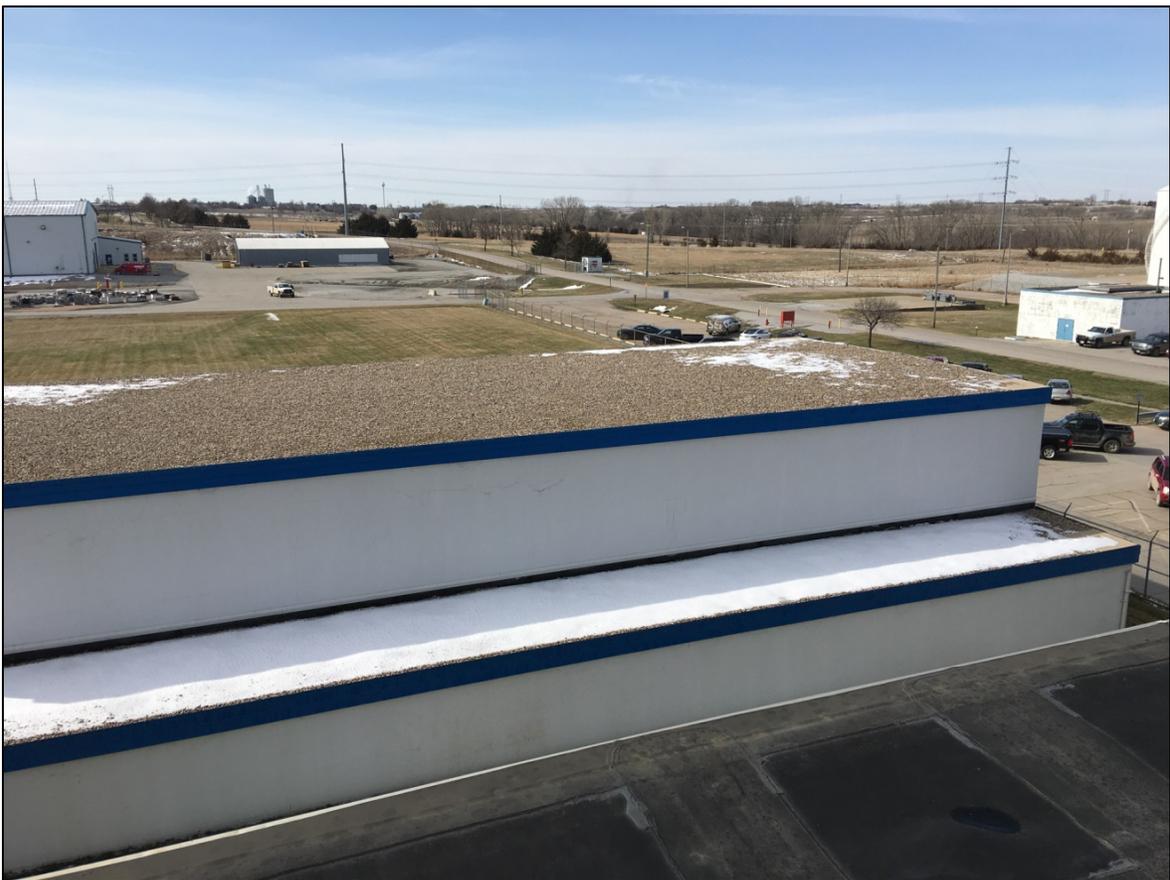
The roof of the IHX Building was replaced in 2007. The entire roof is capped with a layer of rock material that protects the underlying roofing fabric. Inspectors noted in 2008 that roof rock was missing in the northwest and southwest corners of the crowned roof, exposing the underlying fabric. Strong winds are believed to be the cause of the missing stones. Paver stones were placed in all corners of the roof in 2009 to correct the problem. The roof was in good condition during the 2018 inspection. No bare spots were observed (PL-2).

PL-2. IHX roof

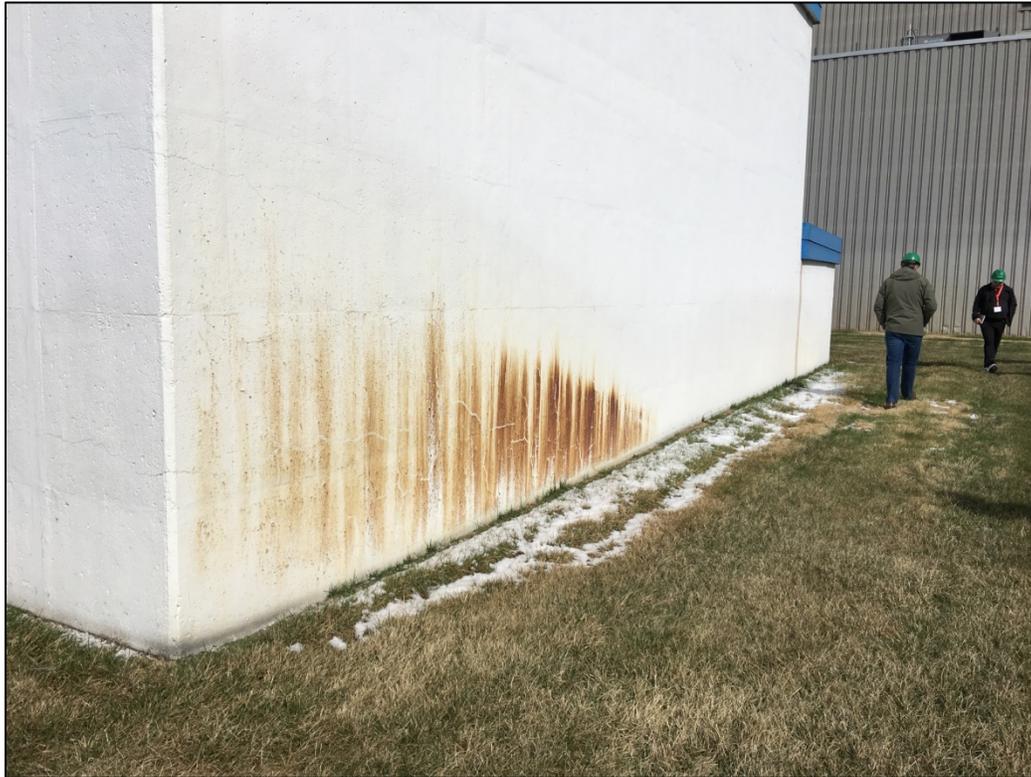
Water stains (noted in previous inspections) remain visible on the outer walls of the IHX Building (PL-3 and PL-4). No corrective action is recommended at this time to address the stains. Inspections of these areas will continue each year to determine whether staining is impacting the protectiveness of the building.

PL-3. IHX Building—east side

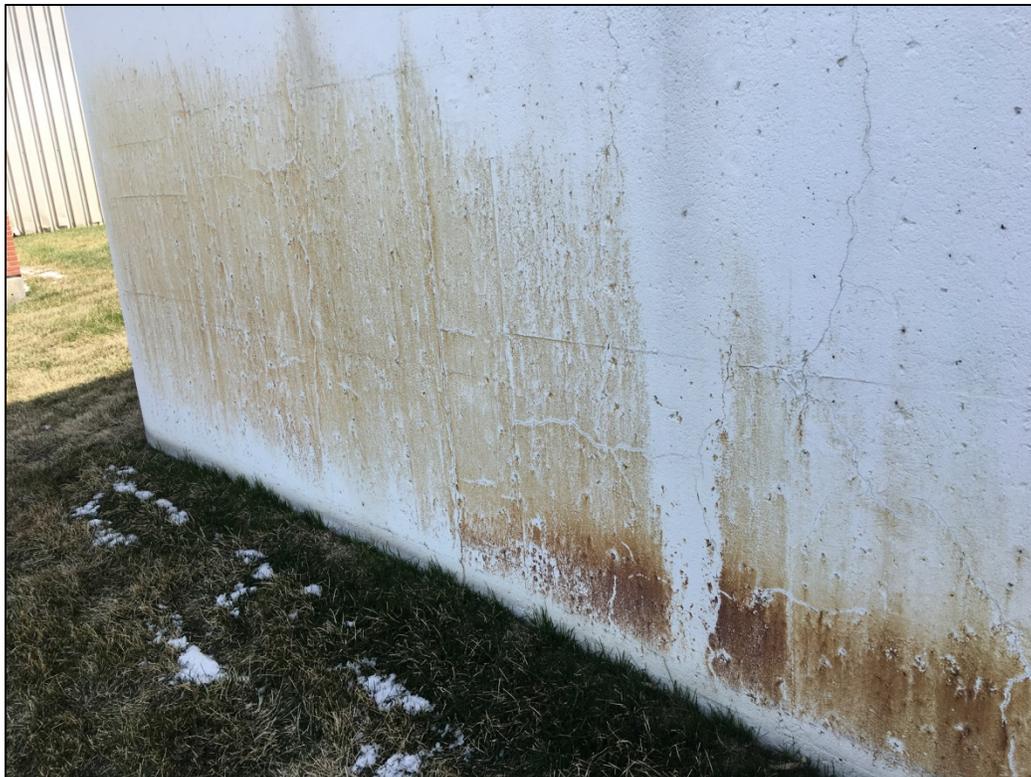
PL-4. IHX Building—west side

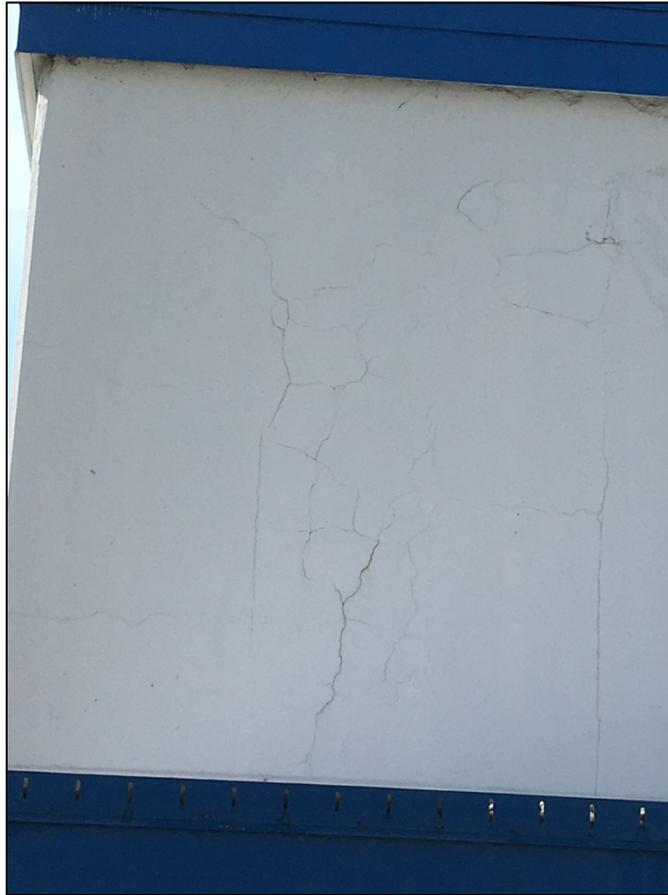
Several surface cracks were observed this year on the walls of the IHX Building that do not appear to compromise the structure (PL-5 through PL-8). No corrective action is recommended at this time to address the cracks. They will be inspected each year to determine whether they are impacting the protectiveness of the building.

PL-5. IHX Building—surface cracks on north side

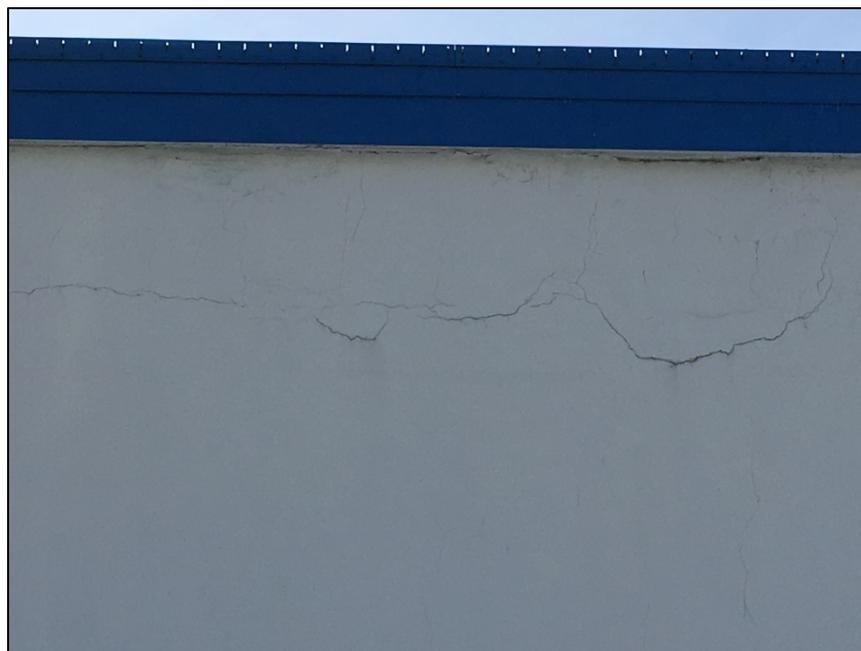
PL-6. IHX Building—surface cracks on north side

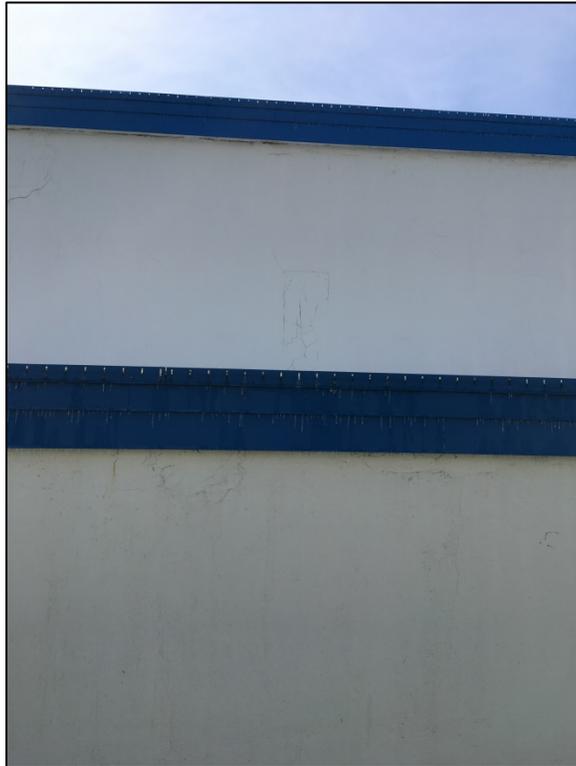
PL-7. IHX Building—surface cracks on north side

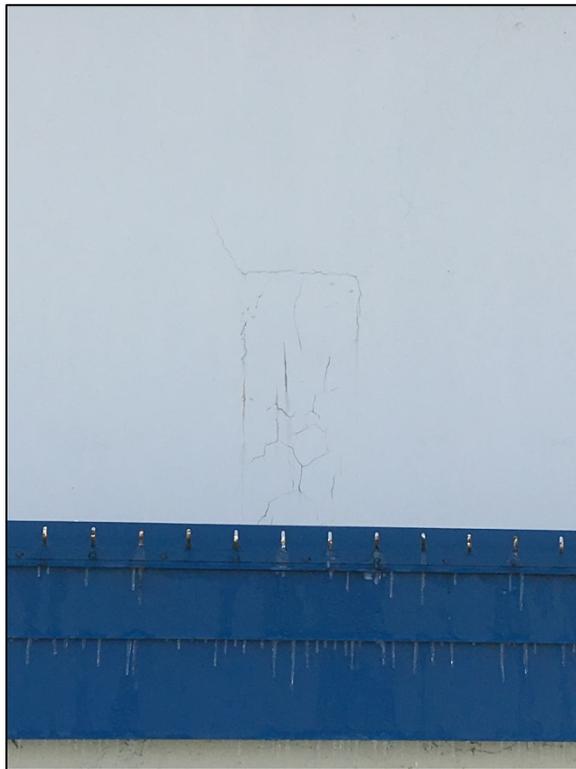
PL-8. IHX Building—surface cracks on north side

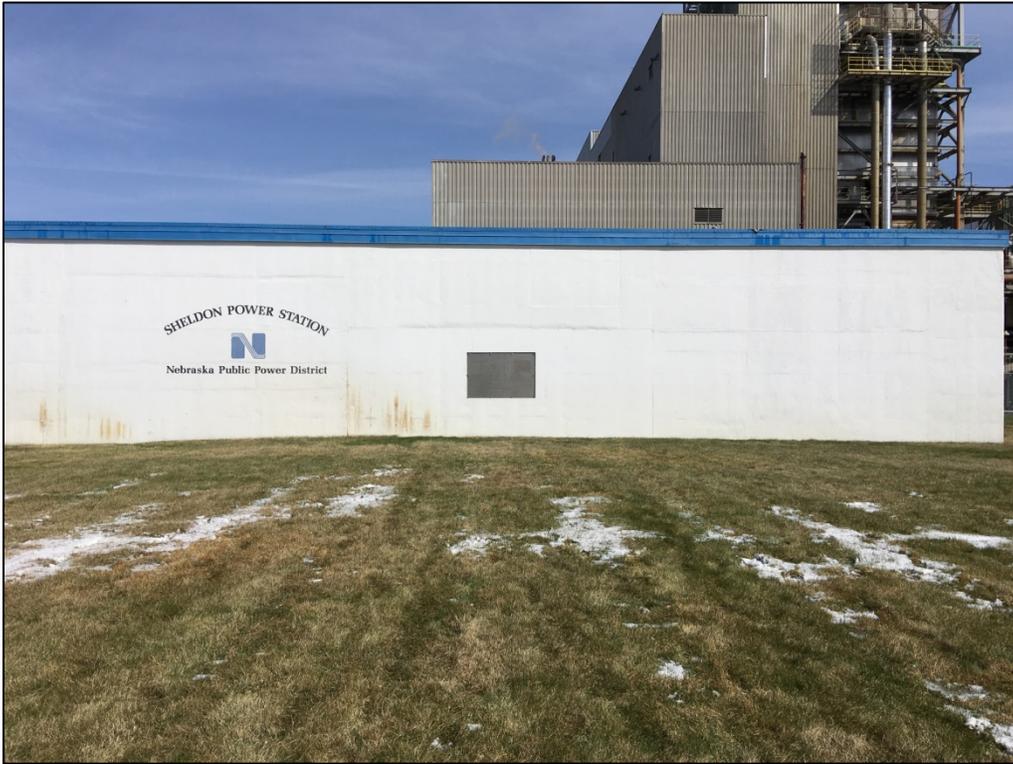
The old reactor foundation is buried beneath a waterproof membrane covered by soil and grass. The buried structure appears as a low, flat-topped, grass-covered mound, 1.4 acres in area, immediately south of the IHX Building (PL-9 and PL-10). Inspectors verified that erosion is not developing on the mound, and the sprinkler system is operating adequately to maintain the grass cover. Mound grass was well-established and in good condition.

PL-9. Grass-covered mound and IHX Building—looking north

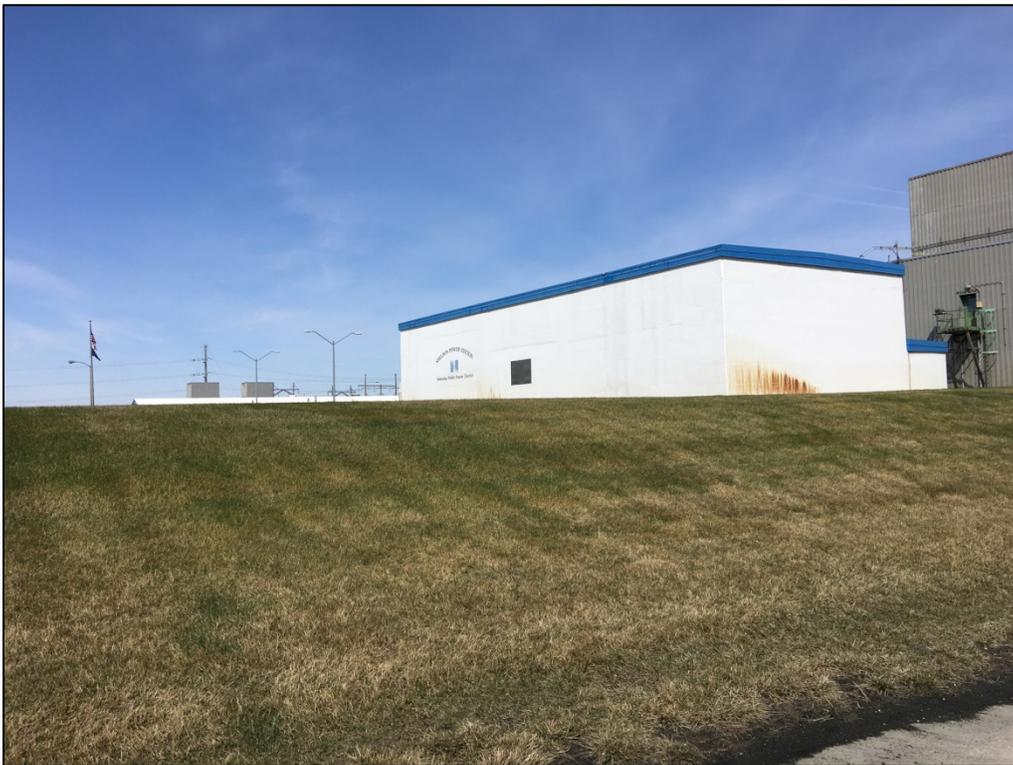
PL-10. Grass-covered mound and IHX Building—looking northwest

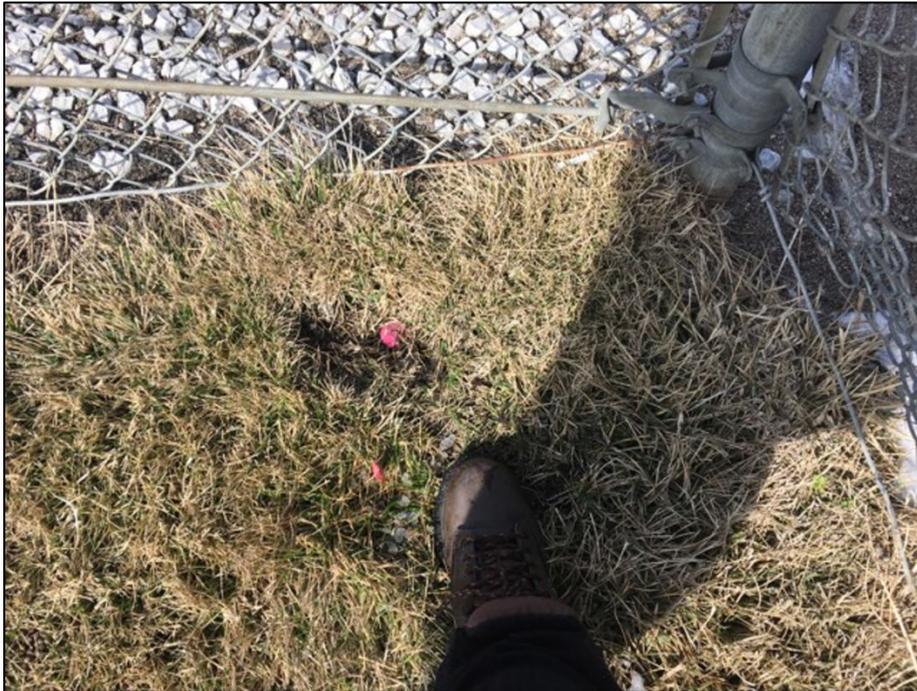
A land survey of the mound area at the Hallam facility was conducted in 2016, and survey pins were installed in 2017 to better define the area of the grass-covered mound that pertains to DOE long-term care and maintenance (PL-11).

PL-11. Survey pins

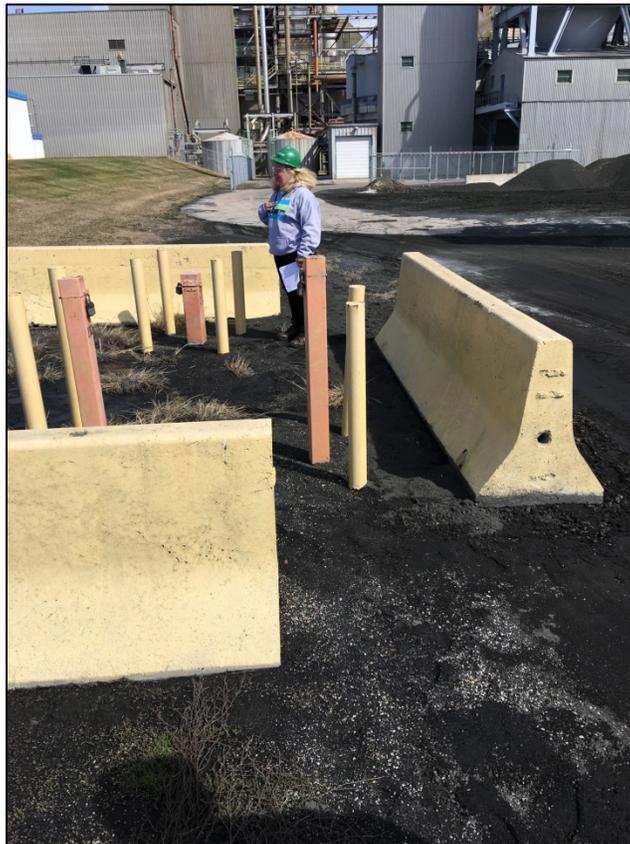
The concrete Jersey barrier on the east side of the OBS-2 well pad protects the well pad from power plant operations. In past years, movement of this barrier was a concern, because the barrier was routinely nudged west, closer to the well pad (PL-12). The barrier position was found to be acceptable this year.

PL-12. Monitoring well OBS-2 well cluster
