12.0 Mexican Hat, Utah, Disposal Site

12.1 Compliance Summary

The Mexican Hat, Utah, Uranium Mill Tailings Radiation Control Act (UMTRCA) Title I Disposal Site (site) was inspected on April 30, 2019. Depressions in the riprap cover identified during the 2016 annual site inspection continue to be observed along lower portions of the disposal cell's northeast side slope and north side slope (as identified in 2018 inspections). Inspectors identified several minor maintenance needs and conducted follow-up inspections.

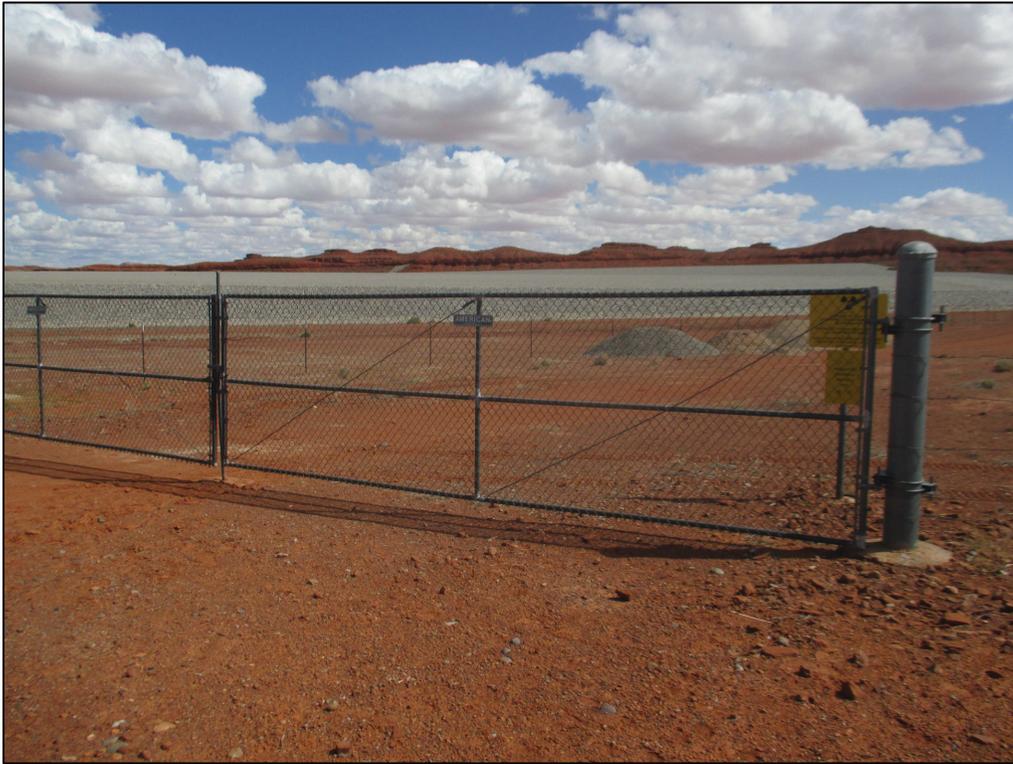
Access to the site is from a short, unmarked dirt road off U.S. Highway 163 that ends at a graded parking area. Minor erosion continues to occur along the dirt access road, but the site remains accessible. Entrance to the site is through a locked steel entrance gate at the northwest corner of the site (PL-1). The entrance gate was locked and functional. The entrance sign is affixed to a steel post immediately behind the entrance gate (PL-1). Before the inspection, two 4-foot access gates and one 8-foot access gate were permanently installed in the perimeter barbed-wire fence to support ongoing disposal cell cover evaluations and maintenance activities, including one temporary access gate within the fence line. No maintenance needs were identified.

PL-1. Entrance Gate; Entrance Sign and Disposal Cell in Background

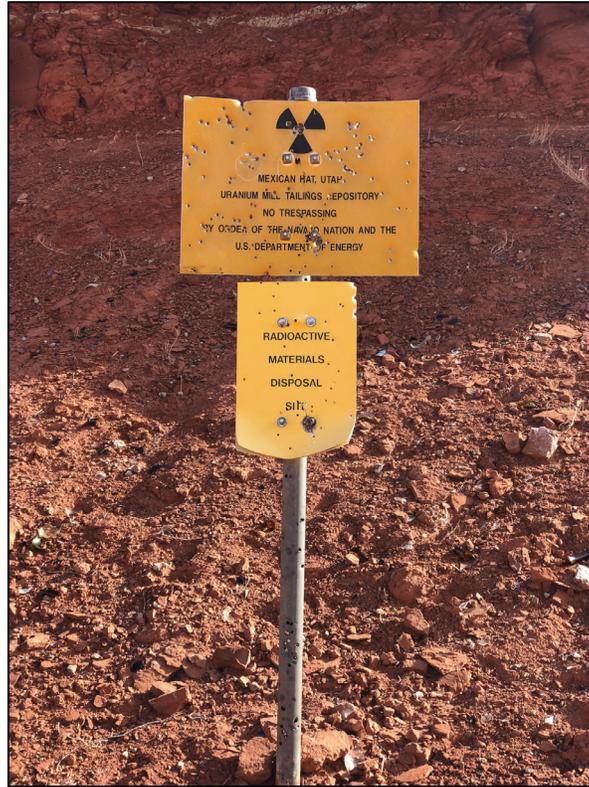
Minor vandalism continues to occur, as indicated by bullet damage in several perimeter signs (P19, P20, P21, P23, P24, P26, and P27), but this is expected to be an ongoing problem because of the site's remote location and because access to these areas cannot be restricted. Damaged perimeter signs are replaced when they become illegible. No other maintenance needs were identified.

PL-2. Perimeter Sign P20

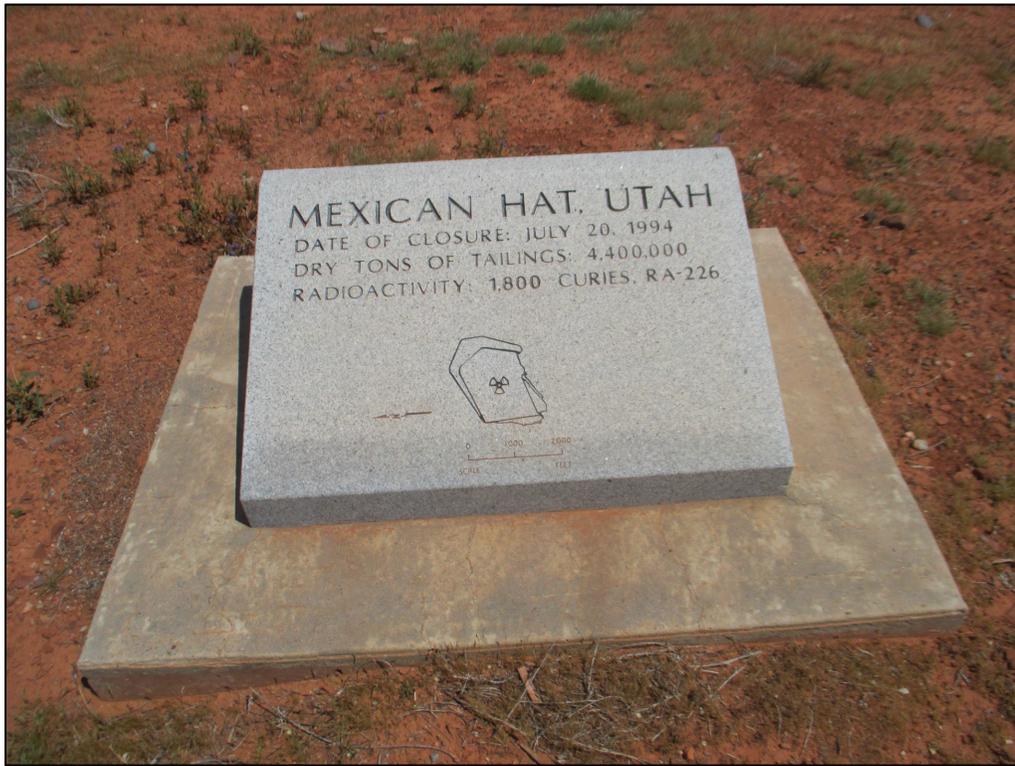
The site has two granite site markers. Site marker SMK-1 is just inside the fence near the entrance gate (PL-3); its concrete base has several minor cracks, but they do not compromise the integrity of the base, and repairs are not necessary at this time. Site marker SMK-2 is on the top slope of the disposal cell. No immediate maintenance needs were identified.

PL-3. Site Marker SMK-1

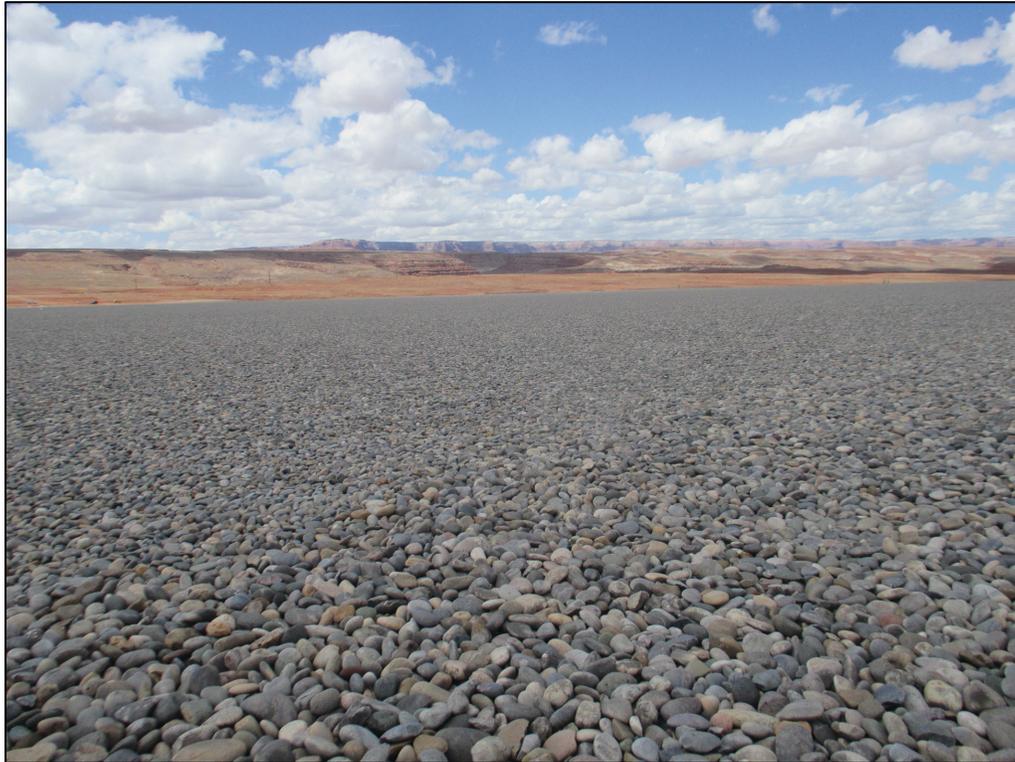
The disposal cell, completed in 1994, occupies 68 acres. The disposal cell is armored with riprap to control erosion. No erosion, settling, slumping, rock degradation, or other modifying processes that might affect the integrity of the disposal cell were evident on the top slope of the disposal cell (PL-4).

PL-4. Central Portion of Top Slope of Disposal Cell

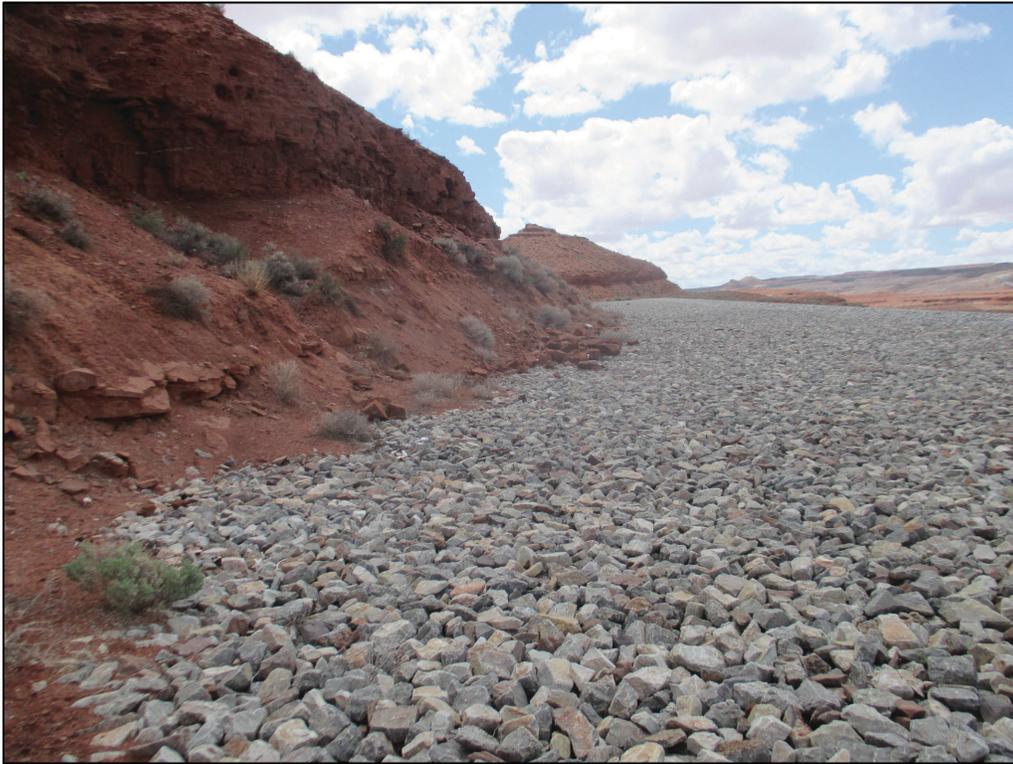
There was no noticeable increase of sloughed red rock and soil along the south apron of the disposal cell (PL-5). Because the apron is adjacent to the base of a steep, rocky cliff, it is expected that sediment and rock from the cliff will continue to fall onto the apron. The accumulated material is not currently affecting the function of the apron, and this area will continue to be monitored.

PL-5. Sloughed Rock on South Apron of Disposal Cell

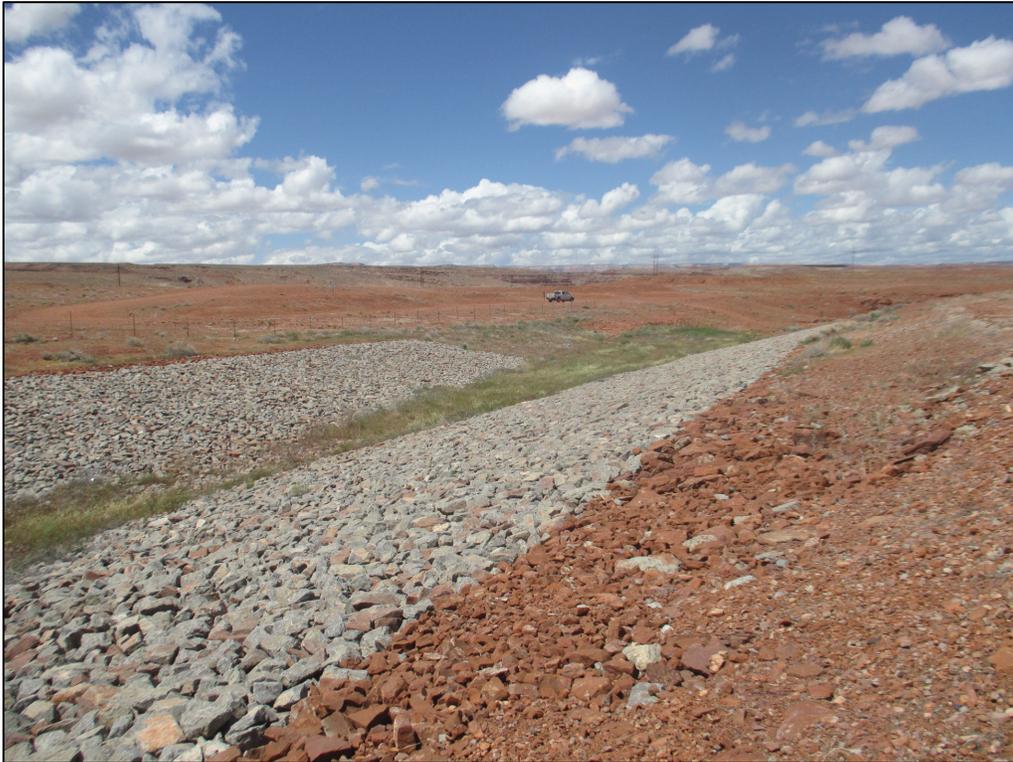
Upgradient offsite areas continue to erode, resulting in the transport of sediment onto the site and into the west diversion channel. Sediment accumulation has promoted the growth of vegetation, including perennial grasses and annual weeds, in the west diversion channel (PL-6). However, sediment accumulation and associated vegetation growth have not adversely affected the performance of the west diversion channel.

PL-6. West Diversion Channel

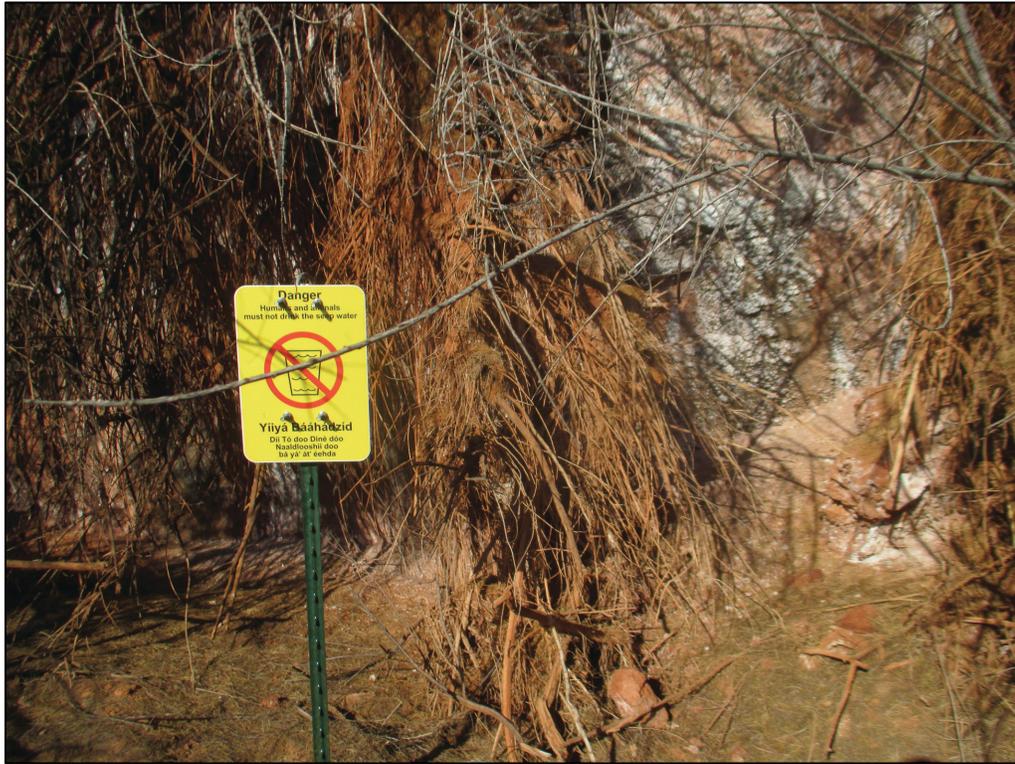
Since 2010, groundwater discharge from seeps had only been observed at cross-gradient Seep 0248, which typically exhibits dripping conditions. During the inspection, Seep 0248 was observed dripping; since the seep was only dripping and did not exhibit steady flow, an estimated flow rate was not evaluated. Additionally, Seeps 0251 and 0264 were damp, and upgradient (background) Seep 0261 was observed to be flowing during the inspection. Seep 0261 is approximately 0.50 mile upstream of Seep 0248 in Gypsum Creek.

PL-7. Seep 0248 (Limited Dripping)

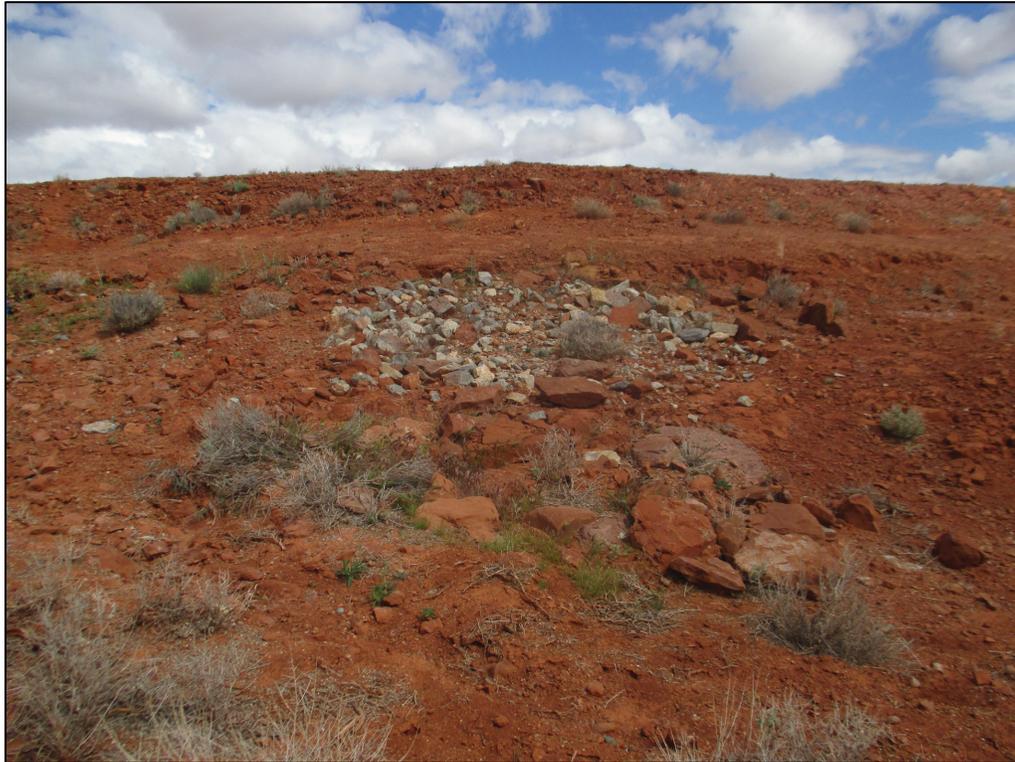
PL-8. Seep 0249 (Dry)

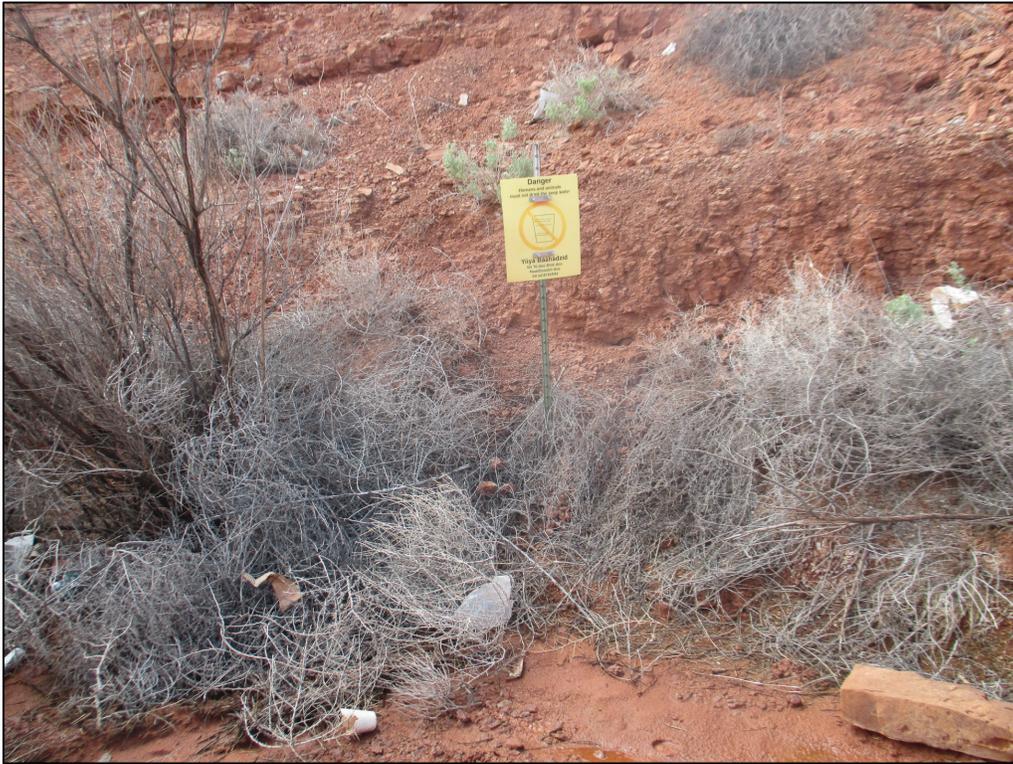
PL-9. Seep 0251 (Damp)

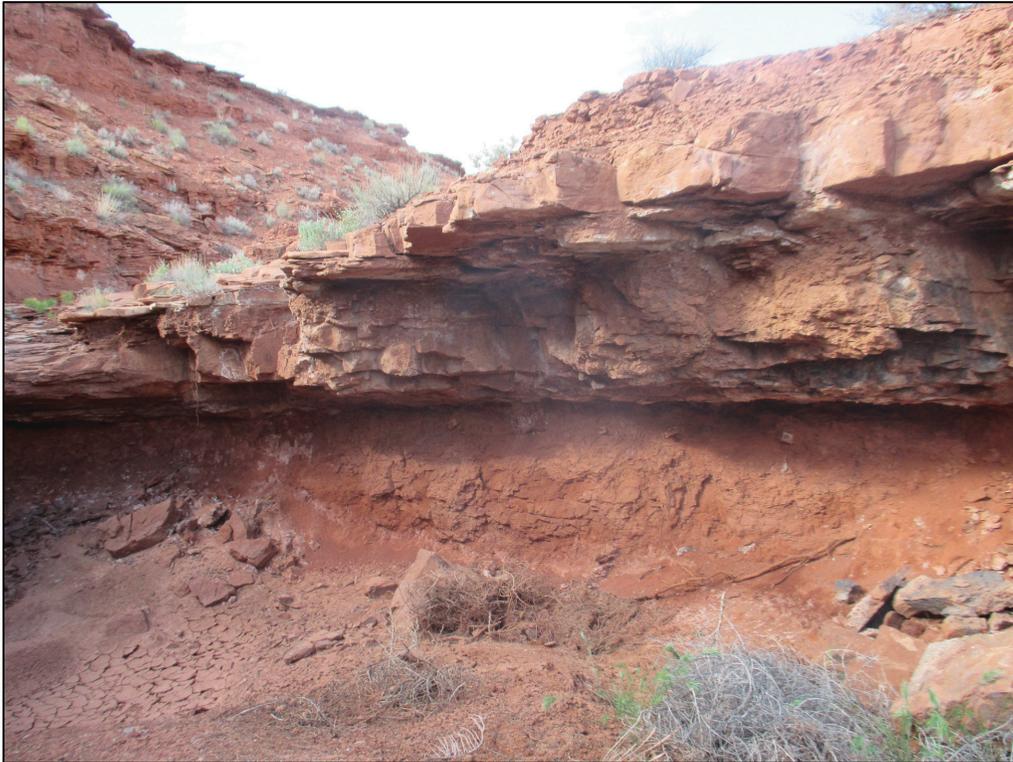
PL-10. Seep 0254 (Dry)

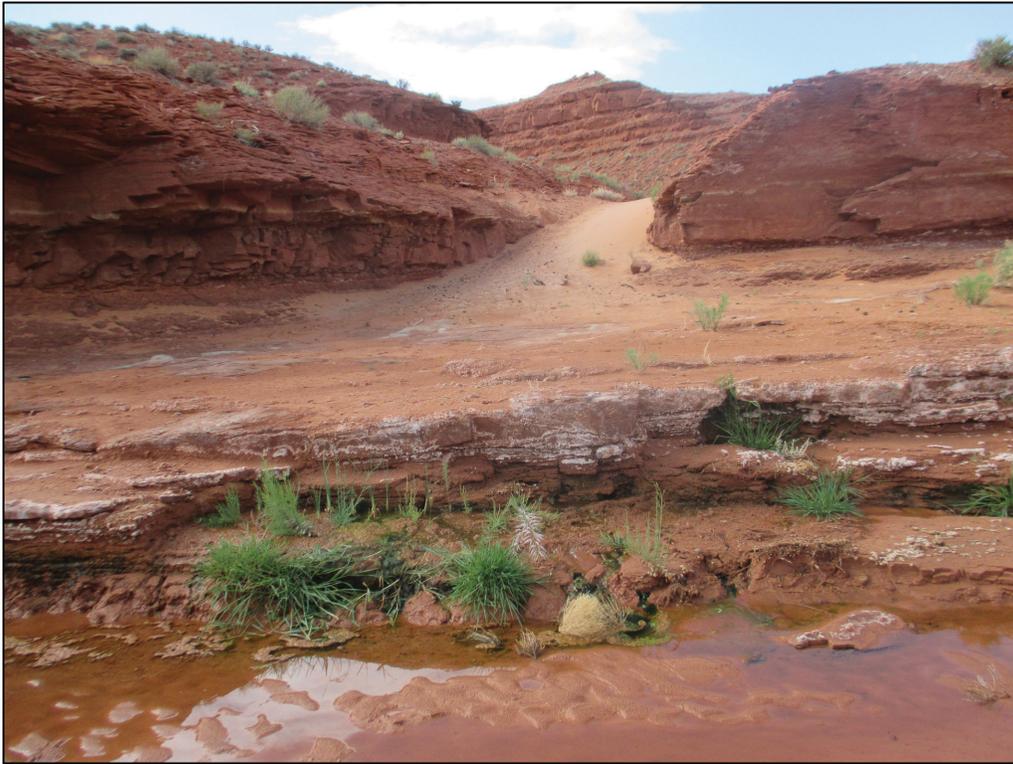
PL-11. Background Seep 0261 (Flowing)

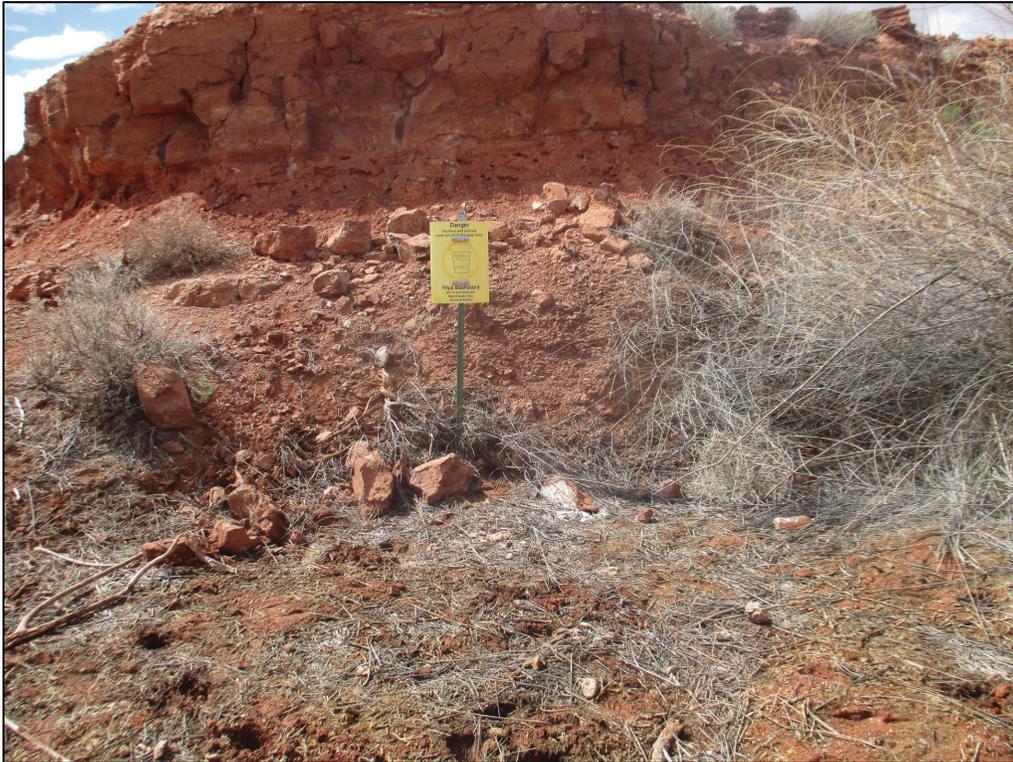
0264	North Arroyo	Downgradient	PL-12	Damp conditions. Ephemeral wash near seep location was wet with no evidence of evaporites in the areas observed during the inspection.
0922	Gypsum Creek	Downgradient	PL-13	Dry conditions (no evaporites present in immediate area). Seep is along the south side of Gypsum Creek, and the seep location is still covered entirely by a sandbar that has formed along this section of Gypsum Creek.

PL-12. Seep 0264 (Damp)

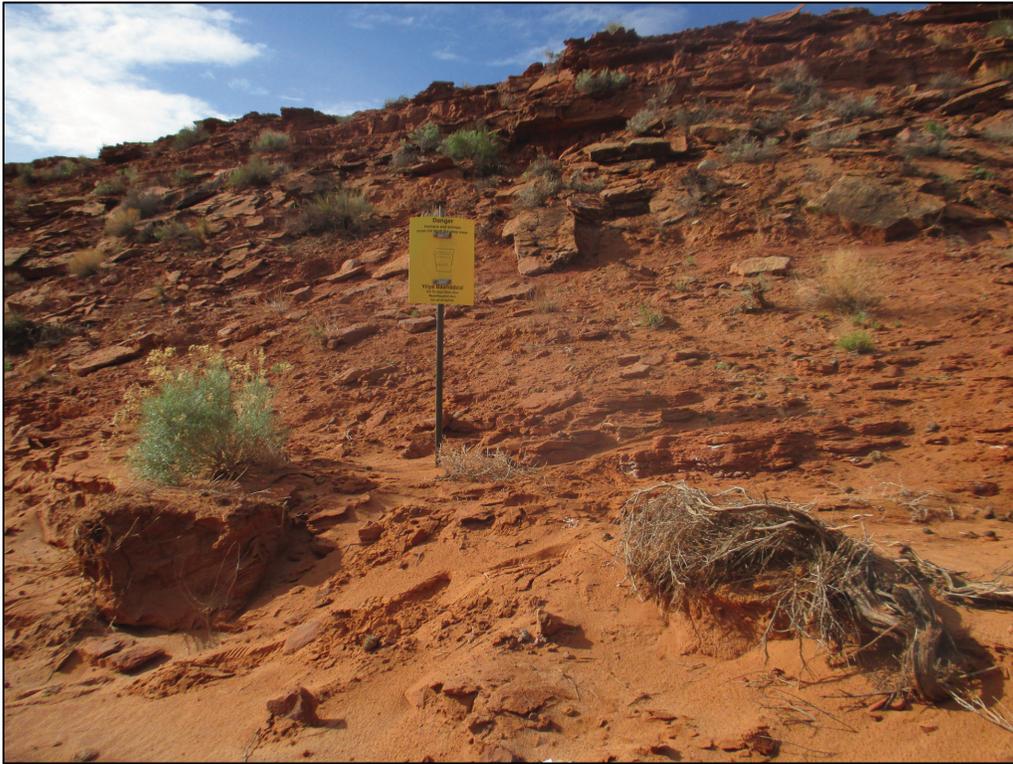
PL-13. Seep 0922 (Dry/Sandbar)
