## 13.0 Naturita, Colorado, Disposal Site

### 13.1 Compliance Summary

Figure 13-1. 2019 Annual Inspection Drawing for the Naturita, Colorado, Disposal Site

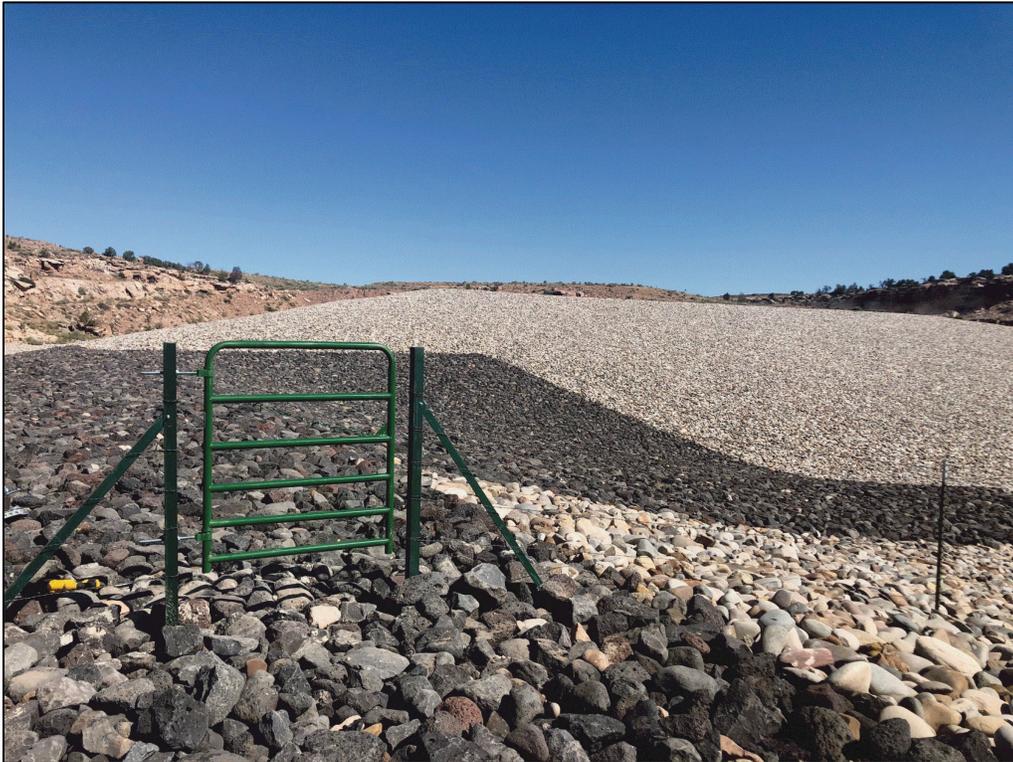
A barbed-wire perimeter fence encloses the site. Three aging wooden stiles identified in the 2018 inspection (DOE 2019a) were replaced with two pedestrian gates following the 2019 inspection (PL-1). A large bush growing in the western perimeter fence line was removed to prevent damage to the fence (PL-2). Inspectors identified a loose fence strand and a detached fence bracket; both were repaired following the inspection.

*PL-1. New Pedestrian Gate on Disposal Cell*

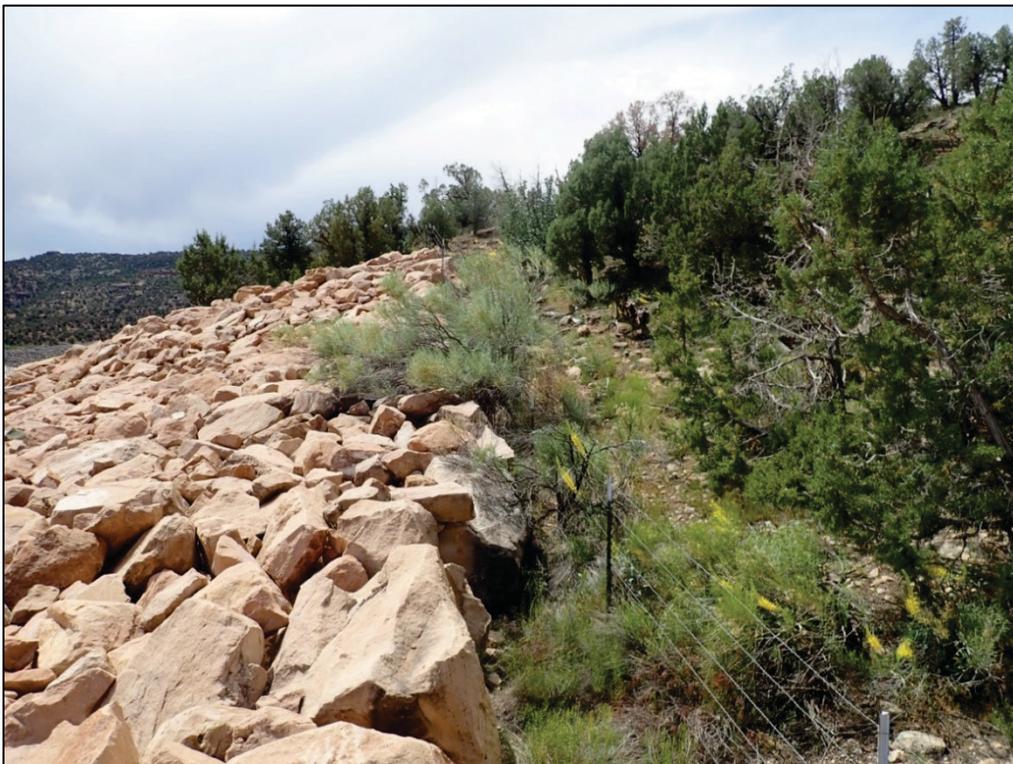
*PL-2. Vegetation Growing in Fence Line*

- Repairs to the perimeter fence (tightened loose fence strand and repaired detached fence bracket)
- Treatment of vegetation growing in the disposal cell apron
- Replacing “Uravan” perimeter signs with “Naturita”
- Turning perimeter sign P18 to face the disposal cell access road
- Removal of the bush in the fence line between perimeter signs P16 and P17
- Replacing the entrance sign

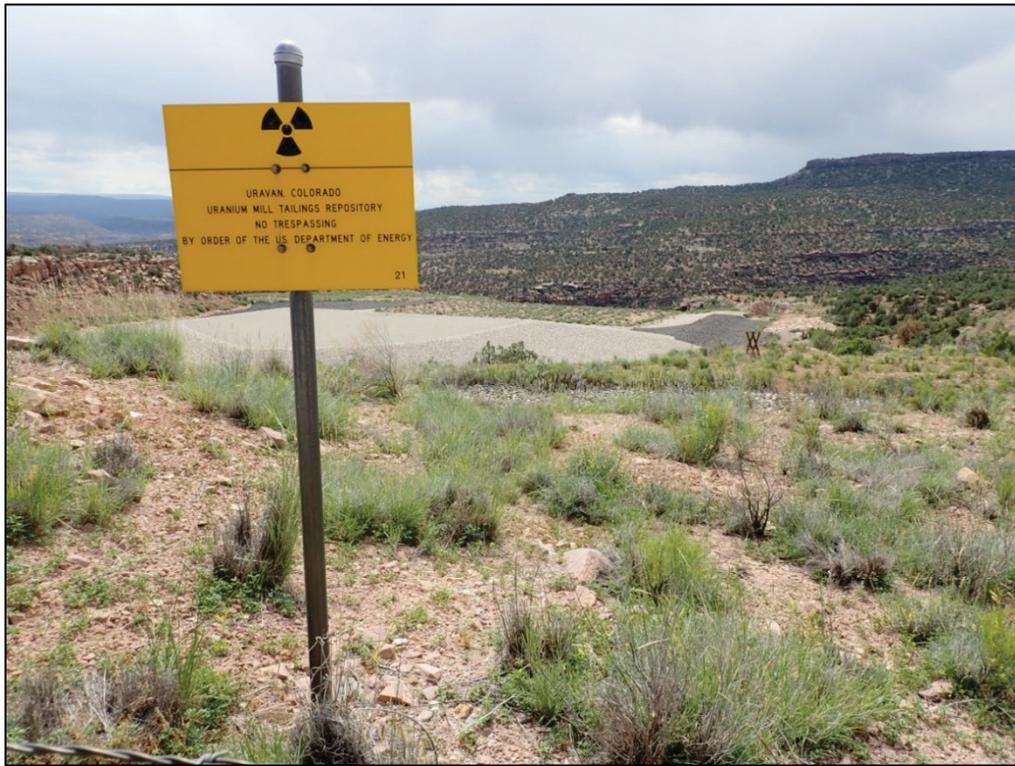
There are 25 perimeter signs positioned along the perimeter fence attached to steel posts set in concrete and set back 5 feet (PL-3). Several perimeter signs identified with “Uravan” as the site name were replaced with “Naturita” following the inspection. Perimeter sign P2 has bullet damage but remains legible. Erosion is occurring around the base of perimeter sign P22, but the perimeter sign is stable. Perimeter sign P18 was facing away from the disposal cell access road and was turned to face the road following the inspection. No other maintenance needs were identified.

*PL-3. Perimeter Sign P21*

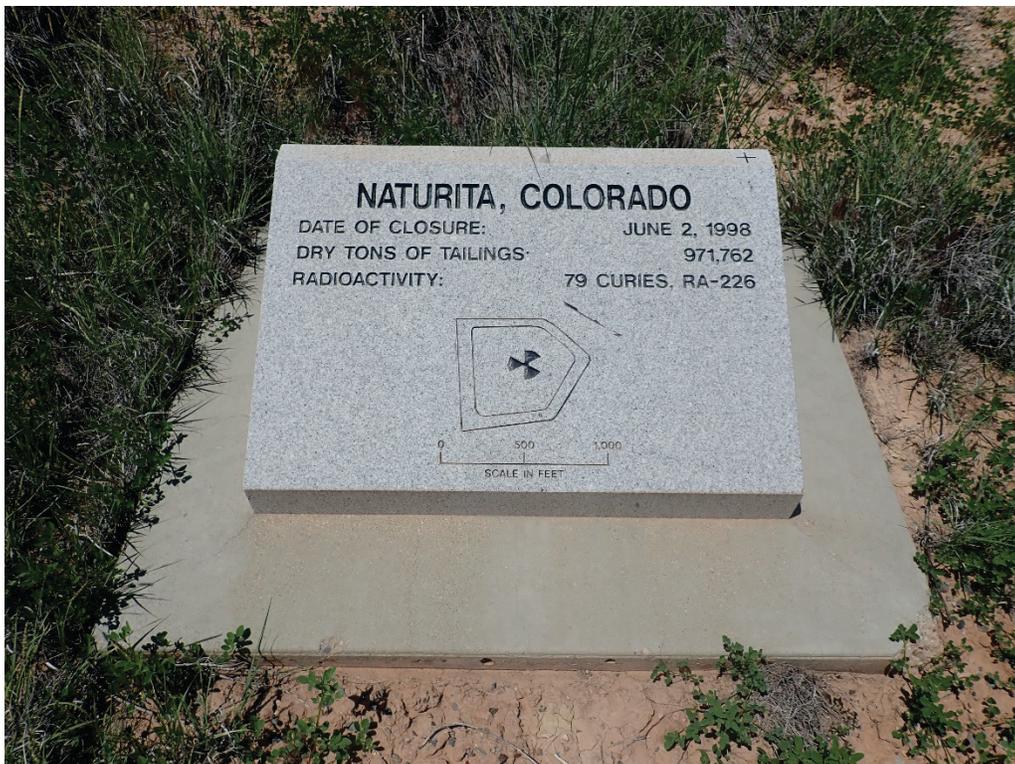
The site has two granite site markers. Site marker SMK-1 (PL-4) is just inside the entrance gate, and site marker SMK-2 is on the top slope of the disposal cell. No maintenance needs were identified.

*PL-4. Site Marker SMK-1*

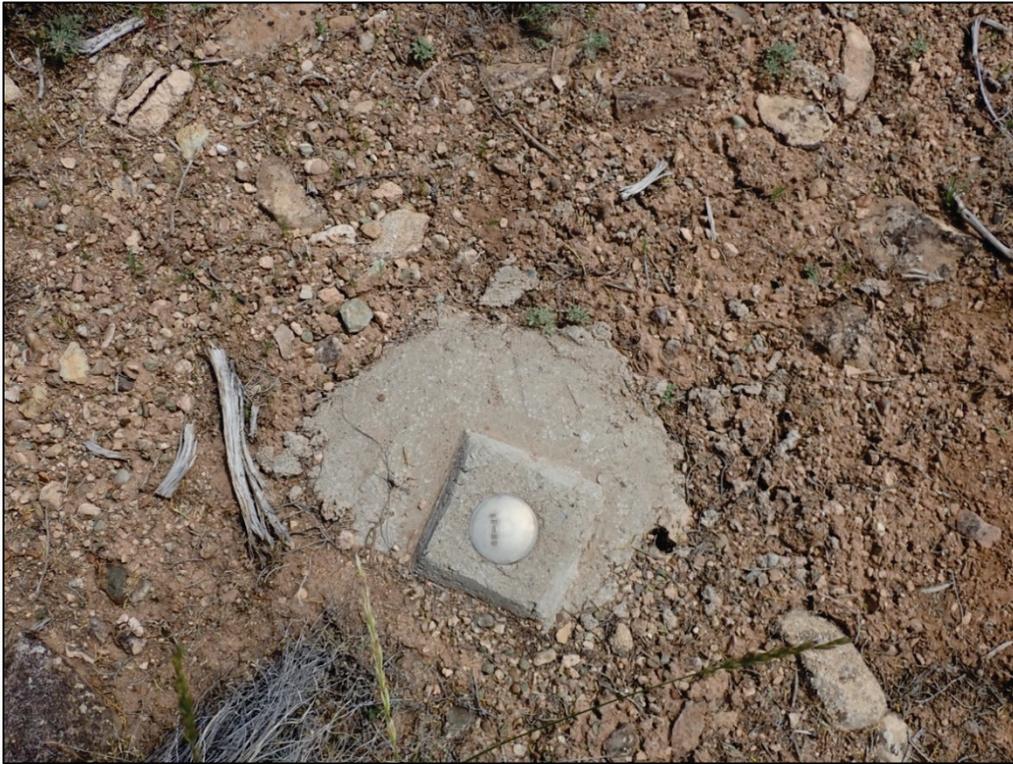
Three survey monuments and 14 boundary monuments delineate the property boundary. Boundary monuments BM-1 through BM-17 mark the property corners. Survey monuments SM-3, SM-4, and SM-11 represent boundary monuments BM-3, BM-4, and BM-11, respectively (PL-5). Boundary monument BM-9 was obstructed by woody vegetation, which was removed following the inspection. No other maintenance needs were identified.

*PL-5. Survey Monument SM-11*

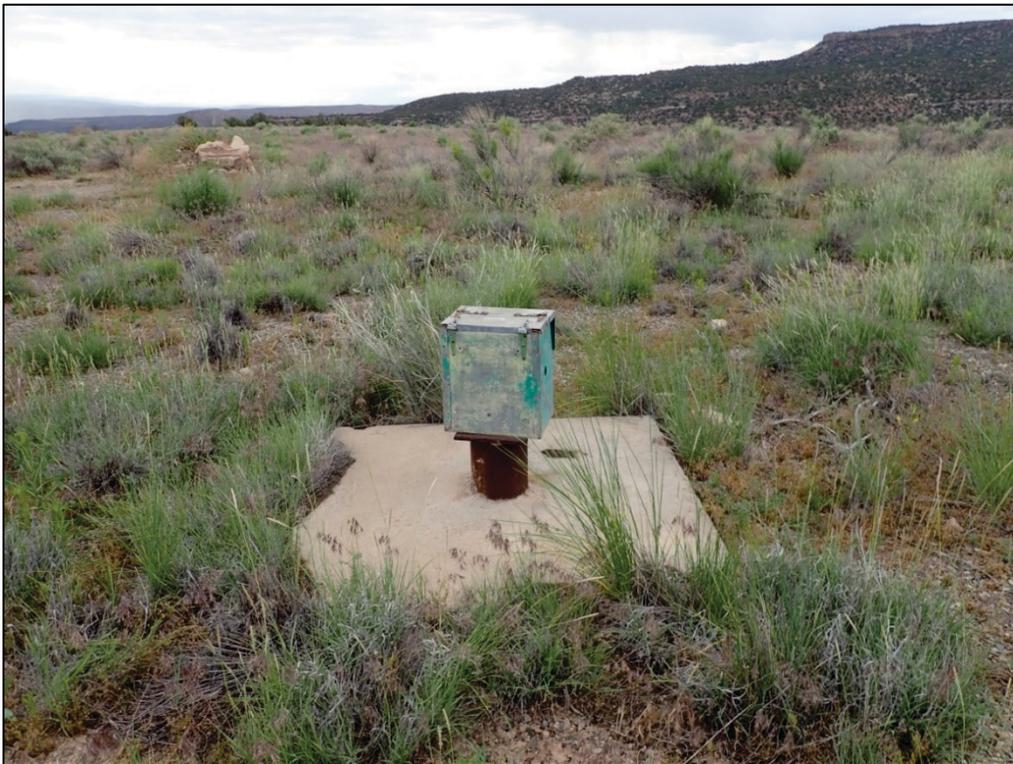
The site has five groundwater monitoring wells. The wellhead protectors were undamaged and locked (PL-6). Monitoring well CM93-1 remains completely surrounded by woody vegetation. Monitoring of the wells is not required, and the vegetation will be removed upon well abandonment. No immediate maintenance needs were identified.

*PL-6. Monitoring Well CM93-2*

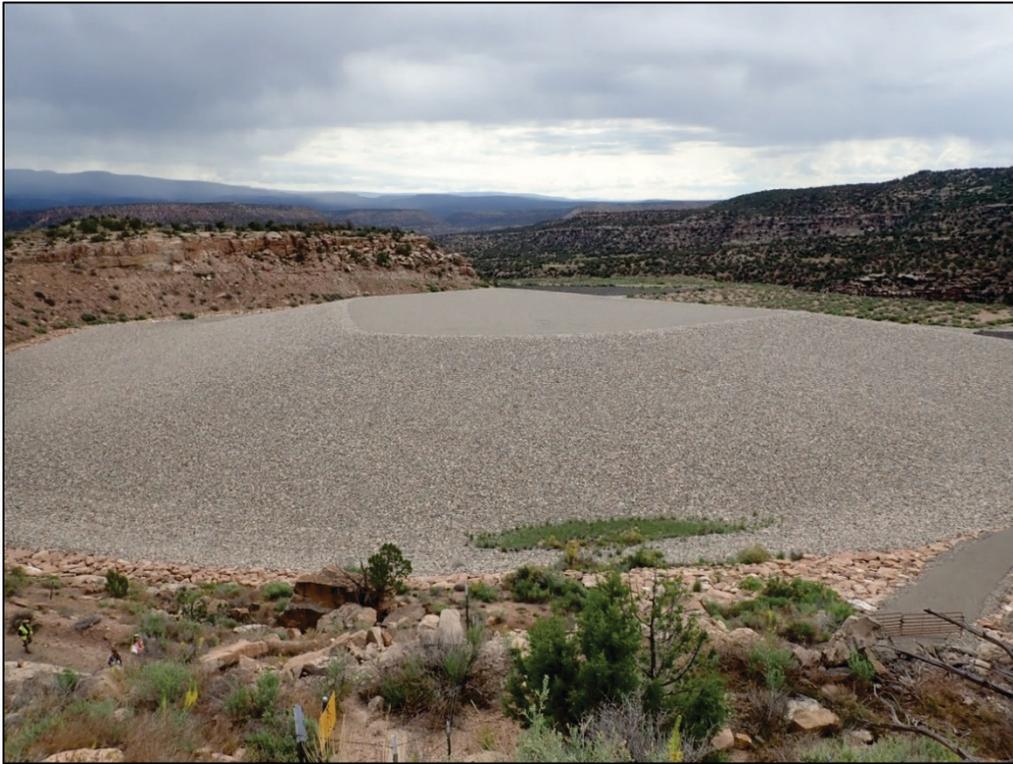
The disposal cell, completed in 1998, occupies 10 acres (PL-7). The disposal cell is armored with riprap to control erosion. The riprap is rounded, with larger diameter rock on the side slopes than on the top slope. There was no evidence of settling, slumping, erosion, rock degradation, or other modifying processes that might affect the integrity of the disposal cell.

*PL-7. Disposal Cell*

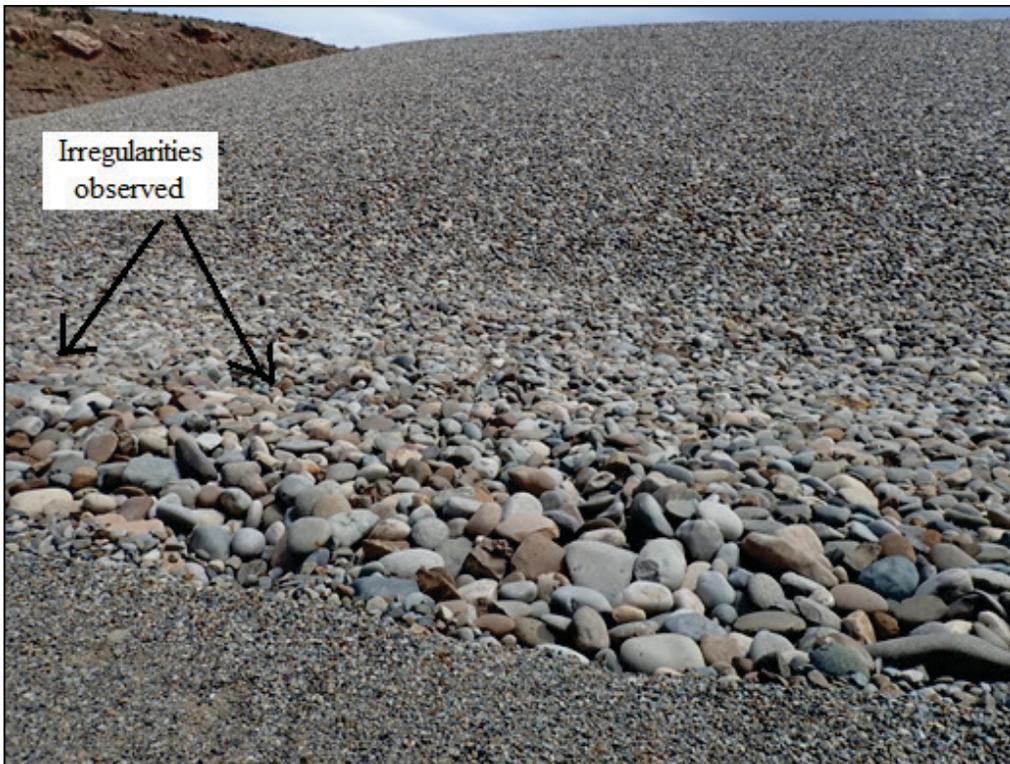
Irregularities in the riprap on the top slope of the disposal cell continue to be observed. The irregularities consist of slightly darker rock at differing angles than the rest of the top slope. The irregularities are not lower than surrounding areas and have not changed over time. They are believed to be a construction artifact. Another irregularity exists in the apron area on the west side of the disposal cell (PL-8) appearing to be old vehicle tracks. The irregularity does not present a hazard to the disposal cell or surrounding area. Inspectors will continue to monitor this area. A large boulder was observed on the northeast side of the disposal cell apron, a presumed result of erosion on the steep cliff above the disposal cell (PL-9). The apron around the boulder remains intact, and the boulder does not currently pose a hazard to the disposal cell. Inspectors will continue to monitor for potential impacts. A rabbitbrush plant (a deep-rooted woody species) growing at the base of the north side slope identified during the previous inspection was successfully treated with herbicide and was not apparent during the 2019 inspection. Additional

*PL-8. Area of Irregularity on Disposal Cell Apron and Interface with Disposal Cell Access Road*

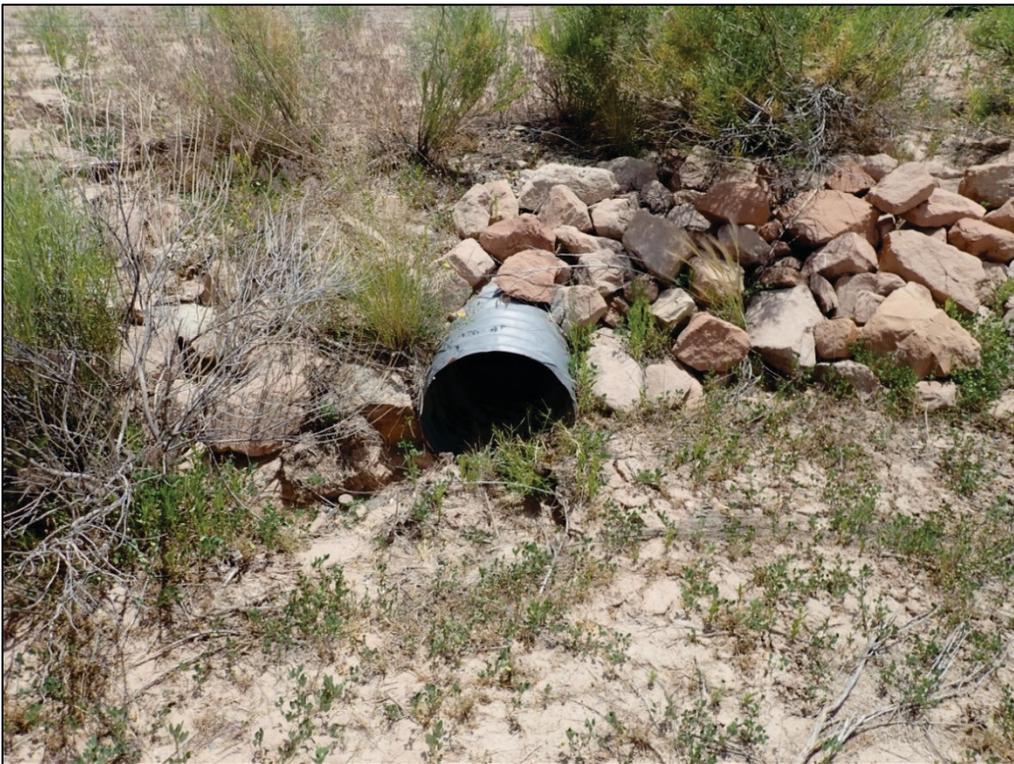
*PL-10. Culvert Inlet Partially Blocked by Sediment*

- Removing sedimentation or vegetation blocking the culverts

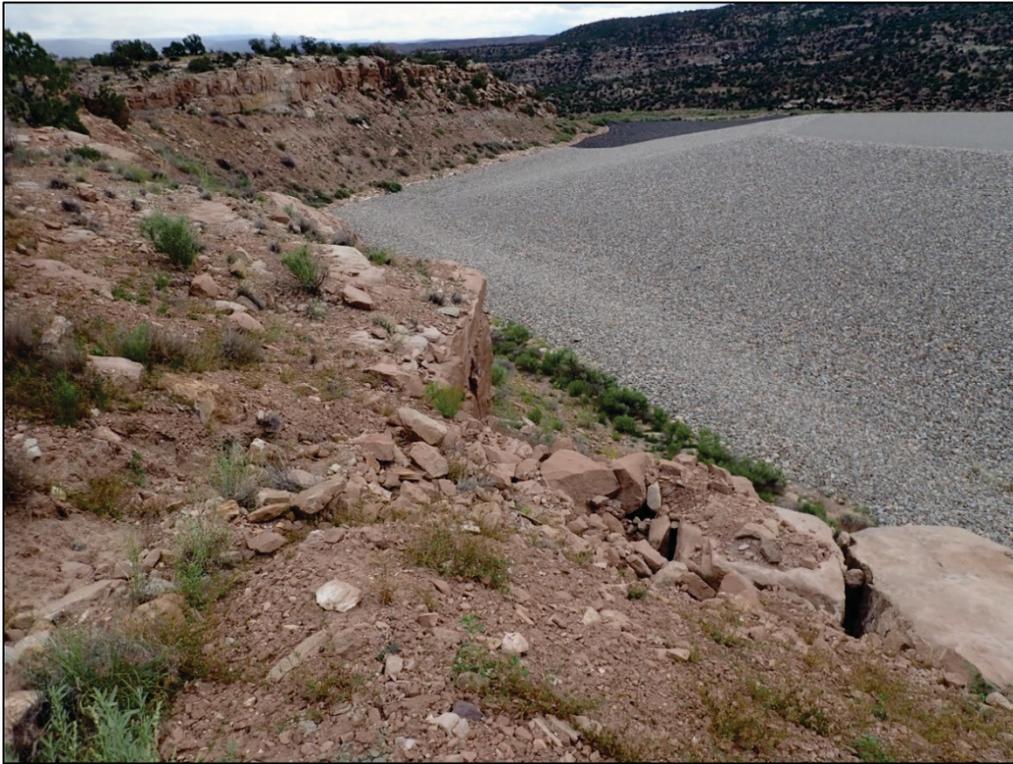
An area south of monitoring well CM93-2 next to a large boulder upgradient of the disposal cell is beginning to show signs of erosion (PL-11). Rills leading in the boulder's direction are becoming apparent. The erosion does not present a hazard to the disposal cell or to any site features, so repairs are not warranted. Inspectors will continue to monitor this area for ongoing erosion.

*PL-11. Erosion Along Cliff Edge Above Disposal Cell*

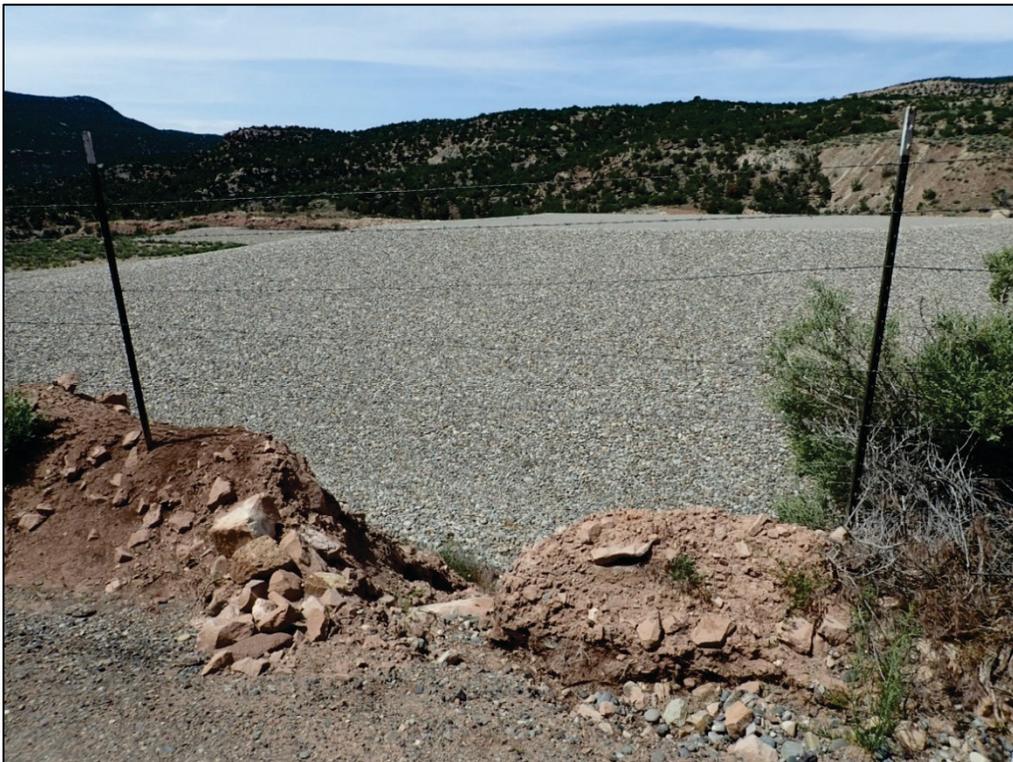
A cut in the berm and resulting erosion alongside County Road EE22 (between perimeter signs P3 and P4) has been observed since 2017 and appeared to have increased in size and depth (PL-12). Erosion in the steep cliff below the berm cut was observed (PL-13), but does not pose a current threat to the integrity of the disposal cell or site features. Following the inspection, the Montrose County maintenance crew repaired the berm cut (PL-14). Inspectors will continue to monitor this area for ongoing erosion. No other maintenance needs were identified.

*PL-12. Berm Cut off County Road EE22 (Repaired Following Inspection)*

- Removal of three pedestrian wooden stiles and installation of two pedestrian gates
- Repair of the berm cut by Montrose County

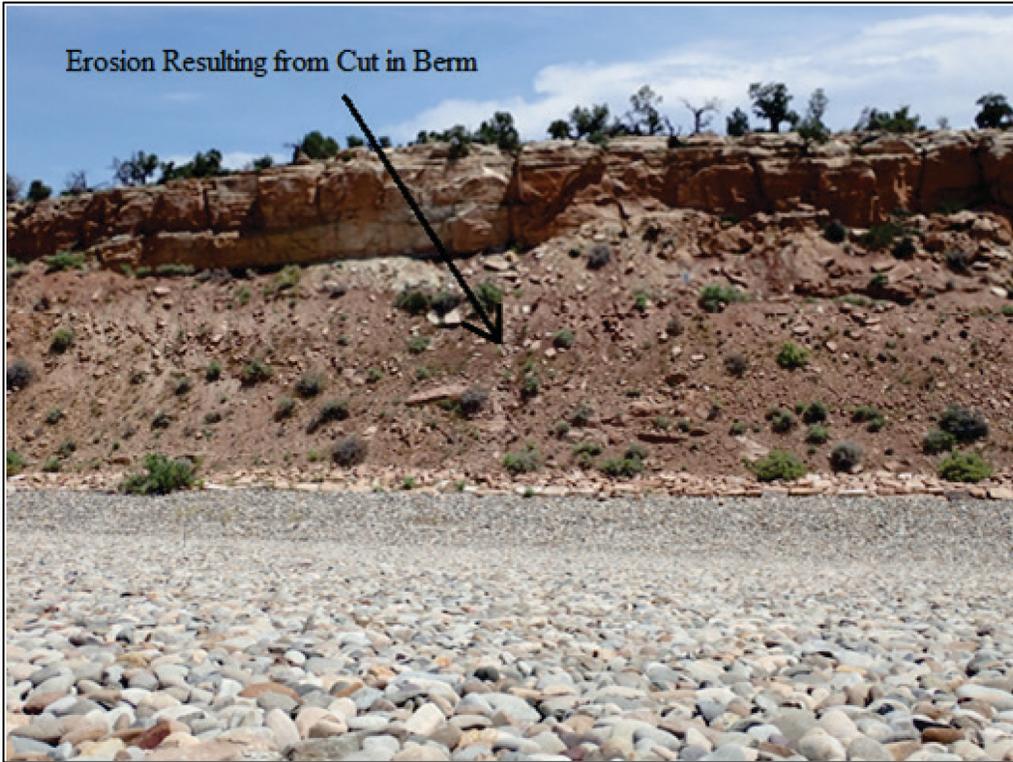
*PL-13. Erosion Along Cliff from Cut in County Road EE22 Berm*

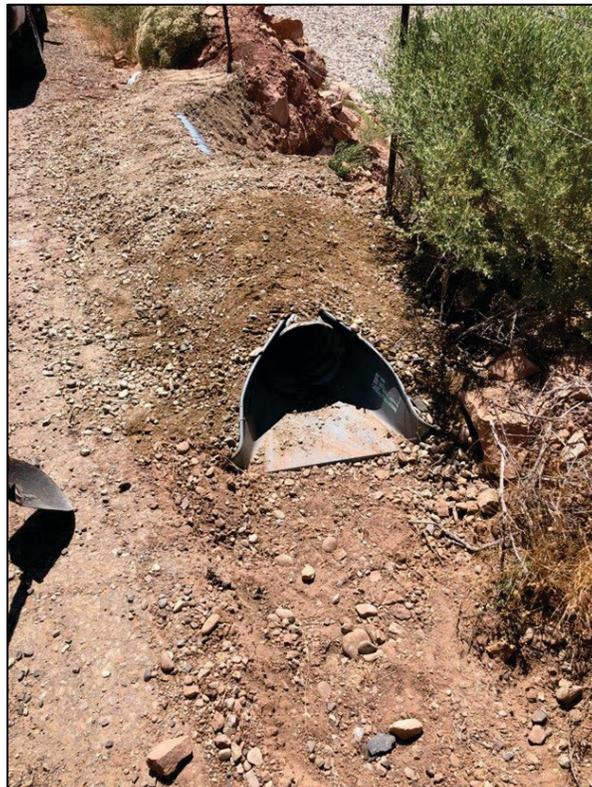
*PL-14. Berm Cut Repaired by Montrose County*

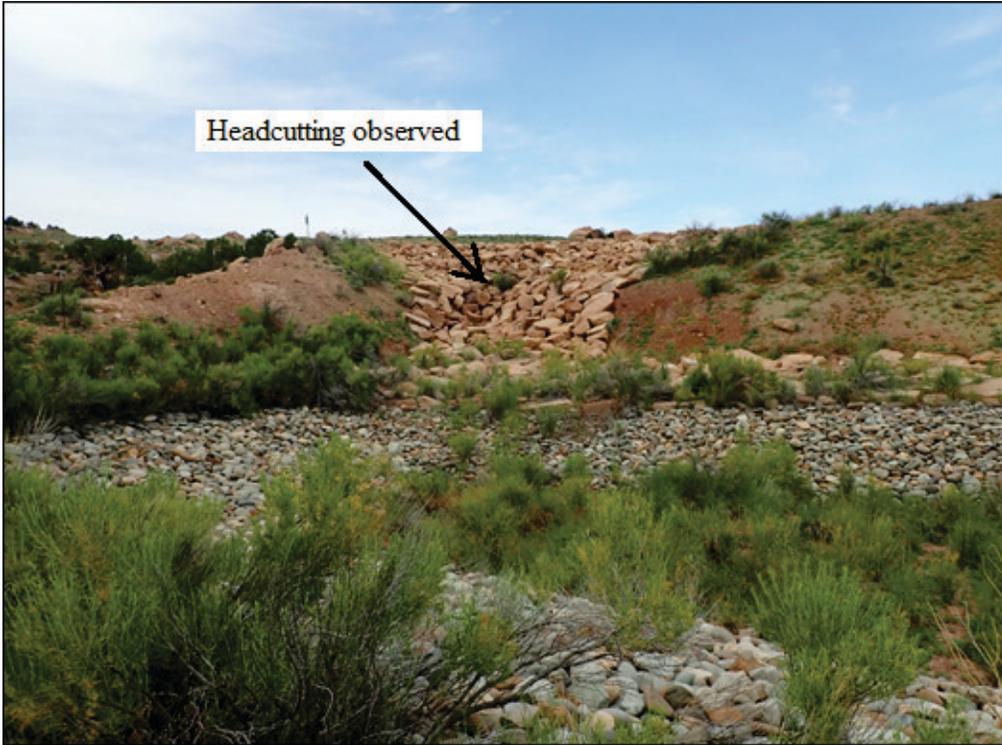
Headcutting erosion was identified within the spillway channel below the sedimentation pond on the outlying area northwest of the site (PL-15). Inspectors will continue to monitor this area for ongoing erosion.

*PL-15. Sedimentation Pond Spillway Area*
