# **Overview of the Third Quarter 2020 Surveillance and Maintenance Report for the Rocky Flats Site, Colorado**

July - September 2020

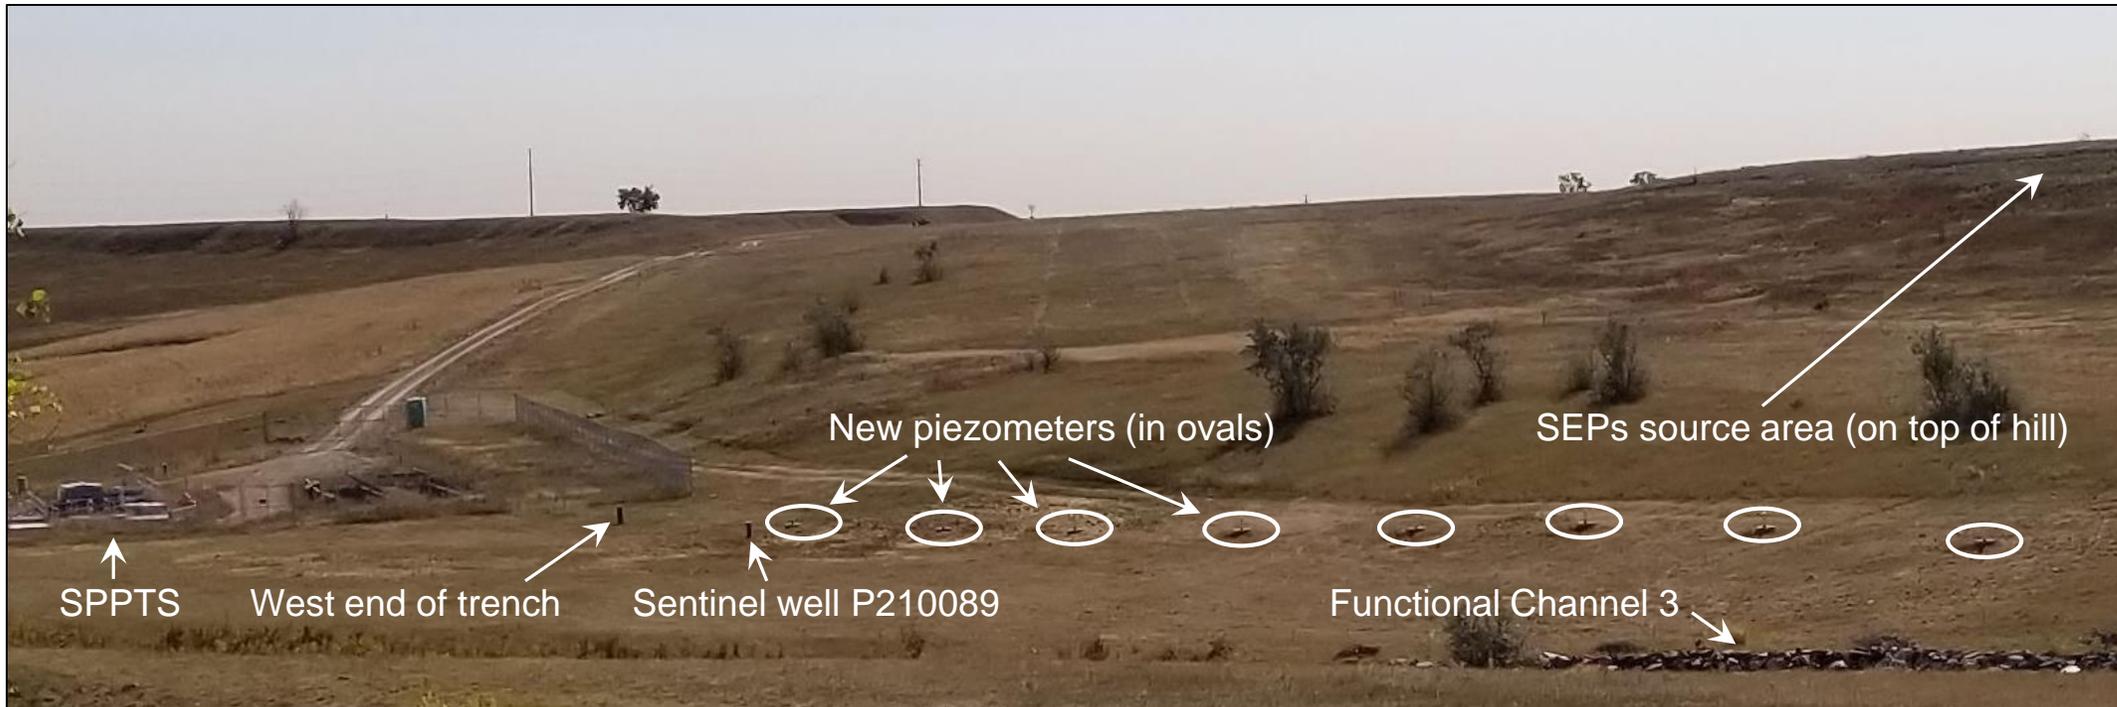
Hillside north of the former Solar Evaporation Ponds (SEPs)

- Evaluating groundwater conditions west of the existing SPPTS groundwater collection trench
  - Installed 9 piezometers (8 shown)
  - Data collection began in December 2020

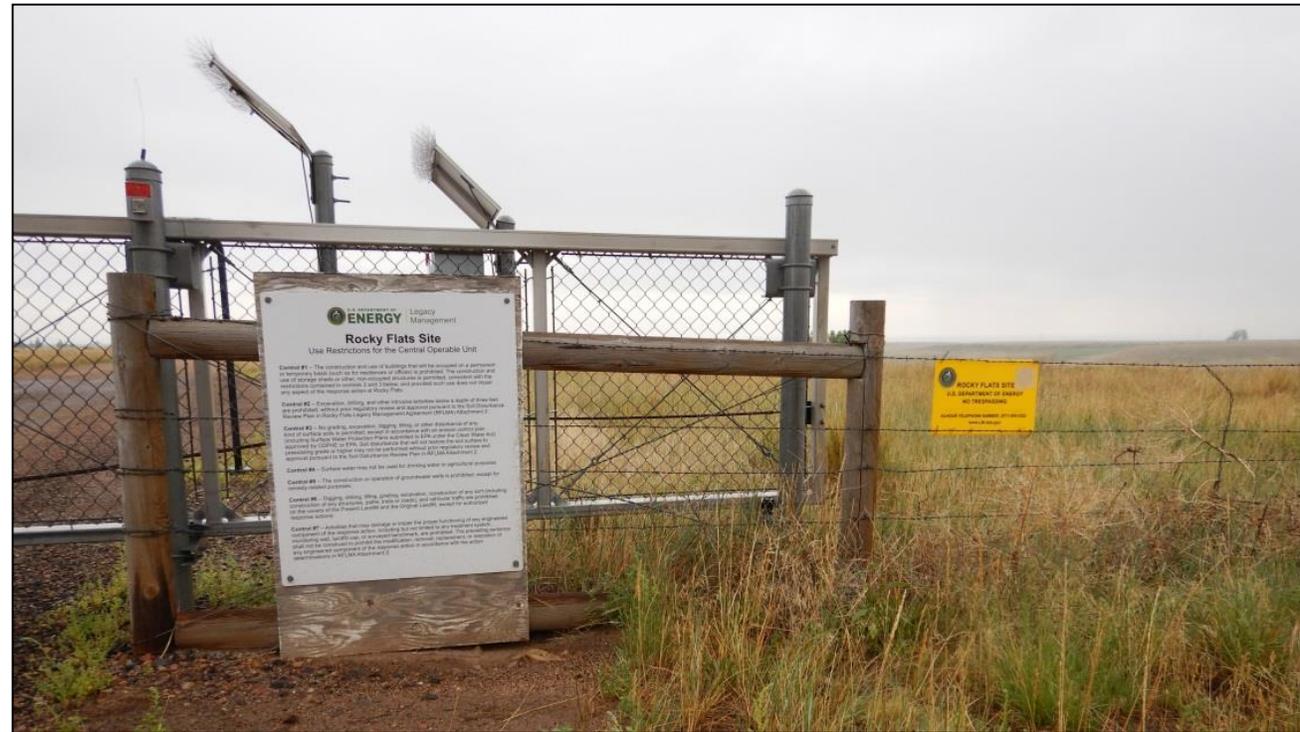
- RFLMA physical control
- Signs inspected on July 10, 2020
  - All signs in good condition and legible

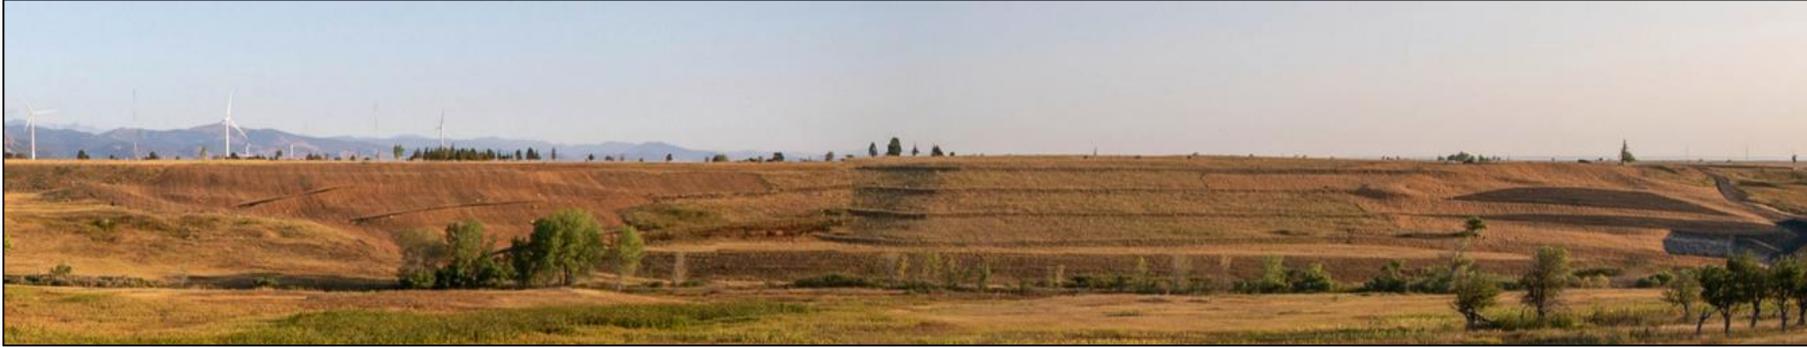
- All 267 anchors installed, tested, locked off
- Anchor, perimeter, and East and West Interceptor trench drains complete
- Temporary dewatering wells no longer required, abandoned
- Berm construction, perimeter channel regrading, and cover placement complete
- Placement of turf reinforcement matting and erosion control blankets complete
- Project was completed, with all equipment and support infrastructure demobilized by September 1, 2020
- East Subsurface Drain continues to function as designed

Original Landfill hillside, 9/01/2020

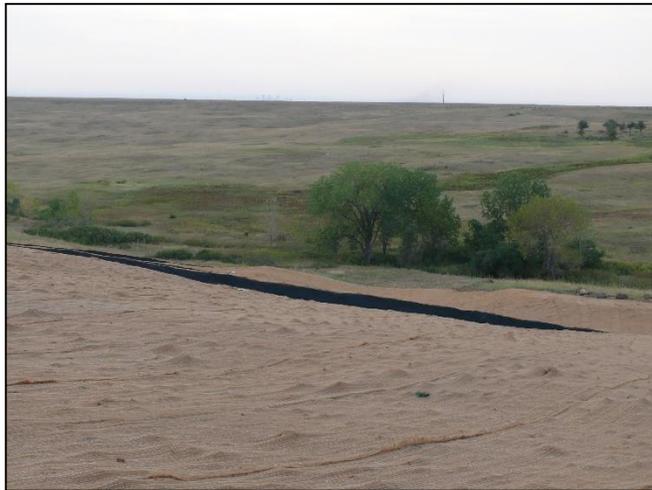
Work completed on western hillside

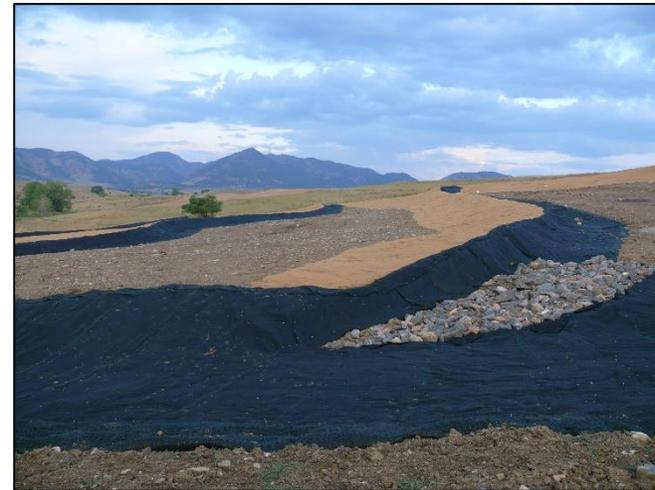
Work completed on eastern hillside

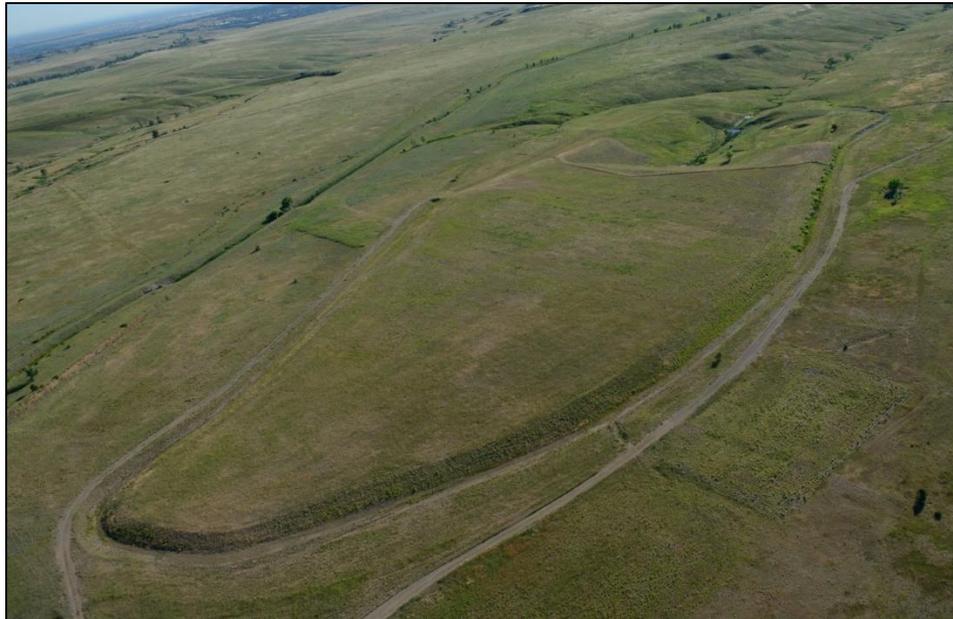
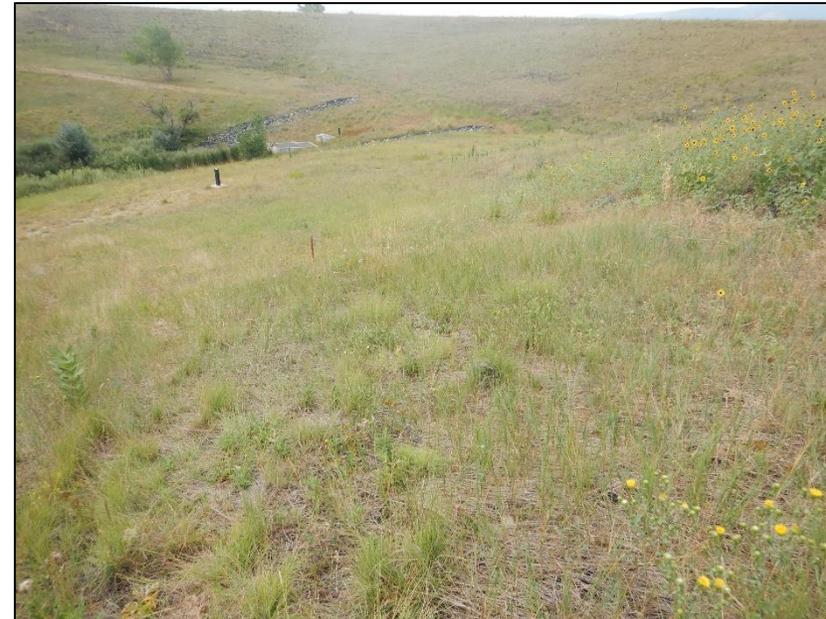
- Quarterly inspection performed on August 11, 2020
- Present Landfill is in good condition

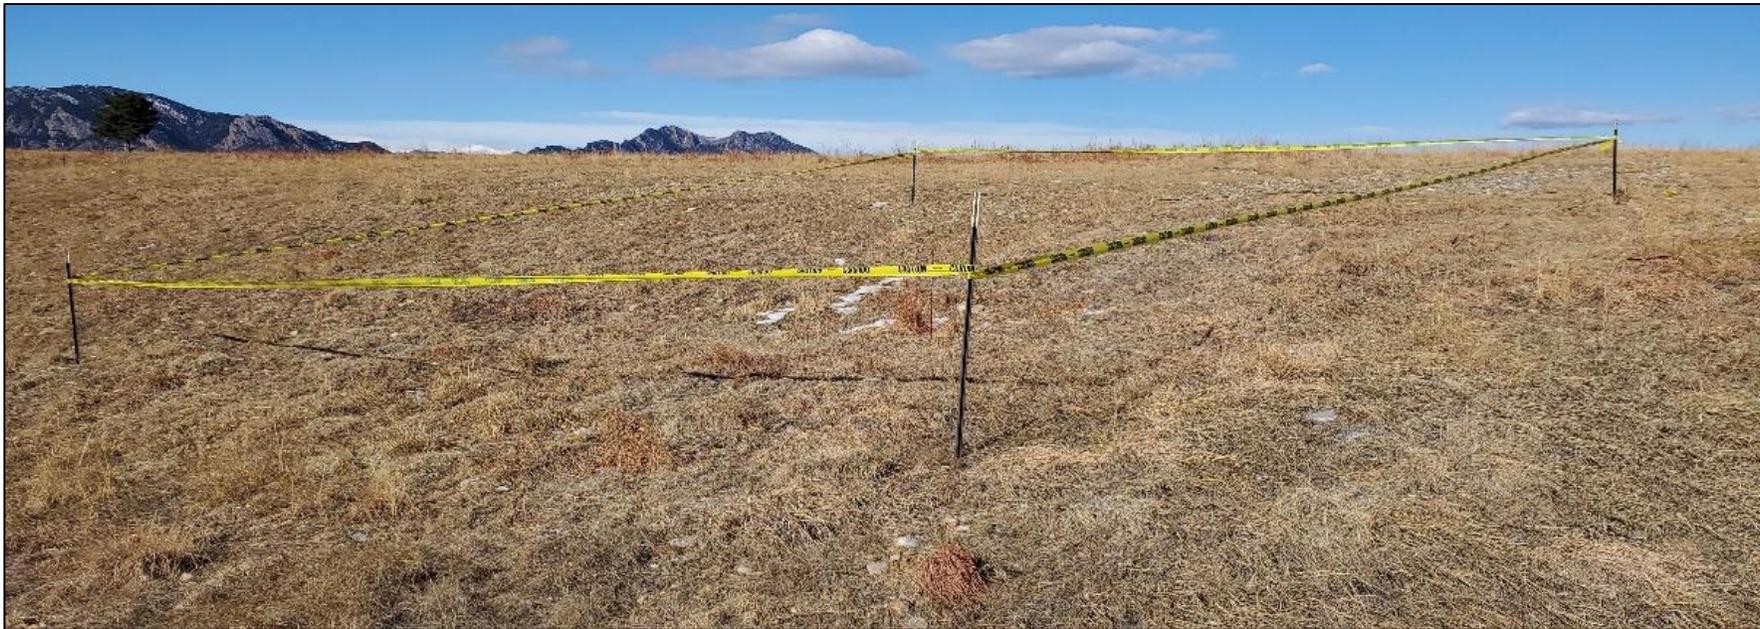
- Third quarter of 2020 inspection of Former Building Areas 371, 771, 881, and 991 was complete on September 24, 2020
  - The depression located near the southeast corner of former building area 881 (December 2019) increased in depth by approx. 3 inches
    - Diameter unchanged (~3.3 ft depth; ~3 ft diameter)

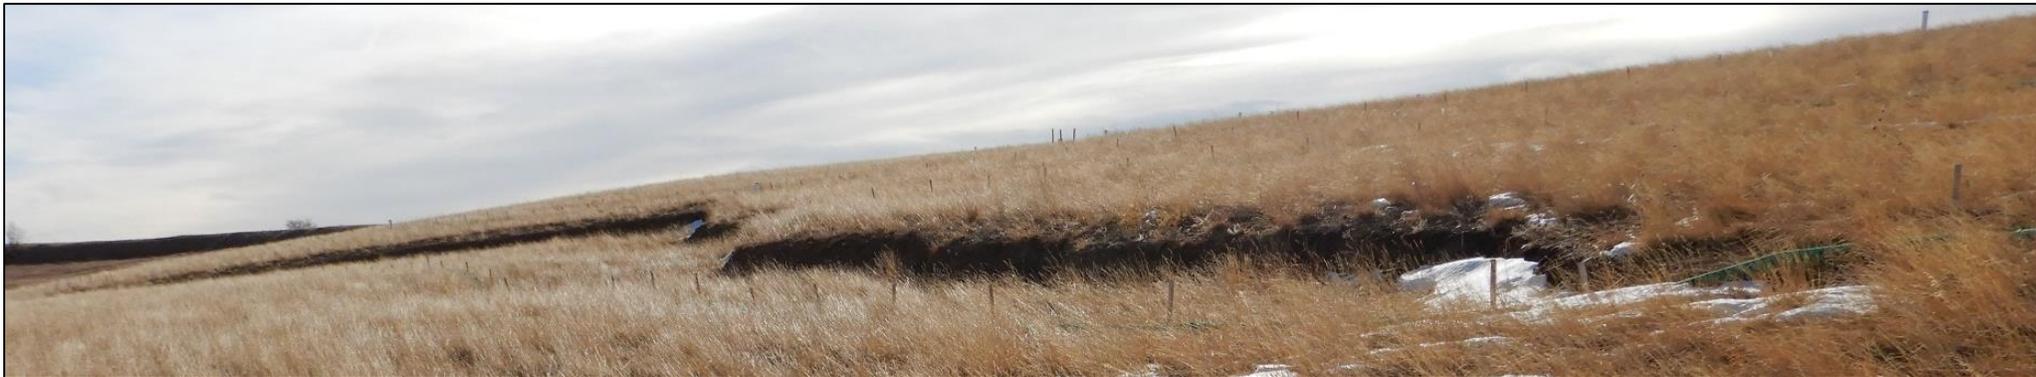
- Continued data collection from piezometers, where possible
- Slump monitoring points are periodically surveyed
  - No substantial change in August
  - Maximum movement approximately 3.5 feet vertically
  - Main scarp crack remains open
