4.0 Sherwood, Washington, Disposal Site

The Sherwood, Washington, Uranium Mill Tailings Radiation Control Act (UMTRCA) Title II Disposal Site was inspected on July 9, 2008. The tailings impoundment, dam, and diversion channel were in good condition. The dam inspection and associated piezometer water level measurements verified that the tailings embankment is functioning as designed. Vegetation monitoring continues in an effort to evaluate the effectiveness of biological control of noxious weeds at the site. Two species of noxious weeds resistant to biocontrol were identified and treated with herbicide. Groundwater monitoring, performed as a best management practice, showed constituent concentrations were significantly less than State of Washington water quality criteria. No cause for a follow-up inspection was identified.

Figure 4-1. 2008 Annual Compliance Drawing for the Sherwood, Washington, Disposal Site

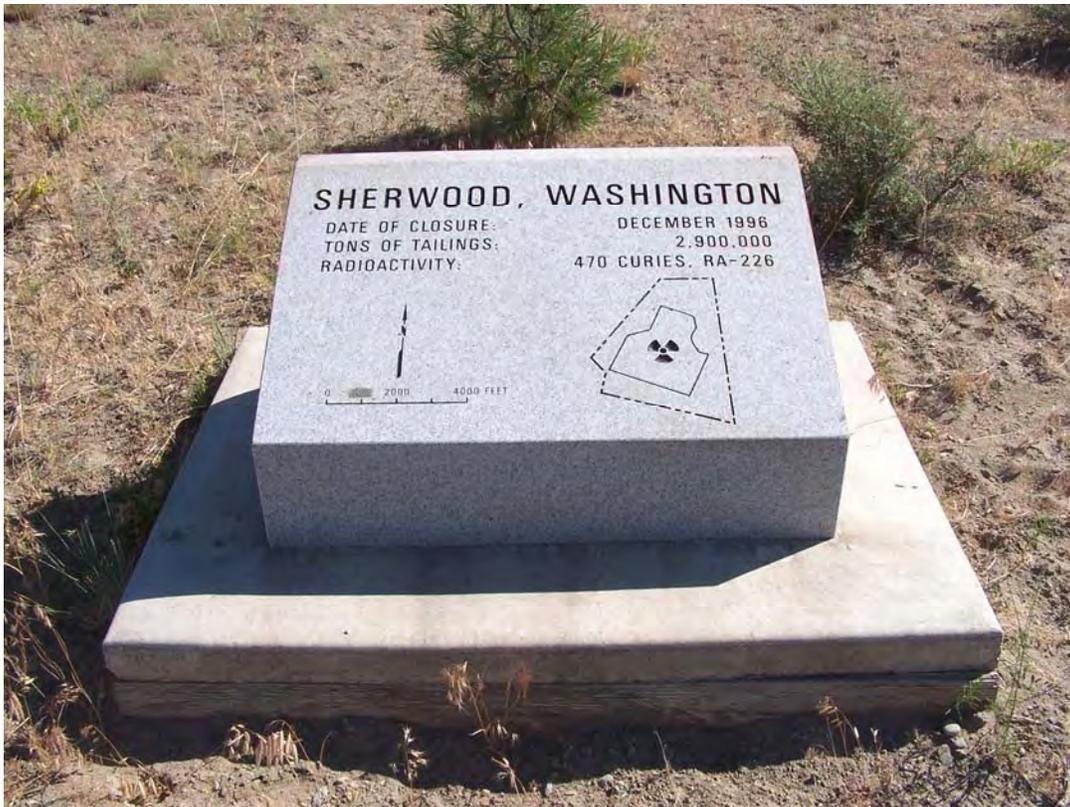
Site Markers and Monuments—One inscribed granite site marker is present on the southwest side of the site where the access road lies closest to the site boundary (PL–1). The marker was in excellent condition.

SHE 7/2008. PL-1. Site marker.

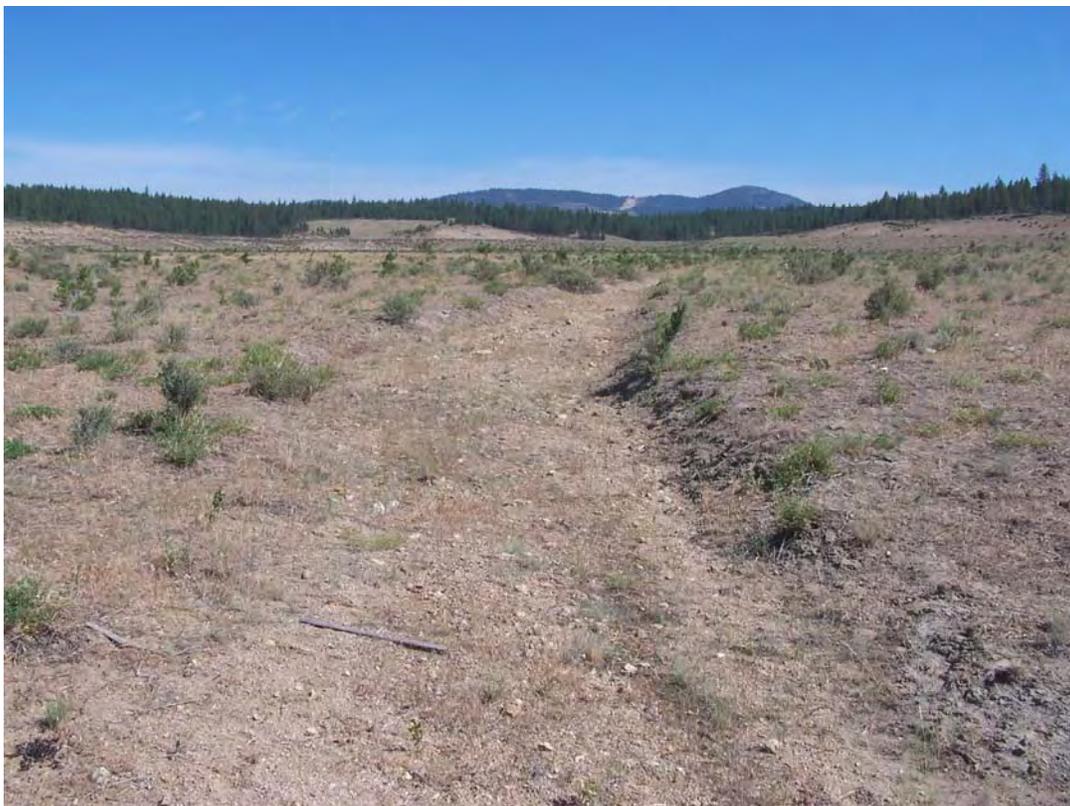
at the base of the riprap-armored swale. No new rills were identified at this location, and the existing rills and gullies are stable. A new small gully was noted adjacent to the dike access road near the outlet of the diversion channel. This gully will be monitored to ensure that sediment does not run off the site.

SHE 7/2008. PL-2. Stable runoff channel east of the tailings dam.

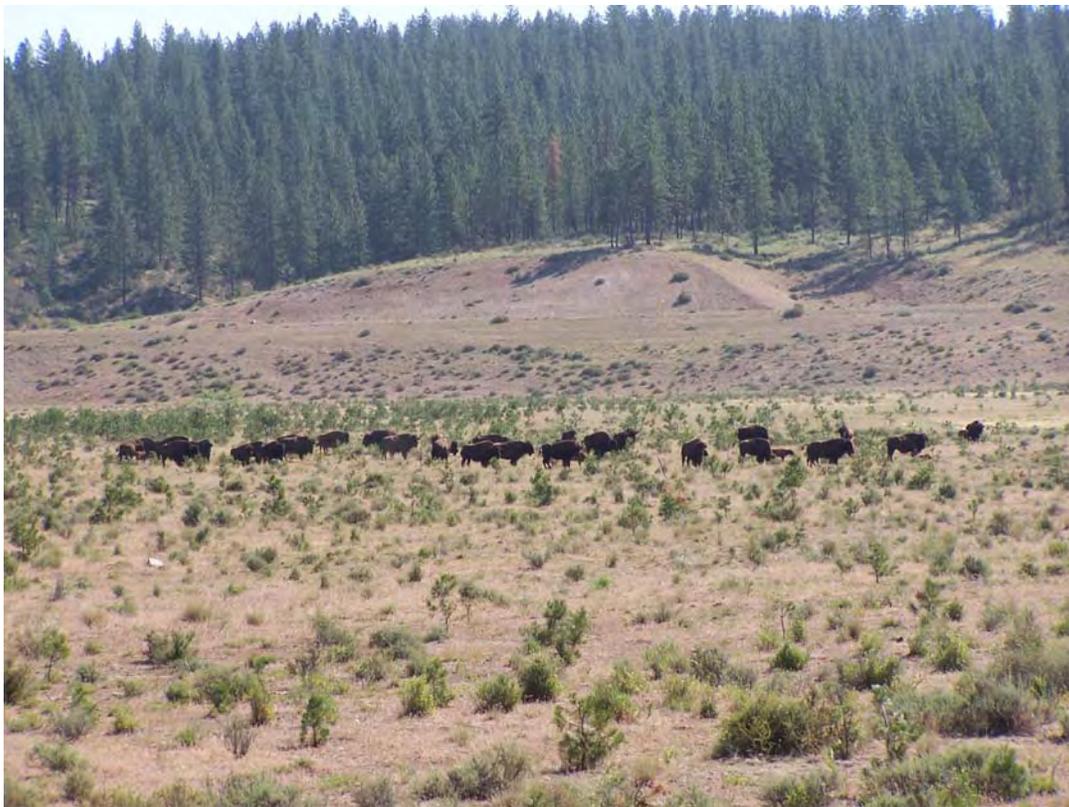
Vegetation in the area of Pond 1 is composed primarily of native wetland species; the other pond areas contain primarily riparian vegetation. The ponds provide habitat for small mammals, birds, amphibians, and reptiles and provide an important water source for larger mammals such as wild horses, deer, elk, bears, coyotes, and buffalo. Buffalo were on the disposal cell during the time of the inspection (PL-3).

SHE 7/2008. PL-3. Buffalo on the disposal cell.

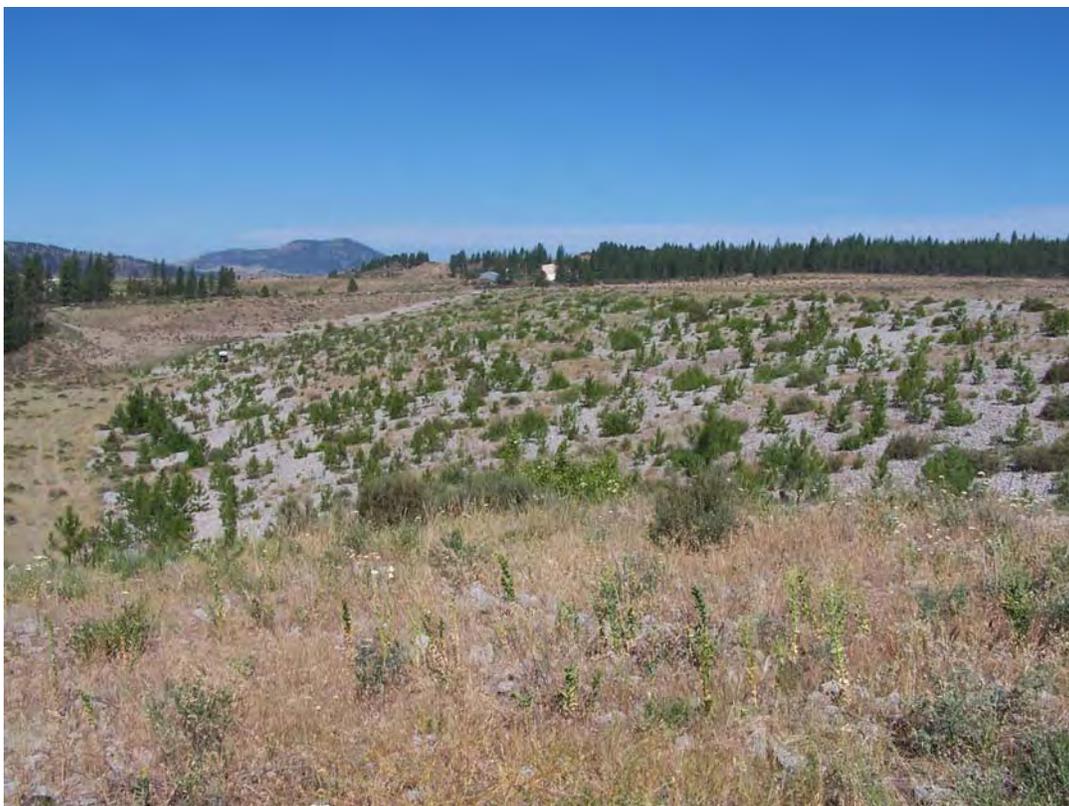
The tailings dam face was designed to allow a vegetative cover, including mature trees, to establish and stabilize the surface and prevent erosion. Consequently, the presence of this vegetation does not negatively affect the function of the dam, and the dam will not be compromised if the rock cover eventually degrades. To out-compete undesirable weeds that were establishing on the face of the dam, seeding with desirable species occurred in fall 2004. Extensive vegetative cover, including Ponderosa pine trees ranging in size from seedlings to 15 feet tall, was observed on the dam face (PL-4 and PL-5). Many seeded species also were observed.

SHE 7/2008. PL-4. Vegetation on the tailings dam face.

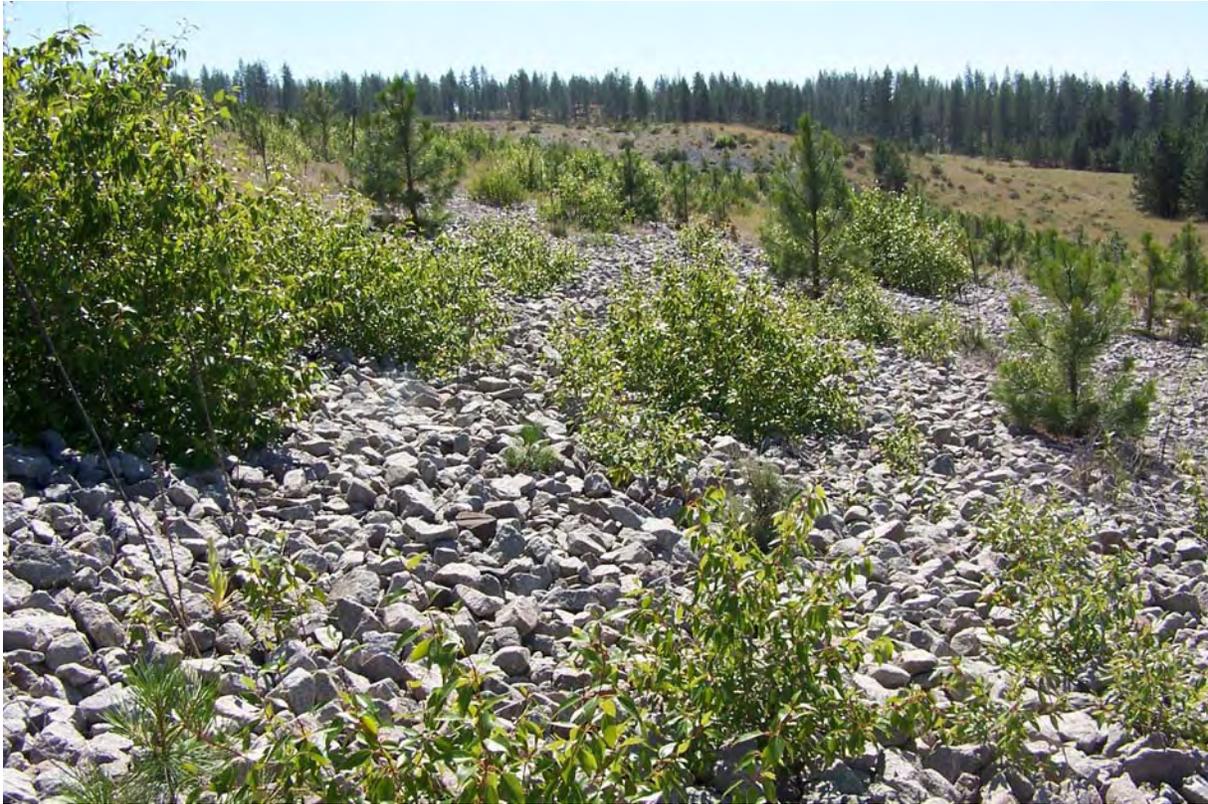
SHE 7/2008. PL-5. View east of vegetation on the tailings dam face.

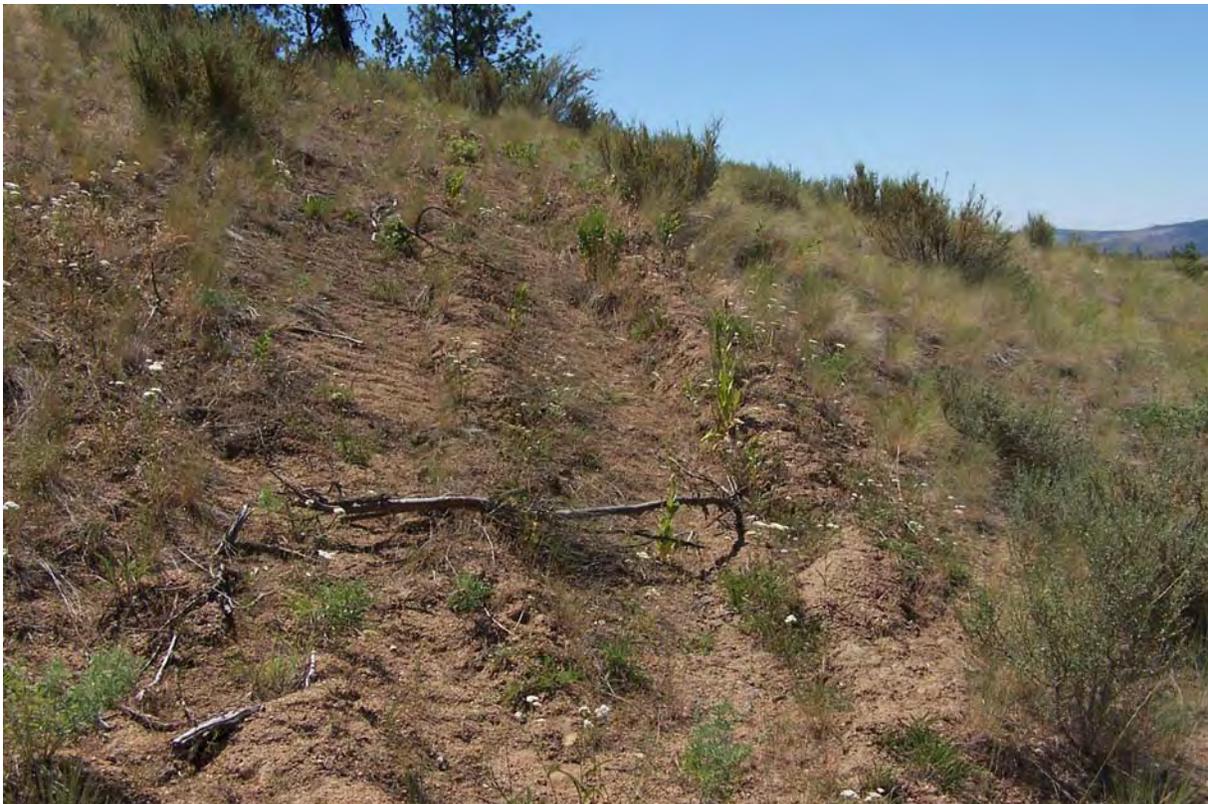
no evidence of trespassing on the site. A damaged area in the northeast corner of the site has not been reclaimed but the vehicle ruts are stabilizing with vegetation (PL-6).

SHE 7/2008. PL-6. Damage by logging equipment on a steep hillside.

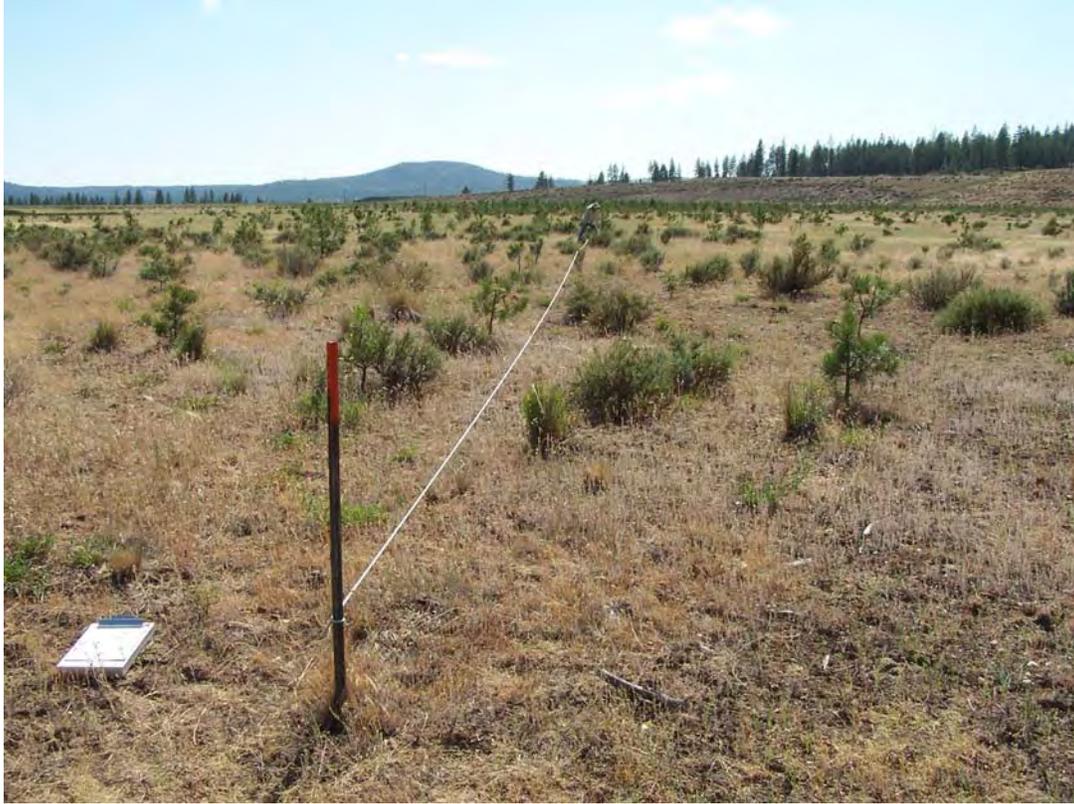
SHE 7/2008. PL-7. Weed monitoring transect WM-10.

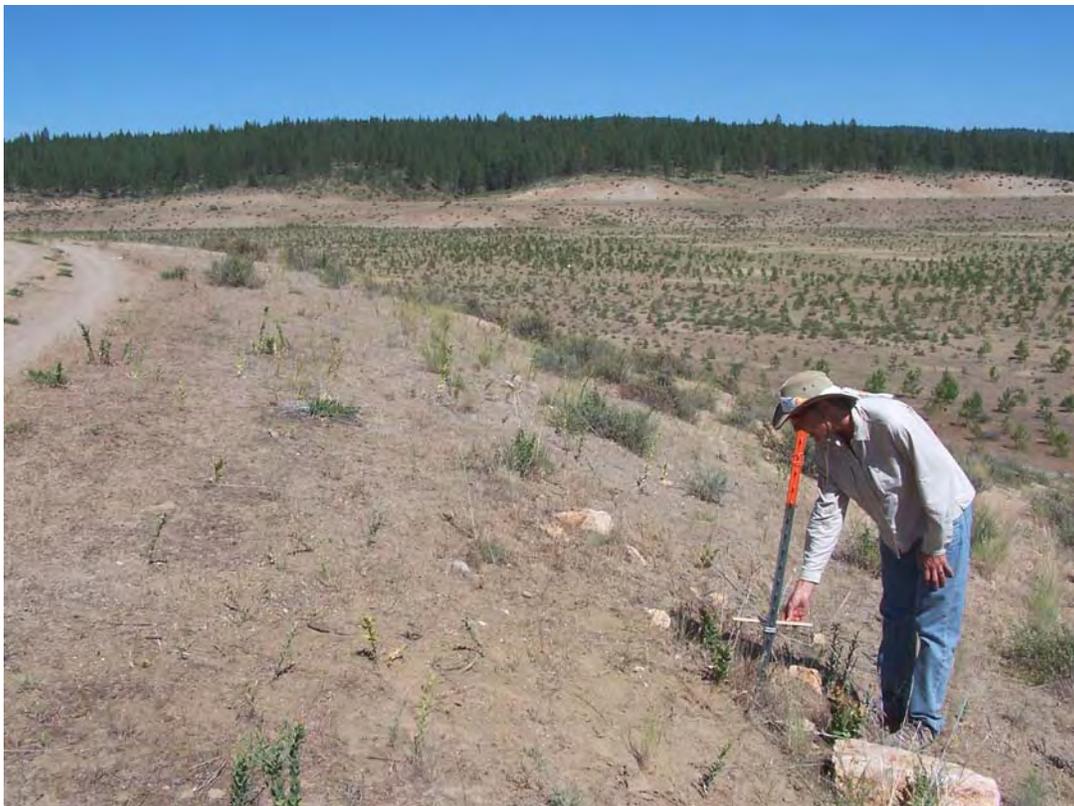
SHE 7/2008. PL-8. Counting weeds at weed monitoring transect WM-4.

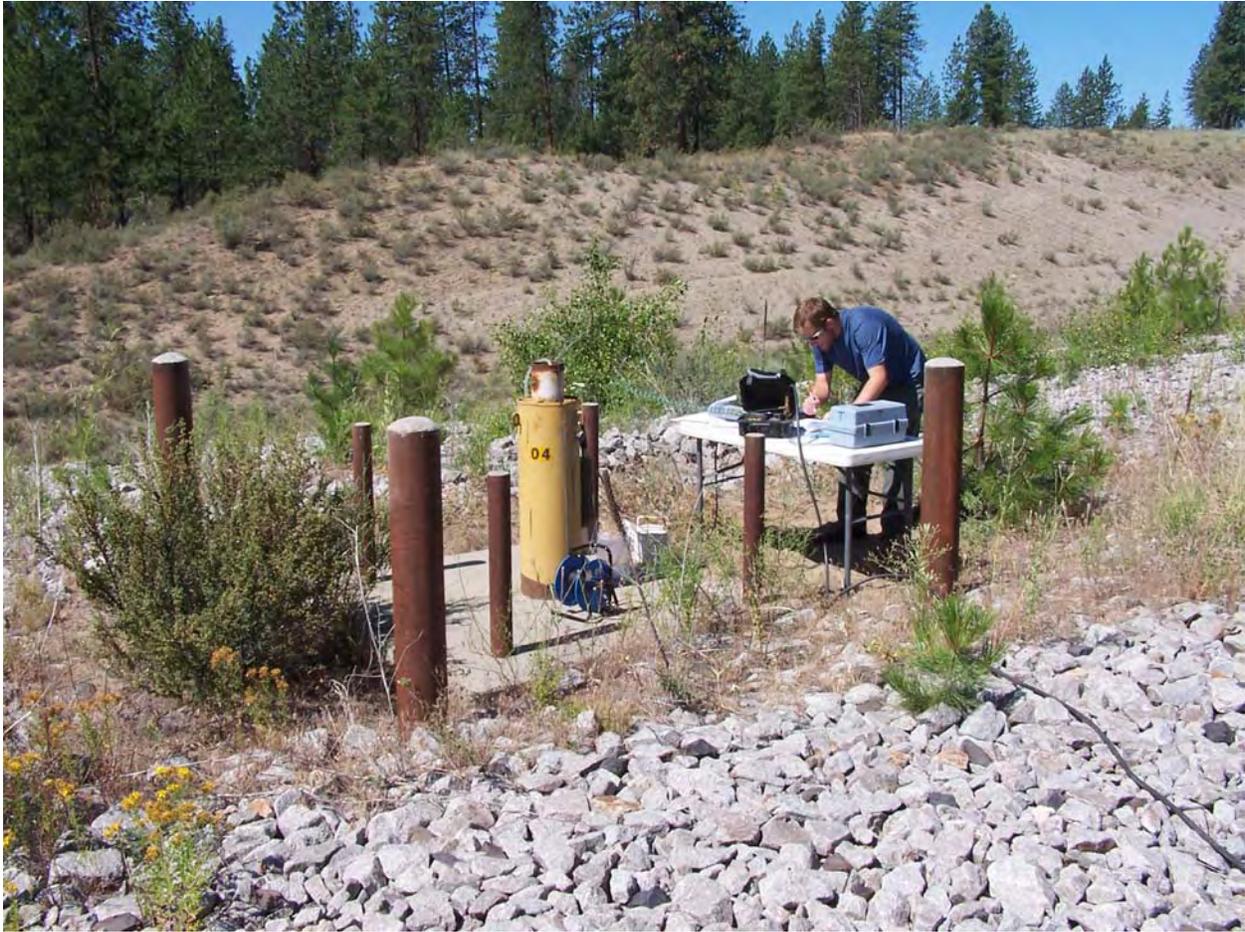
Groundwater sampling was conducted on the same day as the inspection (PL-9), and the results are presented in Table 4-2. Groundwater constituent concentrations were consistent with previous years and continue to be significantly less than the action levels for confirmatory sampling.

SHE 7/2008. PL-9. Sampling activity at monitor well MW-4.
