5.0 Sherwood, Washington, Disposal Site

5.1 Compliance Summary

The Sherwood, Washington, Uranium Mill Tailings Radiation Control Act (UMTRCA) Title II Disposal Site (site) was inspected on August 19, 2020. The disposal cell, containment dam, and associated drainage features were functioning as designed. Inspectors replaced one missing perimeter sign. No additional maintenance needs or cause for a follow-up inspection were identified.

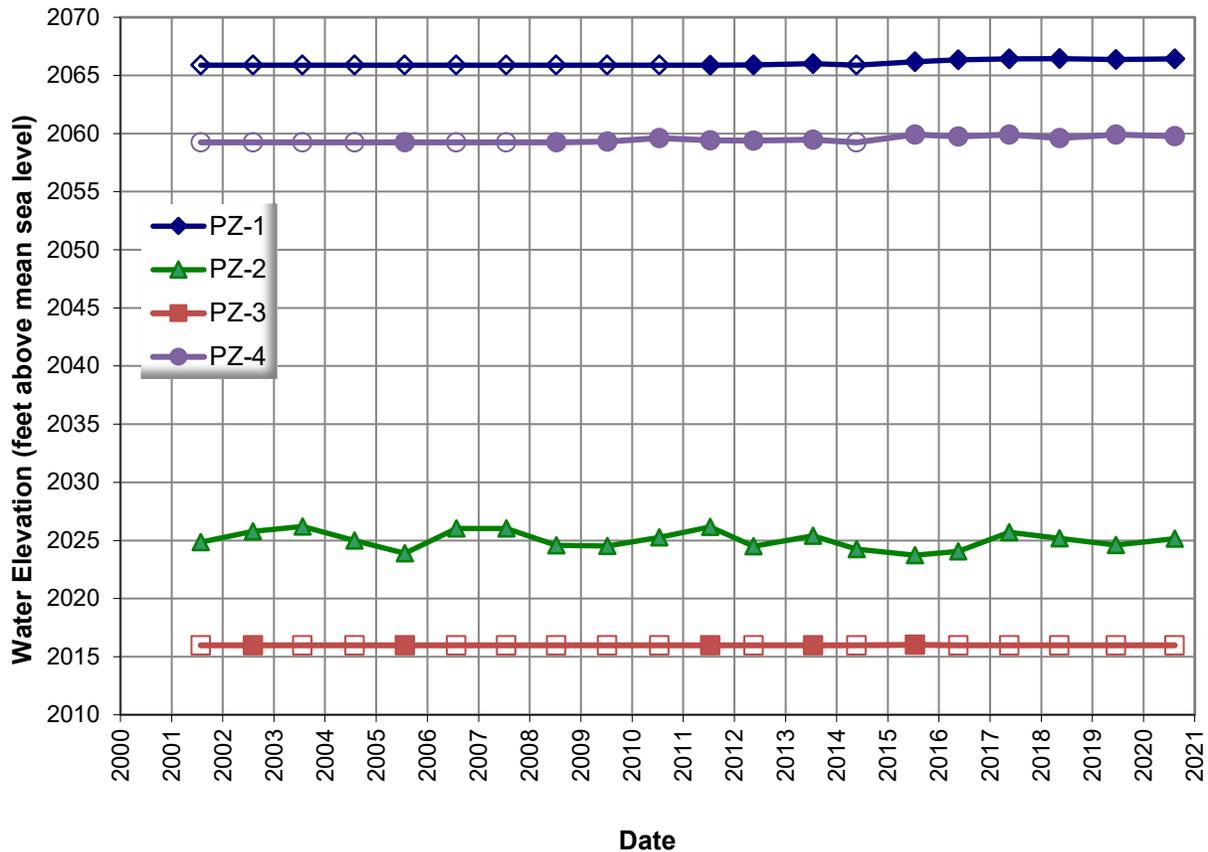
Figure 5-2. Sherwood Piezometer Water Elevations

Measurements of water levels in four piezometers atop the containment dam are collected during the annual groundwater sampling events as part of the annual dam inspection. These annual measurements, collected since the piezometers were installed in 2000, provide a direct means of determining moisture conditions in the containment dam. Steadily increasing water levels in any of the piezometers could indicate a potential problem with the dam’s performance. Measurements collected on August 11, 2020—provided in Table 5-2, Figure 5-2, and the attached *Dam Inspection Checklist*—do not indicate an increase in water levels. Variations in the amount of water in the four piezometers are thought to be seasonal responses to precipitation. The minor amount of water in piezometer PZ-2 is the result of a small, perched lens of water that exists because of localized differences in permeability. While the lateral extent of the lens is unknown, it is estimated, based on water levels in piezometer PZ-2 and monitoring wells 4 and 10, that more than 200 ft of unsaturated material is beneath the piezometer PZ-2 perched zone. On the basis of the recent water levels observed in the piezometers and monitoring wells, the containment dam is considered to be unsaturated.

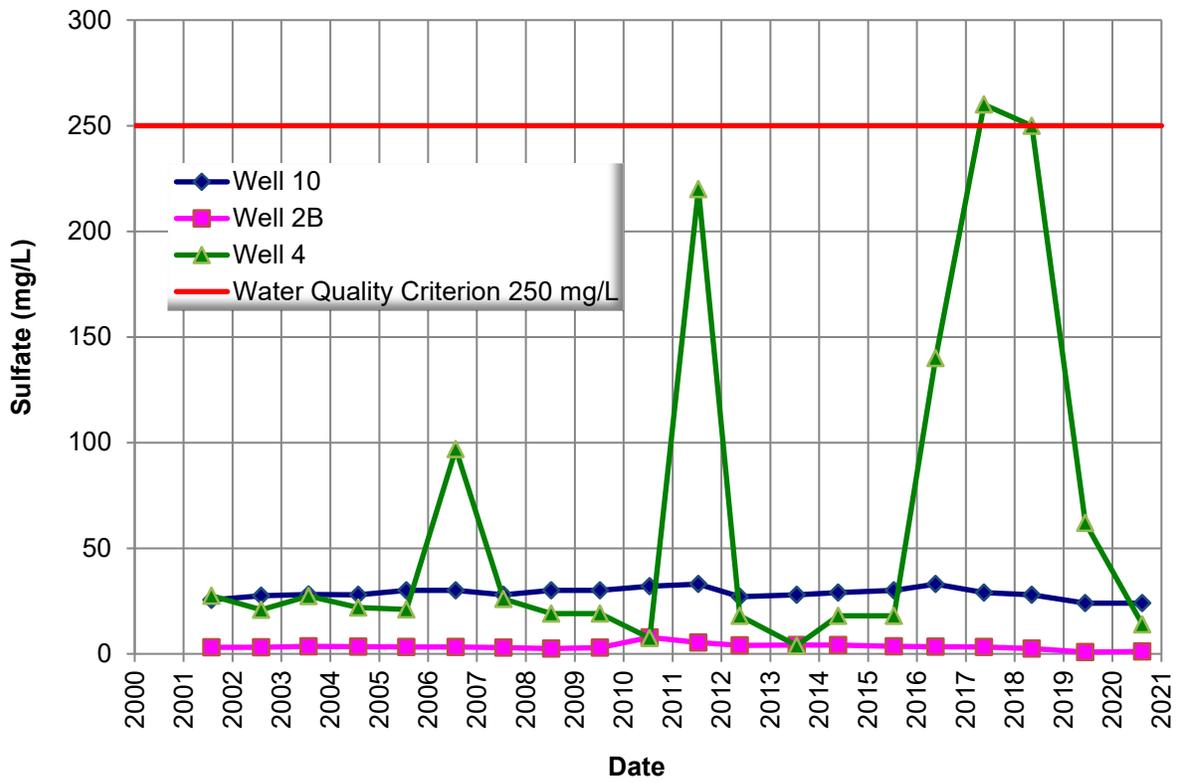
Figure 5-5. Sulfate Concentrations at the Sherwood, Washington, Disposal Site

An evaluative monitoring plan and consultations were not required as there was no exceedance in 2020 (24 mg/L); evaluation of the elevated sulfate values in 2017 (260 mg/L) and 2018 (250 mg/L) indicated the elevated values were related to higher-than-normal precipitation in the area, which caused higher-than-normal groundwater elevations (Kreie 2018). The issue of elevated sulfate spikes in monitoring well 4 had previously been identified by the State and documented as unrelated to the disposal cell.

Increases in water table height in the 2B and 4 wells correspond with the elevated levels of chloride and sulfate measured in well 4 in 2006 and 2011 and from 2016 to 2018. As noted by the Washington State Department of Health in the February 2000 *Sherwood Uranium Mill Project, Technical Evaluation Report, Monitoring and Stabilization Plan Supplement* (WDOH 2000), “One of the downgradient point-of-compliance wells, 4, has seasonal variation in water quality, represented by late spring and summer peaks that are consistent with annual infiltration and the rise in static water levels. This seasonal trend has been evaluated closely and ground water monitoring increased as established by the MSP [Monitoring and Stabilization Plan].” Annual precipitation totals measured in Spokane, Washington, show a correlation with the increased sulfate and chloride concentrations. Years with higher precipitation totals are also years with higher sulfate concentrations.

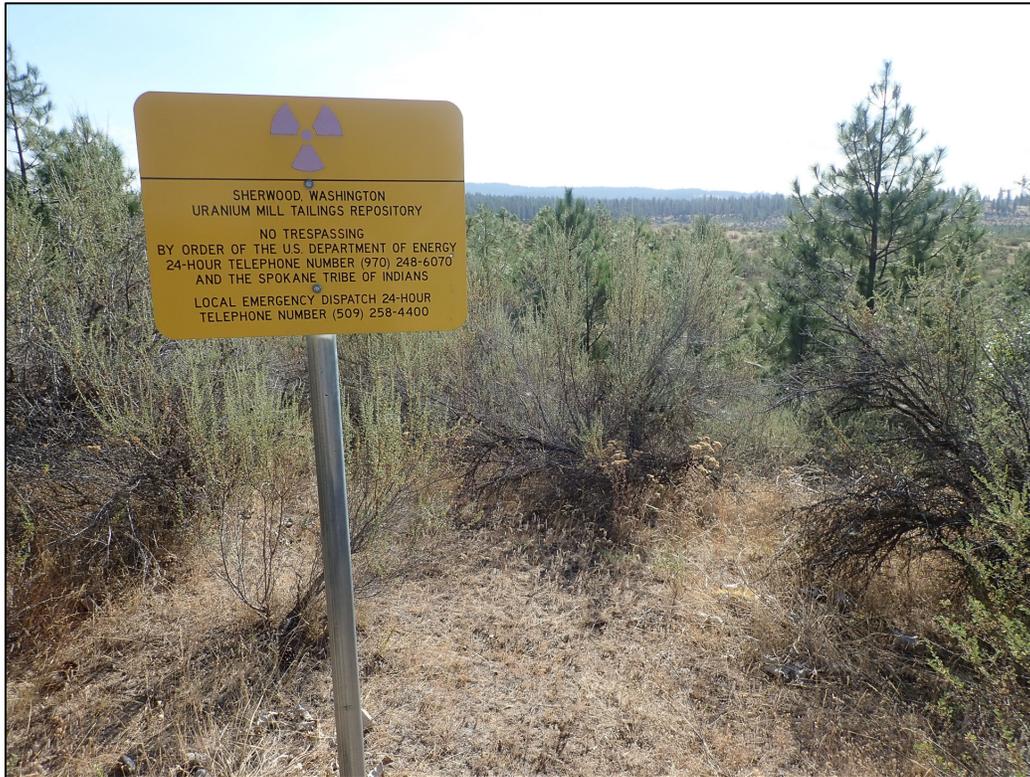
PL-1. Perimeter Sign P5

There are six warning or perimeter signs, attached to steel posts set in concrete, positioned along the site boundary at likely access points around the site (PL-1). Perimeter sign P6 was missing and was replaced during the inspection. No additional maintenance needs were identified.

Perimeter sign P6 was identified as missing and was replaced during the inspection. No additional routine maintenance needs were identified.

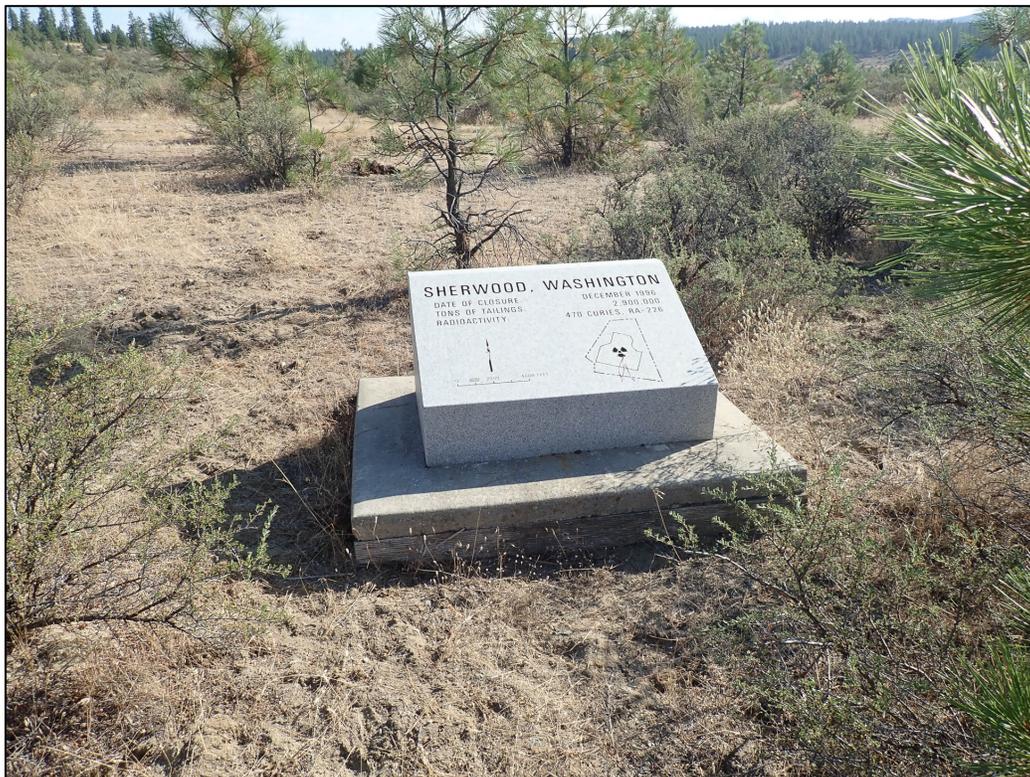
PL-2. Site Marker

There is one granite site marker on the southwest side of the site where the access road lies closest to the site boundary (PL-2). No maintenance needs were identified.

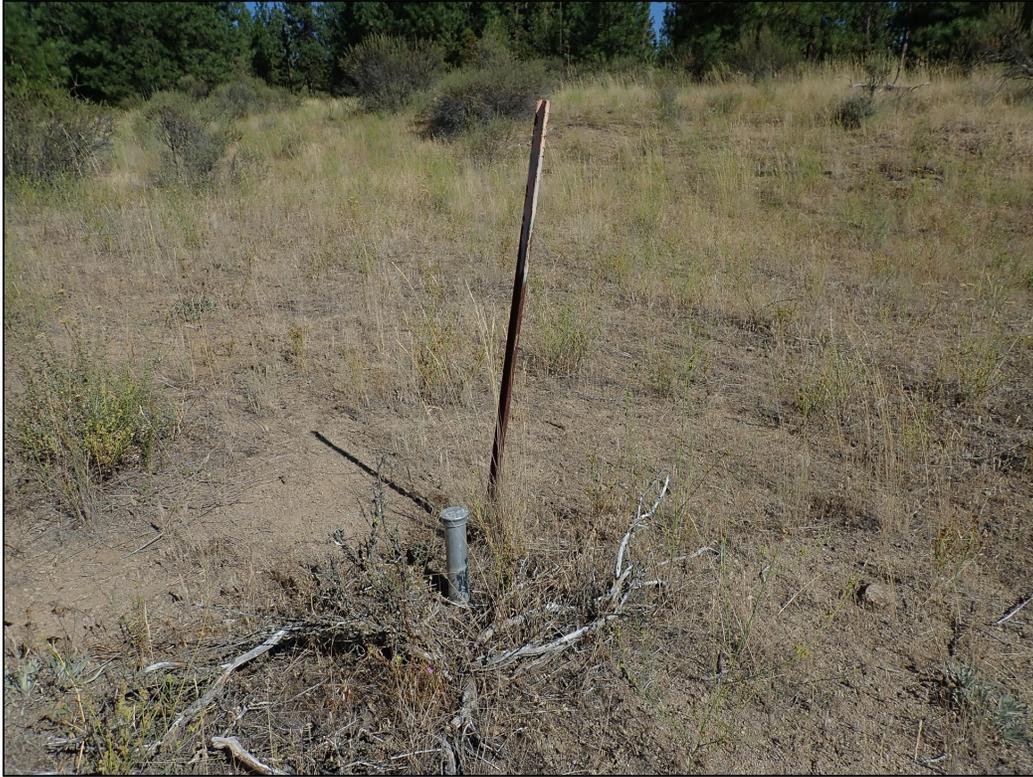
PL-3. Boundary Monument BM-5

Six boundary monuments set in concrete define the site boundary. Because surrounding vegetation has made it difficult to locate some of the monuments, metal T-posts were installed at each monument location (PL-3). All boundary monuments were inspected. No maintenance needs were identified.

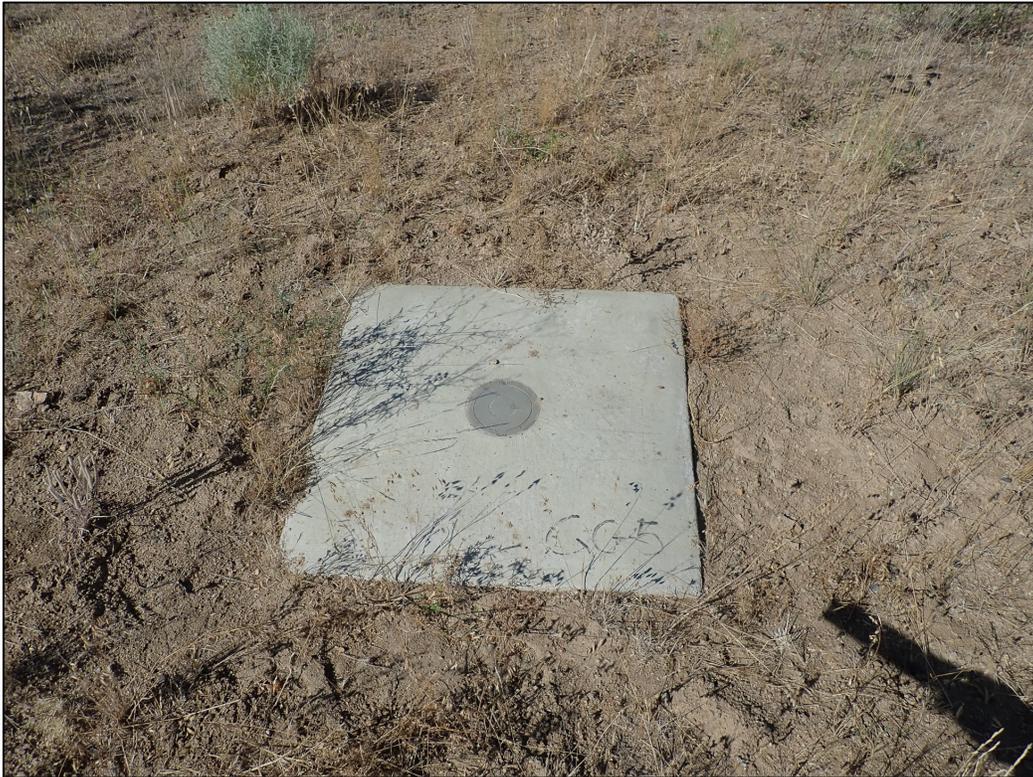
PL-4. Quality Control Monument QC5

Eight aerial survey quality control (QC) monuments, installed in 2019, were inspected during the 2020 inspection (PL-4). No maintenance needs were identified.

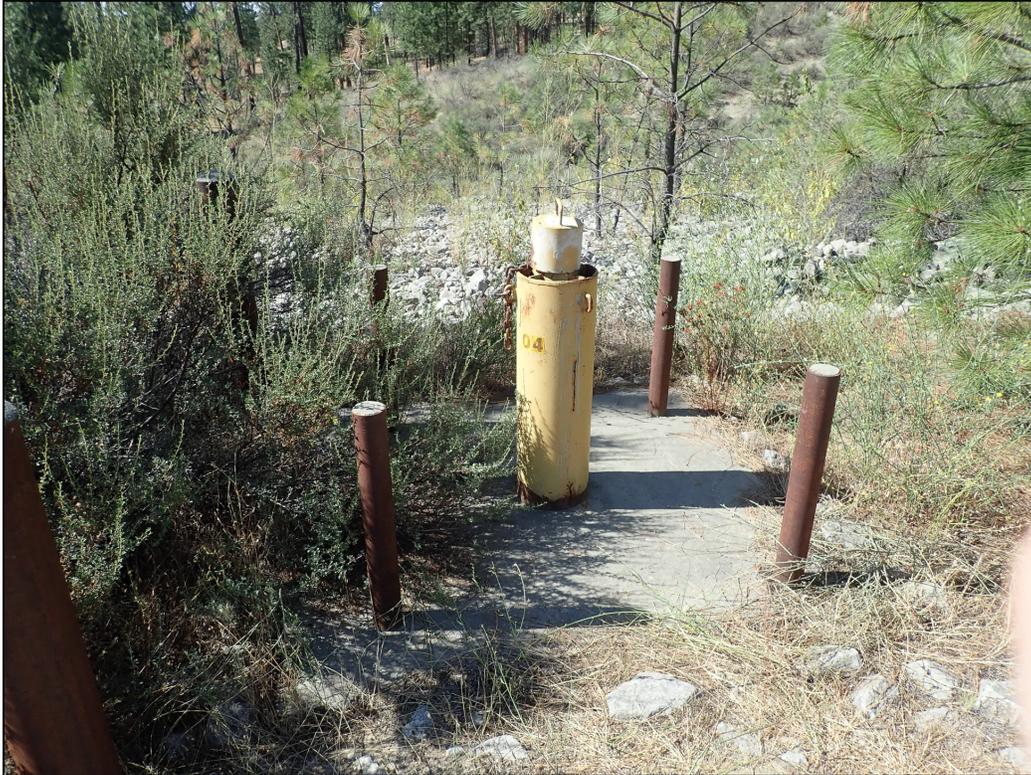
PL-5. Monitoring Well 4

The site groundwater monitoring network consists of monitoring wells 2B, 4, and 10 (PL-5). As part of the dam safety inspection program, four piezometers, designated piezometers PZ-1 through PZ-4, were installed in November 2000 along the crest of the containment dam at a depth equivalent to the base of the dam. All piezometers and wellhead protectors were undamaged and locked. No maintenance needs were identified.

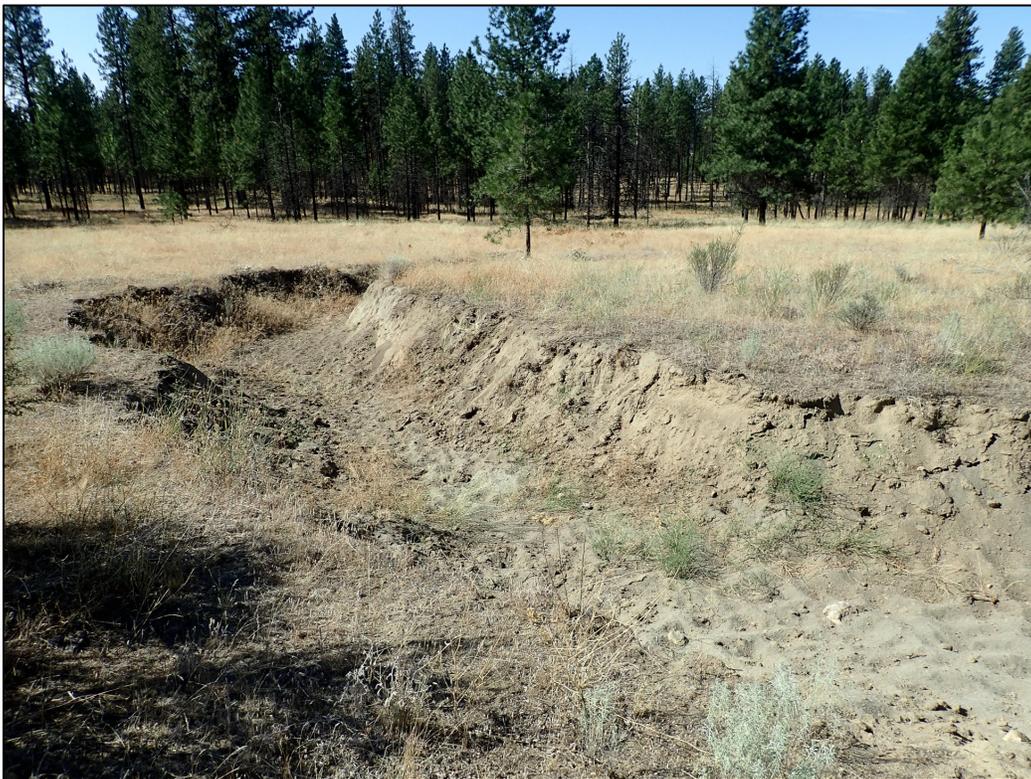
PL-6. Gully Downgradient of Riprap-Armored Swale (Near Perimeter Sign P1)

A gully offsite, downgradient of the riprap-armored swale near perimeter sign P1, was first observed in 2009. The gully is photographed periodically to monitor its development (PL-6). Although erosion continues to occur because of site drainage effects, the gully appears to be stabilizing as its grade reaches equilibrium with the surrounding topography. The gully is not impacting site features or access but will continue to be monitored. No maintenance needs were identified.

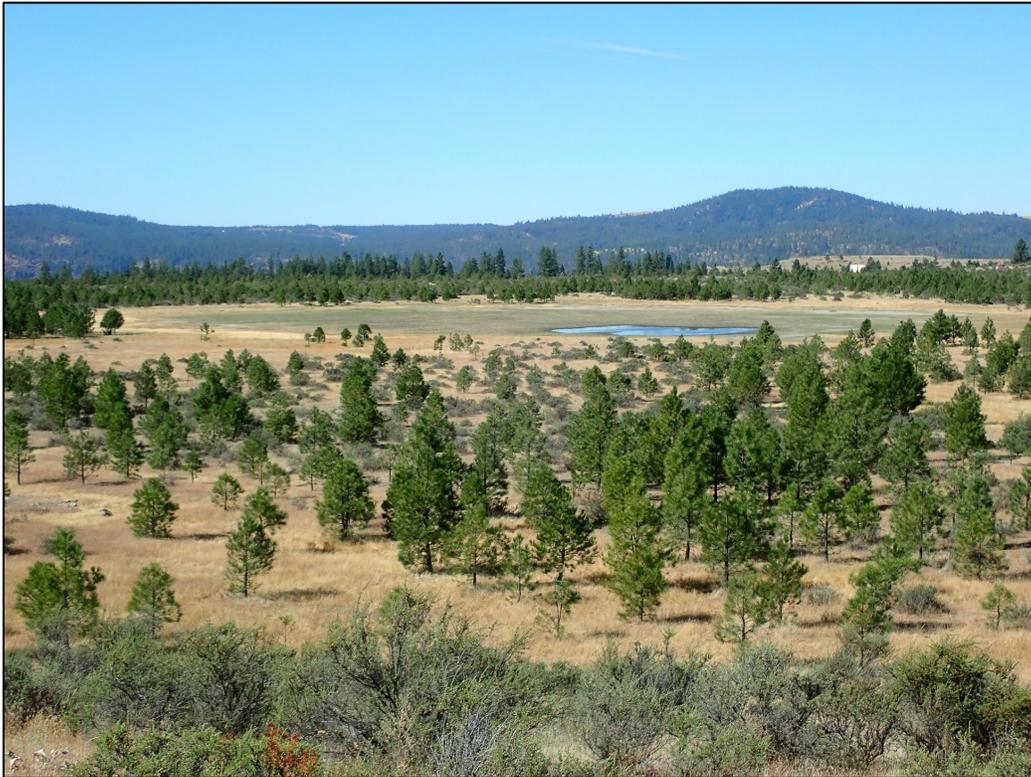
PL-7. Disposal Cell, View Southwest

The disposal cell, completed in 1996, occupies 100 acres. The cover consists of 12 to 20 ft of uncompacted soils. During site reclamation, the surface was seeded and planted with native shrubs, forbs, grasses, and trees (PL-7).

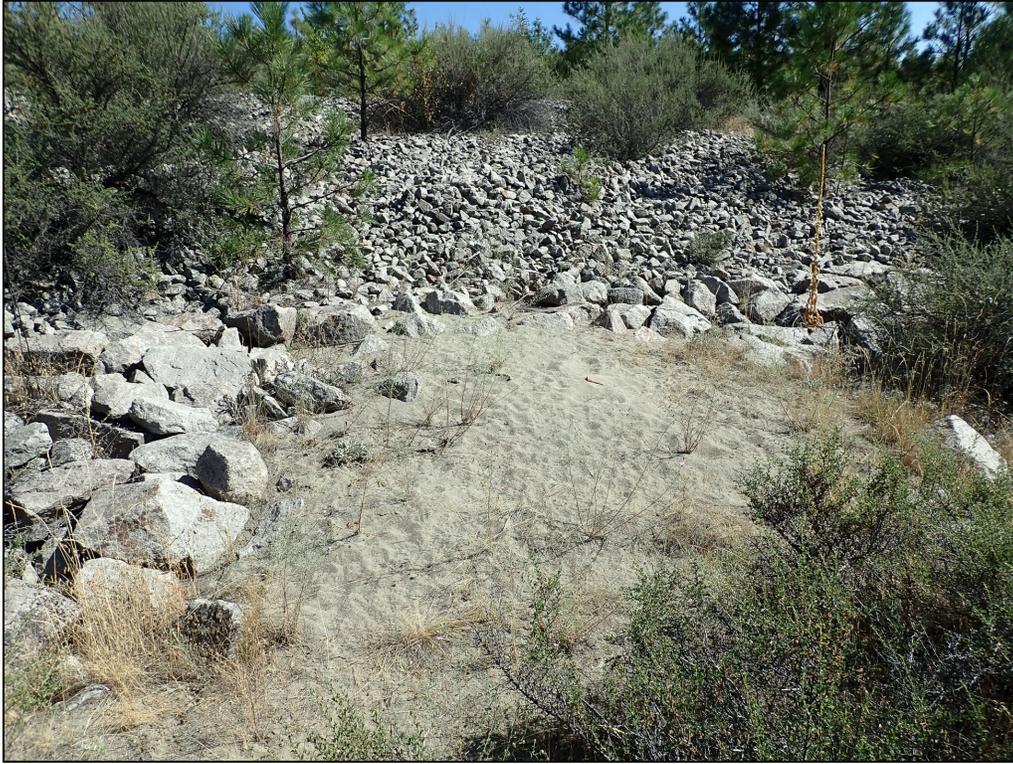
PL-9. Sand Deposit at Toe of Containment Dam Outslope

During the 2016 annual inspection, one location at the base of the rock-covered containment dam face was found to have a deposit of sand that had washed out from underneath the rock cover, as evidenced by a shallow rock-filled erosion feature upgradient of the deposit (Figure 5-1). A subsequent follow-up inspection and evaluation identified that the sandy material was the same as natural undisturbed material nearby. During reclamation, this area of the site was used as a source for fill material used to contour the area below the toe of the containment dam. Review of

original reclamation and as-built drawings showed that the toe of the containment dam is upslope from the area of erosion, which was confirmed during the follow-up investigations. Therefore, it was concluded that the sand deposit location is in a portion of the dam defined as the outslope in the construction completion report and does not impact the containment dam (DOE 2018b).

The sand deposit location was examined during the inspection, and there was no apparent change in the deposit or the upgradient erosion feature (PL-9). The area will be visually monitored during future inspections and by periodic aerial remote sensing surveys. Repair options will be evaluated and implemented, in consultation with NRC, if the erosion area increases such that the containment dam could be affected.

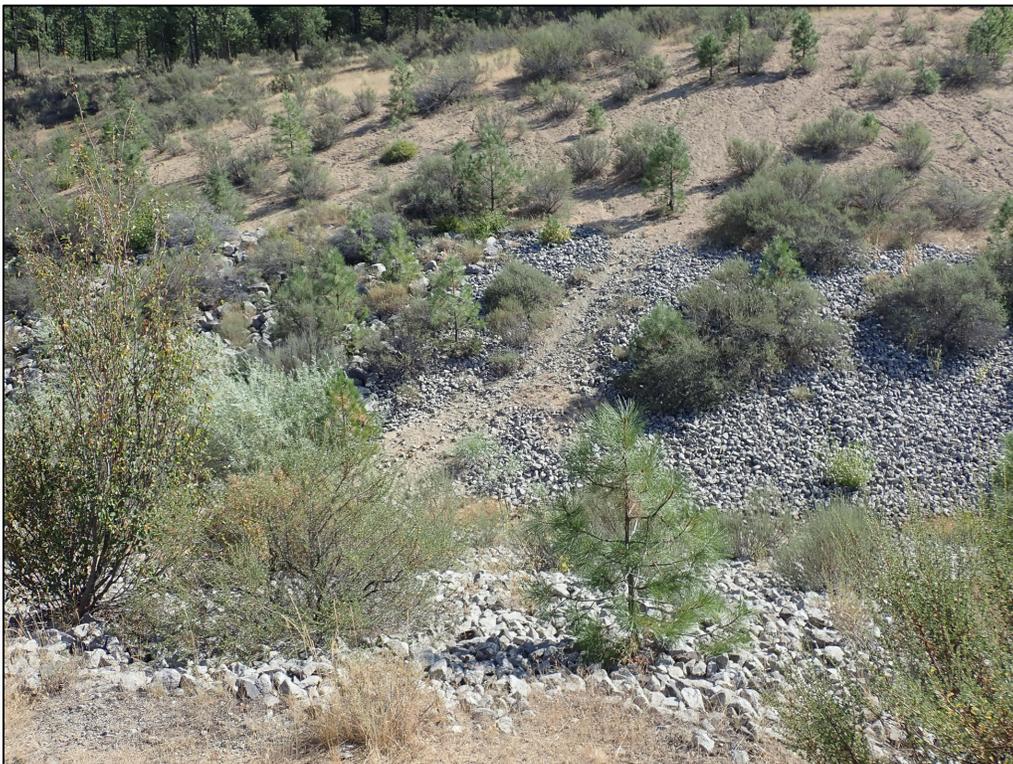
PL-10. Diversion Channel with Wildlife Trail

A riprap-armored diversion channel surrounds the disposal cell and diverts runoff away from the disposal cell surface. The diversion channel was designed to allow trees to grow and stabilize the surfaces, and the presence of trees in the diversion channel is not expected to hinder the diversion channel's ability to convey design flows. The establishment of volunteer plants, including trees, is evident in most areas of the diversion channel. Sediment deposition is found in places on the west leg of the diversion channel but does not interfere with the diversion channel's design function. Upslope areas that have contributed to the sedimentation have stabilized with vegetation. Wildlife trails cross the diversion channel at numerous locations and have displaced the diversion channel riprap in several places (PL-10). These disturbances will be visually monitored for erosion but are not in areas that would impact the disposal cell. No evidence of erosion was observed downgradient of the diversion channel outlet. No maintenance needs were identified.
