Post-Closure Inspection Report for the Tonopah Test Range and Nevada Test and Training Range, Nevada

For Calendar Year 2018

May 2019

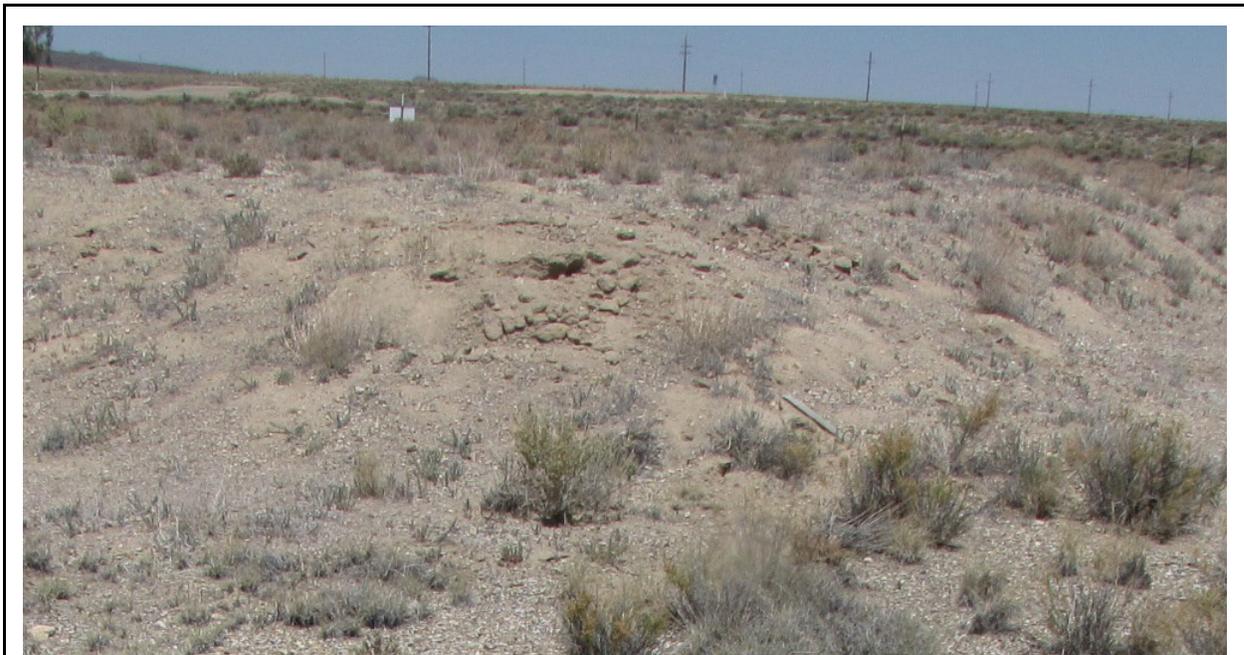
The annual visual inspection was conducted on June 26, 2018. The cover near the southeast corner was disturbed by animal burrowing activities. The cover was repaired during the week of October 8, 2018. Vegetation status appeared to be similar to the vegetation status in the surrounding area.

A new badger hole is located near hole from last year (~10' away). The signs and fence are in good condition. Vegetation is similar to surrounding vegetation.

**Figure E-1
 CAU 407, Facing Northwest, Animal Burrow**

An animal burrow was identified in southeast portion of the cover during the June 26, 2018, inspection. The site was repaired during the week of October 8, 2018. Annual post-closure inspections should continue as scheduled.

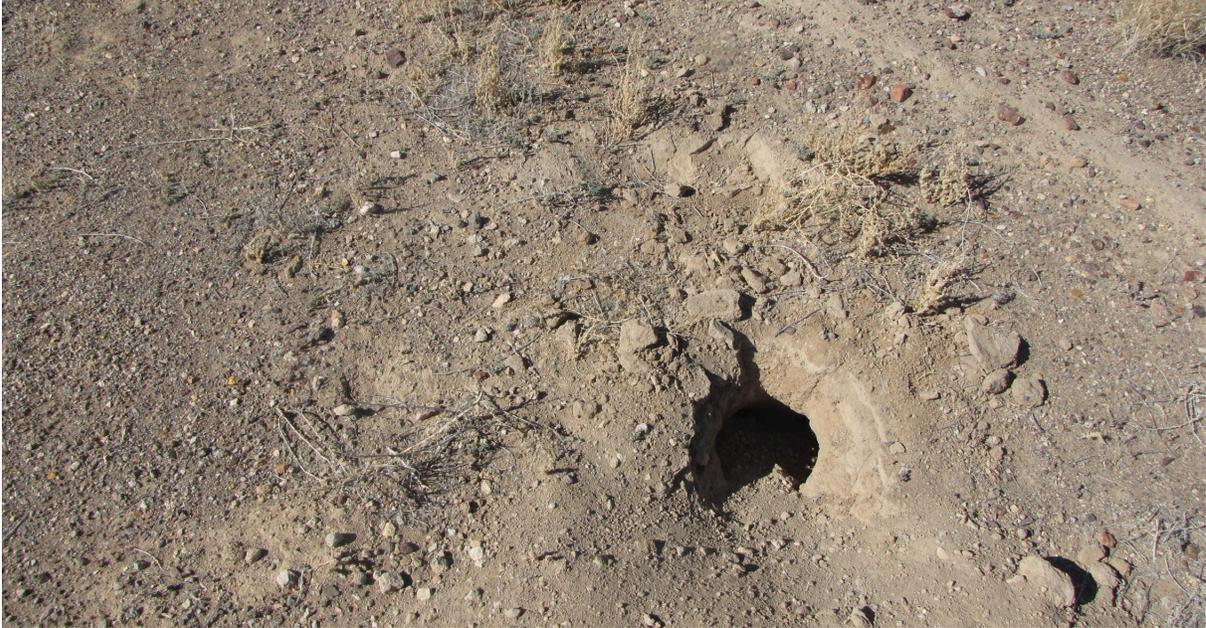
Landfill Cell A3-1 (CAS 03-08-001-A301): Animal burrows were found next to the southwest monument. The cover was repaired during the week of October 8, 2018. No other issues or concerns were identified, and no additional maintenance or repairs were required. Annual visual inspections should continue as scheduled. The site is shown in [Figure A-5](#) of [Appendix A](#).

Generally the site is in good condition, large burrow entrances next to SW monument. No other issues.

Figure E-2
CAU 424, Landfill Cell A3-1, Facing Ground, Animal Burrow

- *Landfill Cell A3-1 (CAS 03-08-001-A301)*. An animal burrow was identified next to the southwest monument. The site was repaired during the week of October 8, 2018. Annual visual inspections should continue as scheduled.

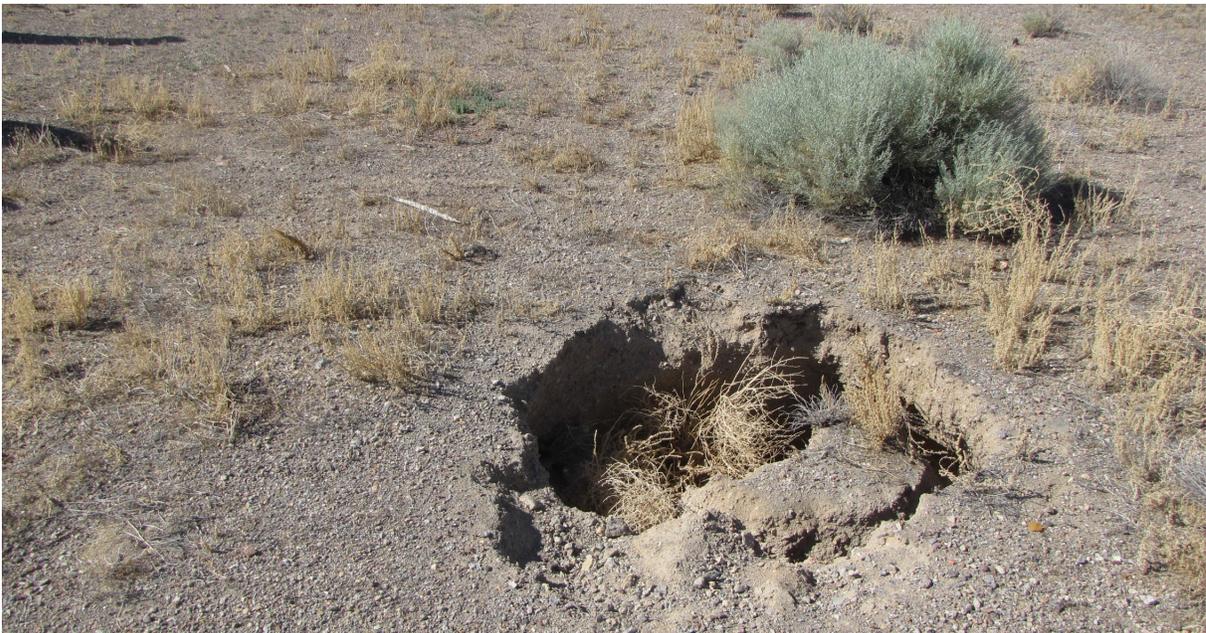
Landfill Cell A3-2 (CAS 03-08-002-A302): Road maintenance waste (ditch scraping) was piled on the cell (south center), and a subsidence hole was identified near the south center of the cell as well. The subsidence hole was approximately 5 feet across. The cover was repaired during the week of October 8, 2018. No other issues or concerns were identified, and no additional maintenance or repairs were required. Annual visual inspections should continue as scheduled. The site is shown in [Figure A-5](#) of [Appendix A](#).

Figure E-3
CAU 424, Landfill Cell A3-2, Facing Ground, Subsidence Hole

- *Landfill Cell A3-2 (CAS 03-08-002-A302)*. Road maintenance waste was piled on the cell (south center), and a subsidence hole (south center) was also identified. The site was repaired during the week of October 8, 2018. Annual visual inspections should continue as scheduled.

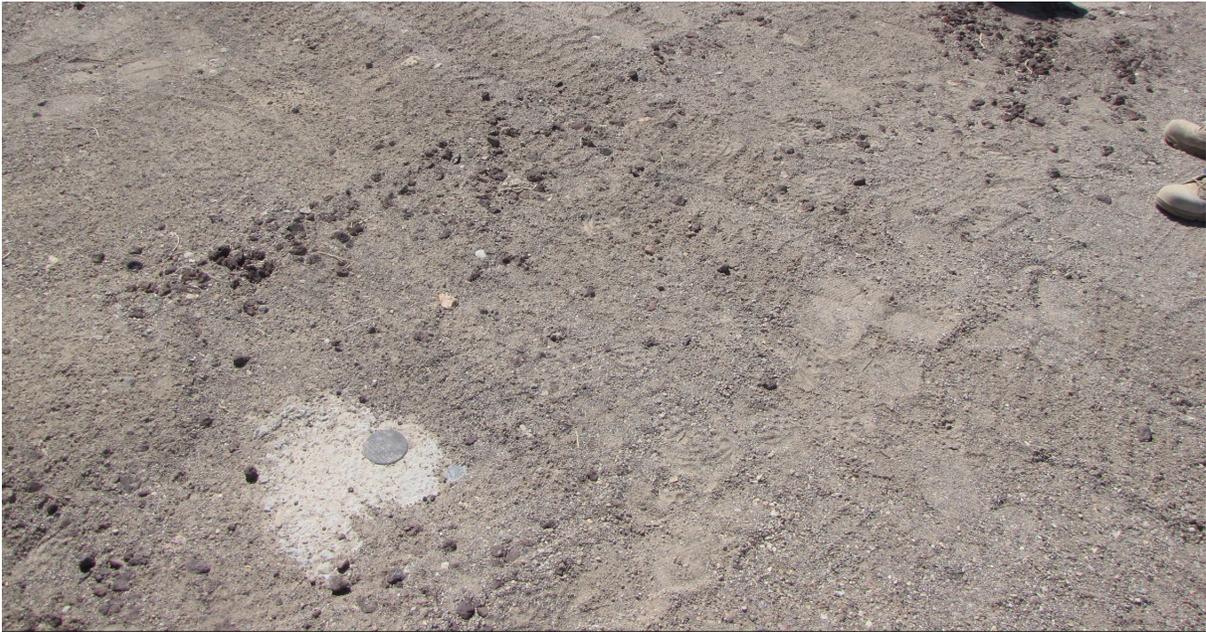
Landfill Cell A3-3 (CAS 03-08-002-A303): Additional marking rock (lava rock) is needed to supplement the marking rock at the ground surface monuments associated with the triangular portion of the CAS. Lava rock was added during the week of October 8, 2018. No problems were noted on the rectangle portion of the CAS. No other issues or maintenance repairs were noted. Annual visual inspections should continue as scheduled. The site is shown in [Figure A-6](#) of [Appendix A](#).

Figure E-4
CAU 424, Landfill Cell A3-3, East Cell, Facing Ground, Lack of Lava Rock

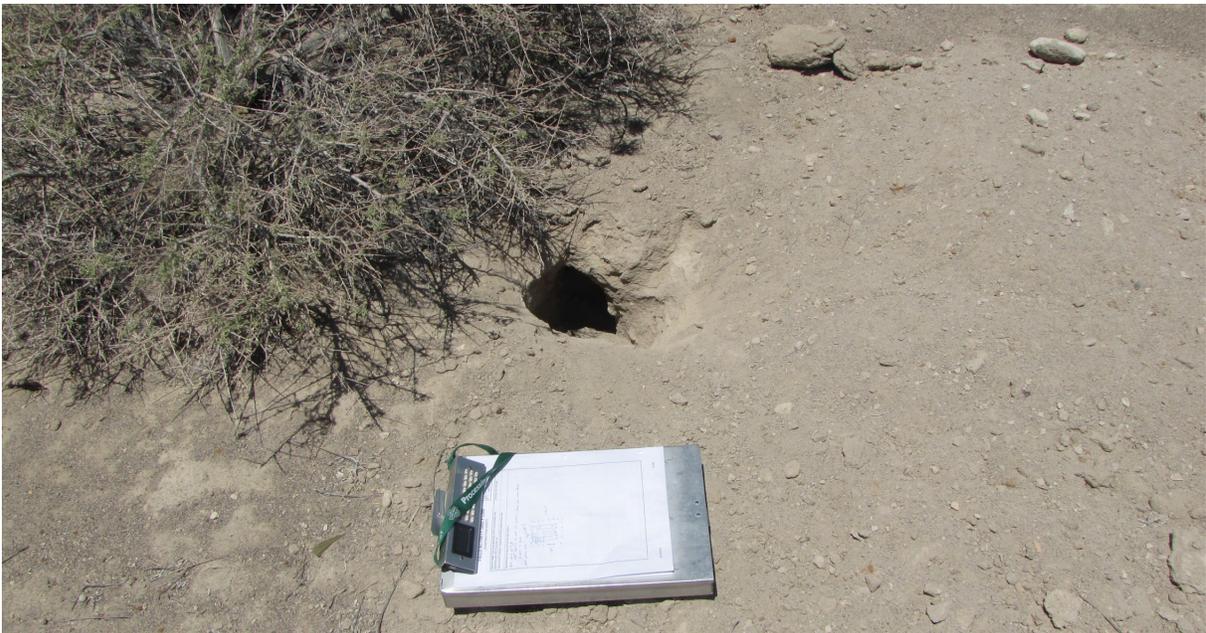
- **CAU 453**, CAS 09-55-001-0952 (Area 9 Landfill): Three animal burrows were observed in each of the waste trenches. Also, the soil mound to the west of the trenches had deep runnels along the west side. The covers and soil mound were repaired during the week of October 8, 2018.

Figure E-5
CAU 453, Facing Ground, Center Trench, Animal Burrow

Animal burrows (center portion of north trench, center portion of center trench, and west portion of south trench) were repaired during the week of October 8, 2018. Runnels on the western edge of the soil mound were repaired during the week of October 8, 2018. Annual visual inspections should continue as scheduled.
