**TRANSMITTAL OF THE MARCH 11, 2004 INSPECTION CHECKLIST FOR ON-SITE DISPOSAL FACILITY CELL 1 AND 2 CAPS**

**OSDF CELL 1**  
**POST CLOSURE INSPECTION CHECKLIST**

**OSDF CELL 2**  
**POST CLOSURE INSPECTION CHECKLIST**

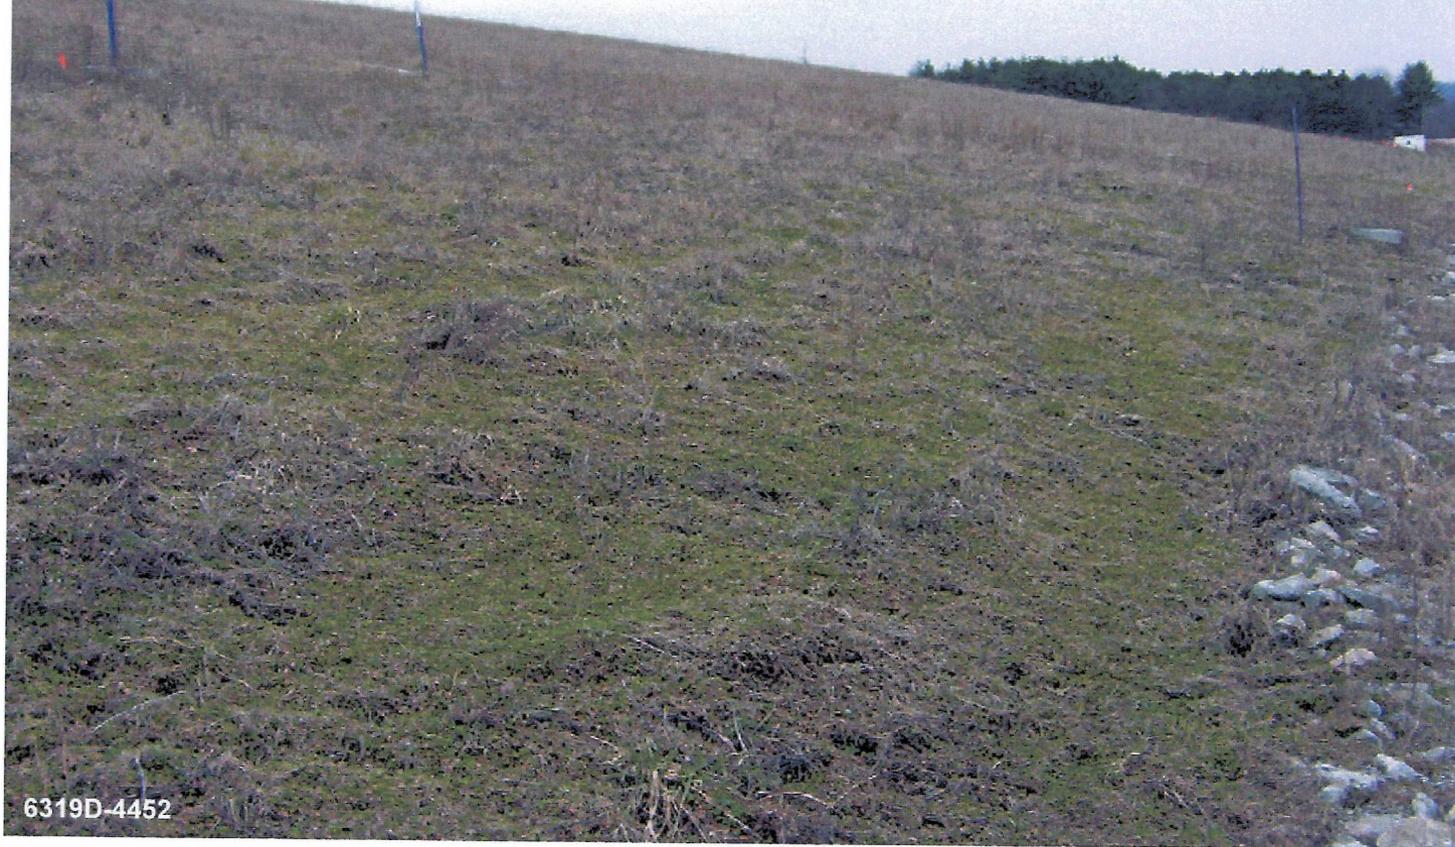
Graphic 8251.1

**North Face Cell 1**  
(looking west)

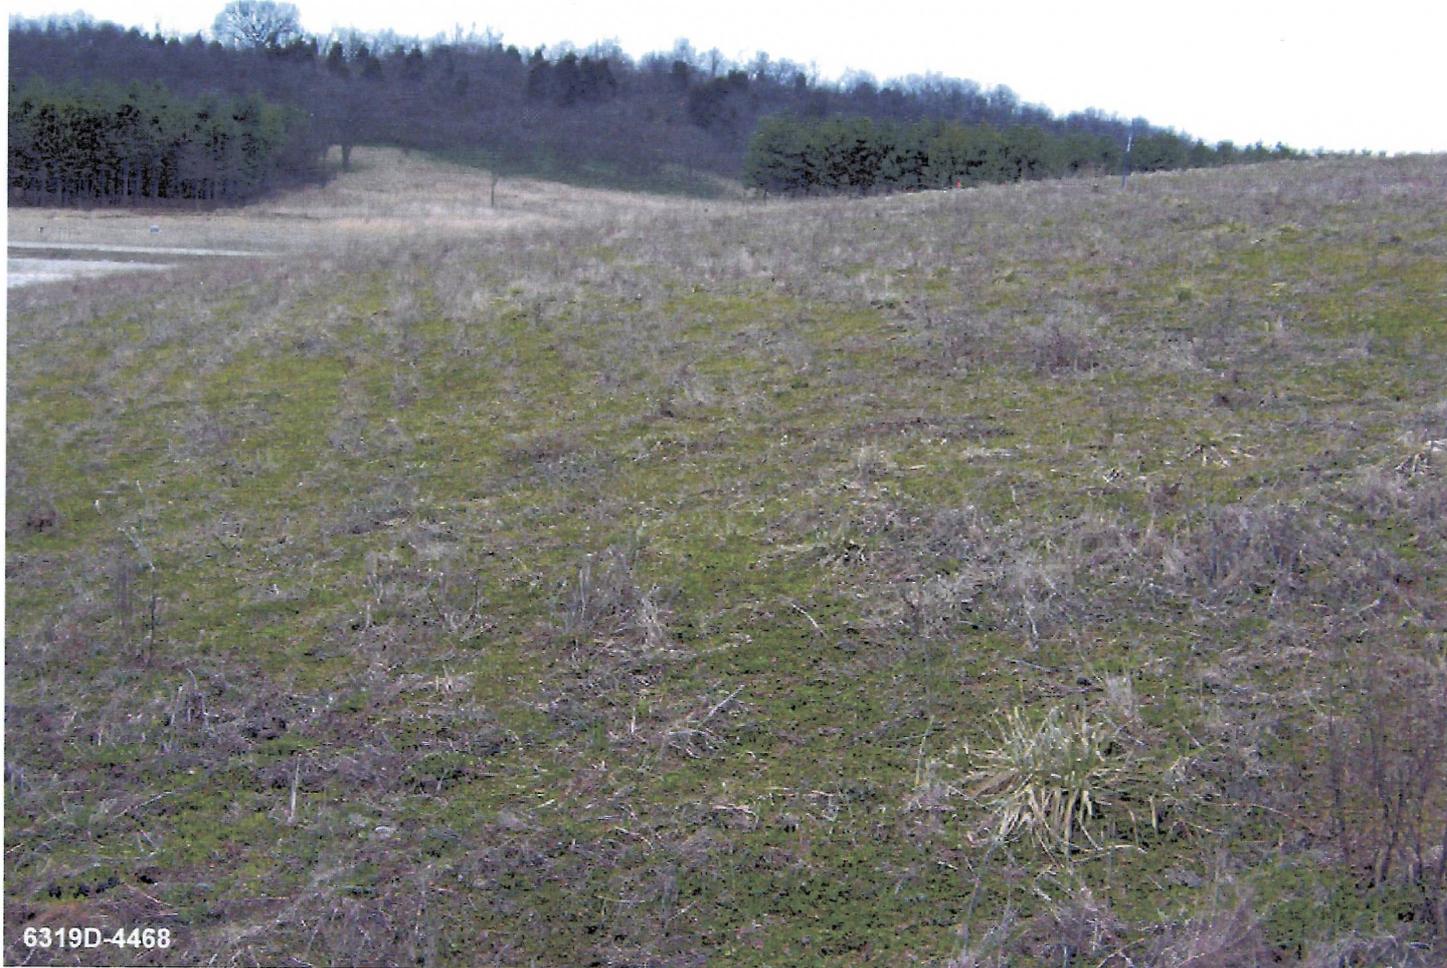
Graphic 8251.2

**West Face Cell 1**  
**(looking north)**

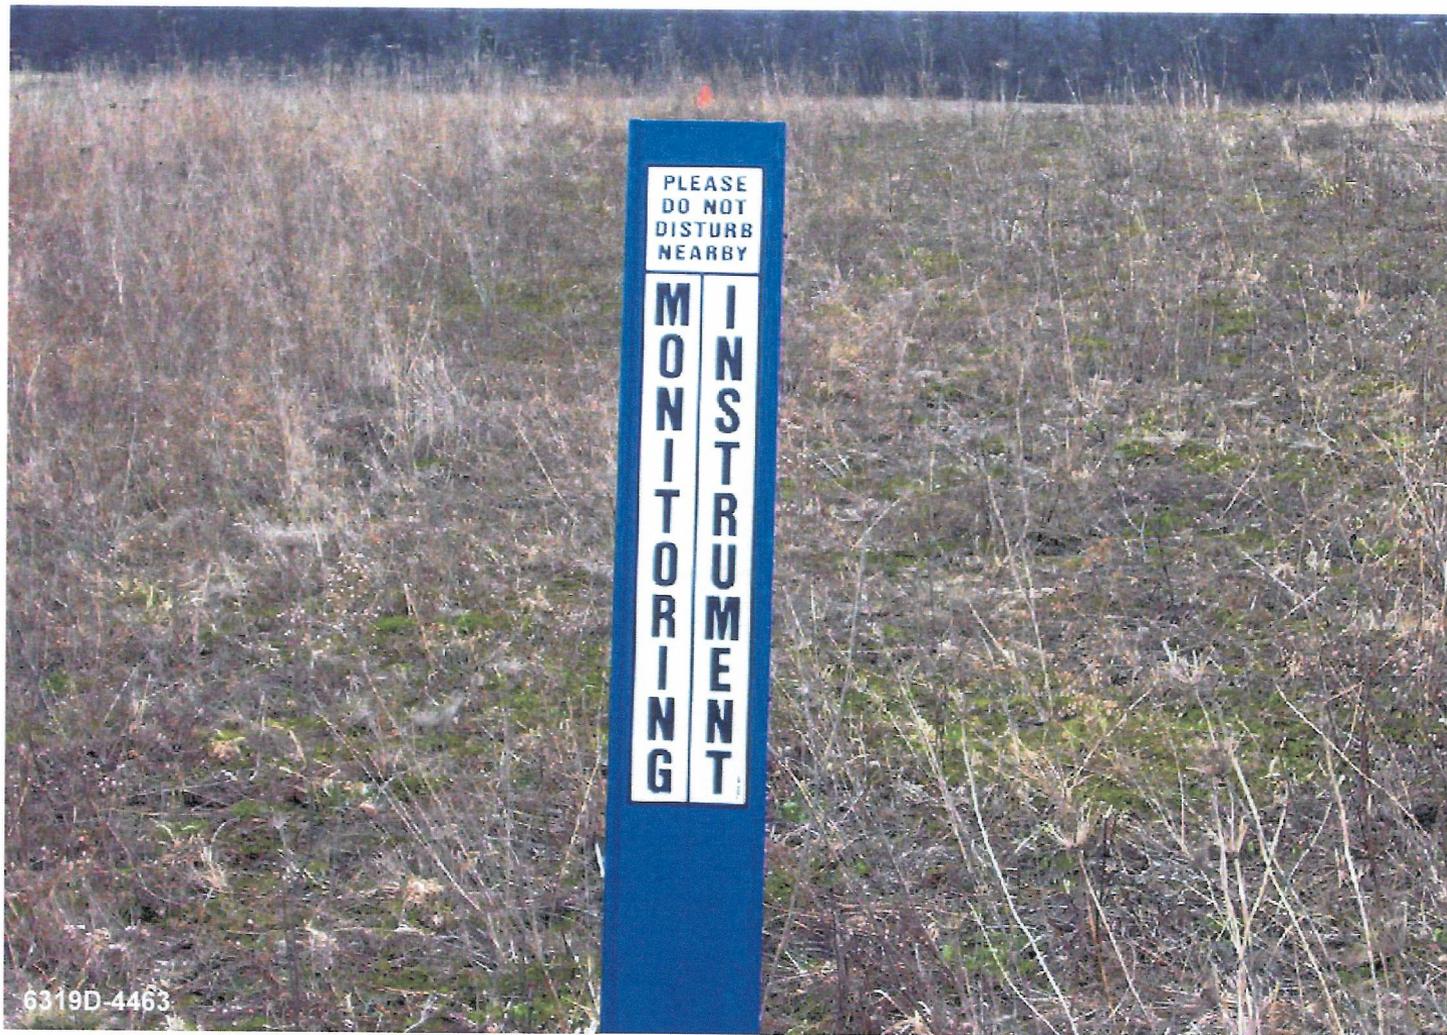
**Cell 1 Monitoring Instrument Marker**

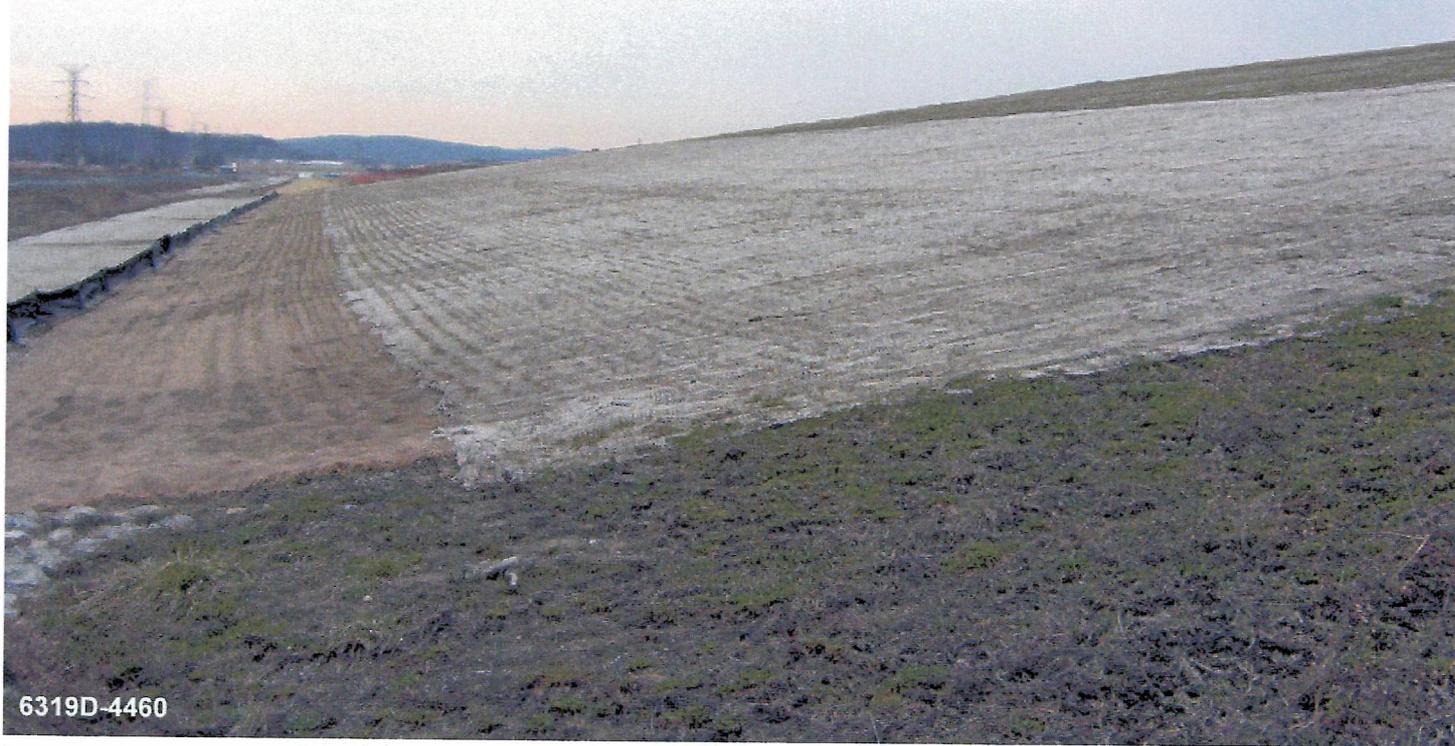
Graphic 8251.4

**East Face Cell 2**  
(looking south)

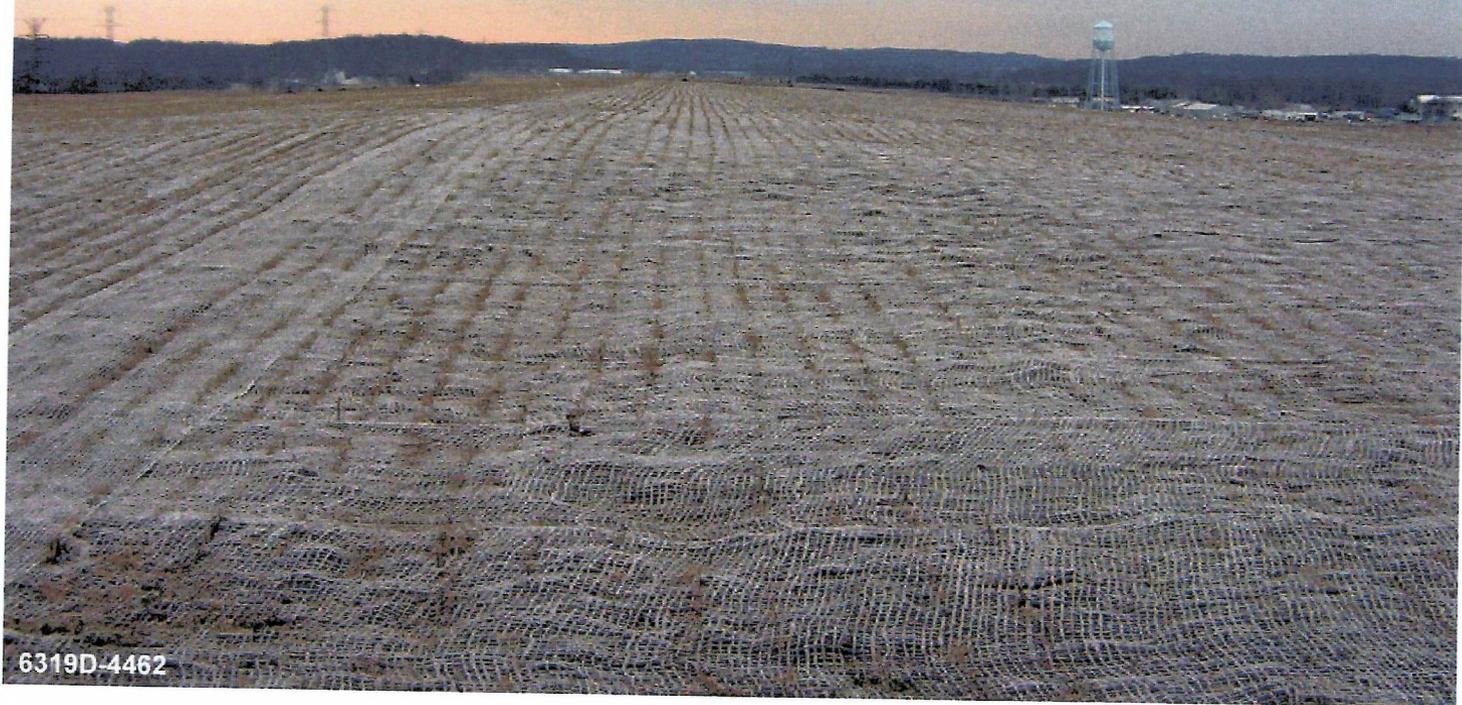
Graphic 8251.5

**Top Cell 2**  
**(looking south)**

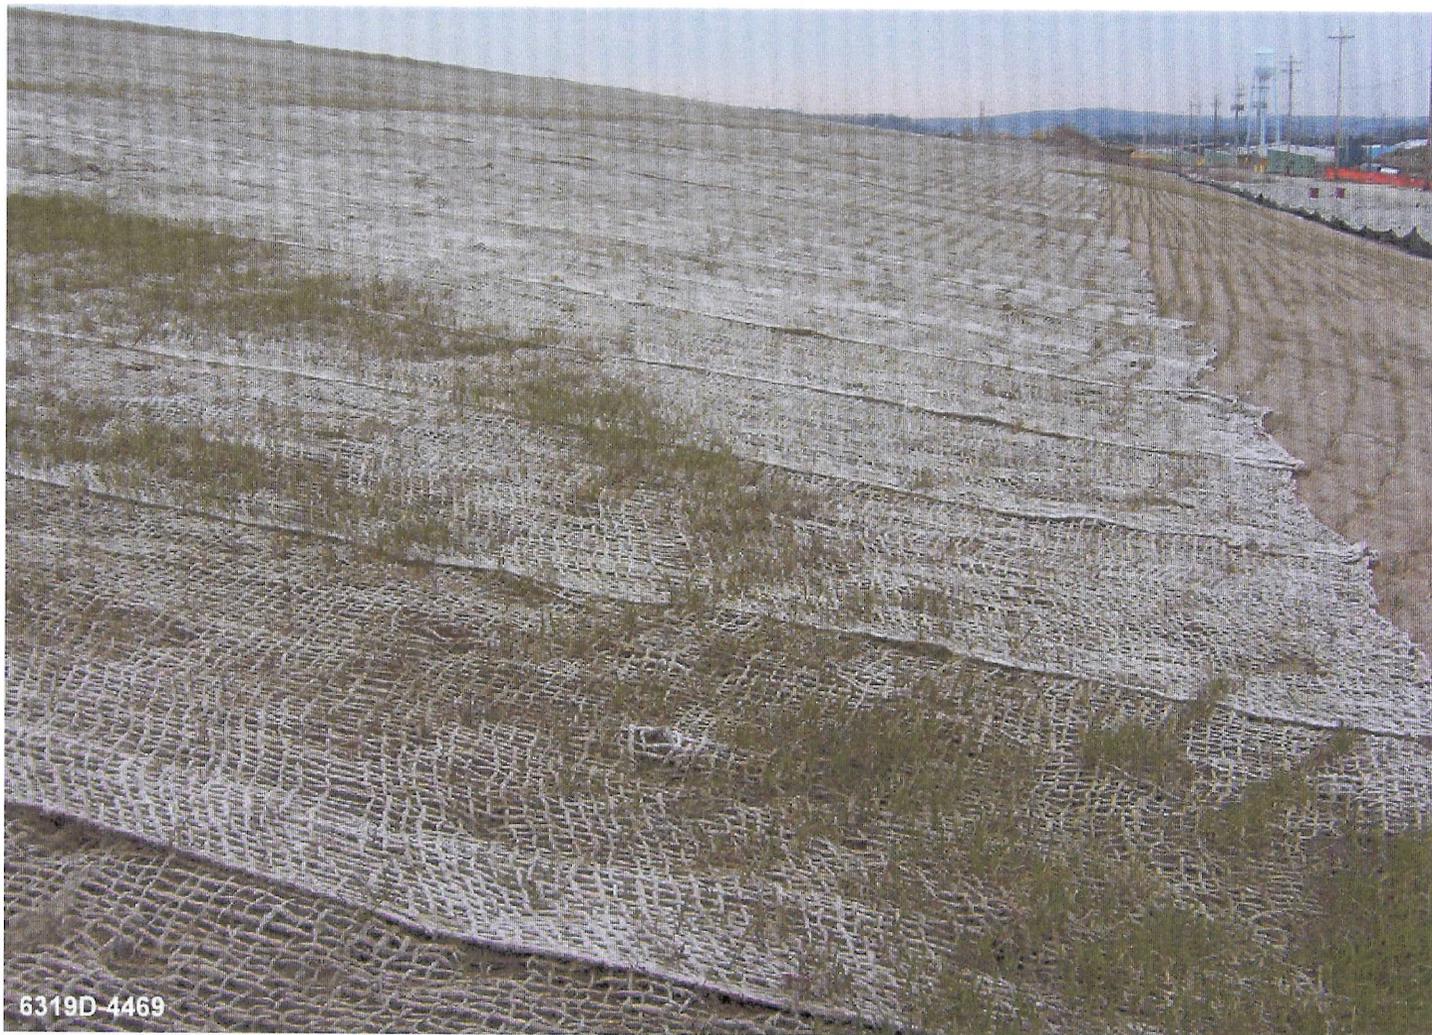
**West Face Cell 2**  
(looking south)

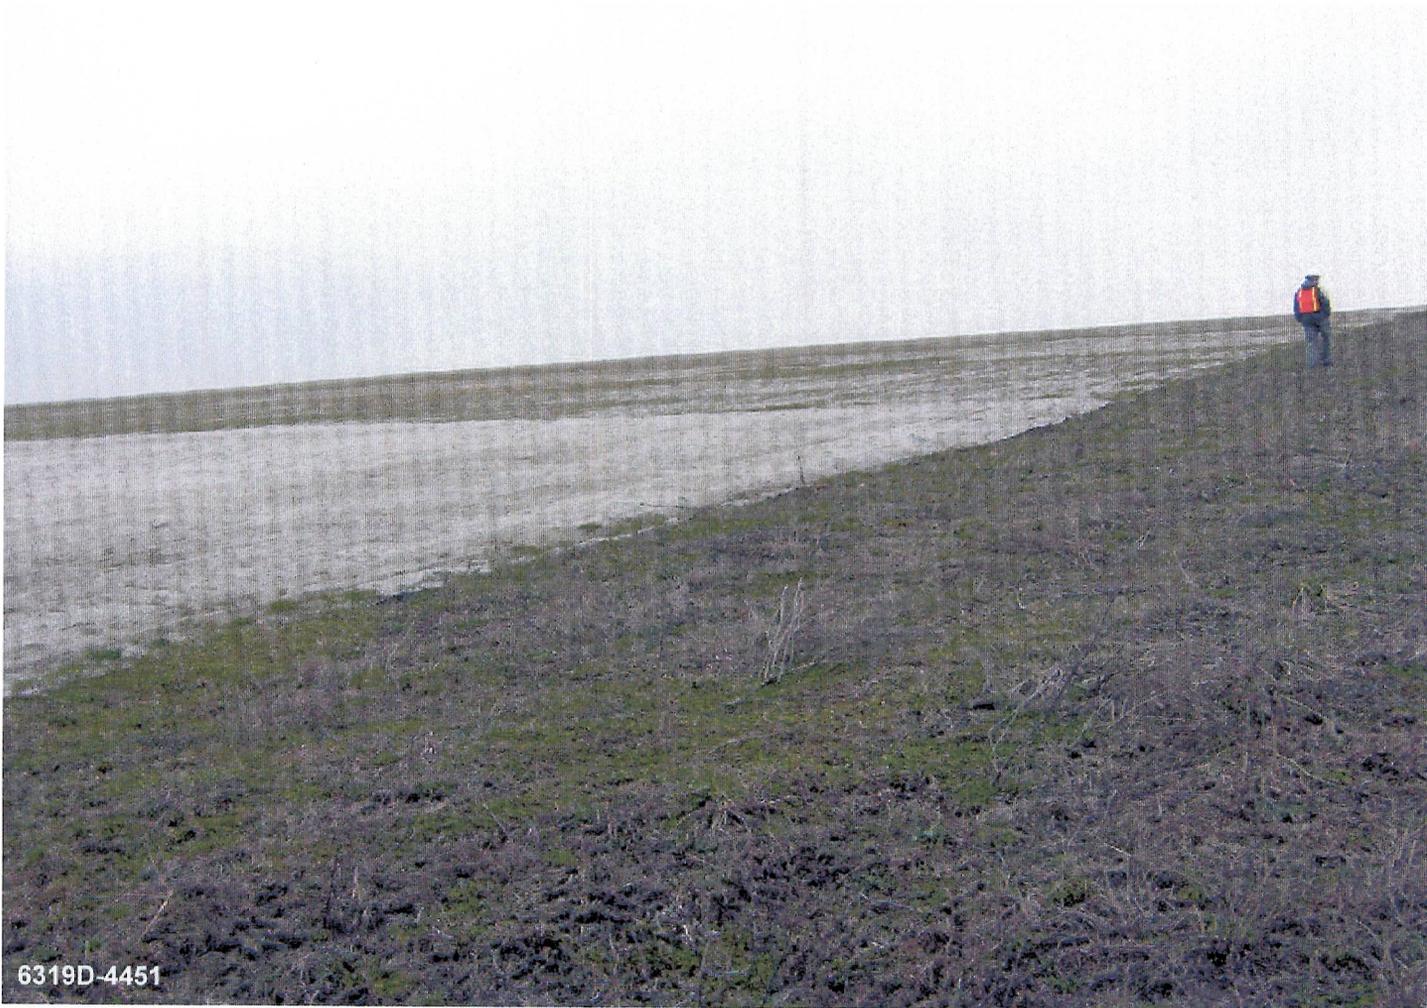
**East Face Cells 1 and 2**  
(looking south)
