TRANSMITTAL OF THE OCTOBER 3, 2005 INSPECTION CHECKLIST FOR ON-SITE DISPOSAL FACILITY CELL 1, 2, 3, 4 AND 5 CAPS

OSDF Cell Cap Post Closure Inspection Checklist

On-Site Disposal Facility Inspection Report

October 2005

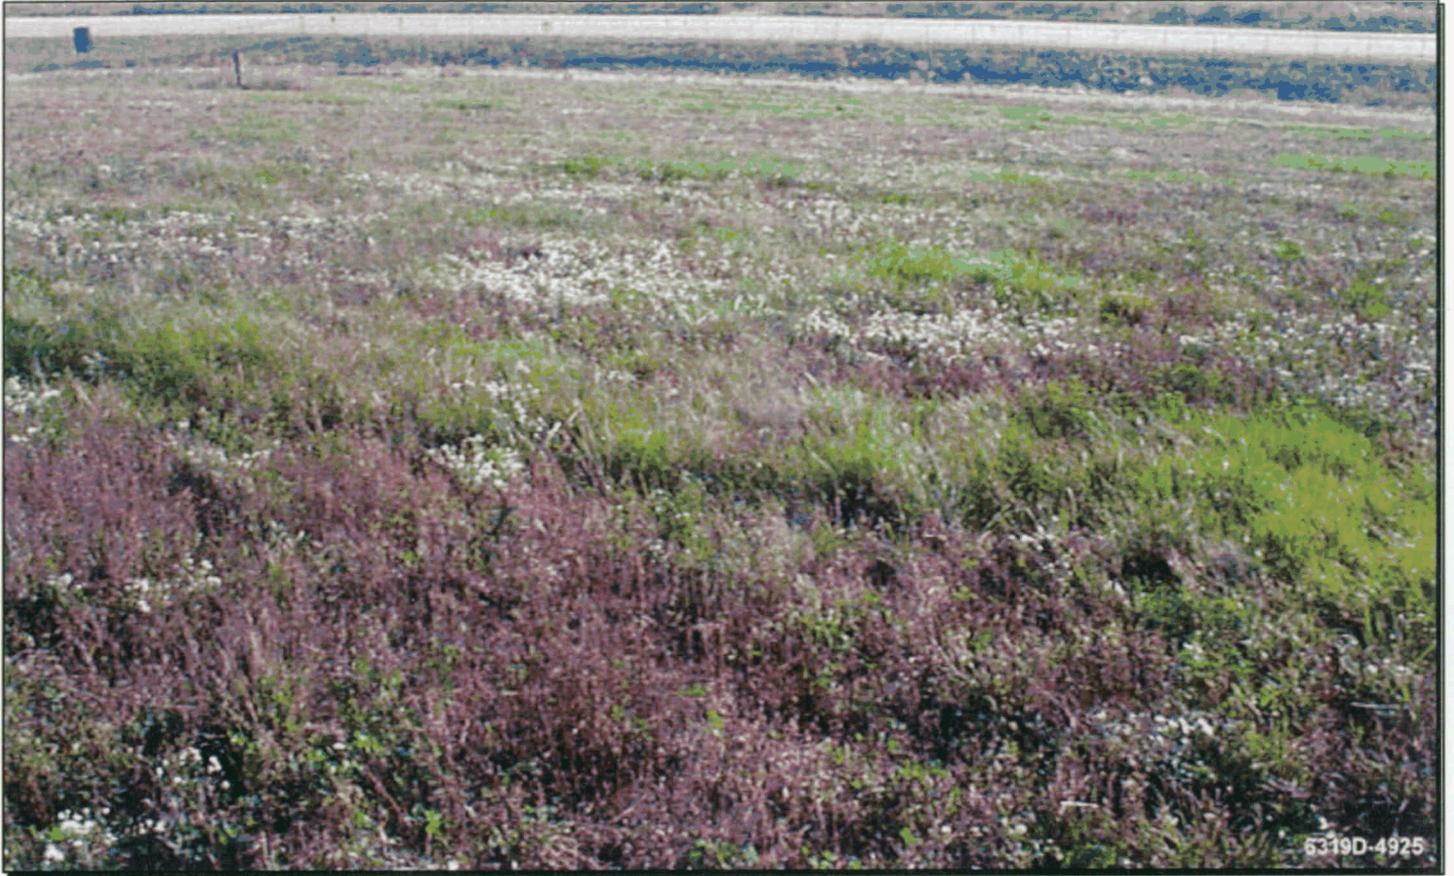
East Face Cell 1

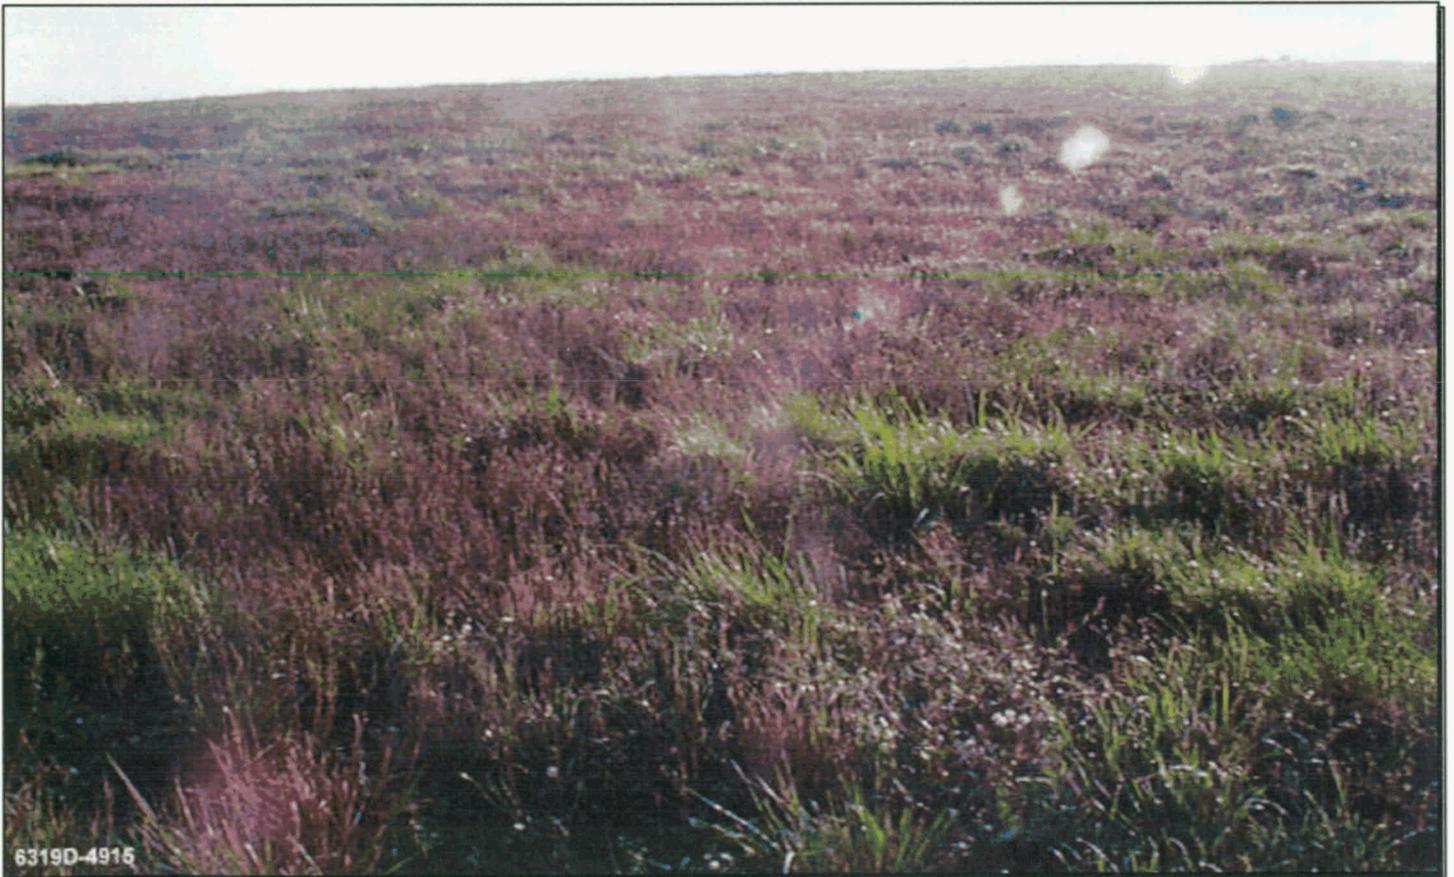
West Face Cell 1

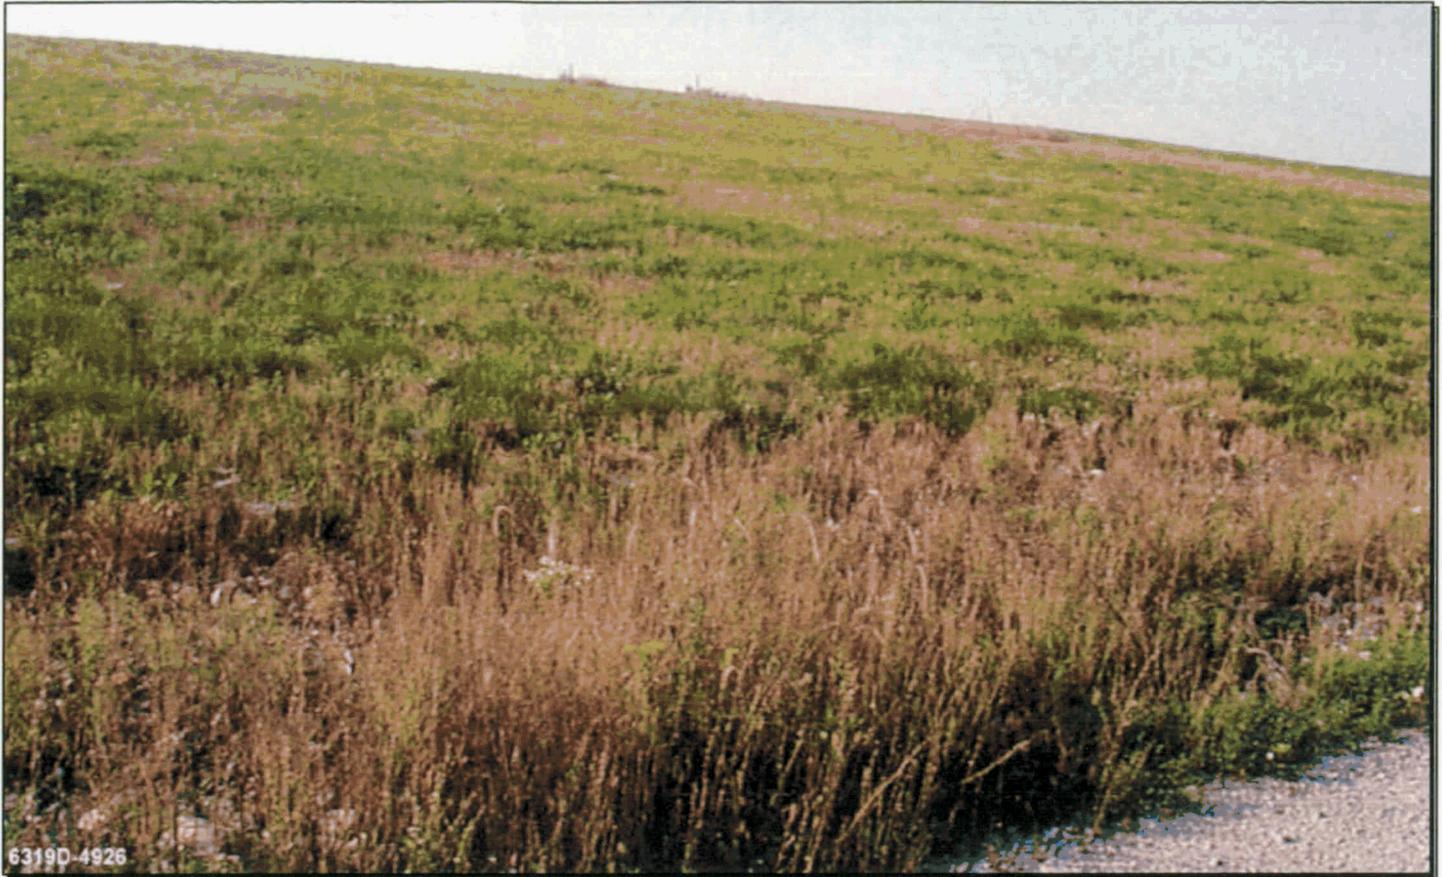
6319D-4926

North Face Cell 1

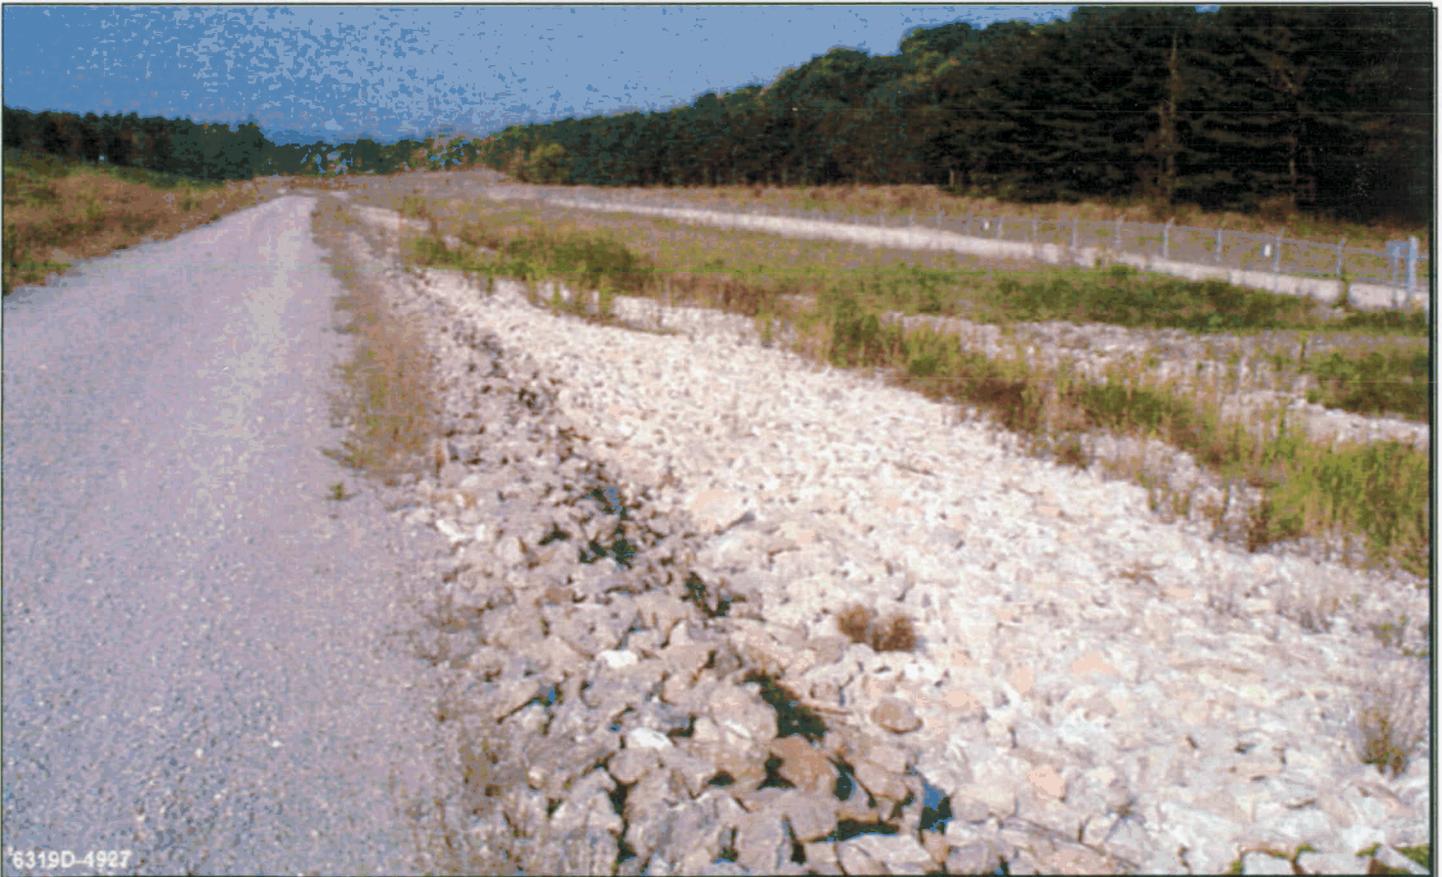
6319D-4927

North Drainage (looking west)

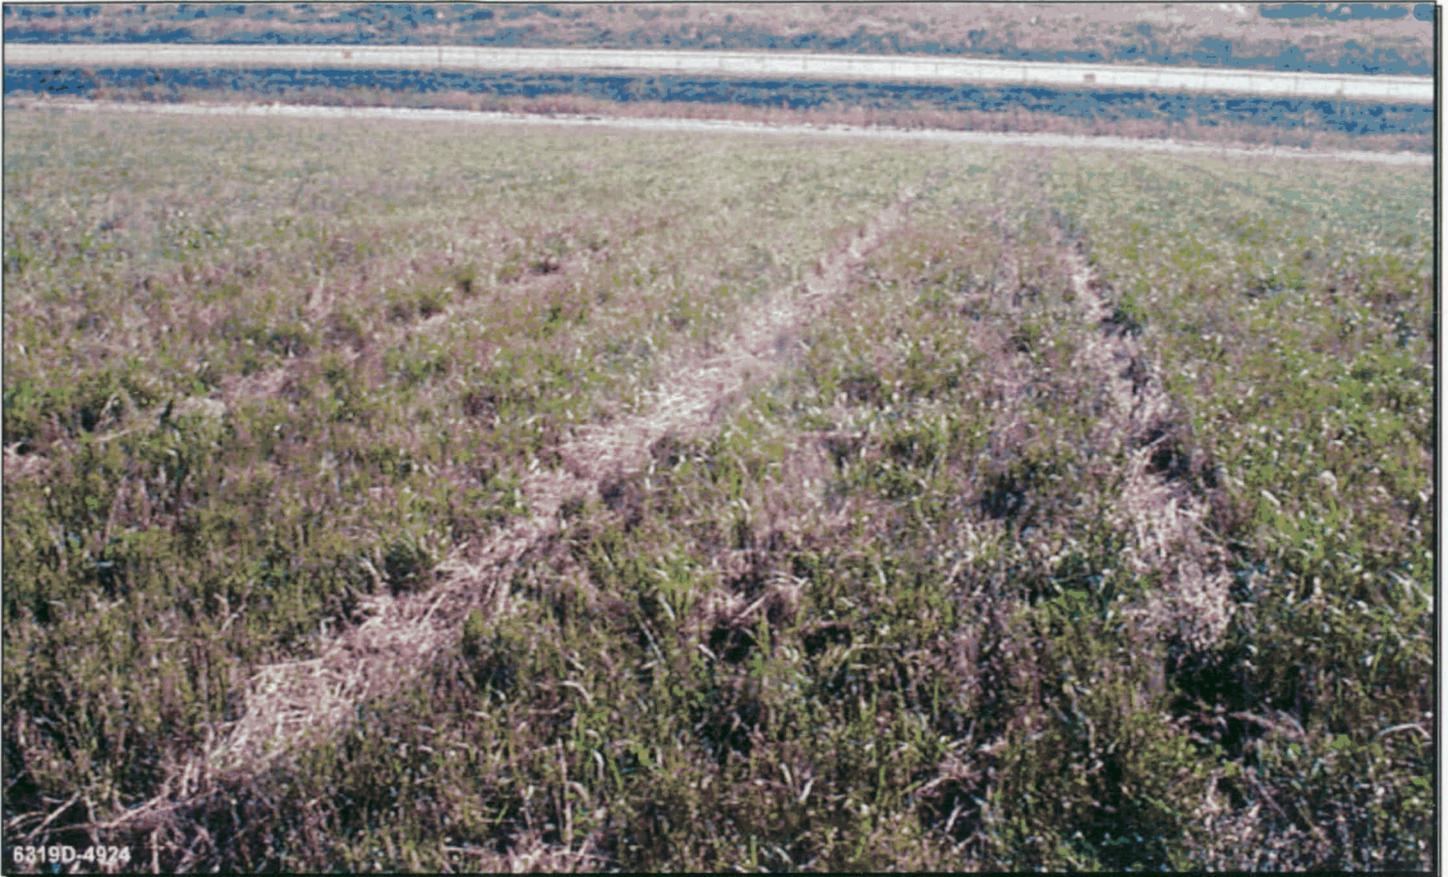
6319D-4924

East Face Cell 2

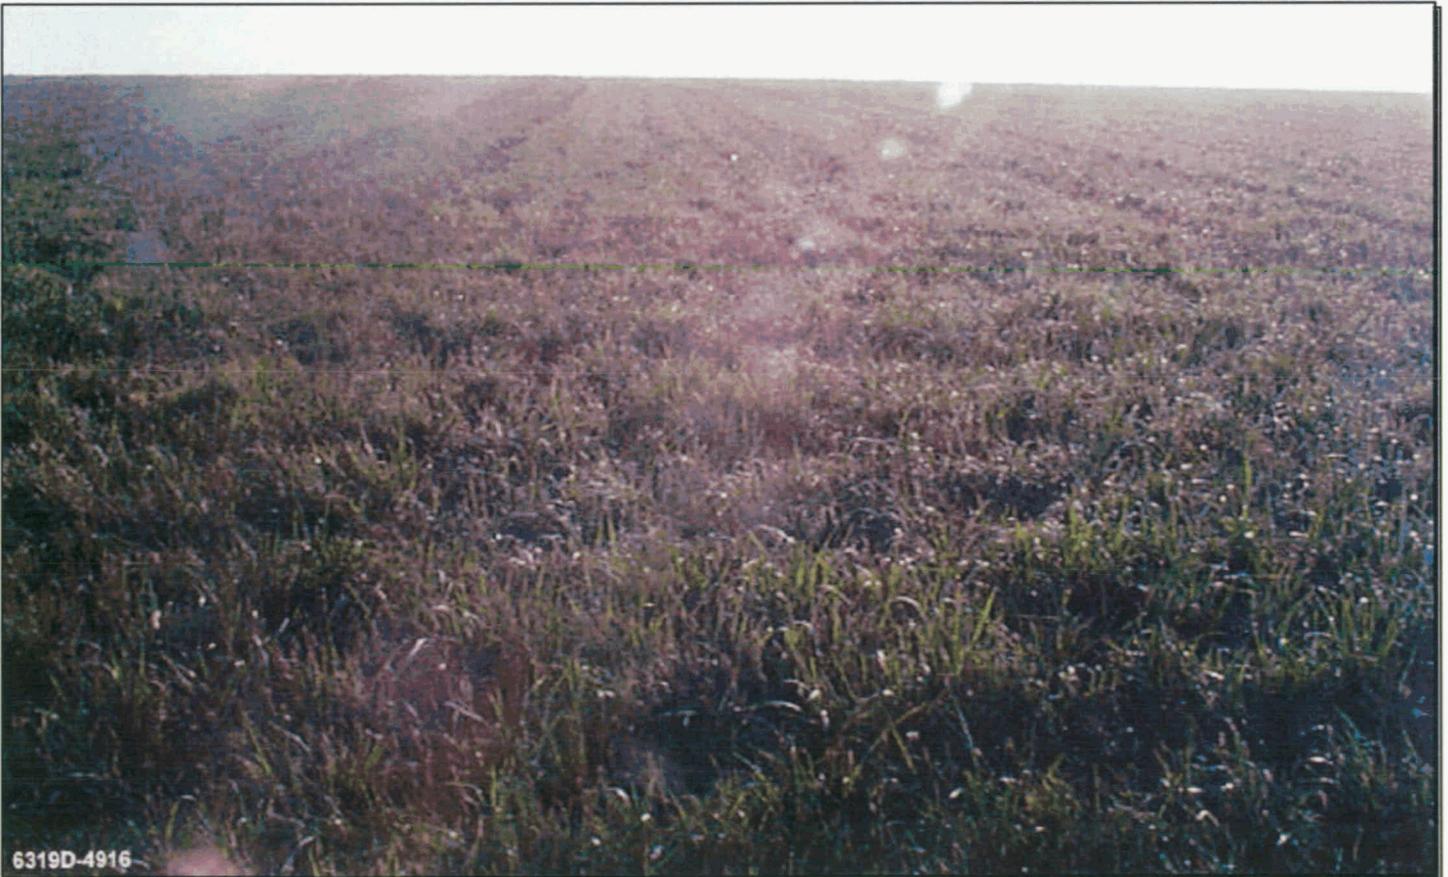
6319D-4916

West Face Cell 2

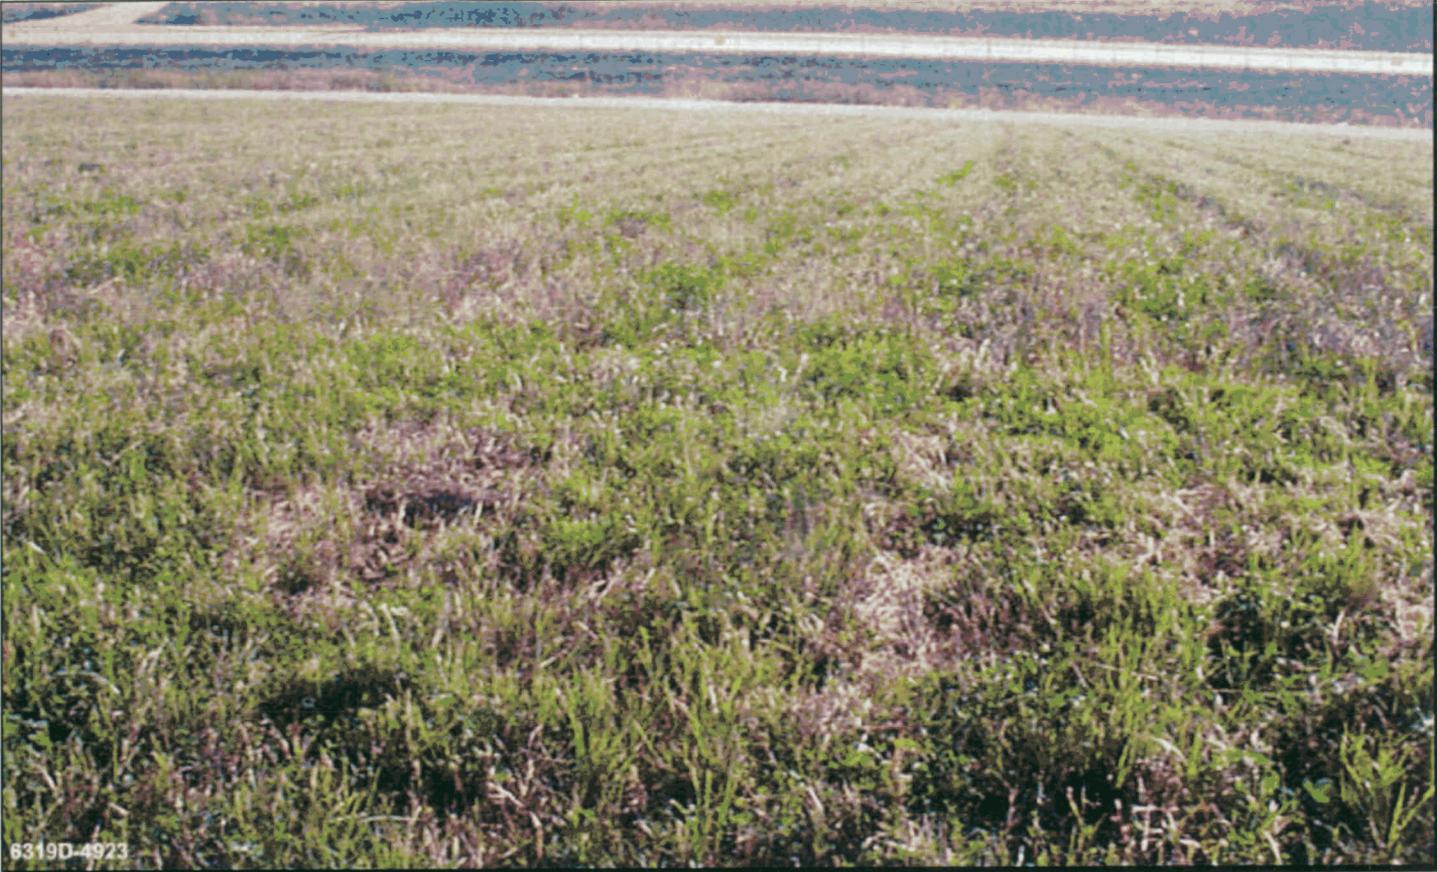
East Face Cell 3

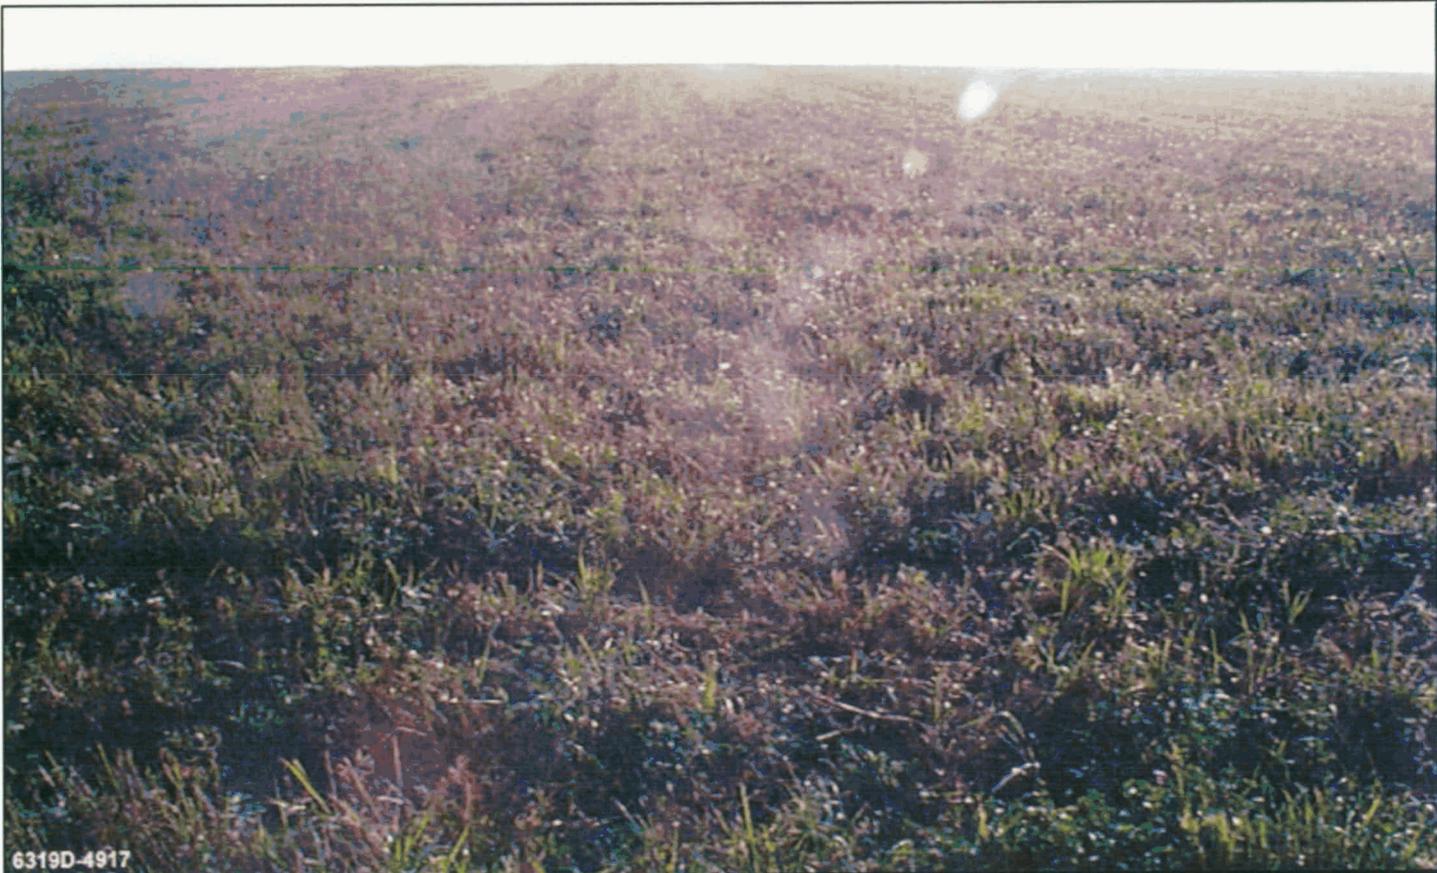
West Face Cell 3

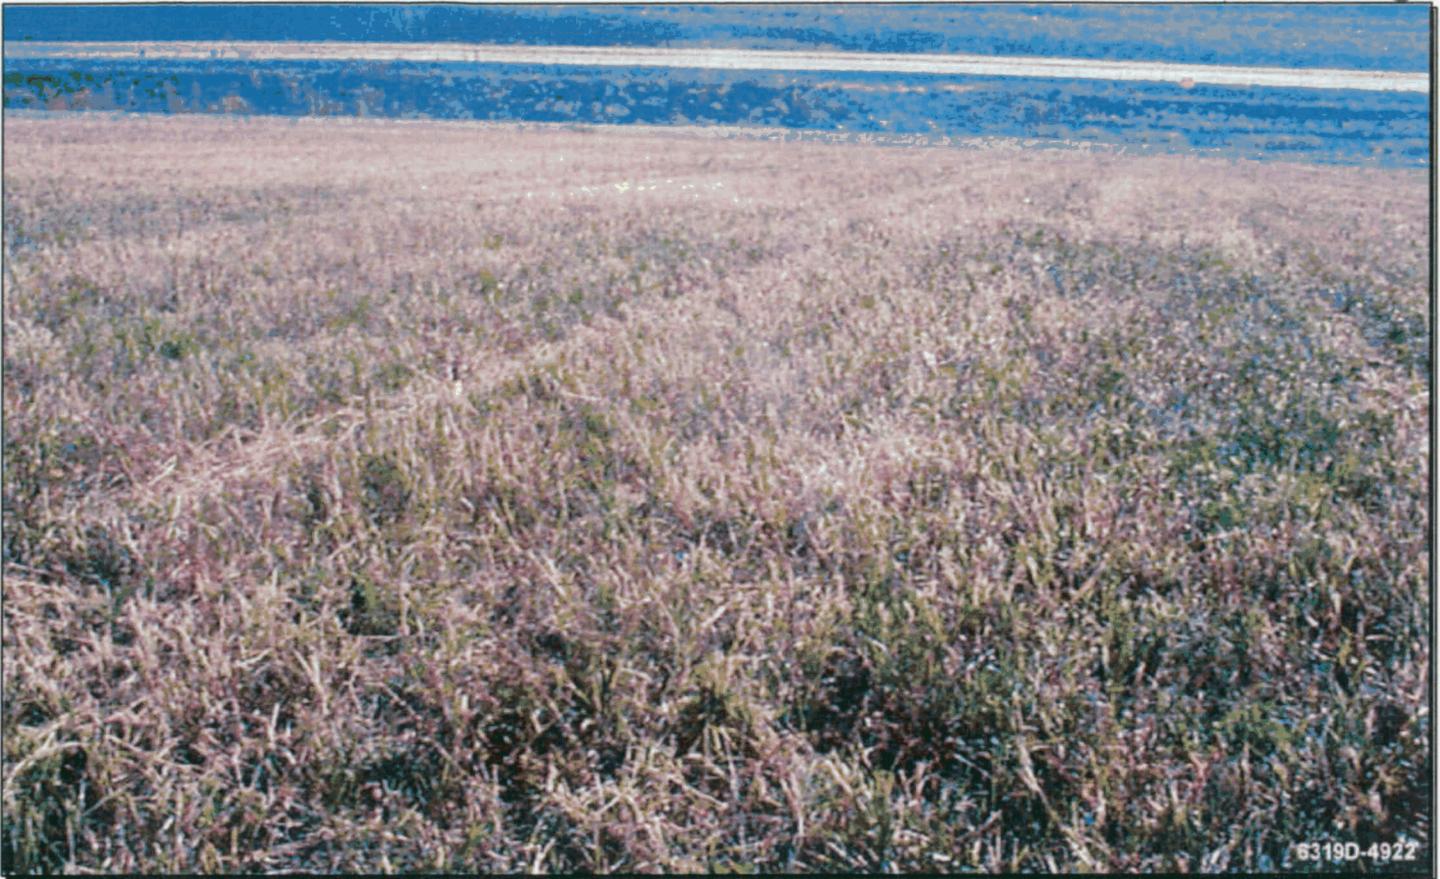
6319D-4922

East Face Cell 4

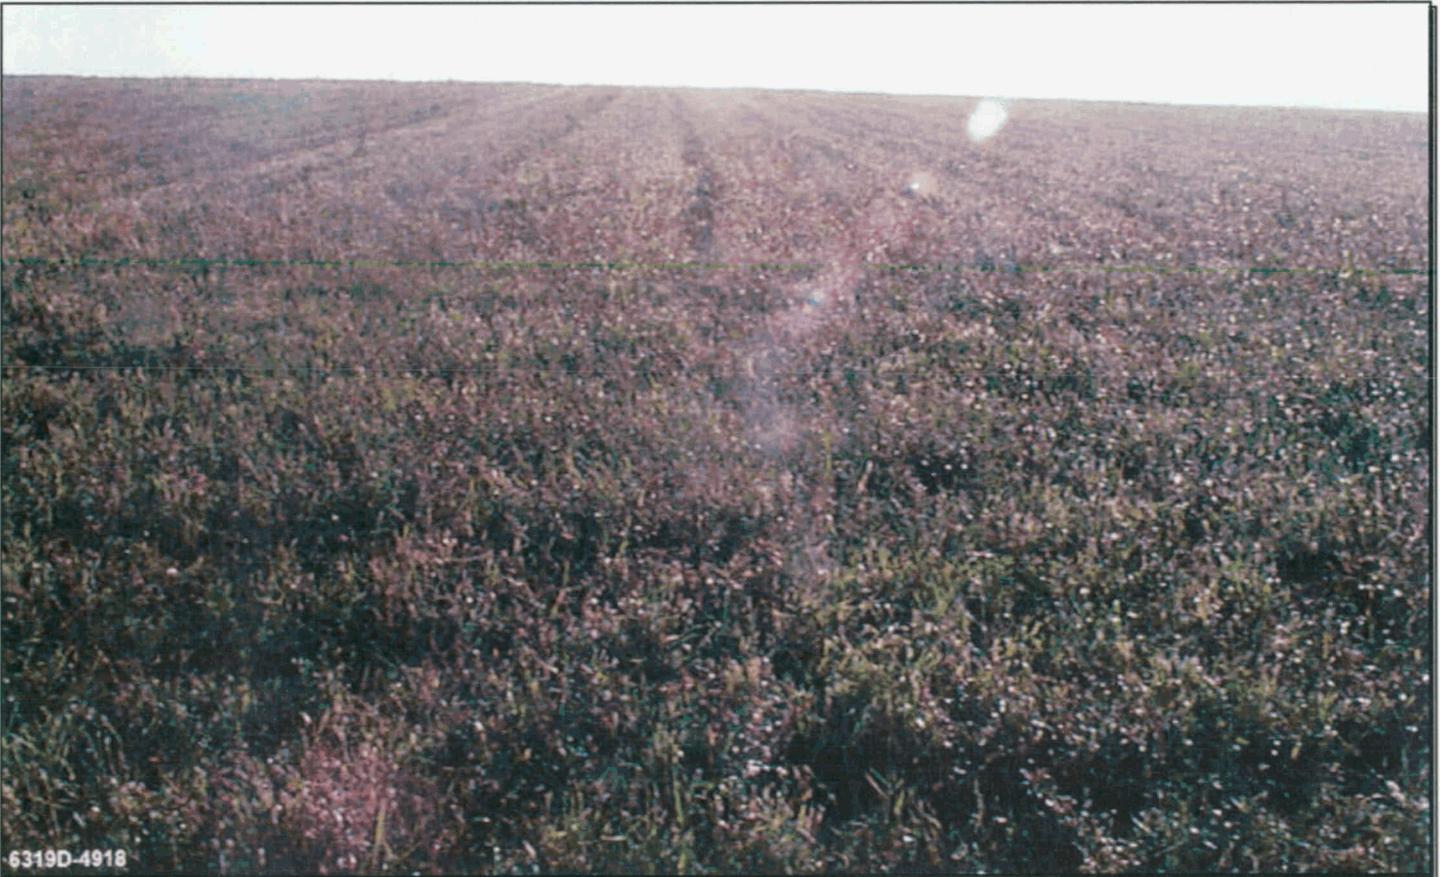
6319D-4918

West Face Cell 4

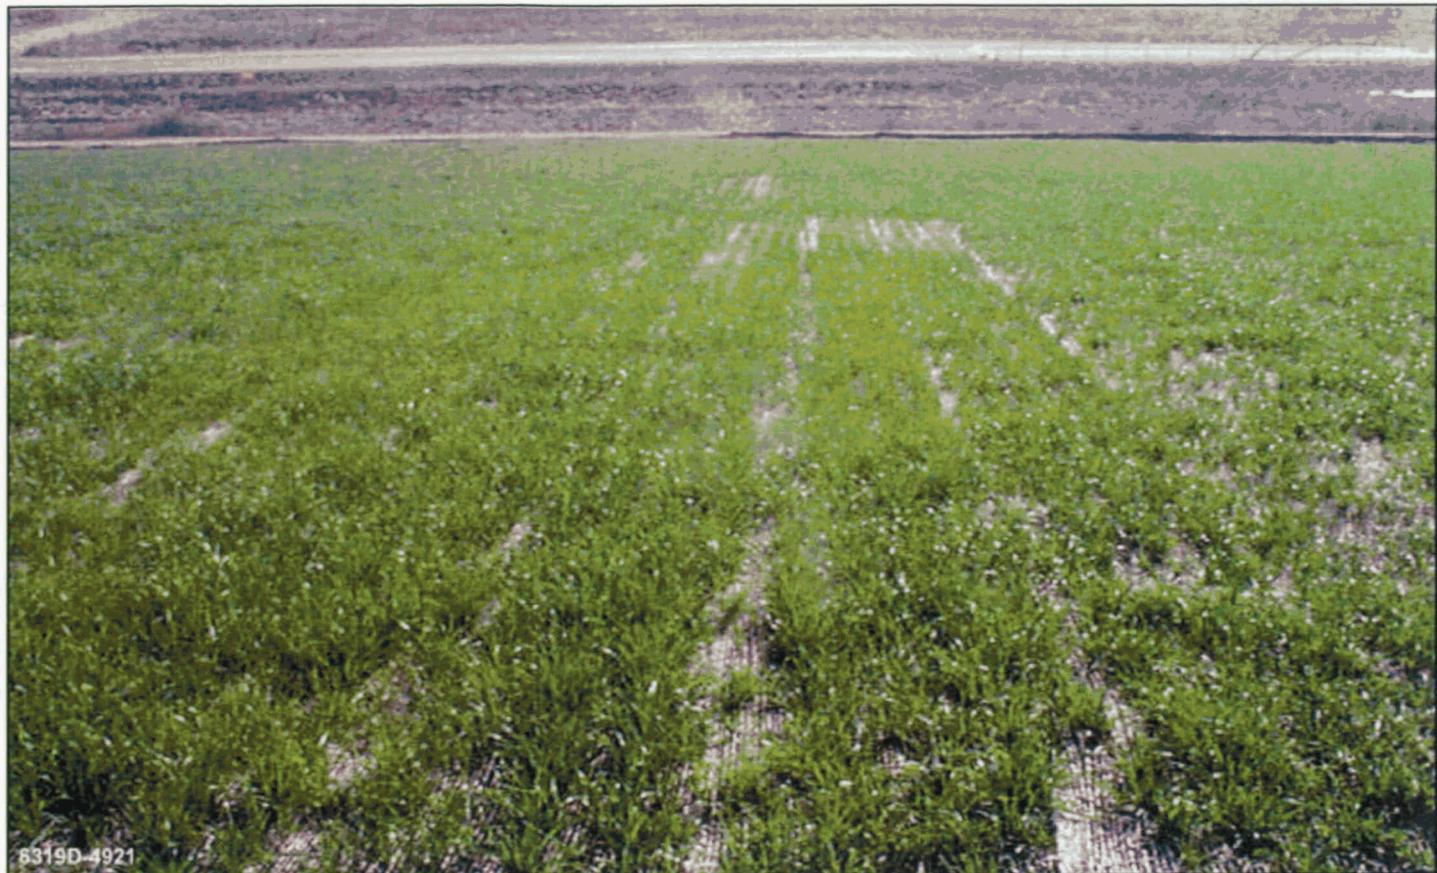
East Face Cell 5

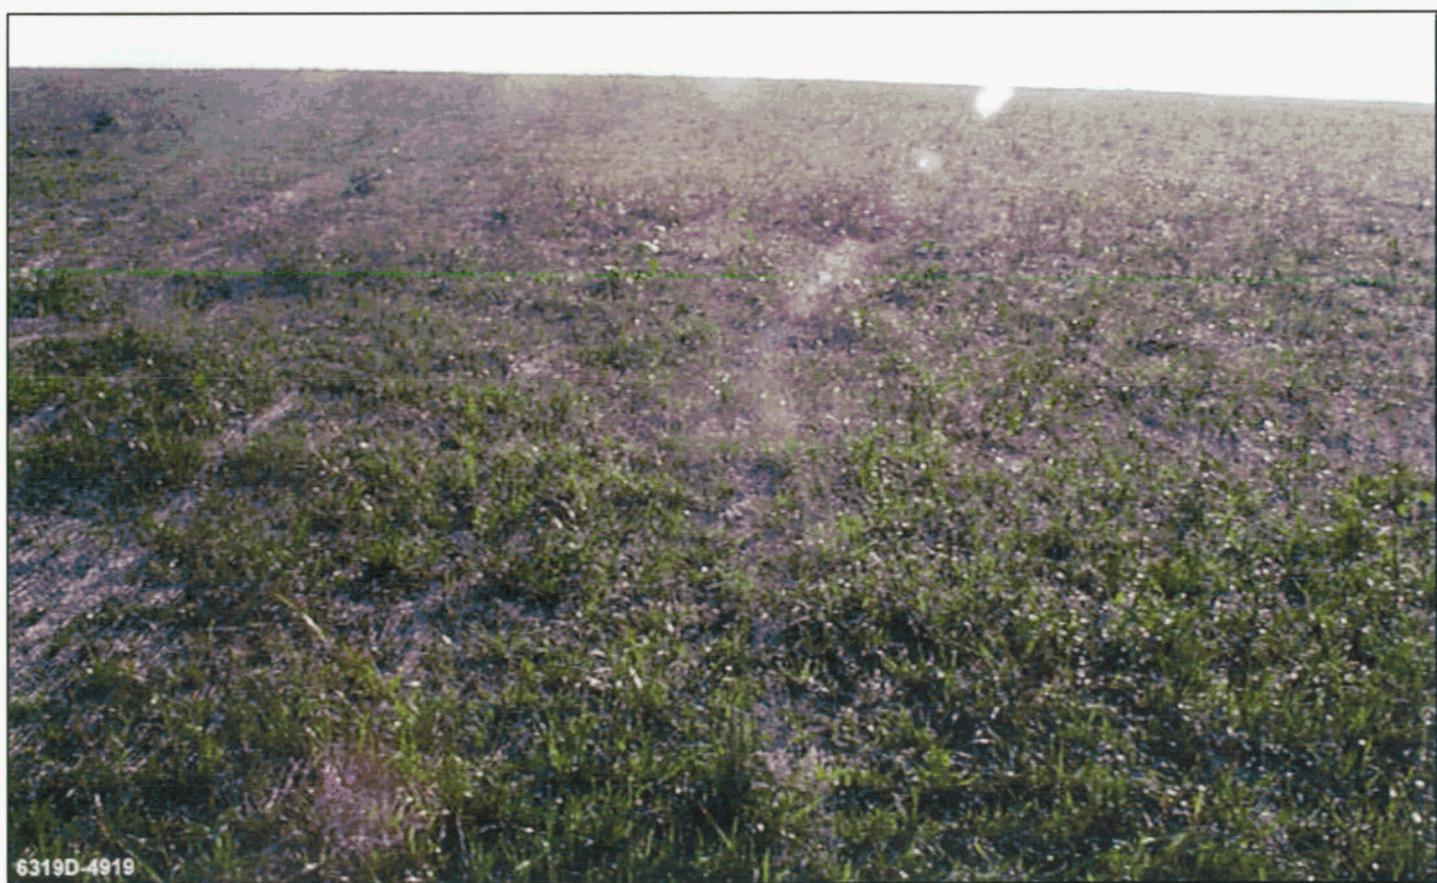
West Face Cell 5

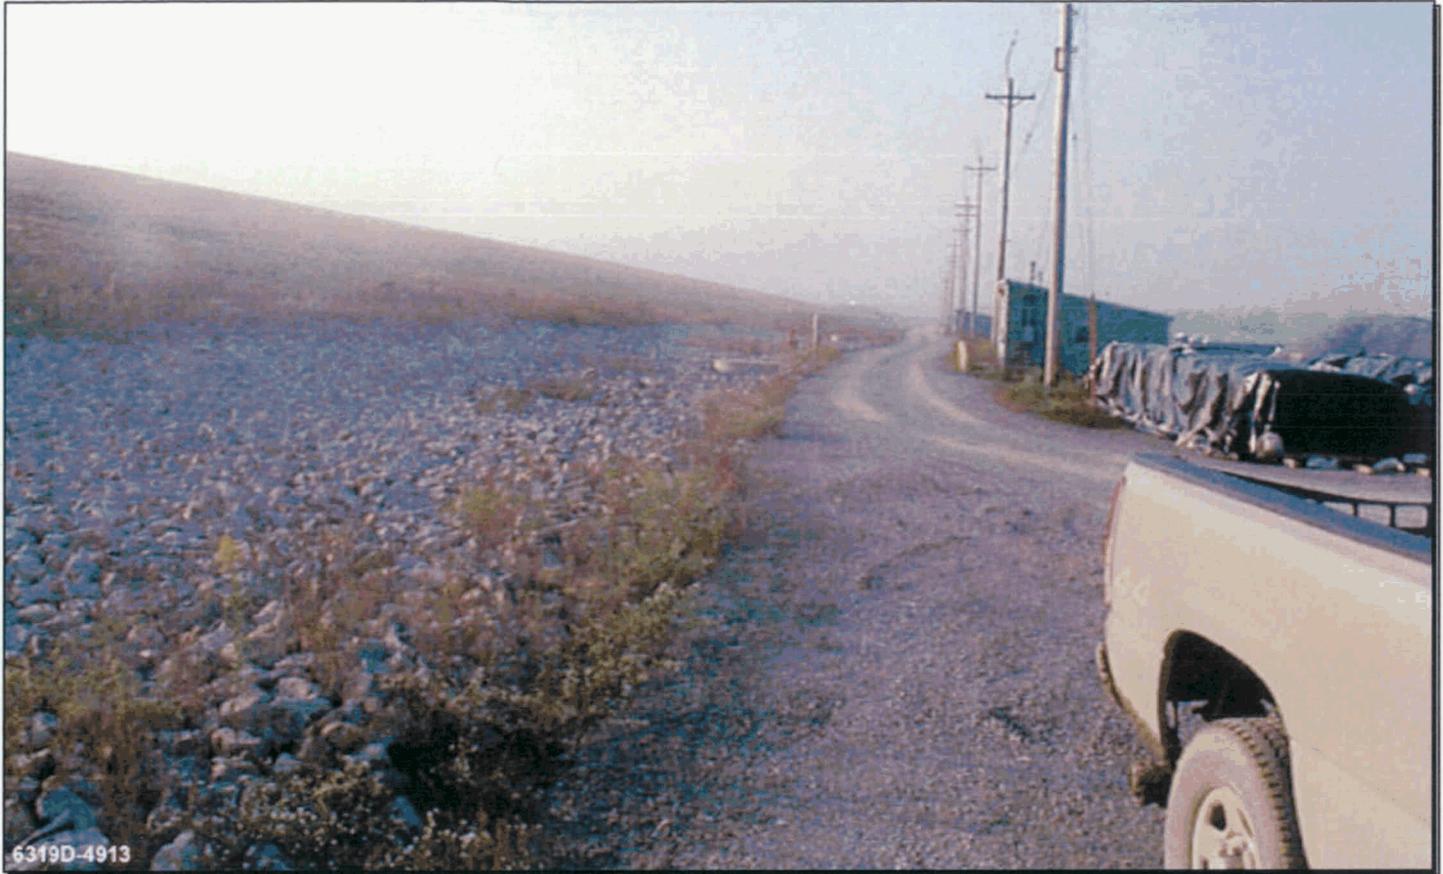
6319D-4913

West Drainage Cell 1 (looking south)

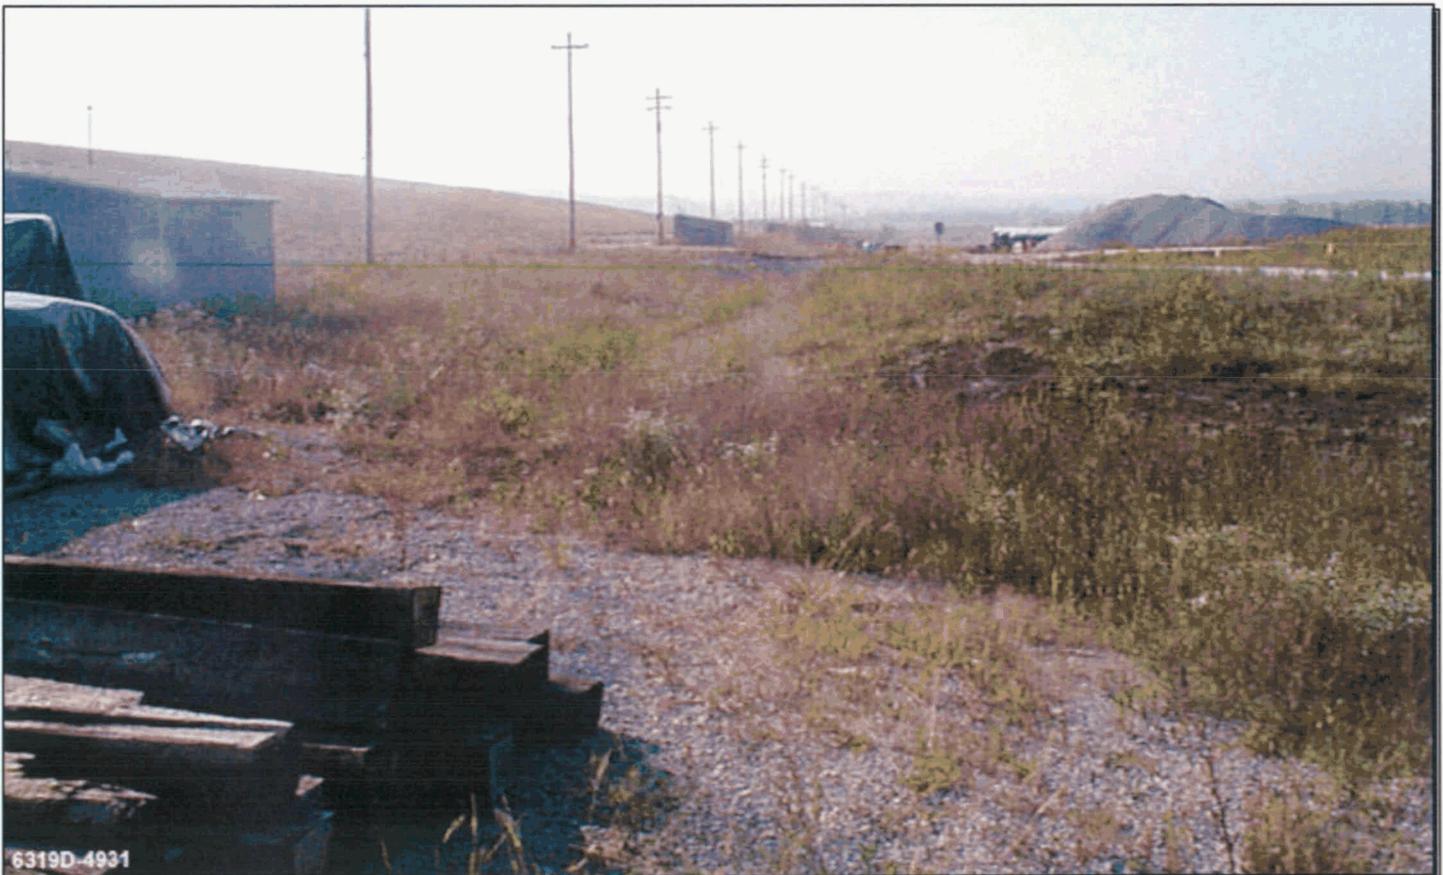
6319D-4931

Outer West Drainage Cell 1 (looking south)

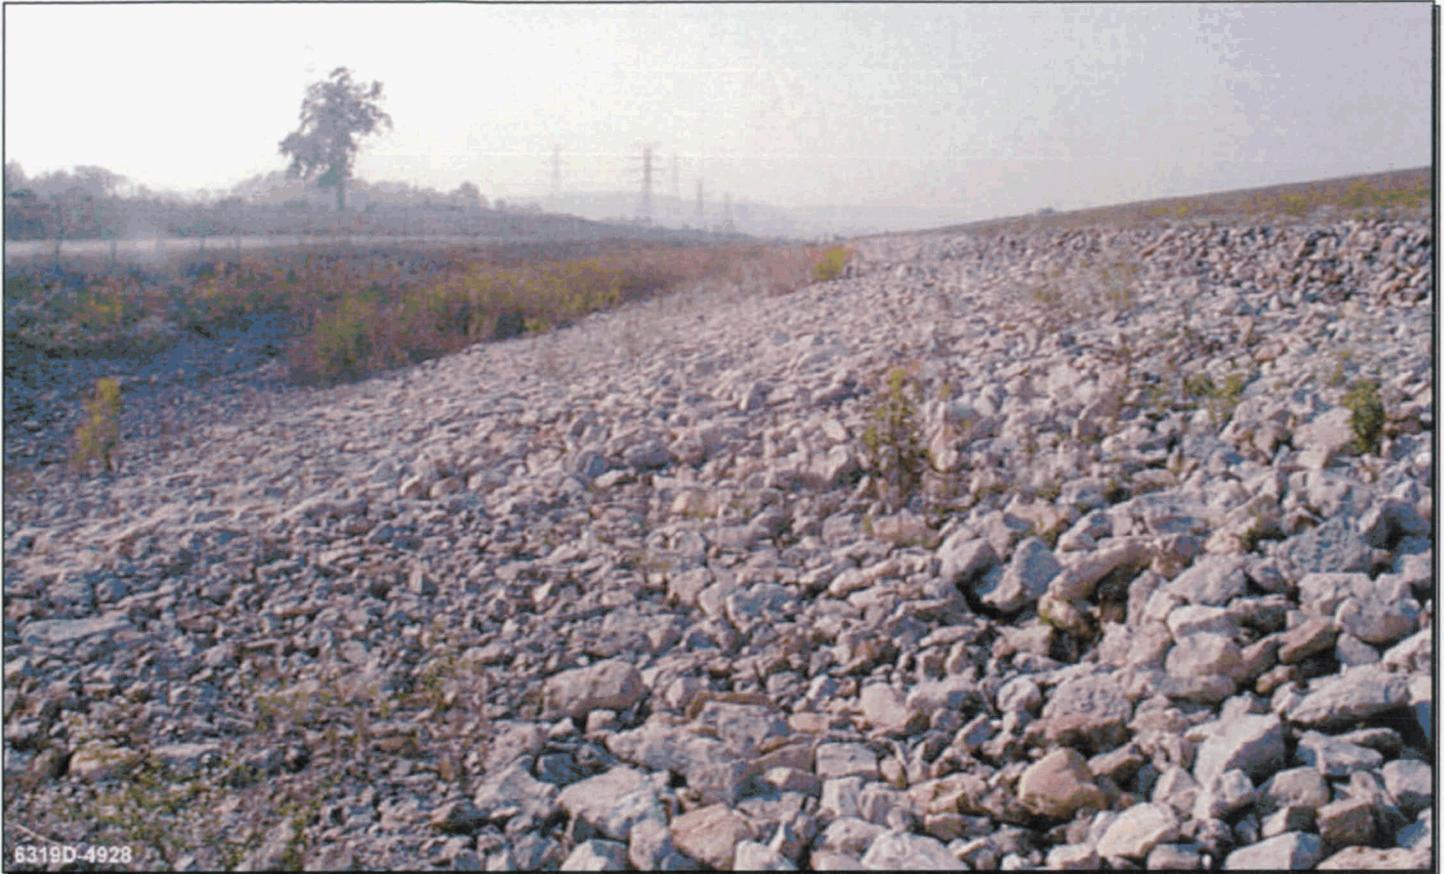
6319D-4928

East Drainage (looking south)

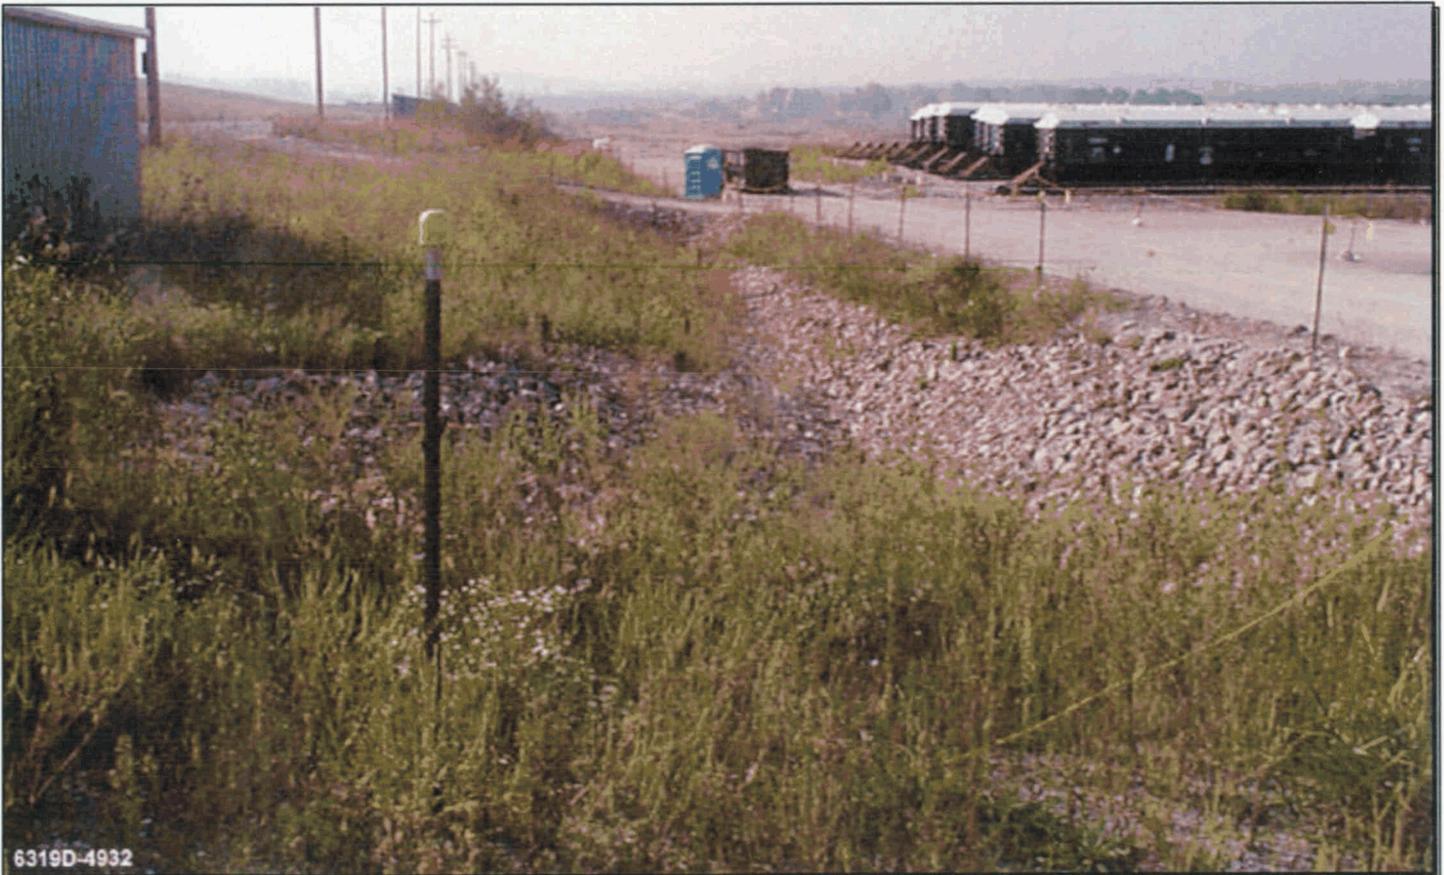
6319D-4932

Outer West Drainage Cell 3 (looking south)

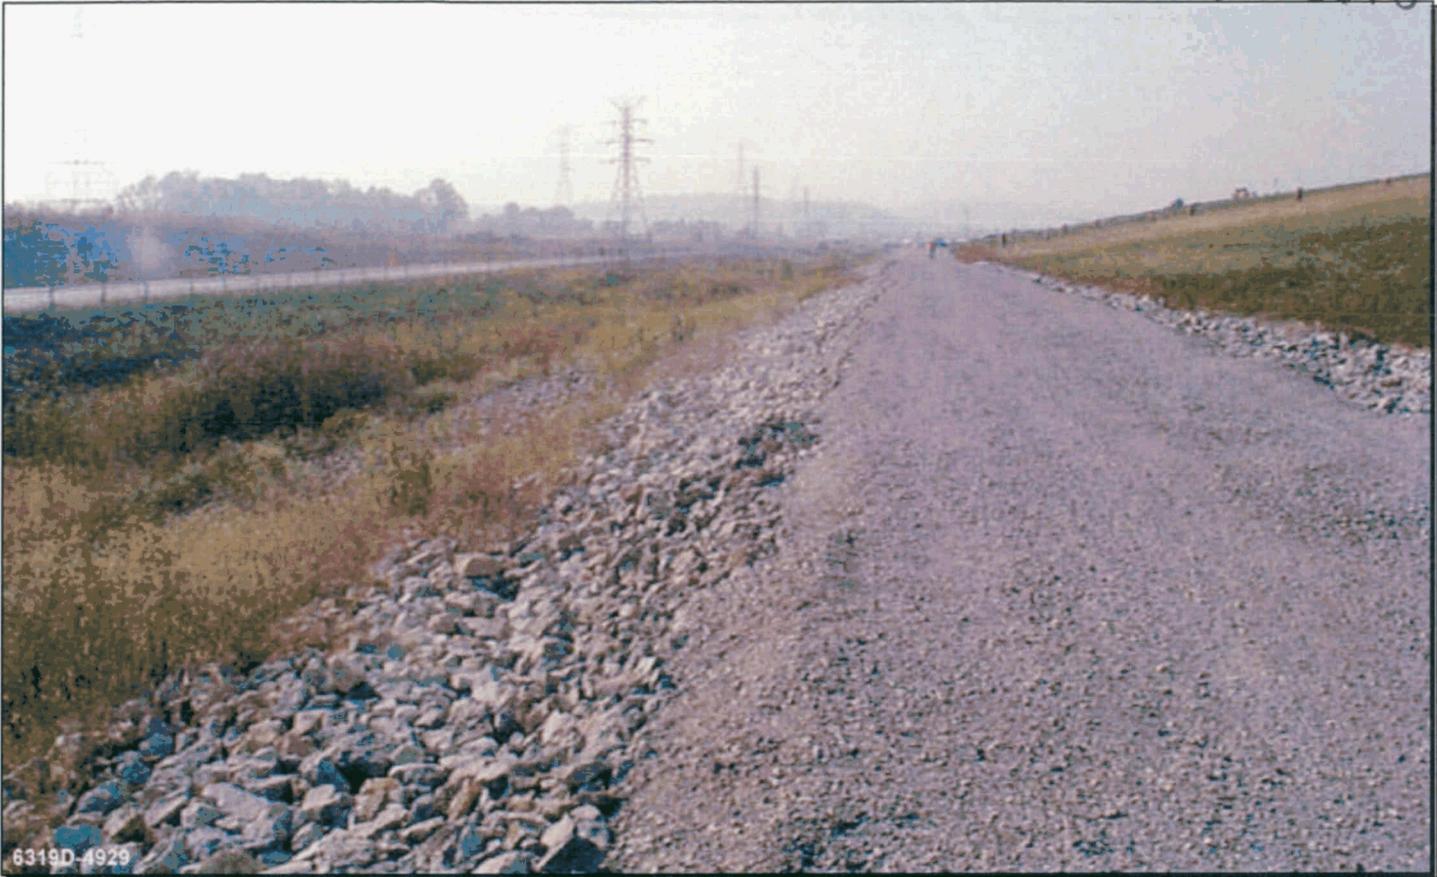
6319D-4929

East Drainage Cell 3 (looking south)

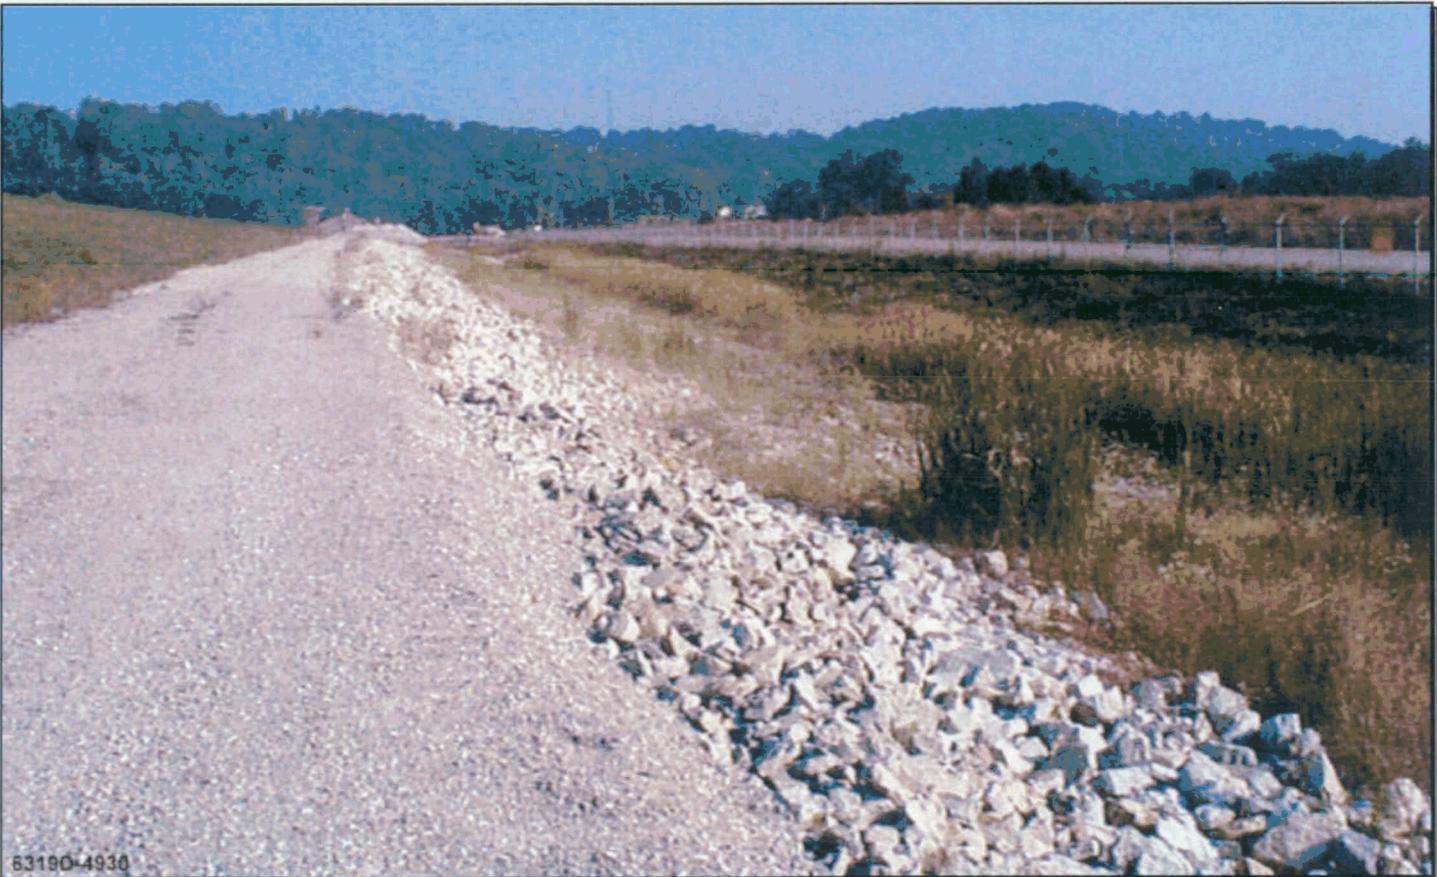
6319D-4930

East Drainage Cell 3 (looking north)
