TRANSMITTAL OF THE OCTOBER 3, 2005 INSPECTION CHECKLIST FOR ON-SITE DISPOSAL FACILITY CELL 1, 2, 3, 4 AND 5 CAPS

OSDF Cell Cap Post Closure Inspection Checklist

On-Site Disposal Facility Inspection Report

October 2005

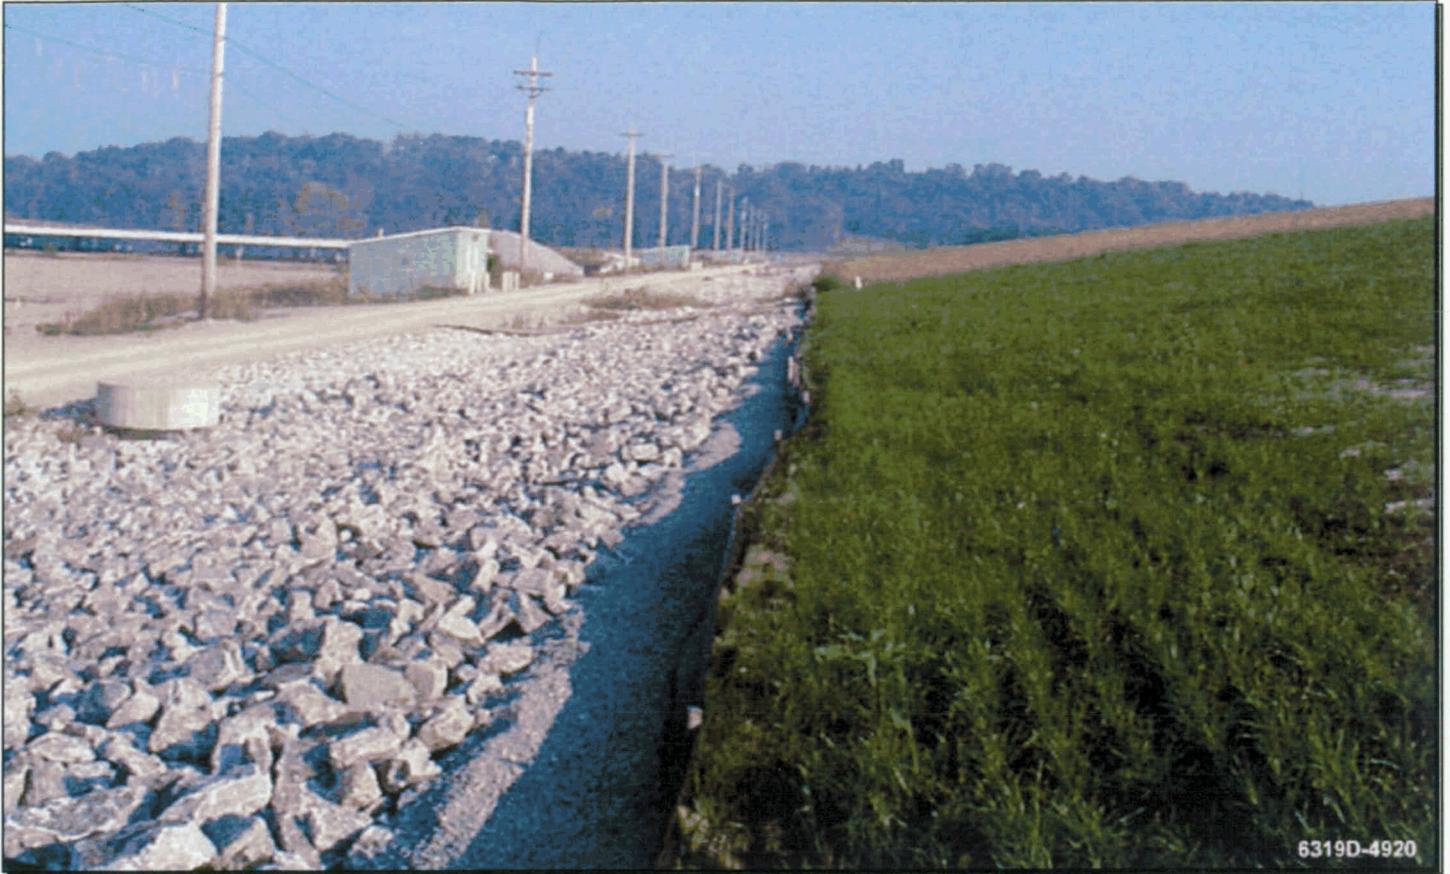
West Drainage Cell 5 (looking north)
