ANNUAL ASSESSMENT
of the
EFFECTIVENESS OF INSTITUTIONAL CONTROLS
applied to the former
MOUND SITE PROPERTY

prepared by the
U.S. Department of Energy
Miamisburg Environmental Management Project

June 13, 2002

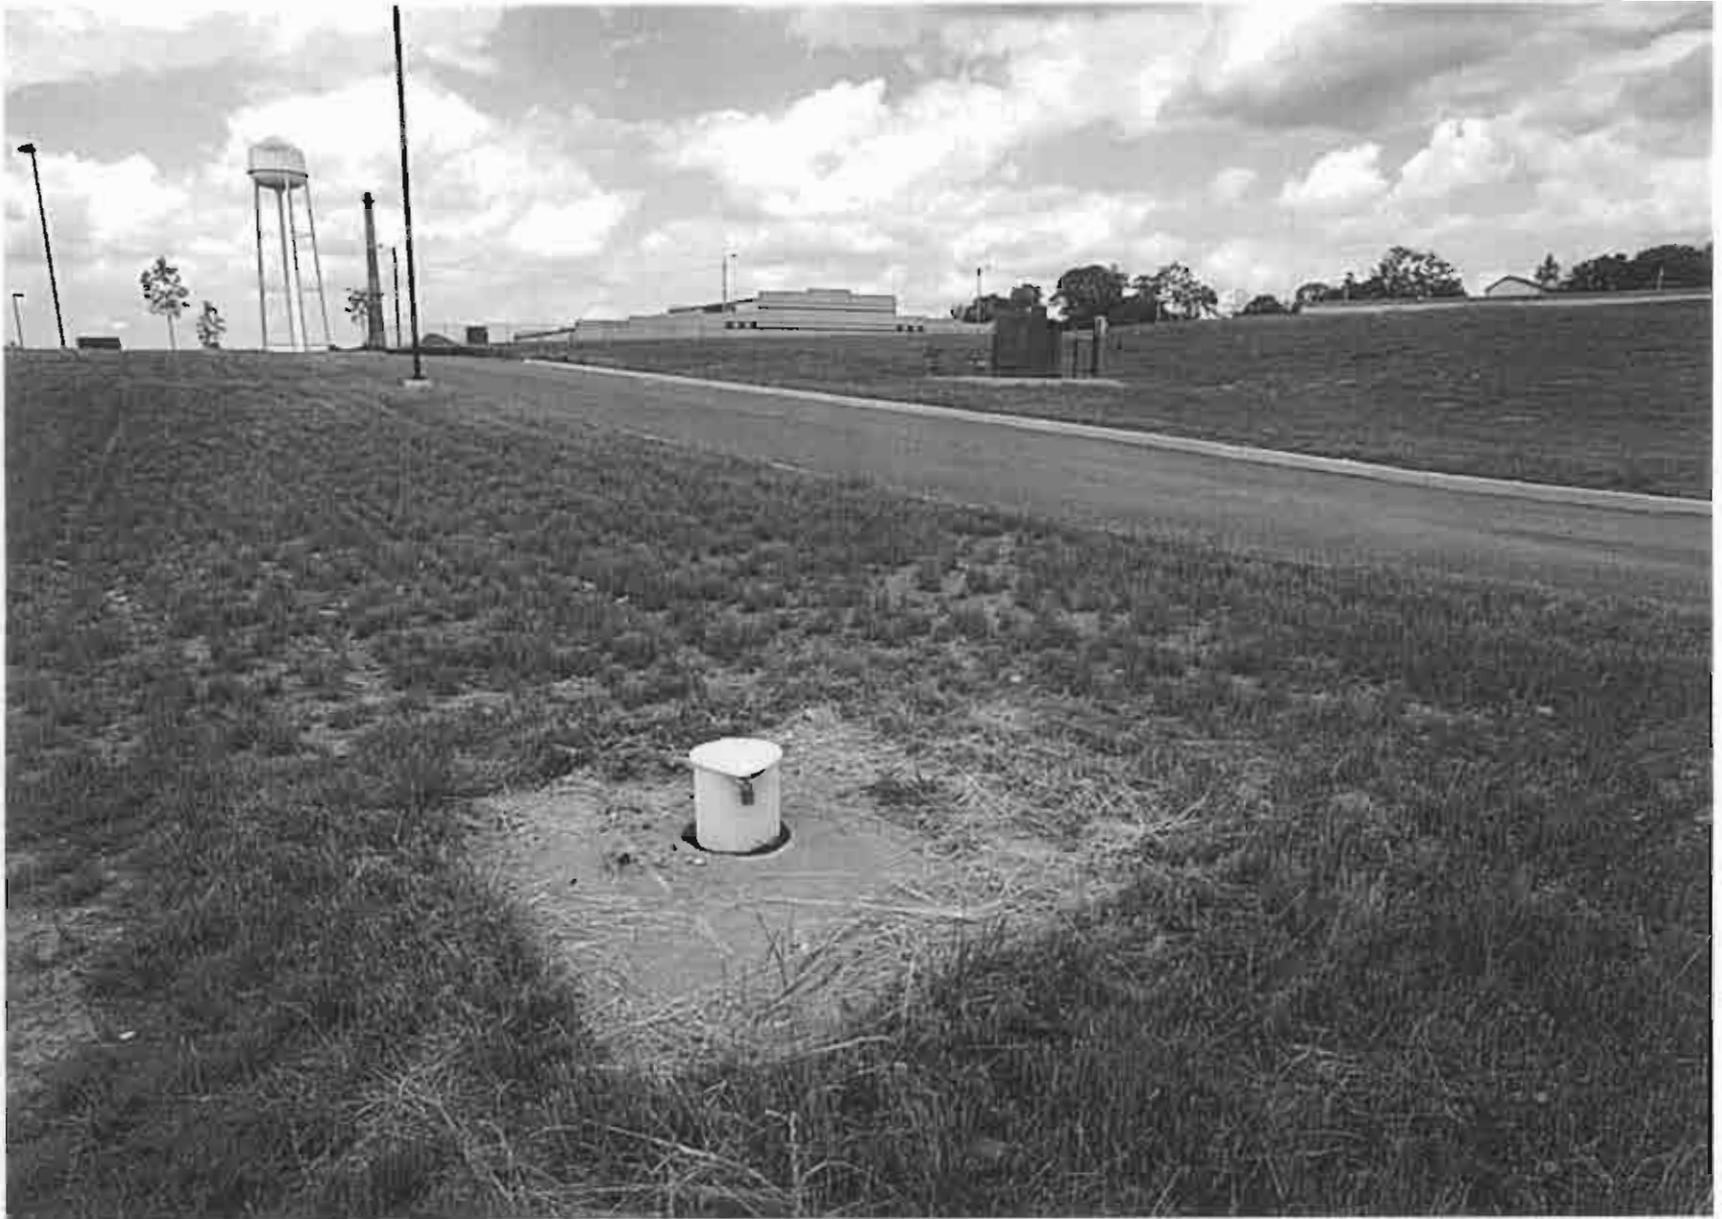
In Parcel D, there were no observations of non-compliance with the IC's, including no evidence of unauthorized well installation or soil movement. Groundwater monitoring well # 0351 was locked and in good repair. The DOE air monitoring station (# 216) that used to reside in Parcel D, prior to the parcel's transfer to the MMCIC, had already been moved to nearby DOE property by the time of the April 2000 visual inspection. Security fencing between Parcel D and the neighboring DOE property was in good repair.

Figure 7: Groundwater monitoring well # 0351, Parcel D.

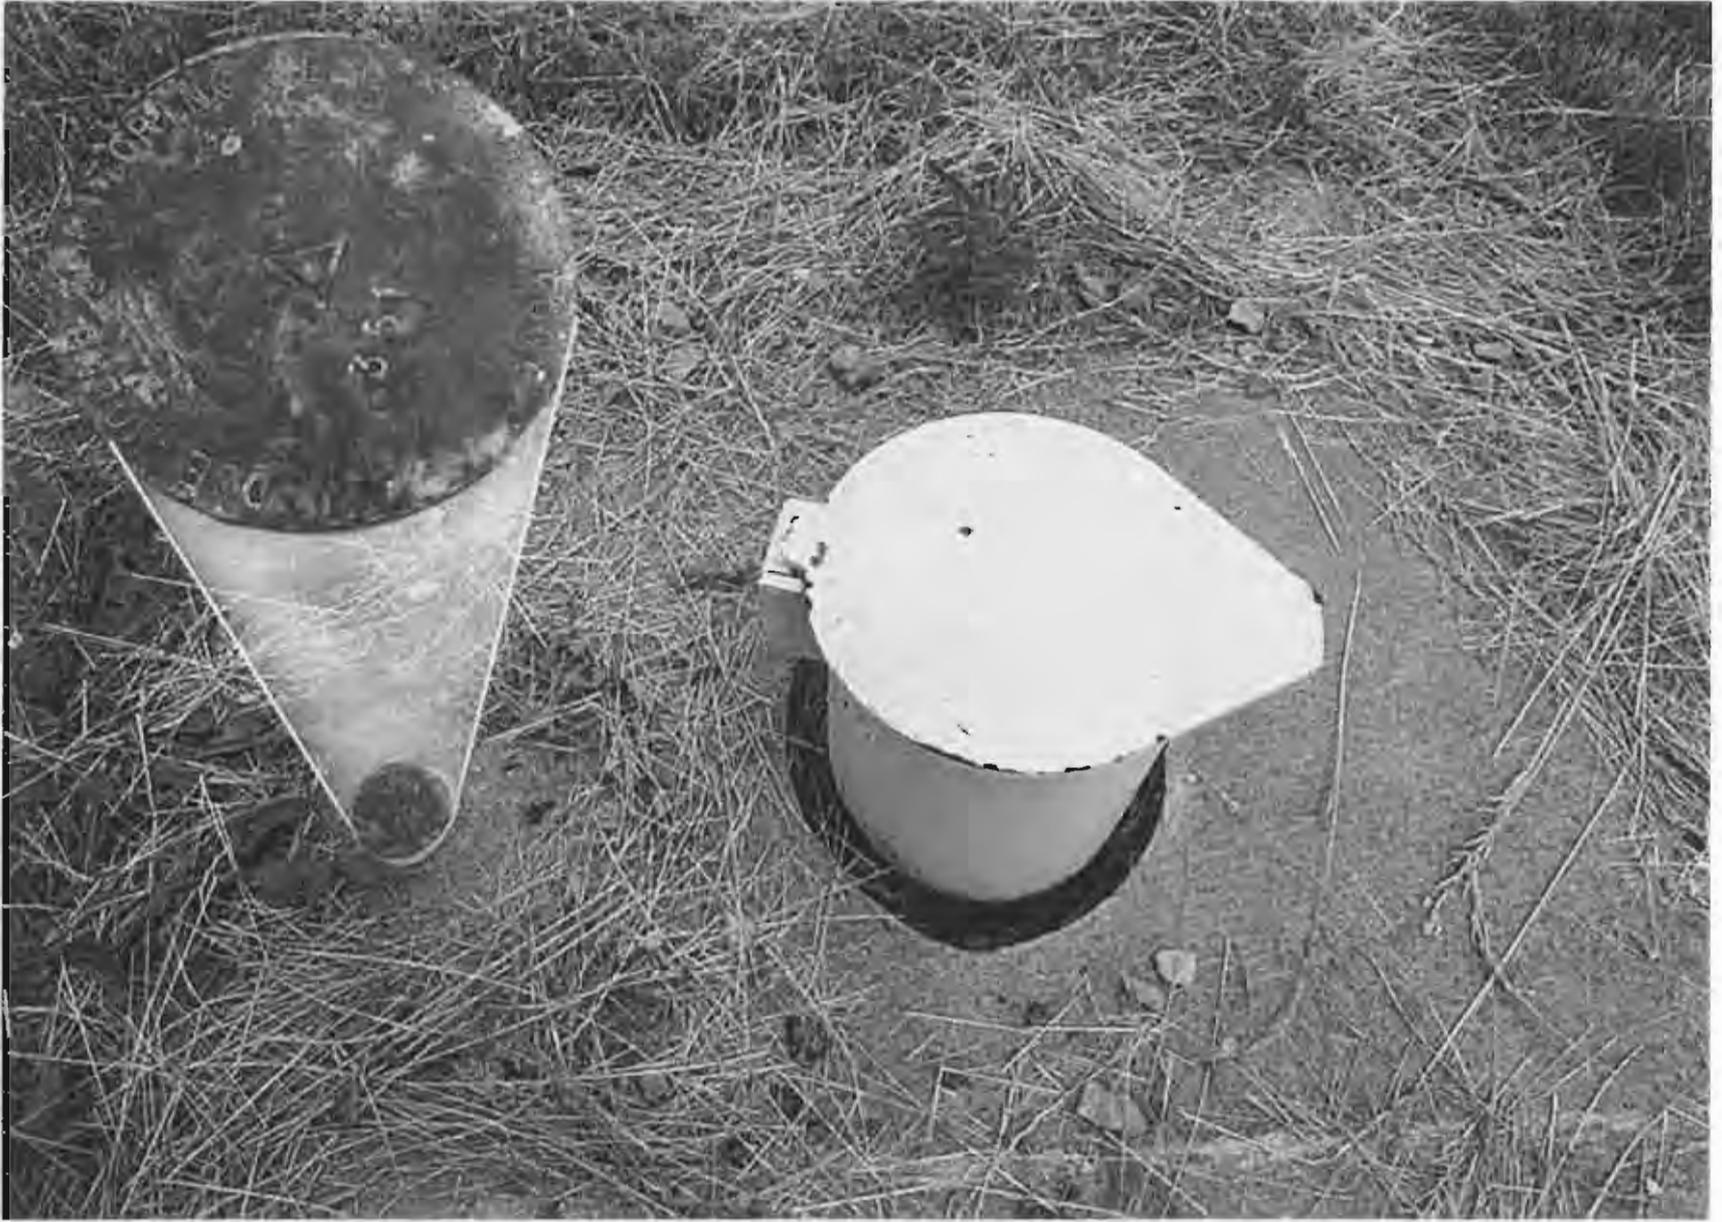
Figure 8: Close-up view, Groundwater monitoring well # 0351.

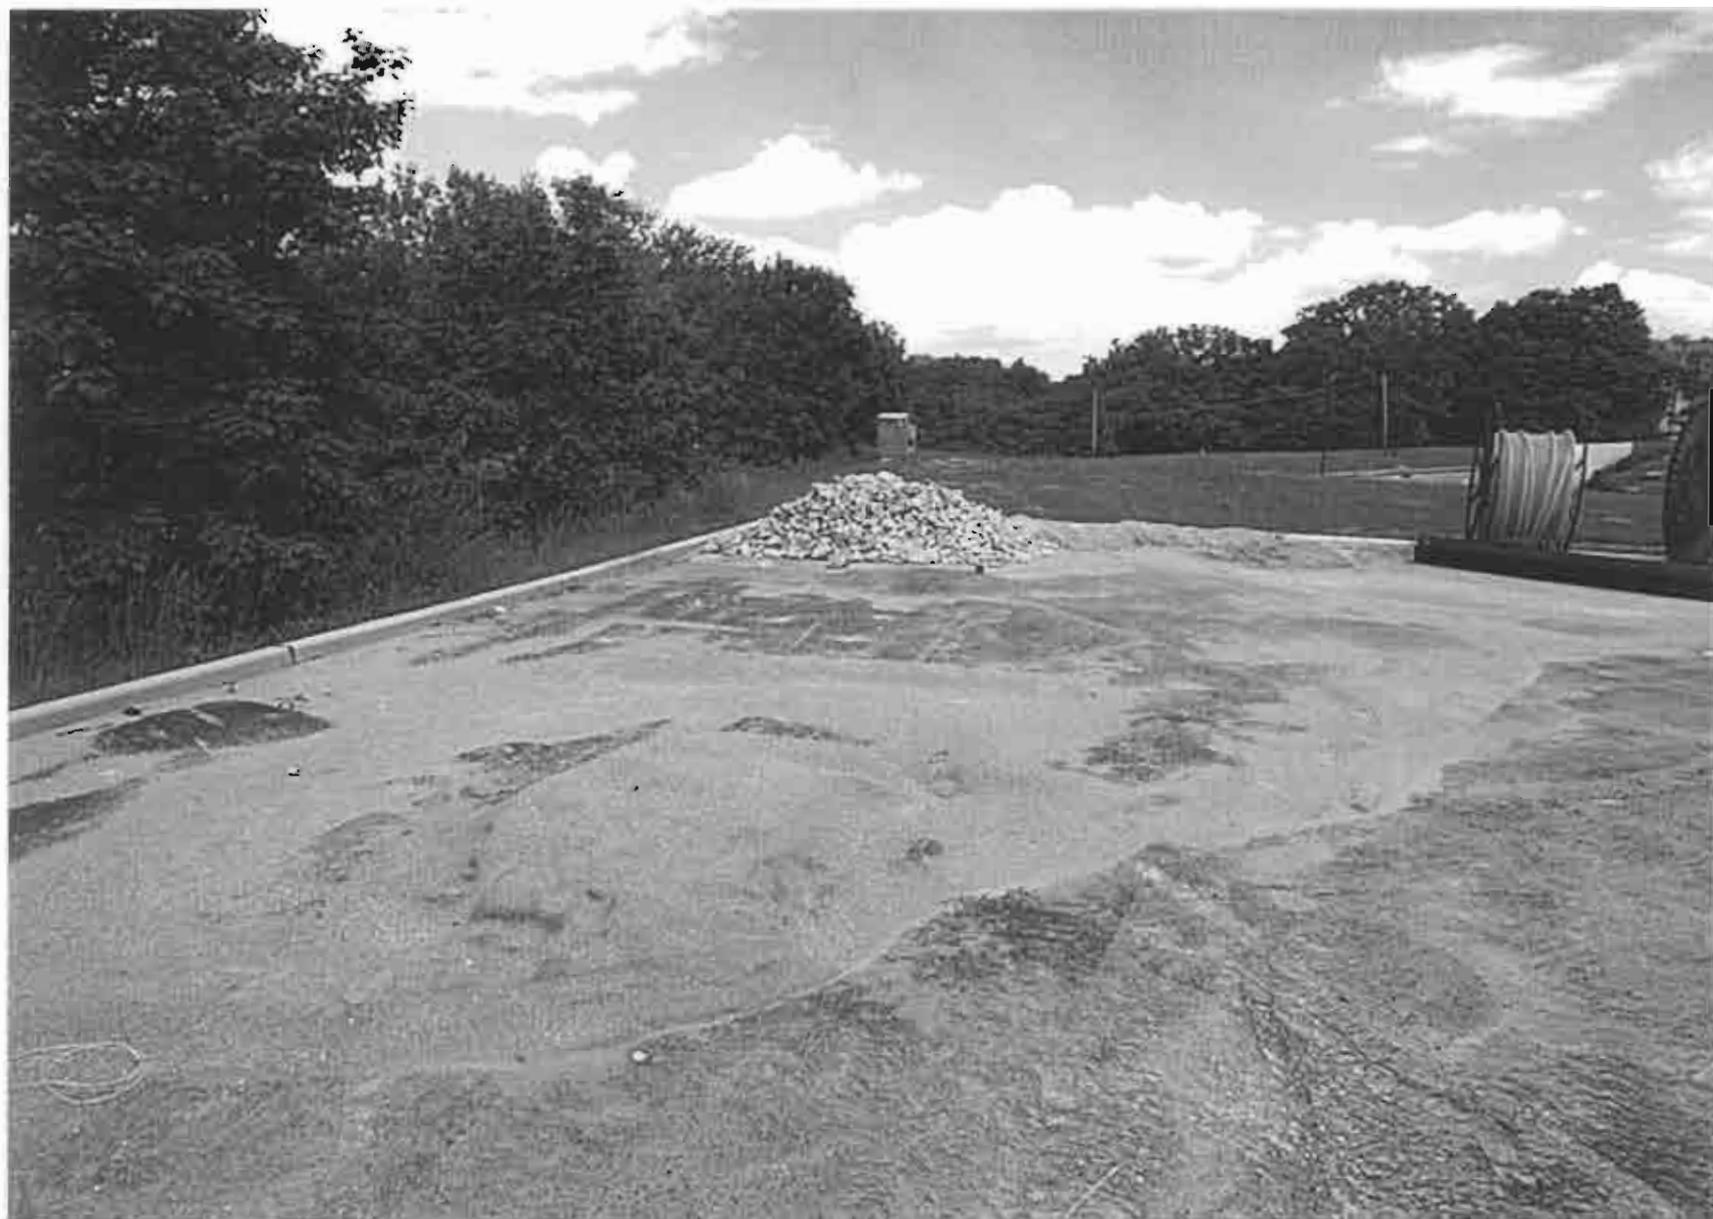
In Parcel H, there were no observations of non-compliance with the IC's, including no evidence of unauthorized well installation or soil movement. However, inspectors were unable to locate groundwater monitoring well # 0332 (using maps that showed the location of the well, relative to other landmarks). The team suspected that the wellhead was covered by a small pile of sand that had been temporarily staged by the MMCIC in the northeast corner of the lower parking lot (see Figure 14). Immediately following the walk-over, BWXTO used a global positioning system (GPS) to confirm the location of the well #0332, and the bulk of the staged material was carefully removed by the MMCIC. Well # 0332 (a flush-mount well, in the parking lot, near the curb) appeared to be in good repair and the cover plate was secured (see Figure 15). Well # 0332 was installed in April 1993 and has been sampled by DOE sporadically since. This well

Figure 14: "Before" photo of Groundwater monitoring well # 0332, Parcel H.

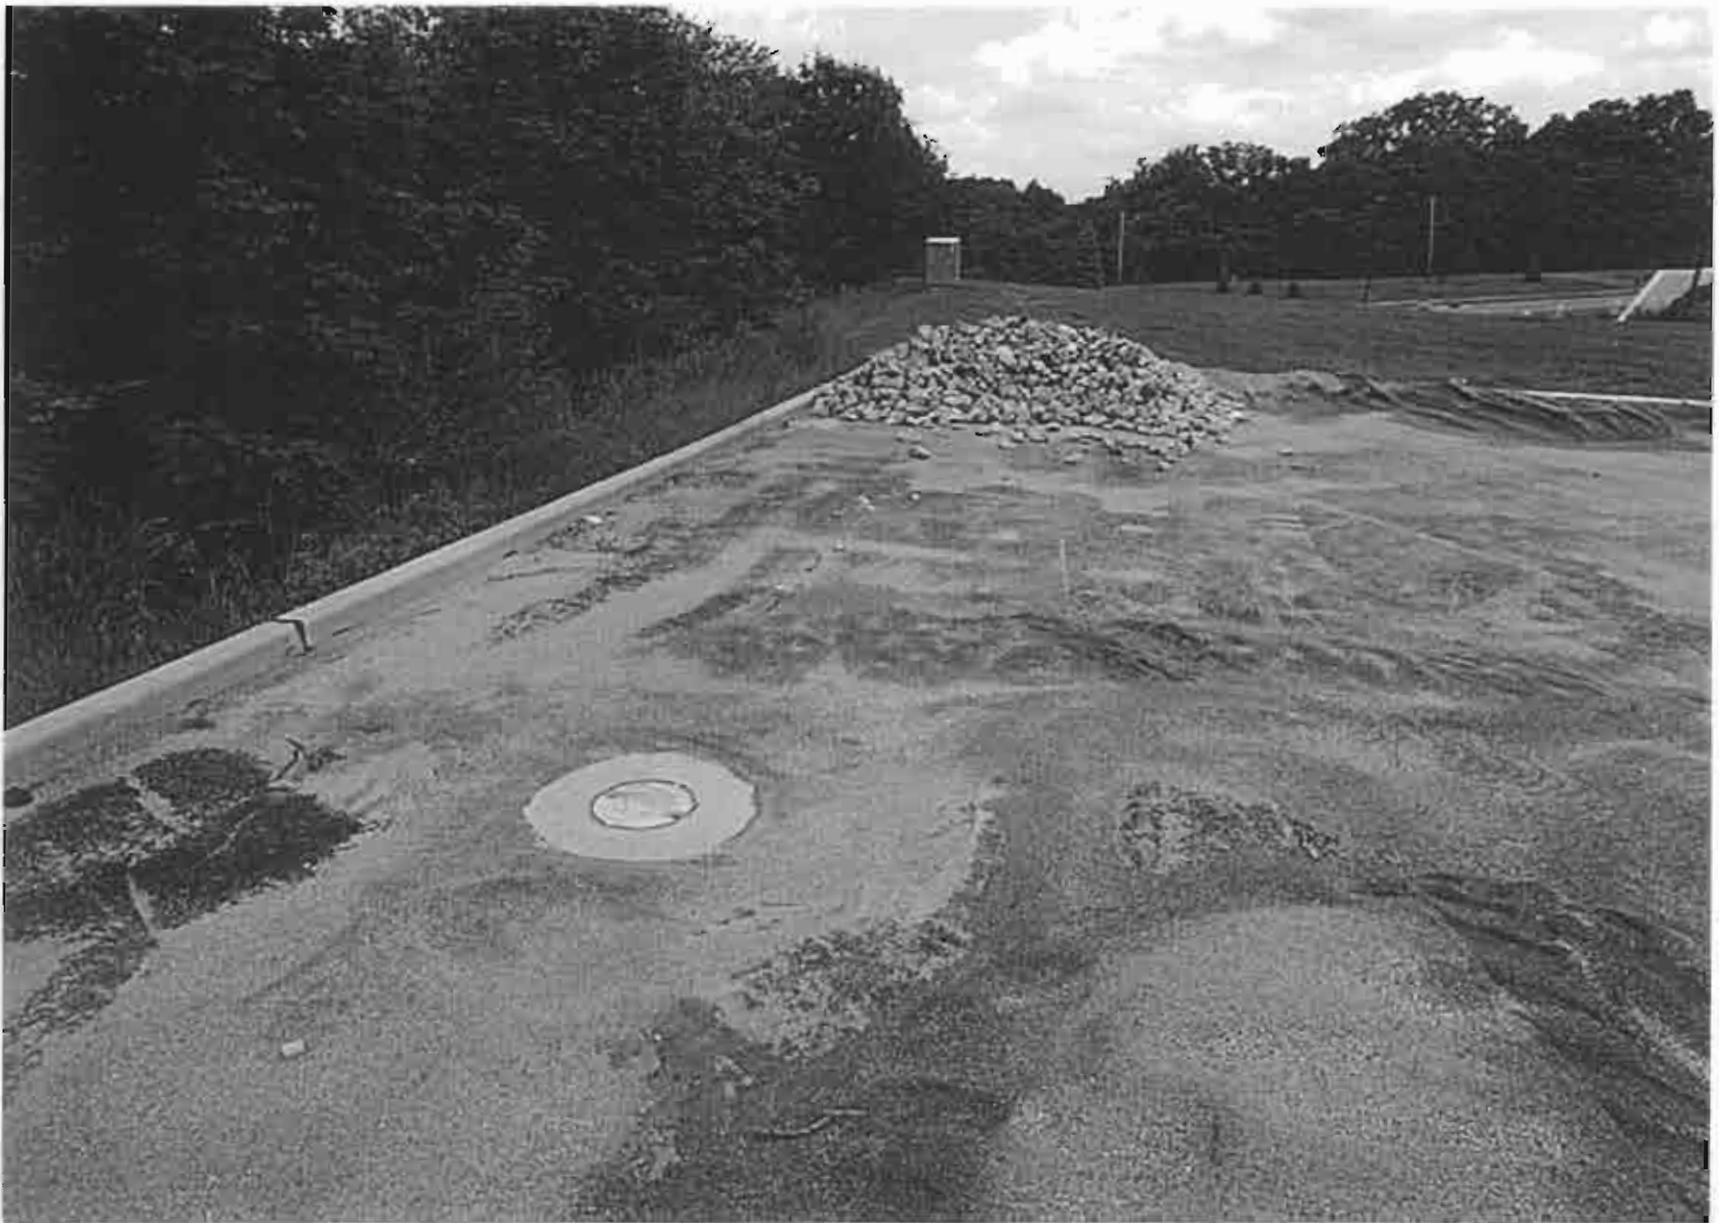
Figure 15: "After" photo of Groundwater monitoring well # 0332.

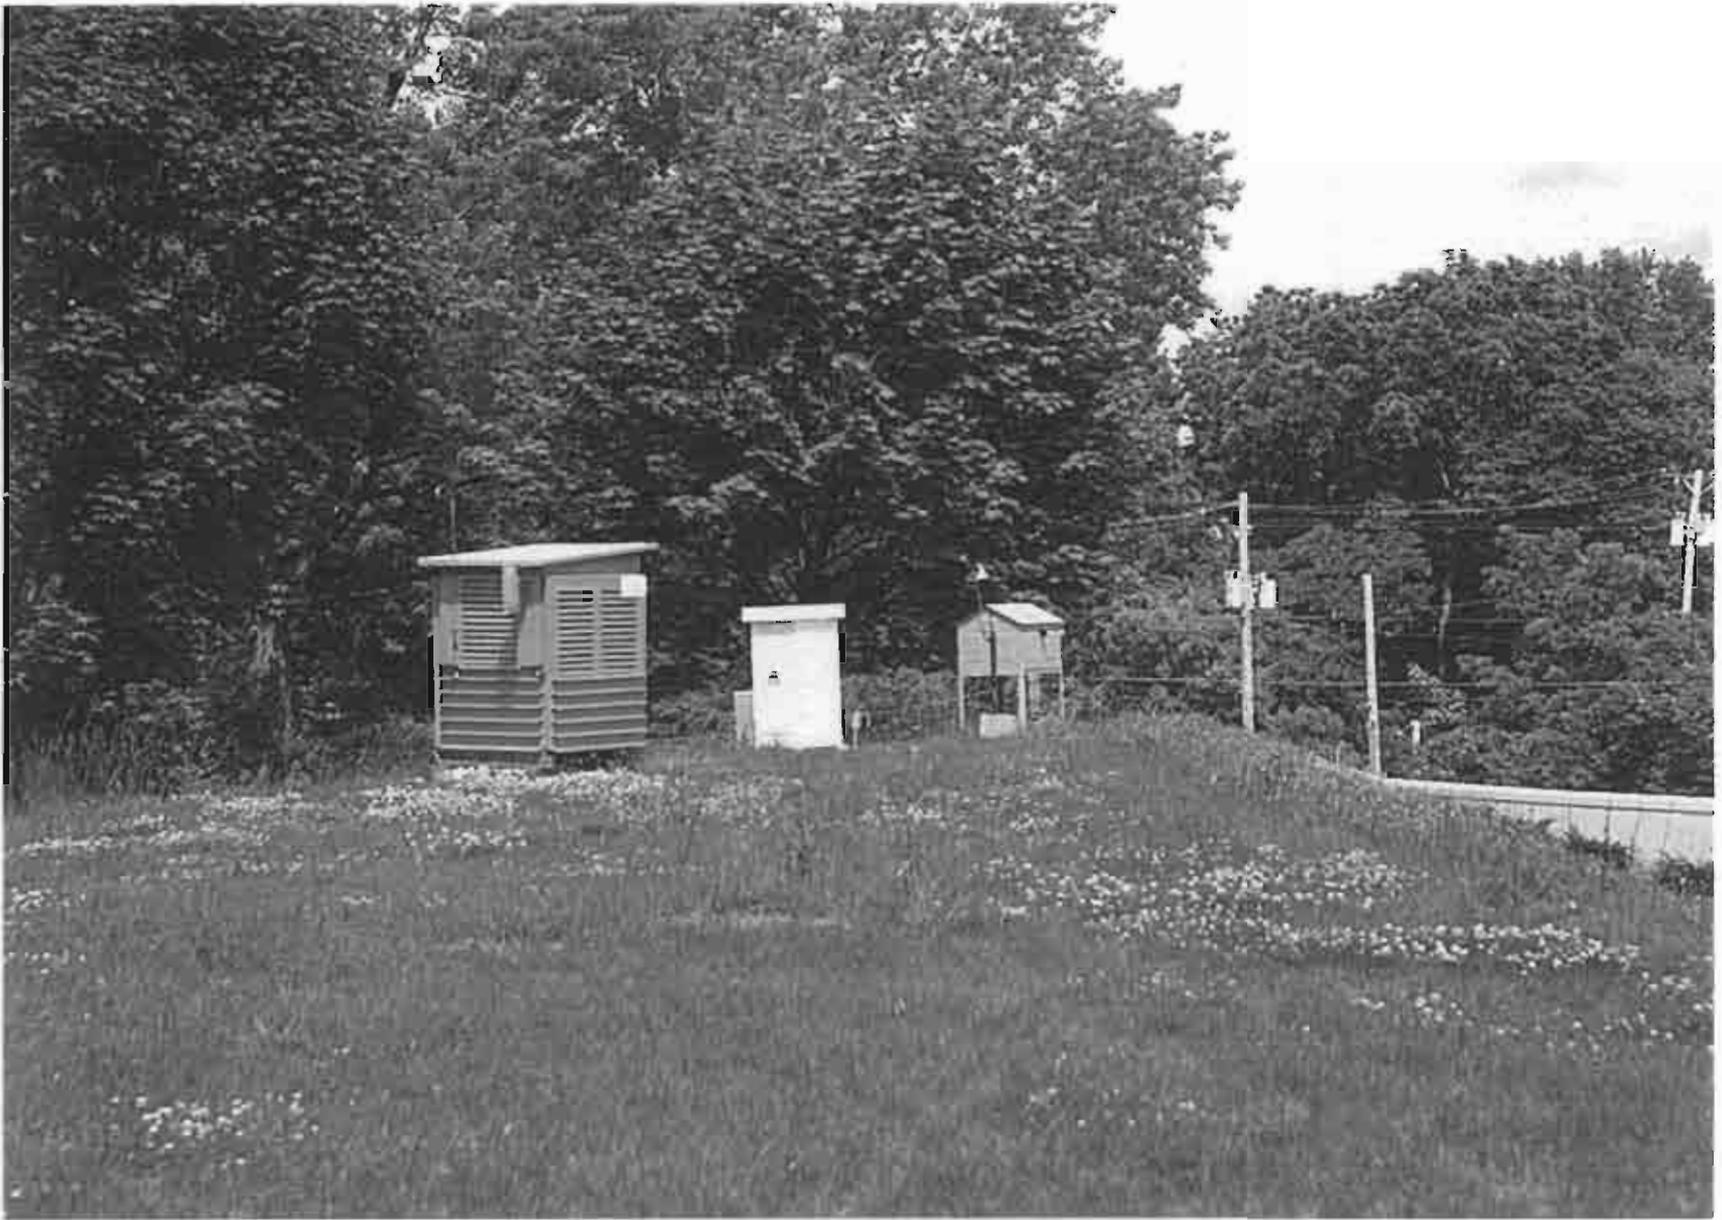
continues to remain accessible for sampling, and has not been abandoned by the DOE. DOE air monitoring station # 212 (co-located with a State of Ohio air sampler), located in the northeast corner of Parcel H, was undisturbed and operating (see Figure 16).

Figure 16: Air monitoring station # 212, Parcel II.

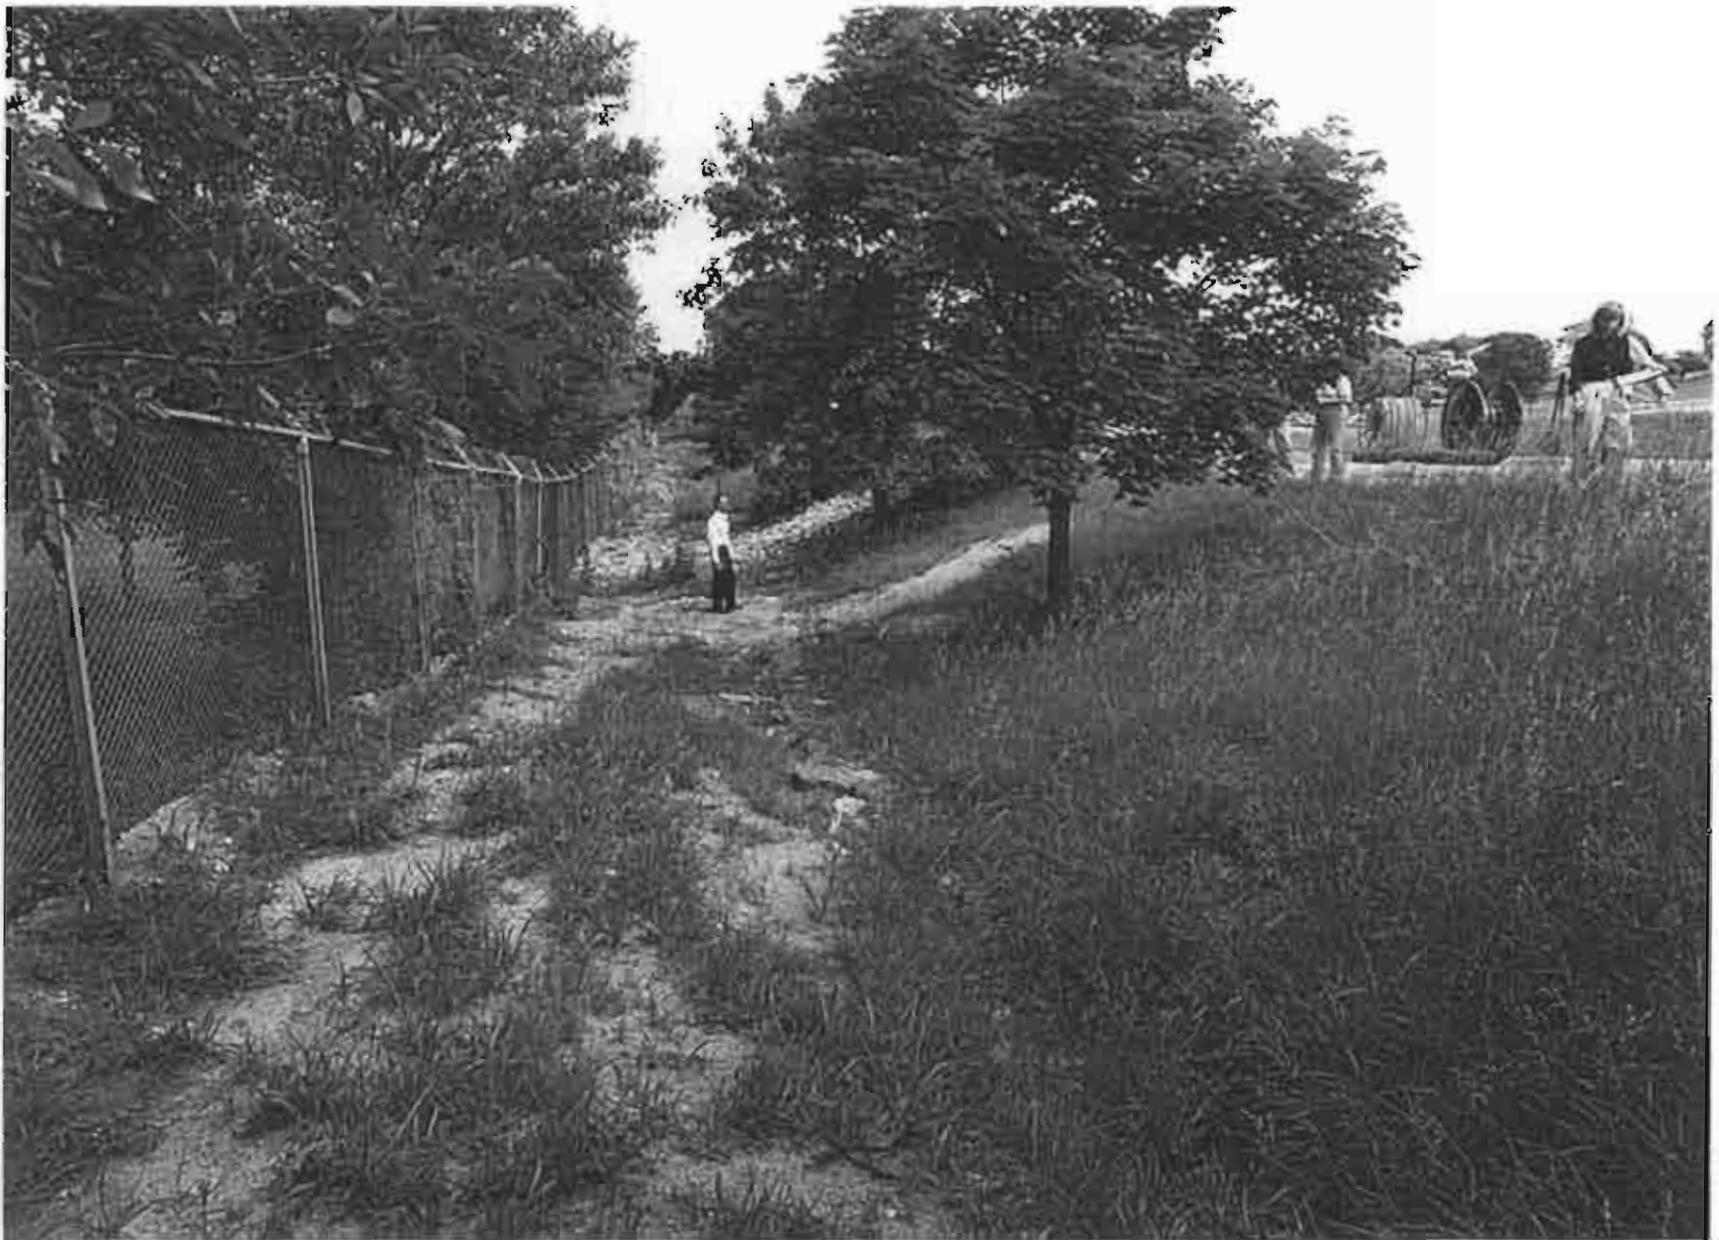
Inspectors toured the northern boundary of Parcel H, where a "T-1" telephone line had been installed. The work was performed at the request of DOE, and involved the installation of a T-1 line along the northern boundary of Parcel H and onto DOE property in front of the OSE/A/OSW building complex. Installation of the T-1 line required excavation and burial of the line (see Figure 17). DOE Headquarters required the T-1 line to support the complex-wide "DOE Net" project. According to the DOE Ohio Field Office Information Management (IM) Team Leader, the DOE Mound Site did not pay for the materials or labor to install the T-1 line, however, BWXTO personnel were present during installation of the line (e.g., Radiation Technicians monitored the excavation work). Sprint subcontracted the job to Ameritech, who subcontracted the work to a third party. It is important to note that a permit to install the T-1 line was not submitted to the City of Miamisburg, because the work was entirely performed within an existing utility easement. Furthermore, the job did not affect utility lines within the City's right-of-way (if it had, a permit would have been required). Since institutional controls prohibit the removal of soil from the original Mound Site Property boundaries, DOE coordinated with the MMCIC on procedures (i.e., other than a City permit) to educate site workers about the deed restrictions associated with a given land parcel. In the case of the T-1 line on Parcel D, the DOE granted a real estate easement to Ameritech (and its successors and assigns) on September 22, 1999, and the easement was subsequently recorded by the Montgomery County Auditor on October 13, 1999. The easement covered work performed under the MMCIC's "East Boundary Improvement Project." Provision 12, Grantee Responsibility, of the subject easement reads, in part: "... Grantee ... shall ensure that any soil within the area identified ... as a 'soil removal restriction area' shall not be placed on property outside the boundaries of that described in [the deeds for Parcels D and H] ...". Provision 12 further states, in part: "... Grantee warrants that it will make its agents, contractors, employees, etc. aware of the restriction on soil removal and contractually obligate agents and contractors to abide by this restriction ...".

Figure 17: Installation of T-1 telephone line, northern border of Parcel H.

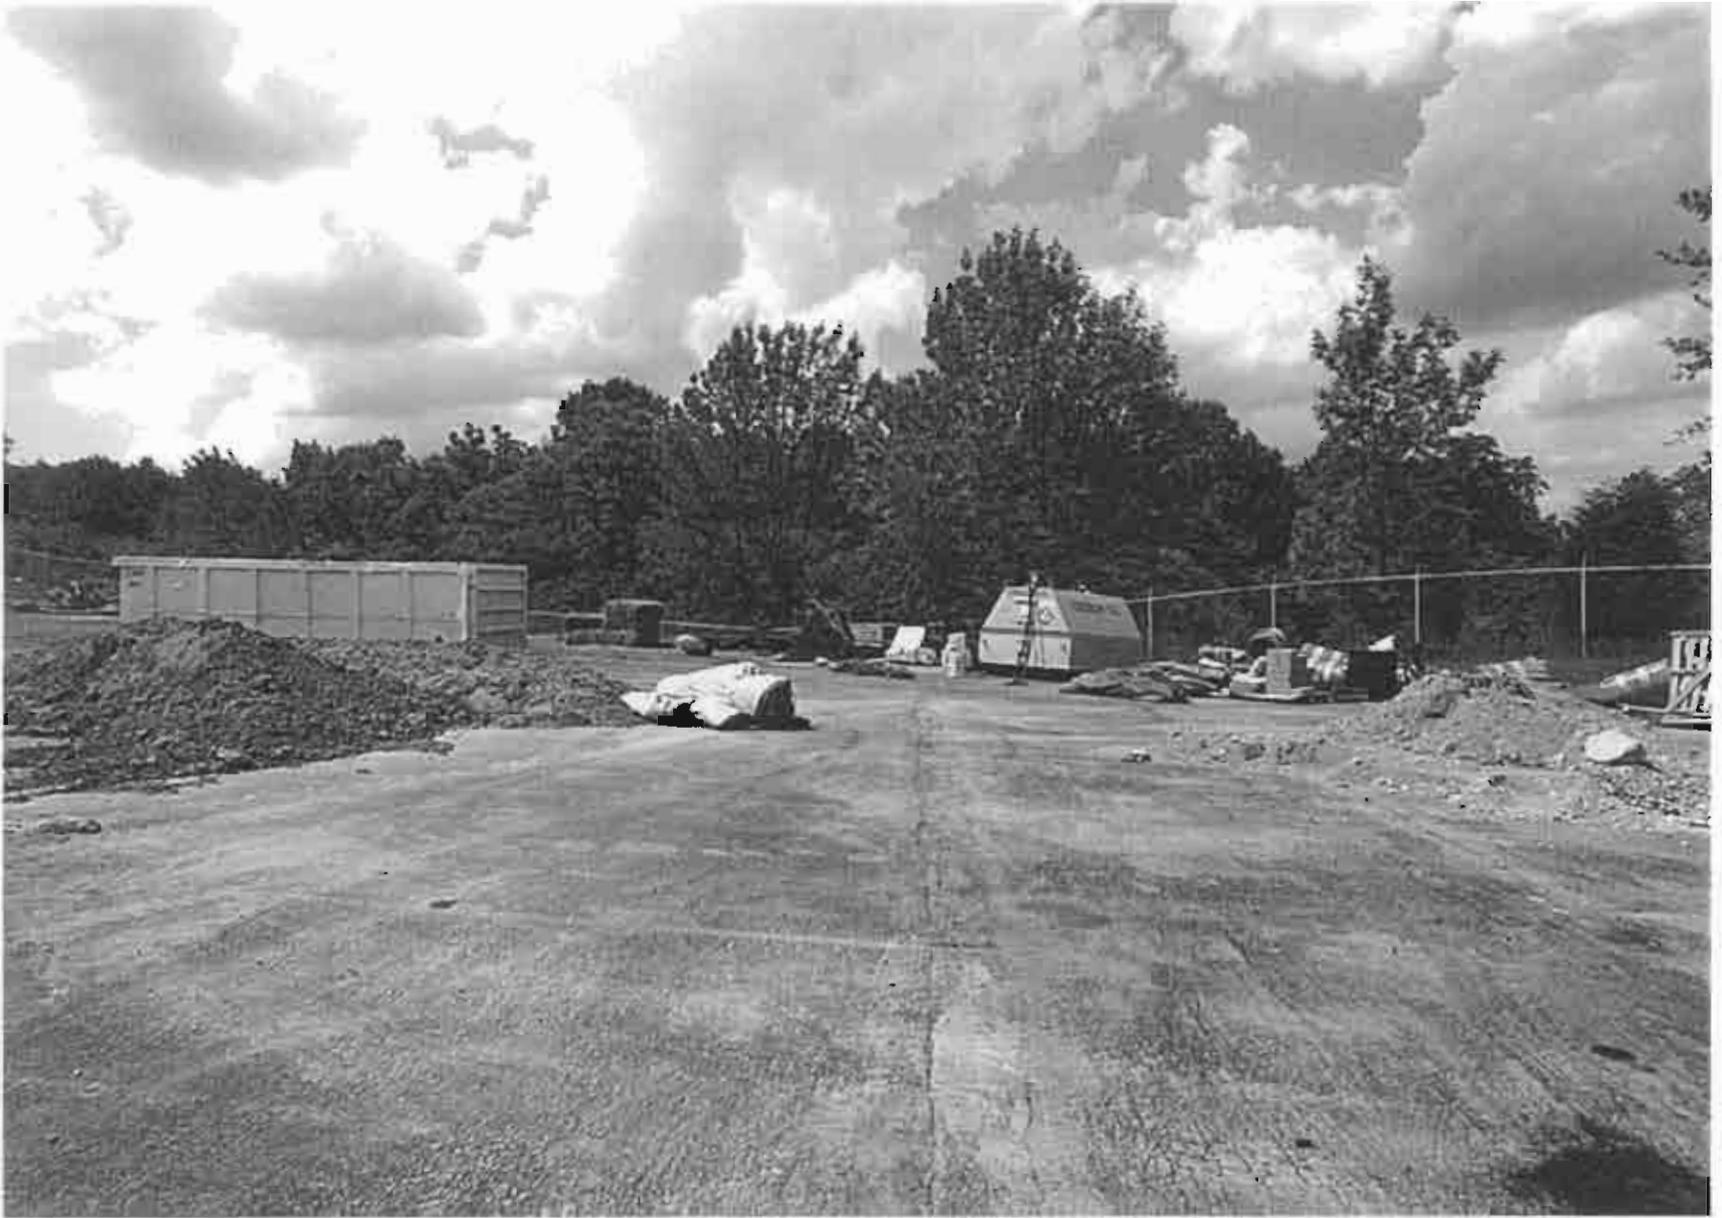
Figure 19: Two piles of staged soil in Parcel H.

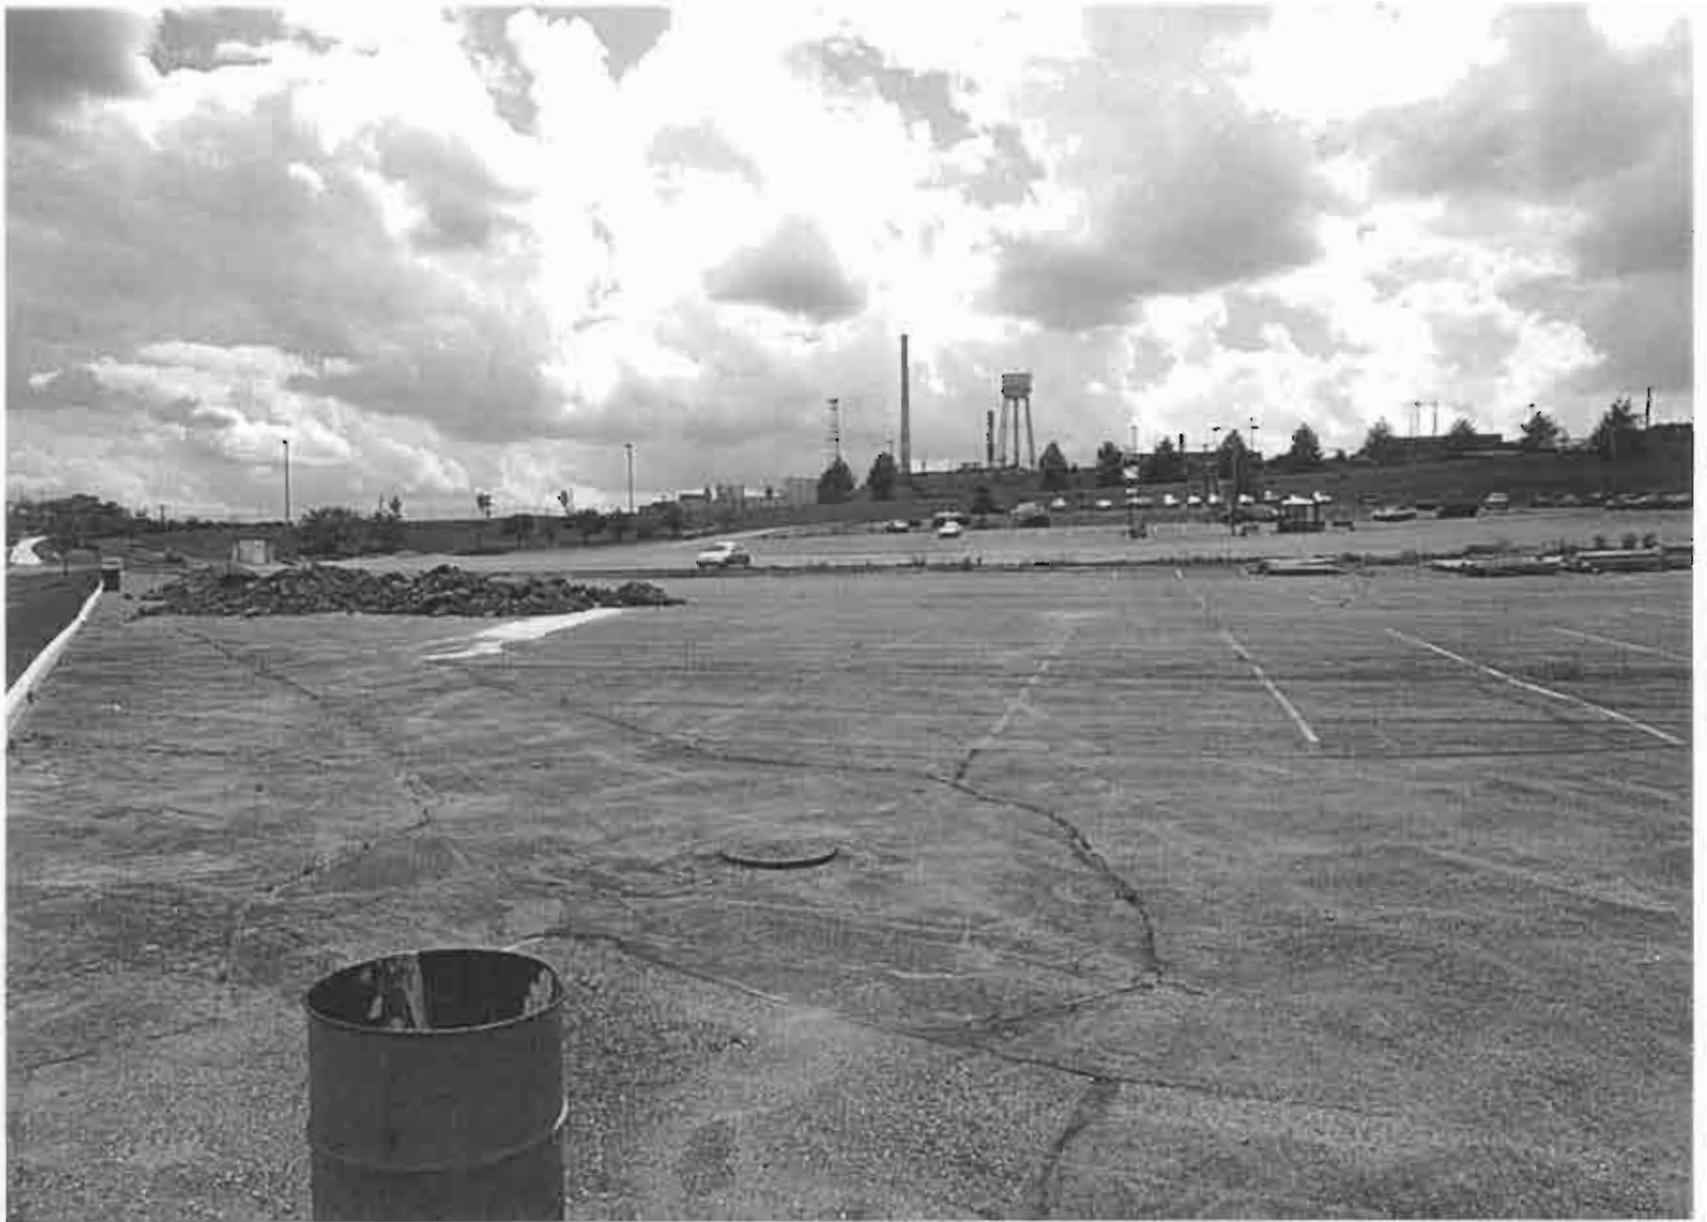
Figure 20: Topsoil purchased by the MMCIC and temporarily staged in Parcel H for site entrance and landscape project.

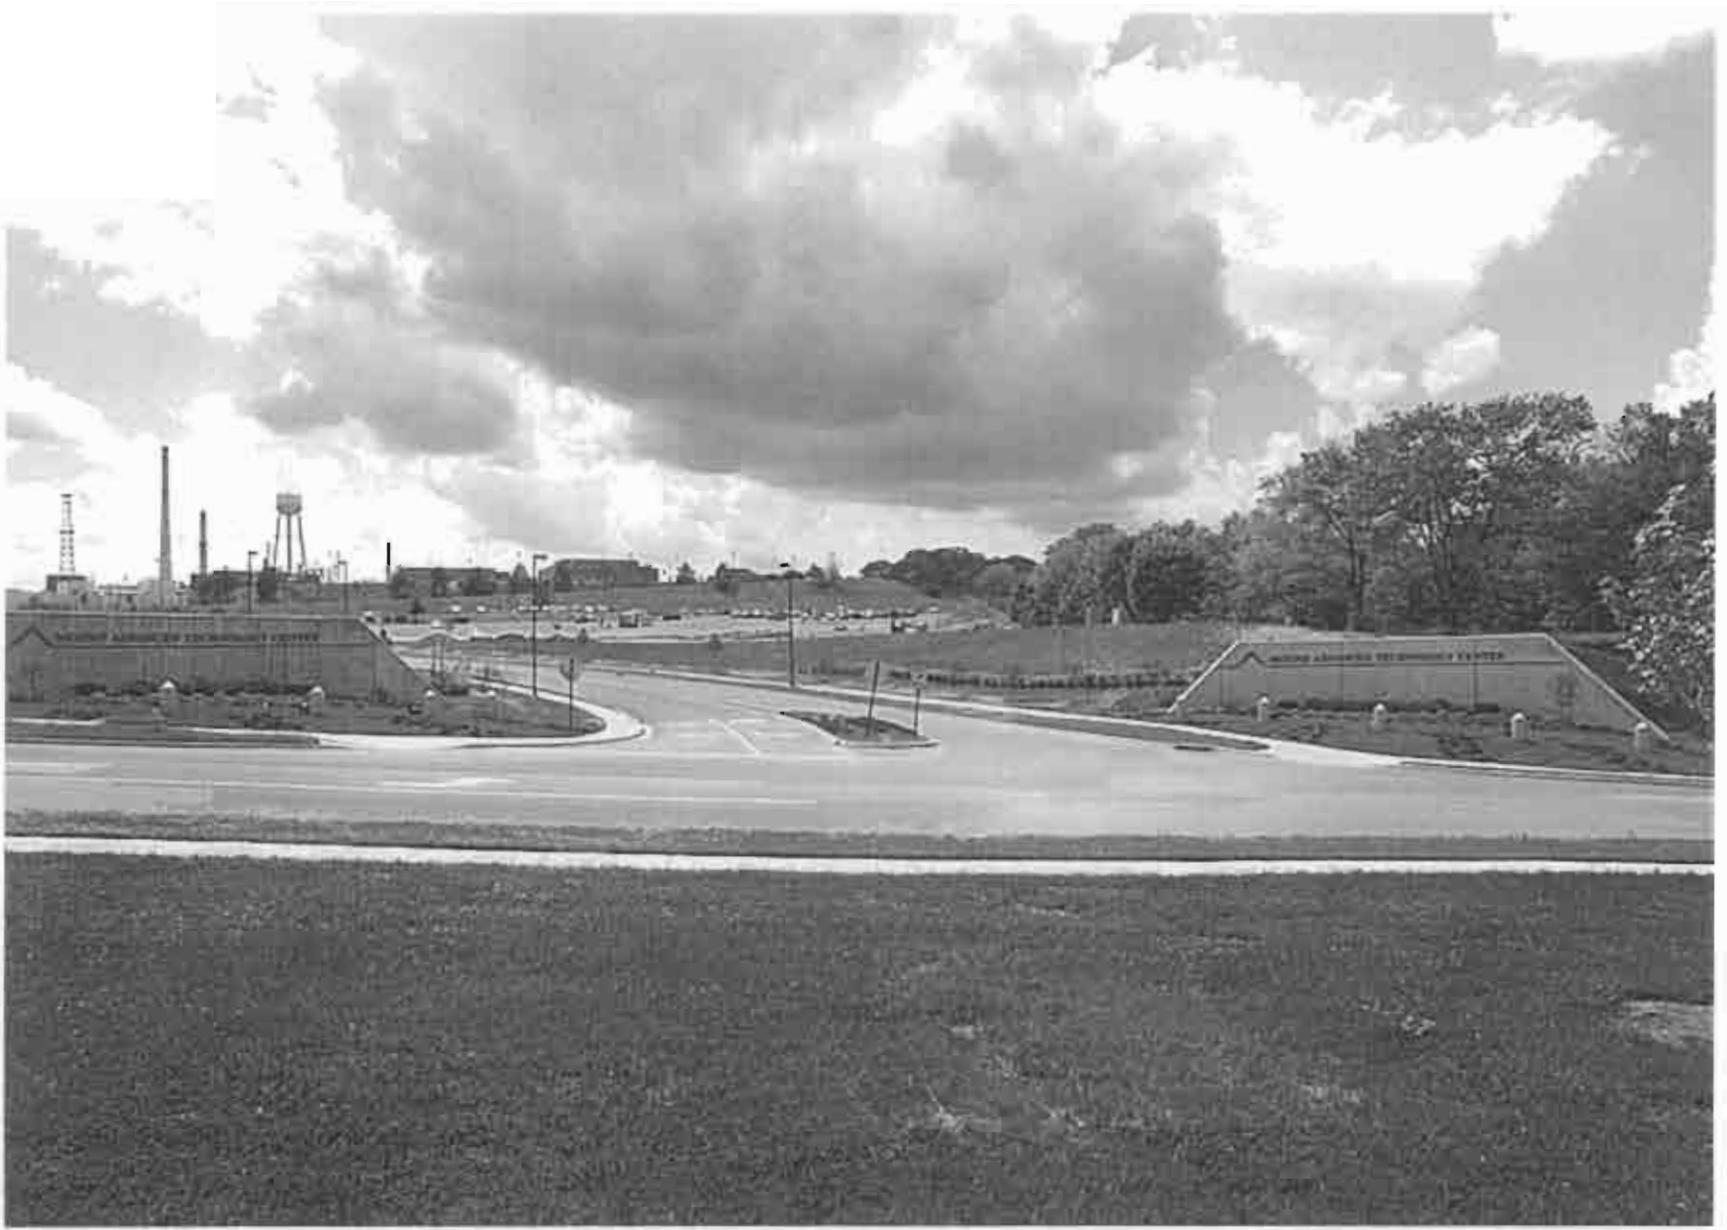
MMCIC's landscaping project at the new site entrance (see Figure 21); the new entrance was the single biggest change to Parcel H since its transfer to the MMCIC.

Figure 21: New entrance to Mound Advanced Technology Center off of Mound Road.

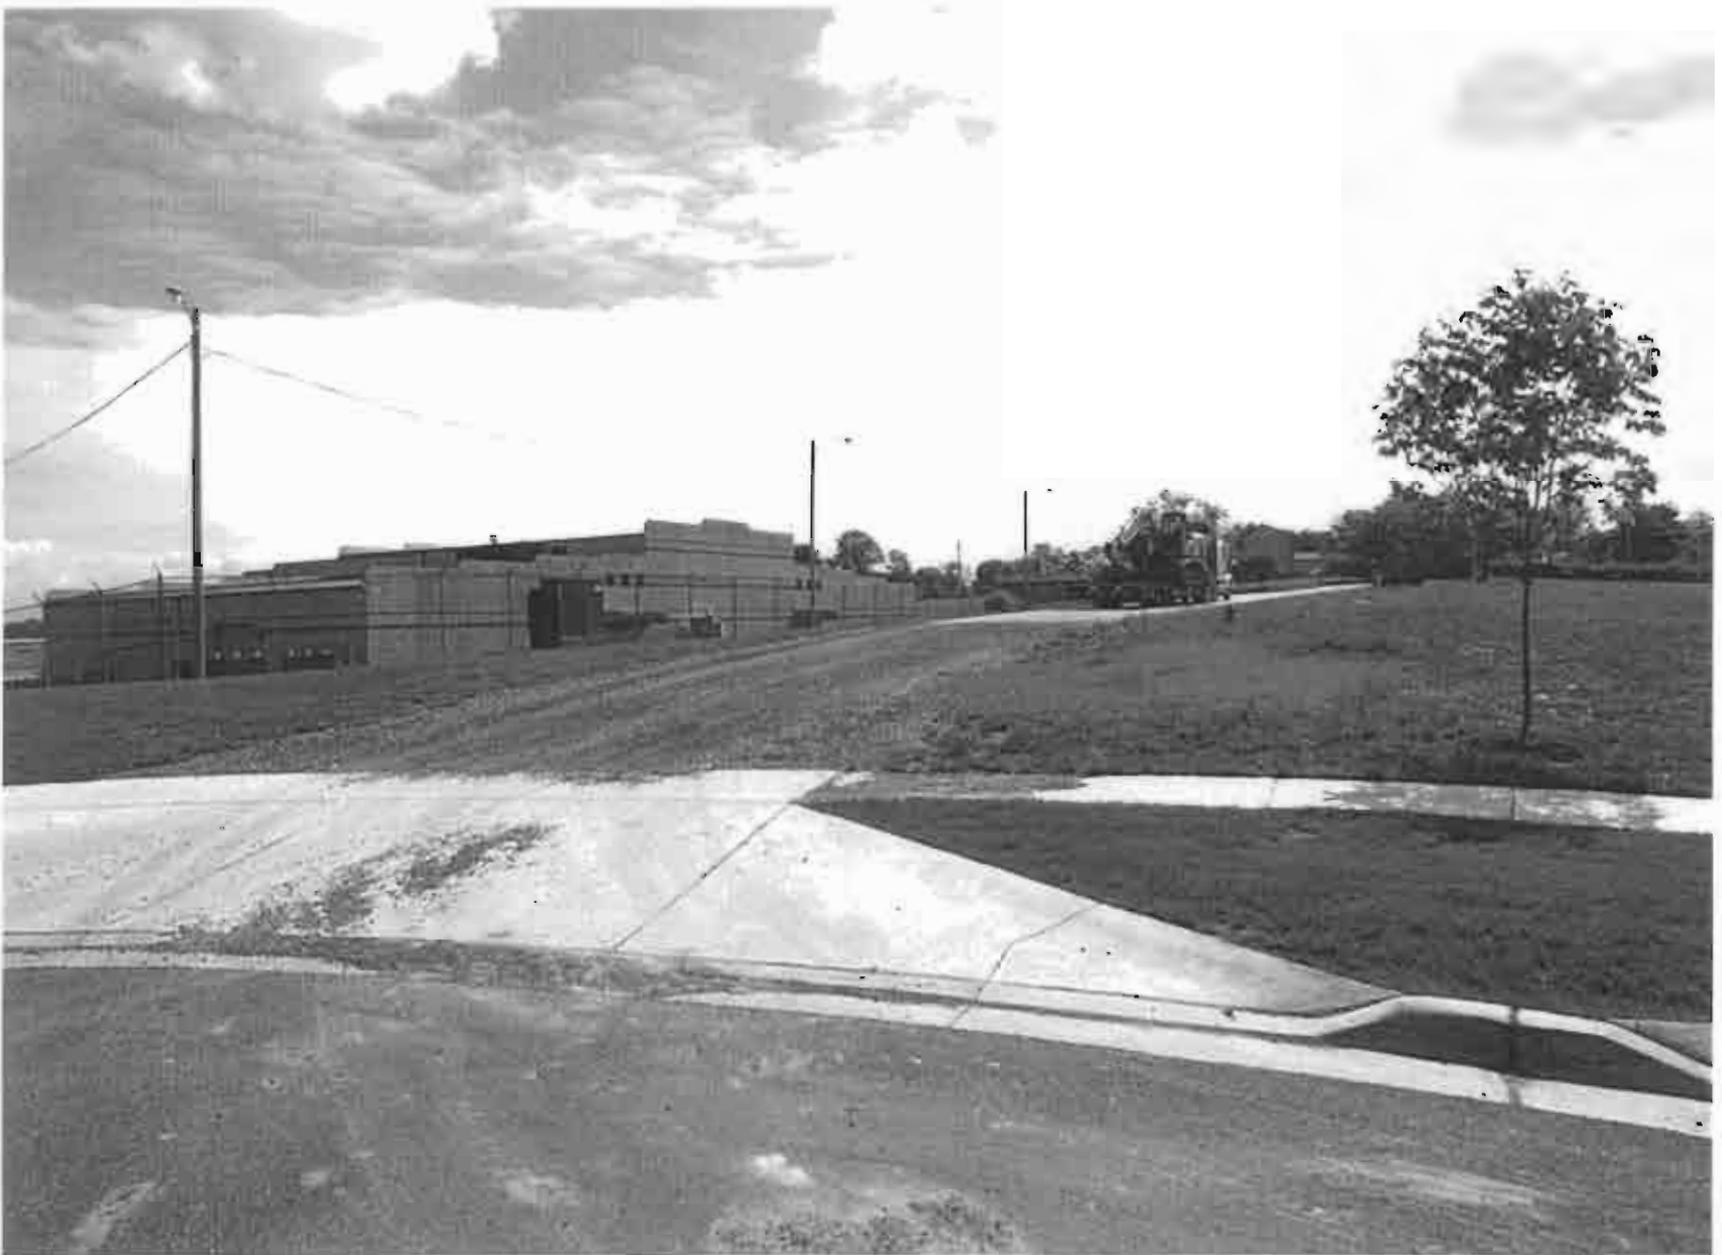
Figure 22: Excavation work in-progress on Parcel D, for installation of underground telecommunication conduits. When not in use, excavation equipment staged behind Building 105.
