ANNUAL ASSESSMENT
of the
EFFECTIVENESS OF INSTITUTIONAL CONTROLS
applied to the former
MOUND SITE PROPERTY

prepared by the
U.S. Department of Energy
Miamisburg Environmental Management Project

June 13, 2002

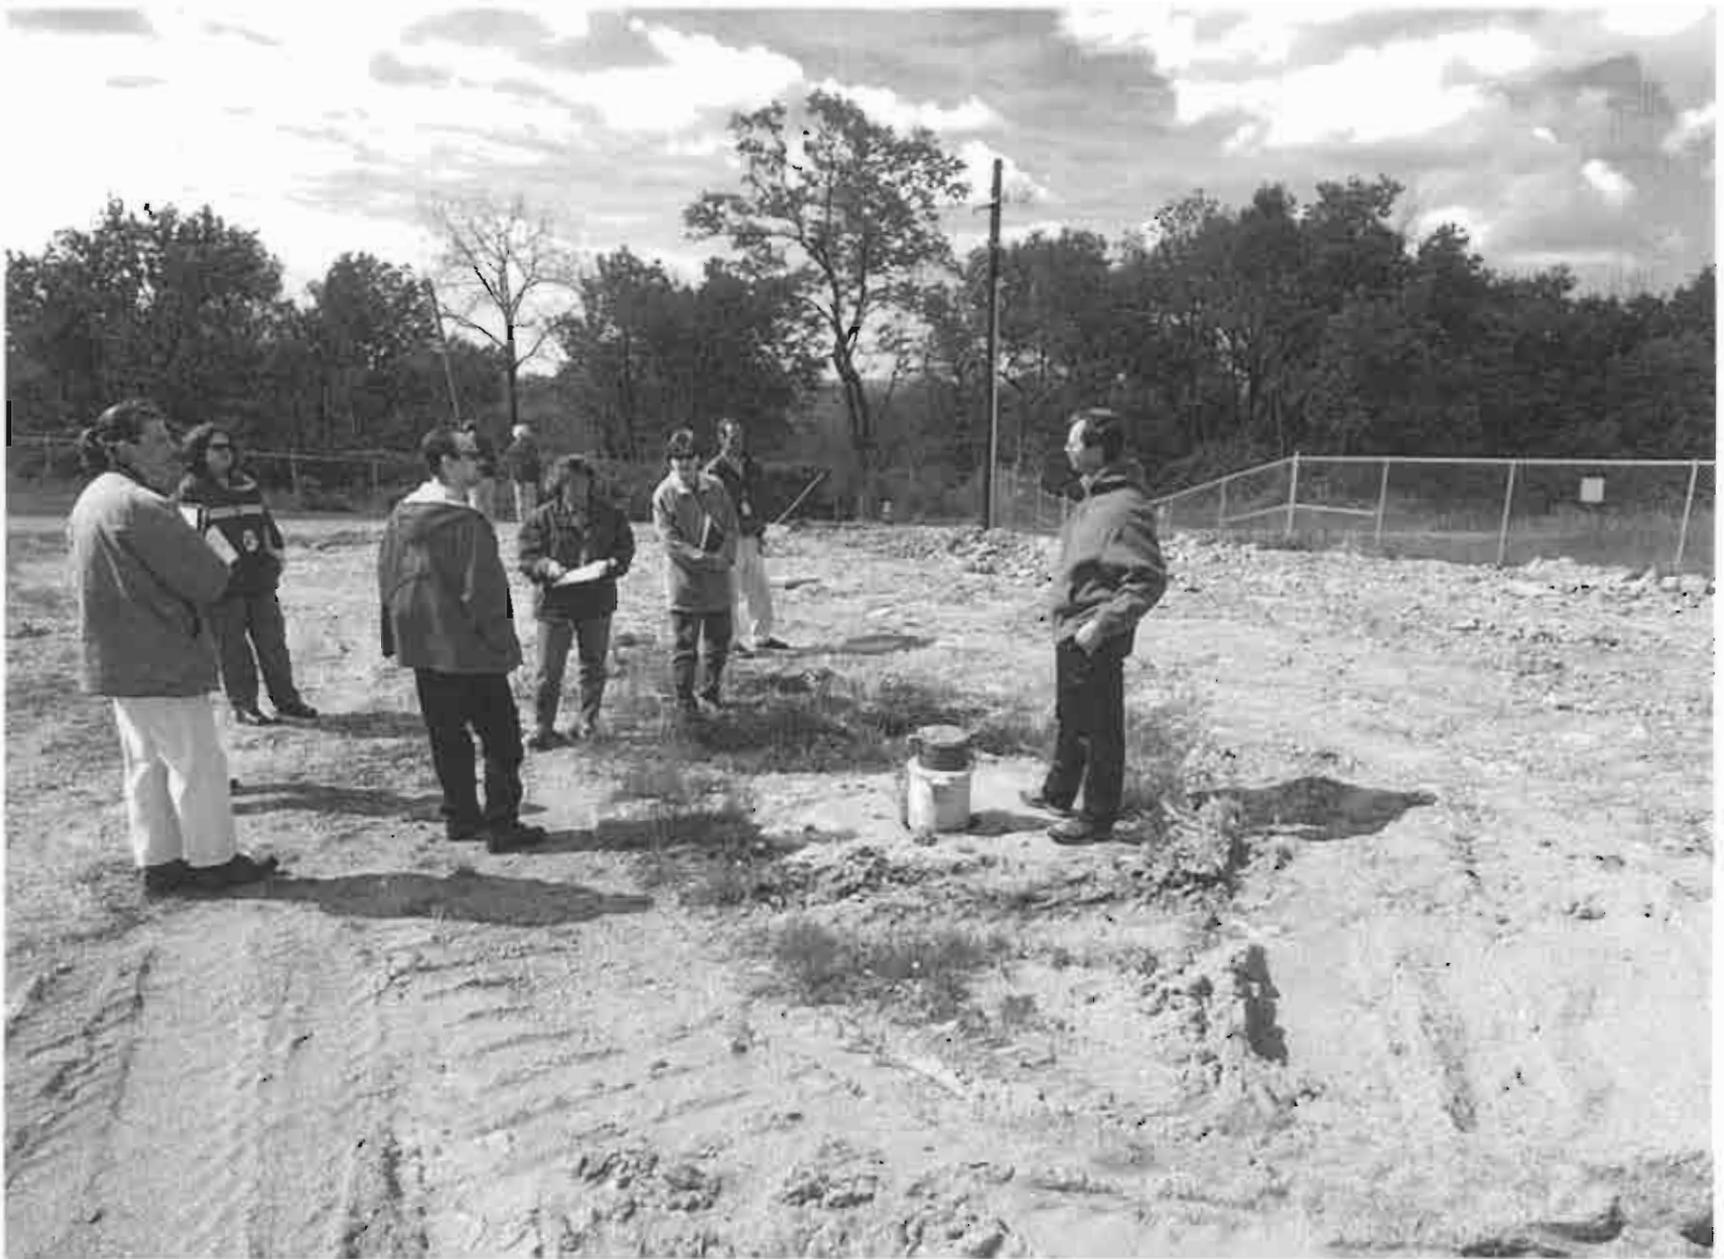
Figure 23: Underground telecommunication conduits in the process of being installed at the end of cul-de-sac, Parcel D. Groundwater monitoring well # 0351 padlocked and in good repair.

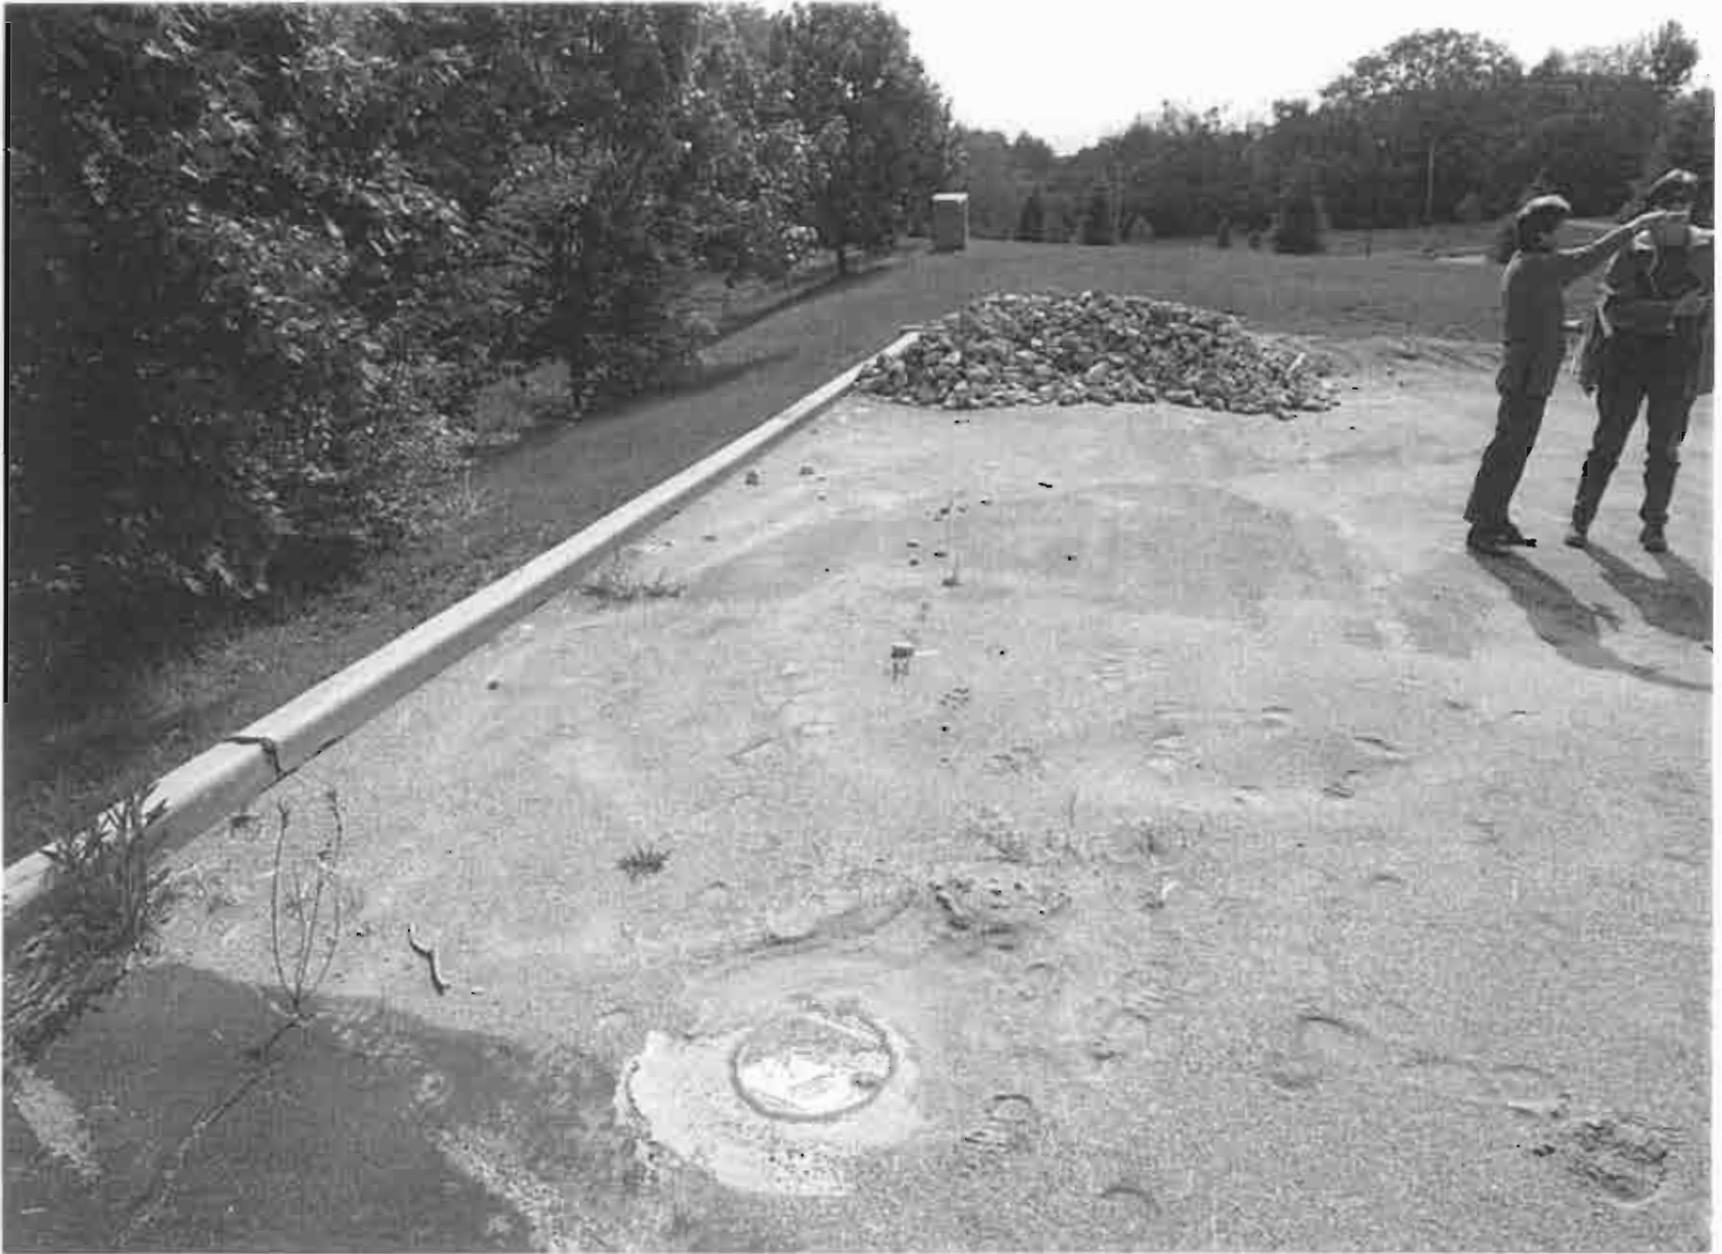
Figure 25: Groundwater monitoring well # 0332 (foreground) and air monitoring station # 212 (background), Parcel H.

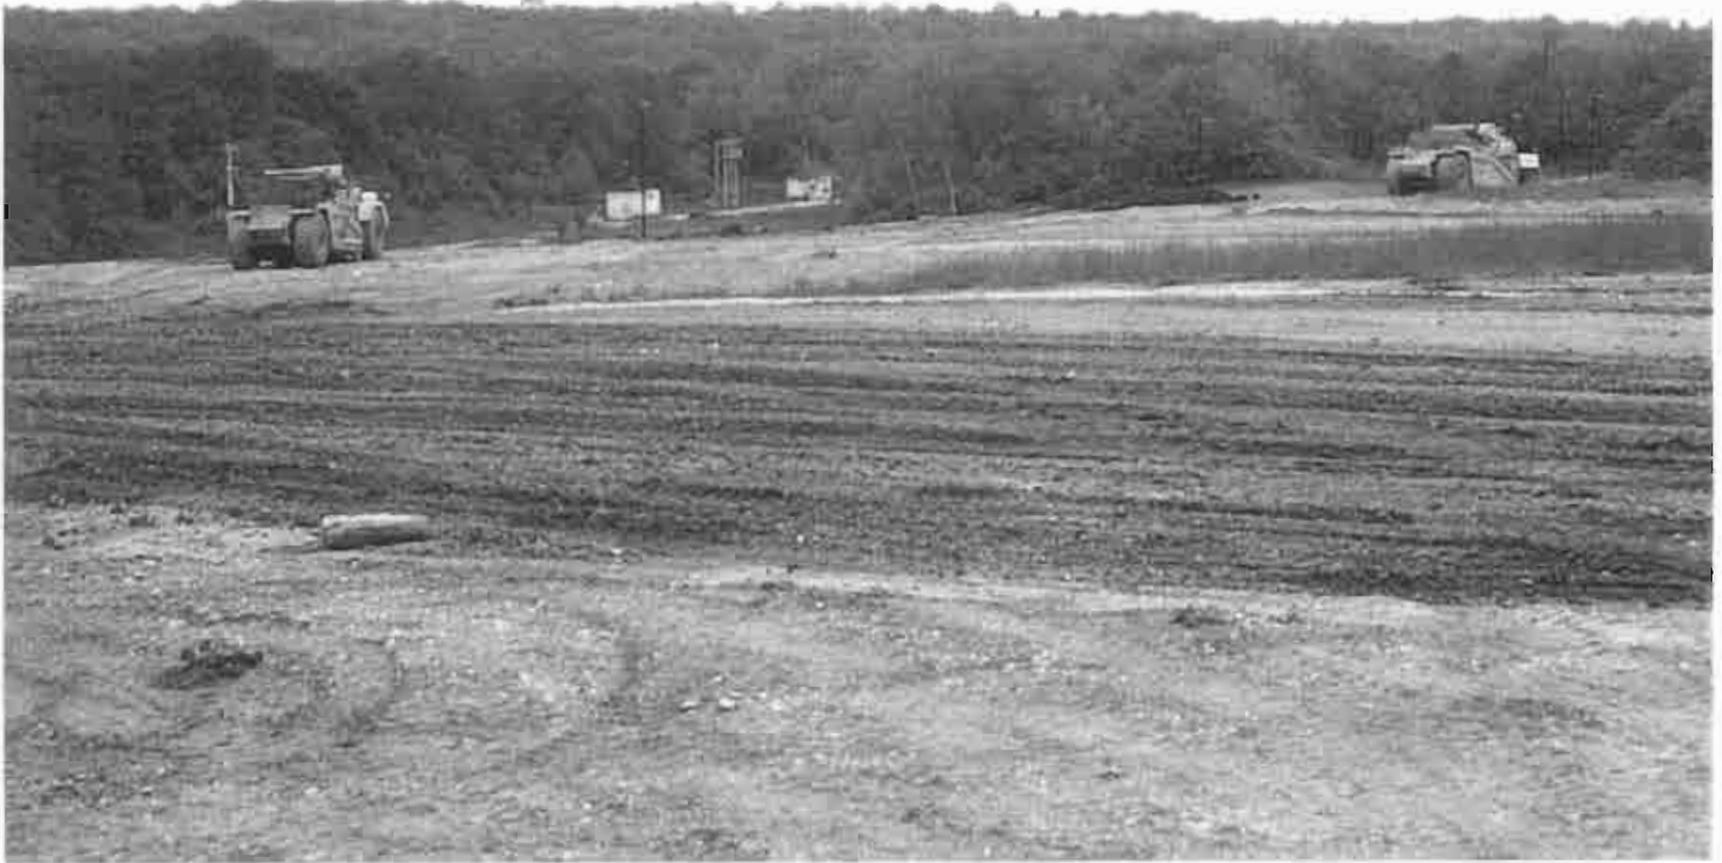
Figure 35: Excavated area visible from Benner road. Two of three (DOE) groundwater production wells in background.

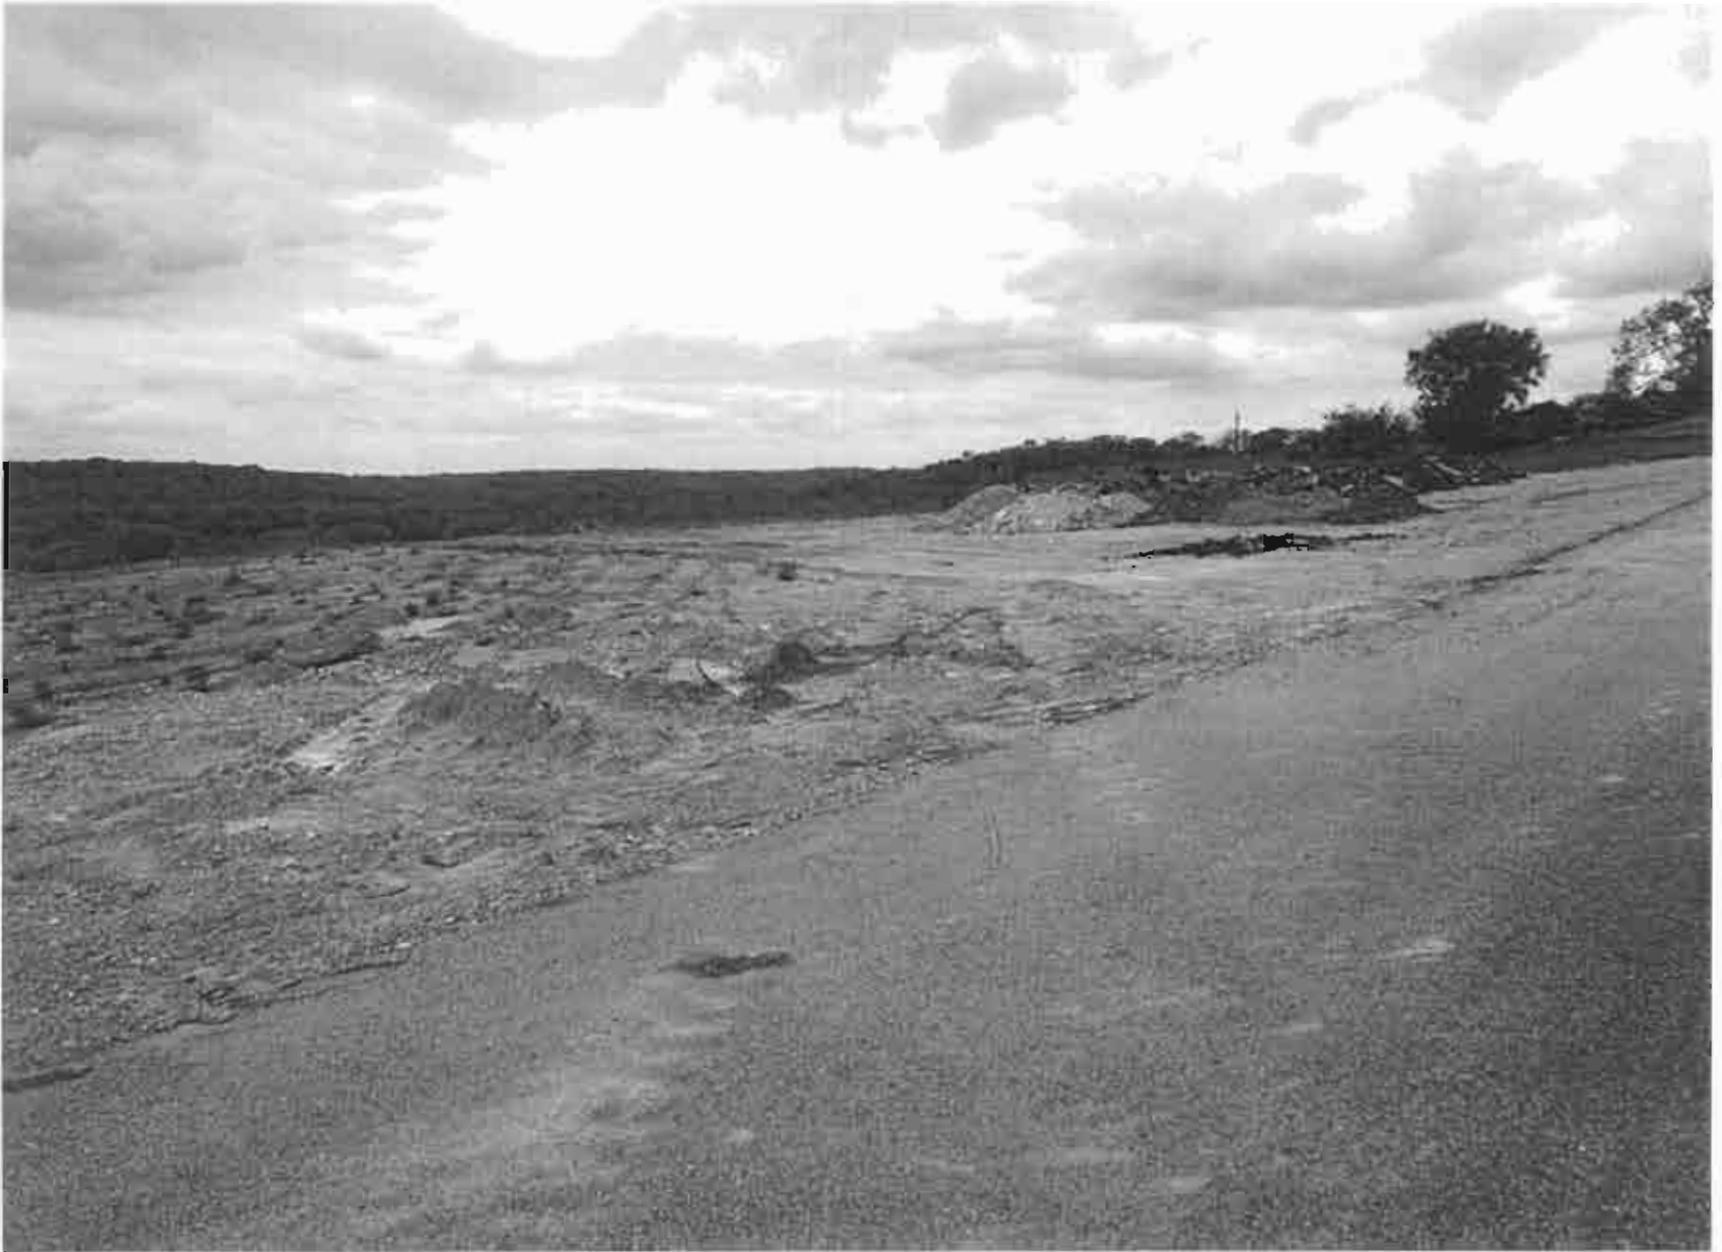
Figure 38: Staged soil and slabs of asphalt by (former DOE) "construction gate" entrance to Parcel 4.

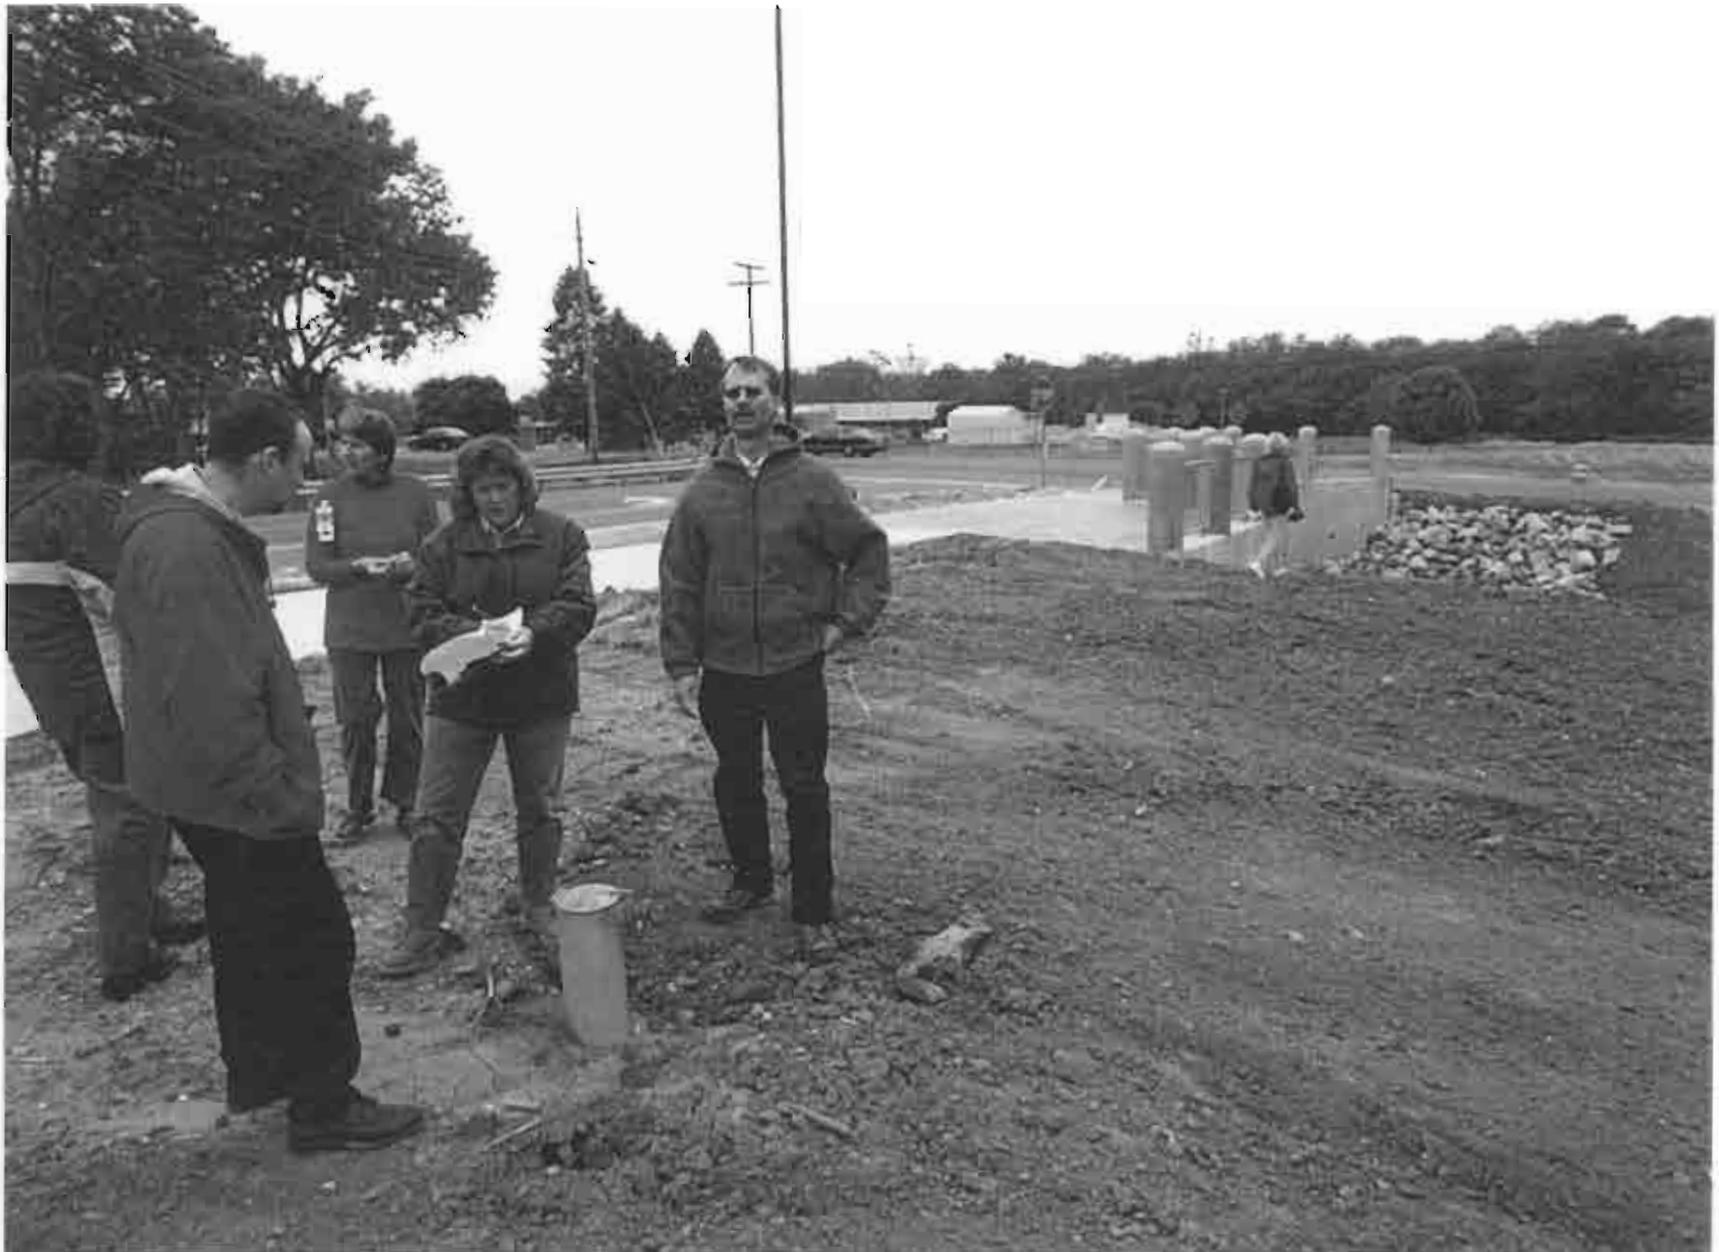
Figure 40: Groundwater monitoring well # 0158, located near intersection of Benner Road and Old State Route 25. Benner Road bridge in background.

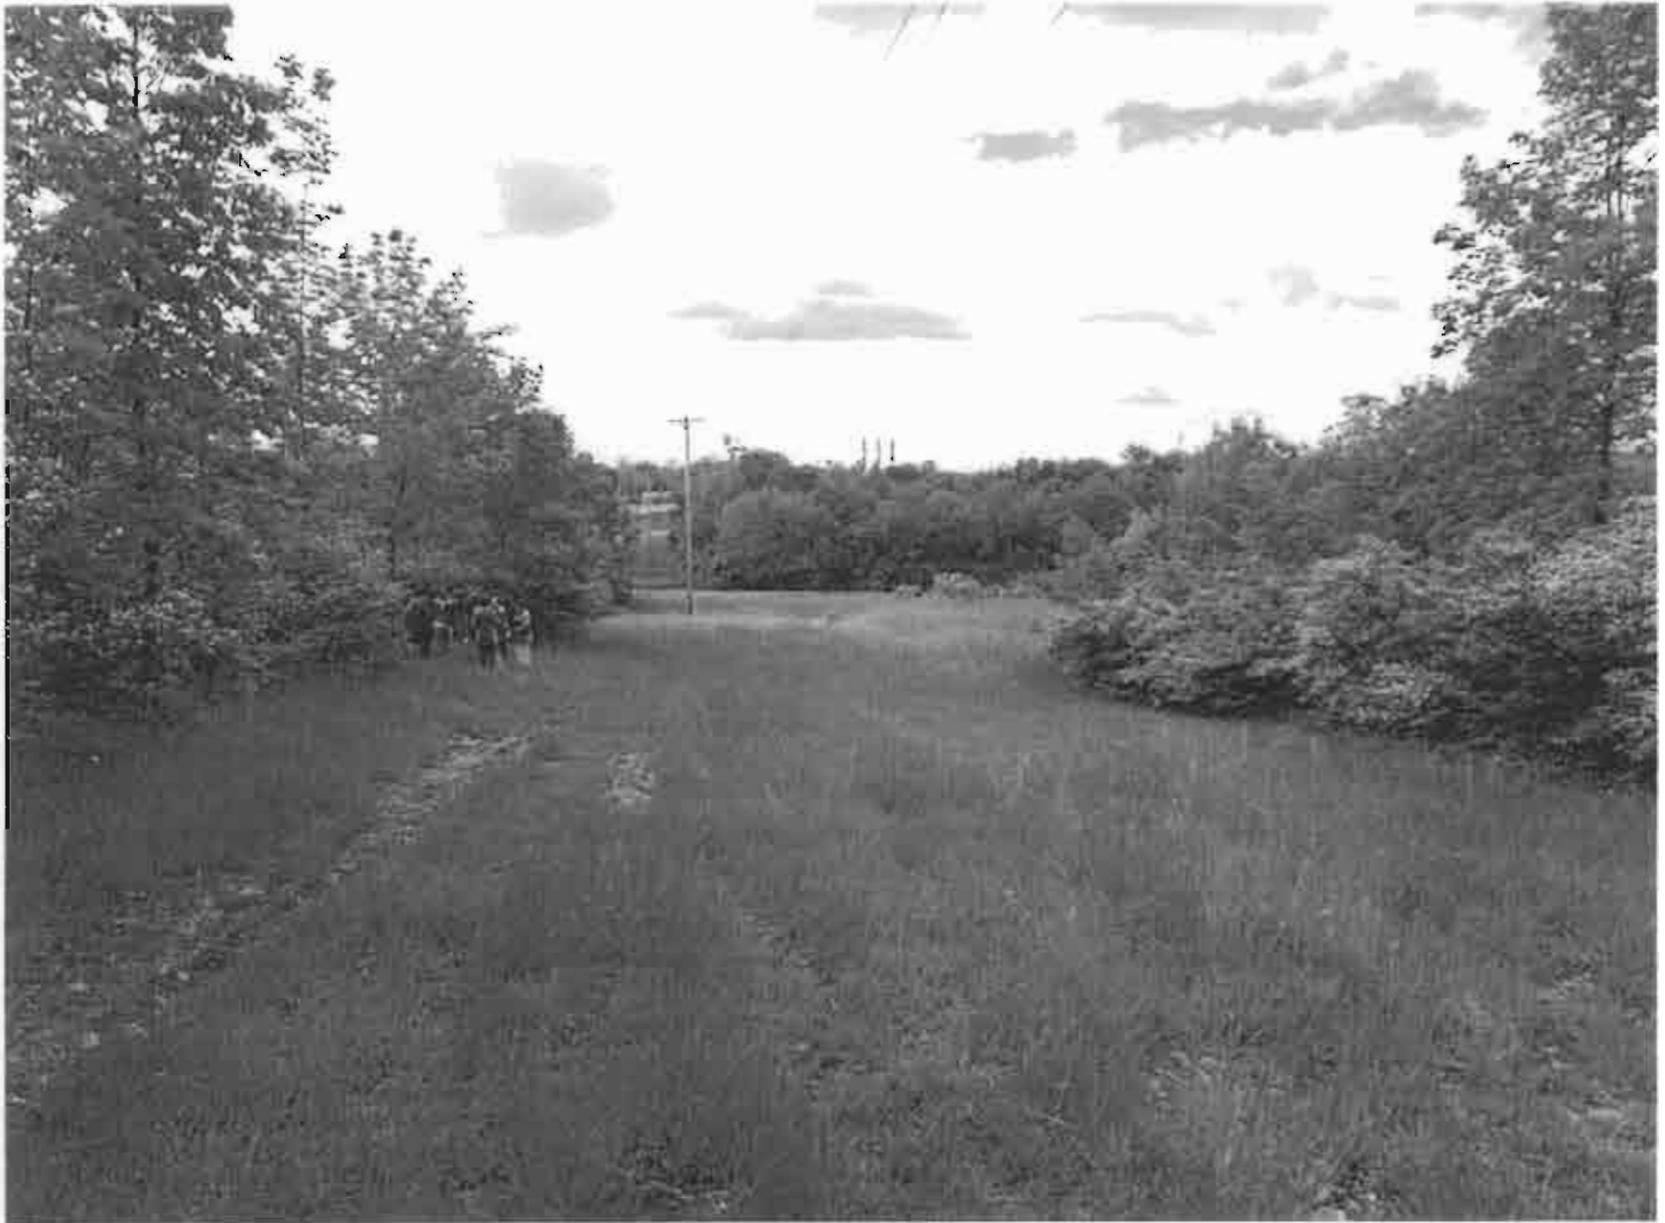
Figure 41: Groundwater monitoring well # 0354 located on edge of clear-cut area for overhead utility lines in Parcel 4. Three smokestacks of coal-fired electricity plant by Chatauqua bridge visible at skyline.

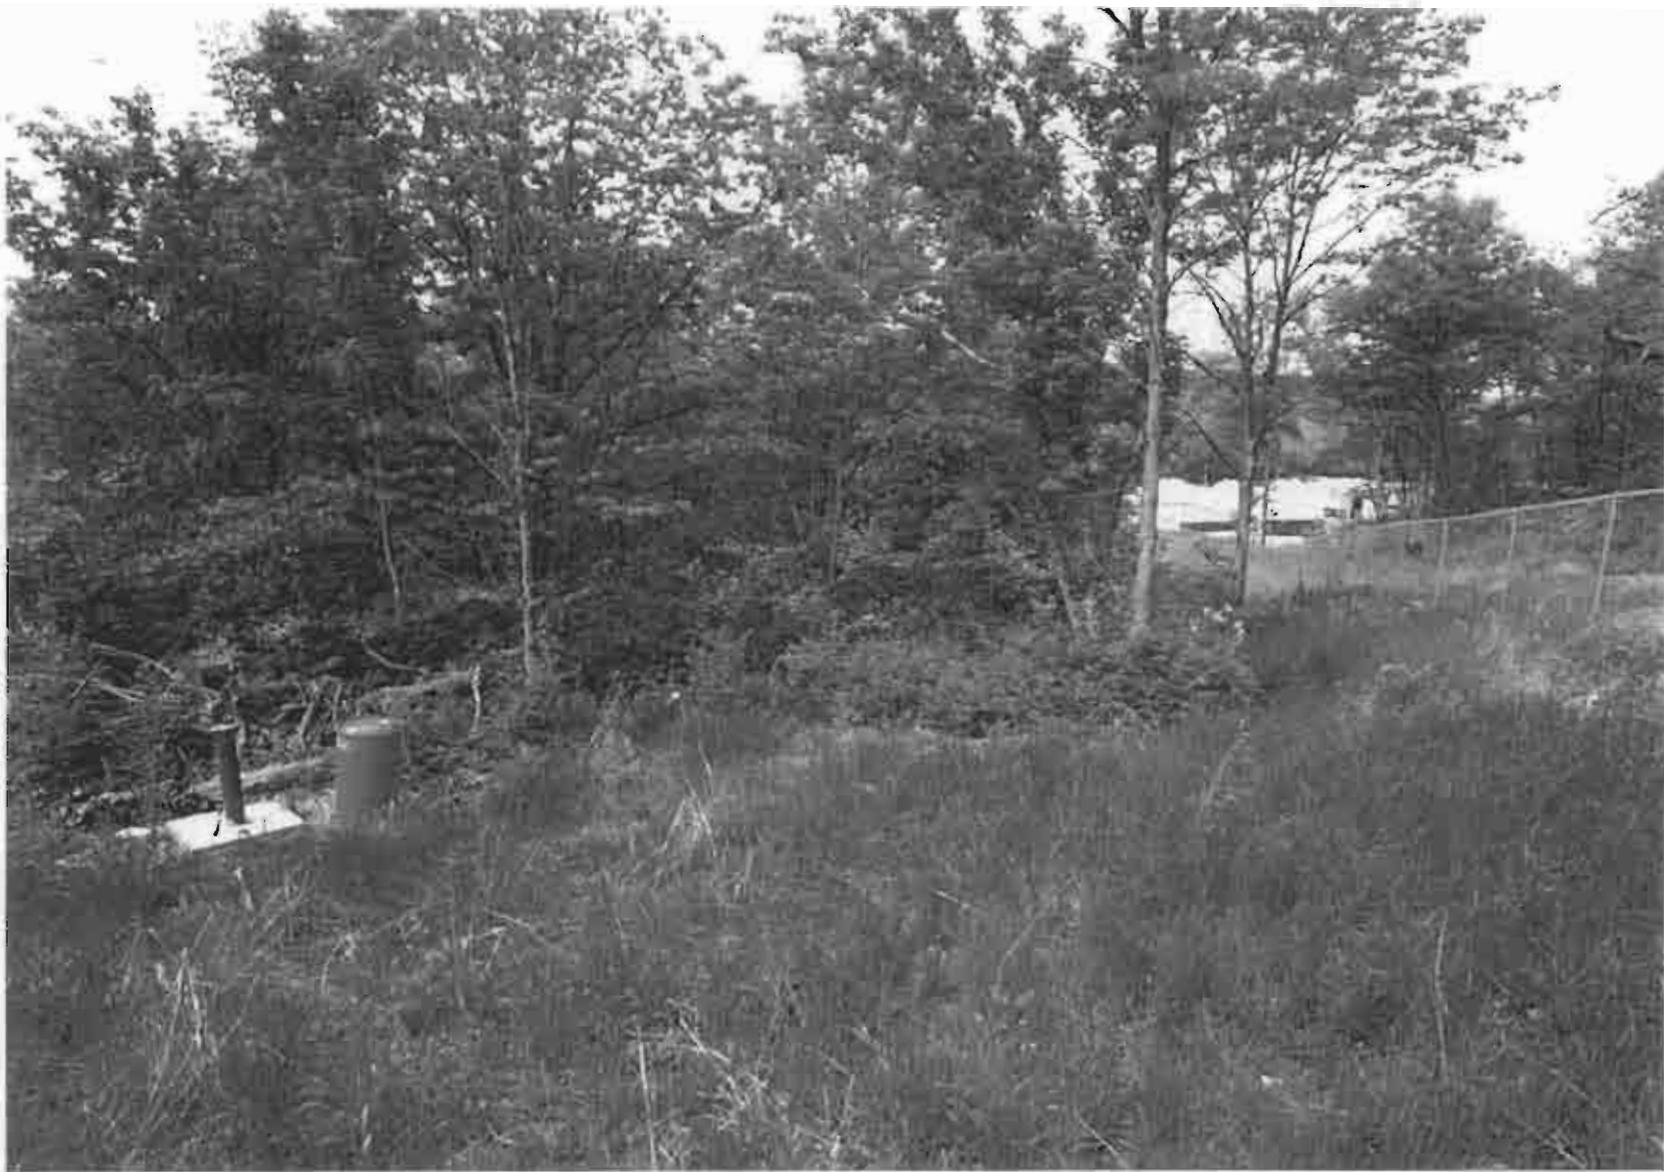
Figure 43: Newly-installed groundwater monitoring well # 0444 on Parcel 4. (DOE) concrete crusher visible center-right of photo.

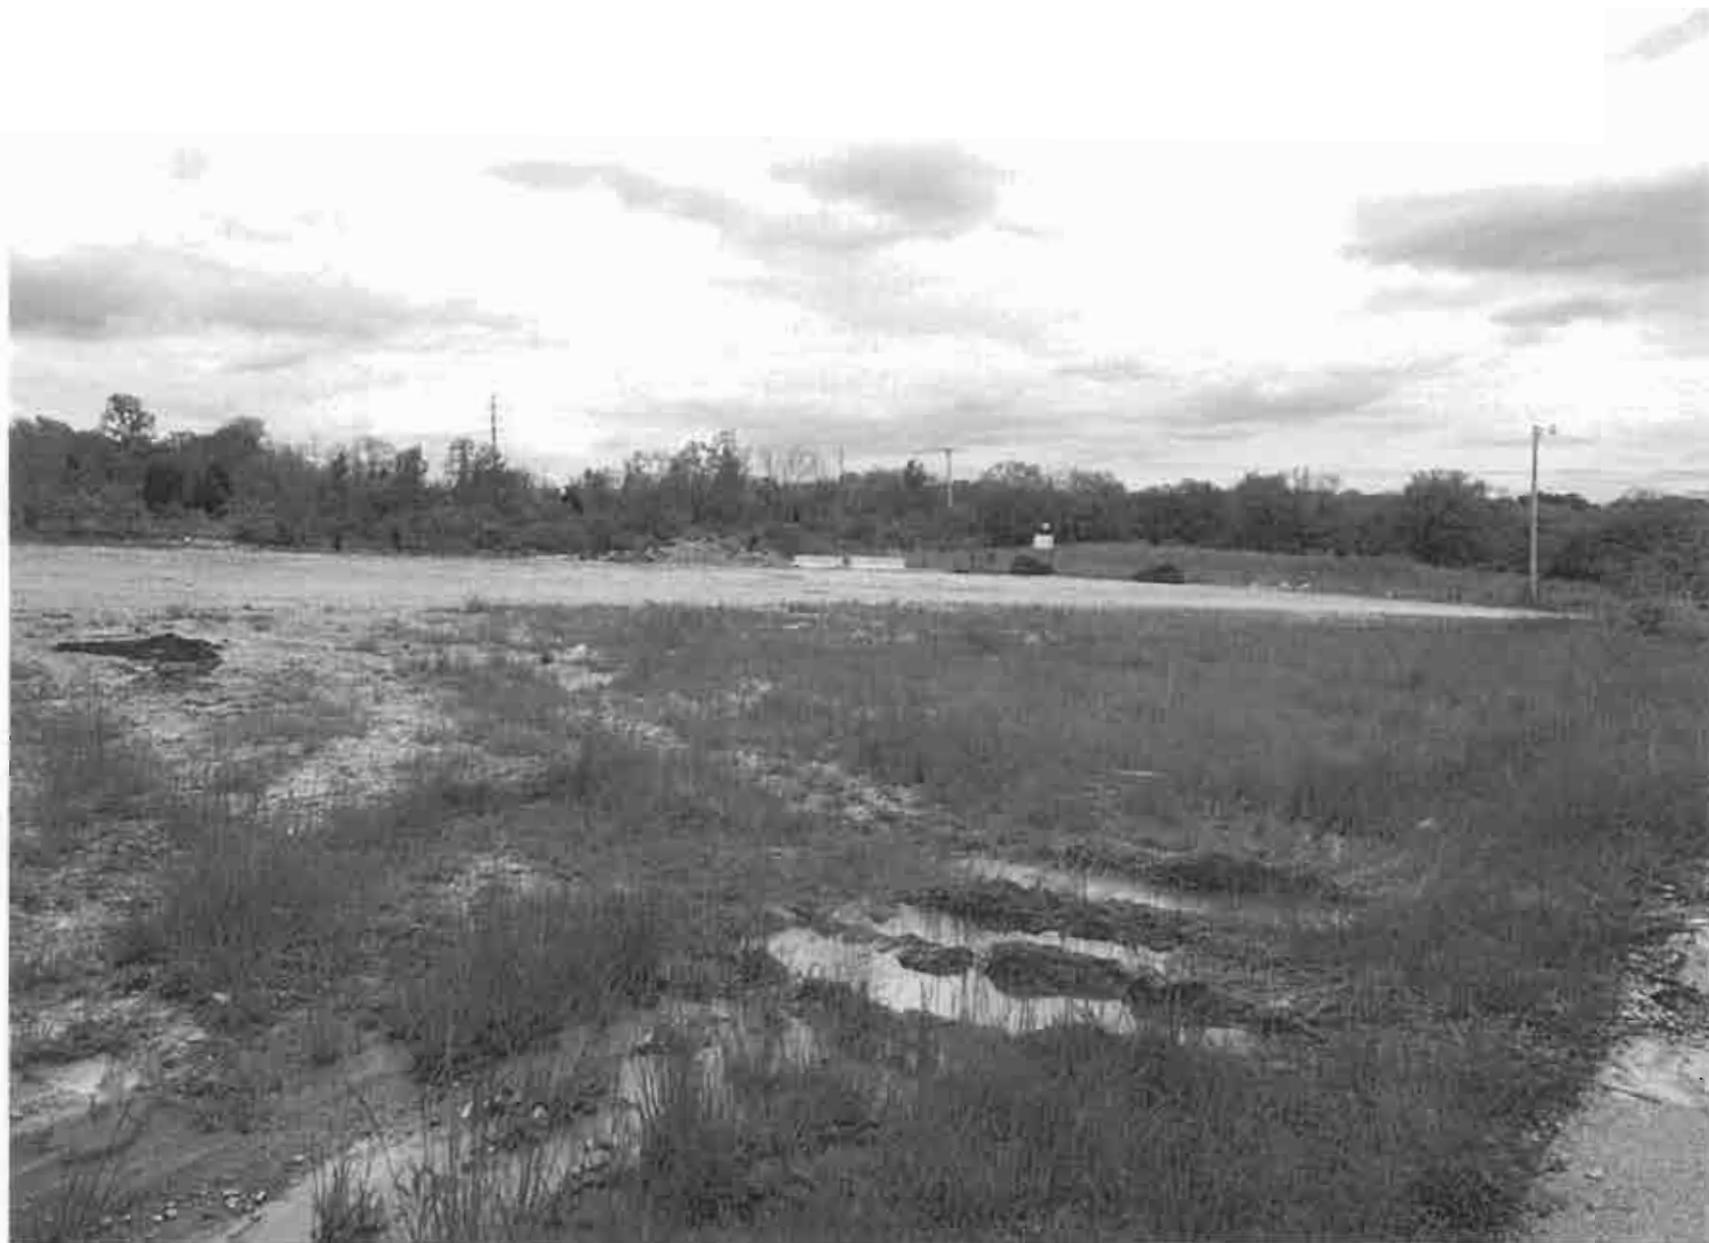
**Figure 44: Air monitoring station # 217 on Parcel 4 (small structure at center-right of photo).
Station located near intersection of Benner and Mound Roads.**
