MOUND PLANT

Potential Release Site Package

PRS # 318

**MAIN HILL SEEPS, OPERABLE UNIT 2
ON-SCENE COORDINATOR REPORT FOR
CERCLA SECTION 104 REMOVAL ACTION,
WEST POWERHOUSE PCB SITE**

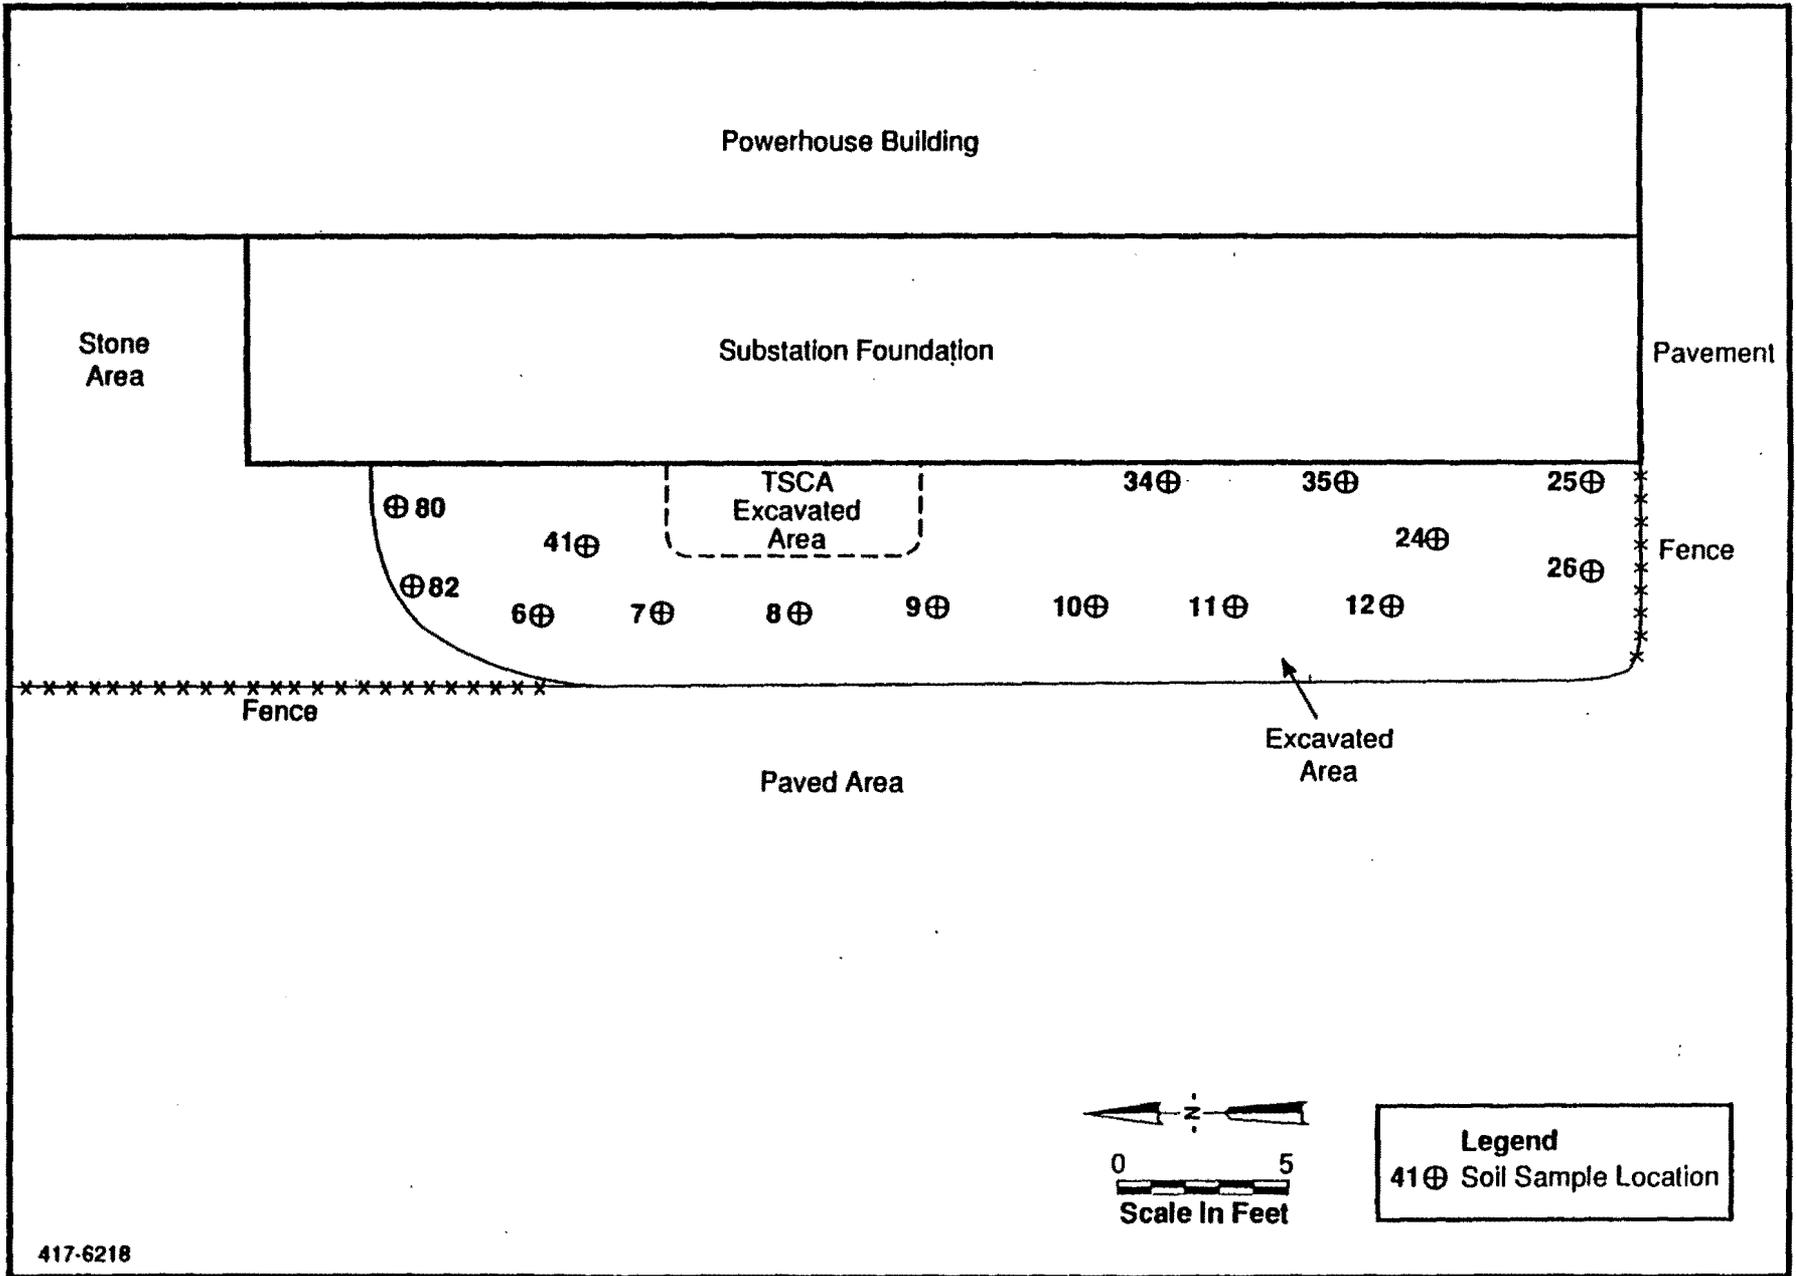
417-6218

As described in subsection 1.1.4.1, a process of vertical and horizontal soil excavation followed by soil sampling and analyses was used to delineate the extent of subsurface PCB contamination at the West Powerhouse site. Figures 1.3 through 1.6 show the approximate boundaries of excavated soils at each two foot vertical interval and the locations of confirmation samples. The confirmation samples represent uncontaminated soil conditions and delineate the horizontal and vertical extent of PCB contamination. As shown in Figure 1.6, the extent of PCB contamination was relatively confined; the excavation measured approximately 30 ft by 5 ft and extended to an approximate depth of 8.5 ft BGS (top of bedrock).

Figure 1.3. Excavated area from 0-2 ft BGS, confirmation sample locations

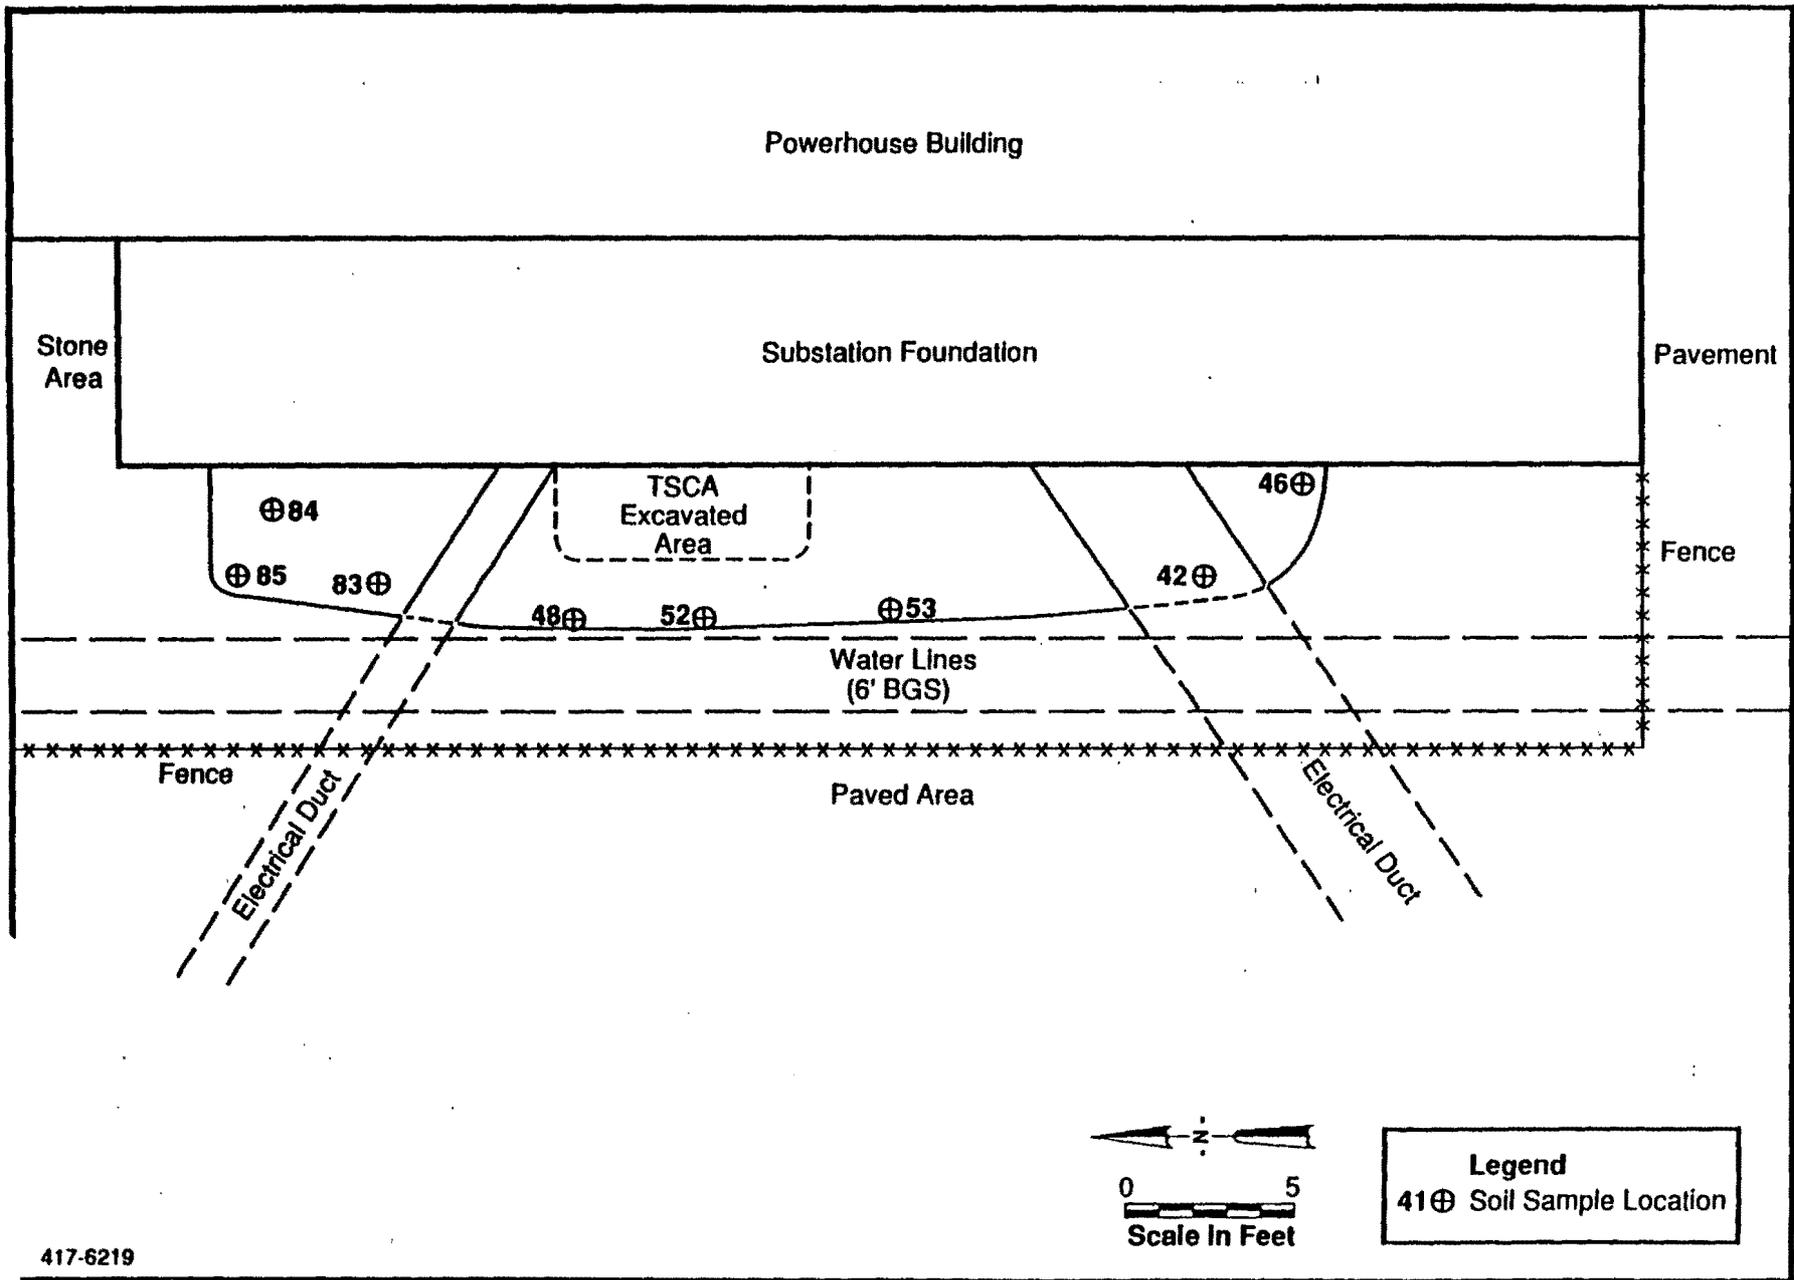
417-6219

Figure 1.4. Excavated area from 2-4 ft BGS, confirmation sample locations

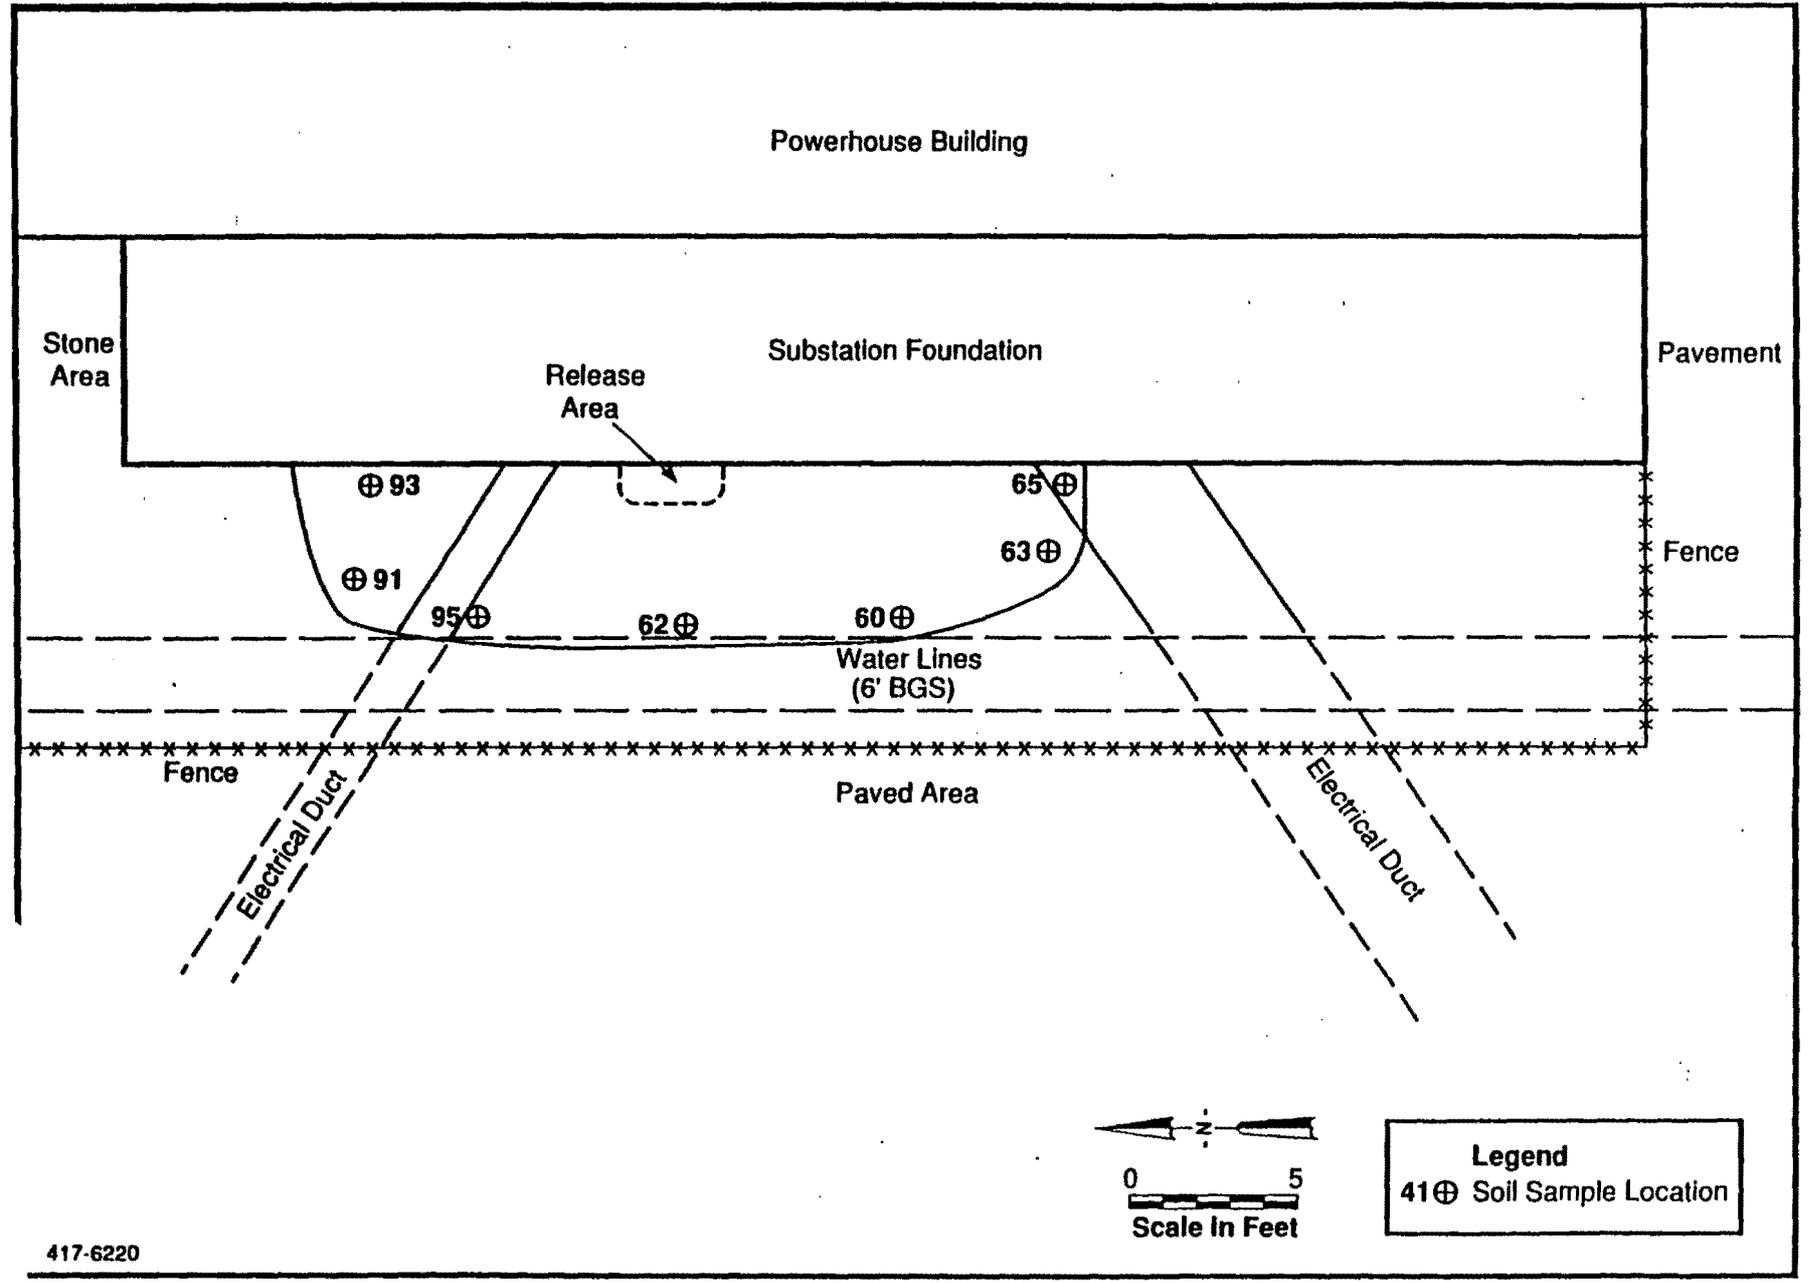
417-6220

Figure 1.5. Excavated area from 4-6 ft BGS, confirmation sample locations

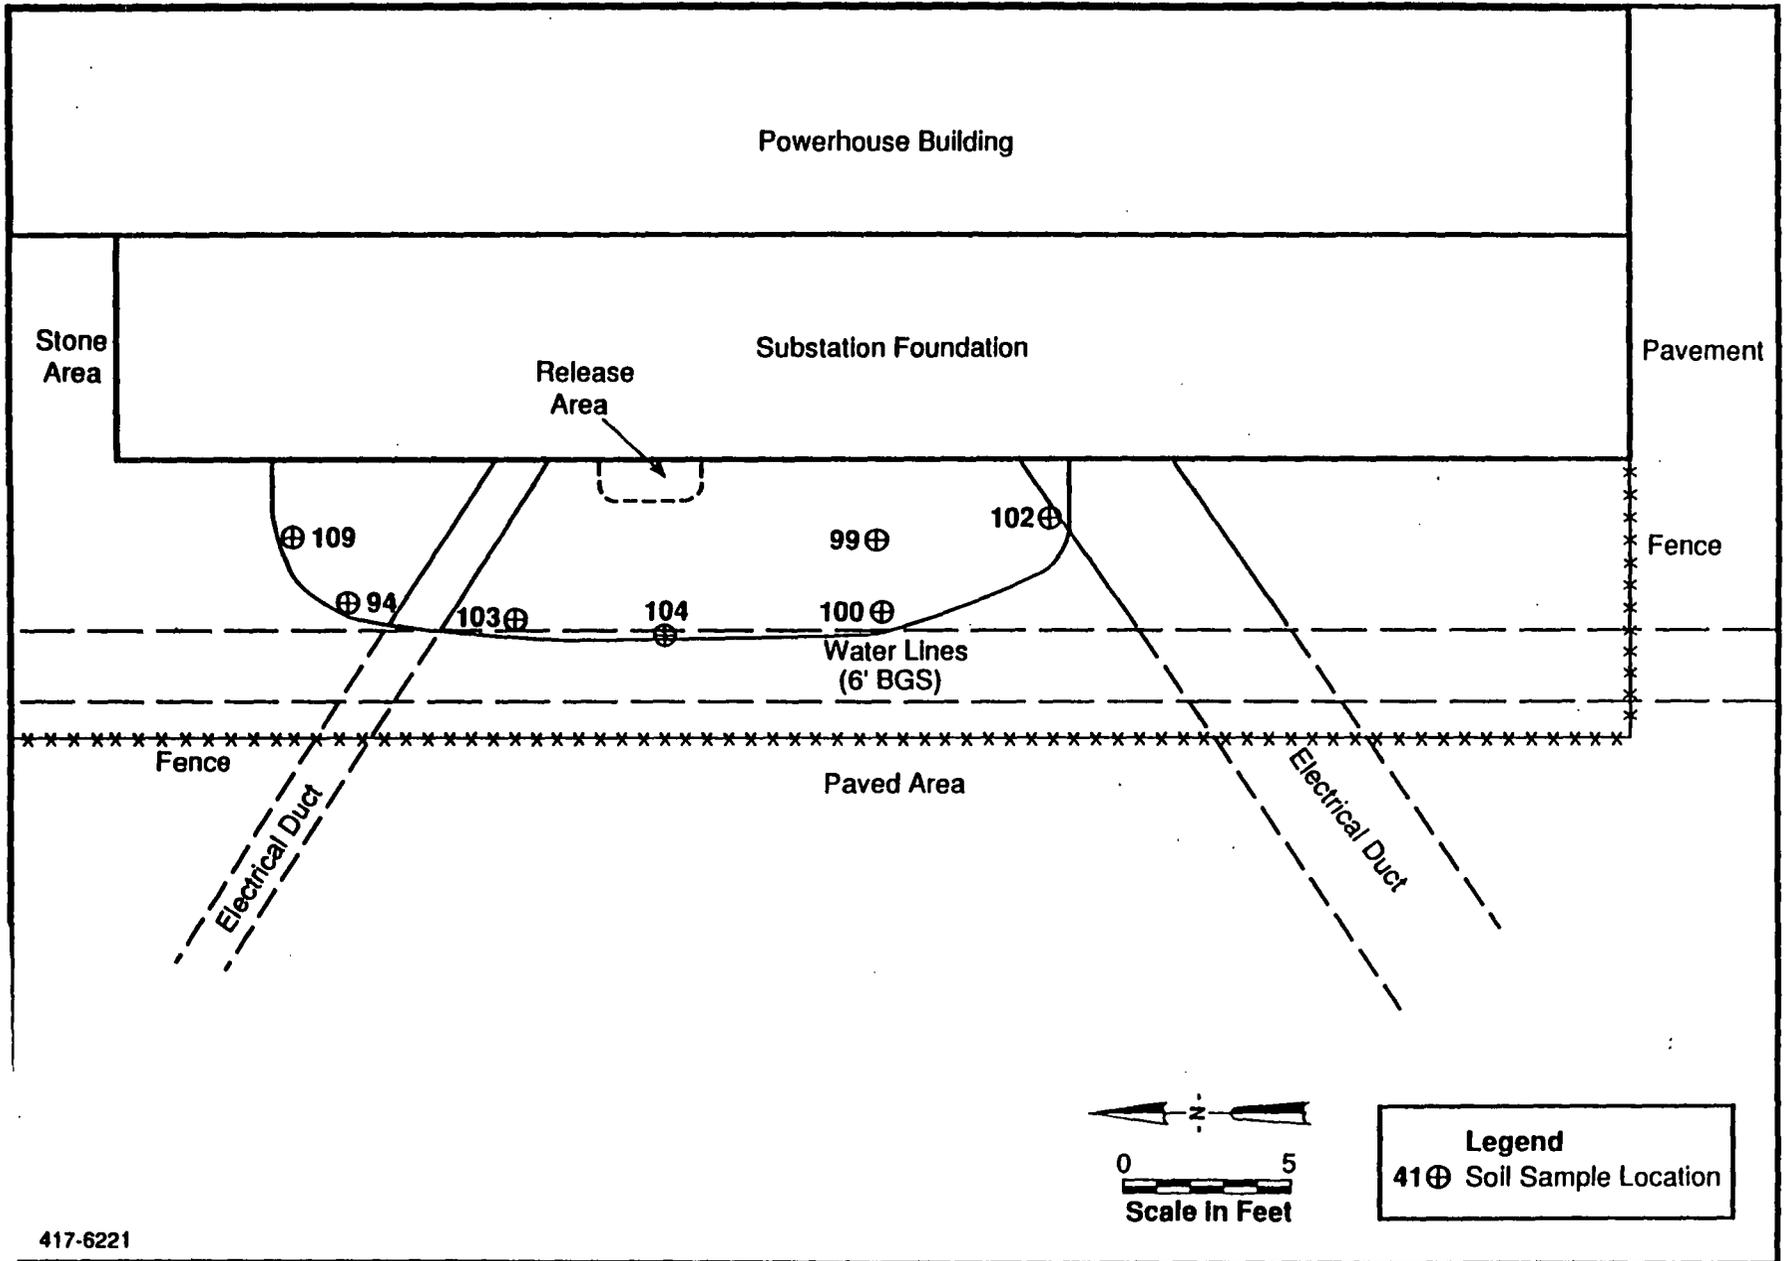
417-6221

Figure 1.6. Excavated area from 6-8.5 ft BGS (Bedrock at 8.5 ft BGS), confirmation sample locations
