MOUND PLANT

Potential Release Site Package

PRS 124

PRS 124: Building 48 Hillside

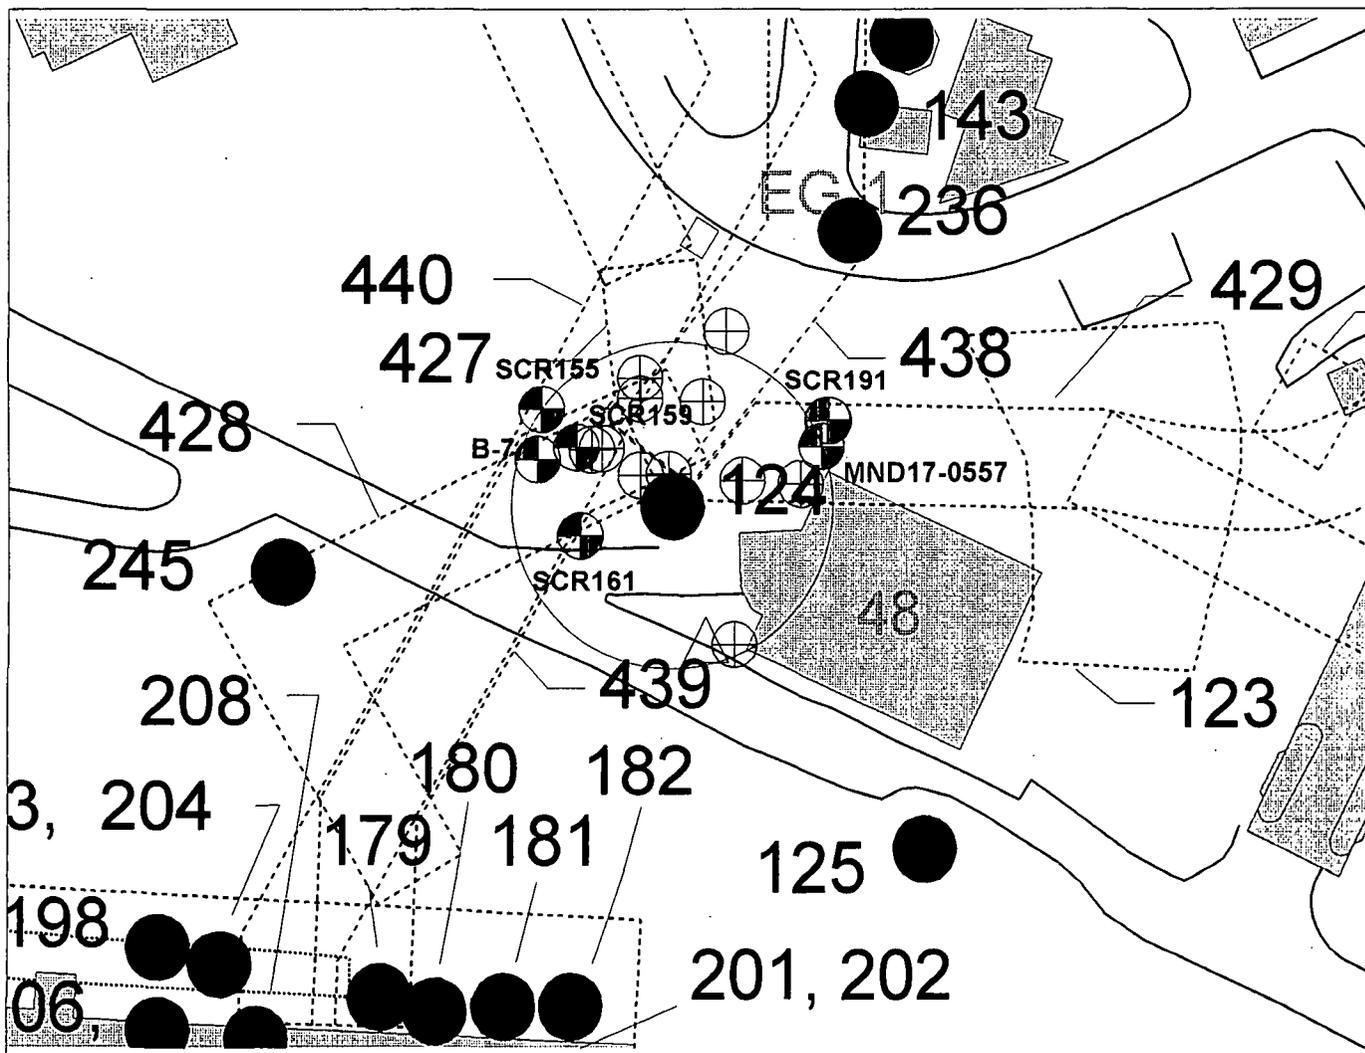
PRS 124 Sample Locations Plutonium and Thorium Detects

Contaminant	Maximum Level (pCi/g)	Guideline Value (10⁻⁶) (pCi/g)	Background (pCi/g)
Plutonium-238 (SCR191)	2902.0	55.0 (10 ⁻⁵)	0.13
Plutonium-238 (SCR159)	225.0	55.0 (10 ⁻⁵)	0.13
Plutonium-238 (SCR155)	74.0	55.0 (10 ⁻⁵)	0.13
Thorium-230 (MND17-5001)	5.23	0.12	1.90
Thorium-232 (SCR191)	182.2	0.09	1.40
Thorium-232 (SCR155)	2.20	0.09	1.40

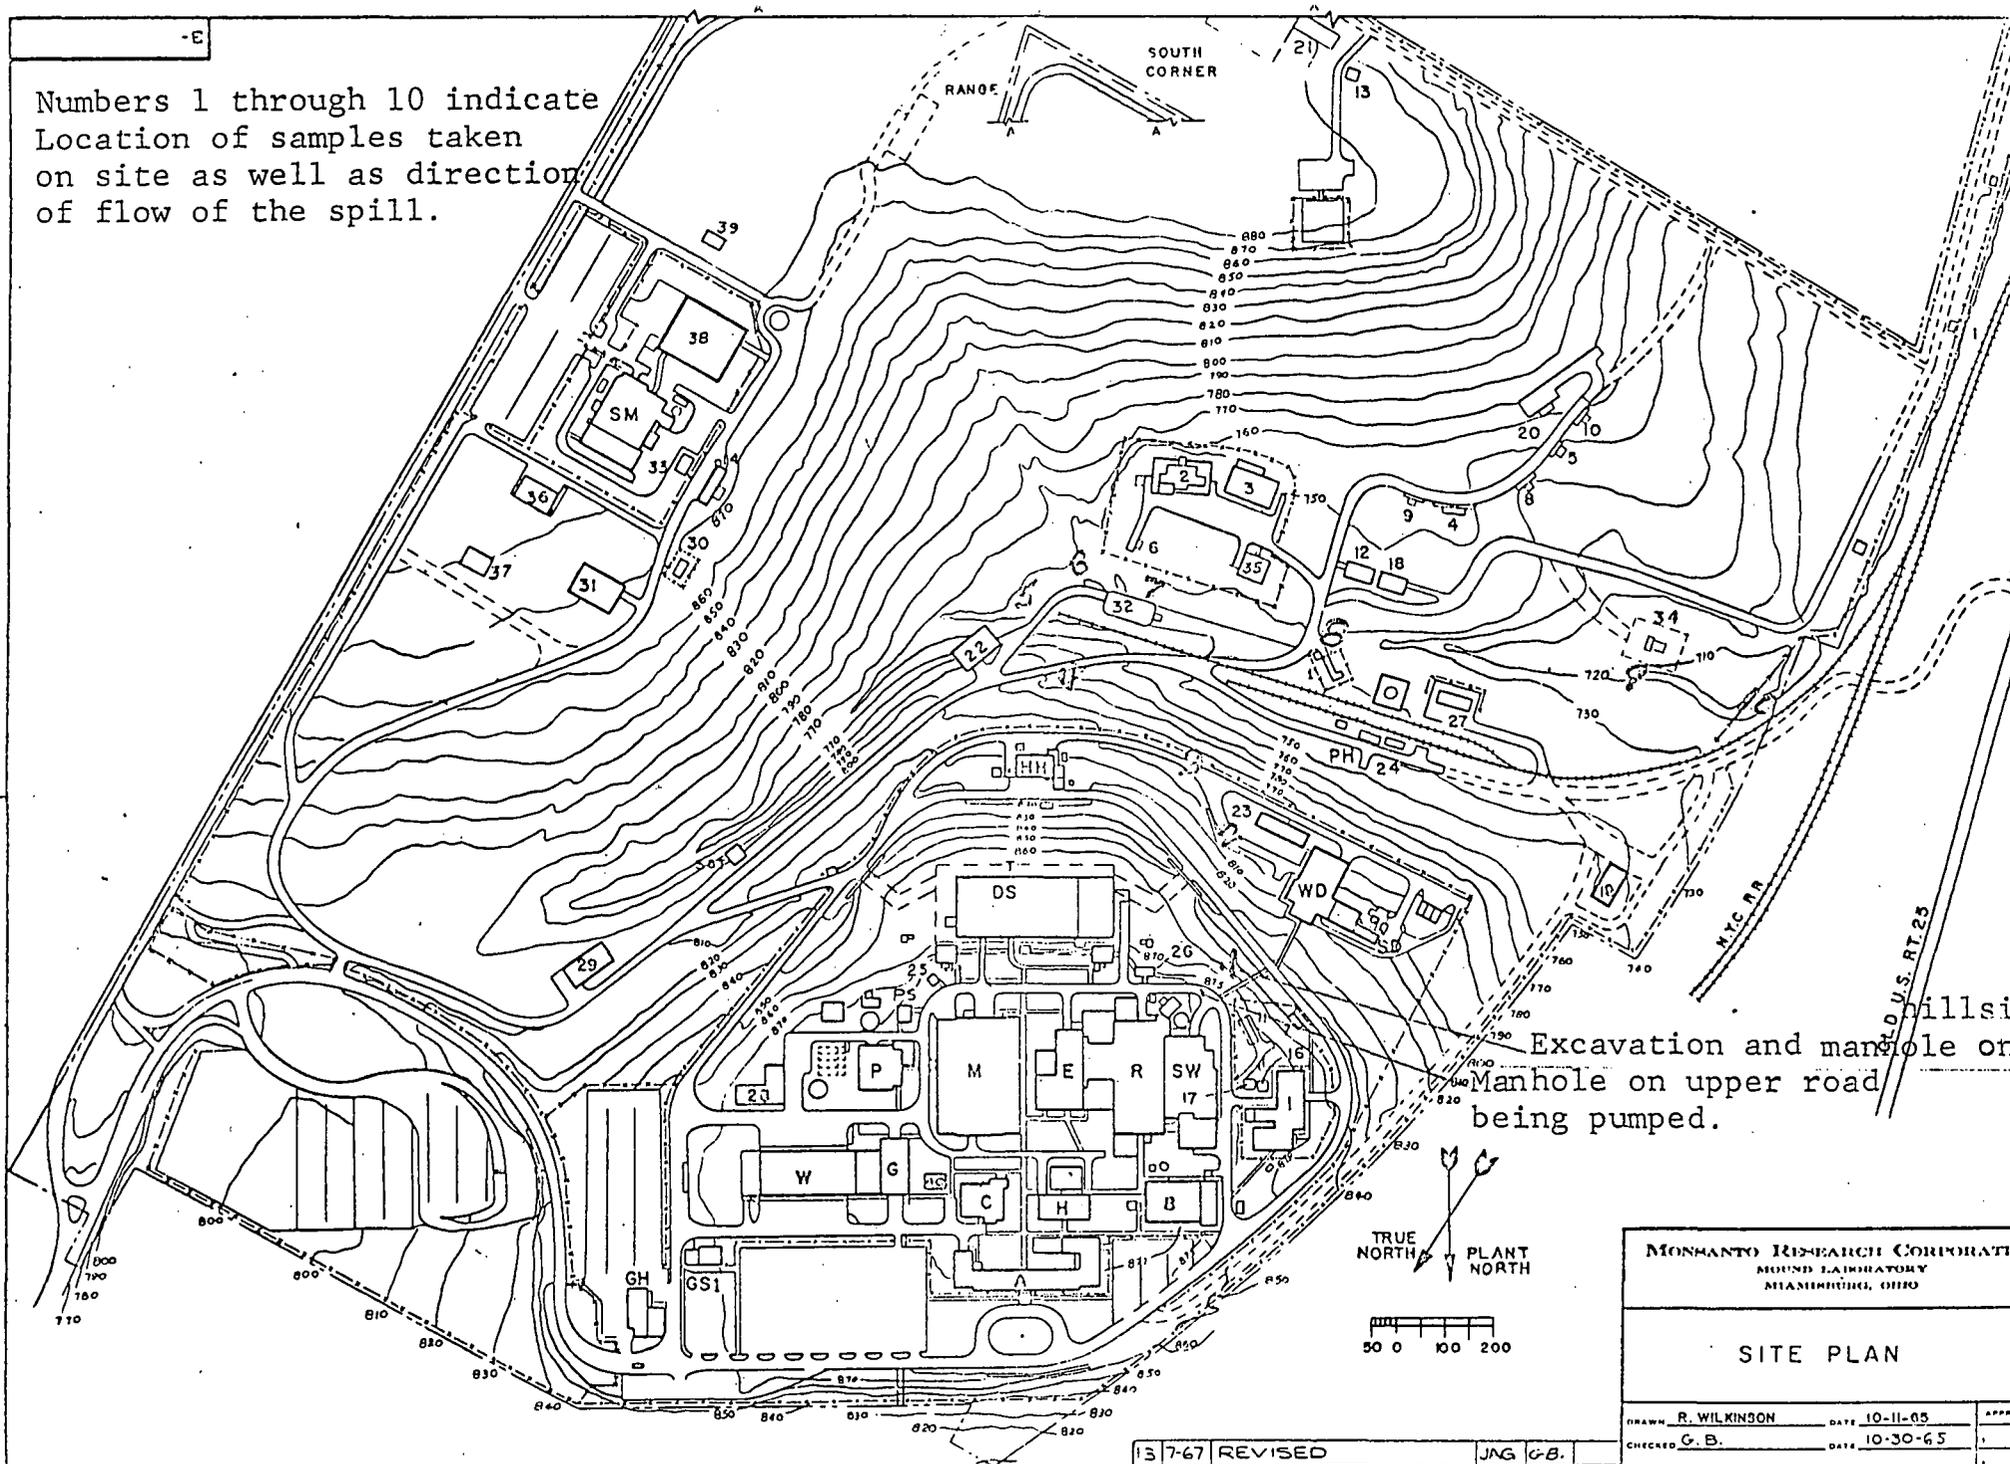
SITE PLAN

<u>On-Site Samples</u>	<u>Disintegrations/minute/ml</u>	
1.	226	The onsite samples were taken from approximately 5 minutes to 20 minutes after the spill.
2.	1200	
3.	460	
4.	466	
5.	348	
6.	200	
7.	282	
8.	466	
9.	0	
10.	0

Numbers 1 through 10 indicate Location of samples taken on site as well as direction of flow of the spill.

Excavation and manhole on upper road being pumped.
