Miamisburg Closure Project Building Data Package

Building 28

Final
September 2003

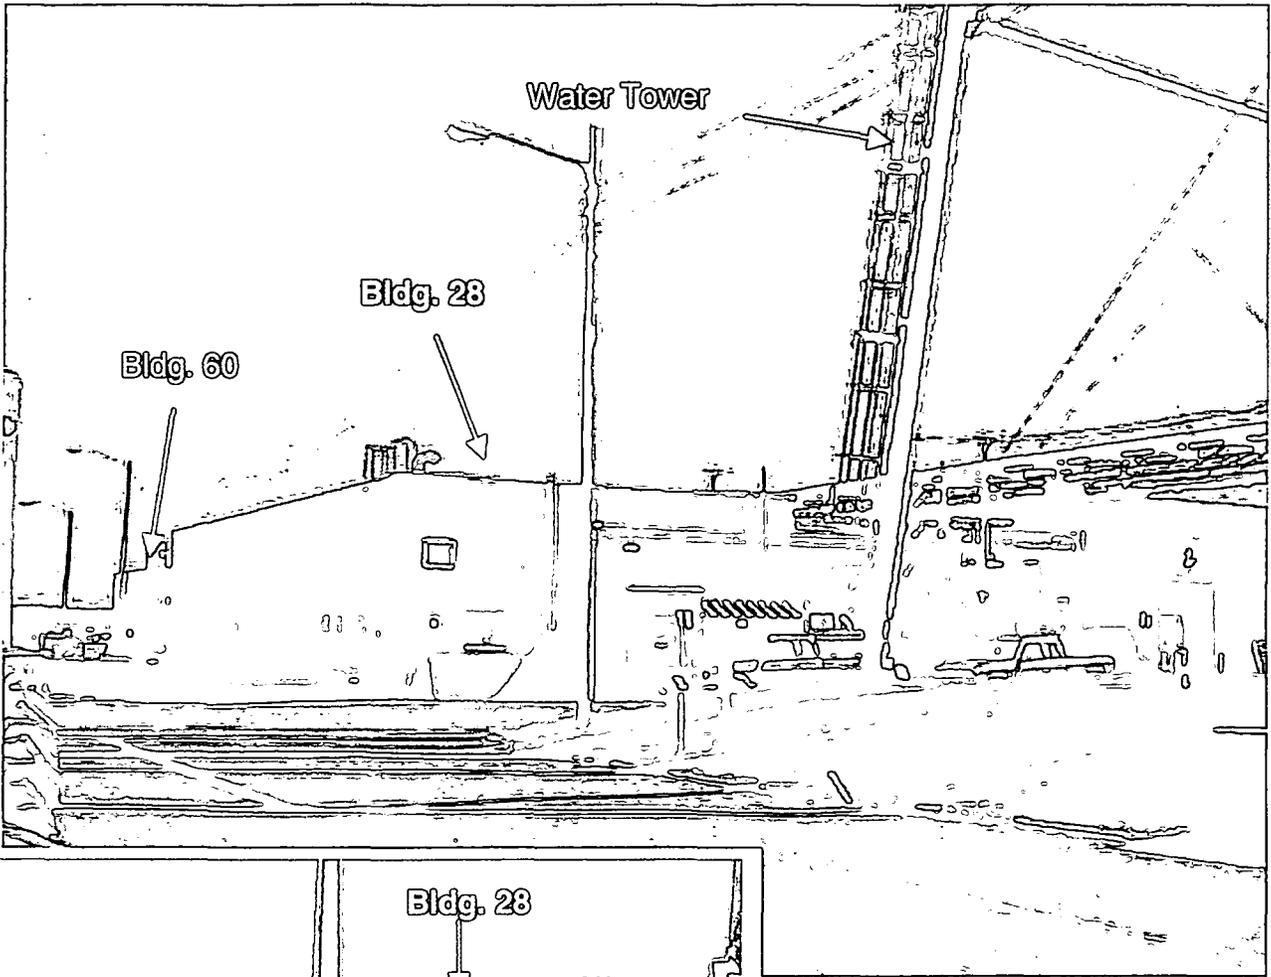
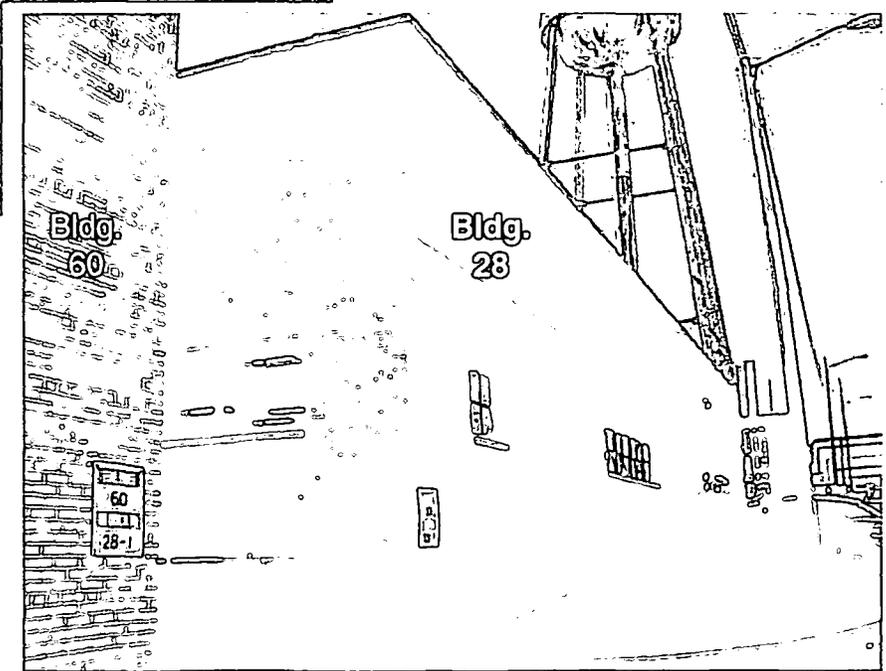
Figure 3: Building 28
Exterior Photos

on Figure 3). The shed has corrugated metal walls and a concrete slab. When Building 28 was used as a ceramics production facility, there was a "dry room" located in the partial basement of Building 28, just on the other side of the wall from the shed. The dry room included glass melting equipment and a large production vacuum/inert gas furnace. The desiccant shed housed a rotating bed of dry gel. Air was pumped from the dry room to the shed where the gel absorbed moisture, thus reducing the relative humidity of the air before it was returned to the dry room. The gel was regenerated by heating with non-contact steam from the plant steam lines.
