**DRAFT PRE-REMEDIAL INVESTIGATION OF IHSS 118 1 DATA SUMMARY REPORT - JEL-120-97**

**DRAFT  
PRE-REMEDIAL  
INVESTIGATION OF  
IHSS 118.1  
DATA SUMMARY  
REPORT**

**RF/RMRS-97-111-UN**

**November 20, 1997**

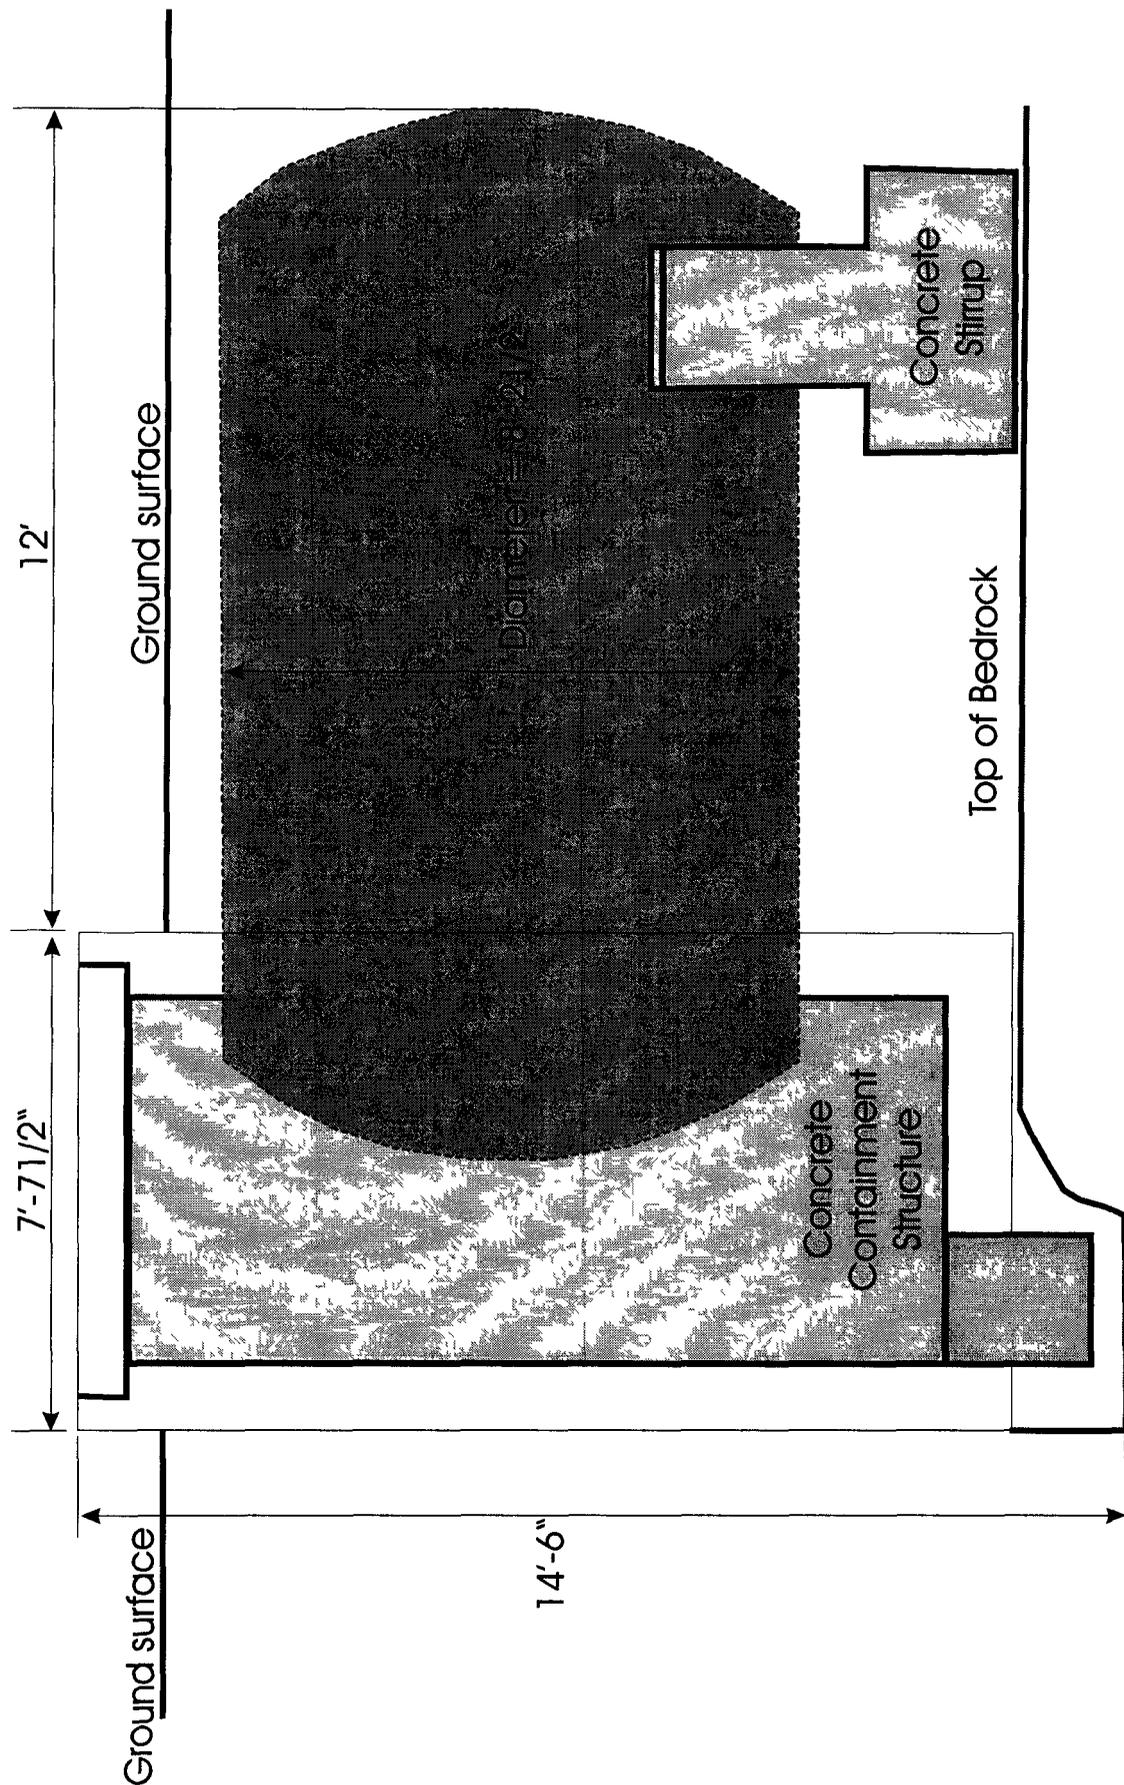
**Figure 2. Cross Section of Former Carbon Tetrachloride Tank  
(Based on Engineering Drawing)**

The 5,000 gallon capacity, underground steel tank was used to store carbon tetrachloride prior to its use in Building 774, and had a concrete containment structure on the south side around the intake area (Figure 2). Numerous surface spills were known to have occurred before 1970, some potentially up to 200 gallons. The intake to the tank failed in June 1981 and released a small amount (volume unknown) of carbon tetrachloride into the containment structure. The tank was removed along with a limited amount of soil around the tank (DOE 1992).

Retiree interviews conducted during the investigation found that at least two major spills occurred during tank filling operations. In the late 1970s, the sight gauge used to indicate the level of the contents in the tank malfunctioned, and showed that the tank was nearly empty. The nearly full tank was refilled, and up to 1,000 gallons of carbon tetrachloride was spilled on the ground. The spilled carbon tetrachloride flowed in the gutter and along the street north of Building 774 (south of Building 701), then flowed to the north along the west side of Building 701 towards Building 771. On a later occasion, another sight gauge malfunctioned, the tank was again overfilled and about 200 to 300 gallons of carbon tetrachloride was spilled through the vent pipe onto the ground. While the tank may have also leaked, no information has yet been found about the condition of the tank when it was pulled. Based on the volume of carbon tetrachloride spilled on the surface, the spills are the most likely cause of the detected NAPL.

Location 05497 was drilled as planned, however, a concrete structure was encountered in the subsurface which is believed to be the stirrup supporting the northern end of the former carbon

tetrachloride tank (Figure 2) This structure was encountered in the subsurface at depths of 7.5 to 9 feet. Numerous offsets were required, and a core barrel was lost downhole, before total depth could be reached. No NAPL was encountered during drilling operations. However, a well was installed at this location because elevated PID readings and a sweet odor were noted when drilling at depth. This well produced sufficient quantities of NAPL during groundwater sampling to collect both a NAPL and a NAPL duplicate sample.

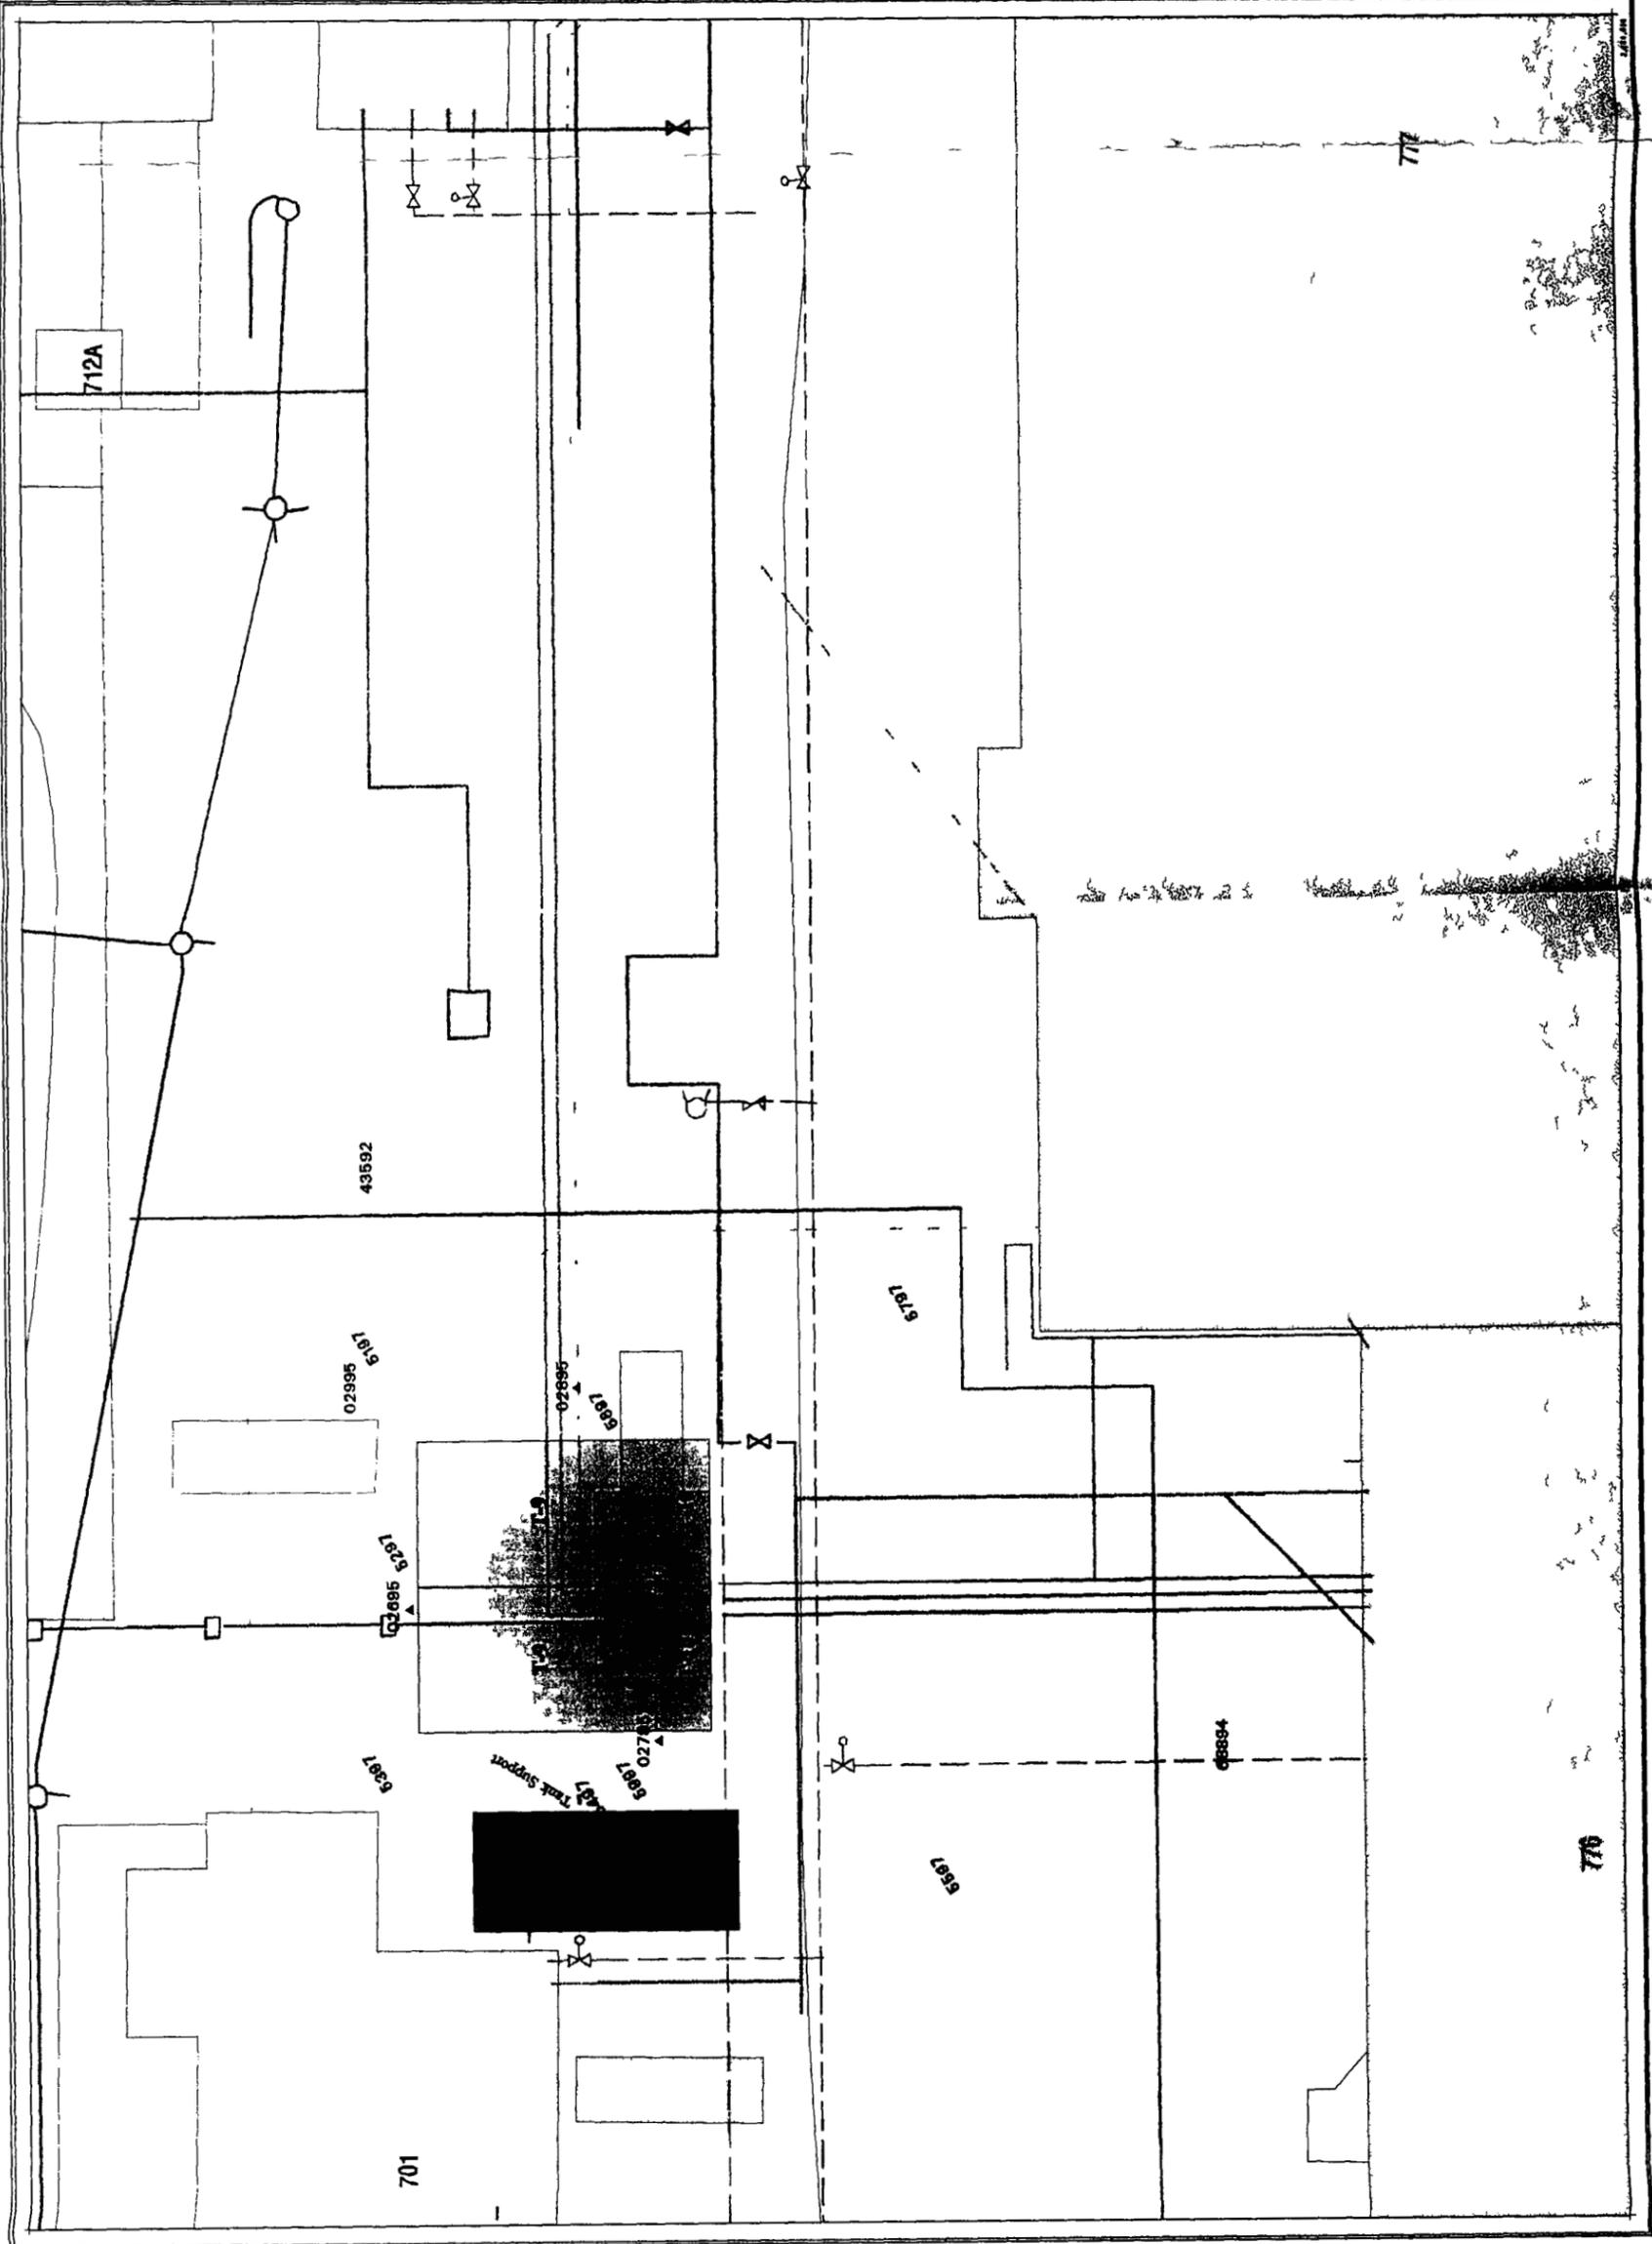
Figure 3  
IHSS 118 1 Hydrogeologic Cross Section

Due to the high concentrations of carbon tetrachloride, and the lack of radiological contamination, the NAPL is assumed to be a result of spills and leaks from the carbon tetrachloride storage tank. Because both the NAPL samples and high concentrations in soil are found only near the bottom of the excavation, the carbon tetrachloride is thought to currently occur in a thin layer, approximately one foot thick, pooled on the bedrock surface at the bottom of the closed depression. The carbon tetrachloride may fill the bottom of the excavation, including underneath Tanks T-9 and T-10 and the associated sump (Figure 3). However, there is

a possibility that the NAPL is pooled at several intervals near the bottom of the excavation, rather than a continuous shallow layer. Installation of the wells could have intercepted several small pools which then drained into the well, giving the appearance of a single pool of NAPL. Insufficient data exists to fully differentiate between these scenarios. However, as the NAPL is thought to occur within a one foot interval near the bottom of the excavation foot thick interval, it is likely that the NAPL is perched on undisturbed bedrock claystone.
