INTERIM - UNUSUAL OCCURRENCE REPORT [UOR], RFP 89-5--460 89-1, "CLEAN ROOM SPILL"

UOR RFP 89-5--460 89-1
CLEAN ROOM SPILL

RI - Assembly Cleaning, Room 158, Tanks 4 and 6, and the portable acid waste vessel, east side of Building 460.

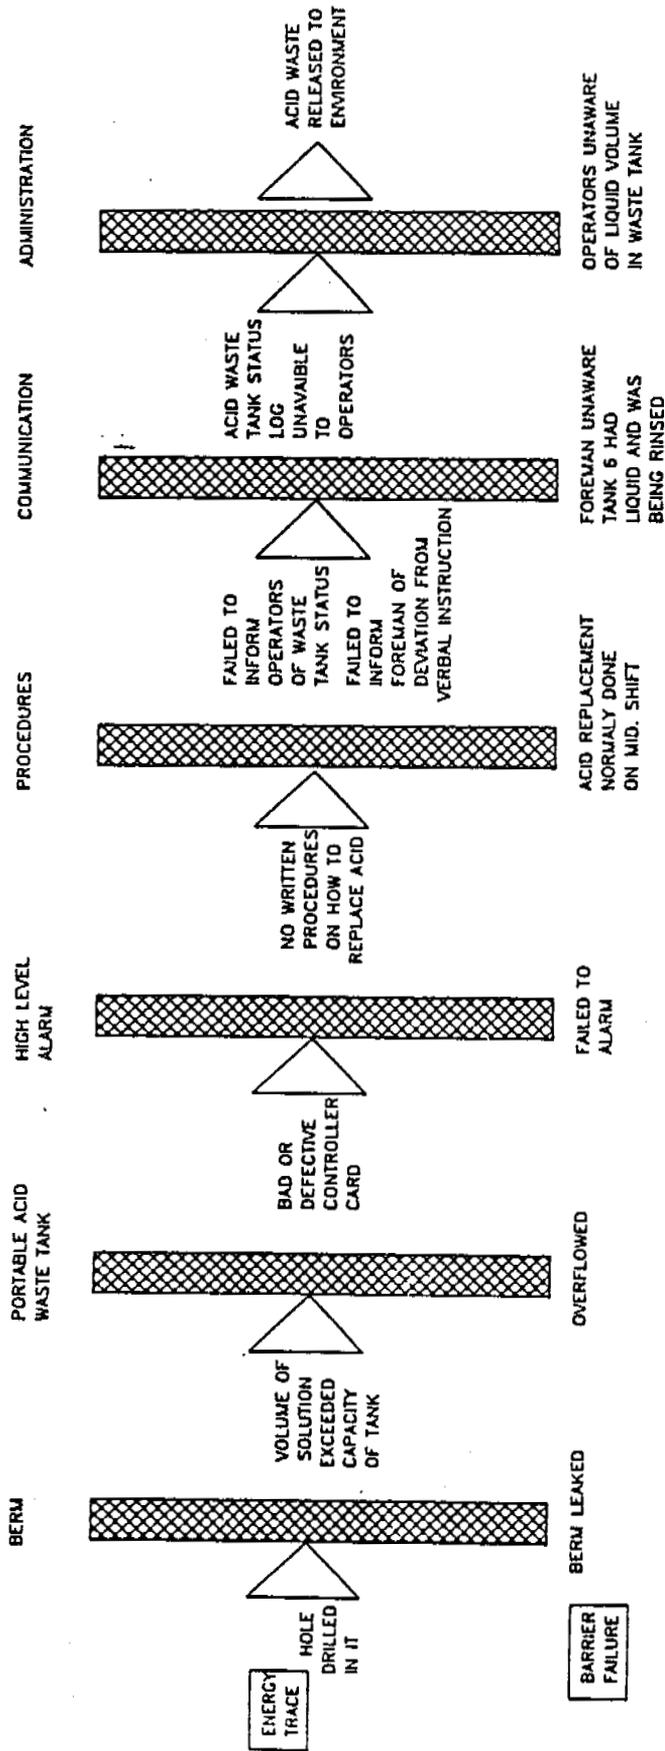
UOR 89-5--460 89-1
 CLEAN ROOM SPILL
 ENERGY TRACE AND BARRIER FAILURE ANALYSIS

BARRIER FAILURE
